**ASSESSING TREE HEALTH AND SPECIES IN THE GENTRIFYING  
NEIGHBOURHOOD OF THE JUNCTION TRIANGLE IN TORONTO, ONTARIO**

A thesis

Master of Applied Science

Toronto, Ontario, Canada, 2018

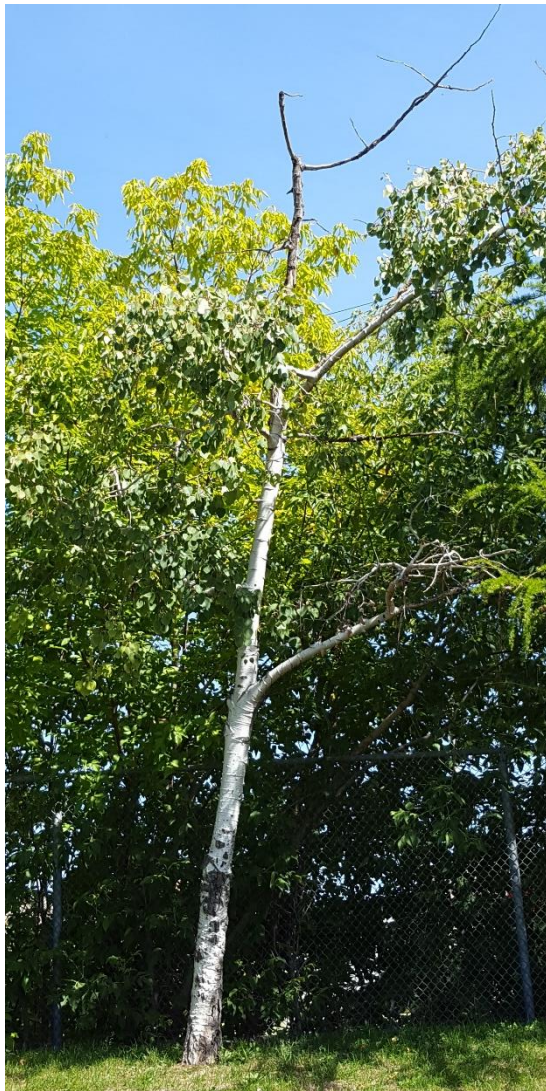
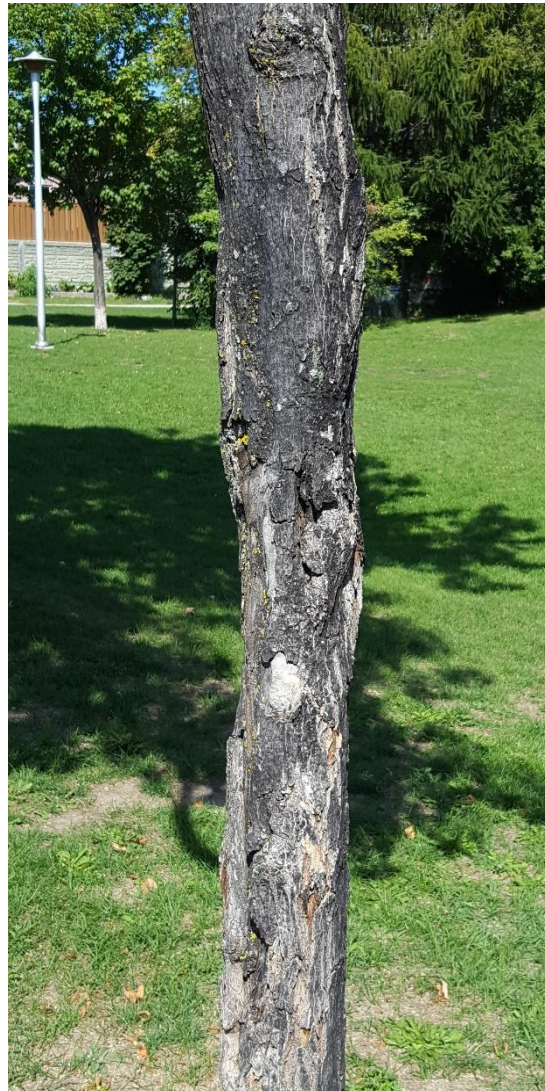
As shown in Table 13, the mean condition rating for trees located in parks is 2.07. Higher condition ratings represent poor health, and this rating is the worst average rating among all areas of land within the study area, signifying that park trees are in very bad condition. During the inventory, no tree within the two parks were recorded to be in good condition, having a rating of 0. The poor health of these trees stems from them having multiple defects on each individual tree, the most common injuries being tree lean and cracks along the trunk. Of the 57 trees located

within parks, 33 have experienced tree lean, and 15 experienced cracks along the trunk. A tree that is leaning suggests that it has weak root systems that is not able to keep the weight of the tree balanced, while the cracks on the main stem of the tree suggests that the tree experienced mechanical damage, or is suffering from decay from fungus or pests (Albers & Hayes, 1993; Angwin et al., 2012).

Figure 9: Park trees showing extensive damage.

Both of these defects are extremely serious and hazardous, especially in parks as they may cause the tree to fail and harm those in the vicinity of the tree. Furthermore, trees in poor
