# **LOW VELOCITY IMPACT ASSESSMENT OF A CARBON FIBER BICYCLE WHEEL**

A thesis

Master of Applied Science

in the program of  
Aerospace Engineering

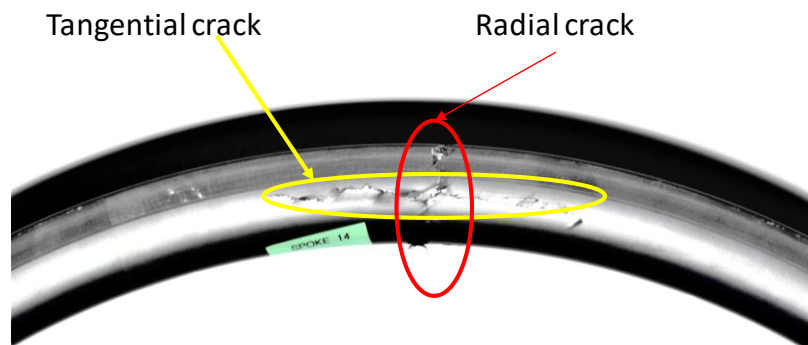
**Figure 2 - Fractured carbon fiber wheel**

An industry partner was observing from the design and manufacturing of its high-performance bicycle wheels, impact related damage during field use. The wheels are composed of aerospace grade carbon fiber laminates (T700/YPH200) and designed for professional racing. Figure 2 shows a wheel specimen provided by the industry partner in which the rim has fractures propagating radially from the top of the rim to the bottom, and tangentially across the rim.

These cracks would be unsafe during a ride as there is a high chance of a catastrophic failure leading to injury. The company did not understand the cause and the origin of these impact failures which may be due to several parameters, such as wheel design, material and manufacturing process used. Therefore, the main objective of this research project is to evaluate the impact performance of this composite wheel and provide recommendation for design improvement to the company. Specifically, this study will focus on low velocity/low energy impact loading of a single bicycle rim design under different wheel configurations. The impact tests will be performed on the same rim design with eight different variations with respect to spoke tension, the number of spokes, and the impact location. The impact performance of the composite rim is evaluated based on its energy absorbing capacity, maximum radial deflection, damage initiation and propagation.

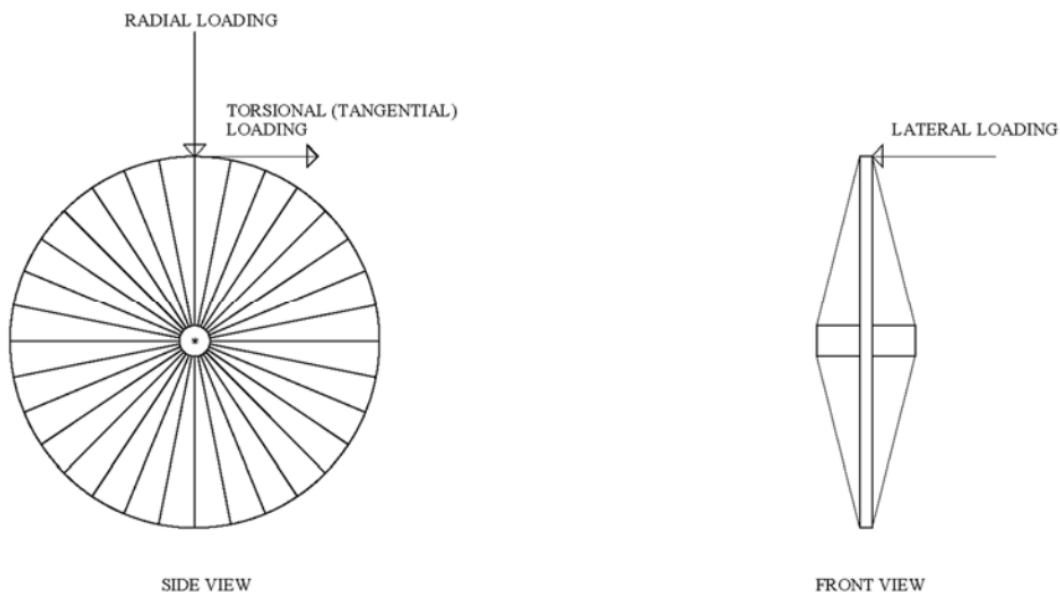
**Figure 4 - Loading types on bicycle wheel [7]**

The bicycle wheel supports a variety of static and dynamic loads. Loads including spoke tension and tire inflation are known to be static because they remain constant. Dynamic loads can be applied laterally, tangentially, and radially. The weight of the cyclist, frame, and the flatness of the road cause radial loads as it displaces the portion of the rim in contact with the ground towards the hub [8]. Impact loading such as jumps, and uneven terrain can create high radial and lateral forces resulting in large spoke deformation. Tangential or torsional loads can occur through braking or in the rear wheel with the chain turning the sprockets. Road friction can also cause tangential loading.

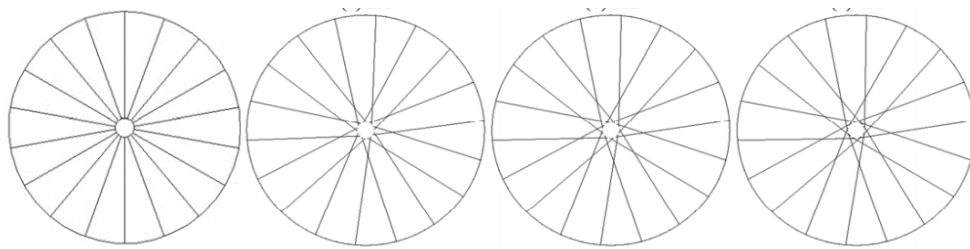
**Figure 5 - Spoke lacing patterns ( left to right: Radial, 2X, 3X, 4X) [7]**

Conventional wheel building is the process of selecting the best components and configuration for the specific application. After designing the rim, the number of spokes, spoke tension and spoke pattern need to be defined while ensuring compatibility with off-the-shelf hubs. The different spoke patterns provide a trade-off between radial strength and tangential strength. The most common spoke patterns are radial, 1X, 2X, 3X, and 4X. In general, the more crosses result in higher tangential strength [7]. A cross is the number of times a spoke crosses over another spoke and can be achieved by ensuring the spoke is installed on a hub spoke hole that is not radially in line with the rim spoke hole. The radial pattern should never be used for a rear wheel as it has no support for tangential loading, however it can be used on front wheels to provide high impact resistance [7].

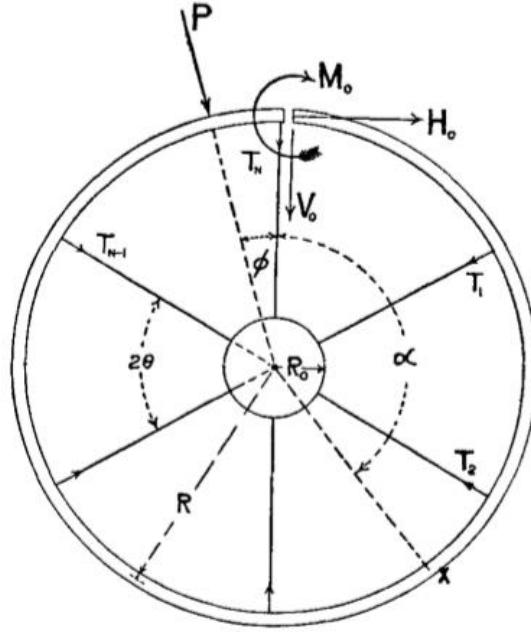
**Figure 6 - Bicycle wheel free body diagram [9]**

rim section have a bending moment ( $M_0$ ), a tangential force ( $H_0$ ), and a radial shear ( $V_0$ ). The strain energy theorem can then be applied to find a static equilibrium and solve for the associated stresses.

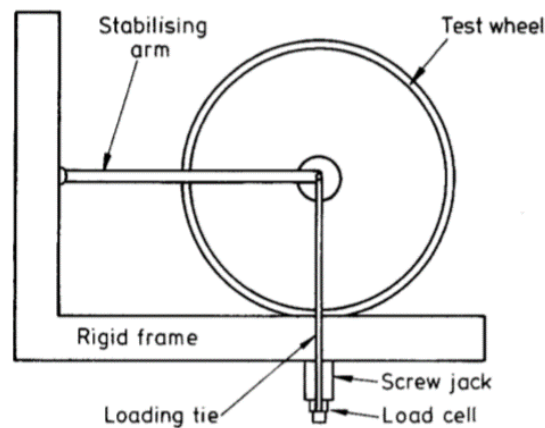
**Figure 7 - Burgoyne static load test setup [4]**

Burgoyne and Dilmaghanian [4] tested Pippard’s theories and validated Whitt et al. [8] observation by demonstrating how pre-stressing was the key element in building an efficient bicycle wheel. They did a variety of tests in which they instrumented 4 spokes and monitored its strain as the wheel revolved. The setup consisted of the wheel attached to a rigid frame, through a horizontal stabilizing arm attached to its hub axle. A loading tie was also connected to the axle vertically and the applied load was adjusted with a screw jack. Figure 8 below illustrates the custom setup in this test.

Burgoyne et al. [4] proved that Pippard's analysis was valid for the case of the bare rim and proved the models of a straight beam rested on a uniformly distributed elastic foundation was in good agreement, and thus could work as a simplified approximation. In this test the influence of the tire was apparent as the peak stress on the spoke was reduced. By assuming a uniformly distributed applied load over a short length, the influence of the tire could be accurately modeled.

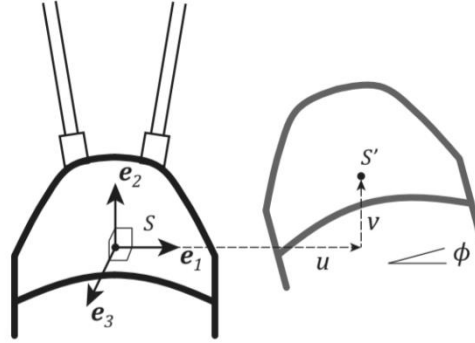
**Figure 8 –Rim displacement [13]**

Ford extends that the accepted models of radial deflection are limited as they do not consider the lateral and torsional reactions of the spokes or rim cross section [13]. By redefining rim displacement (Figure 8), into the rim is subject to in-plane bending ( $v$ ), out-of-plane bending ( $u$ ), and twist ( $\phi$ ) [13]. The rim is modeled initially as a circular beam with a constant cross-section, where the shear center and centroid coincide. Ford concludes that knowledge of stress distribution under large loads could reveal how plastic deformation and buckling occurs [13].

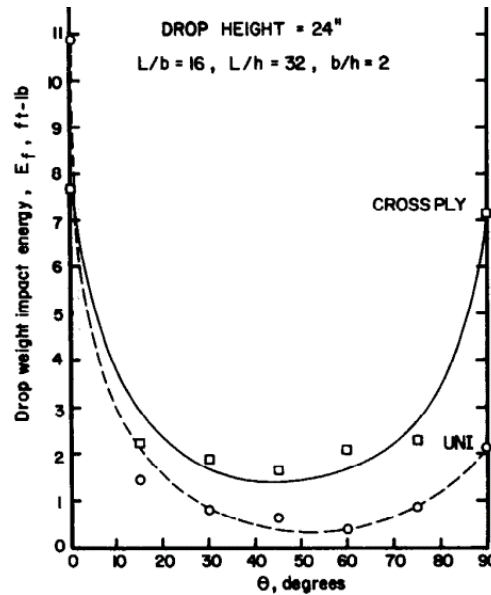
**Figure 10 - Impact energy threshold vs ply angle [18]**

Fiber orientations can influence composite failure threshold as it they can change which mode of failure is activated first. Figure 10 illustrates the out of plane energy threshold of a glass epoxy laminate, using unidirectional and cross-ply laminates. As the angle of the unidirectional and in-between the angle-ply changes, the activation threshold does as well. It can be observed from this study a 60-degree unidirectional laminate recorded the lowest impact energy threshold.

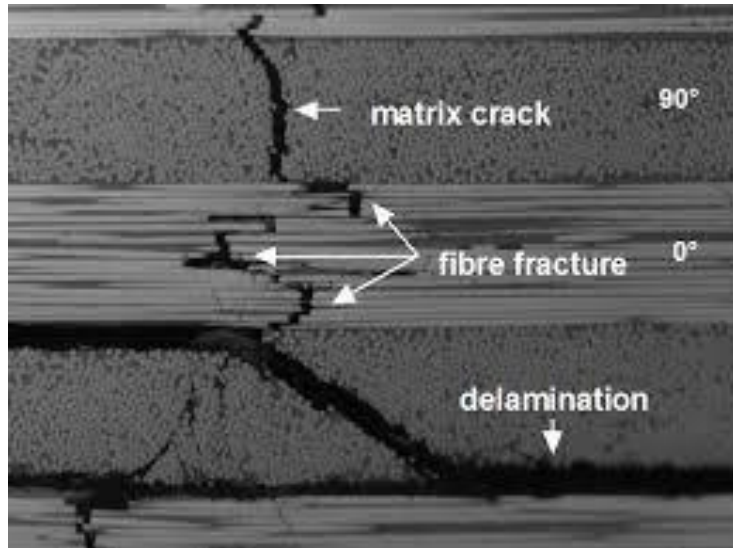
**Figure 11 - SEM image of prominent CFRP failure mechanisms [20]**

There are 5 major impact low velocity damage failure modes in a composite material. They include delamination, fiber fracture, matrix fracture, fiber debonding and fiber pullout. The summation of the failure modes involved in the fracture process account for the total energy absorbed during impact.

Fibre breakage (Figure 11) or fracture occurs when the fiber strain exceeds its maximum strain threshold. The crack that forms is perpendicular to the direction of which they align. Upon impact loading, fiber breakage usually occurs at the back face of the composite, where the face experiences its highest tensile stresses [15]. Generally, amongst the failure modes, fibre breakage accounts for a small amount portion of the total damage.

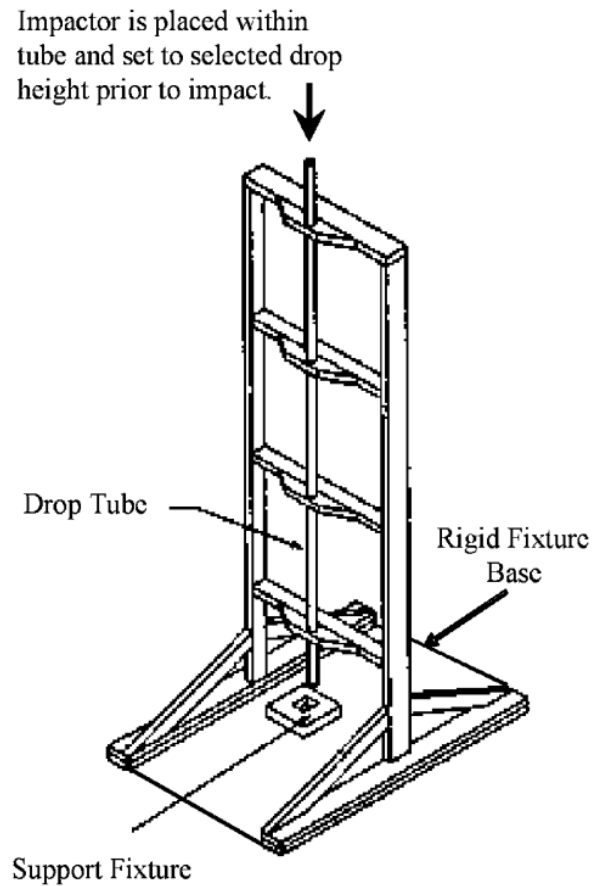
**Figure 12 - Impact drop test ASTM D7136 [21]**

impacts do not occur. The mass and height of the falling weight are adjustable and are set to achieve desired impact velocity.

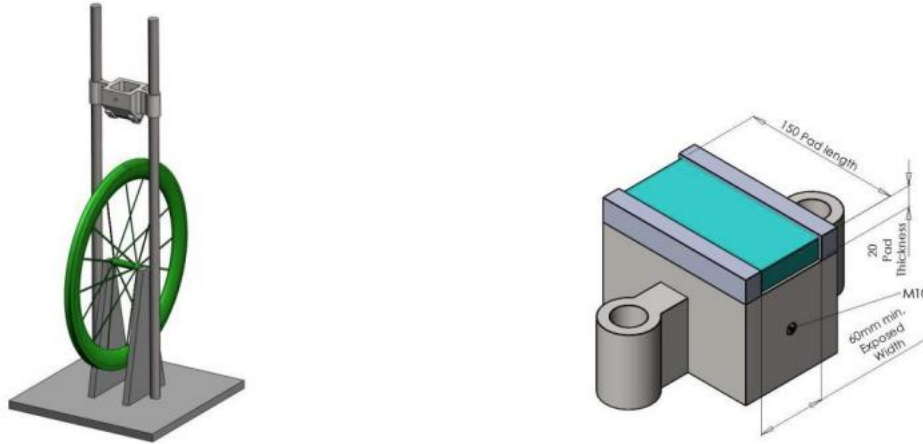
**Figure 13 - UCI Wheel impact tester sample design [22]**

The UCI cycling body (Union Cycliste Internationale) has a wheel impact test for qualifying new wheel designs. In this test, a drop test impactor is required with a weight of 6-10 kg and dropped at a starting energy of 40 J. The impactor shall have a flat steel anvil with an impact surface covered with a 20 mm thick rubber pad of hardness shore A50, and compression set 40% [22].

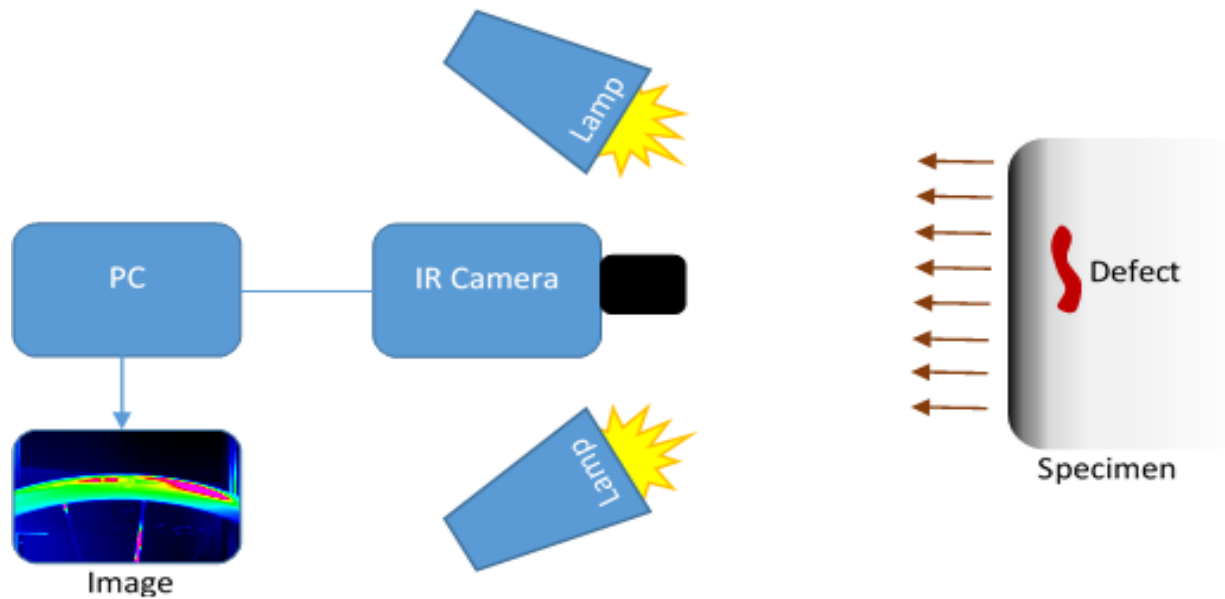
**Figure 14 – IR thermography setup**

IR camera which provides live monitoring of the surface of the specimen under test. And a data acquisition system to store the data and allow processing.

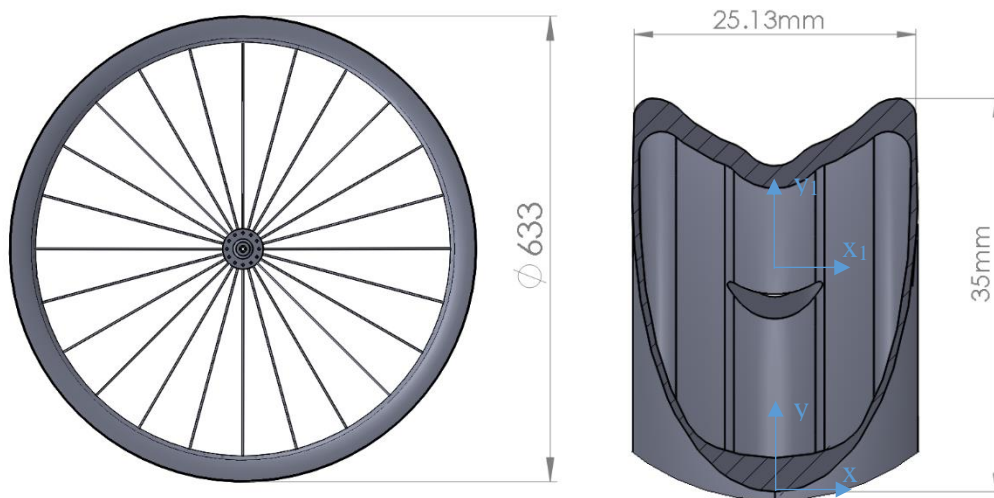
**Figure 16 – Size and cross section of wheel under test**

The wheel that is being used in this test is a tubular racing wheel. A tubular rim differs from a classic bicycle clincher rim, in which the top of the rim is enclosed whereas the clincher rim has overhangs that constrain the tire from getting loose. The tubular tire and casing are sewn together and glued onto the surface of the rim. The rim has a semi-deep cross-section which provides performance advantages such as increased aerodynamic efficiency, and a greater moment of inertia which adds structural rigidity [5]. The deeper cross section also offsets the need of additional spokes, helping to reduce weight [5]. Figure 16 highlights the physical specifications of the wheel. Table 1 lists the physical specifications of the wheel.

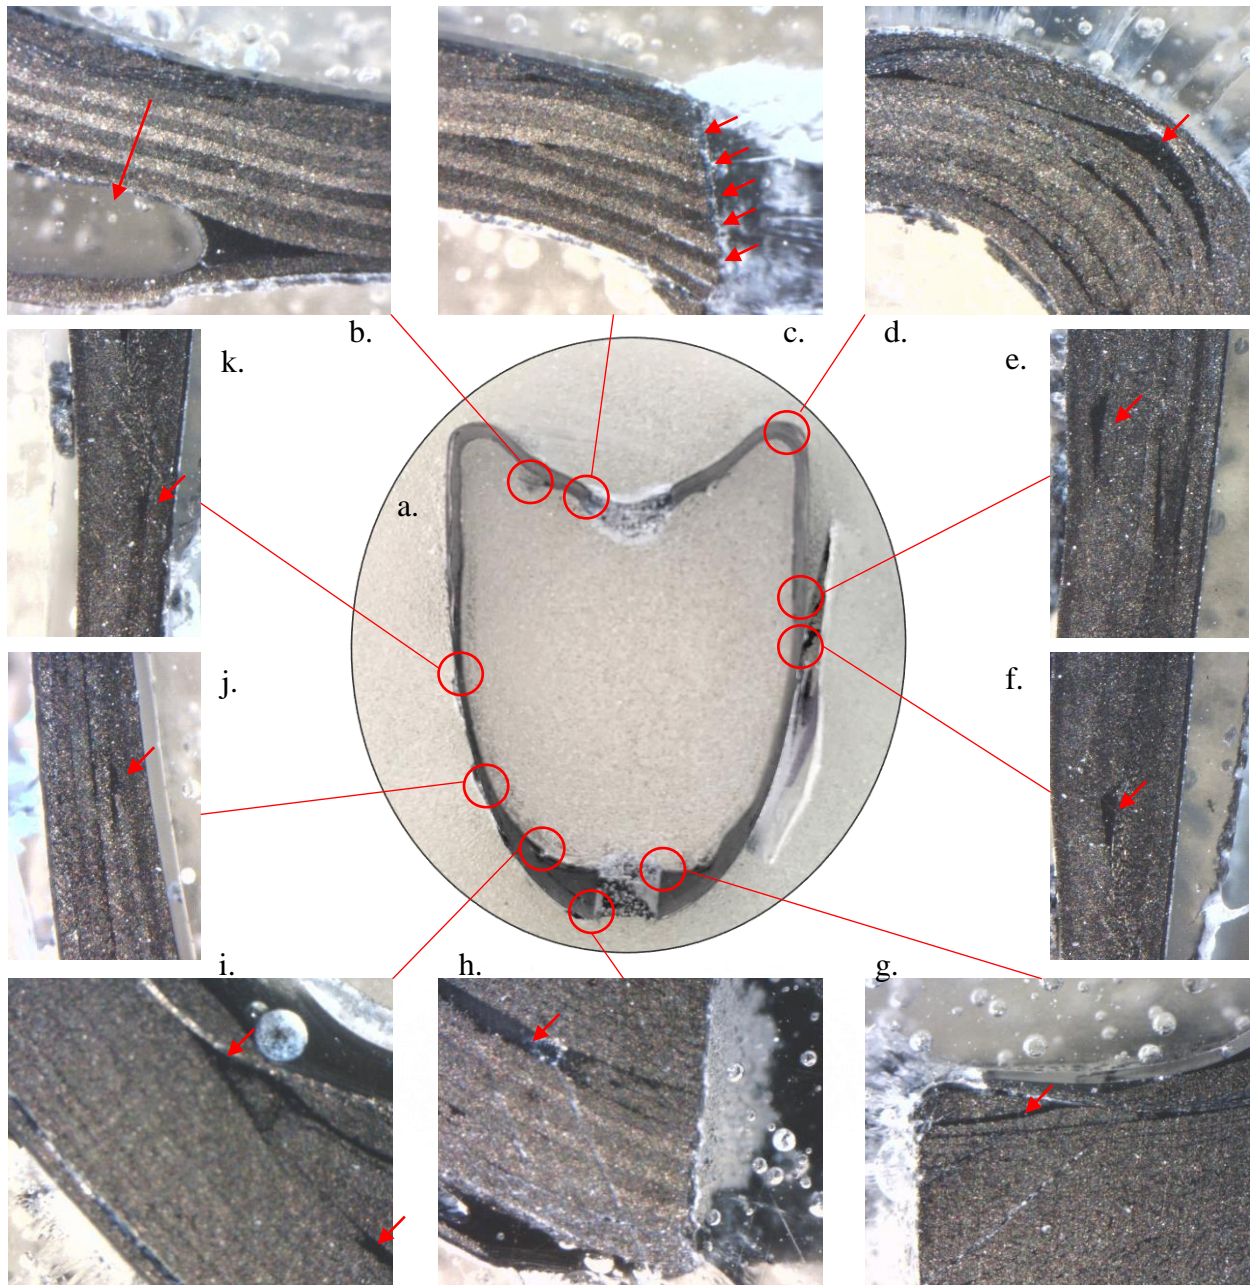
**Figure 18 – Optical inspection of manufactured wheel cross section – (a) wheel cross section (b) top delamination (c) top wavy fibers and hole edge (d) wavy fibers and resin rich areas at top left corner (e) ply tapering and resin rich area – R2 (f) ply tapering and resin rich area – R3 (g) top of right bottom hole edge with micro cracks (h) bottom of left bottom hole edge with resin rich areas and delamination (i) delamination at L5 (j) new ply introduction at L5 (k) ply tapering and resin rich area – R4**

In Figure 18a, the cross section of the wheel is shown. Figure 18b shows a separation between the bottom most layer and the rest of the top section. This problem raises concerns over the fit of the internal bladder mold and the curing settings of the manufacturing process. Figure 18c highlights the edge of the spoke installation hole. Holes are stress releases and can initiate cracks. The addition of layer 11 can also be seen with an acceptable resin pocket. In Figure 18d, the top right corner shows larger degree of layer separation and resin rich areas. The layer also seems to have shifted from its intended location, TR, into TR1. Figures 18e,f,j and k show the ply tapering features of sections L2, L3 and R5, R4 respectively. Figures 18g and 18h, show the top and bottom sections of the spoke nipple mount area on the rim cross section. The edges here are rough, and some ply separation can be seen. This is another area susceptible for crack initiation. Figure 18i shows the junction where the weave and layer 19/20 are introduced.

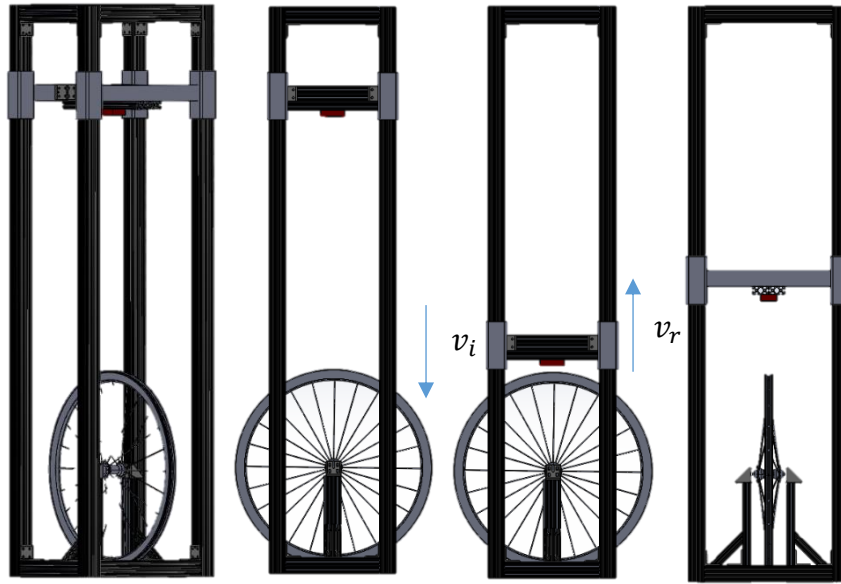
Figure 19 - Impact test design

Although there is no standard protocol for performing a low velocity impact test on a bicycle wheel, the UCI impact test and the ASTM-D7136 can be used as a reference for the design of the apparatus. Since, the university does not have access to one, an impact test machine was designed and manufactured to perform the low velocity impacts and with the capabilities of impacting the wheels to failure. This apparatus allows one to evaluate how much impact energy needs to be introduced to activate the damage mechanisms of the carbon fiber rim. The design of the apparatus is shown in Figure 19.

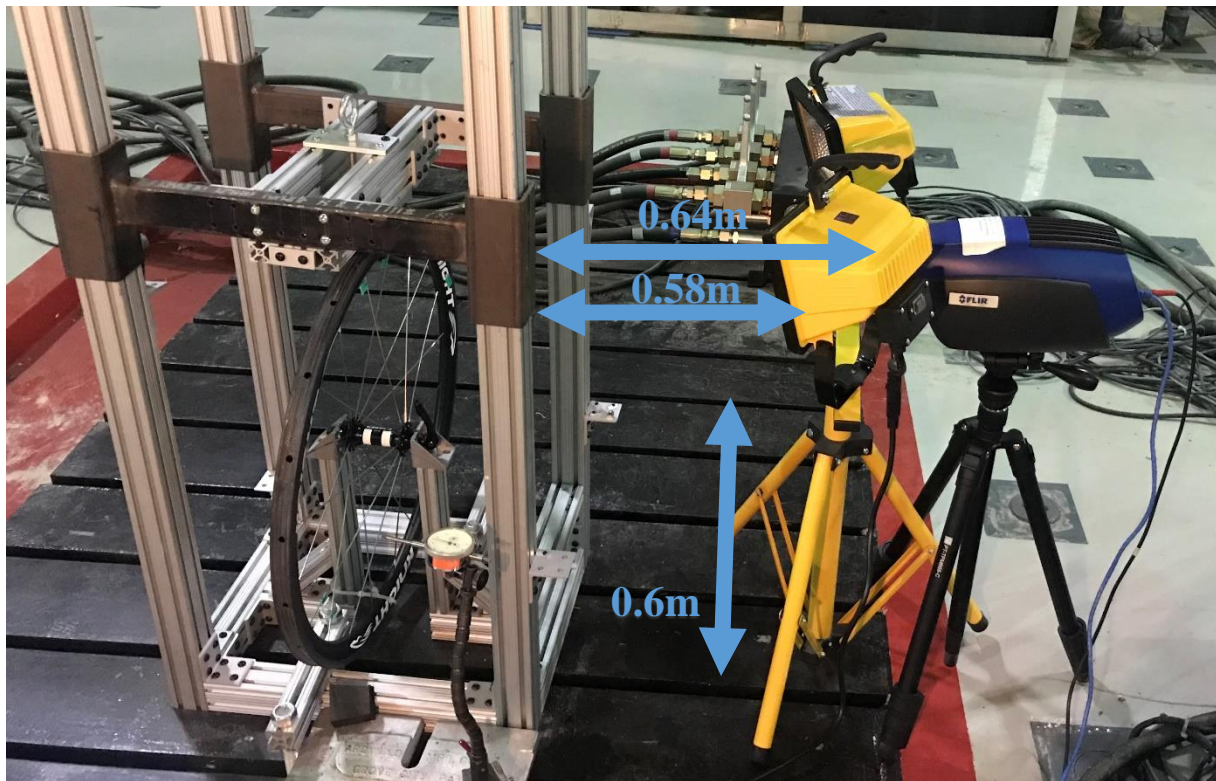
**Figure 20 – FLIR SC5000 and halogen lamps setup**

The IR camera is on a tripod 0.64 meter away from the rim and at a height of 0.5 meter. The purpose of the IR camera is to monitor the impact event by monitoring the heat dissipation of the impact on the surface of the rim. If there is a sudden increase in temperature, the progression of the damage can be observed. The FLIR Research IR software [41] is used to record the event at the frame rate of 173 frames per second. Using post-processing techniques, the IR camera can also be used to evaluate the structure for internal and barely visible damages. By importing the file into Matlab [42], and applying an image processing algorithm using principle component thermography (PCT), pre and post processing for NDE can be performed. The halogen lamps are used to heat up the surface of the rim for NDE.

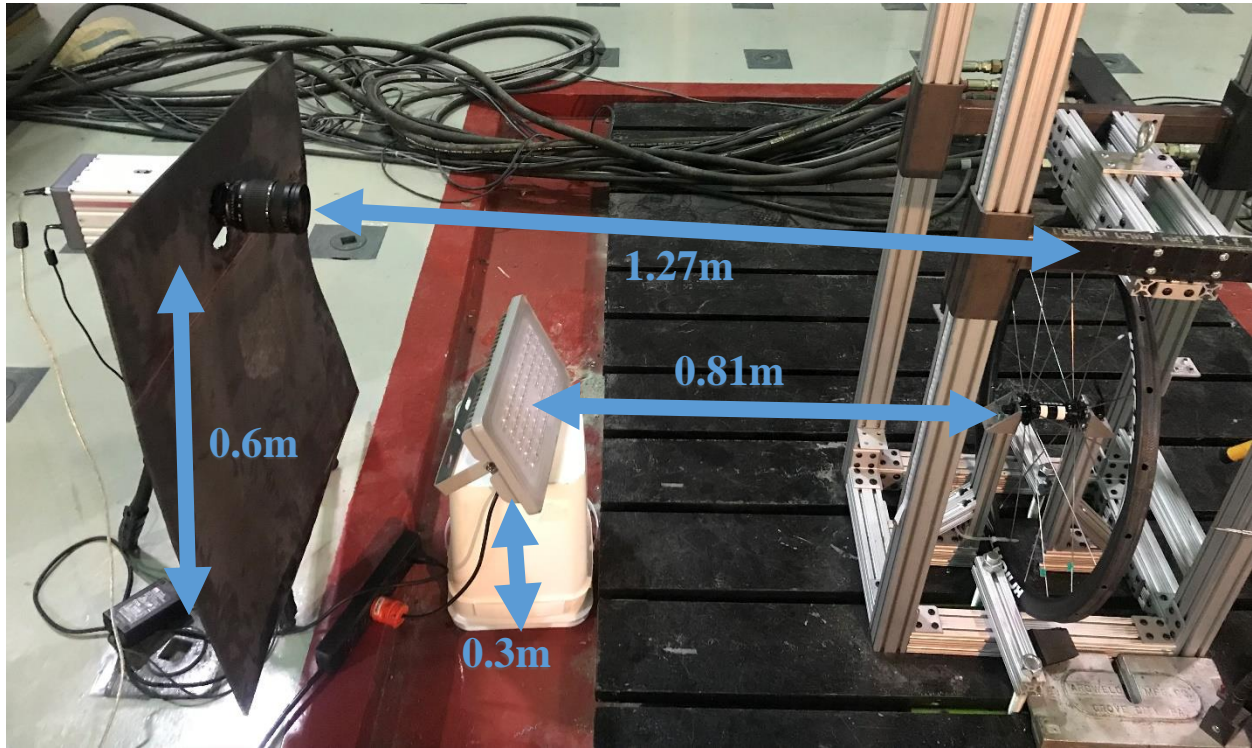
**Figure 21 – High speed camera and LED illumination setup**

to the lighting conditions. This frequency creates 2.0 ms timestamps, which has the resolution to capture the low velocity impacts. The IDT MotionStudio x64 video acquisition software was used to collect the recordings. An onscreen ruler calibrated with the measuring tape on the pillar was used to measure the displacements of the impactor and rim across each frame.

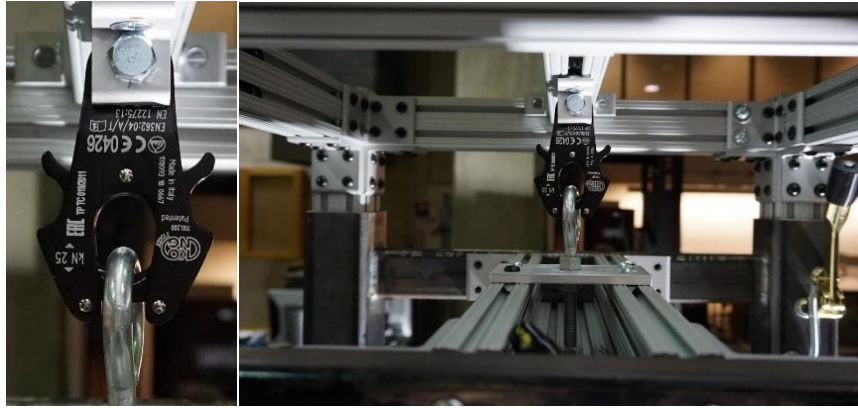
**Figure 22 – Double caliper quick release**

The impactor is held by an eye bolt hung on a double caliper quick release mechanism. This clip ensures that when the impactor is released, it falls straight minimizing the potential of friction between the guide rails and slides. The Kong quick release has a load bearing capability of 25 kN.

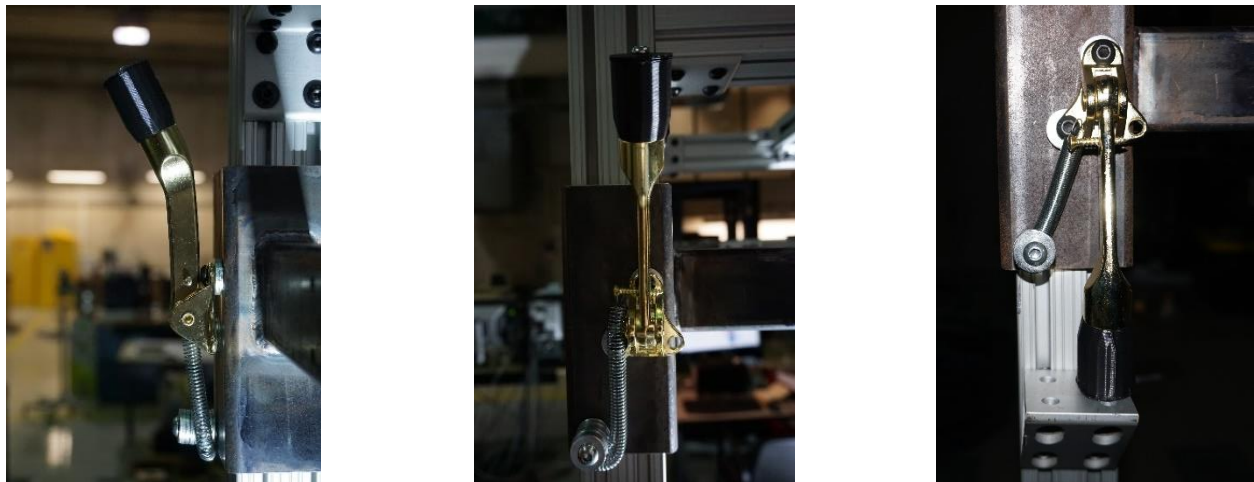
**Figure 23 – Spring loaded impactor stop (a) side (b) front pre-impact position (c) front post-impact position**

After the impact, it is necessary for the wheel to be guarded so that a secondary hit on the wheel from the impactor does not occur. For this a stopping mechanism was designed and installed. This mechanism consists of a spring-loaded stopper. Before impact, the stopper is in a loaded vertical up position. After impact, the sudden change in momentum releases the stopper into the vertical down position. As the impactor is settling post rebound, the length of the stopper ensures it rests on a suspended platform from the frame. This ensures that the impactor is physically constrained from hitting the wheel a second time.

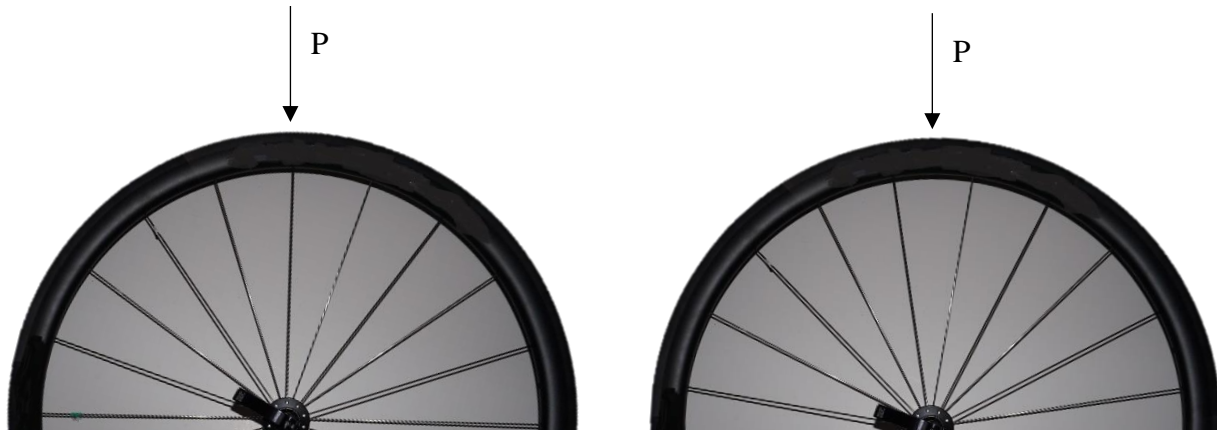
**Figure 25 – Loading locations for impact test**

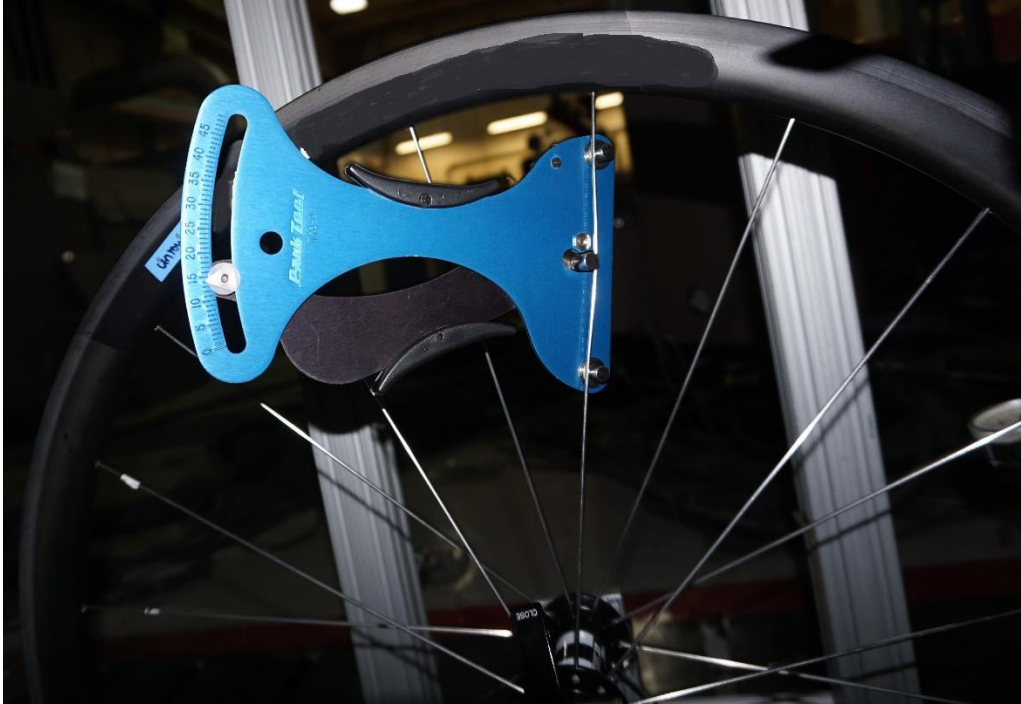
**Figure 26 – Spoke tensionmeter reading**

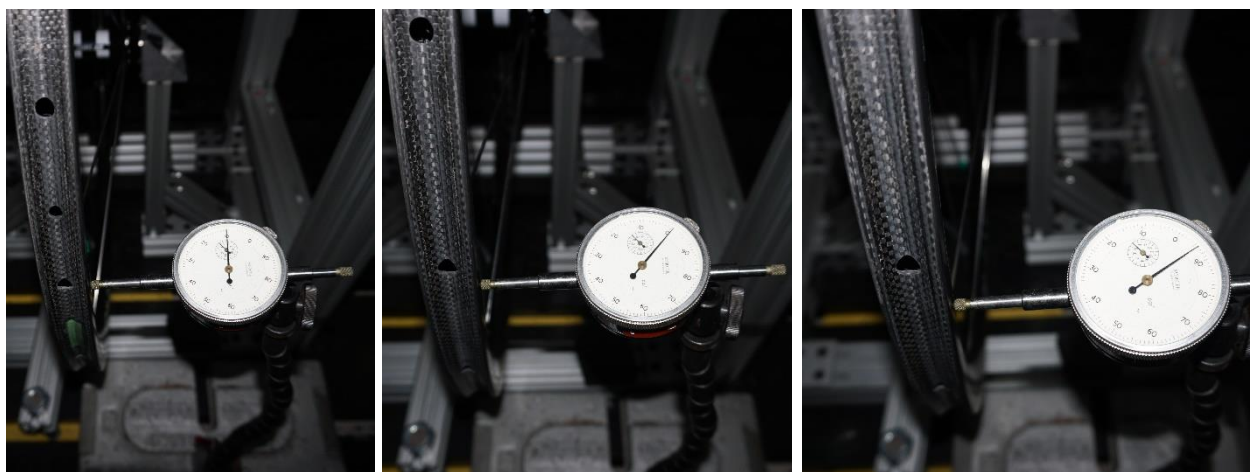
**Figure 27 - Wheel truing dial gage (a) left true (b) center true (c) right true**

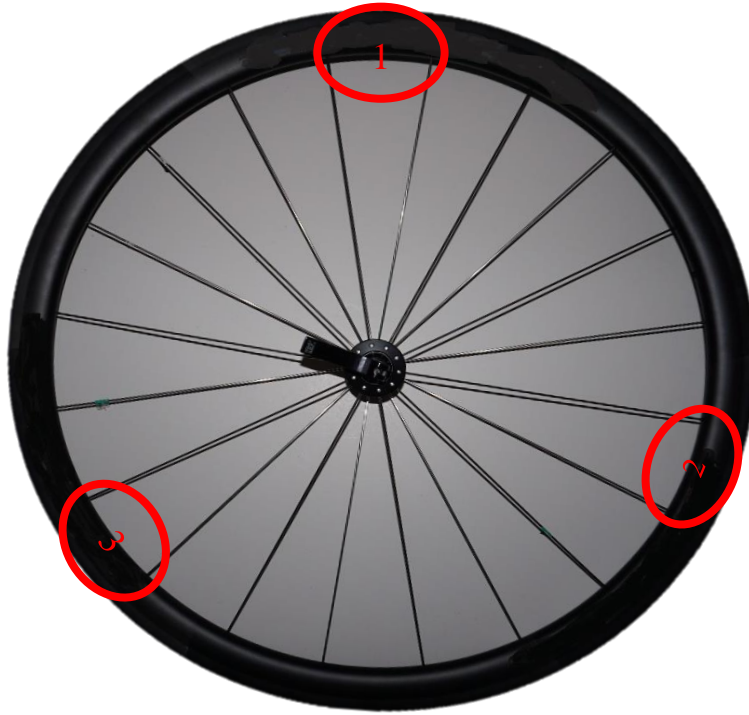
**Figure 28 – Impact locations on wheel under test**

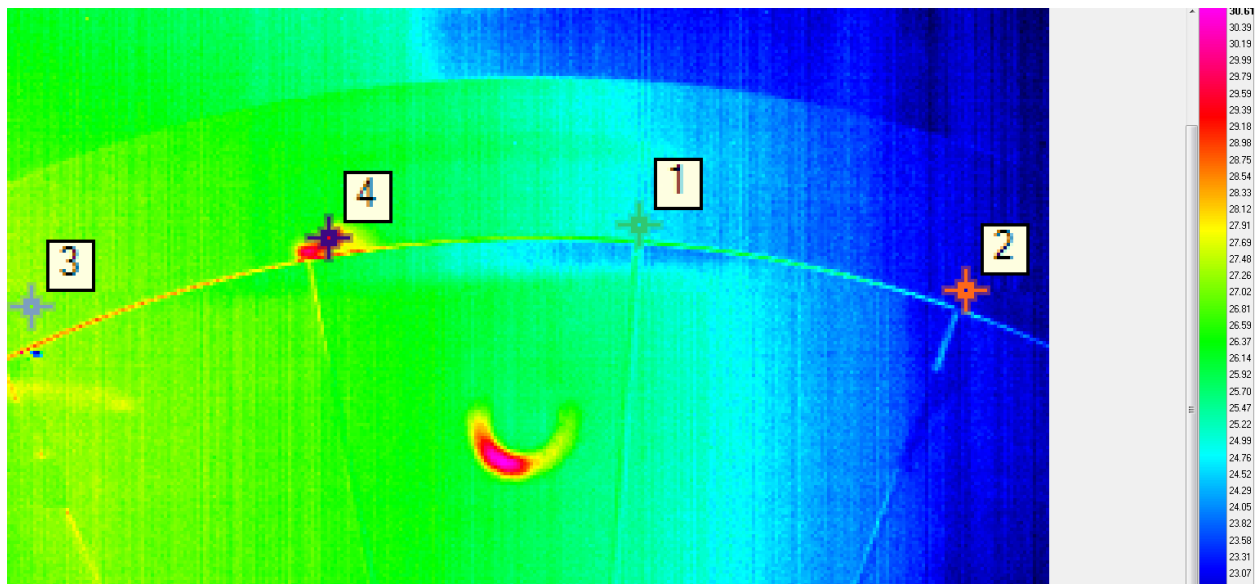
Figure 30 – IR image of test wheel

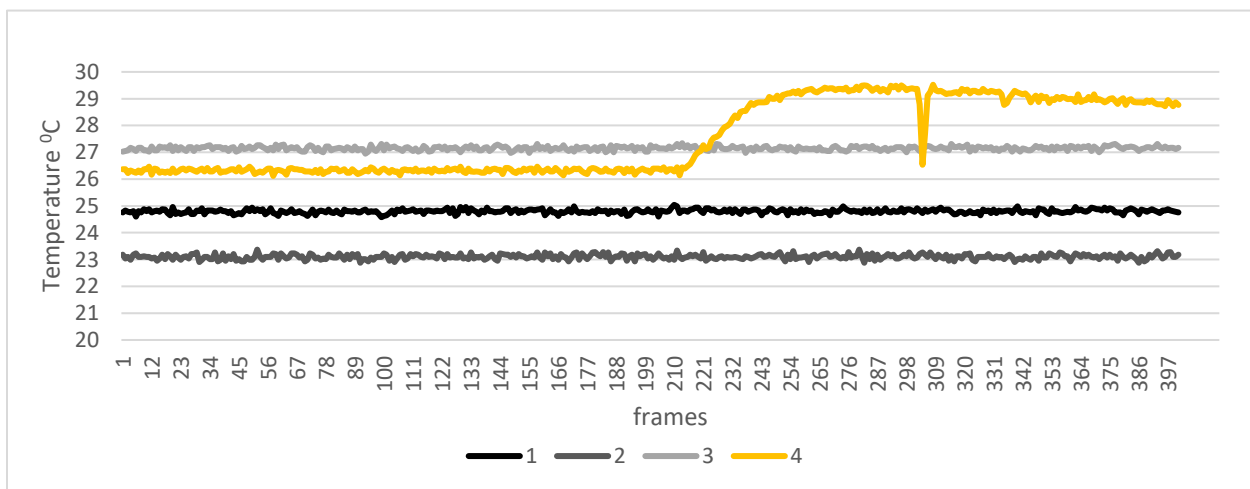
Figure 29 – Thermal monitoring of impact on wheel

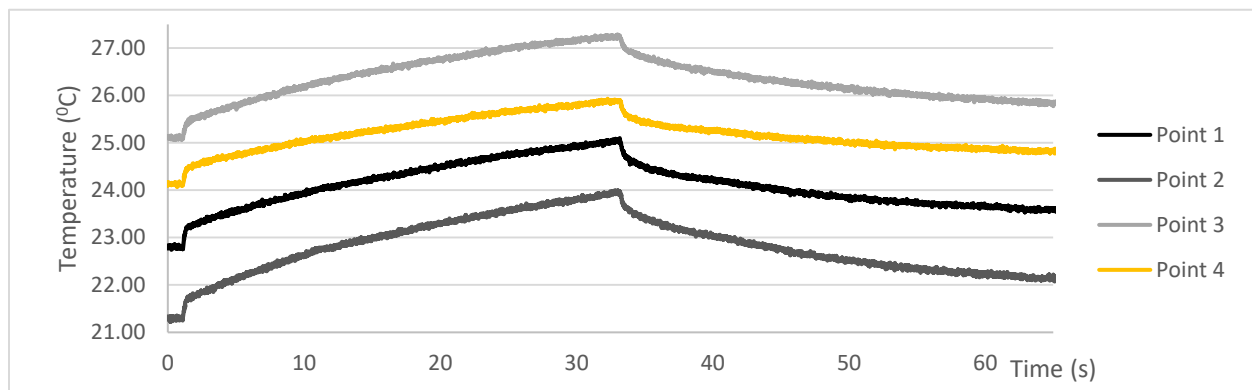
**Figure 31 - IR PCT thermal sequence of test wheel**

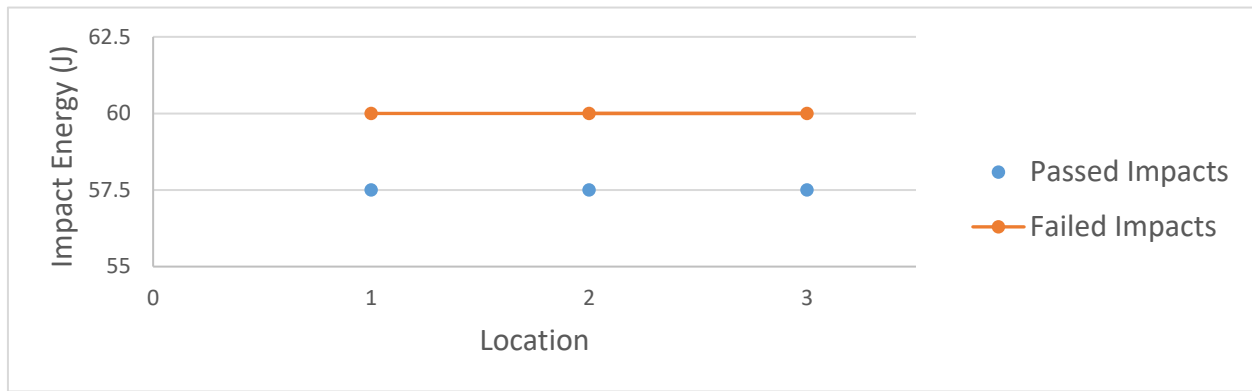
**Figure 33 - Impact results of wheel 1 - 24 spoke – high tension – in between spokes**

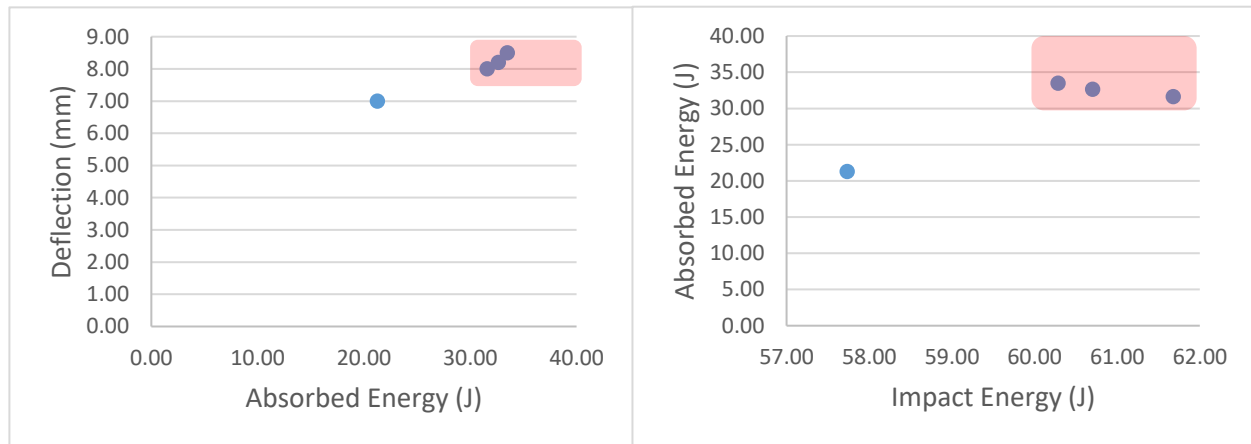
**Figure 34 - Absorbed Energy vs Radial Deflection of wheel 1**

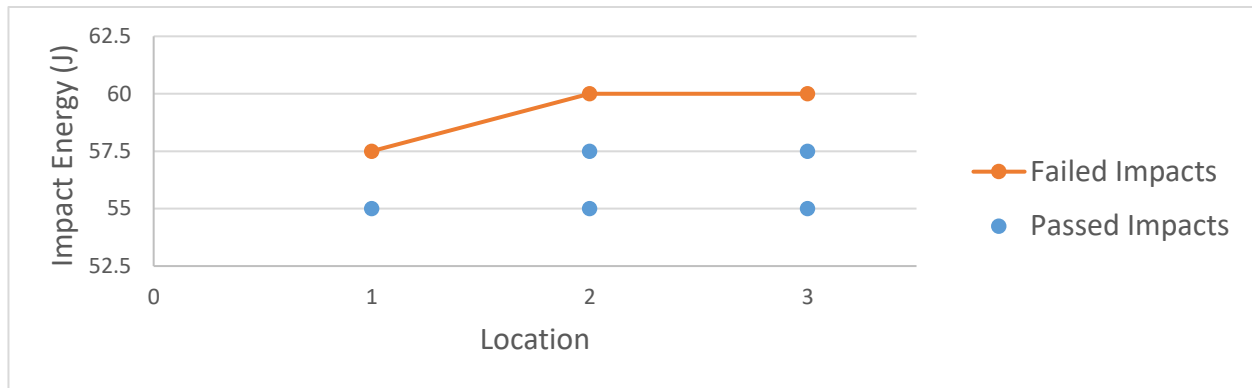
**Figure 36 - Impact results of wheel 2 - 24 spoke – low tension – in between spokes**

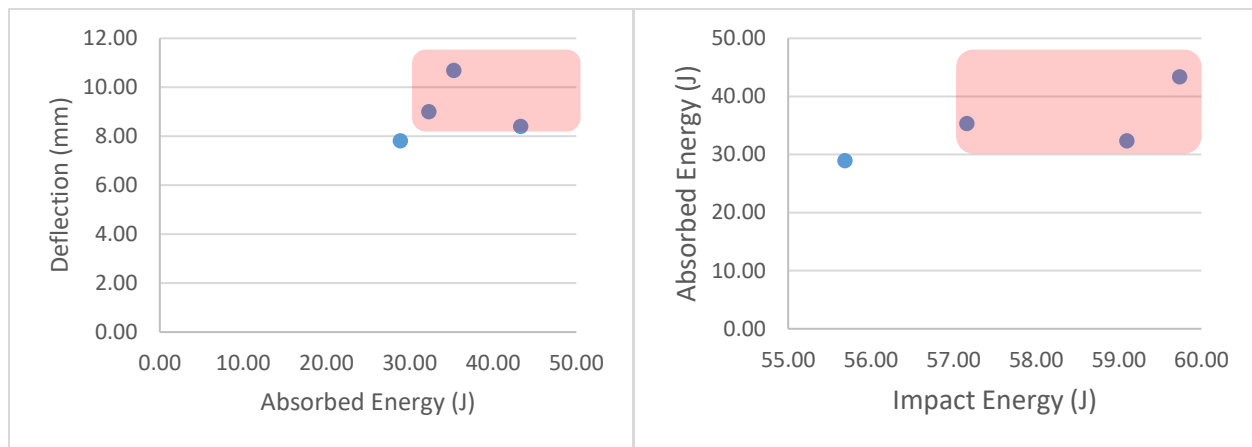
**Figure 37 - Absorbed Energy vs Radial Deflection of wheel 2**

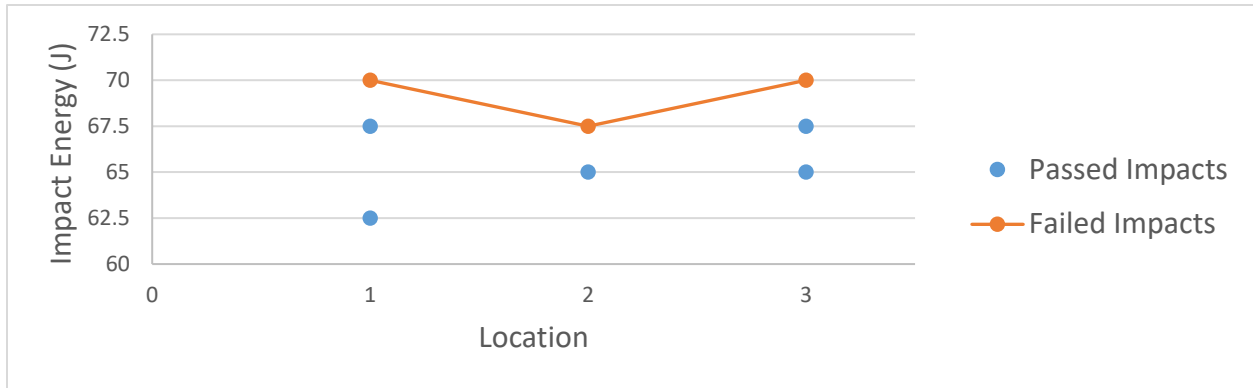
**Figure 39 - Impact results of wheel 3 - 24 spoke wheel - high tension - in line**

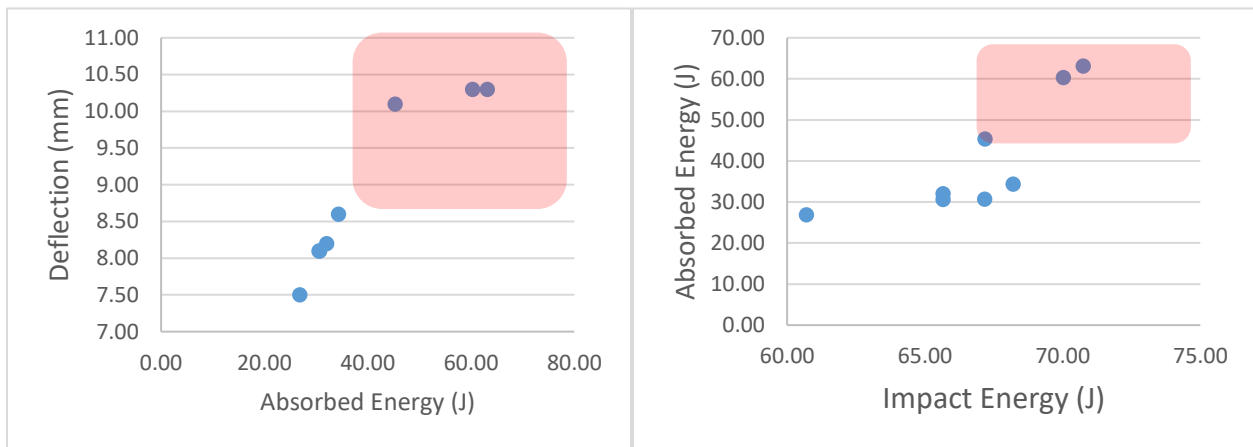
**Figure 40 - Absorbed Energy vs Radial Deflection of wheel 3**

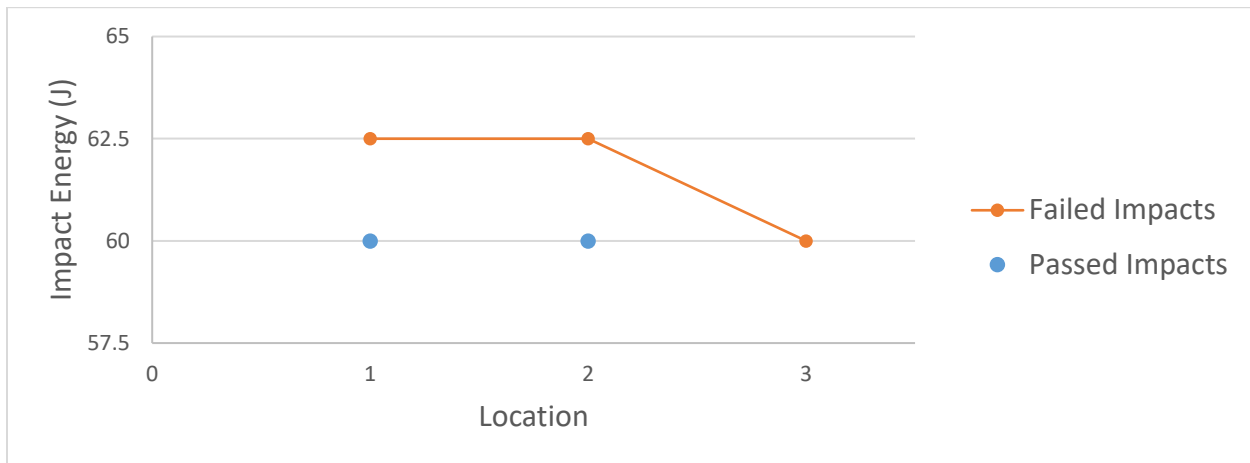
**Figure 42 – Impact results of wheel 4 – 24 spoke wheel – low tension – in line**

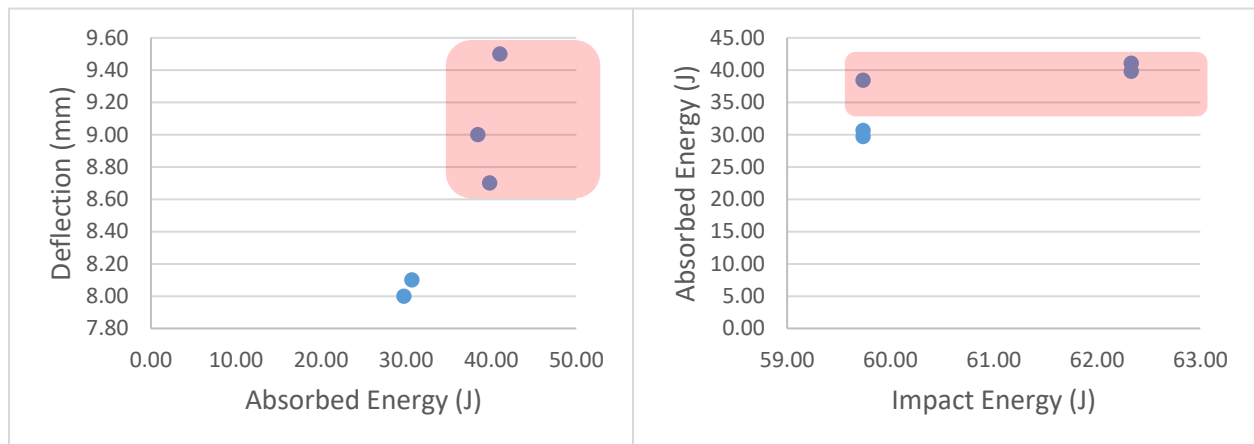
**Figure 43 - Absorbed Energy vs Radial Deflection of wheel 4**

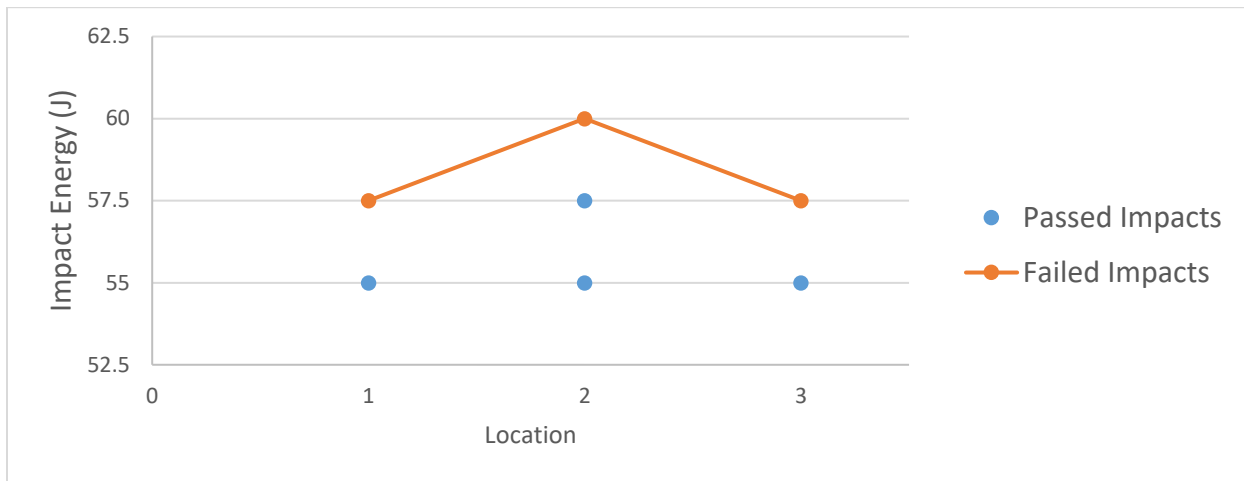
**Figure 45 - Impact results of wheel 5 - 20 spoke wheel - high tension - in between**
