# **LOW VELOCITY IMPACT ASSESSMENT OF A CARBON FIBER BICYCLE WHEEL**

A thesis

Master of Applied Science

in the program of  
Aerospace Engineering

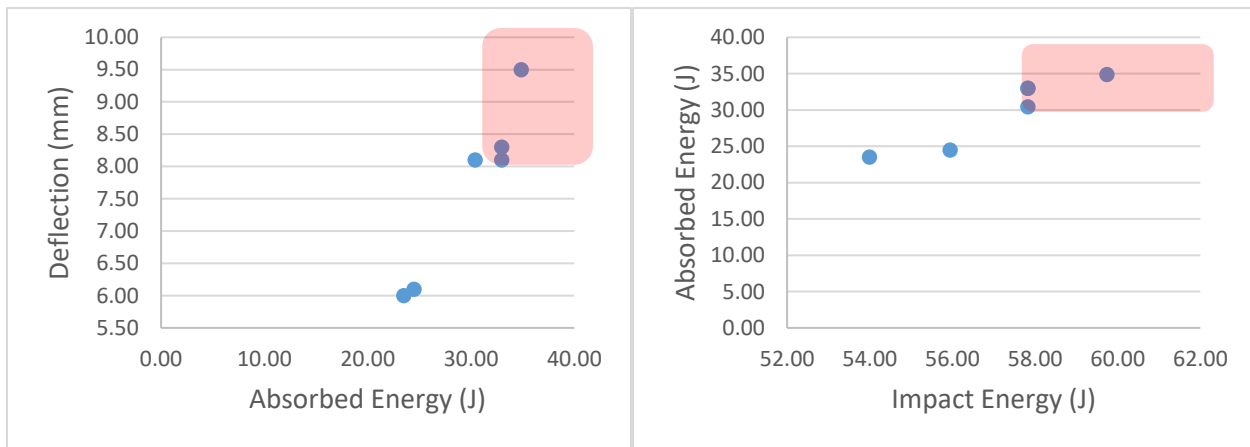
**Figure 46 – Absorbed Energy vs Radial Deflection of wheel 5**

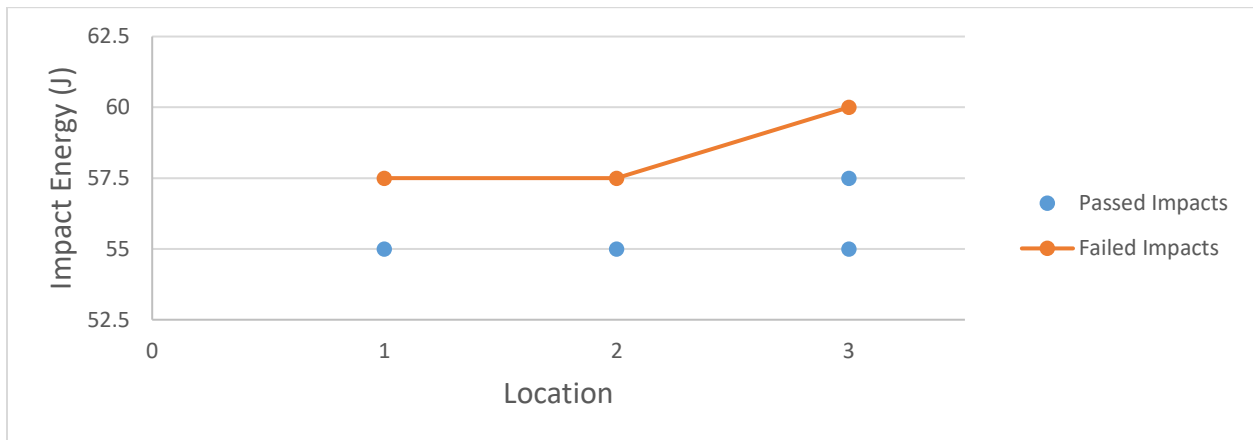
**Figure 48 - Impact results of wheel 6 - 20 spoke wheel - low tension - in between**

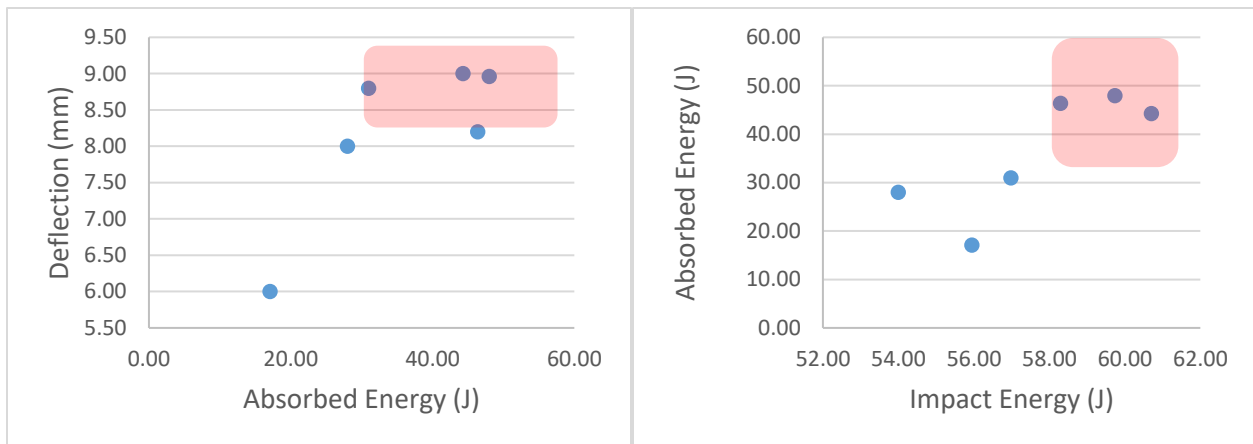
**Figure 49 - Absorbed Energy vs Radial Deflection of wheel 6**

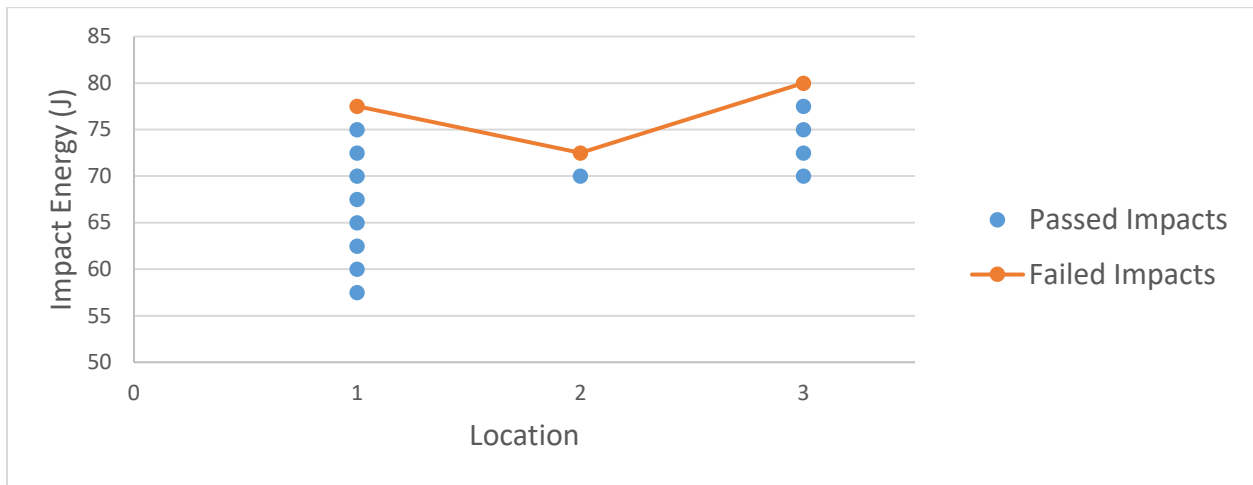
**Figure 51 - Impact results of wheel 7 - 20 spoke wheel - high tension - in line**

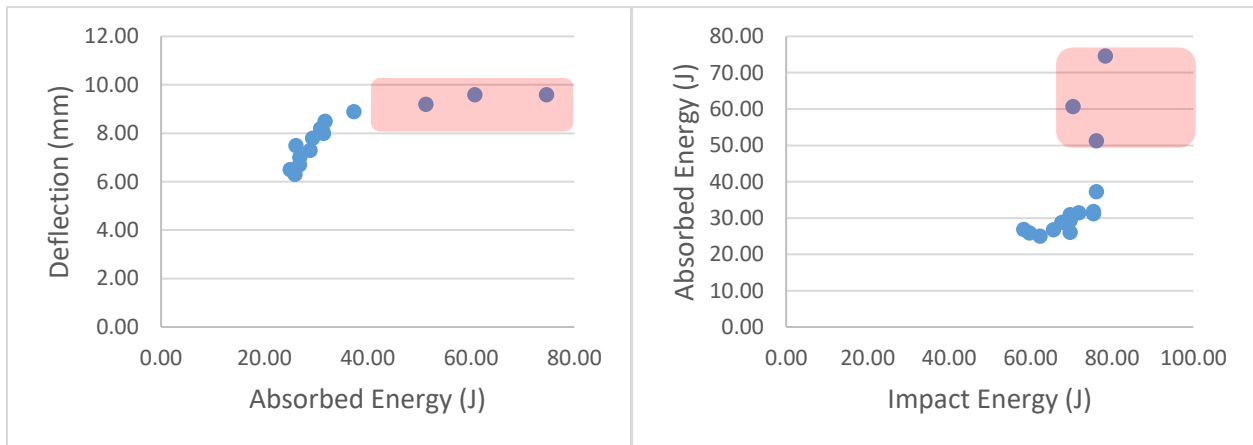
**Figure 52 -Absorbed Energy vs Radial Deflection of wheel 7**

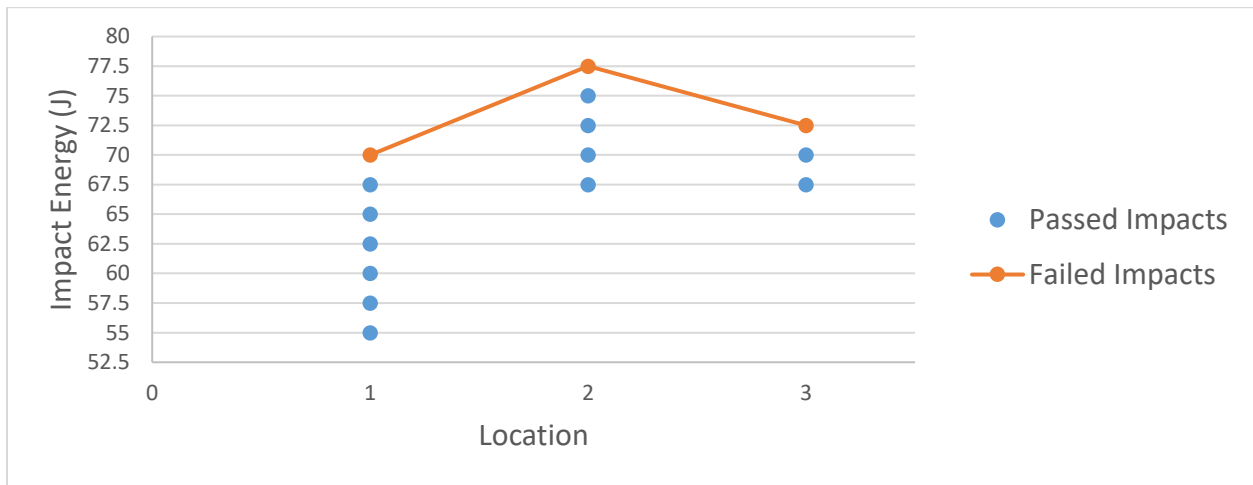
**Figure 54 - Impact results of wheel 8 - 20 spoke wheel - low tension - in line**

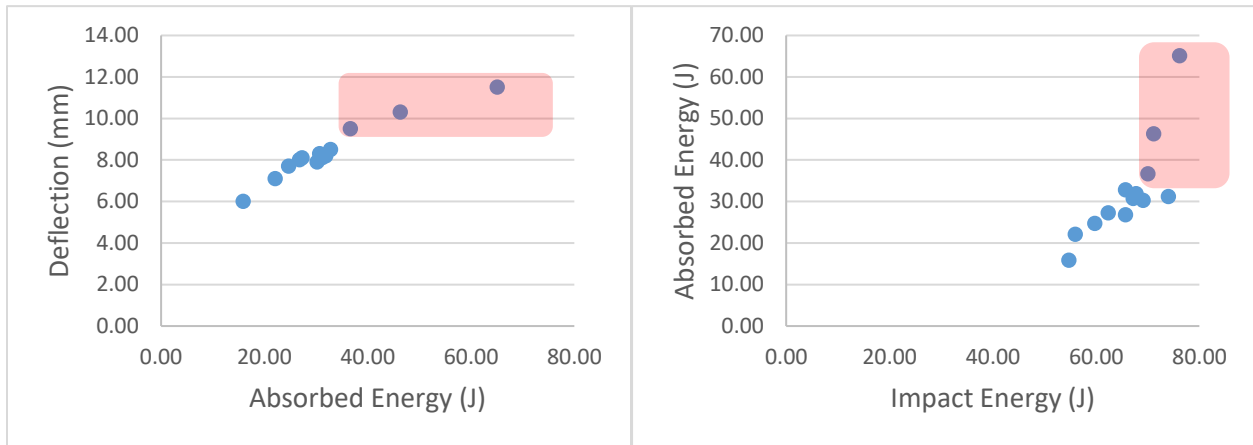
**Figure 55 - Absorbed Energy vs Radial Deflection of wheel 8**

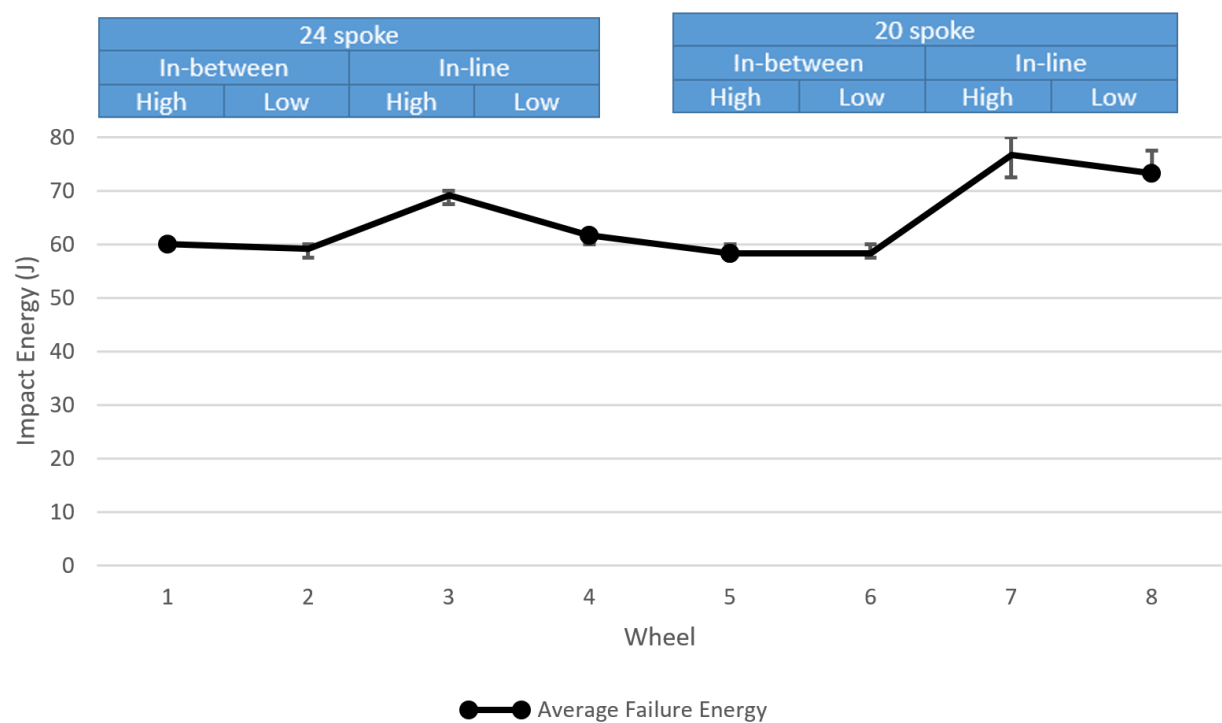
**Figure 57 - Impact test summary of all wheels**

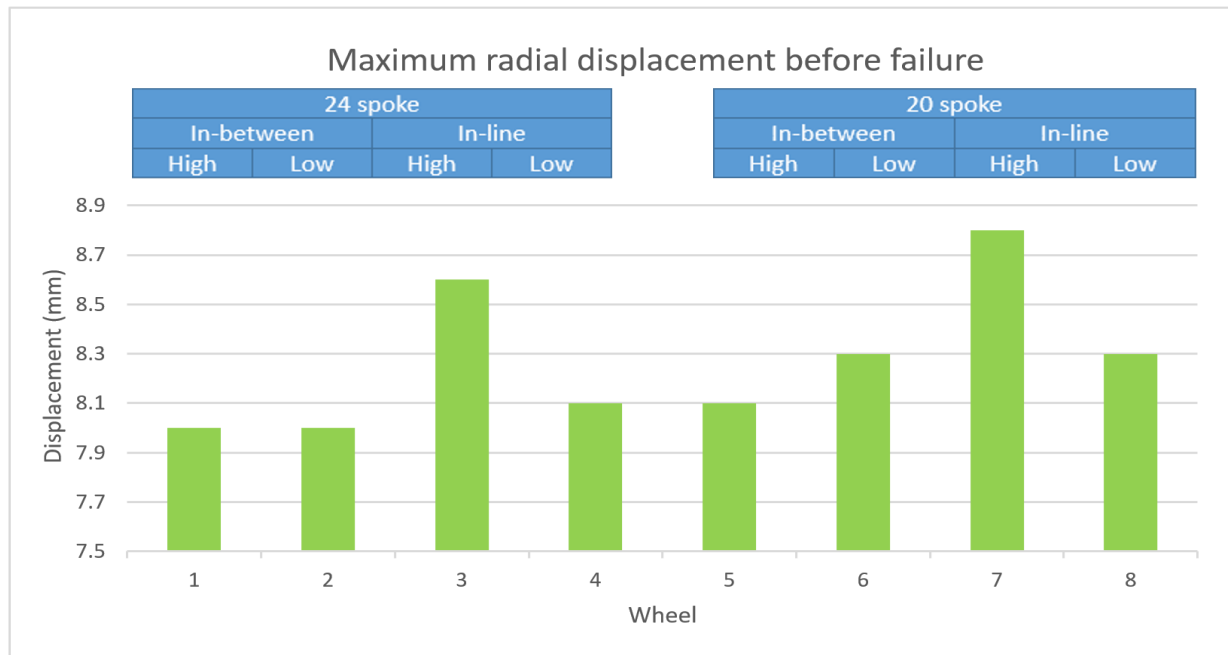
**Figure 58 - Maximum rim radial displacement before failure**

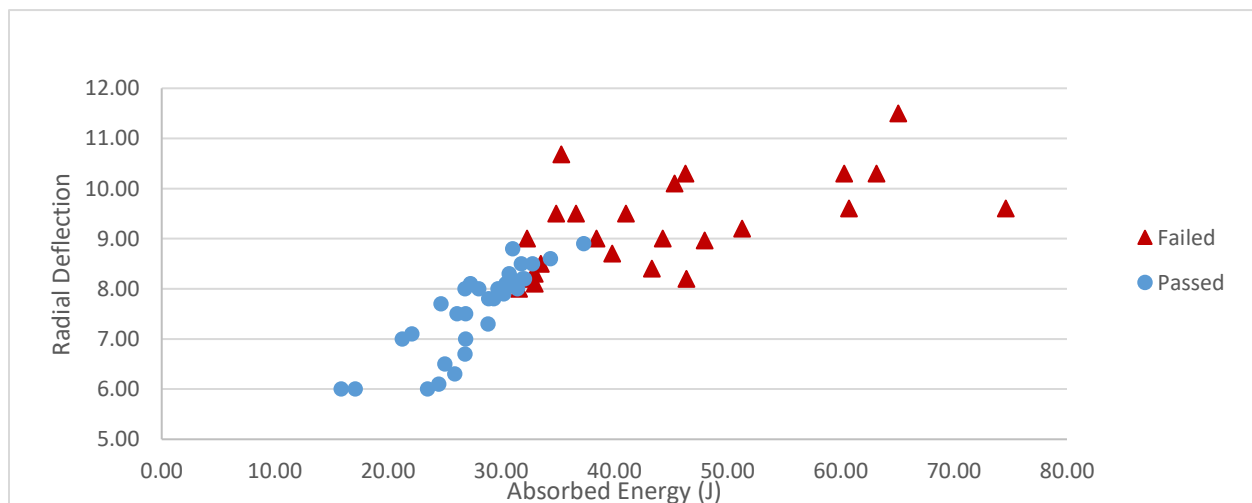
**Figure 59 - Absorbed Energy vs Radial Deflection**

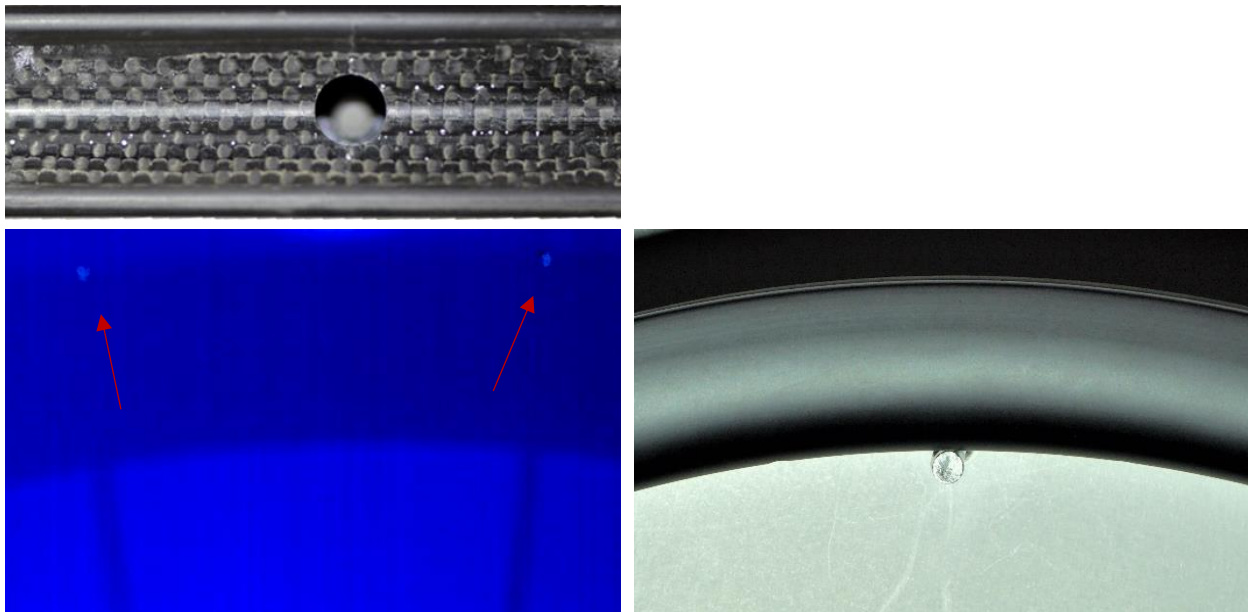
**Figure 60 - Wheel 1 Location 1 – 33 J absorbed energy (a) top view – spoke hole (b) IR side view (c) side view**

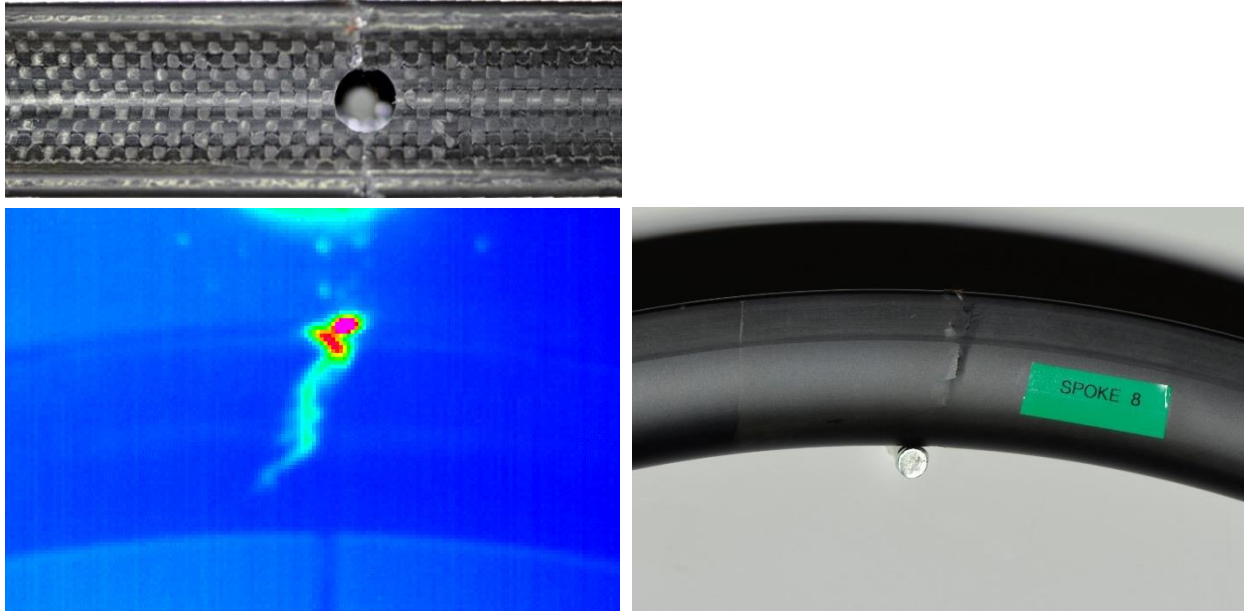
**Figure 61 - Wheel 4 location 2 – 41 *J* absorbed energy (a) top view – spoke hole (b) IR side view (c) side view**

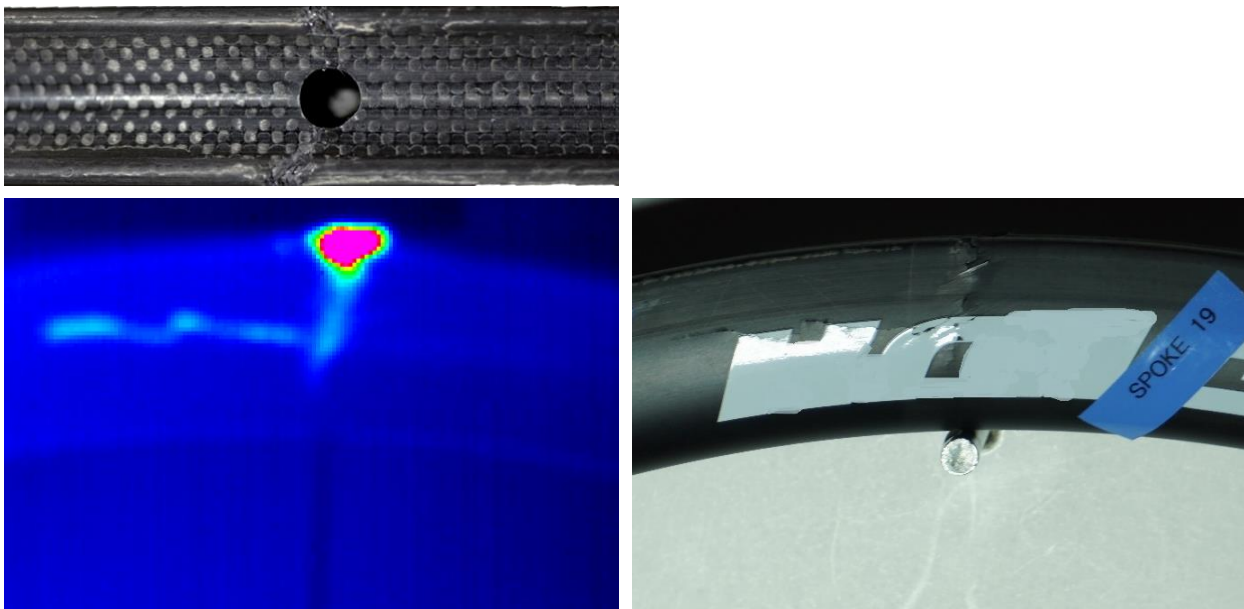
**Figure 62 - Wheel 8 location 3 – 46 *J* absorbed energy (a) top view – spoke hole (b) IR side view (c) side view**

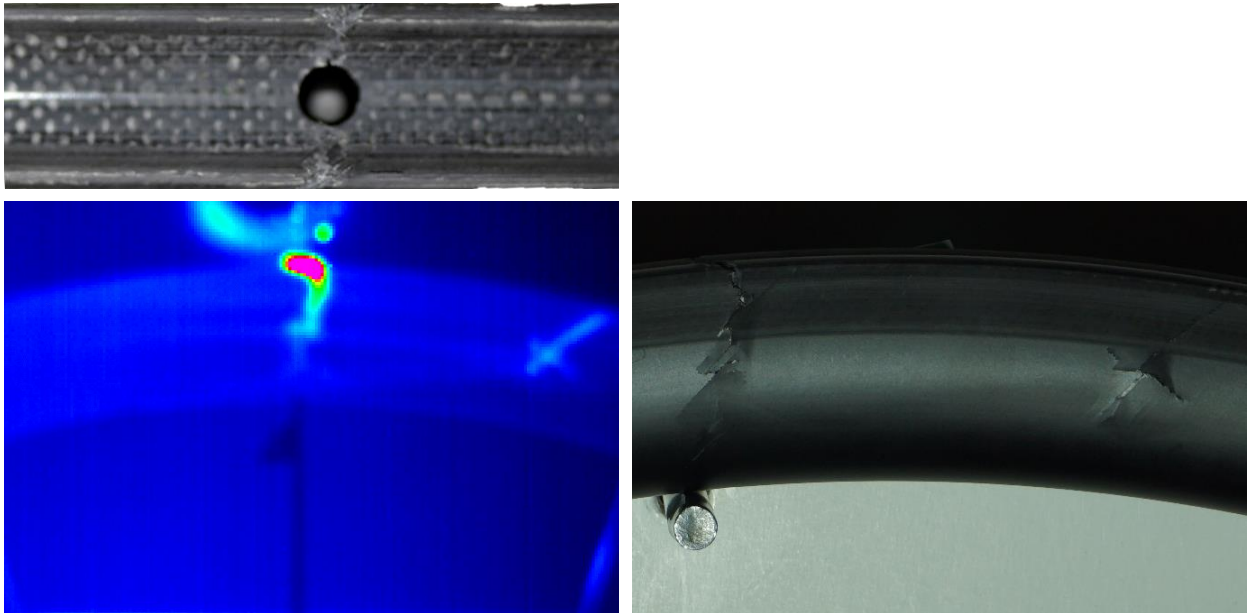
**Figure 63 - Wheel 7 location 1 – 51 *J* absorbed energy(a) top view – spoke hole (b) IR side view (c) side view**

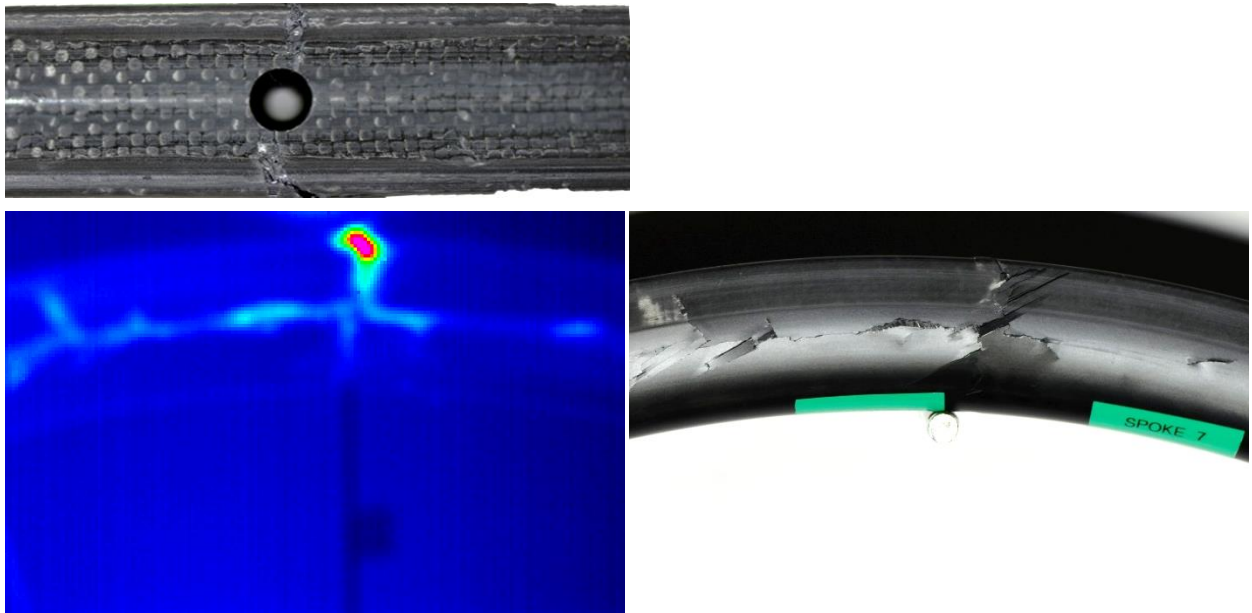
**Figure 64 - Wheel 7 location 2 – 61 *J* absorbed energy (a) top view – spoke hole (b) IR side view (c) side view**

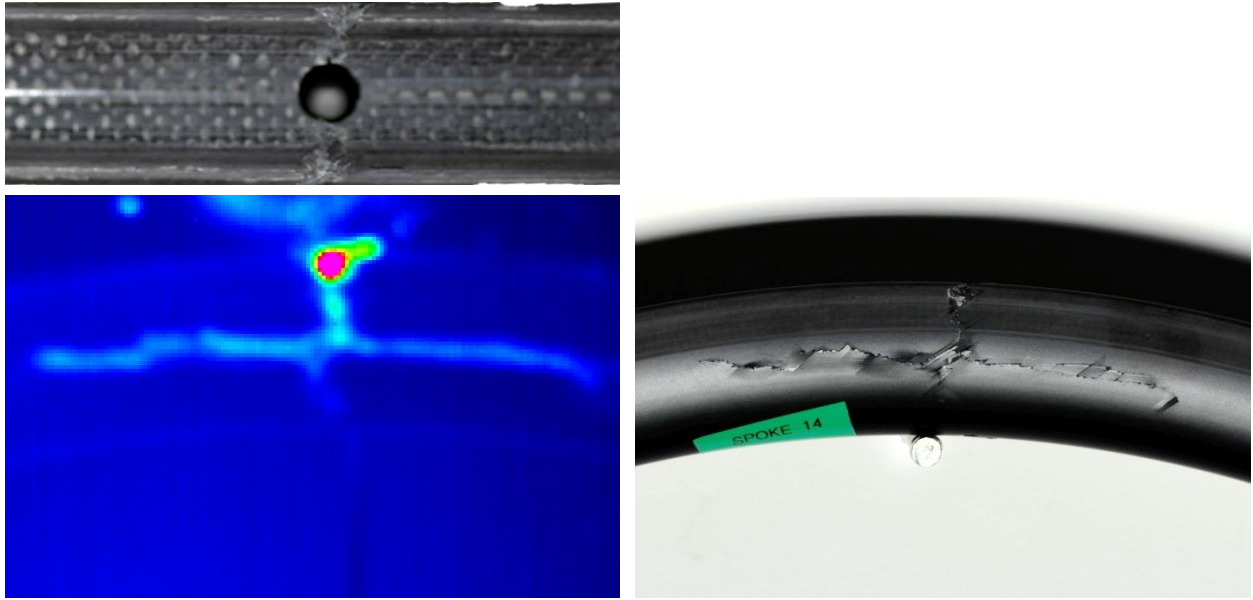
**Figure 65 - Wheel 7 location 3 74 J absorbed energy (a) top view – spoke hole (b) IR side view (c) side view**

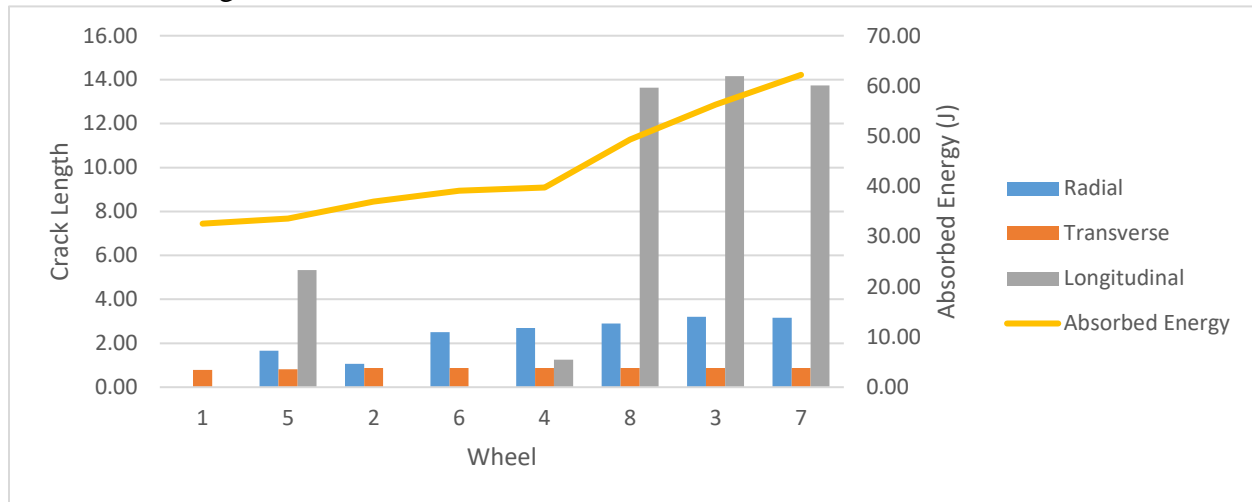
**Figure 66 - Average crack length vs energy absorbed of each test**

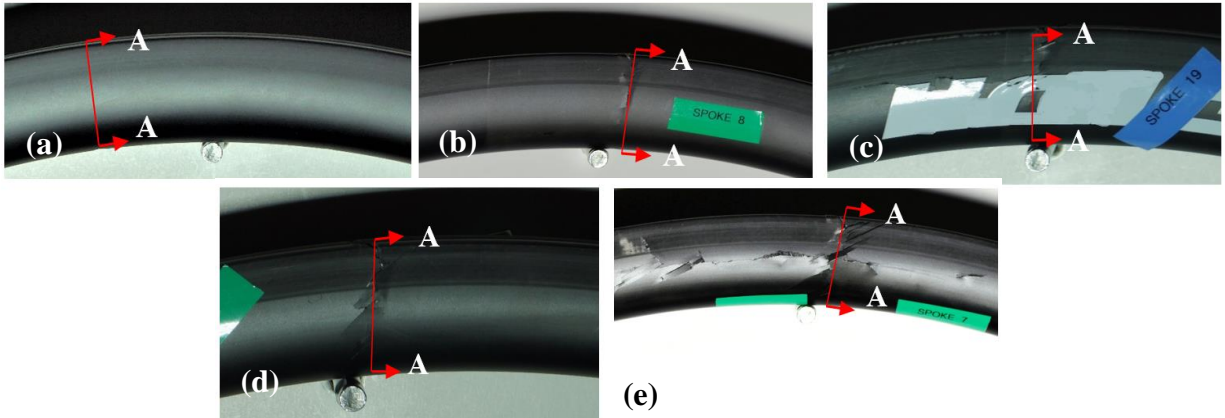
**Figure 67 – Section cuts on (a) Wheel 1 (b) Wheel 4 (c) Wheel 8 (d) Wheel 7 location 1 (e) Wheel 7 location 2**

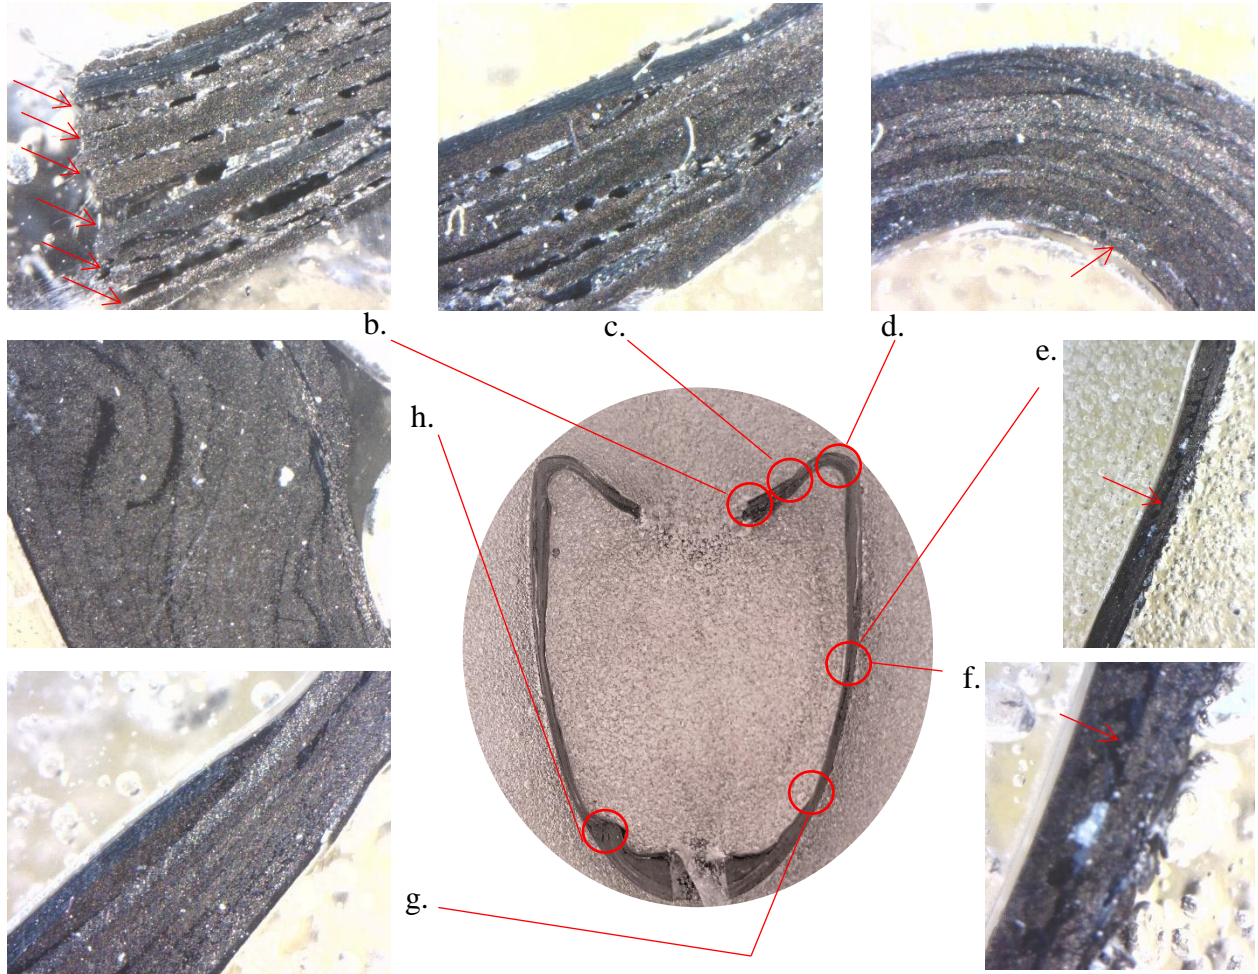
**Figure 68 – Wheel 1 location 1 – 33 *J* absorbed – (a) cross section (b) layer separation at TM (b) layer separation at TR (c) microcracks and delamination TR1 (d) delamination in R1 (e)(f) delamination in L3/L4 (g) right cured zone R4/R5 (h) wavy fibers in L4/L5**

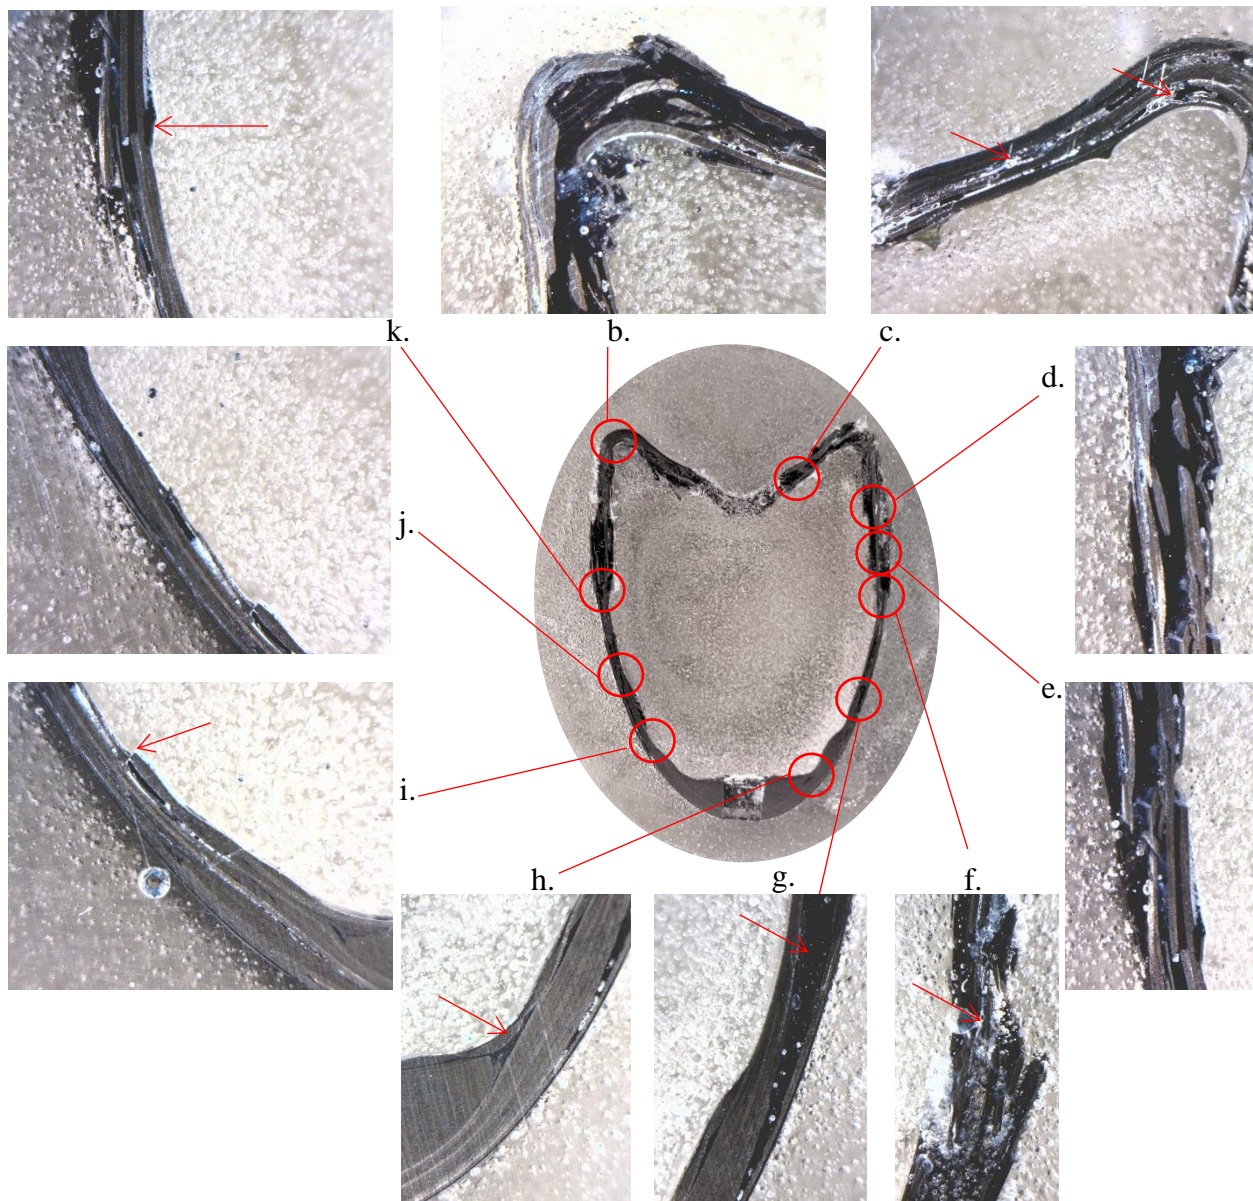
**Figure 69 – Wheel 4 – 41 *J* absorbed energy – (a) cross section (b)fracture at L1 (c) delamination and layer separation in TM/TR/TR1 (d) delamination in R2 (e) delamination in R3 (f) fiber fracture in R3/R4 (g) delamination in R4 (h) delamination in R5/BR (i) ply fracture in L4/L5 (j) ply fracture in L4 (k)fiber fracture in L3/L4**

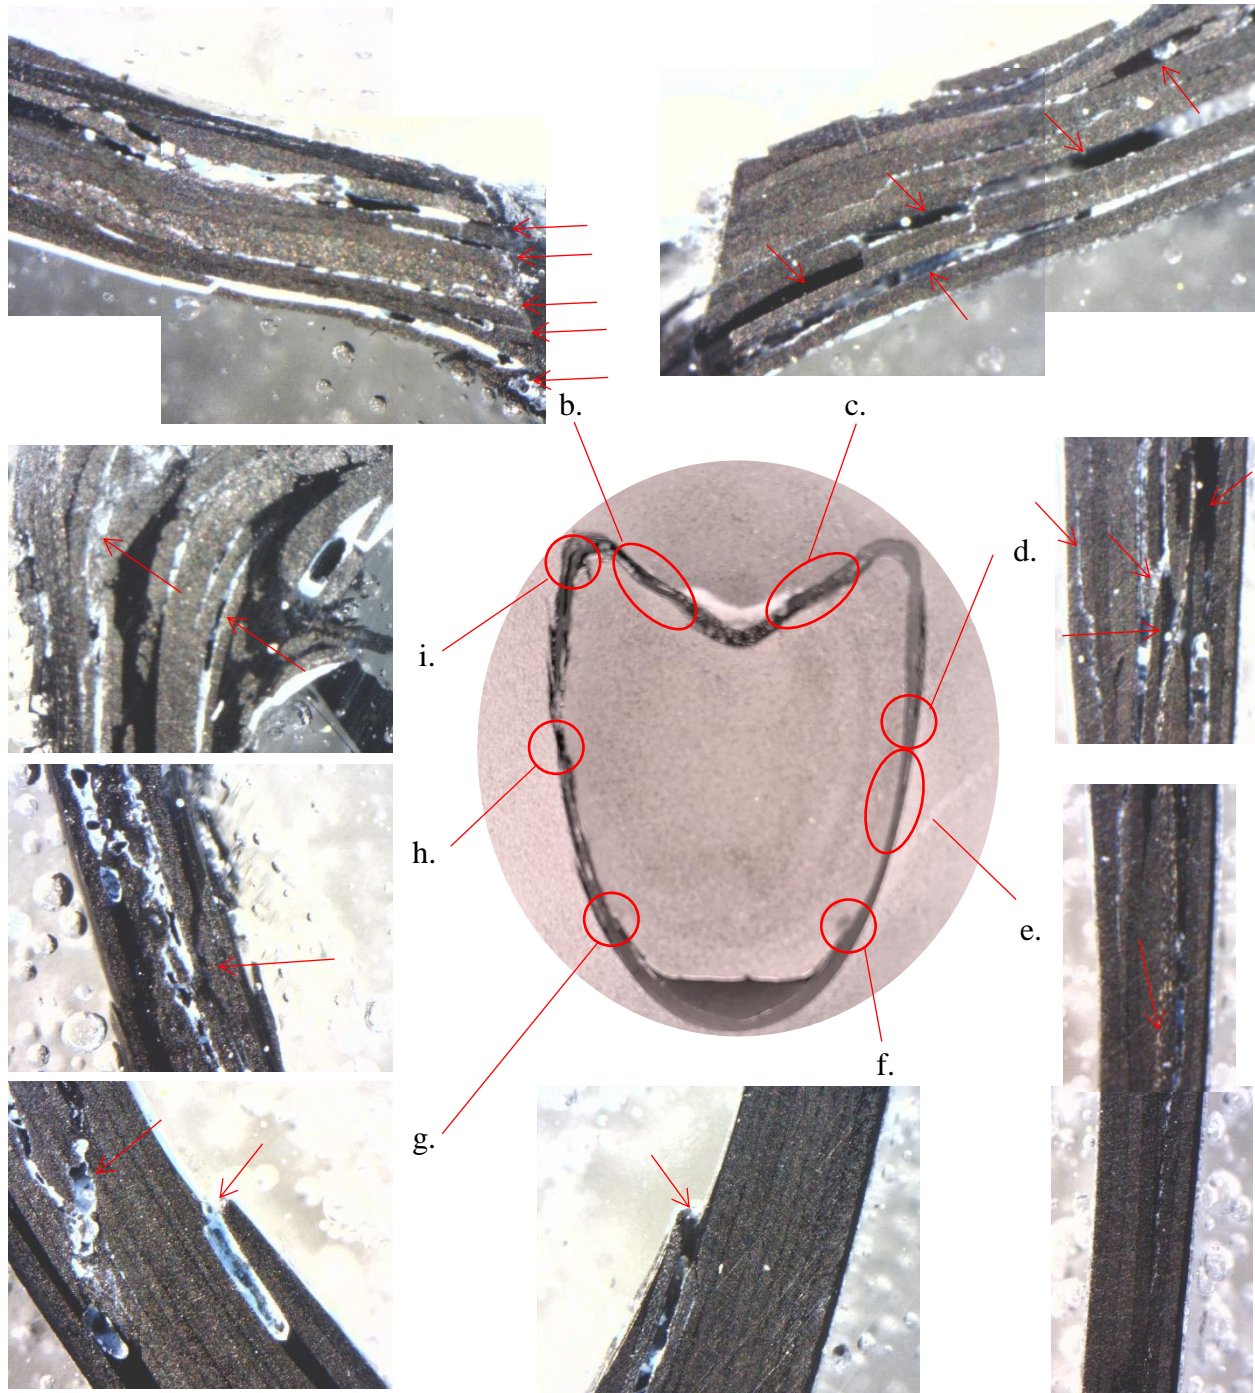
**Figure 70 – Wheel 8 – 46 *J* absorbed energy - (a) cross section (b) delamination and fracture in TL/TM (c) fiber fracture in TM/TR/TR1 (d) delamination and fracture in R3/R4 (e) delamination in R4 (f) fiber fracture in R4/R5 (g) fiber fracture in L4/L5 (h) fiber fracture in L3/L4 (i) delamination in R1**

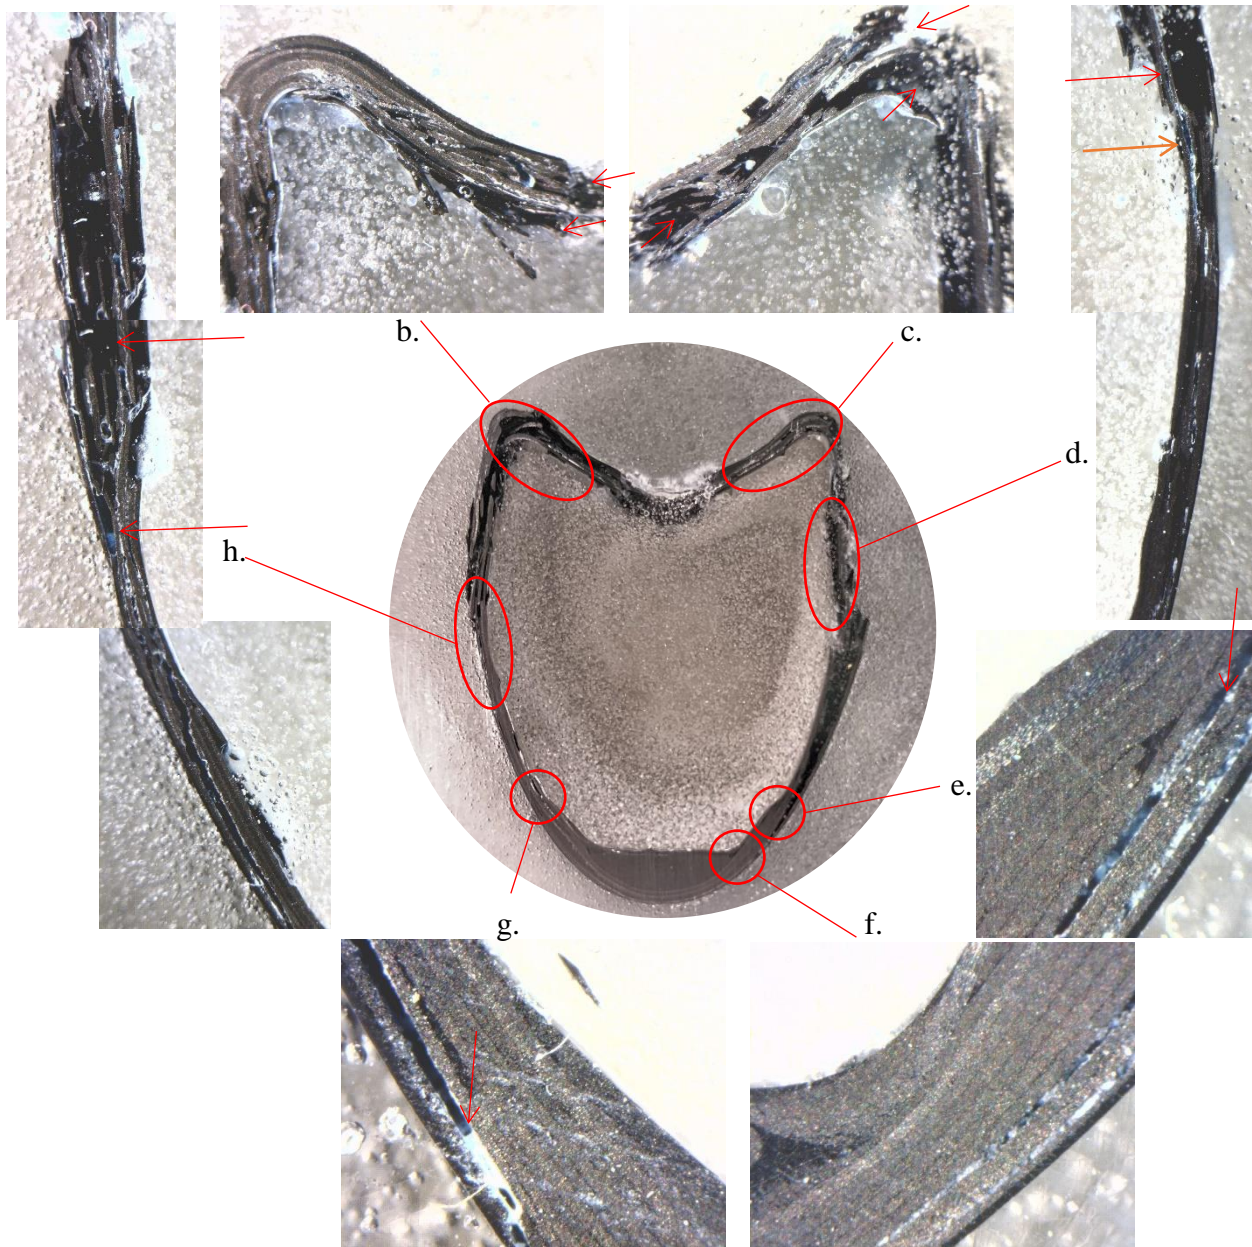
**Figure 71 - Wheel 7 – location 1 - 51 J absorbed energy - (a) cross section (b) delamination across L2→TM (c) delamination across TM→R2 (d) delamination and fragmentation across R2→R4 (e) delamination in R5 (f) delamination in BR (g) delamination in BL (h) fiber fracture and delamination across L2→L4**

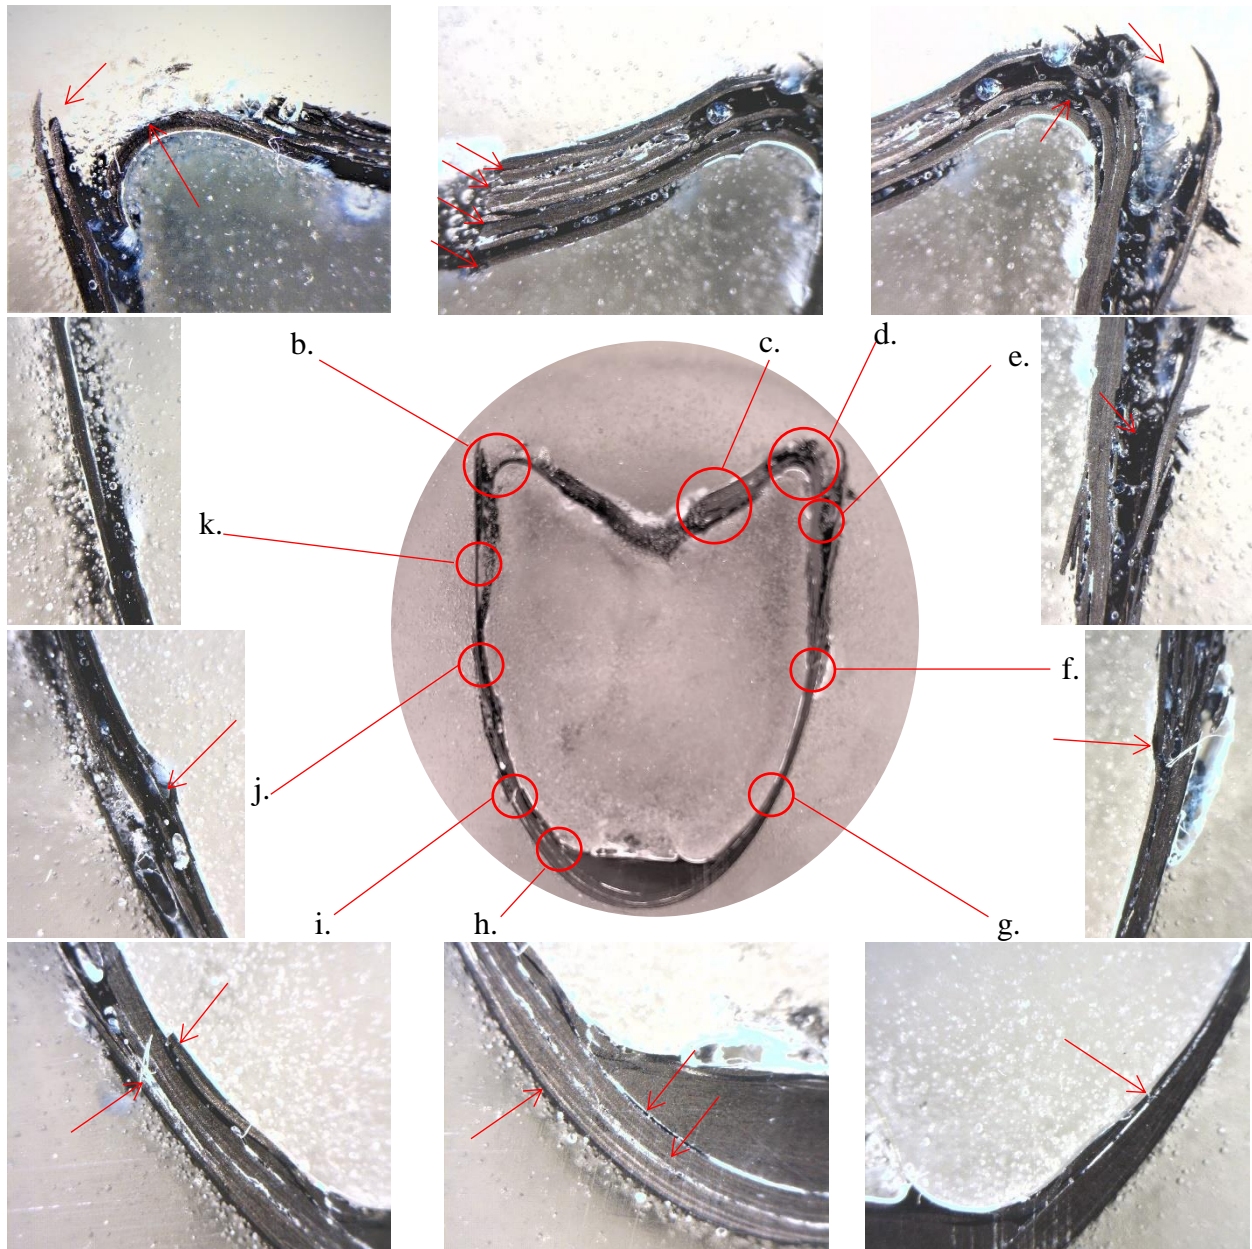
**Figure 72 - (a) cross section (b) fracture and fragmentation across L2→TM (c) delamination across TM→TR1 (d) delamination and fracture across TR1→R2 (e) delamination in R2 (f) fiber fracture in R3/R4 (g) delamination in R5 (h) delamination in BL (i) delamination and fiber fracture in L4/L5 (j) delamination and fracture in L3/L4 (k) fracture and fragmentation in R2/R3**

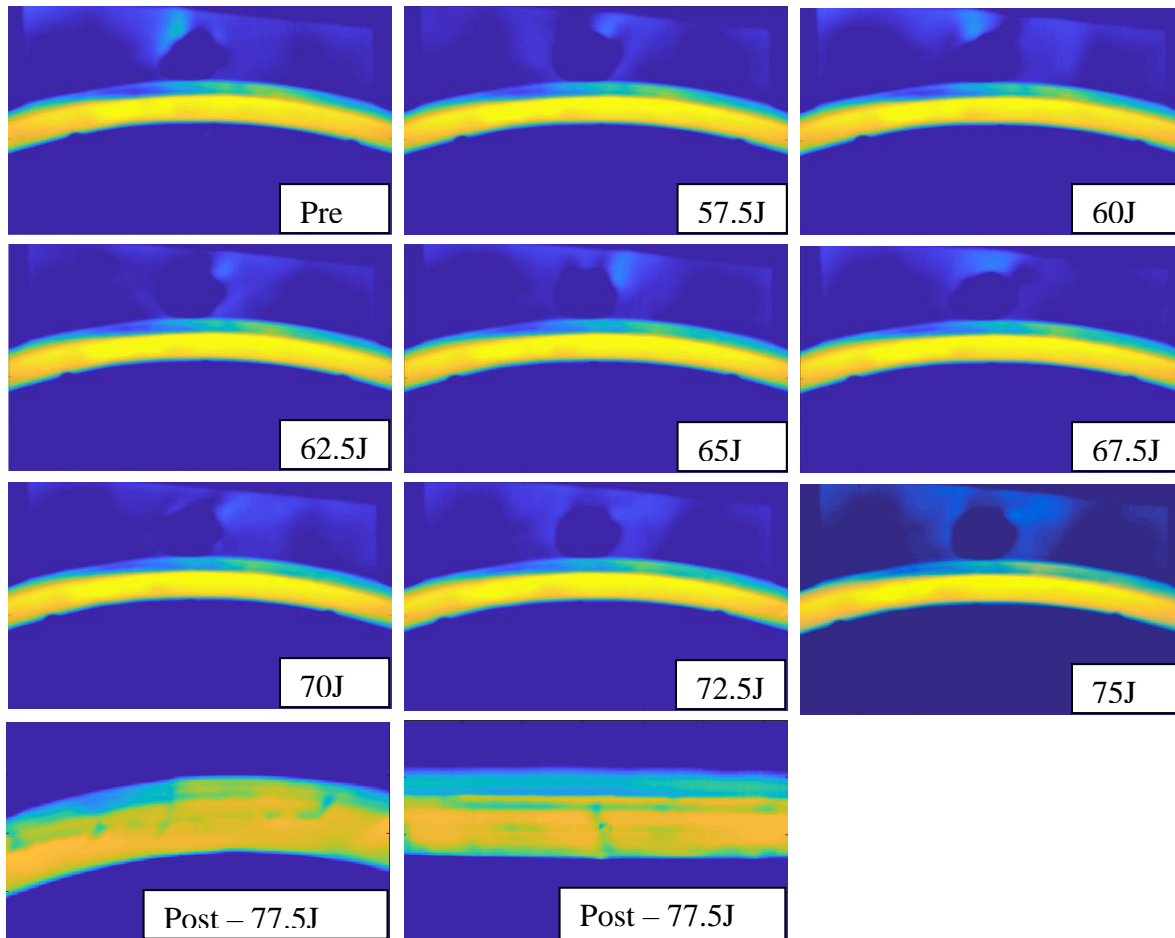
Figure 74 – Wheel 7 Location 3 PCT

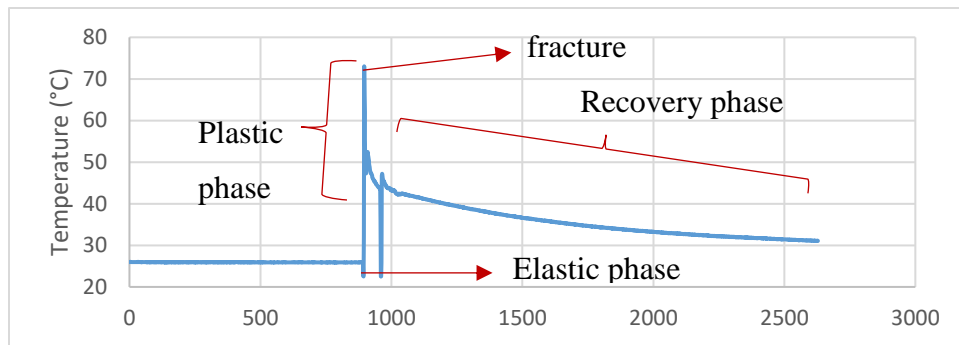
**Figure 75 - Temperature profile of wheel 7 location 3 – 74J absorbed energy**

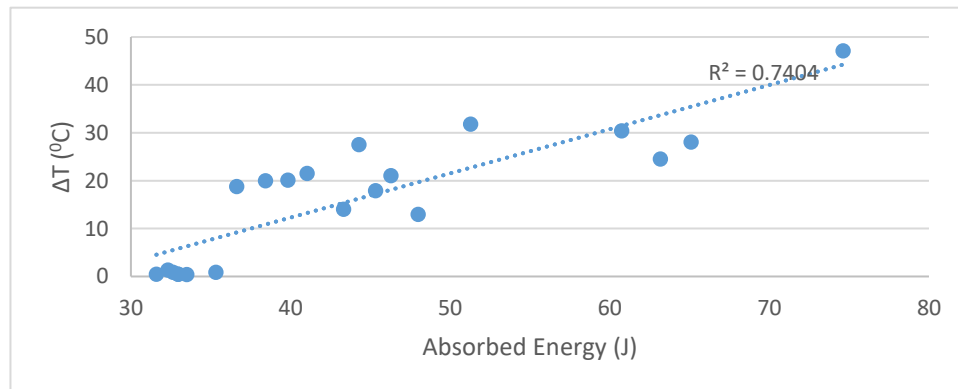
**Figure 76 – Change in surface temperature from absorbed energy in failed specimens**
