A COMPARATIVE STUDY ON THE PERFORMANCE OF DIFFERENT TYPES OF WALL-SLAB CONNECTIONS IN LIQUID CONTAINING CONCRETE STRUCTURES

A thesis

presented to Ryerson University

Civil Engineering

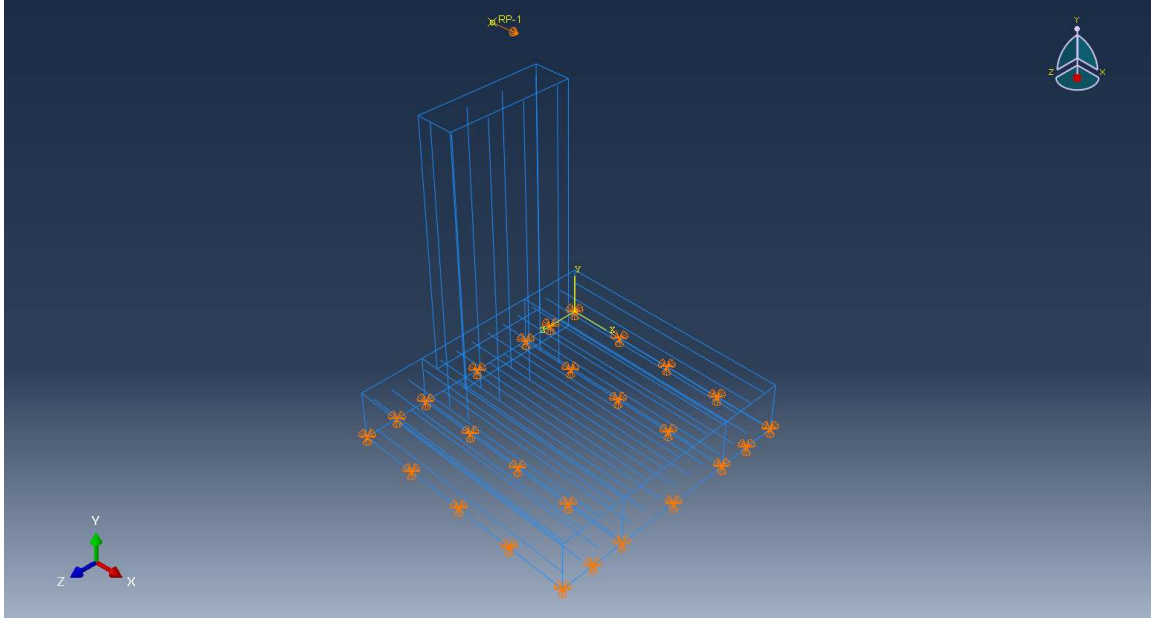
Figure 2-8: Applied displacement and the boundary conditions at the support region

For the support region of the slab, the bottom surface of the slab is fixed by omitting the translational degrees of freedom in that region. An illustration of the applied displacement at the top of the wall and the boundary conditions at the support are provided in the Figure 2-8.

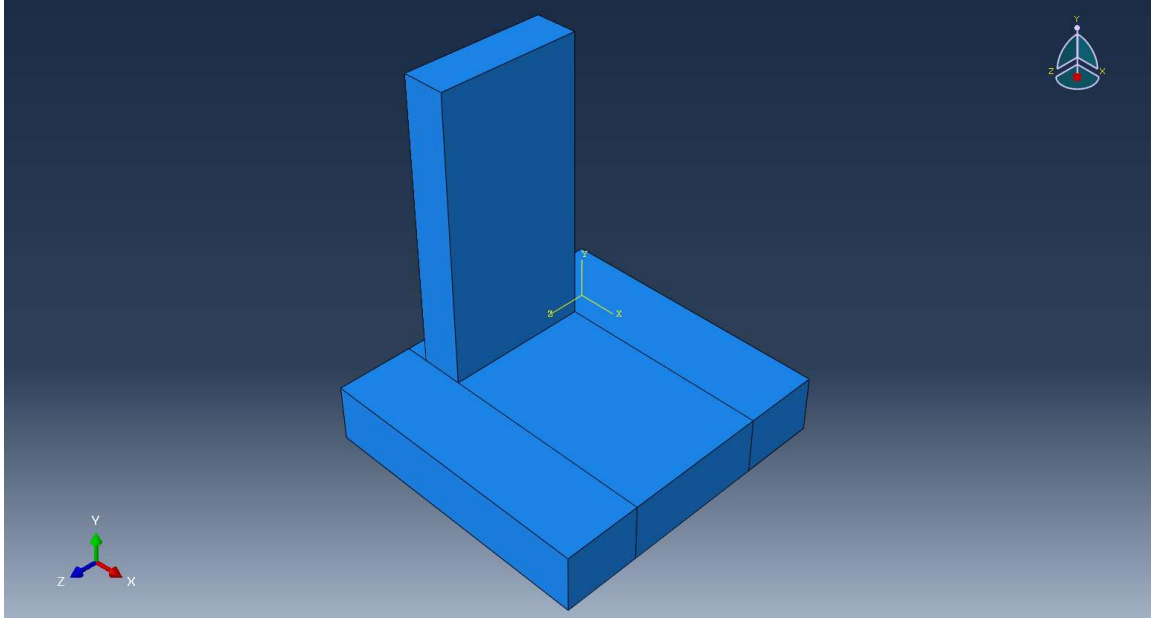
Figure 2-9: Partitioning of the slab, as required for the structured mesh

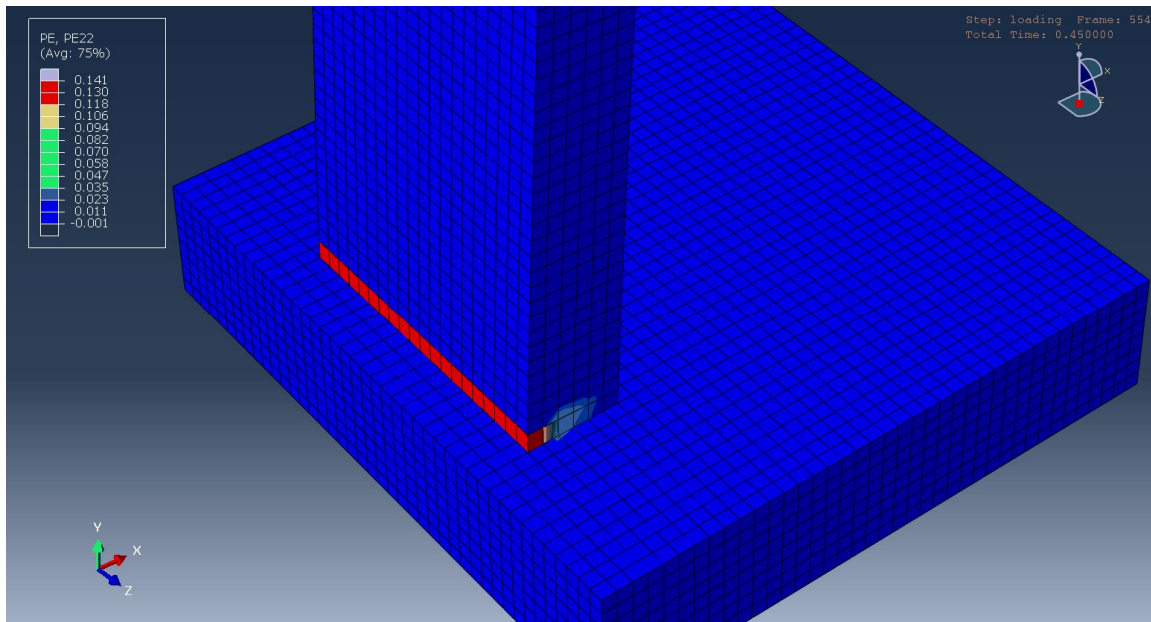
Figure 2-11: Tensile plastic strain and cracking of the section at the limit state

Also, based on the nonlinear tensile behavior of concrete which was defined in previous sections, we can plot the plastic strains developed at the joint location. This provides an illustration of cracking of the section at the joint as it can be seen in the Figure 2-11 below.

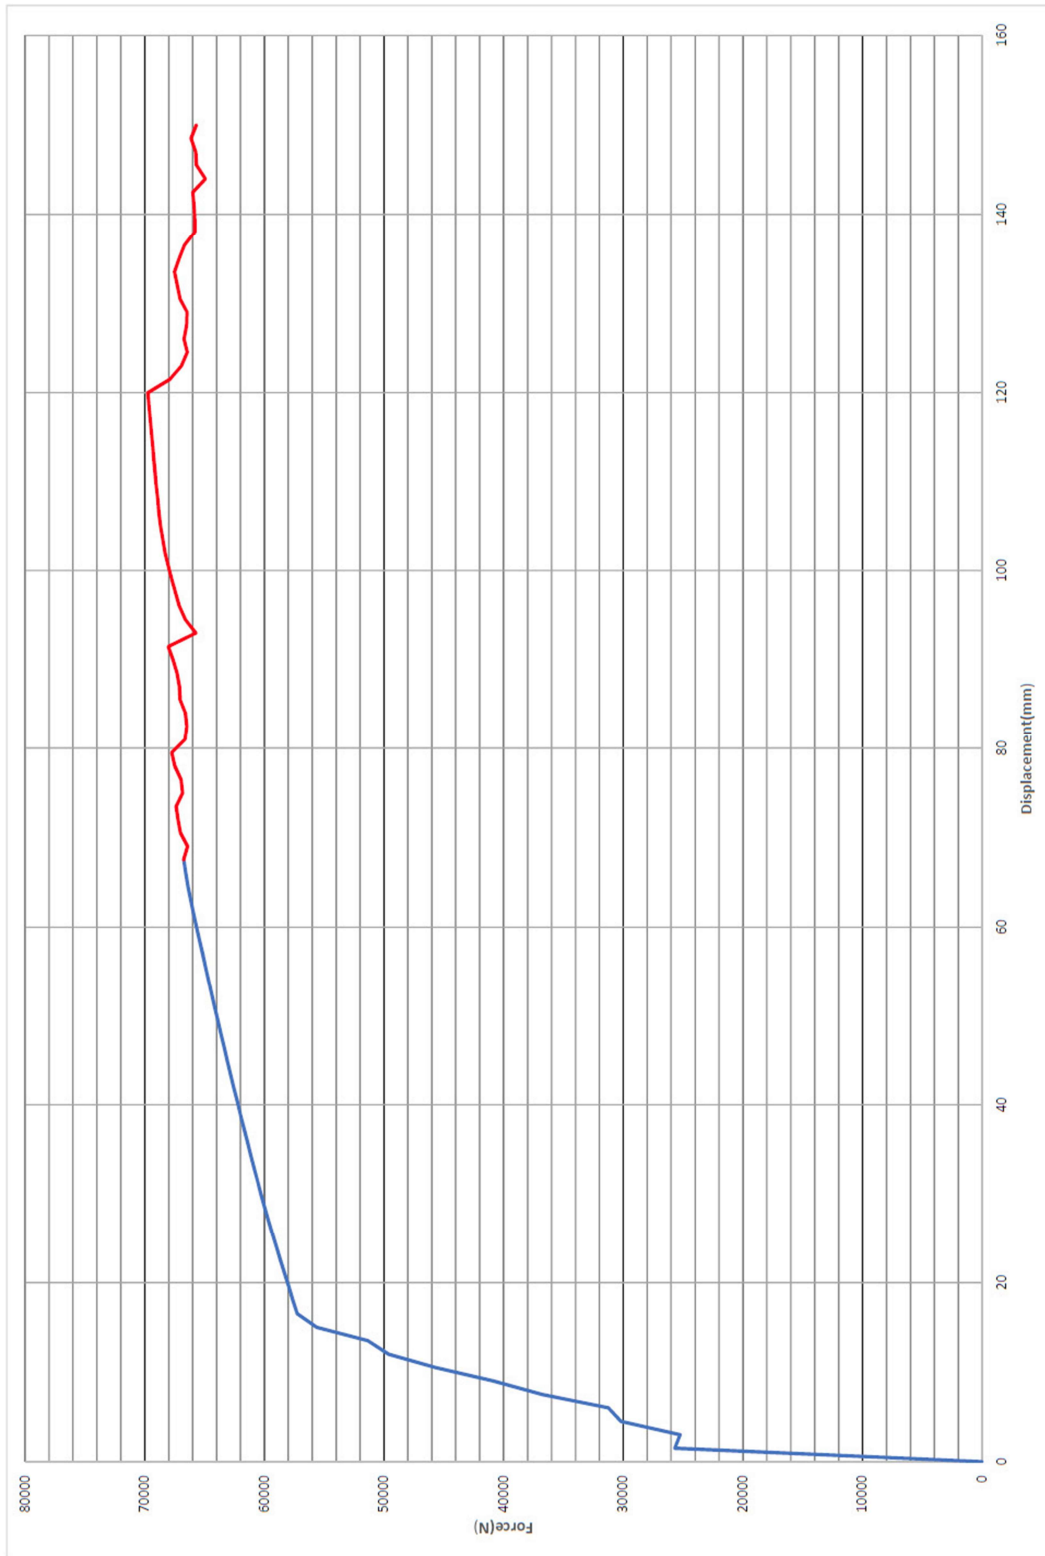
Figure 2-12: Raw force-displacement diagram of the structure

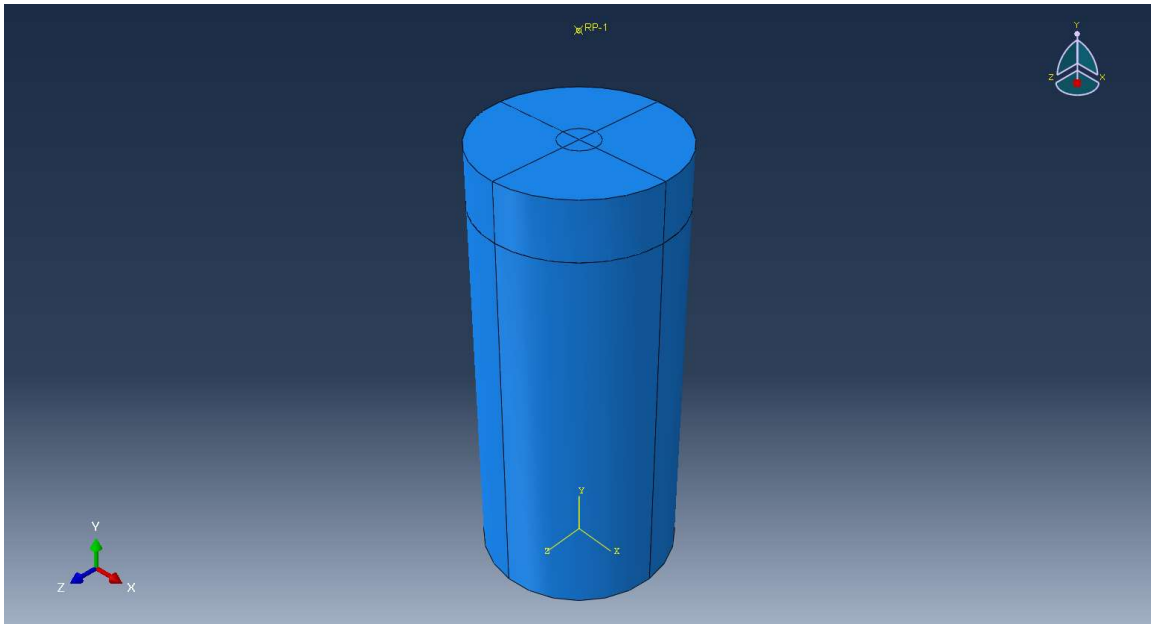
Figure 2-14: Model assembly for the compressive strength test

To impose uniform stress distribution, a *surface to surface contact* between the bottom surface of the disc and top surface of the cylinder is implemented. The interaction properties of this contact are chosen as *frictionless tangential behavior* and *hard contact normal behavior*. Also, in order to preserve symmetrical stress and strain distribution around the axis of the cylinder, boundary conditions have been applied to limit the translational degrees of freedom in x and z directions, in the $z - y$ and $x - y$ planes respectively. These boundary conditions would allow the expansion of the cylinder due to Poisson's effect while limiting the movement of the cylinder and ensuring that it would not slip out of the uniaxial loading condition. Illustrations of the model assembly, loads and boundary conditions and the mesh are presented in the following figures (Figure 2-14 to Figure 2-17).

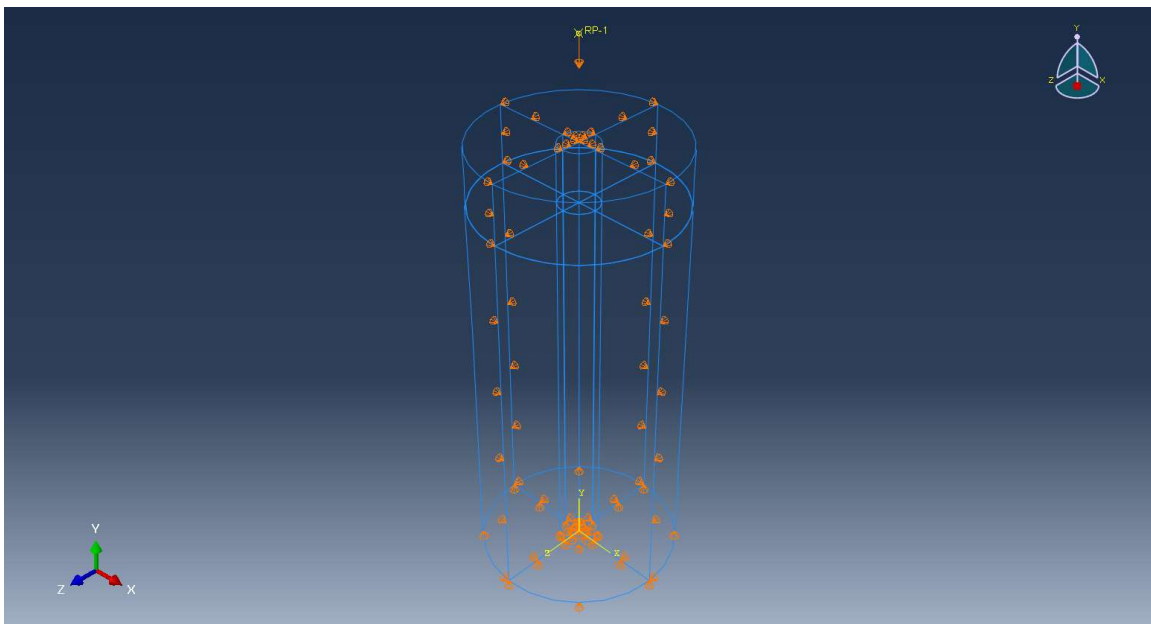
Figure 2-15: Loading and boundary conditions

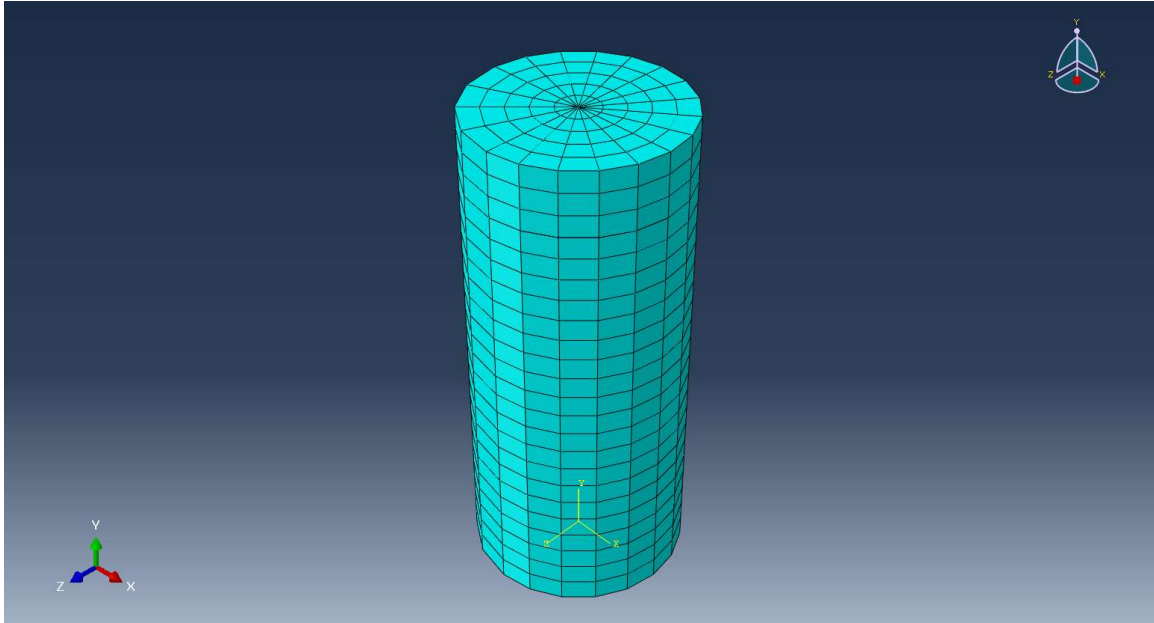
Figure 2-16: Structured mesh with cubic and wedge elements, with an element size of 10 mm

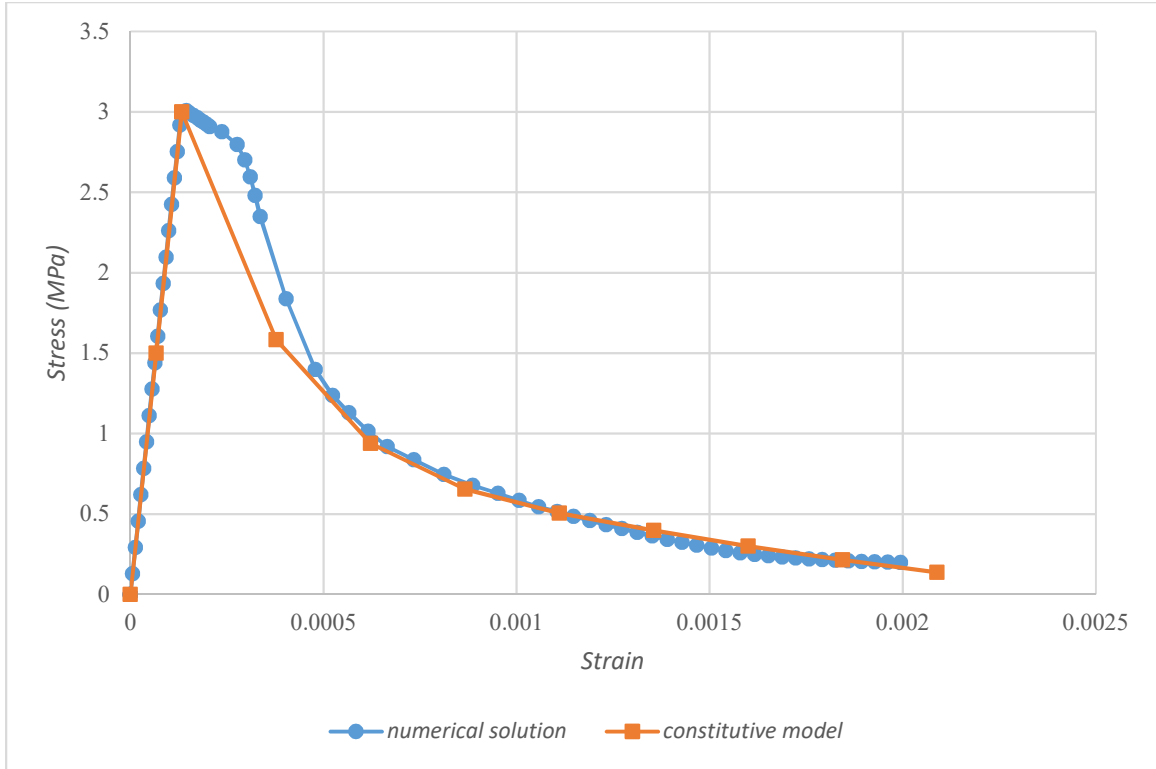
Figure 2-19: Comparison of tensile stress-strain curve obtained from numerical simulation with stress-strain curve of constitutive model

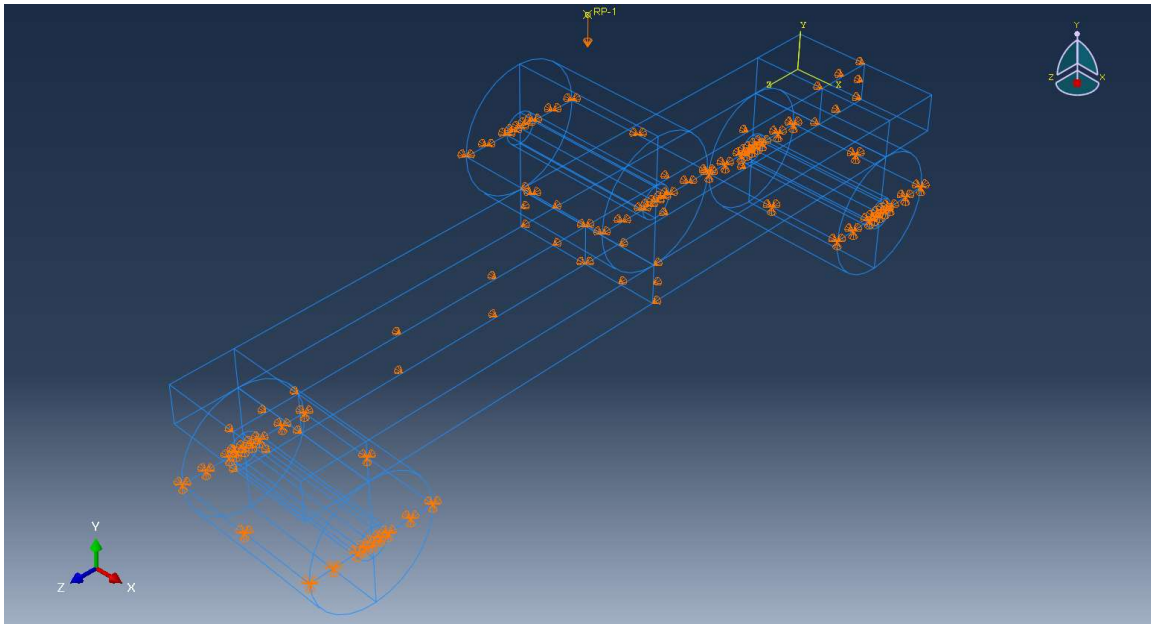
Figure 2-21: Loading and boundary conditions

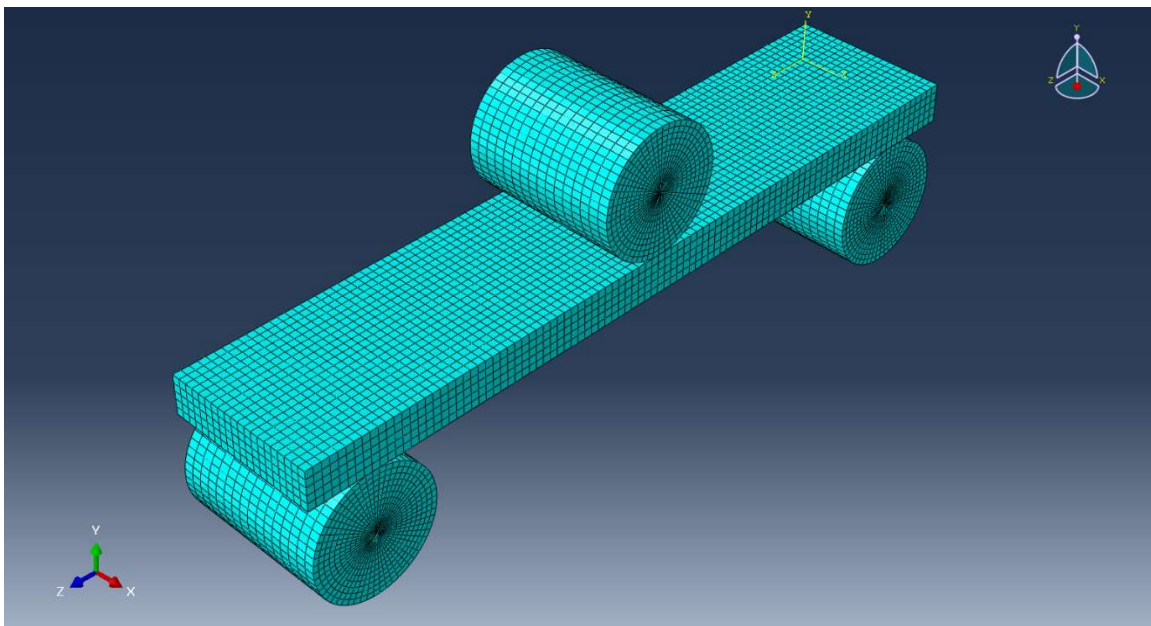
Figure 2-22: Structured mesh with cubic and wedge elements, with an element size of 10 mm

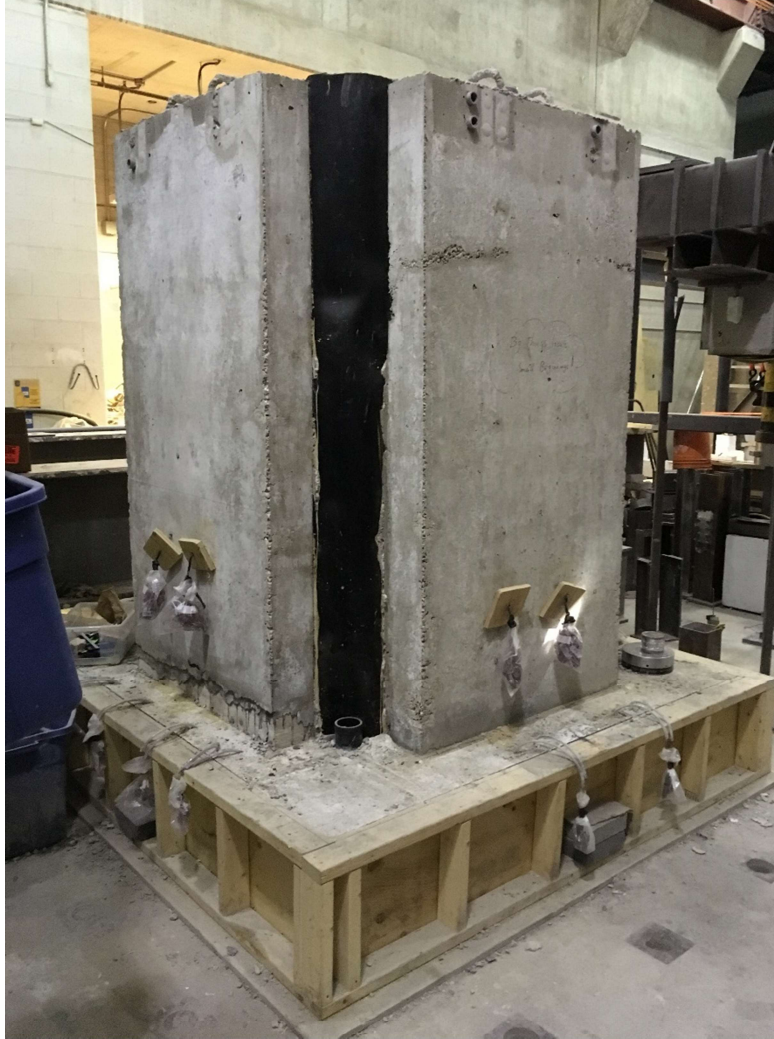
Figure 3-1: The fully constructed specimen

The specimen that was used in this study, was designed and constructed in a unique way compared to similar test setups. While it would have been more common to build four different specimens, each with a separate base slab and a wall, in this study a single base slab was constructed to support four walls. To follow the common construction practice, the slab and the walls were cast at two separate stages. The slab was cast first and then all of the walls were cast together at a later date. The fully constructed specimen is shown in the Figure 3-1.

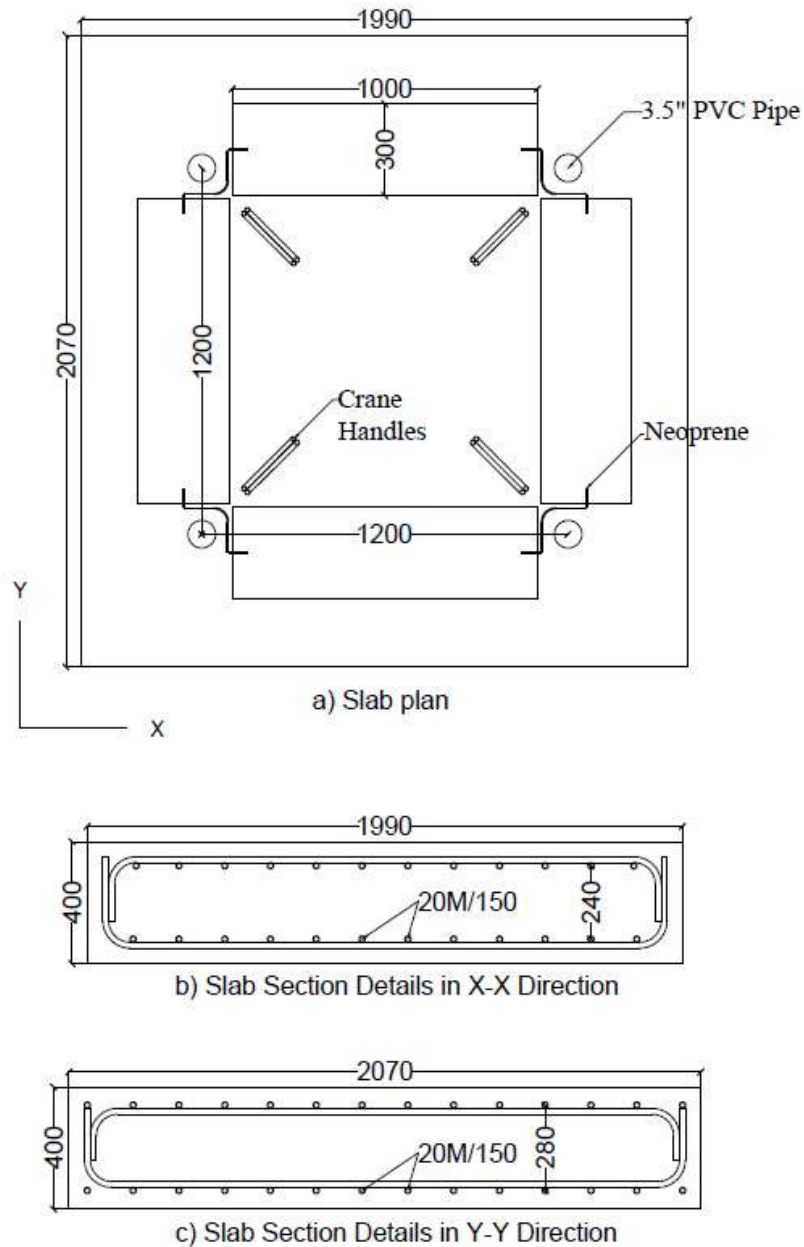
Figure 3-2: a) slab plan b) slab section in x direction c) slab section in y direction

Even though flexural mode of failure is dominant in this type of structure, horizontal stirrups were considered to provide confinement for the concrete section and to comply with typical design practice. The stirrups were chosen as 10M rebars placed at 300mm intervals throughout the length of the walls.

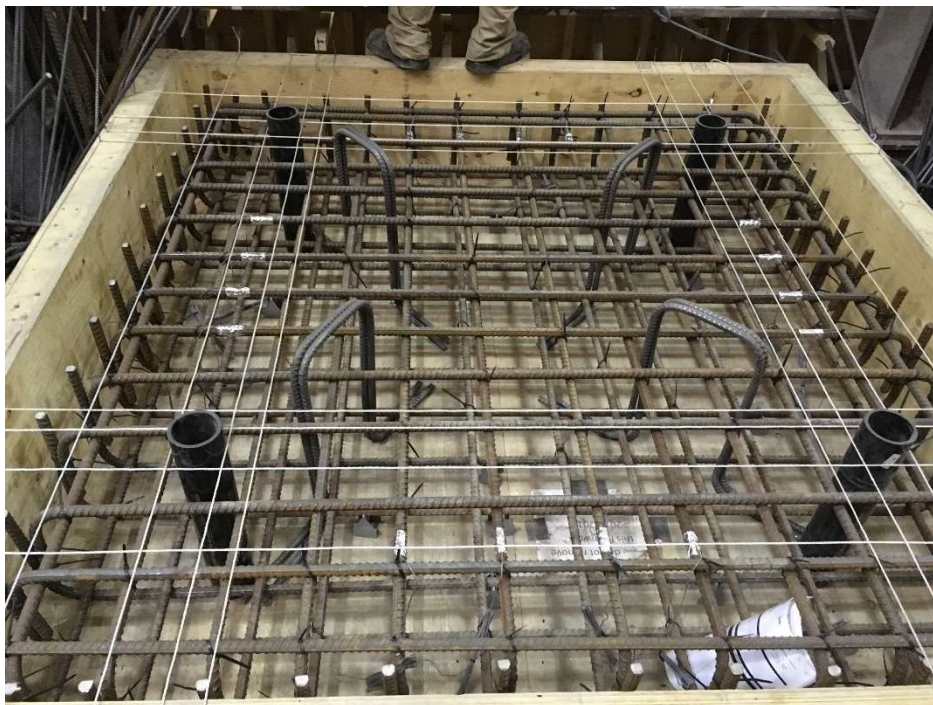
Figure 3-8: Location and arrangement of the strain gauges under the walls

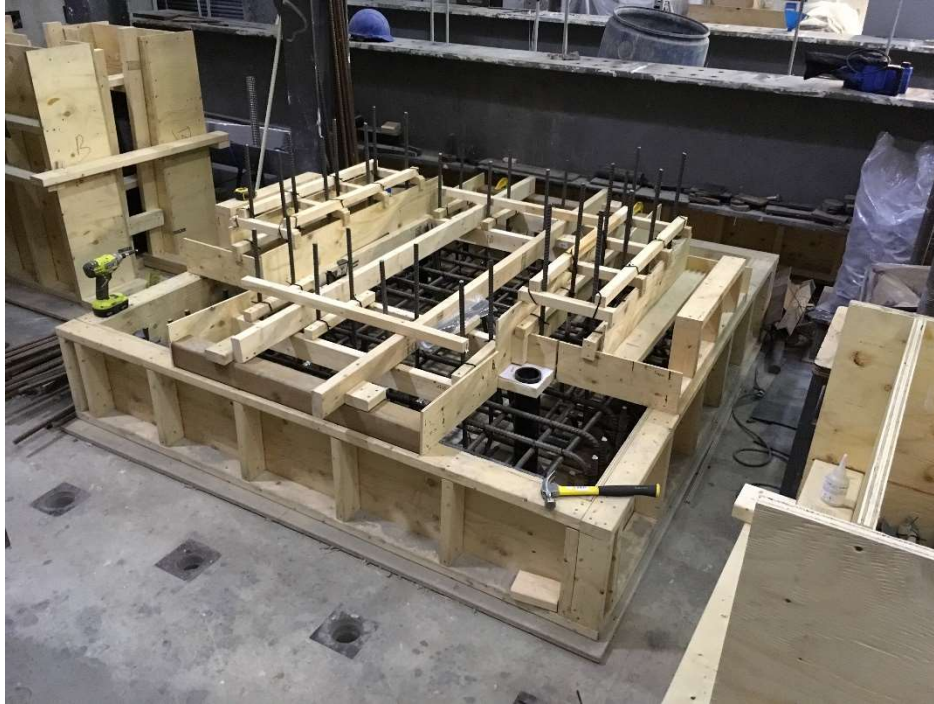
Figure 3-9: The template used for the formwork of the upturn parts

To build the upturn parts, another set of formwork had to be built on top of the foundation slab. For this purpose, a template was constructed using 3/8" plywood, 2"x2" and 2"x4" lumber. In addition to providing a formwork for the upturn parts, the template was necessary to exactly locate the position of walls, dowels, neoprene membranes and PVC pipes. It also provided a means to firmly keep them in place during the concrete pouring and vibration.

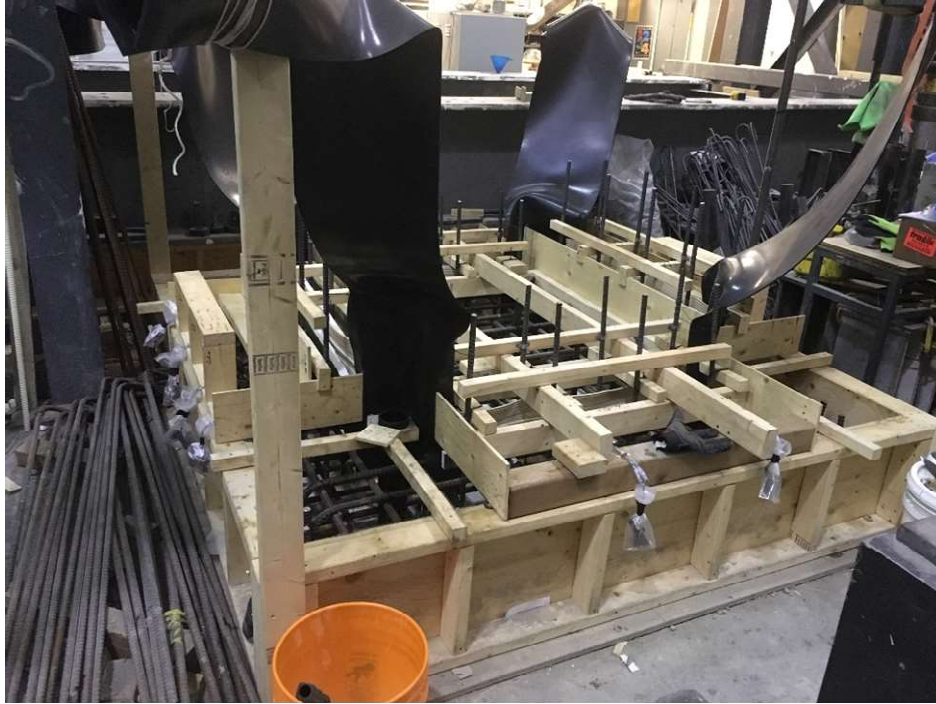
Figure 3-10: Installation of neoprene membranes using the posts and the template

As the neoprene membranes were designed to be placed vertically between the walls, it was necessary to properly integrate them into the formwork so that they can fulfill their intended role after the concrete pouring of the slab was finished. To achieve this, four wooden posts made with 2"x4" lumber were installed at the four corners of the foundation to keep the membranes in a vertical manner. The membranes were then anchored to the rebars by using steel wires to prevent their movement during concrete pouring. About 200mm of the membranes were placed inside the slab to provide sufficient anchorage with the concrete. They were also extended by 50mm inside the walls through a series of slots that were precut into the template. Figures below show the installation of the membranes with better details.

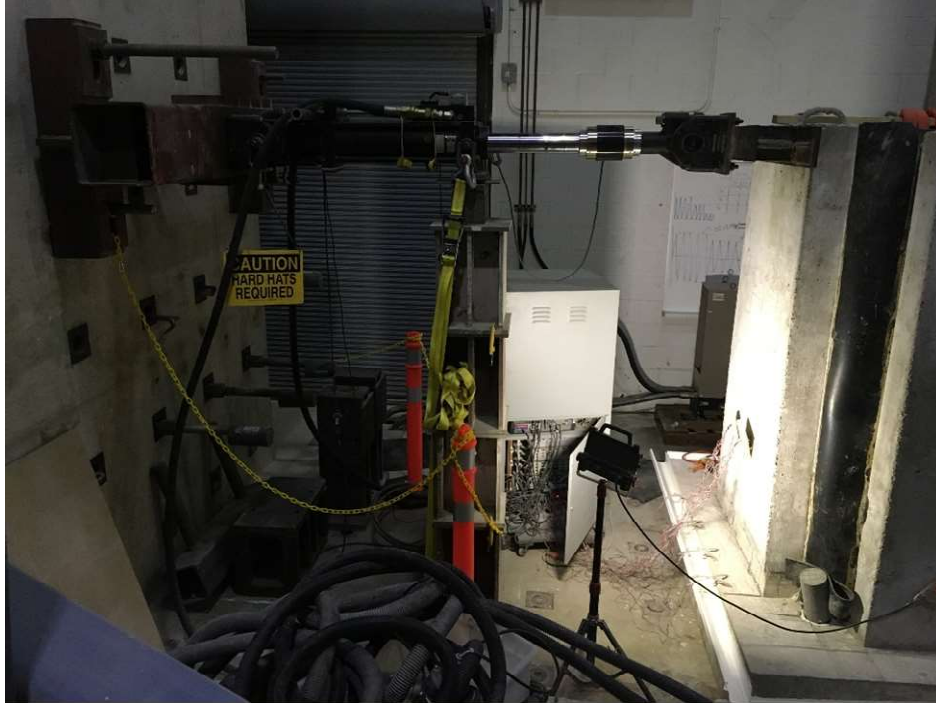
Figure 4-1: Setup of the experiment

Once a wall was connected to the actuator and prepared for testing, the wires of strain gauges were connected to a data acquisition system so that a time history of strain values could be recorded during the period of each test. The values of the force, displacement and time were also collected and recorded by the software associated with the actuator. These recordings provided sufficient information to plot the force-displacement, force-time, displacement-time and stain-time diagrams at the end of each test.

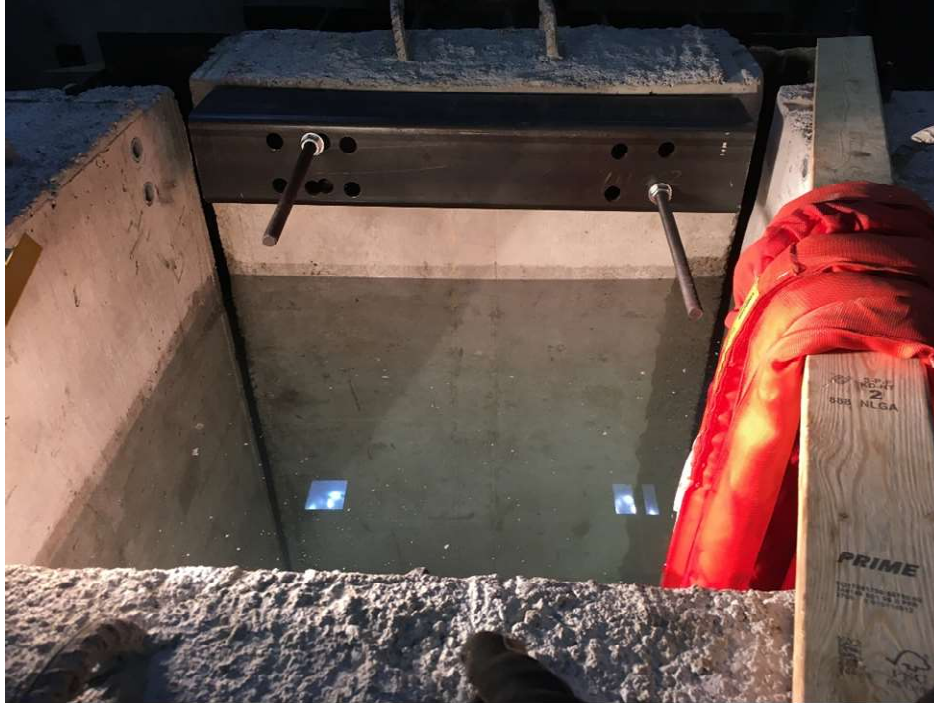
Figure 4-5: HSS beam on the back of the wall

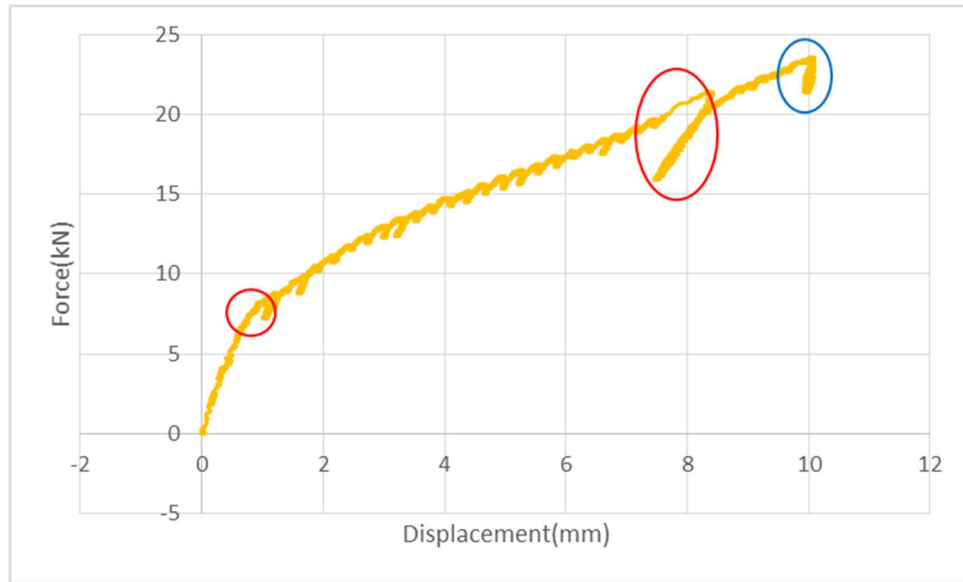
Figure 4-8: Force-Displacement diagram of the first cracking test of the US joint

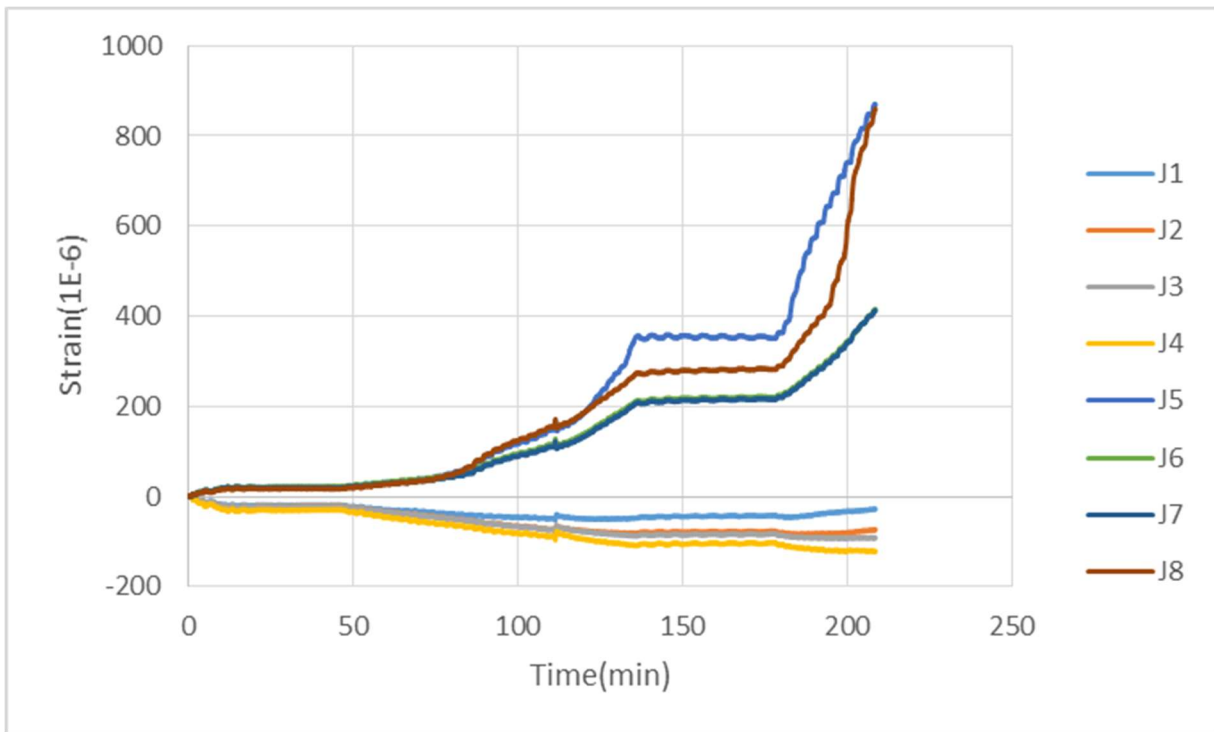
Figure 4-9: Strain-Time diagram of dowel strain gauges (J1 to J8) of the first cracking test of the US joint

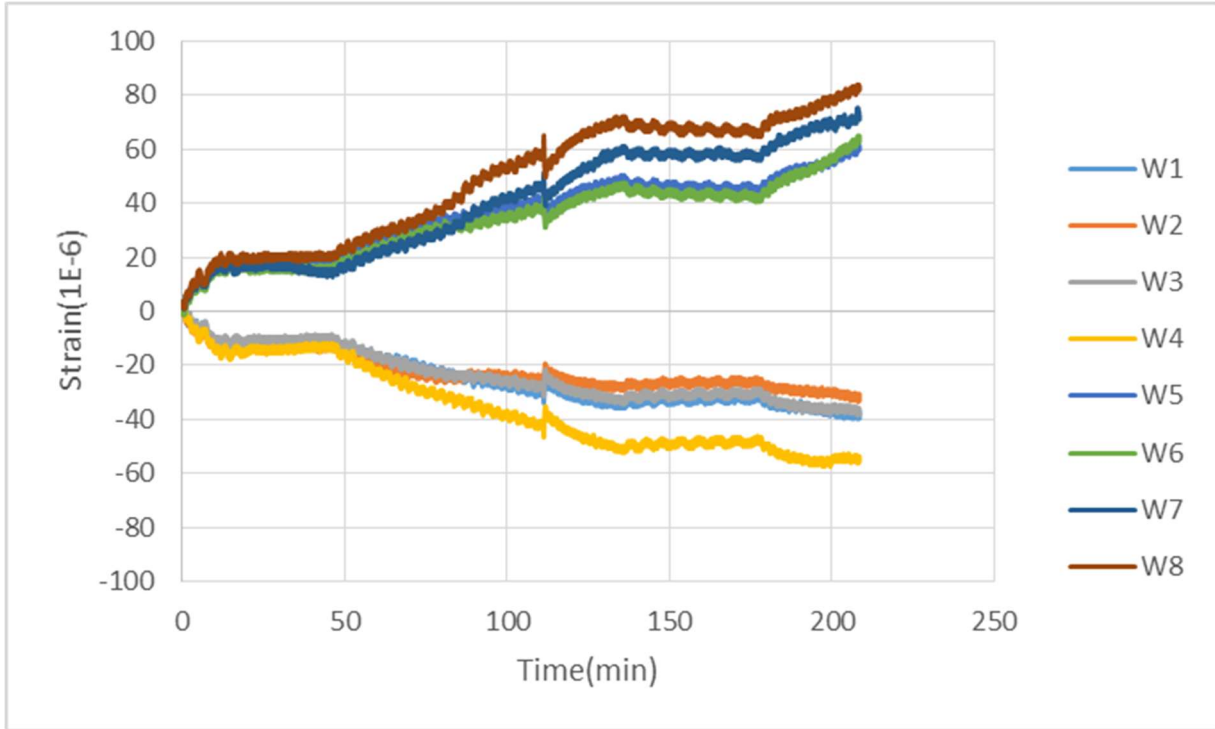
Figure 4-10: Strain-Time diagram of the strain gauges installed on wall reinforcements (W1 to W8) for the first cracking test of the US joint

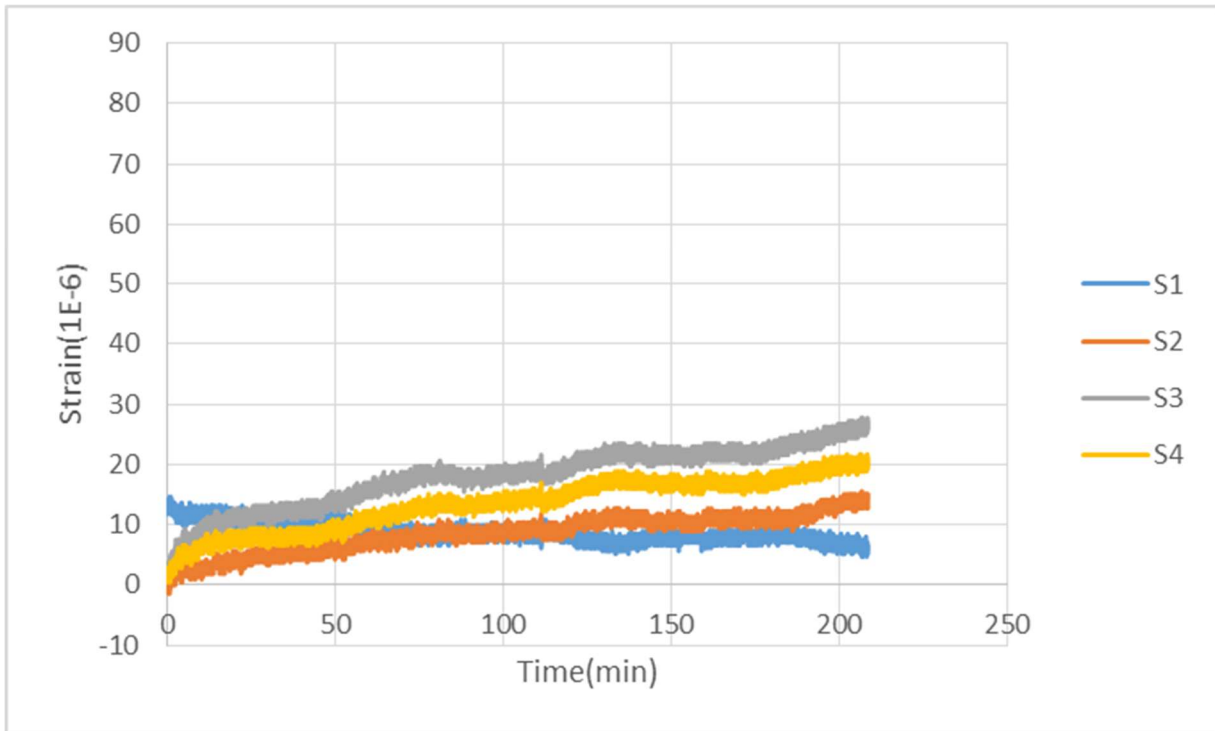
Figure 4-11: Strain-Time diagram of the strain gauges installed on slab reinforcement (S1 to S4) for the first cracking test of the US joint

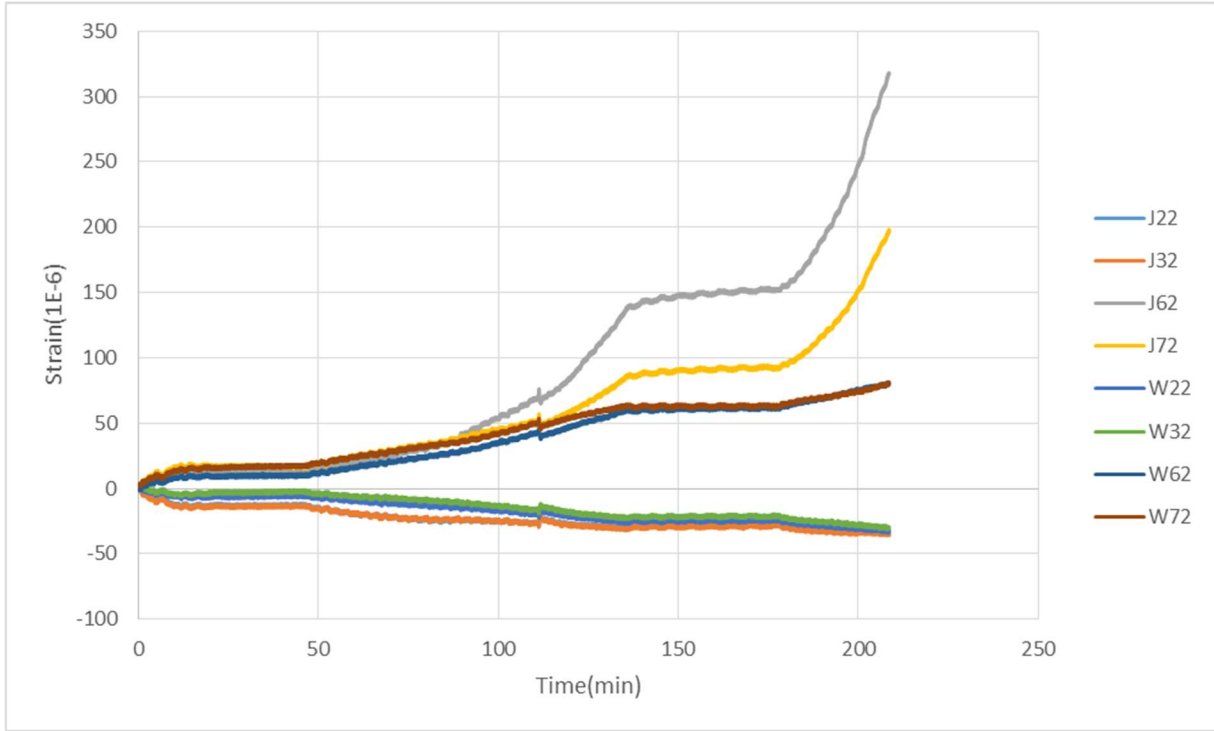
Figure 4-12: Strain-Time diagrams of the secondary strain gauges installed on dowels and wall reinforcements for the first cracking test of the US joint

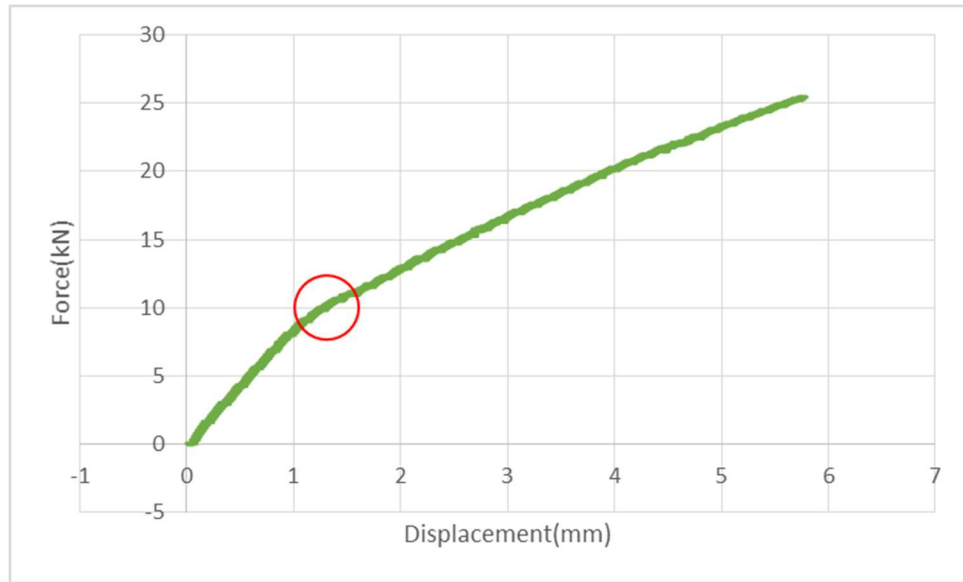
Figure 4-15: Force-Displacement diagram of the first cracking test of the UF joint

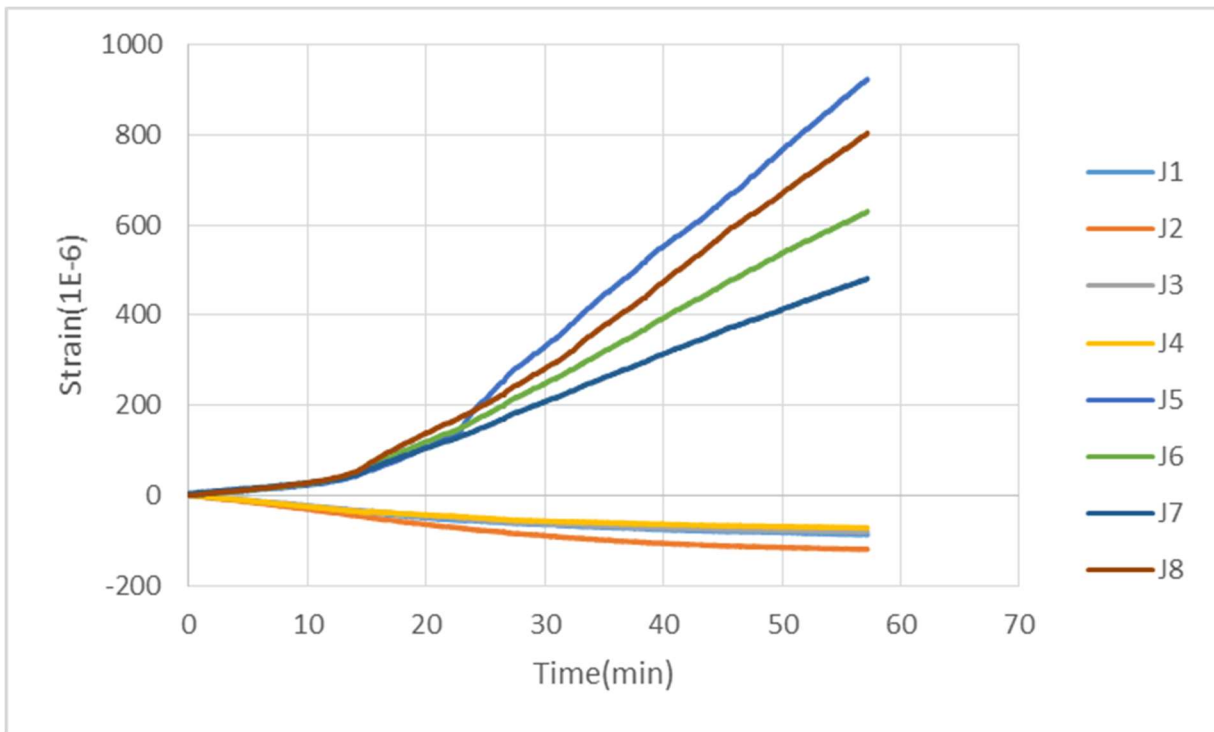
Figure 4-16: Strain-Time diagram of dowel strain gauges (J1 to J8) of the first cracking test of the UF joint

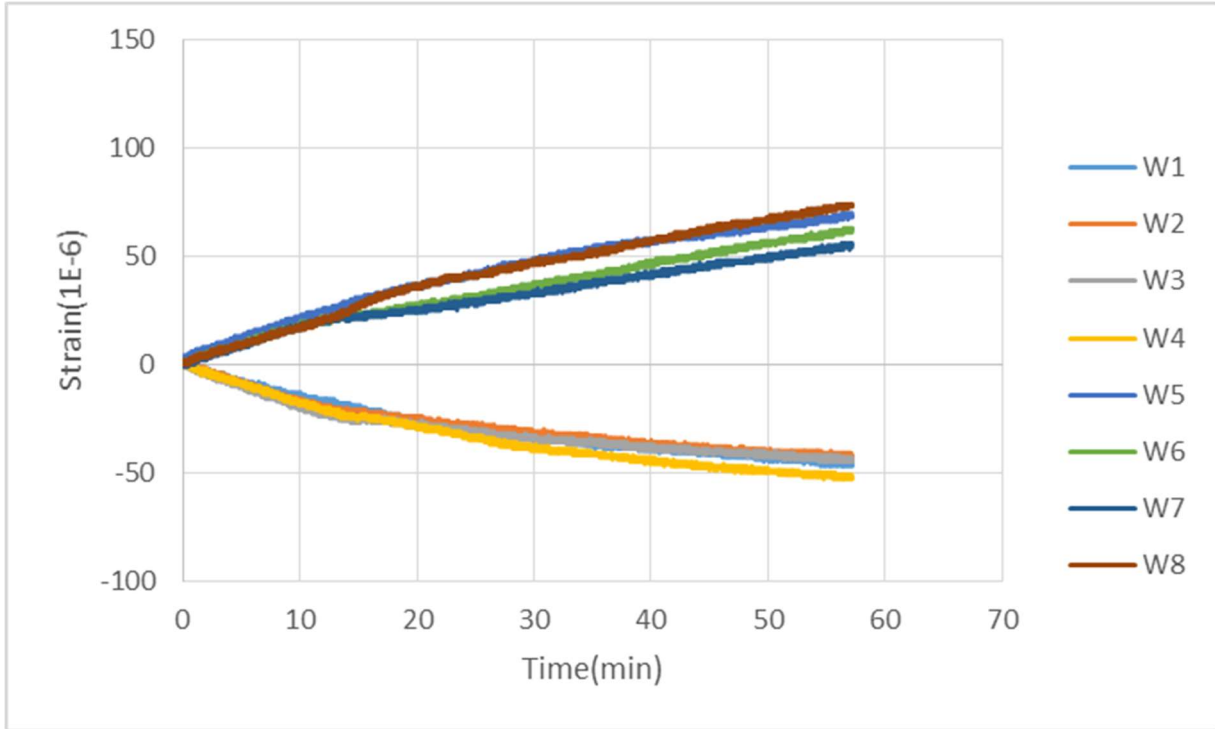
Figure 4-17: Strain-Time diagram of the strain gauges installed on wall reinforcements (W1 to W8) for the first cracking test of the UF joint

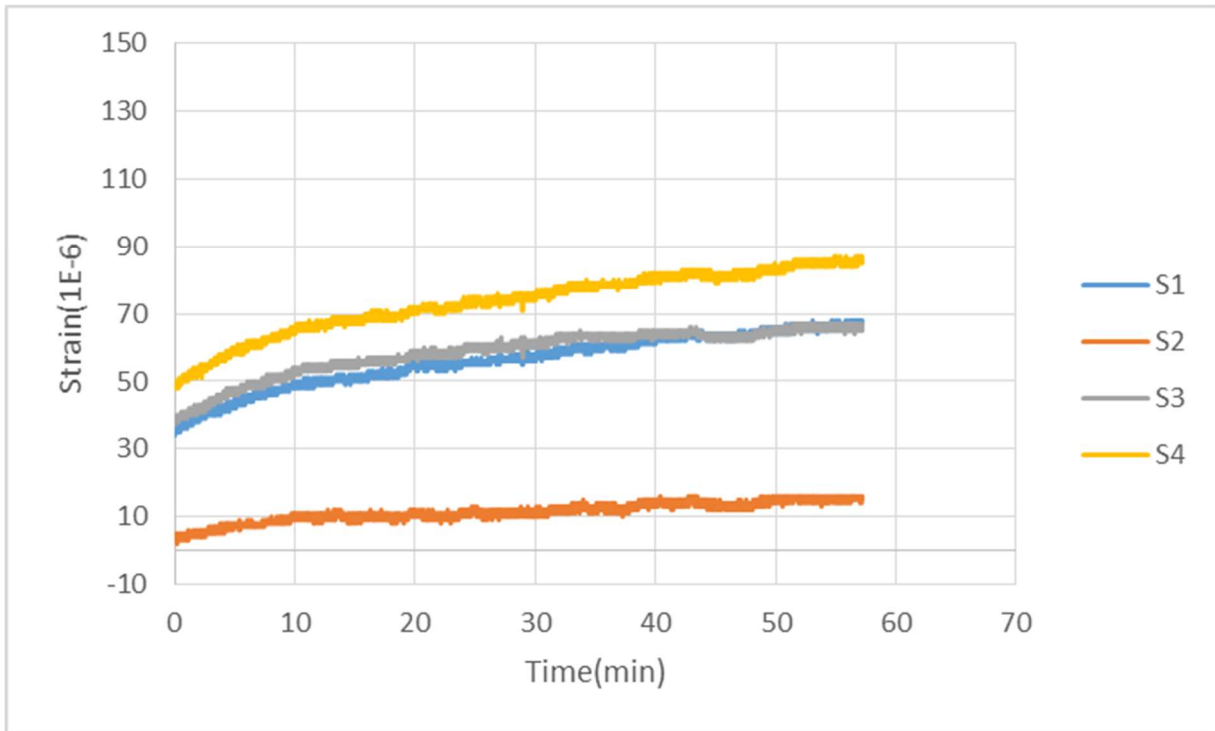
Figure 4-18: Strain-Time diagram of the strain gauges installed on slab reinforcement (S1 to S4) for the first cracking test of the UF joint
