A COMPARATIVE STUDY ON THE PERFORMANCE OF DIFFERENT TYPES OF WALL-SLAB CONNECTIONS IN LIQUID CONTAINING CONCRETE STRUCTURES

A thesis

presented to Ryerson University

Civil Engineering

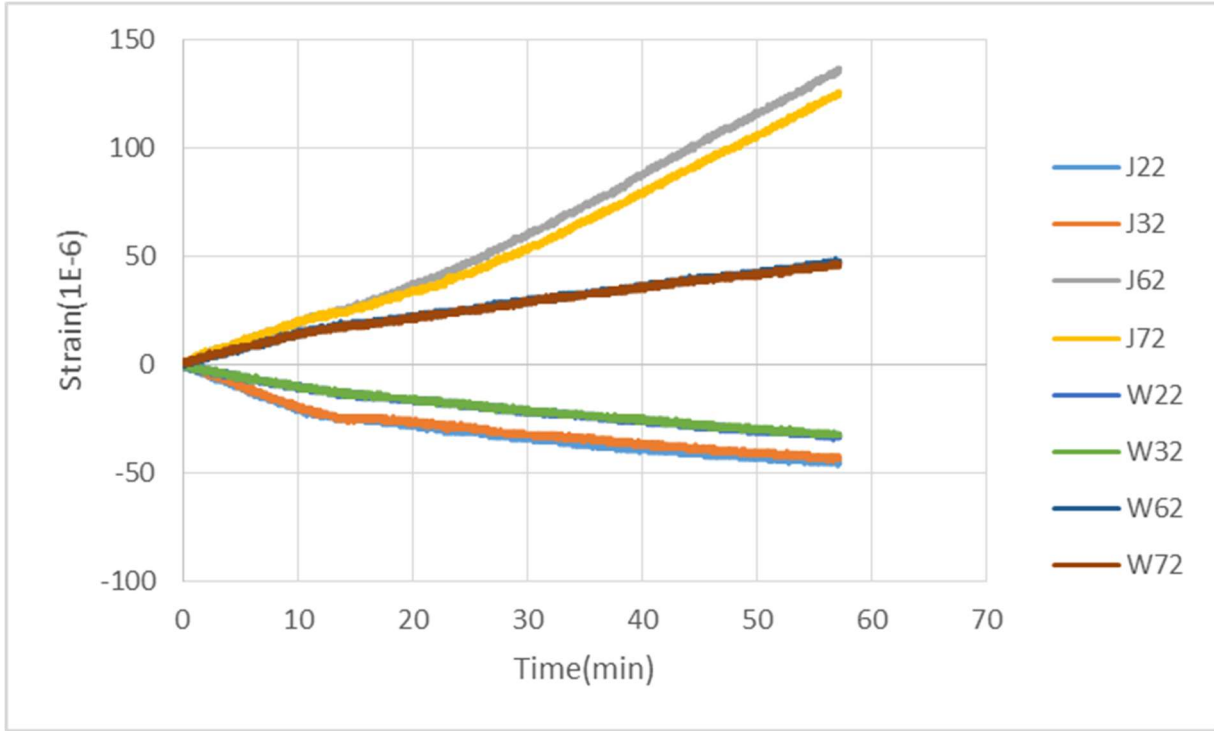
Figure 4-19: Strain-Time diagrams of the secondary strain gauges installed on dowels and wall reinforcements for the first cracking test of the UF joint

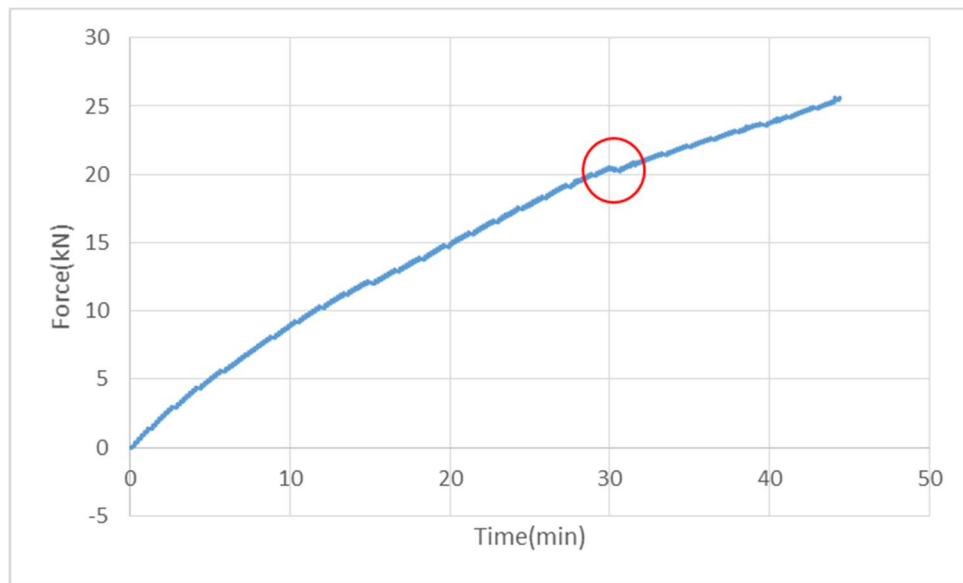
Figure 4-21: Force-Time diagram of the first cracking test of the CF joint

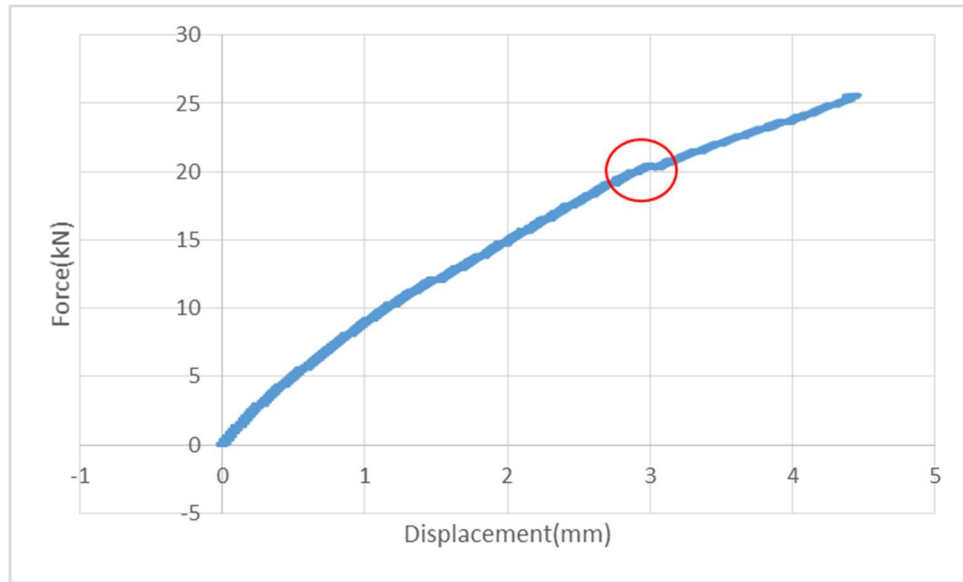
Figure 4-22: Force-Displacement diagram of the first cracking test of the CF joint

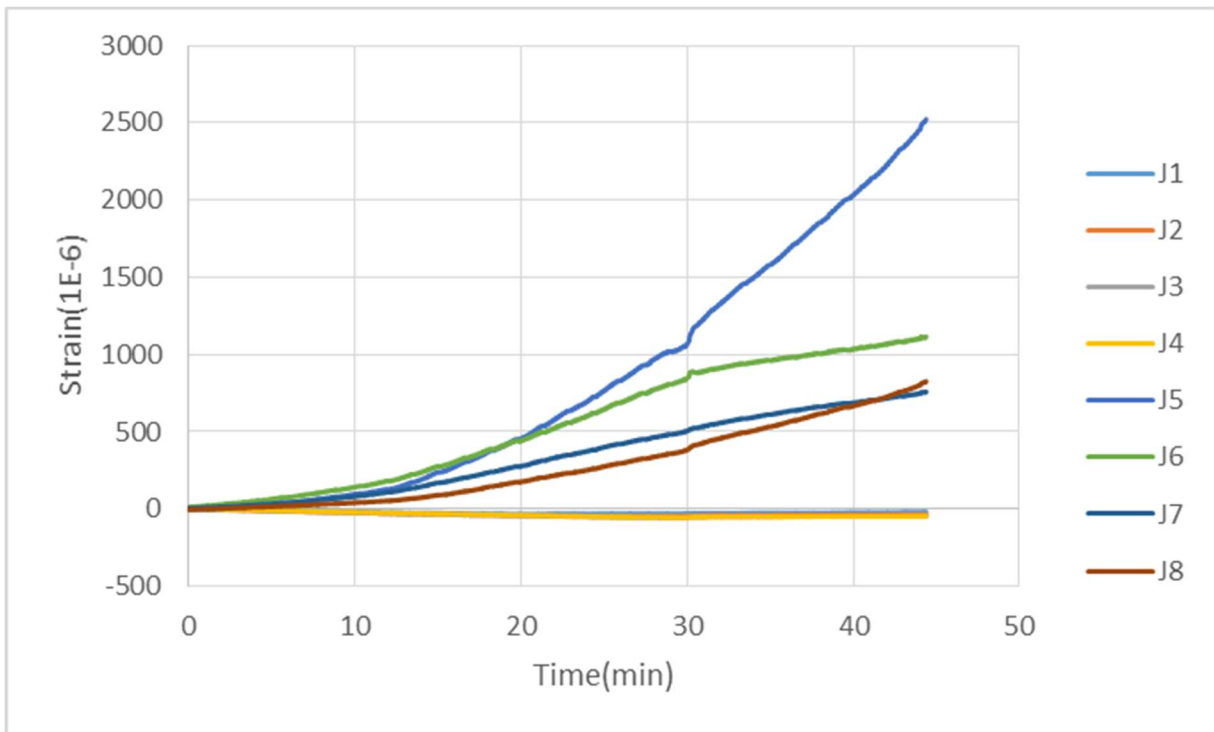
Figure 4-23: Strain-Time diagram of dowel strain gauges (J1 to J8) of the first cracking test of the CF joint

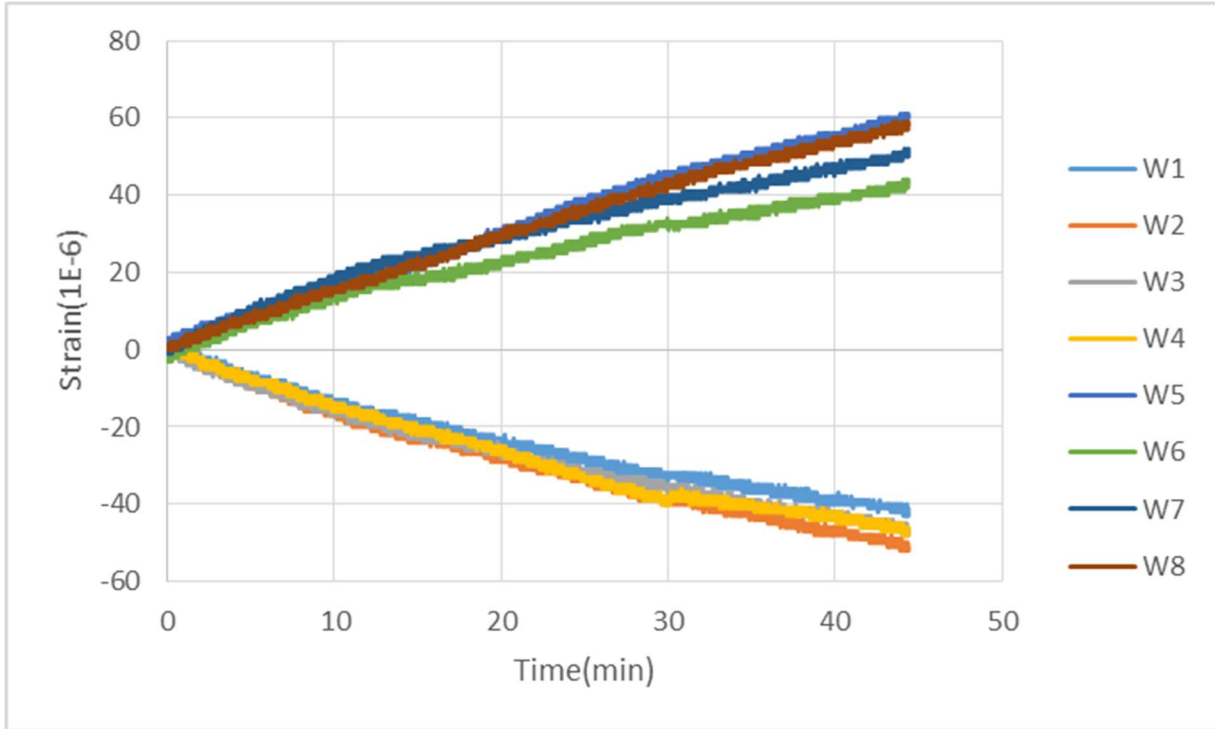
Figure 4-24: Strain-Time diagram of the strain gauges installed on wall reinforcements (W1 to W8) for the first cracking test of the CF joint

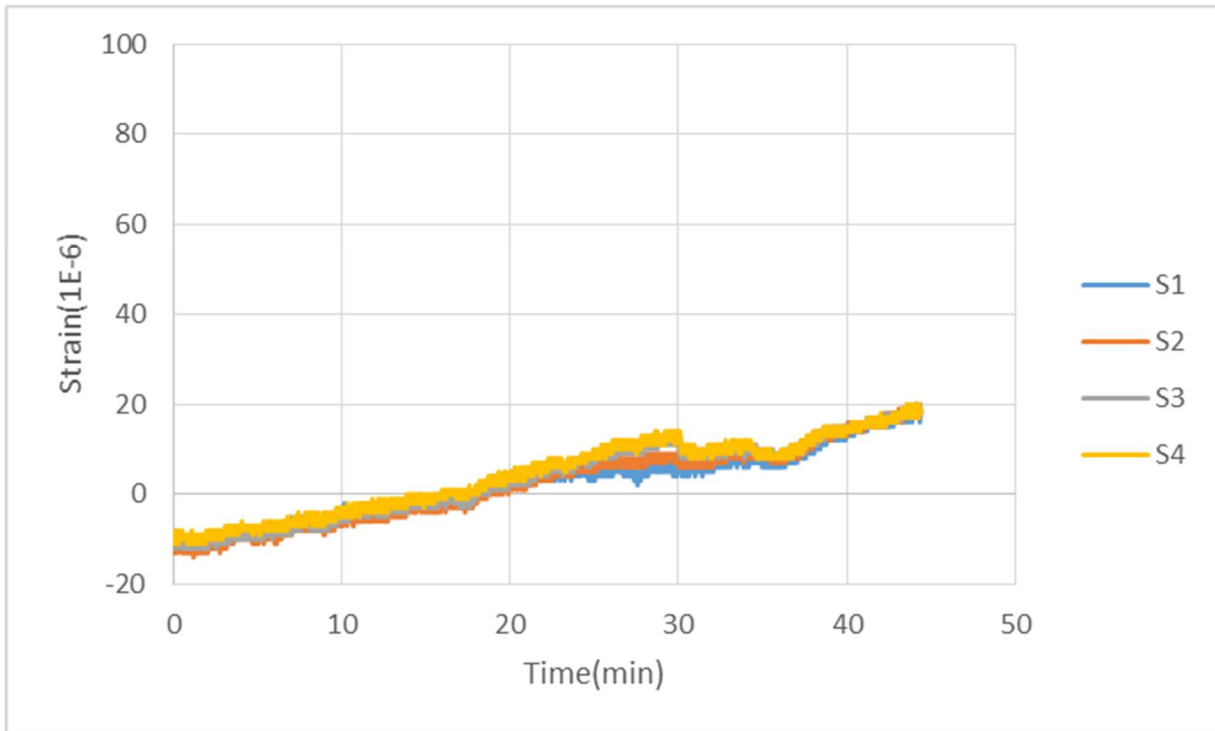
Figure 4-25: Strain-Time diagram of the strain gauges installed on slab reinforcement (S1 to S4) for the first cracking test of the CF joint

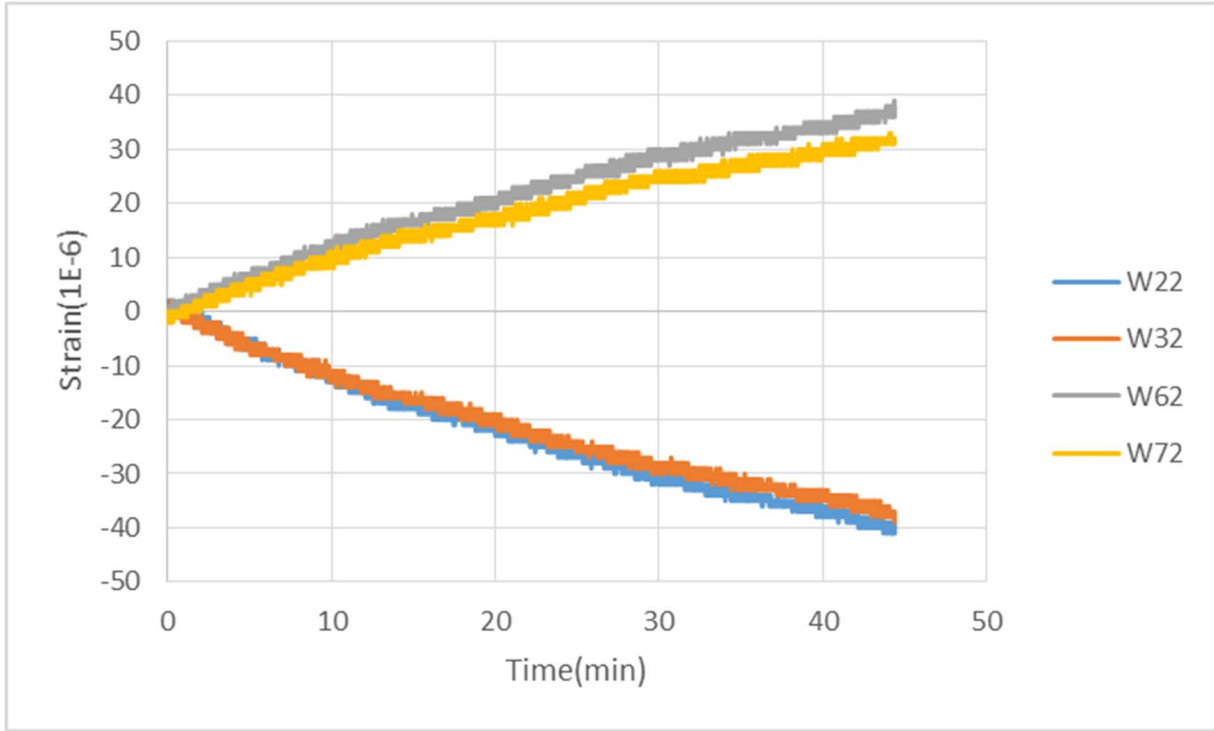
Figure 4-26: Strain-Time diagrams of the secondary strain gauges installed on dowels and wall reinforcements for the first cracking test of the CF joint

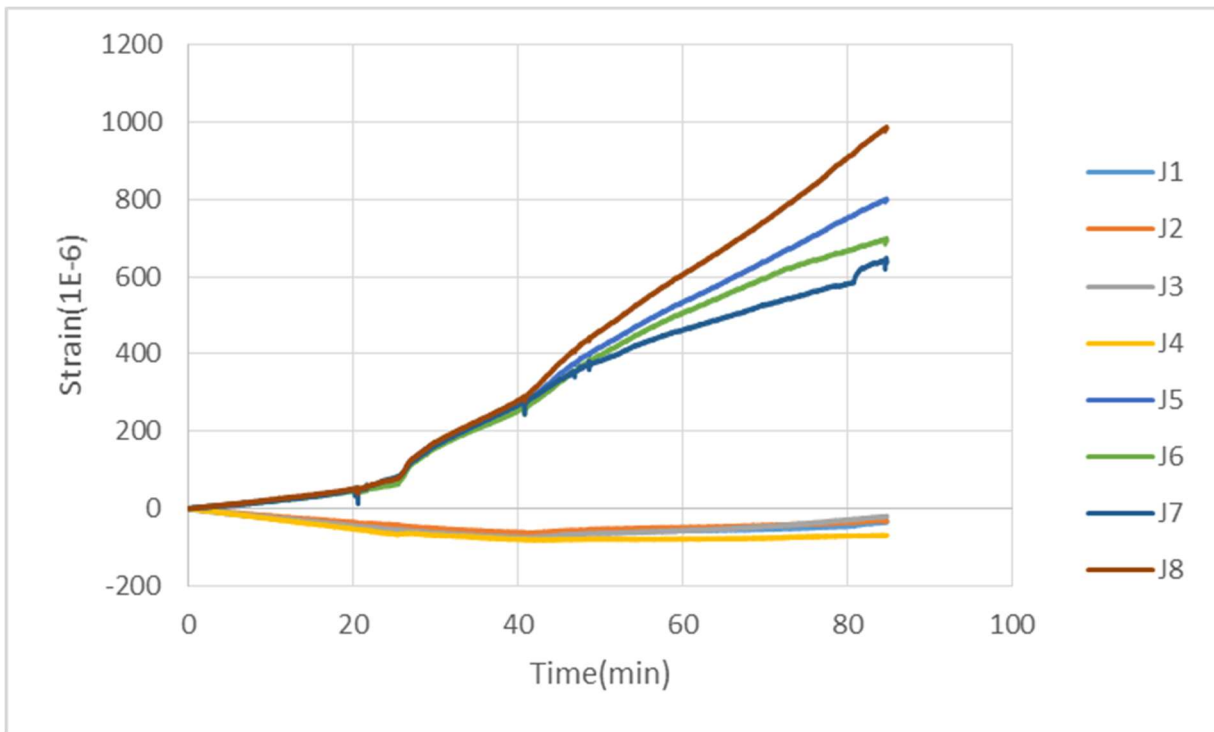
Figure 4-30: Strain-Time diagram of dowel strain gauges (J1 to J8) of the first cracking test of the CS joint

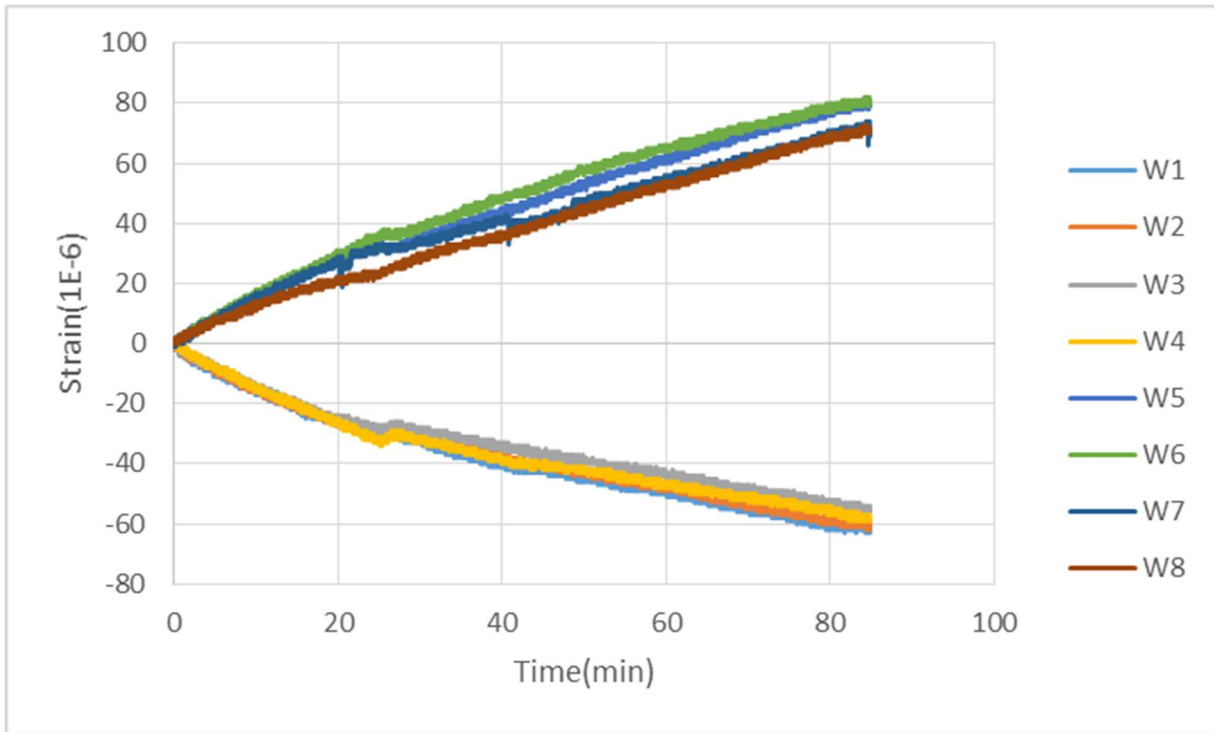
Figure 4-31: Strain-Time diagram of the strain gauges installed on wall reinforcements (W1 to W8) for the first cracking test of the CS joint

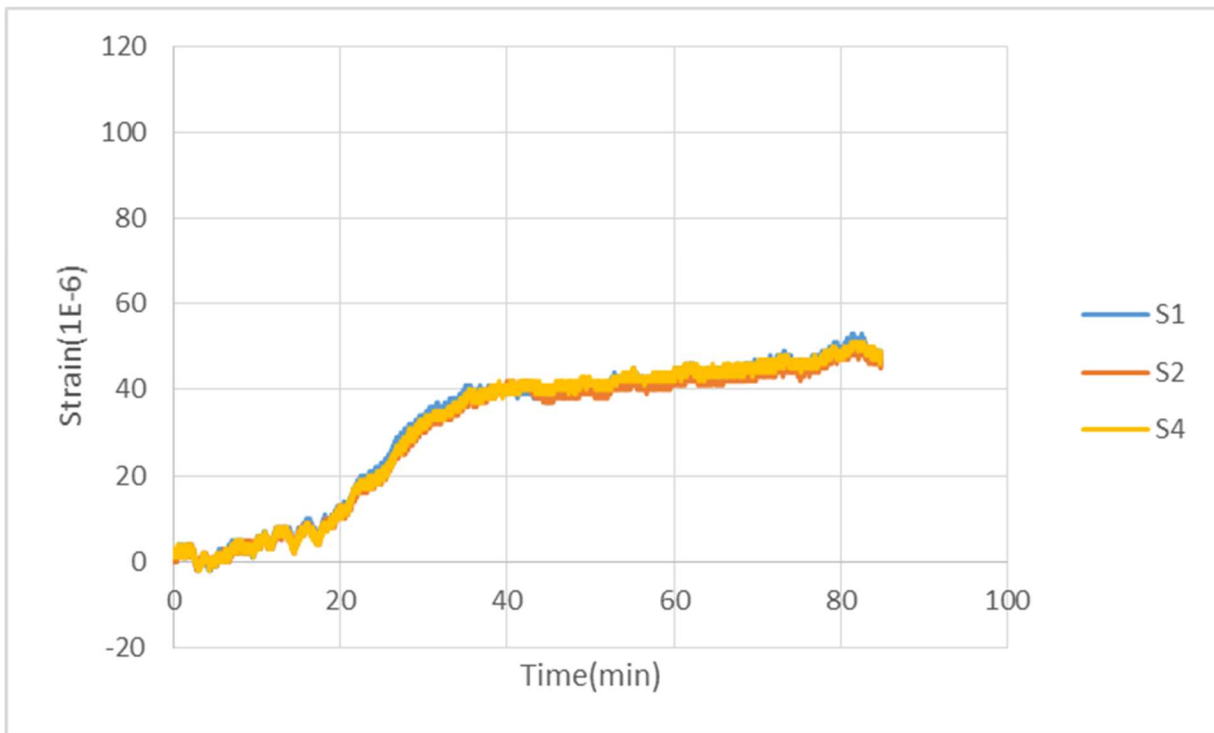
Figure 4-32: Strain-Time diagram of the strain gauges installed on slab reinforcement (S1 to S3) for the first cracking test of the CS joint

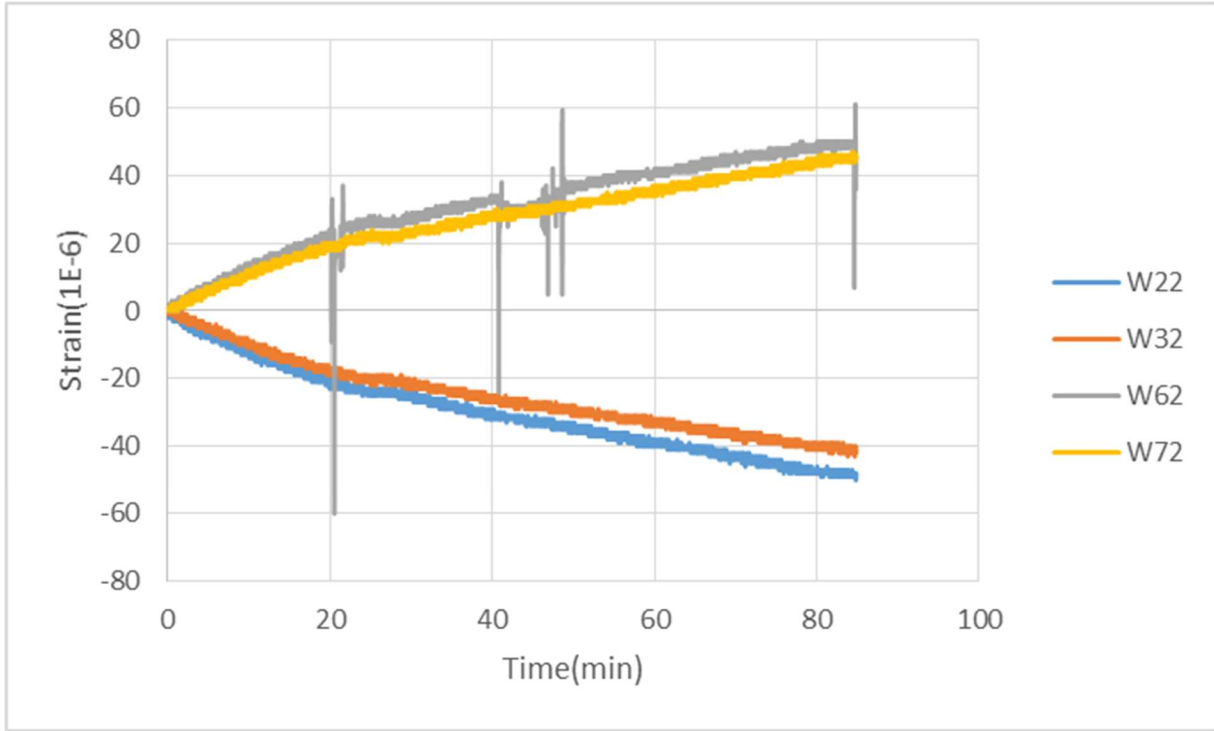
Figure 4-33: Strain-Time diagrams of the secondary strain gauges installed on dowels and wall reinforcements for the first cracking test of the CS joint

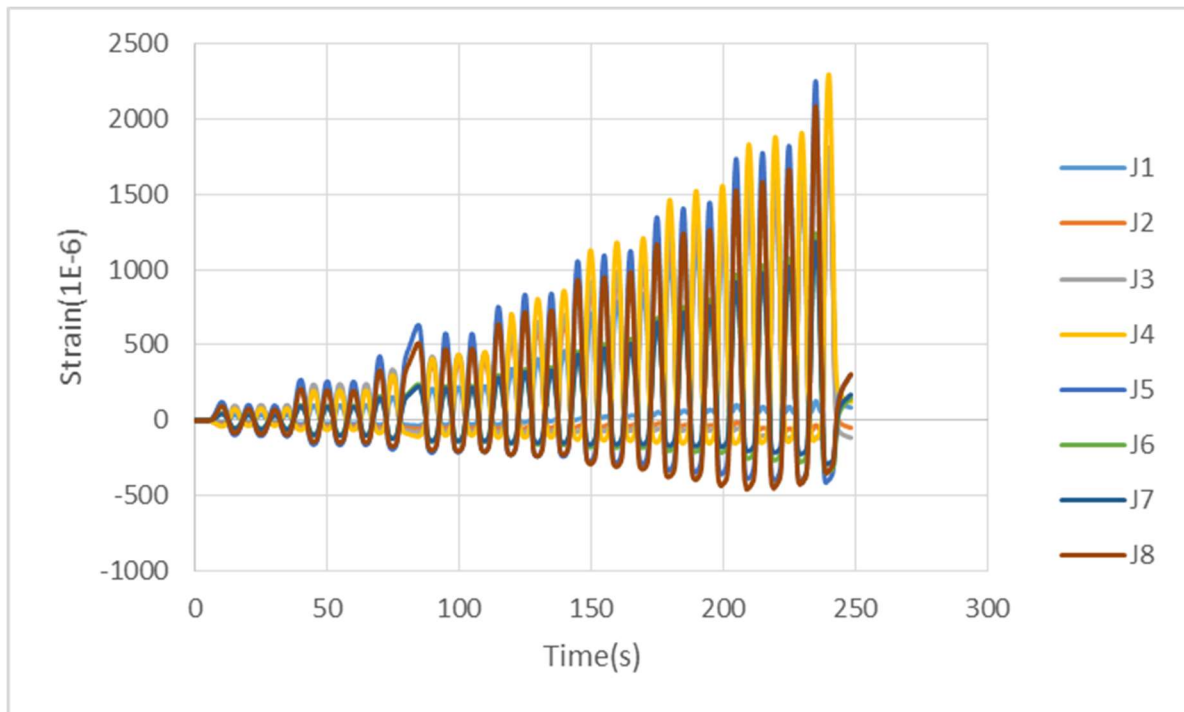
Figure 4-37: Strain-Time diagram of dowel strain gauges (J1 to J8) of the leakage test of the US joint

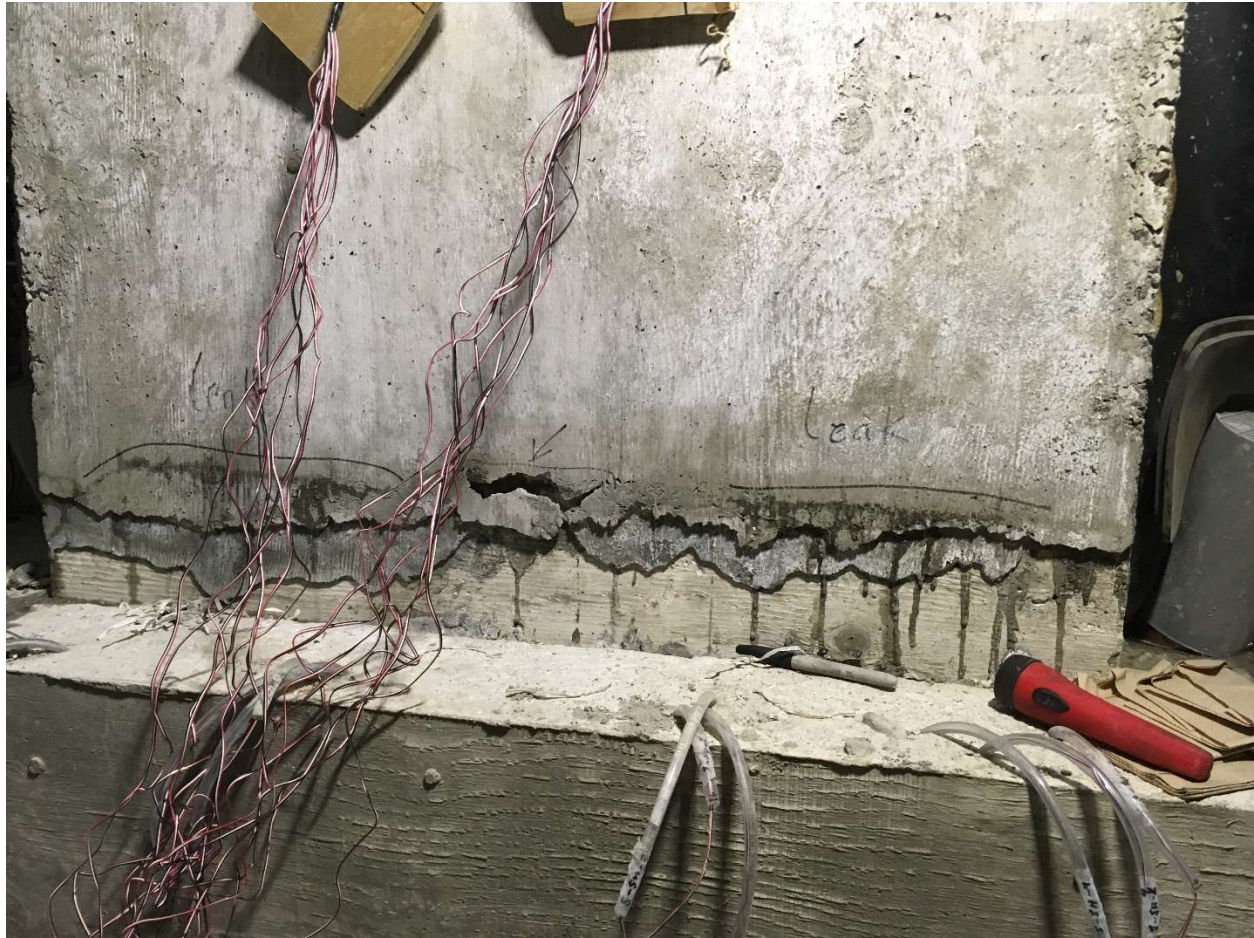
Figure 4-38: Occurrence of leakage at the end of the leakage test of the US joint

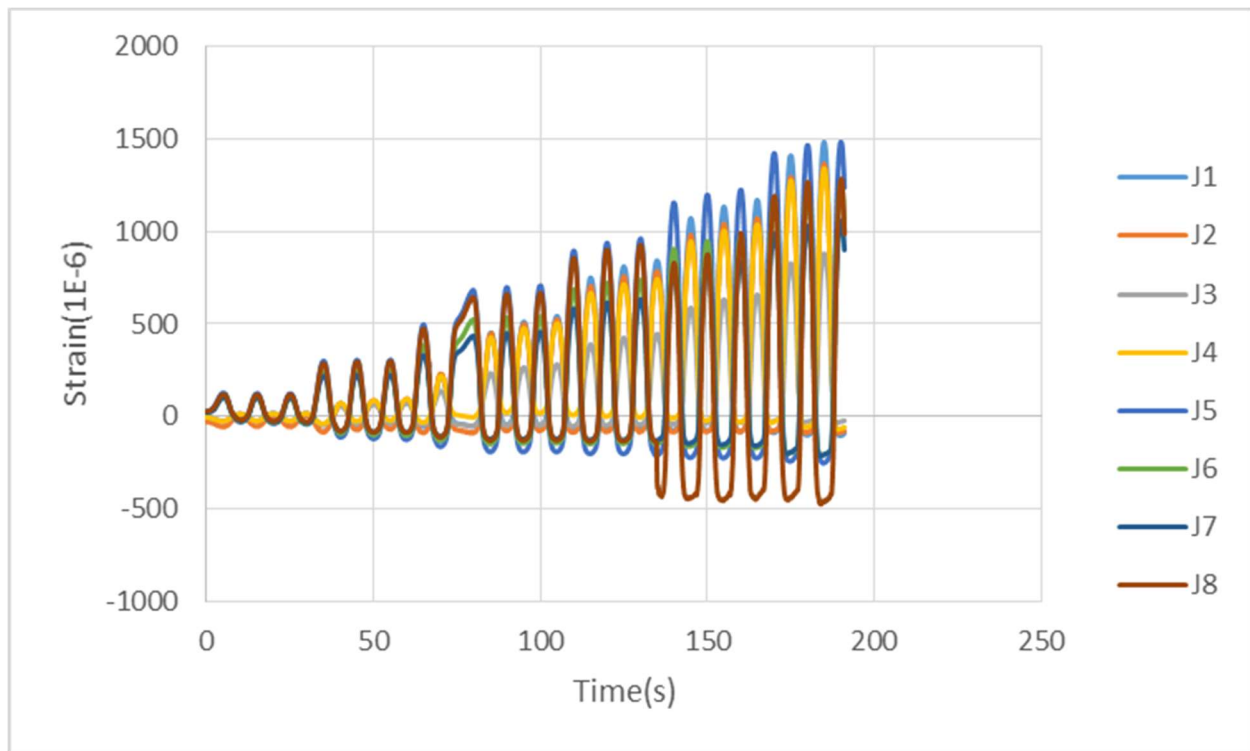
Figure 4-42: Strain-Time diagram of dowel strain gauges (J1 to J8) of the leakage test of the UF joint

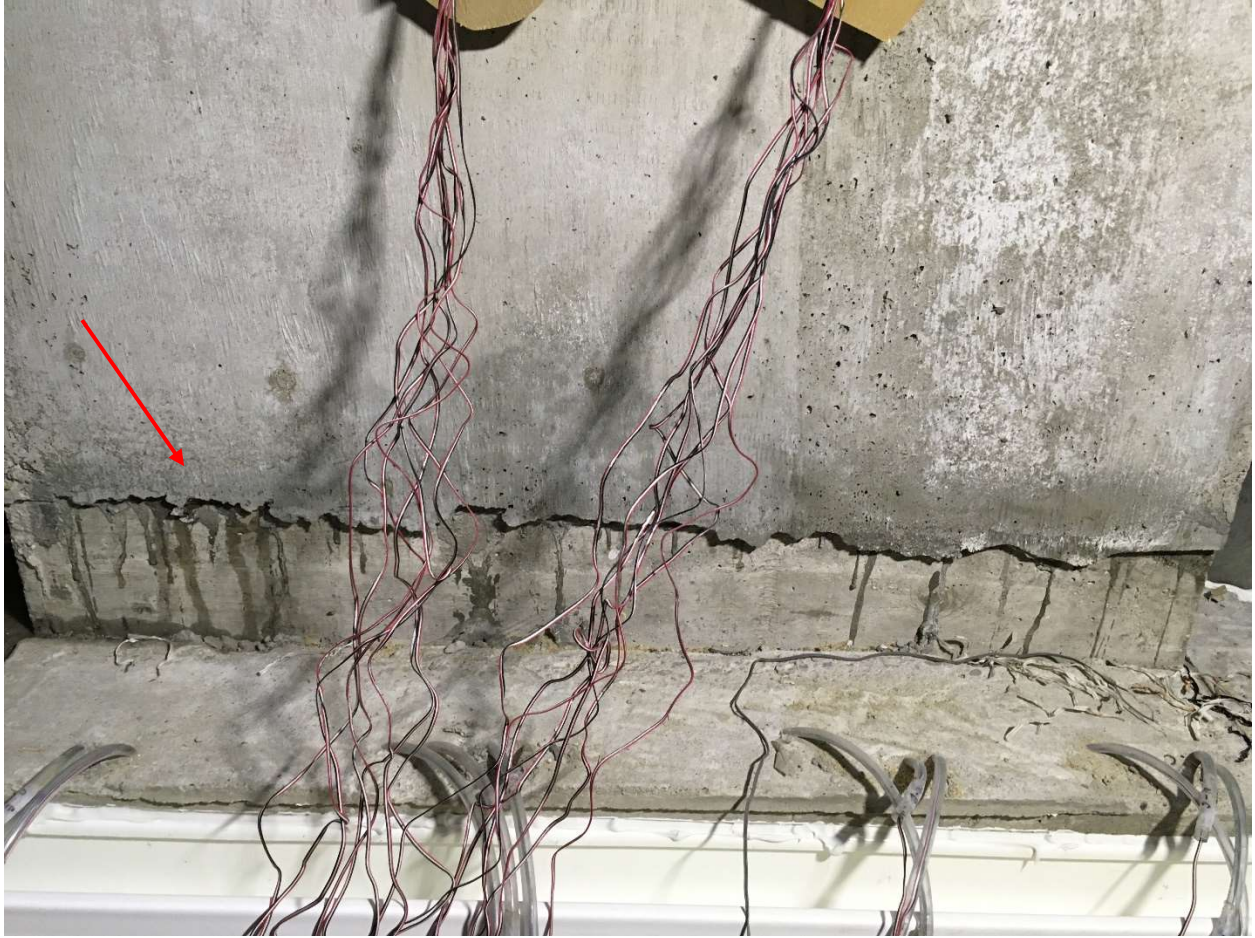
Figure 4-43: Occurrence of leakage at the end of the leakage test of the UF joint

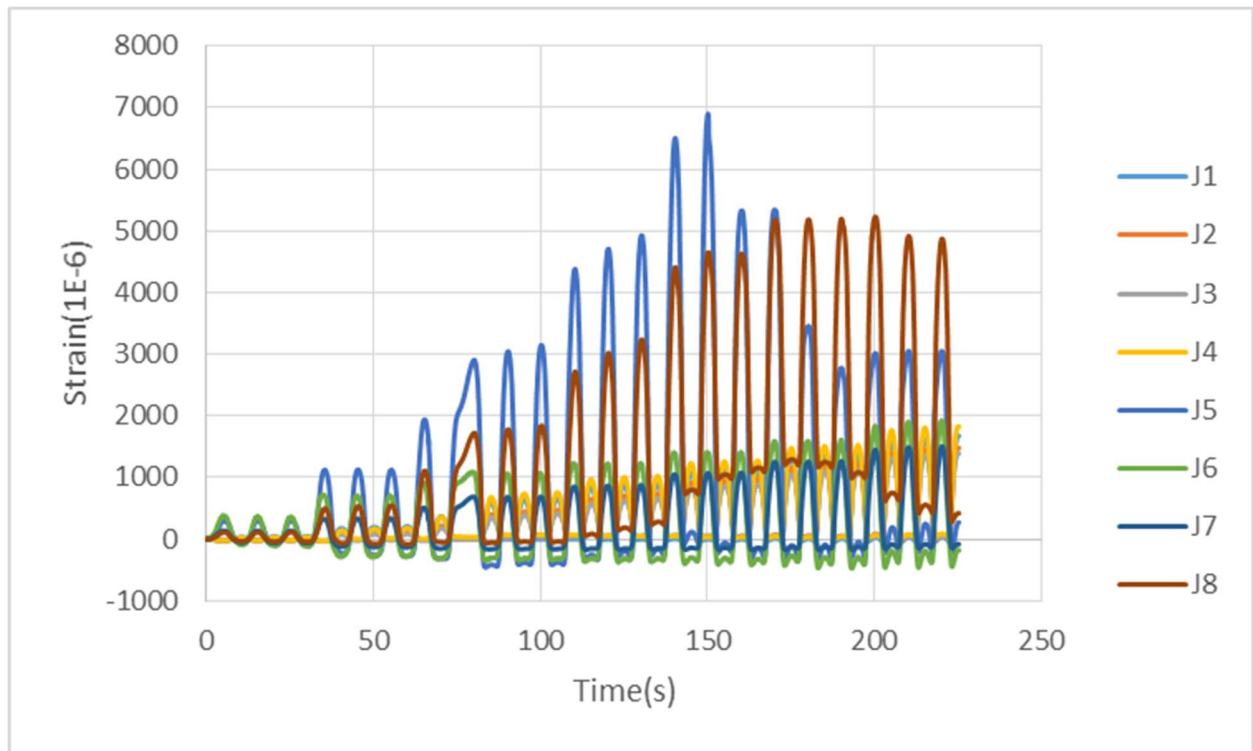
Figure 4-47: Strain-Time diagram of dowel strain gauges (J1 to J8) of the leakage test of the CF joint

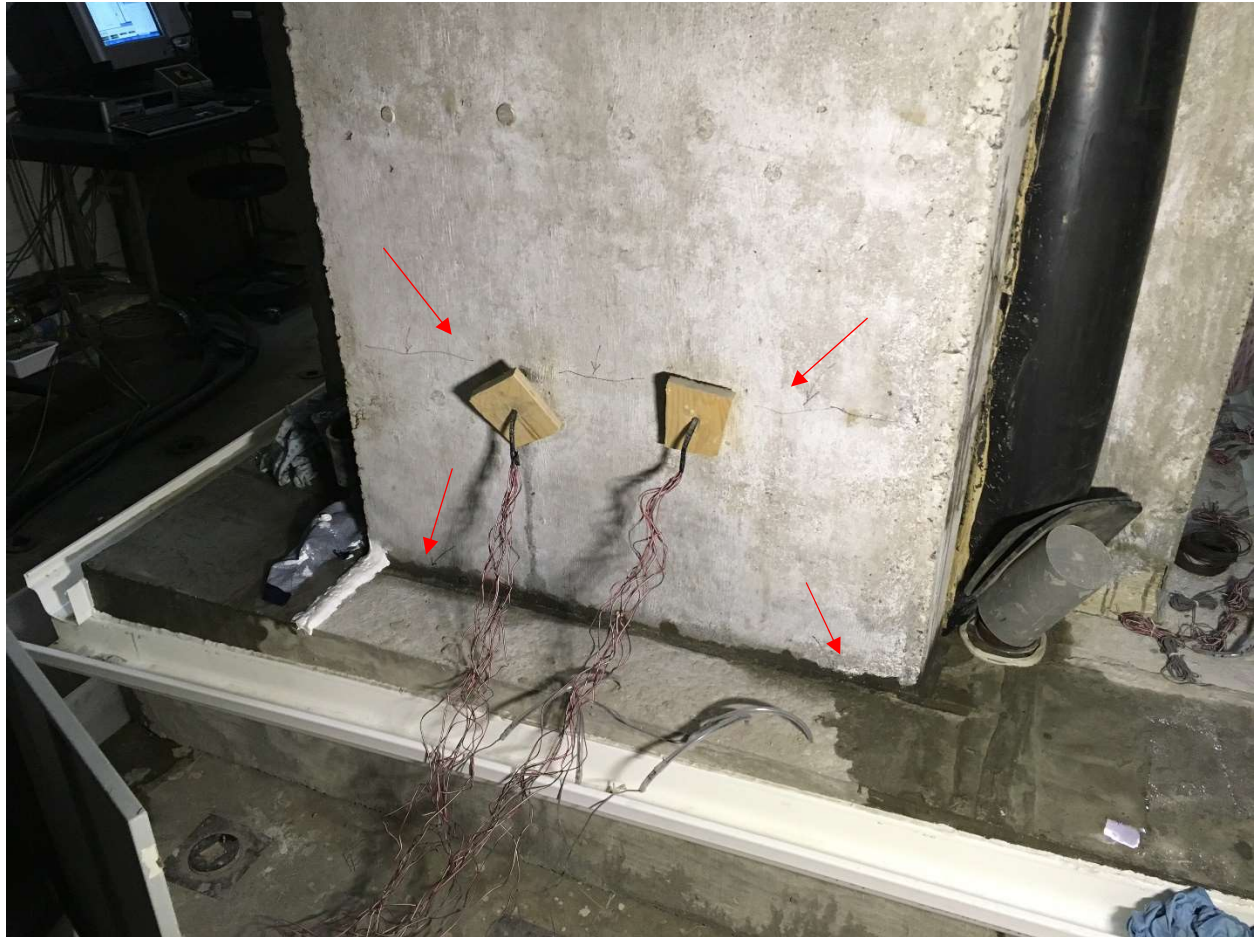
Figure 4-48: Formation of cracks at the end of the leakage test of the CF joint

at the two corners of the wall. Also, it is important to mention that the CF joint was the only joint for which during the leakage test, a secondary crack line was formed at the location of rebar splices (at the end of dowels) through which leakage was also observed in addition to the cracks formed at the joint location. This was probably due to the high stiffness of the wall-slab connection, which caused higher magnitudes of stress to develop in the dowel reinforcements which resulted in the secondary line of cracking at the splice location.

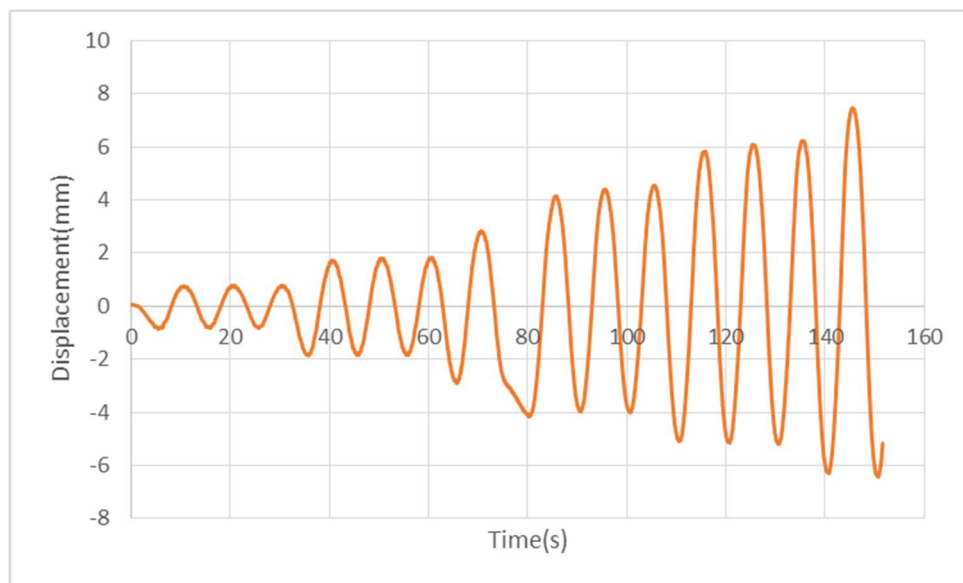
Figure 4-50: Displacement-Time diagram of the leakage test of the CS joint

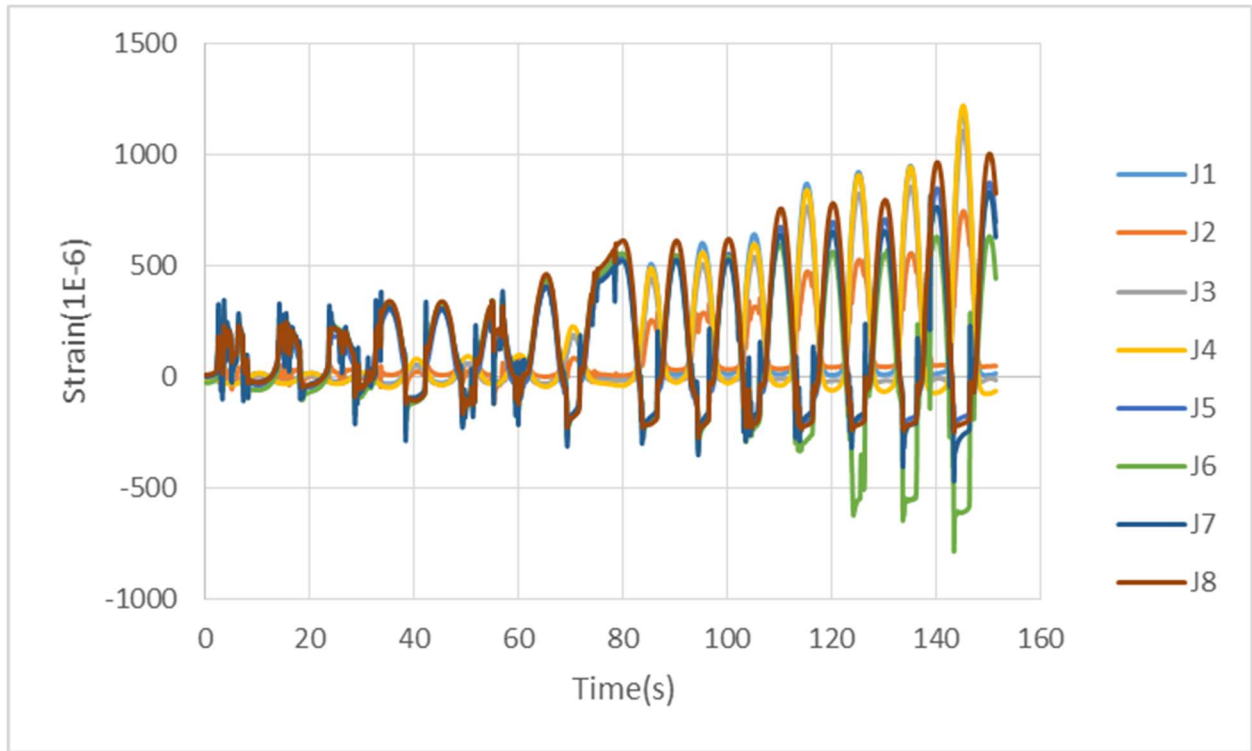
Figure 4-52: Strain-Time diagram of dowel strain gauges (J1 to J8) of the leakage test of the CS joint

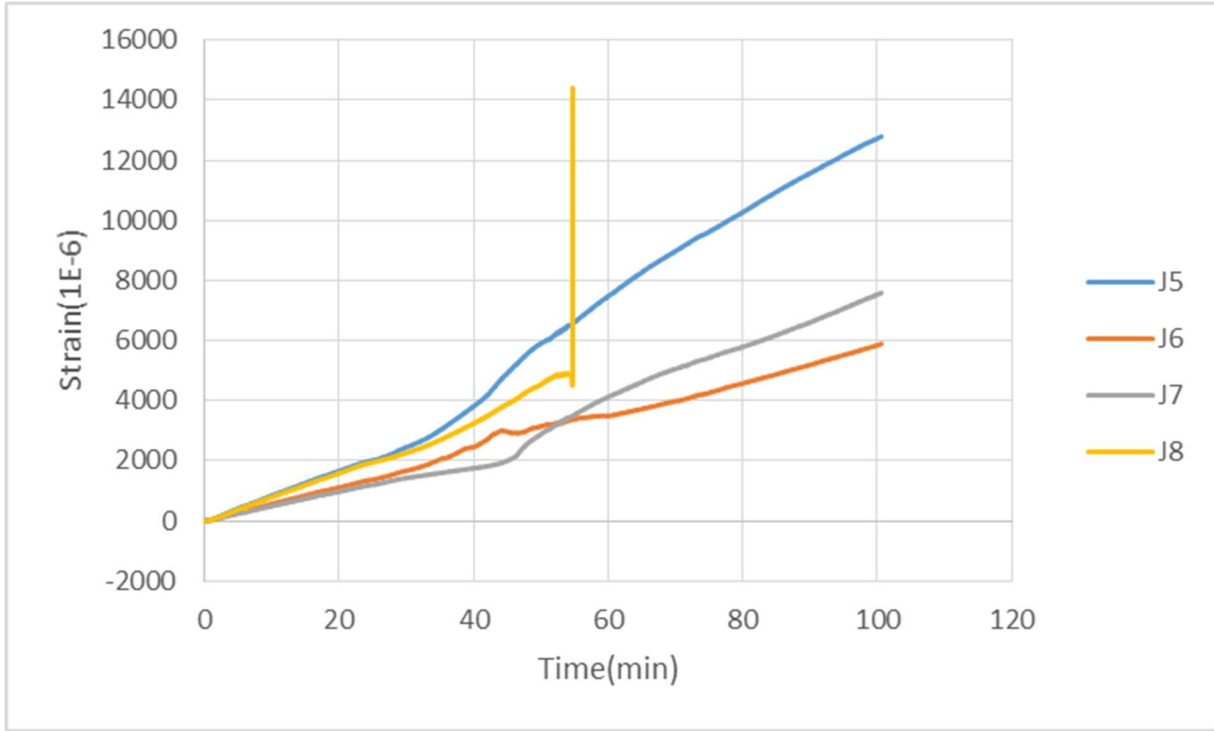
Figure 4-57: Strain-Time diagram of dowel strain gauges (J5 to J8) of the limit state test of the US joint

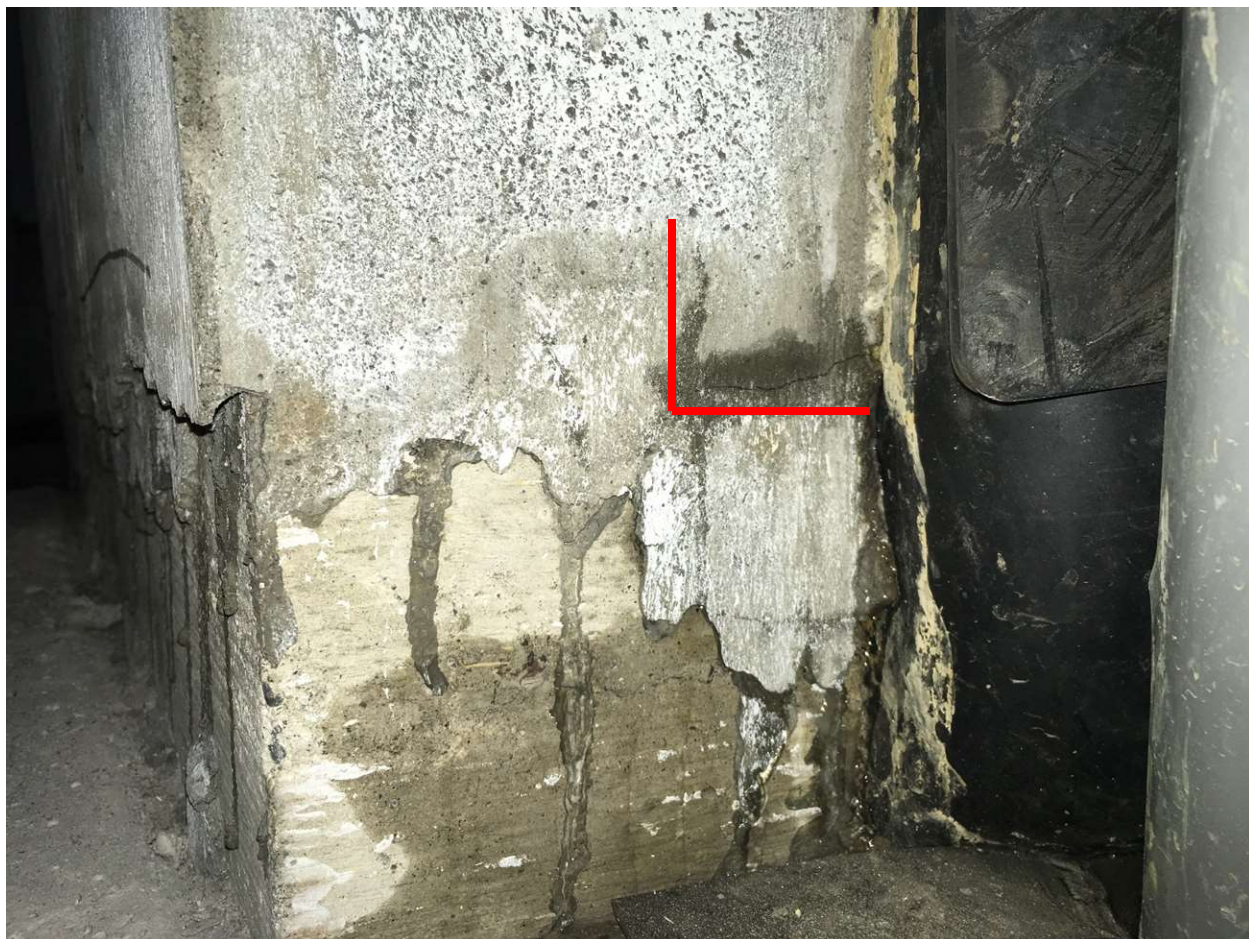
Figure 4-58: Formation of cracks on the outline of the shear key in the US joint

One of the key observations near the end of this test was the formation of cracks on the upturn part. These cracks developed on the tension side of the upturn key, at force and displacement values of 57kN and 26mm respectively (Figure 4-59). Near the end of the test, at force and displacement values of 63kN and 36mm, these cracks were extended deeper into the section such that only 42mm of concrete was left as the compression zone (Figure 4-60). Also, as it can be seen in Figure 4-60, the measured depth of the compression zone (42mm) at ultimate state, is consistent with the results of the analytical study.

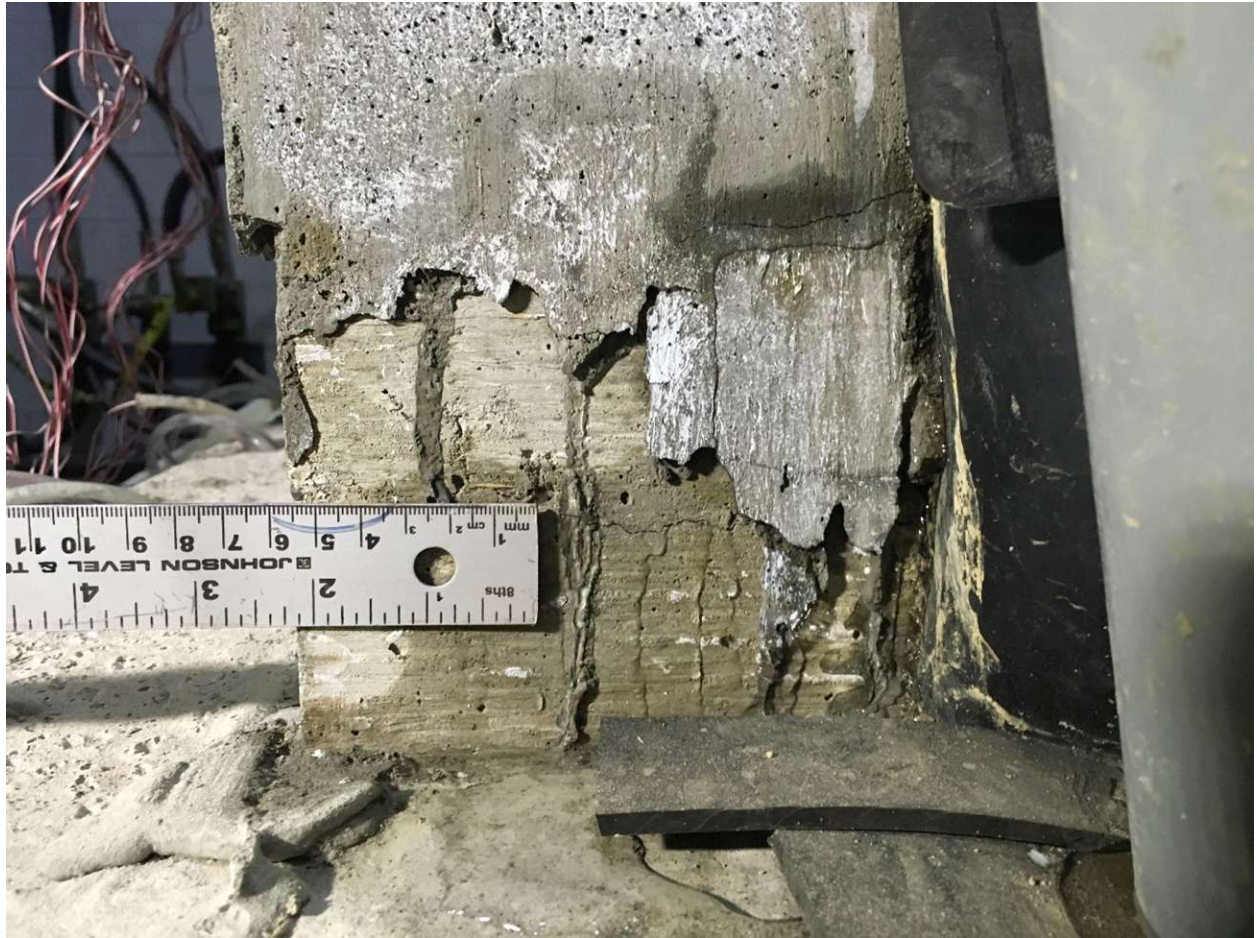
Figure 4-59: Formation of cracks on the tension side of the upturn key

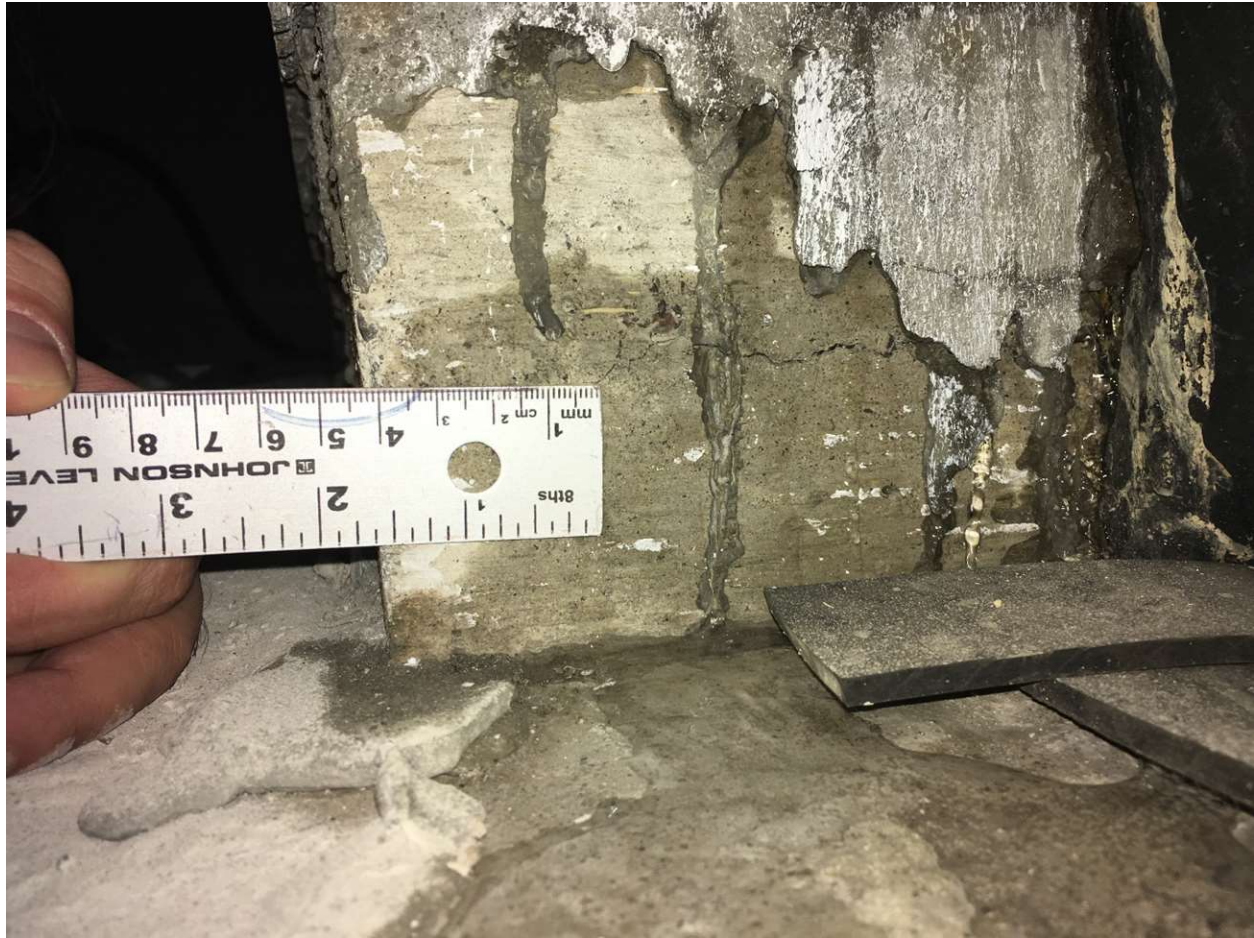
Figure 4-60: Extensive cracking in the upturn part near the end of the test

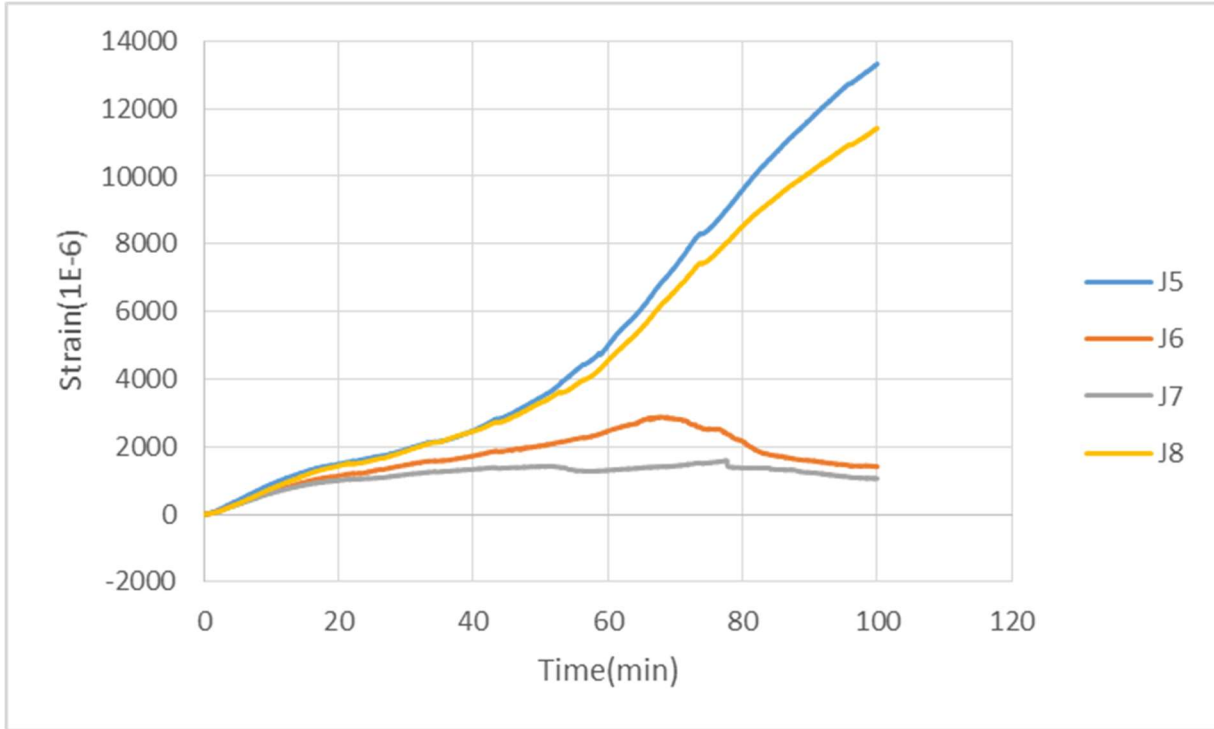
Figure 4-65: Strain-Time diagram of dowel strain gauges (J5 to J8) of the limit state test of the UF joint
