A COMPARATIVE STUDY ON THE PERFORMANCE OF DIFFERENT TYPES OF WALL-SLAB CONNECTIONS IN LIQUID CONTAINING CONCRETE STRUCTURES

A thesis

presented to Ryerson University

Civil Engineering

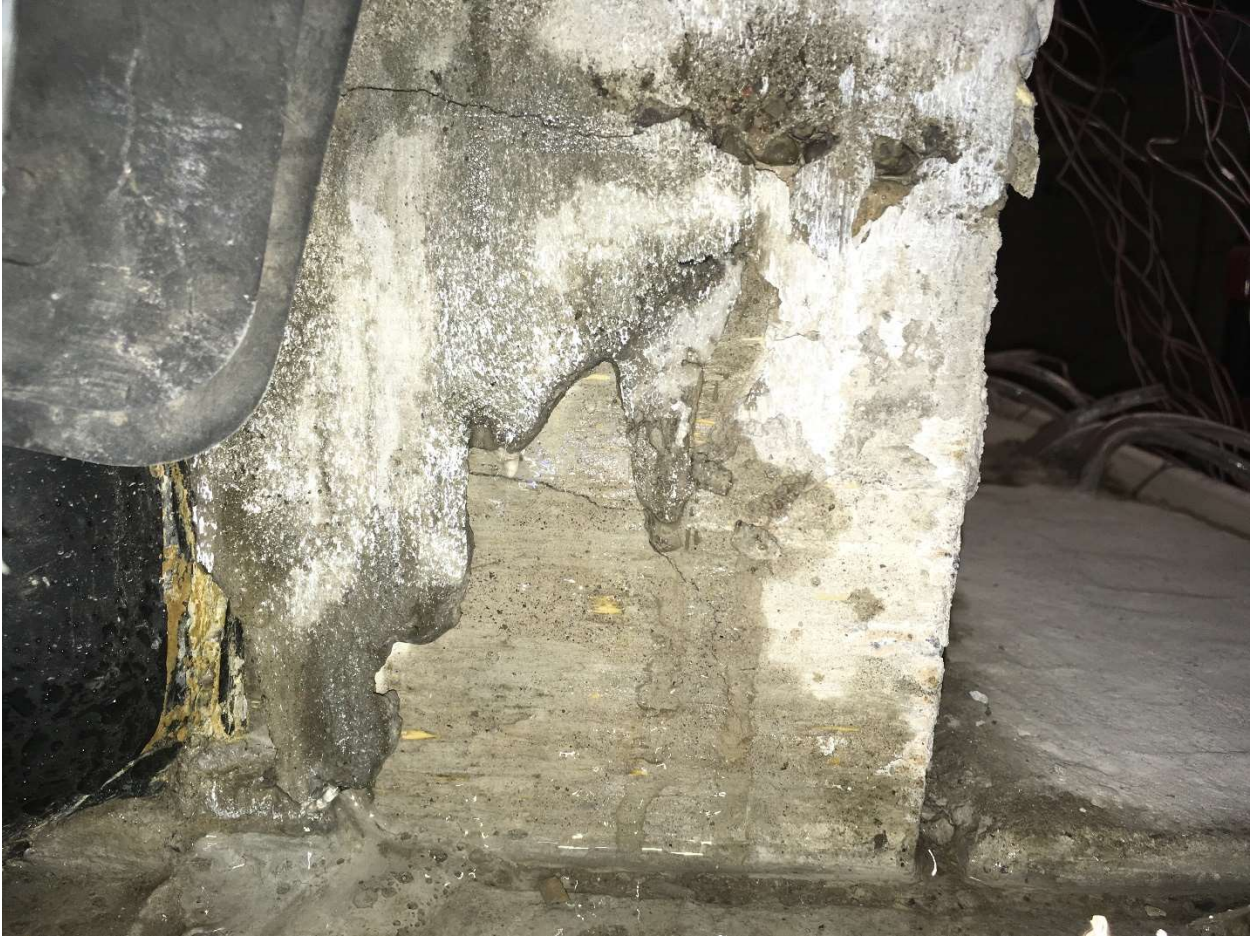
Figure 4-66: Formation of cracks along the construction joint.

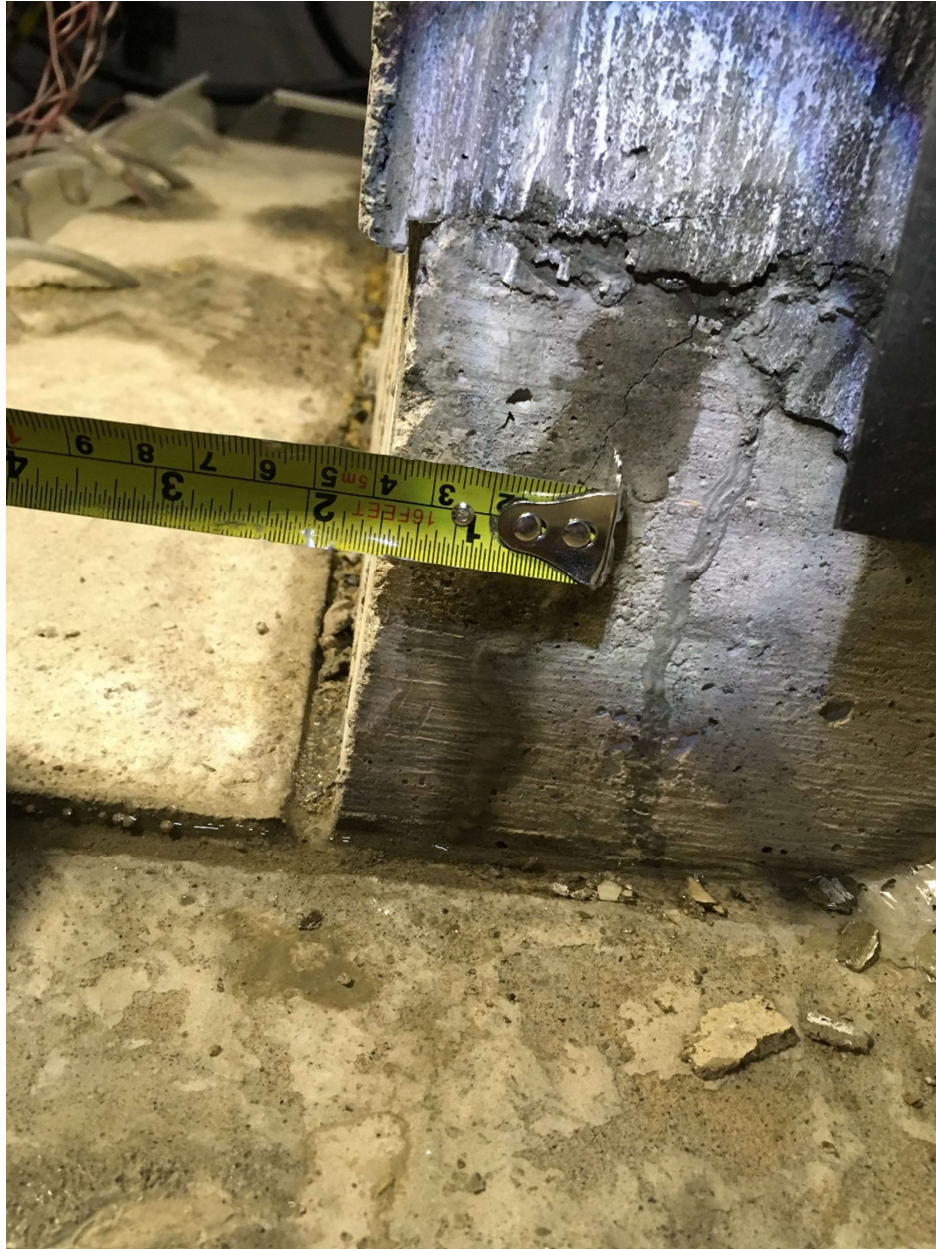
Figure 4-67: Formation of vertical cracks on the compression side of the upturn part

Important observations during this test include the formation of cracks on the compression side of the upturn part. The cracks formed along an almost vertical path and could be due to crushing of the concrete (Figure 4-67). The development of cracks happened at lateral force of 59.5kN and 41mm deflection. It is safe to speculate that on the compression side, the bearing capacity of the concrete in upturn part, which is in fact acting as a column for the wall, was exceeded, which led to the formation of the vertical cracks. Expectedly, cracks were also formed along the joint between the wall and the upturn part (Figure 4-66). Also, after the formation of the plastic hinge at the bottom, additional cracks were formed along the height of the wall as a result of moment redistribution. During this test, leakage was observed through the cracks on the sides of the wall, but no leakage was seen through the compression zone.

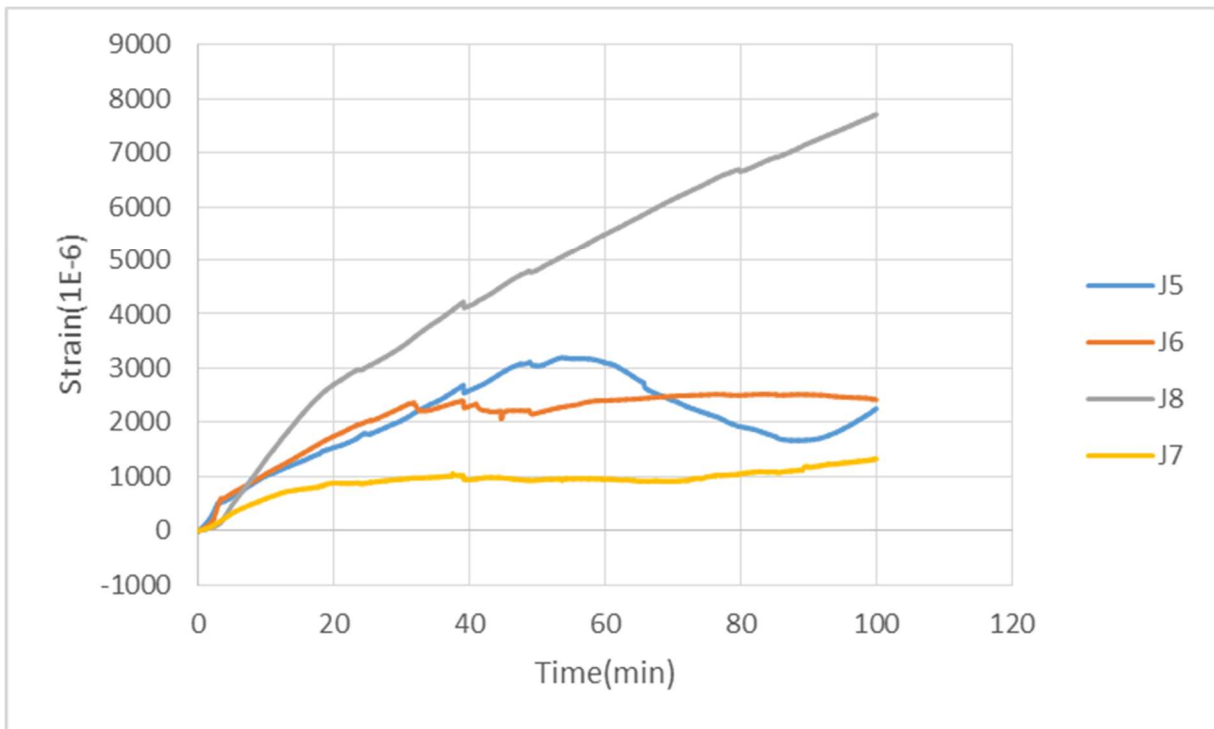
Figure 4-72: Strain-Time diagram of dowel strain gauges (J5 to J8) of the limit state test of the CF joint

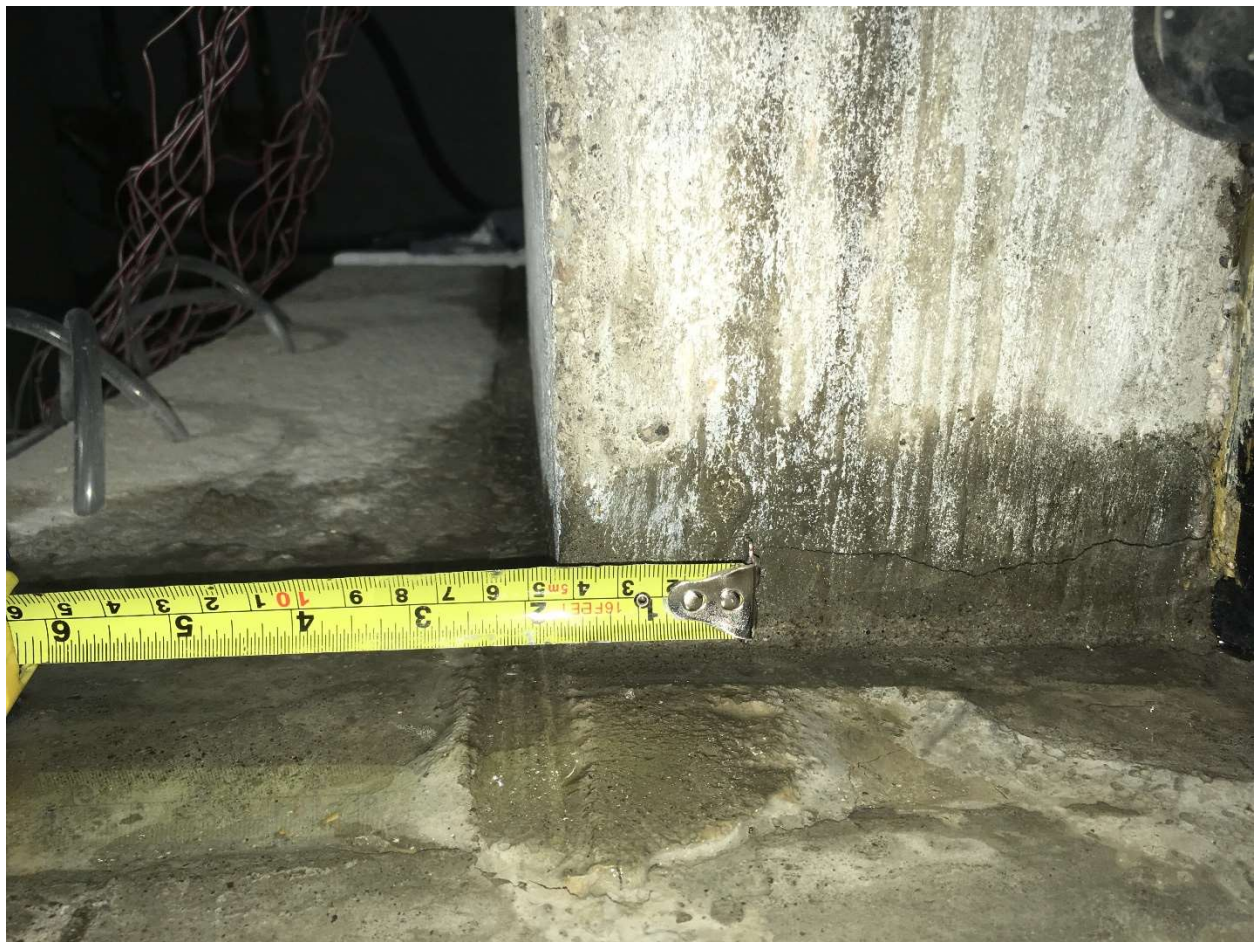
Figure 4-73: Formation of cracks along the joint between the wall and the base slab

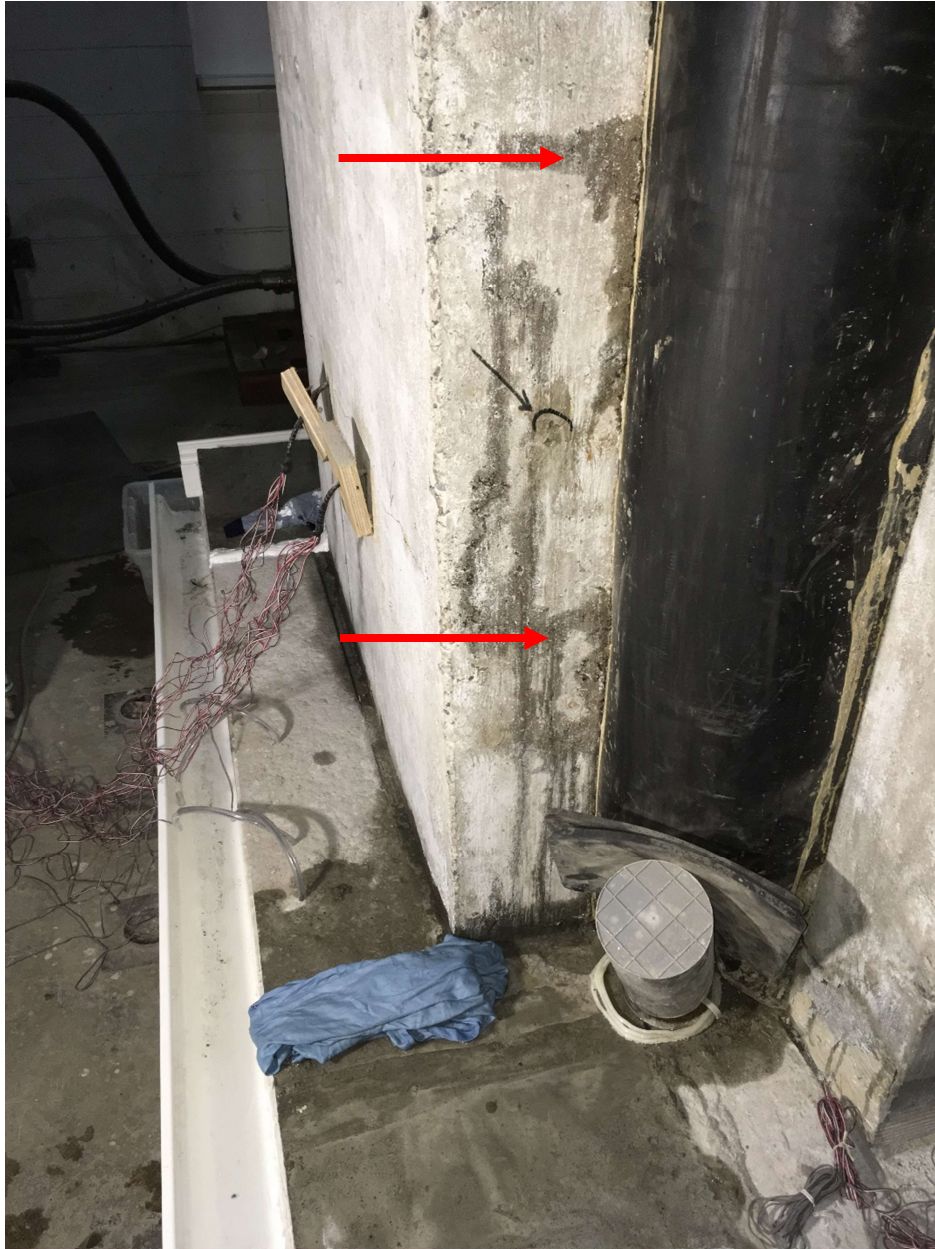
Figure 4-74: Formation of additional cracks along the height of the wall

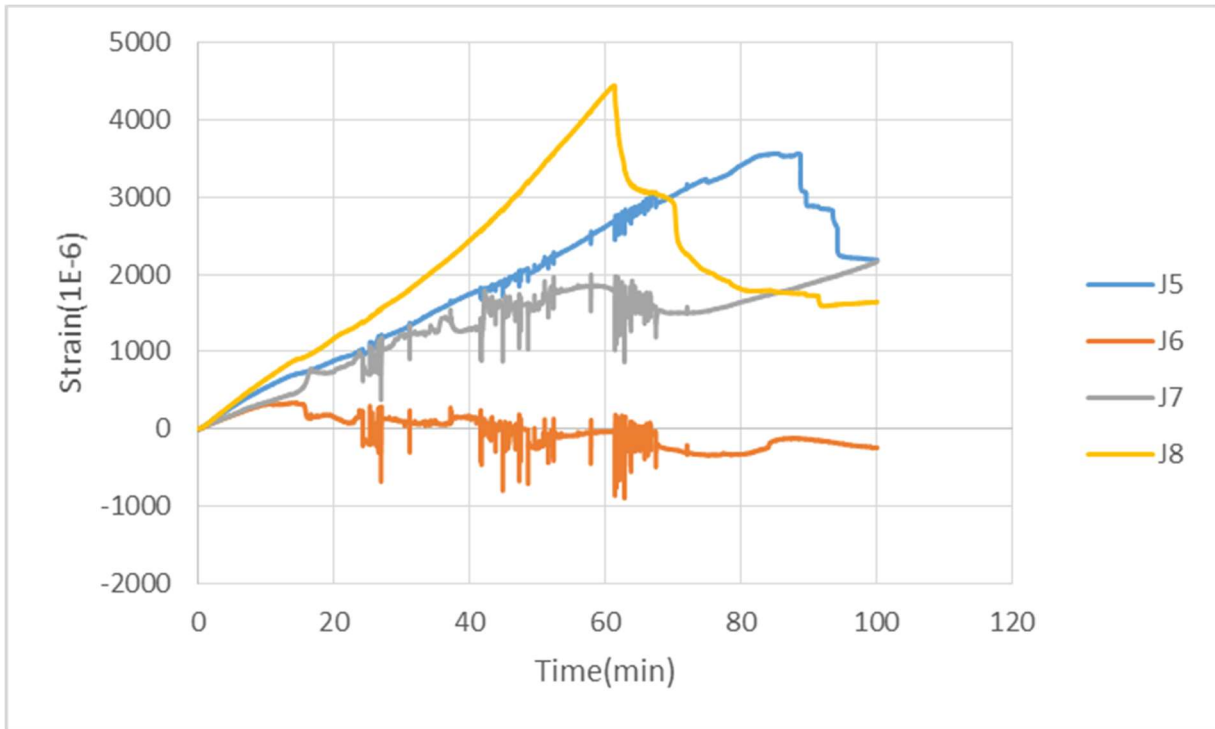
Figure 4-79: Strain-Time diagram of dowel strain gauges (J5 to J8) of the limit state test of the CS joint

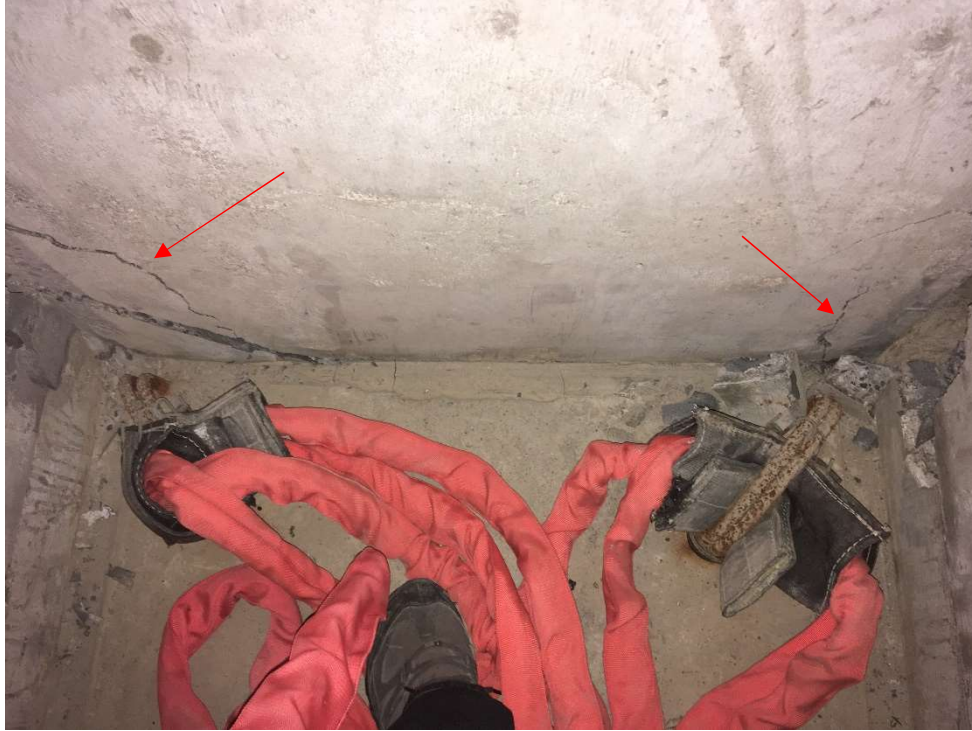
Figure 4-94: Cracking of concrete near the corners on the back of the wall at the end of the collapse test of the CF joint

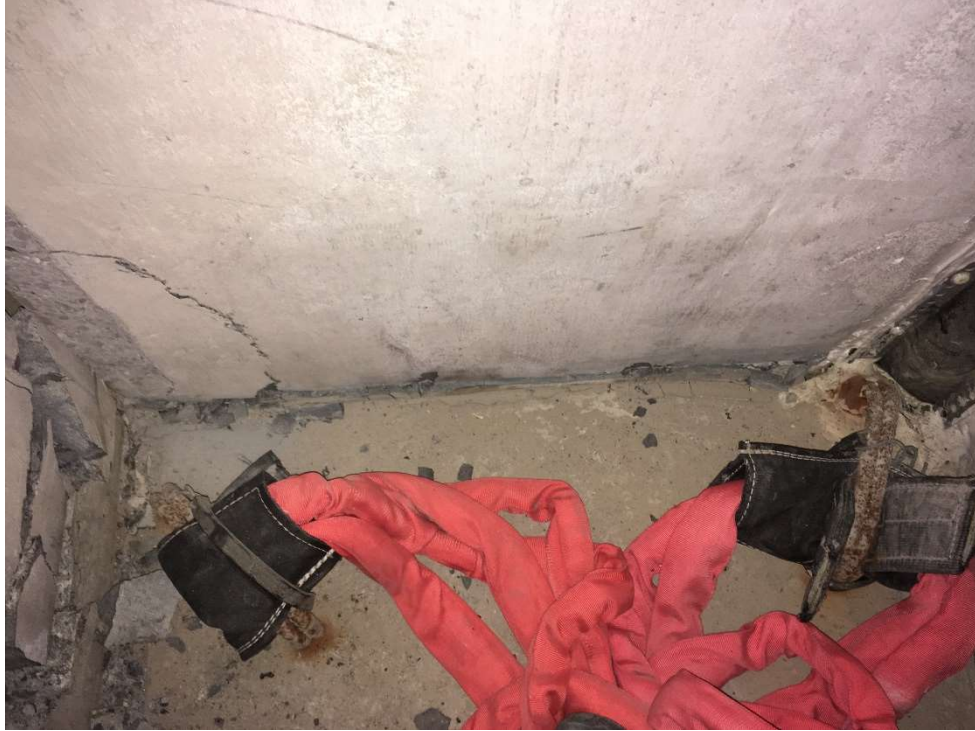
Figure 4-99: Cracking of concrete near the corners on the back of the wall at the end of the collapse test of the CS joint

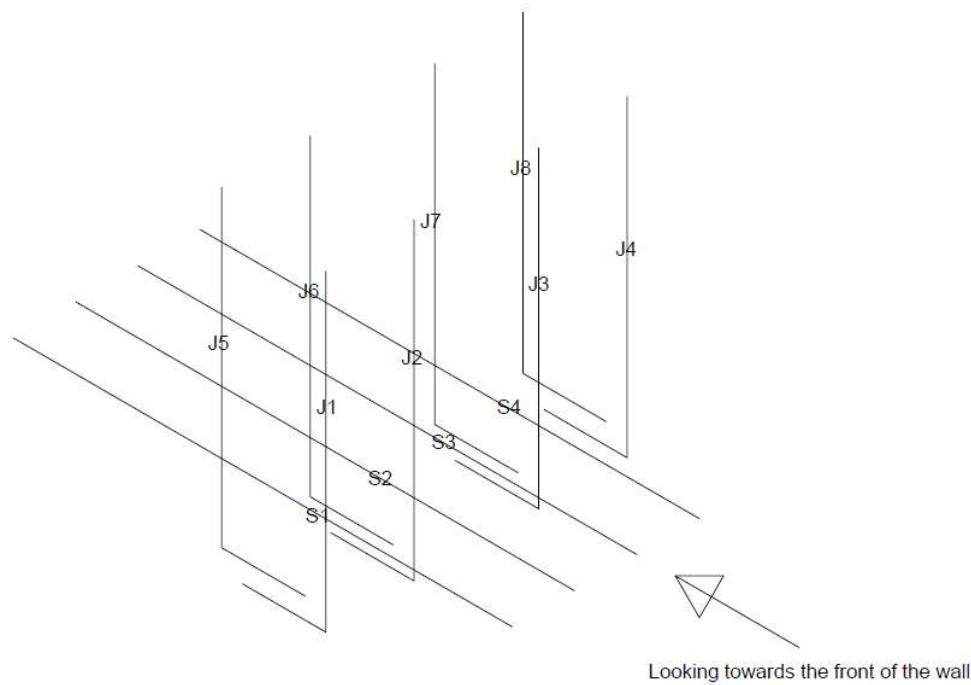
Figure 5-3: Location of the strain gauges on the slab reinforcements (S1-S4) and the dowels (J1-J8)

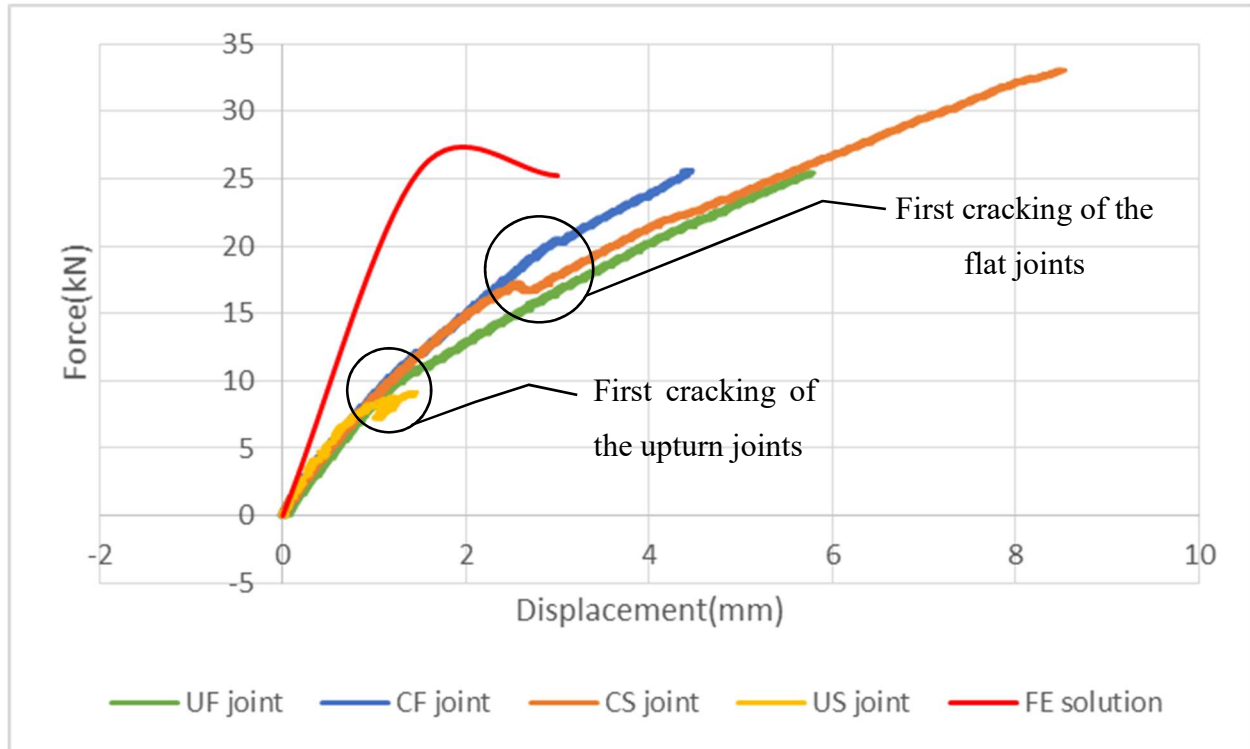
Figure 5-4: Force-Displacement graphs of the first cracking test of all four joints

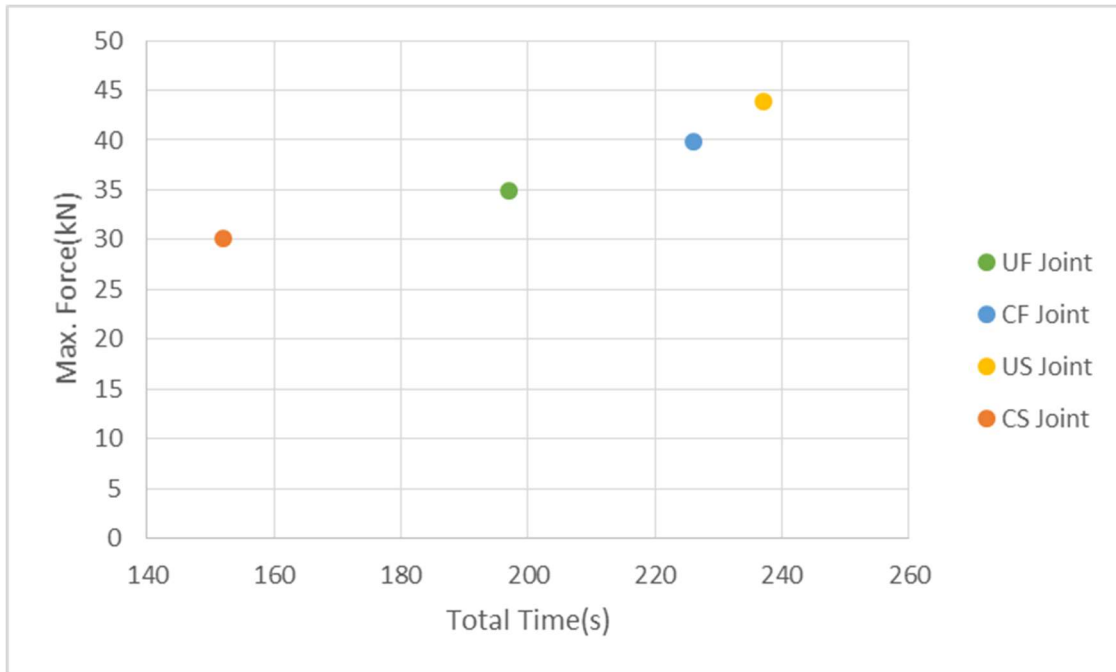
Figure 5-5: Combined results of all the leakage tests

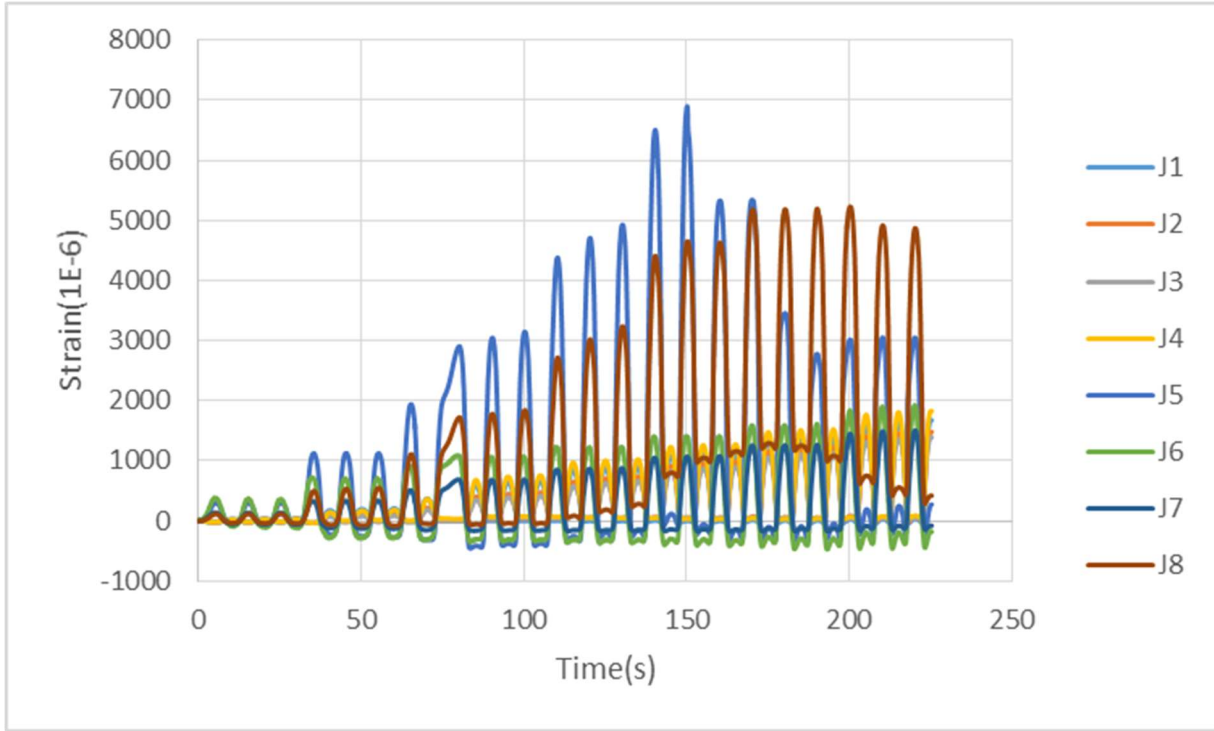
Figure 5-6: Strain-Time diagram of the leakage test of the CF joint

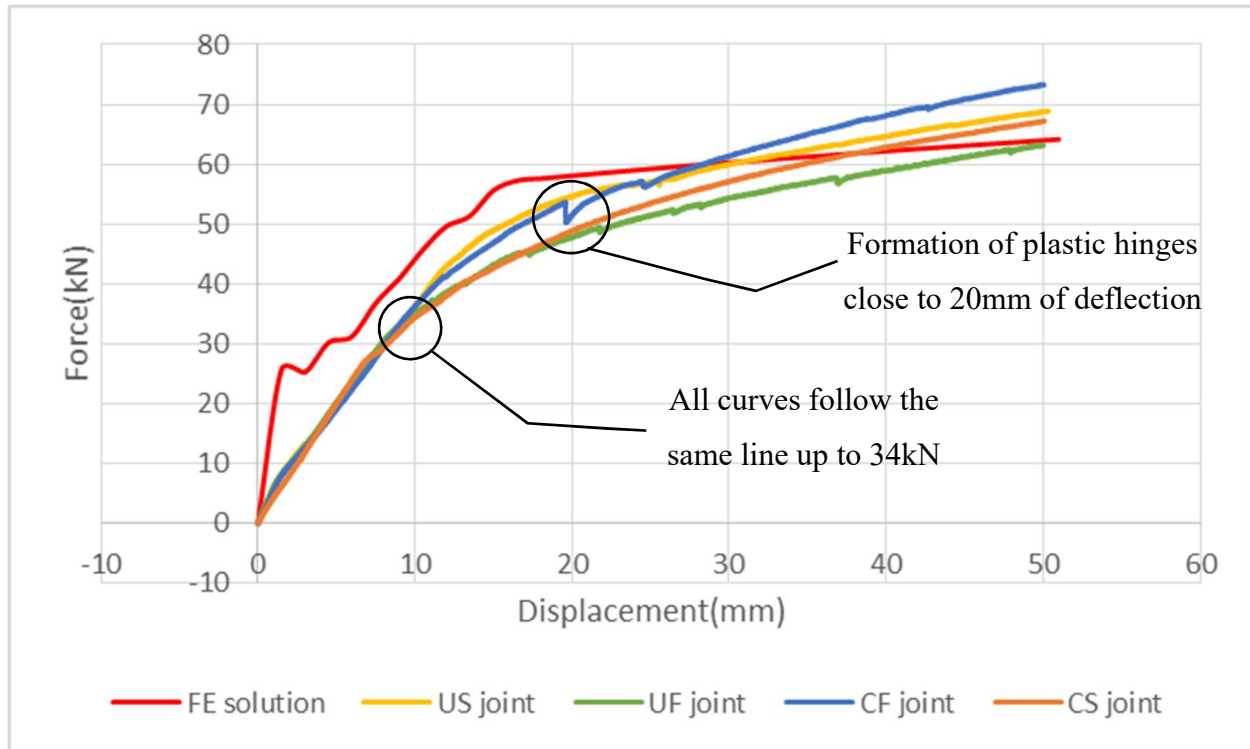
Figure 5-7: Force-Displacement graphs of the limit state test of all four joints

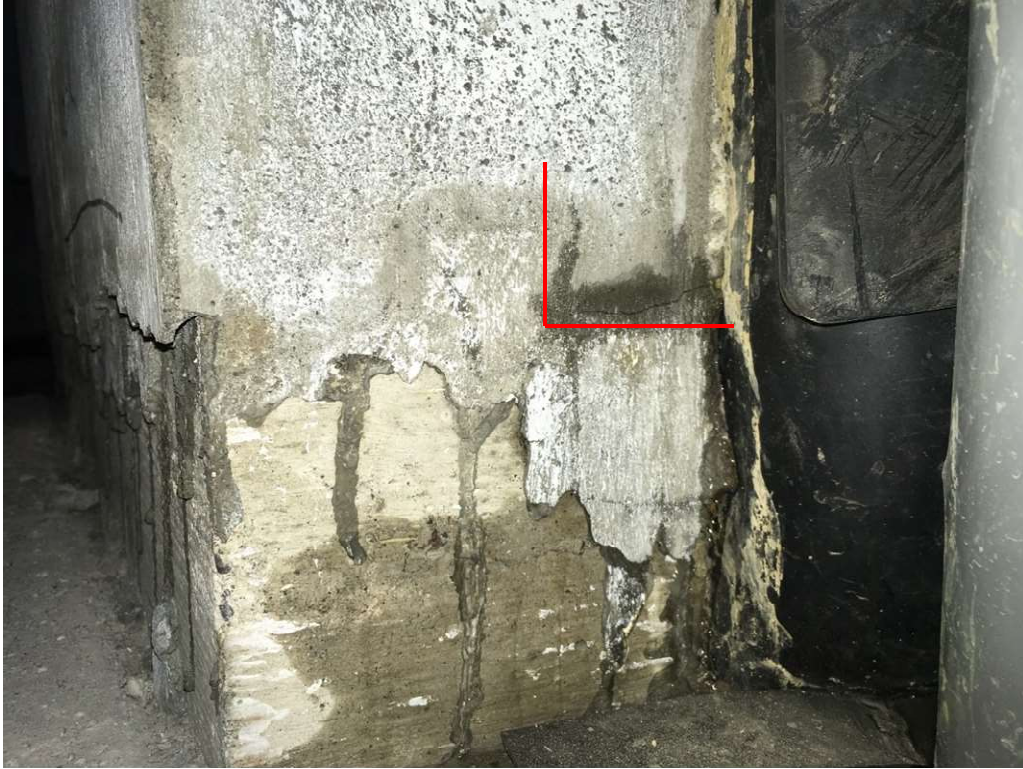
Figure 5-8: Formation of cracks on the outline of the shear key in limit state test of the US joint

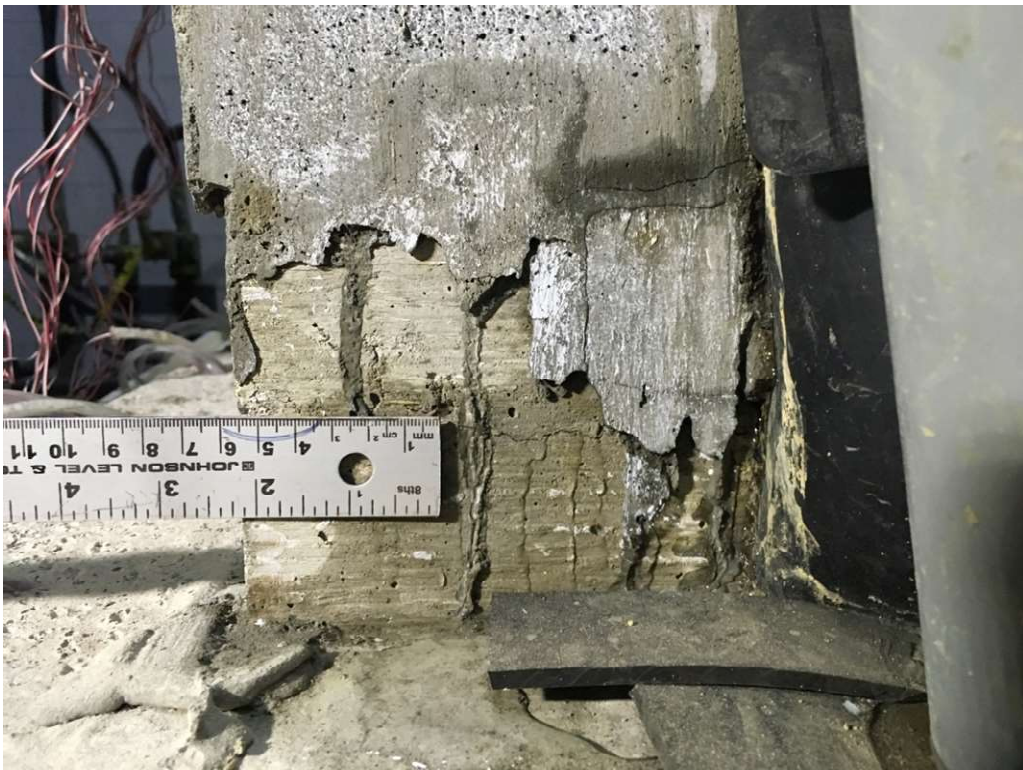
Figure 5-9: Formation of cracks on the tension side of the upturn part in limit state test of the US joint

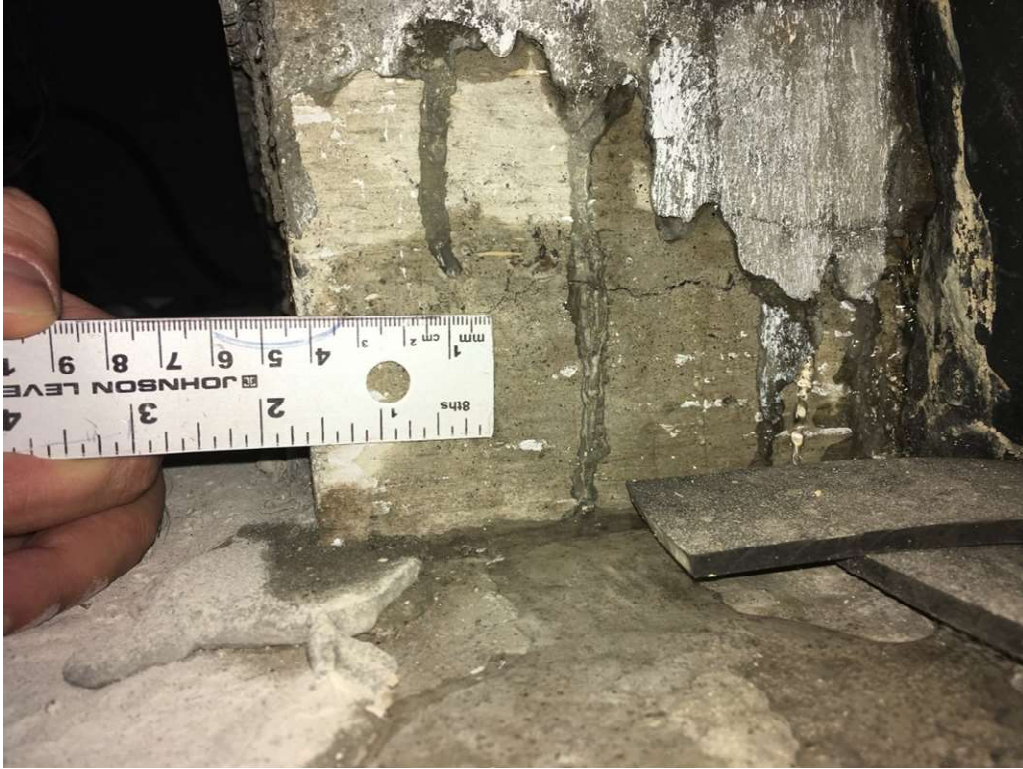
Figure 5-10: Extensive cracking on the upturn part in limit state test of the US joint

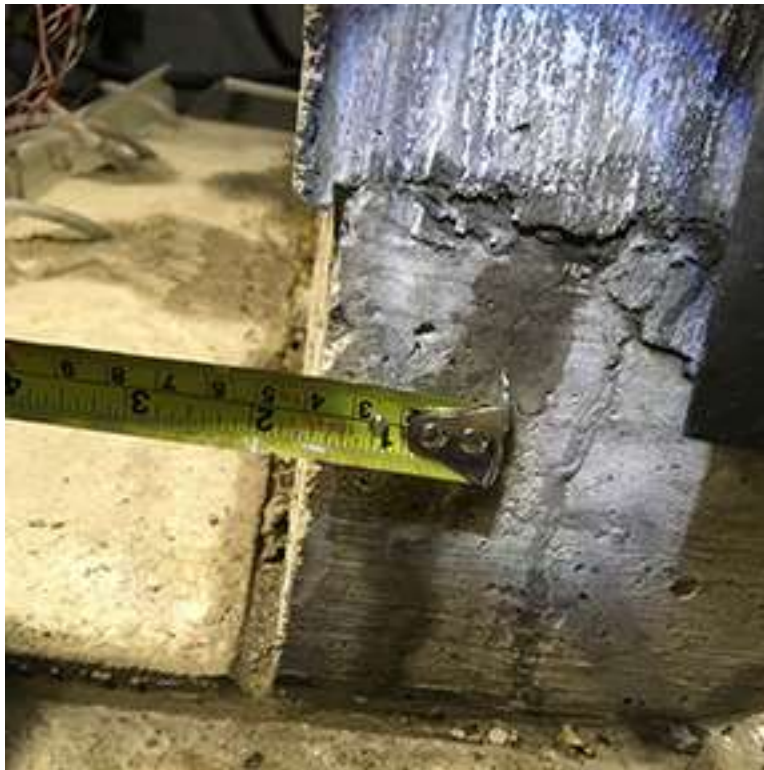
Figure 5-11: Formation of the cracks on the compression side of the upturn part in limit state test of the UF joint

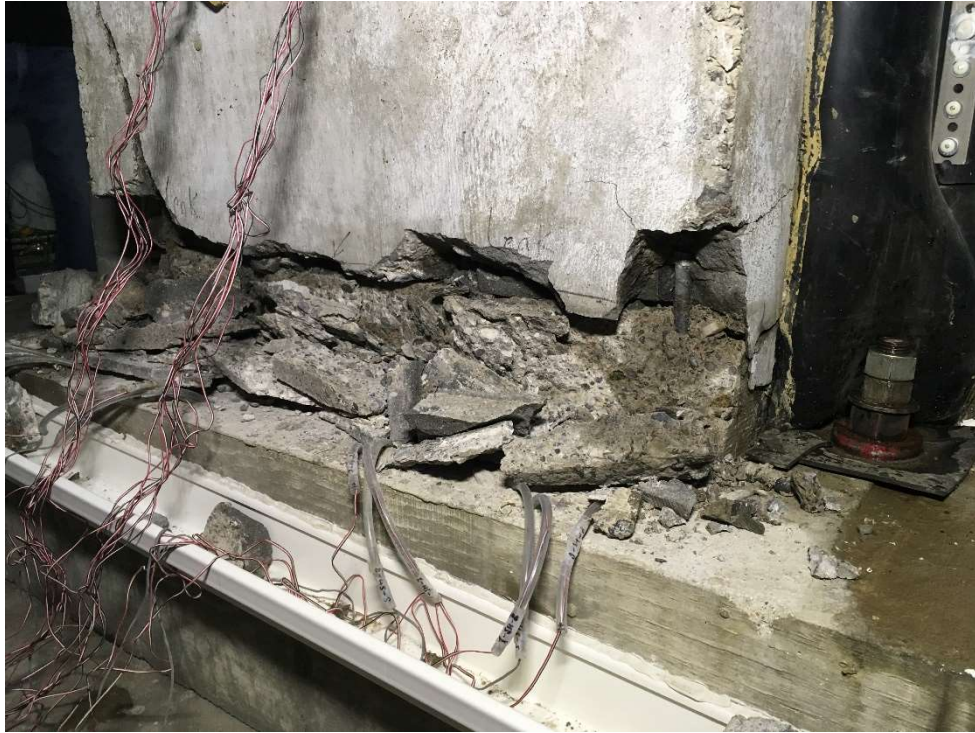
Figure 5-12: Crushing of concrete on the front of the wall in the collapse test of the US joint

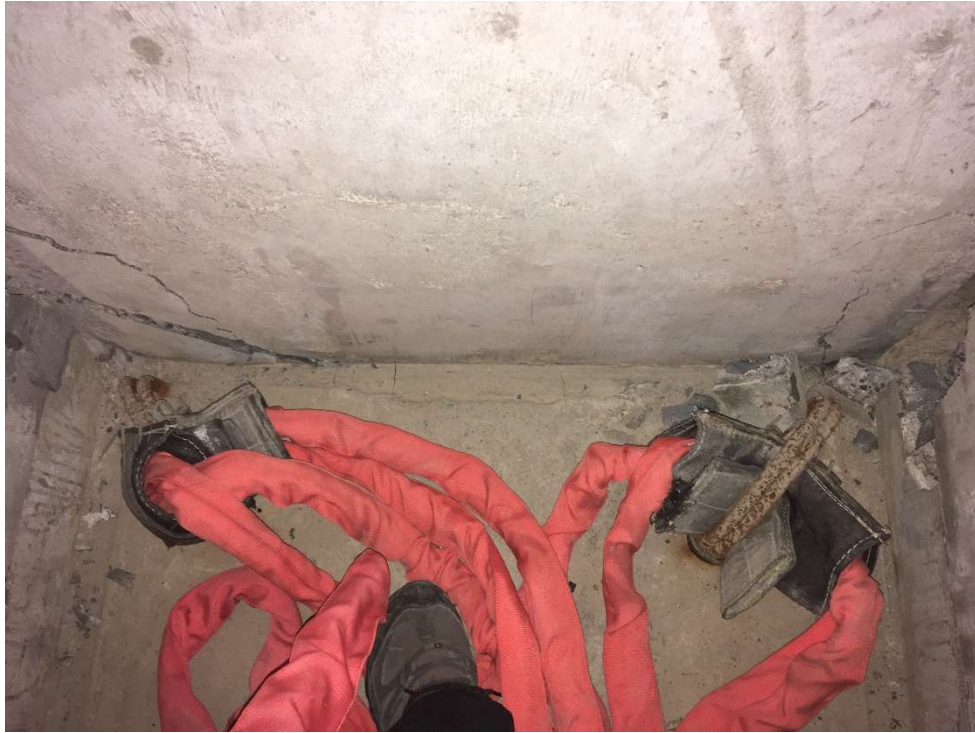
Figure 5-18: Cracking of concrete on the back of the wall in the collapse test of the CF joint

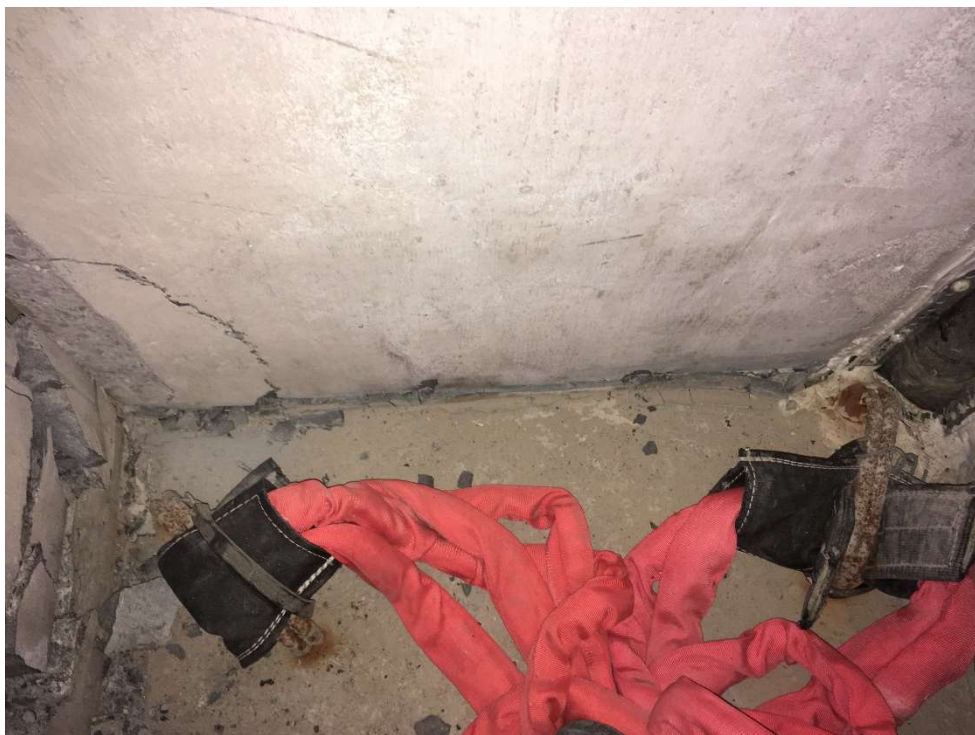
Figure 5-19: Cracking of concrete on the back of the wall in the collapse test of the CF joint
