INVESTIGATION ON THE CAPACITY OF TL-5 GFRP-REINFORCED CONCRETE BRIDGE BARRIER-
DECK ANCHORAGE SUBJECTED TO TRANSVERSE VEHICLE IMPACT LOADING

A thesis

Master of Applied Science

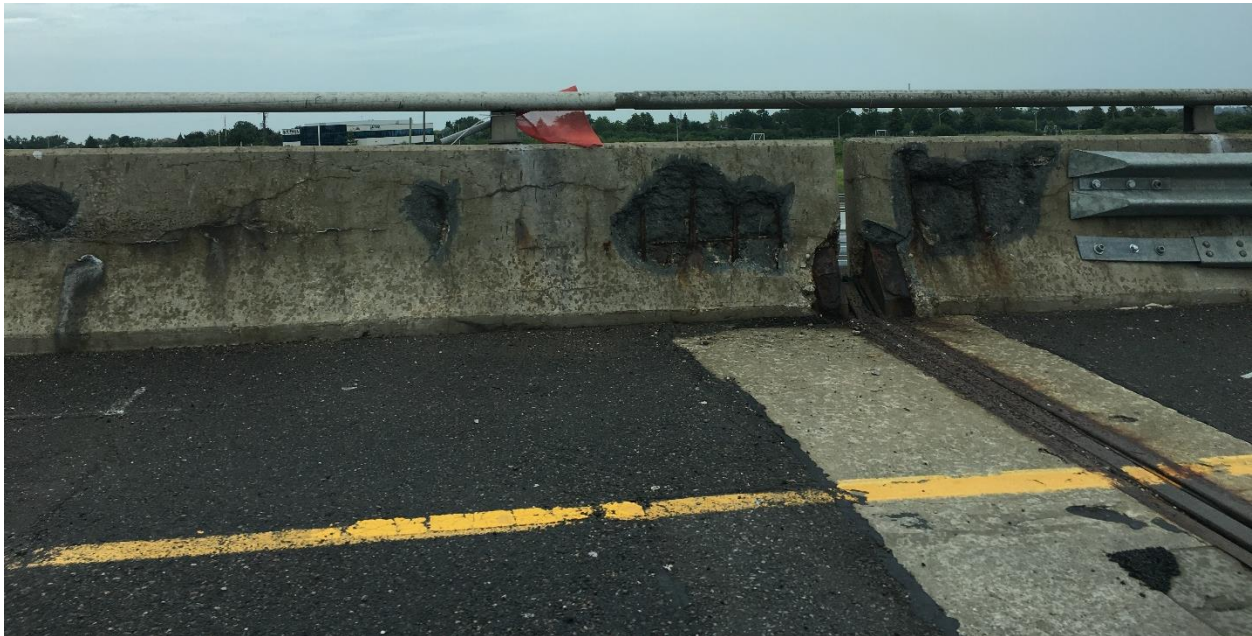
Figure 1.1: Photo of a deteriorated bridge barrier

Bridge barriers are exposed to large amounts of de-icing salts during the winter season which act as catalysts in the corrosion of traditional steel reinforcement. Figure 1.1 shows a photo a deteriorated bridge barrier through steel bar corrosion and concrete spalling which showcases the need for an alternative to steel reinforcement. Due to the composition of GFRP bars excluding steel properties, corrosion is no longer an issue and is thought to be an appropriate replacement.

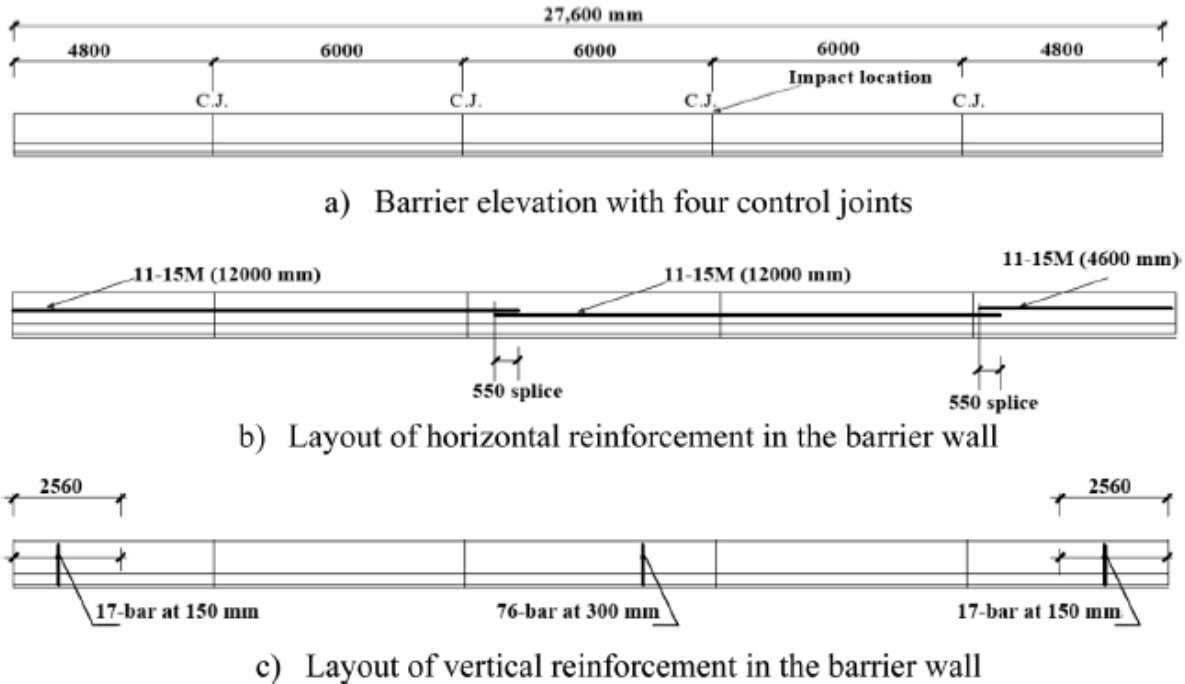
Figure 2.7: Elevation details for the crash tested PL-3 barrier (Sennah and Khederzadeh, 2014)

In the full scale crash test, the constructed barrier wall was of 27.6 m and with the same detailing as the static load testing. The barrier details for the crash test are depicted in Figure 2.7. The vehicle used in the crash test was a 36000V van-type tractor trailer (cab-behind-engine model with a total mass of 36,000 kg) which had to be traveling at 80 km/h (+/- 4 km/h) and impact at a 15° angle (+/- 1.5°) in order to satisfy the MASH requirements (Sennah and Khederzadeh, 2014). The vehicle used in the test satisfied these criteria and was within the tolerance levels. The tractor-trailer was loaded with concrete and ballast to achieve the weight requirements for the test. Upon testing the authors deemed the best location for impact was at the control joint, which would be a more critical location and possibility of failure is increased (Sennah and Khederzadeh, 2014).

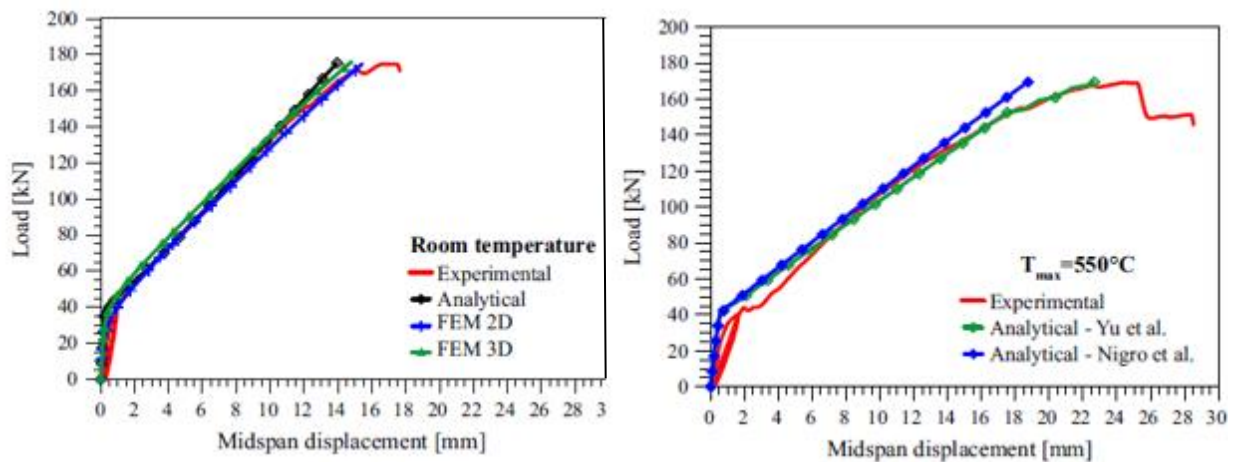
Figure 2.8: Comparison of loading at room temperature vs. loading at 550 degrees Celsius (Pagani et al., 2014)

Pagani et al. stated the conditions necessary for a bridge deck to achieve temperatures which would be higher than the glass transition temperature. They stated various conditions in a sense of which would apply to everyday situations and others which would indicate more rare instances such as a truck carrying chemicals and igniting underneath a fly-over. A vehicle burning on the bridge deck would not yield temperatures in excess of 600°C due to the fact that the flames would rise and not apply constant heat to the deck which in combination with asphalt acts as added protection for the GFRP bars (Pagani et al., 2014). The temperature of 600°C was determined to be a point in concrete elements where most strength and reliability is lost (Di Luzio et al., 2009). According to Pagani et al., a bridge would need to have a clearance beneath of a minimum 20 meters to allow for dense trees to grow and simulate a higher temperature bushfire, and even then the flames would not be constantly applied directly beneath the bridge deck. Nevertheless, their experiment proceeded and the objective was achieved, which was to study the effects of elevated temperatures on a GFRP reinforced bridge deck.

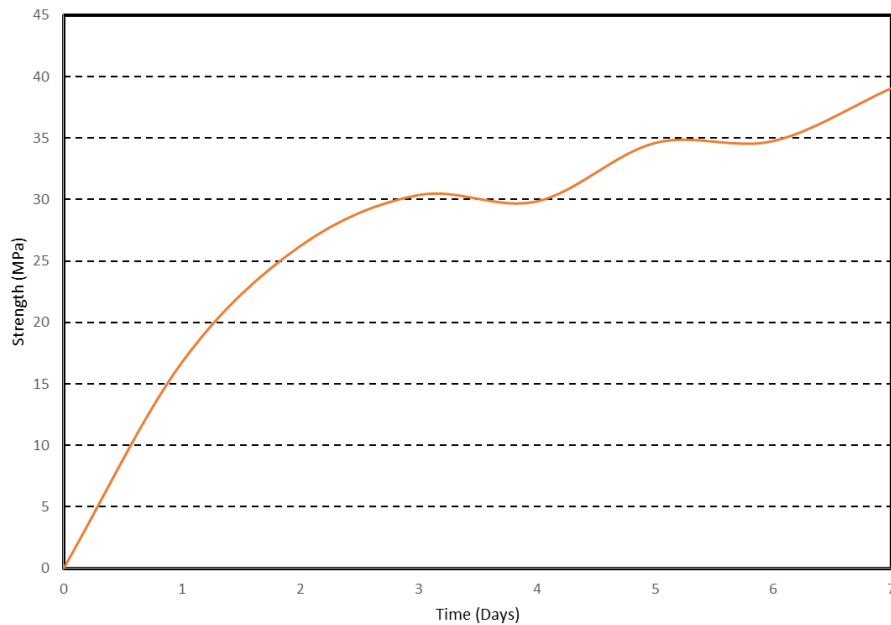
Figure 3.3: Slab concrete maturity throughout 7 days after casting

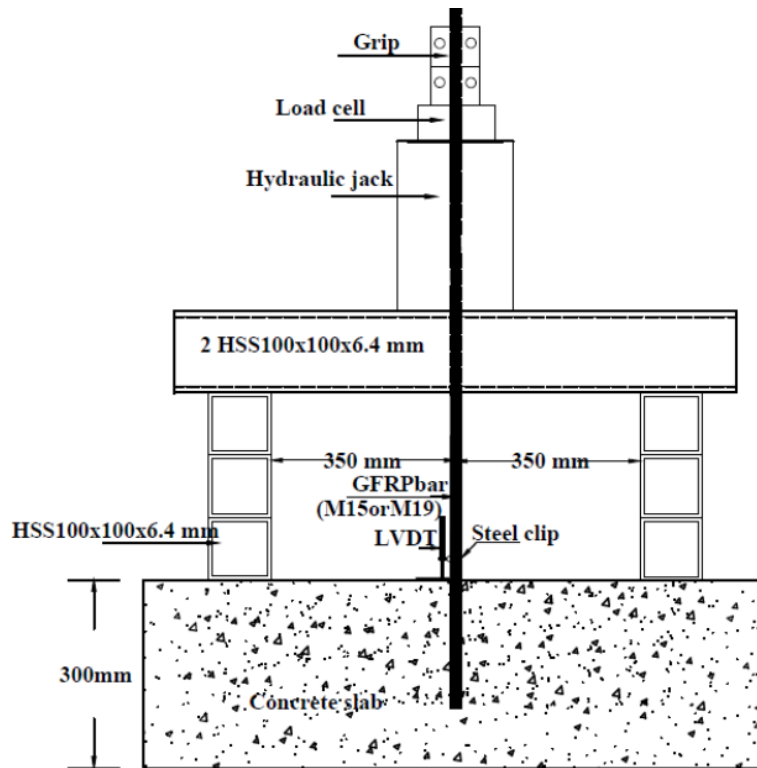
a) Schematic diagram of the test setup

The pullout test follows ASTM E488/E488M-15 test method (ASTM, 2015) which describes all appropriate equipment and setup needed to conduct the experiment. The test setup consisted of a series of HSS sections resting on metal bearing plates that were spaced in a manner so that there was a minimum clearance radius of about two times the bar embedment length, from the bar being tested to each individual support. The ASTM test method specifies this clearance radius in order to allow for all types of pullout failures. Three HSS sections stacked on top of one another on one side of the bar and in a parallel fashion on the opposite side of the bar, all of which were resting on 4 square metal plates. On top of these 6 HSS sections were two longer HSS sections which were perpendicular to the supporting HSS members, while the GFRP bar of interest was centered between them. On top of these two sections proceeds a series of plates, rubber pad, load cell, hydraulic jack, and pull-out grips. This setup is clearly demonstrated in Figure 3.15. Once the rigorous steel setup is complete, a potentiometer (POT) was placed adjacent and connected to the bar, while the tip of the needle was on the top of the concrete, as shown in Figure 3.15. This procedure was then repeated a total of 15 times for the pre-installed bars, and another 15 times for the post-installed bars. Maintaining a consistent setup, allows for properly analyzing data and limit variables in the experiment.

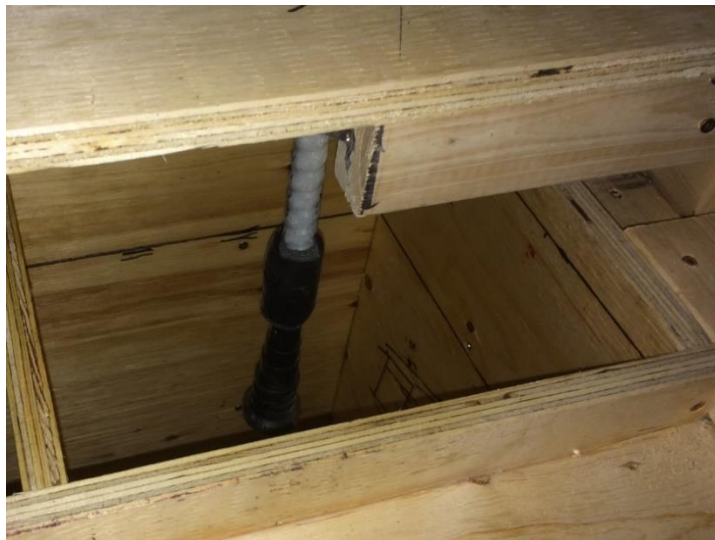
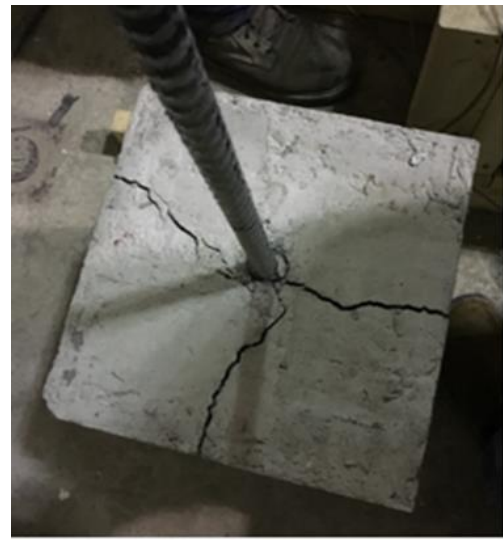
a) View of the timber form and unbonded headed bar

b) View of concrete splitting failure

As a first step to examine the capacity of the headed-end GFRP bar developed by the GFRP manufacturer, a timber form of 300x300 mm cross-section and 500 mm deep was constructed as shown in Figure 3.16(a) to form a concrete block with a headed-end GFRP embedded from the top. The total bar embedment length was 200 mm. The first portion of the embedment length represents an unbonded straight portion of the bar, followed by the bonded head of 100 mm length. The bar was pulled out of concrete resulting in an experimental pullout force of 119 kN which is more than the 100 kN limit specified in MTO Standard Drawing for #5 headed-end GFRP bars when tested to slip the headed bar from concrete. Figure 3.16(b) shows concrete splitting when bar slipped from concrete. Figure A-1 in the Appendix shows the load-slip curve for the tested bar. It can be observed the bar slip at ultimate load was 0.72 mm, with 0.61 mm value at the 100 kN MTO specified limit.

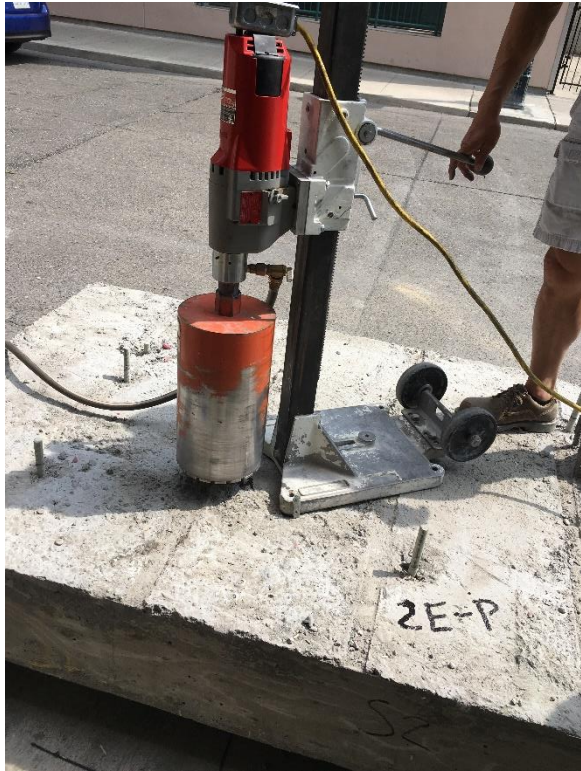
Figure 3.18: Coring of the slab for analysis

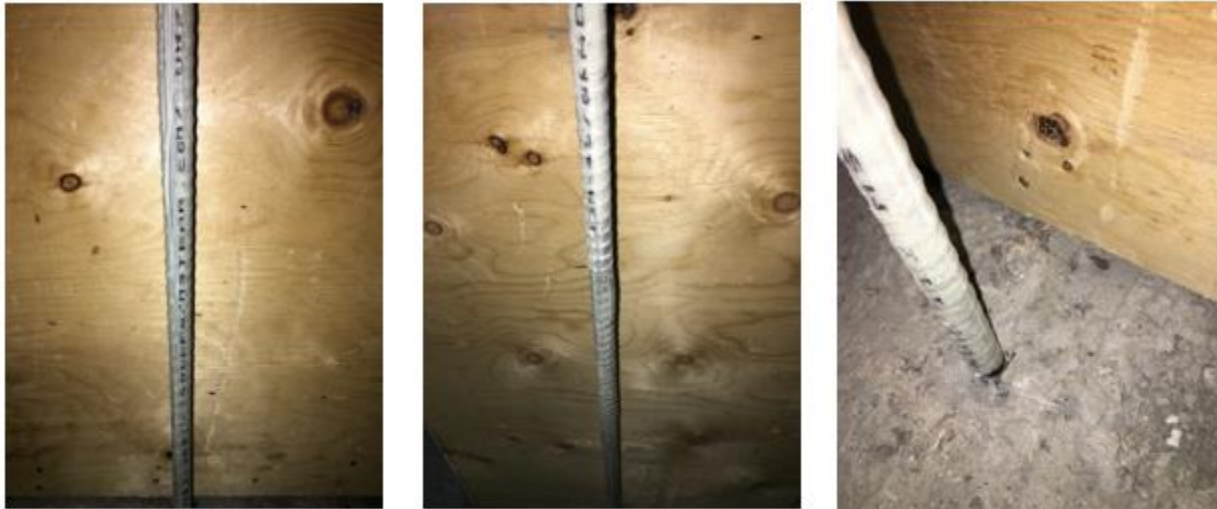
a) Bar rupture

b) bar rupture at grip area

Figure 3.21: Views of failure modes for group 2

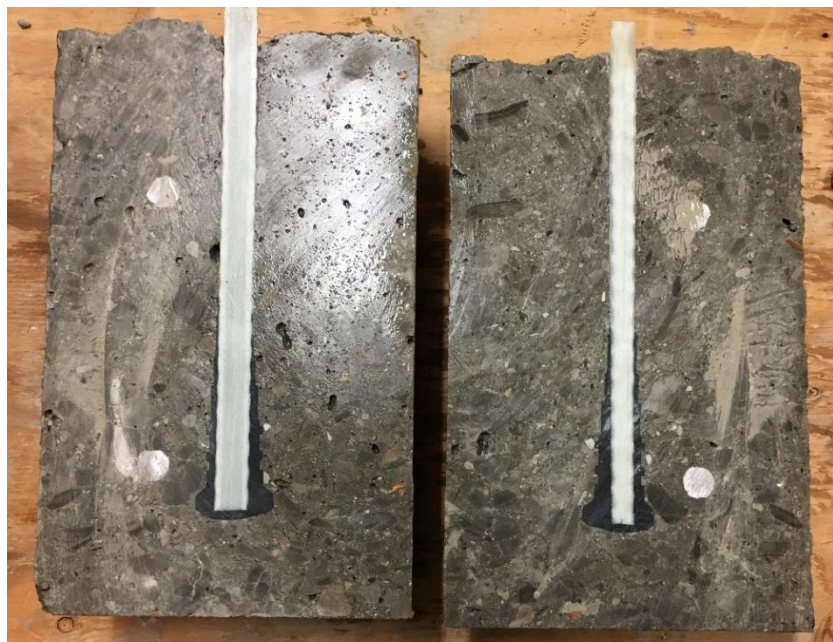
Figure 3.22: Sliced core sample for group 2

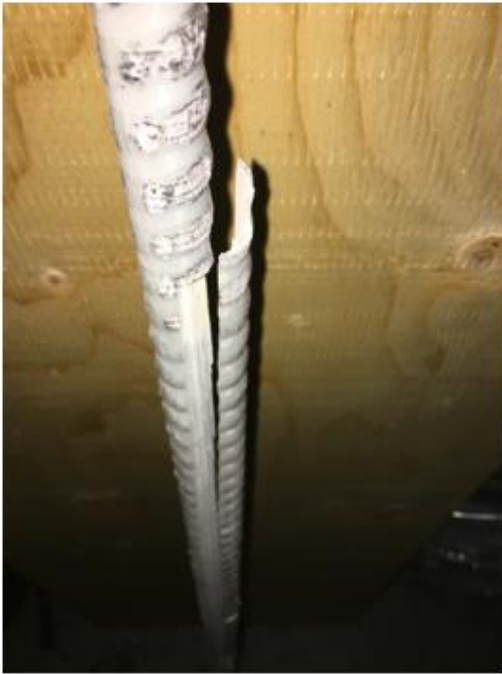
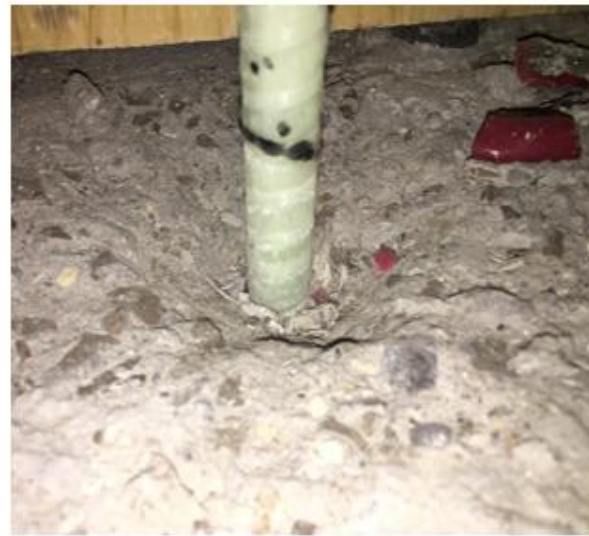
a) Bar A rupture at the anchorage

b) Bar B slippage

Figure 3.25: Views of failure modes for the group

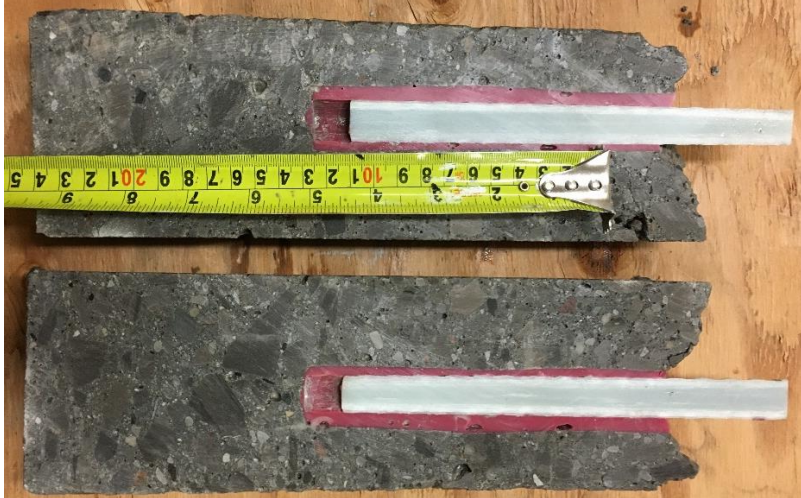
Figure 3.26: Sliced core sample for post-installed bars in group 1 showing bar slip

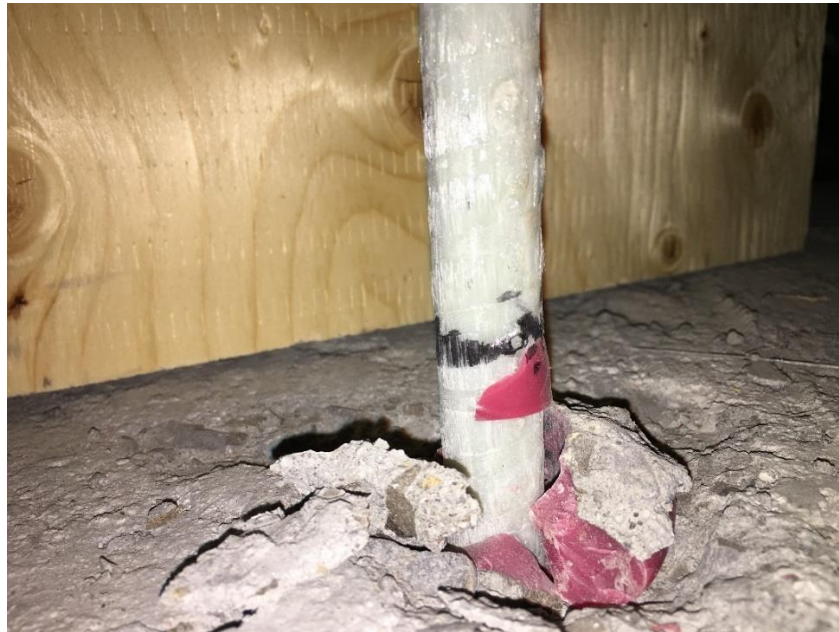
Figure 3.28: Slippage failure mode of post-installed bars in group 2

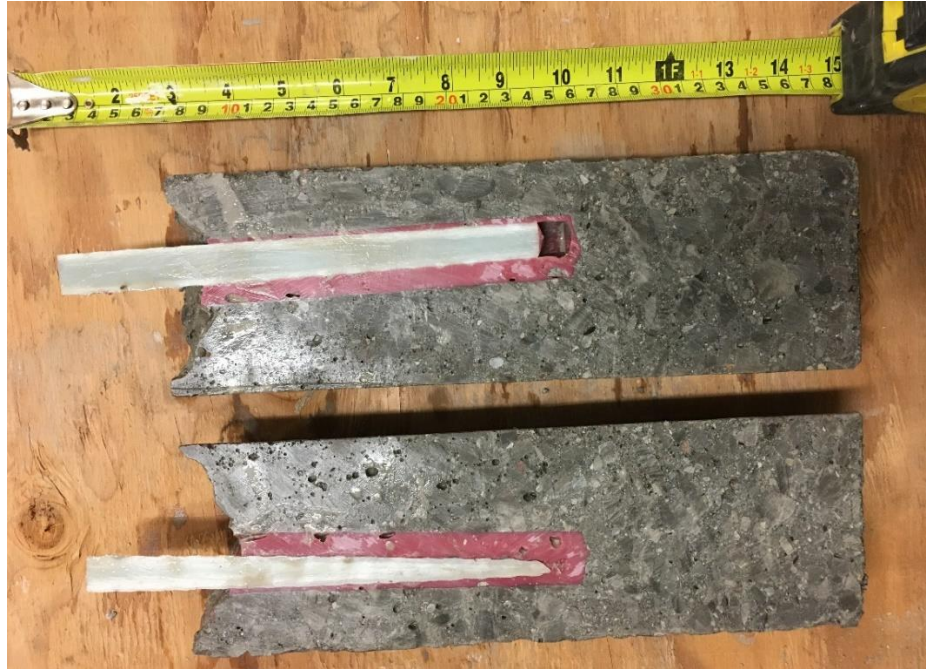
Figure 3.29: Sliced core sample for post-installed bars in group 2 showing bar slip

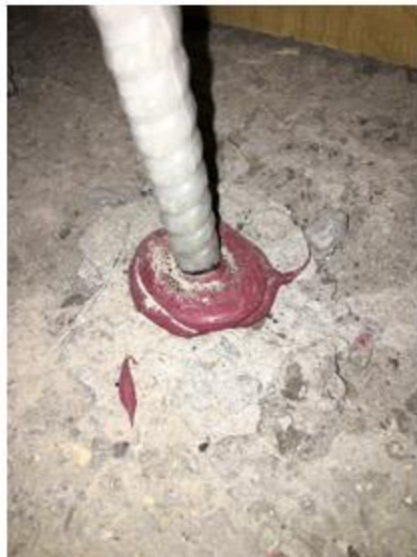
b) Conical concrete failure in 3-A

Figure 3.30: Different failures of the group

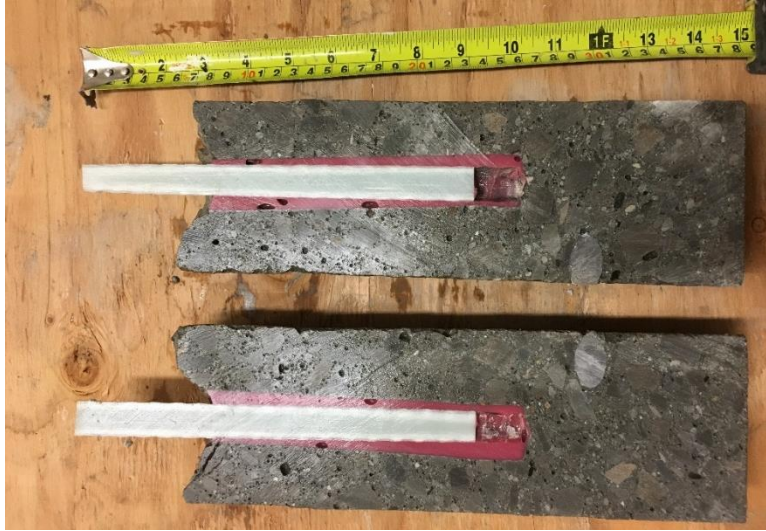
Figure 3.31: Sliced core sample for post-installed bars in group 3 showing bar slip

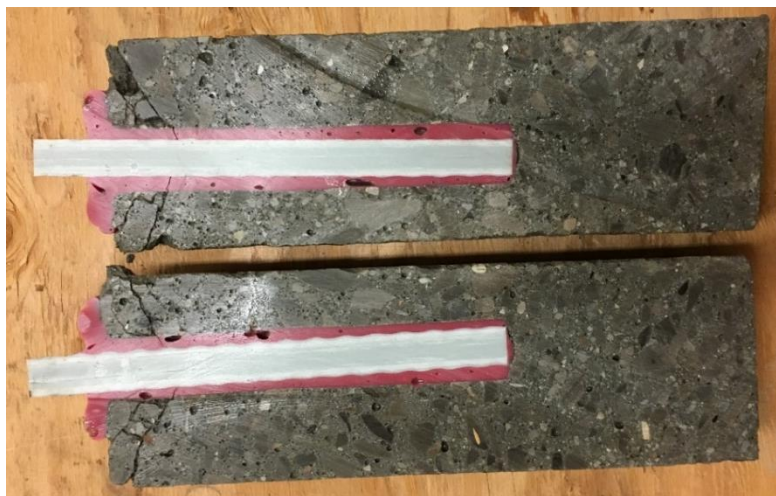
Figure 3.32: Sliced core sample for post-installed bars in group 3 showing conical failure

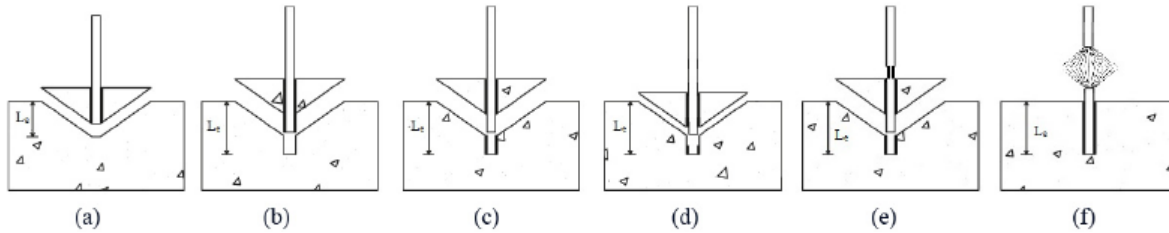
Figure 3.33: The different types of pullout failures: a) concrete cone breakout; b) adhesive/concrete interface pullout; c) GFRP/adhesive interface pullout d) pull through (adhesive/ concrete and GFRP); e) ribbed interface pullout; f) bar rupture (Azimi et al., 2014)

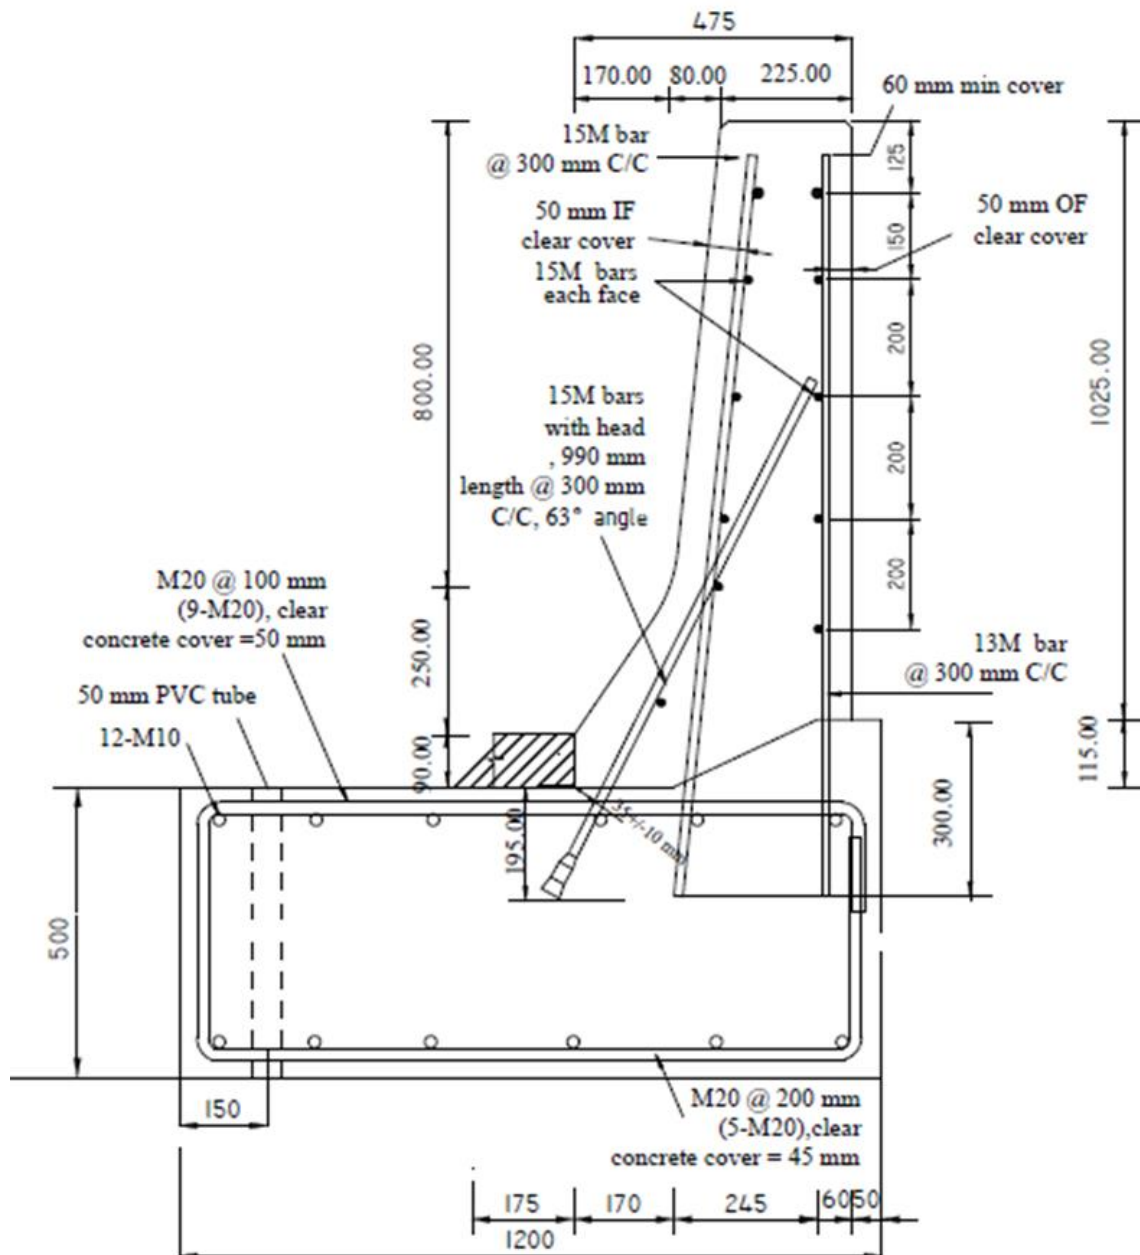
Figure 4.1: Barrier specimen B-1 details (Interior Location - No Cantilever)

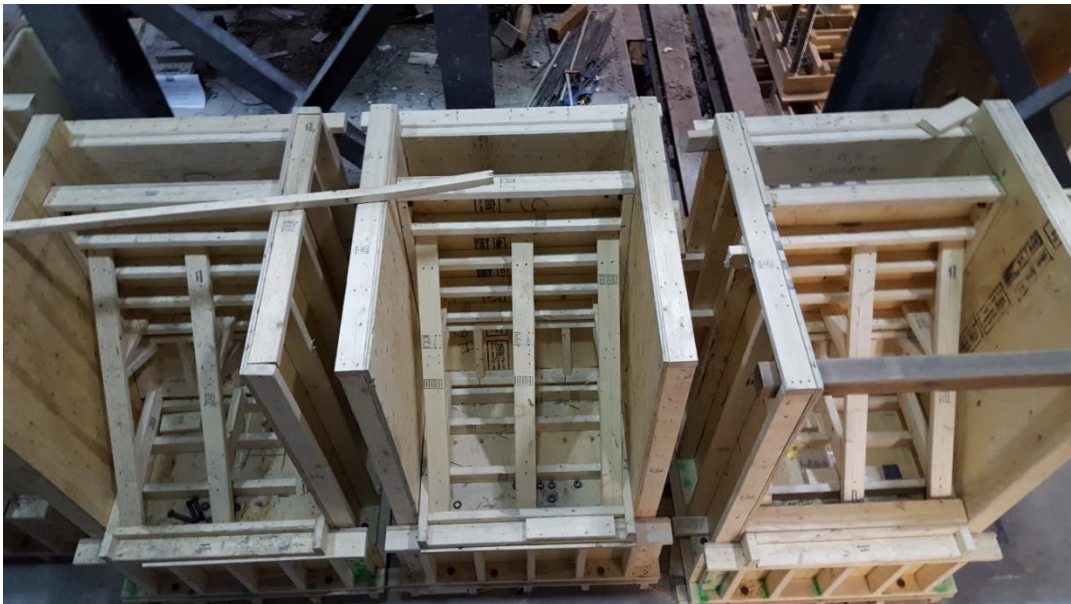
Figure 4.8: Typical formwork construction for TL-5 barriers in phase 2

The formwork for the barriers was constructed out of wood materials, and connected with wood screws, as well as a series of bolts. The heavy reinforcement for the formwork was done to ensure no bulging or deformation of the concrete elements, which may impact experimental results and test setup. The forms consisted of three stud walls around the sides and the rear of the barrier. The front face of the barriers was constructed out of four separate sections which were bolted at the top to simulate a pivot point and could then be lifted and lowered manually while rotating at that point, they would best be described as overhead gates. The bottom section (one of the four separate sections) remained in place and did not pivot as this was for the slab constructability. Figure 4.8 provides a clear image of the formwork construction. On the inside of the barriers, all joints were sealed with typical silicone based sealant via a caulking gun.

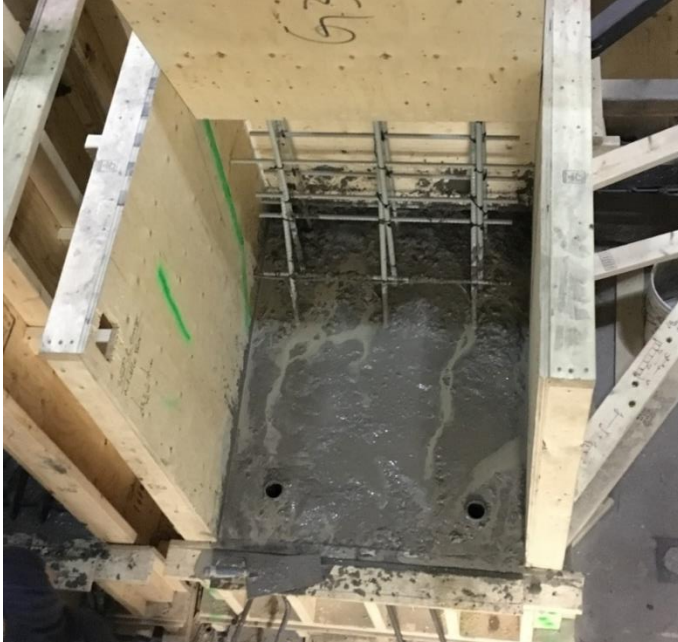
a) Pouring concrete over slab section

The barriers were kept moist (only for the first four days) by applying water to all of the wood formwork, which concealed approximately the entire barrier exterior surface area. The barriers were not covered with any burlap or plastic, but were left to cure in normal conditions inside the laboratory at approximately 23°C and with a relative humidity of about 50% (the concrete cylinders were cured in the same manner). After approximately a week, the formwork for all barriers was removed. Figure 4.15 shows a typical cantilevered barrier in the process of the formwork being removed. There were no deficiencies noted upon removal of the forms, and no signs of “honeycombing” were visible.

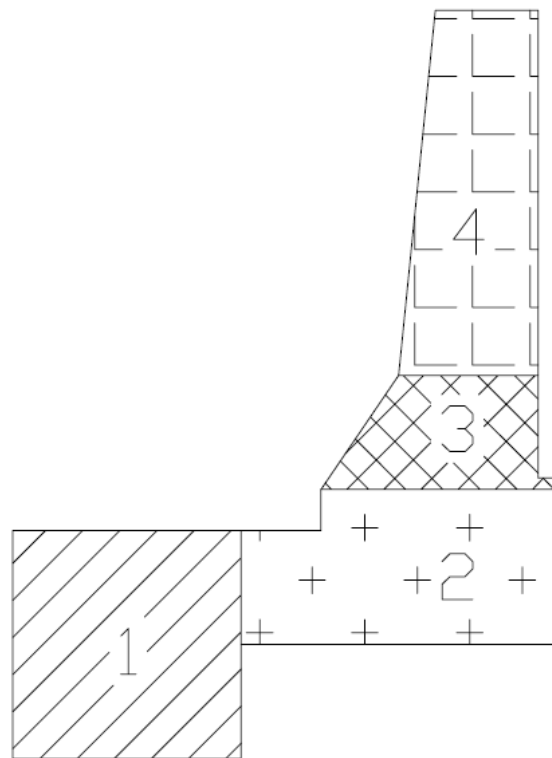
Figure 4.20: Sections to be used for crack location reference

While discussing results, cracks and failure mechanisms are described through dividing the barrier-deck specimen into 4 sections or regions as depicted in Figure 4.20 for visual understanding. Section 1 is classified as being the part of the deck slab anchored to the laboratory floor while Section 2 represented the deck slab-barrier wall junction. Section 3 represents the segment of the barrier wall over the height of the lower tapered portion on the traffic side. Section 4 represents the barrier segment along the height of the top tapered portion on the traffic side.

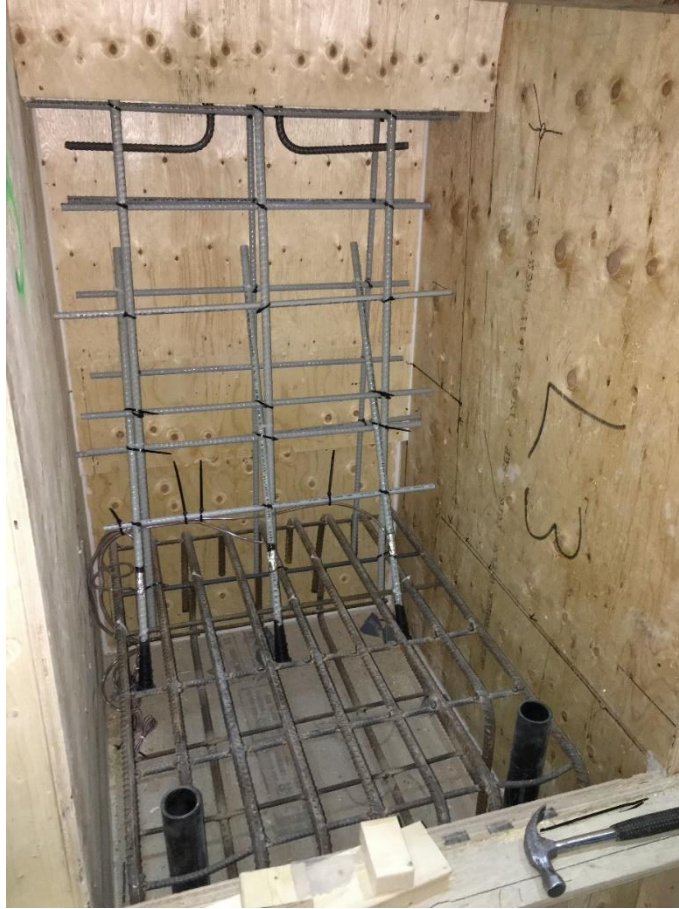
Figure 4.21: Barrier B-1 bar detailing prior to casting

In barrier specimen B-1, the 500-mm thick deck slab base was completely rigid indicating that the barrier is resting on non-deformable slab bridge section. The front GFRP bars were spaced at 300 mm center-to-center to simulate vehicle impact at interior location. Detailing of the bar arrangement before concrete casting is shown in Figure 4.21.

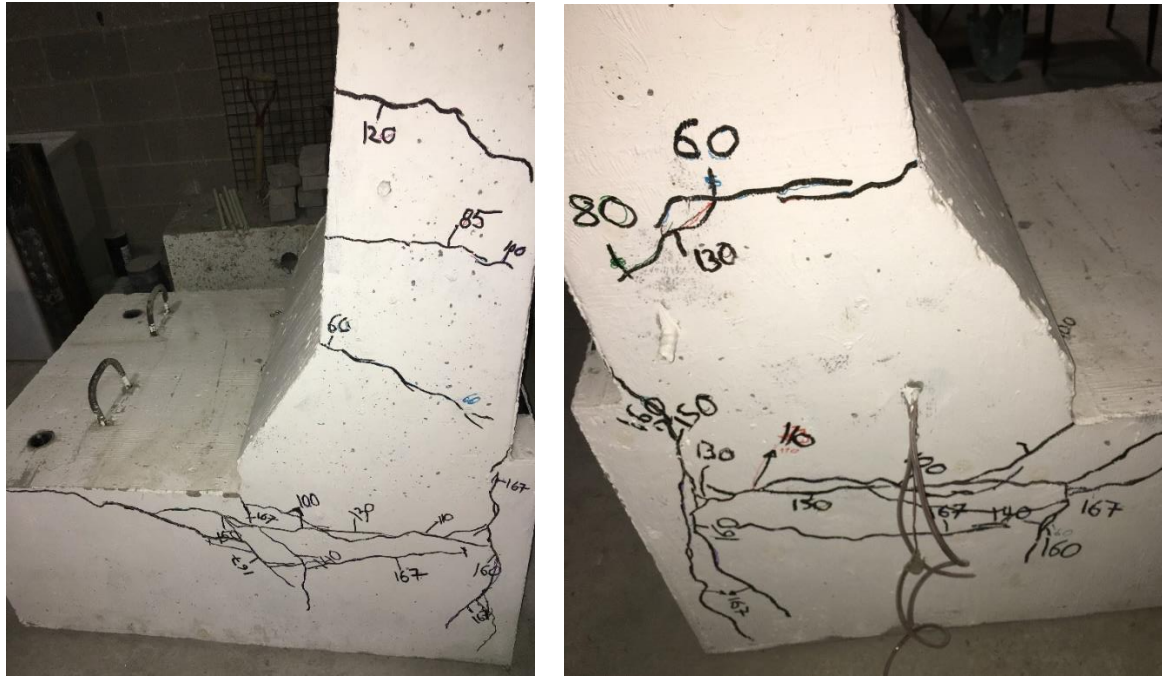
Figure 4.23: Close up view of crack pattern after failure of specimen B-1

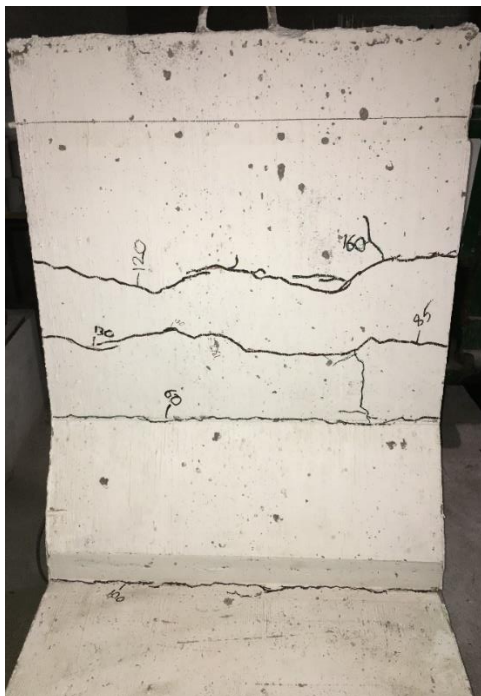
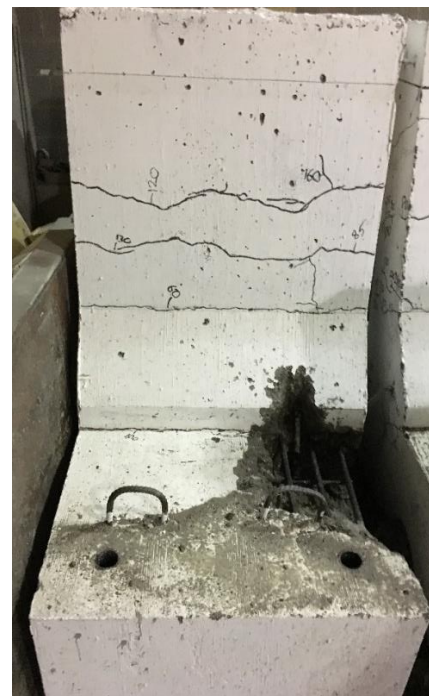
(a) Before jackhammering

(b) After Jackhammering

Figure 4.24: View of cracks at front side of specimen B-1

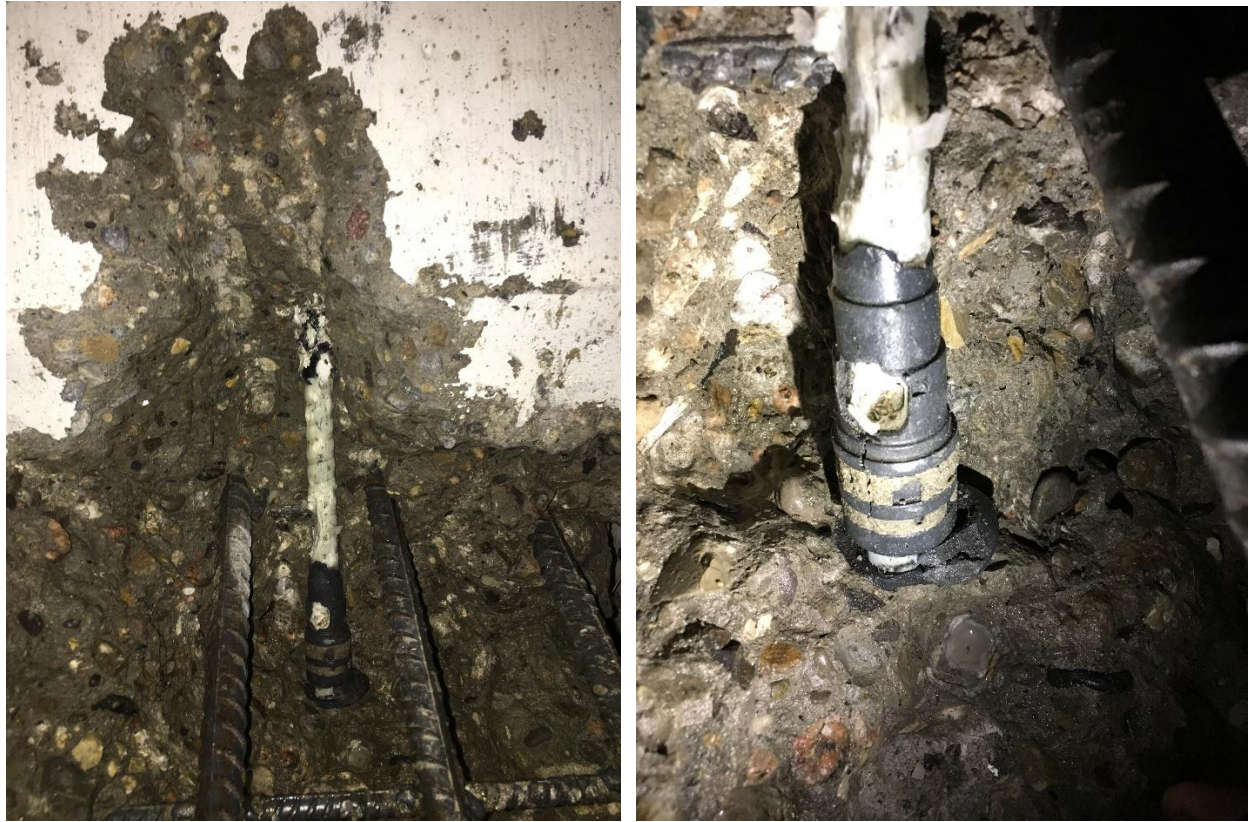
Figure 4.25: Close up of failed headed GFRP bar in specimen B-1 after jack hammering concrete at barrier-deck junction

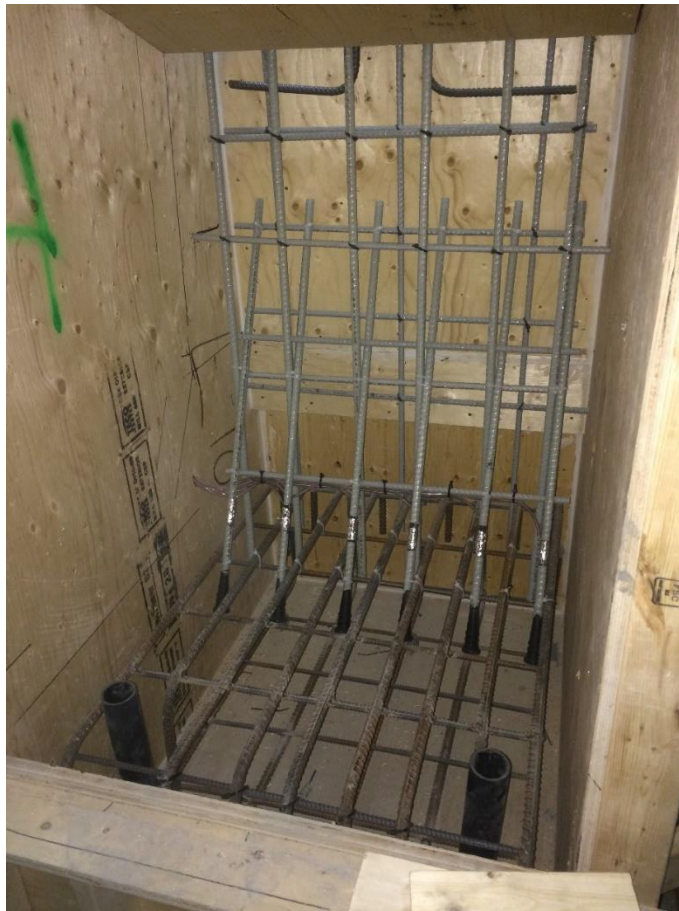
Figure 4.26: Barrier B-2 bar detailing prior to casting

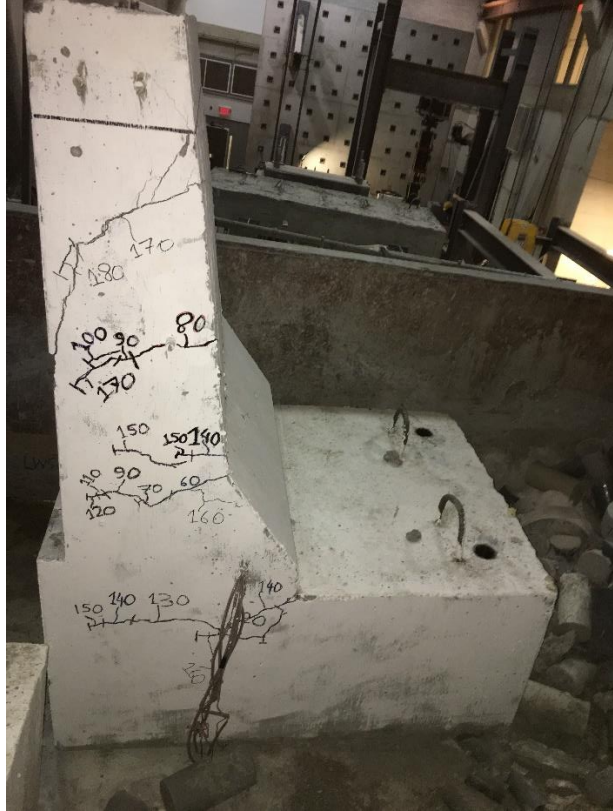
(b) Left side

Figure 4.27: View of crack pattern after failure of the tested specimen B-2

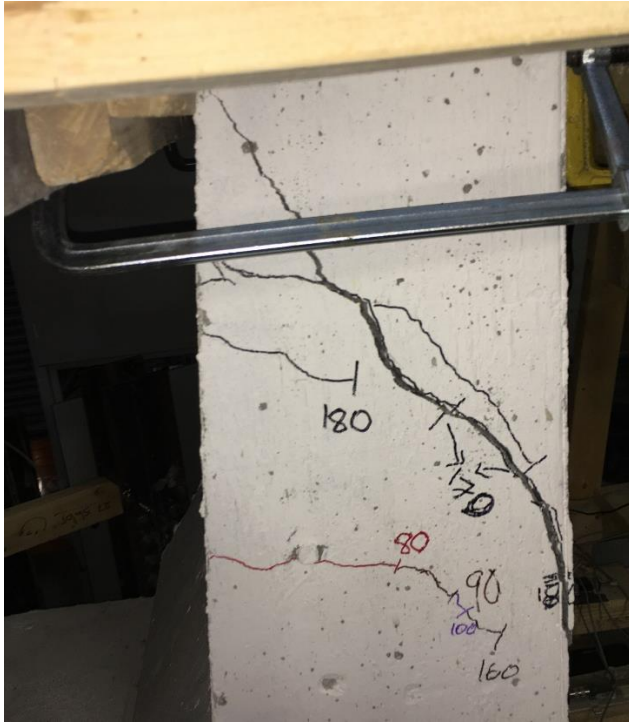
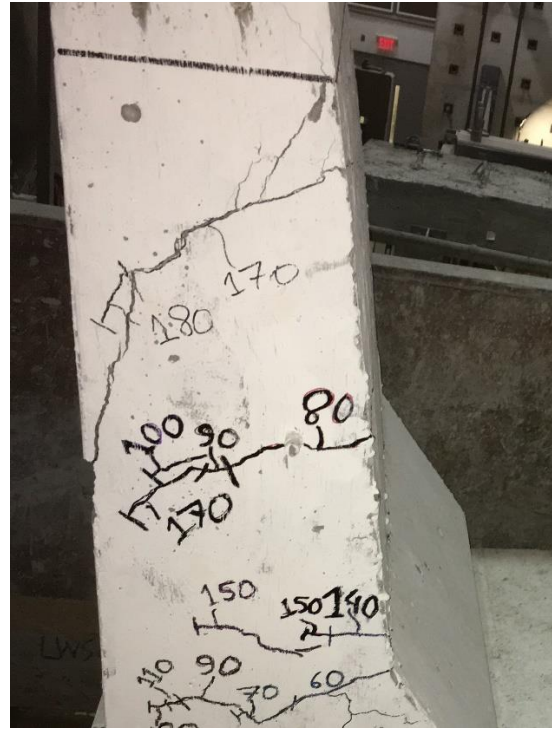
Figure 4.28: Close up view of crack pattern after failure of specimen B-2

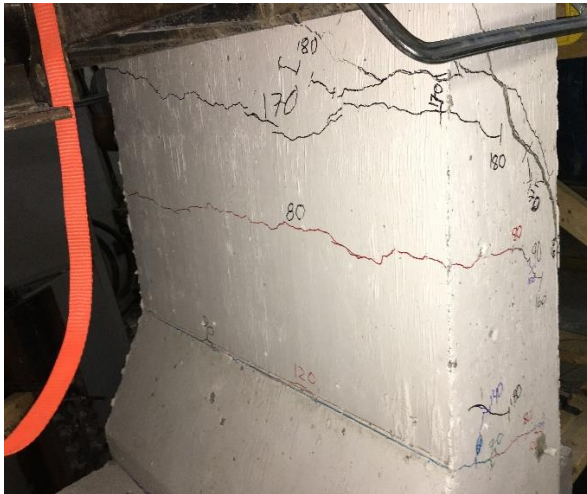
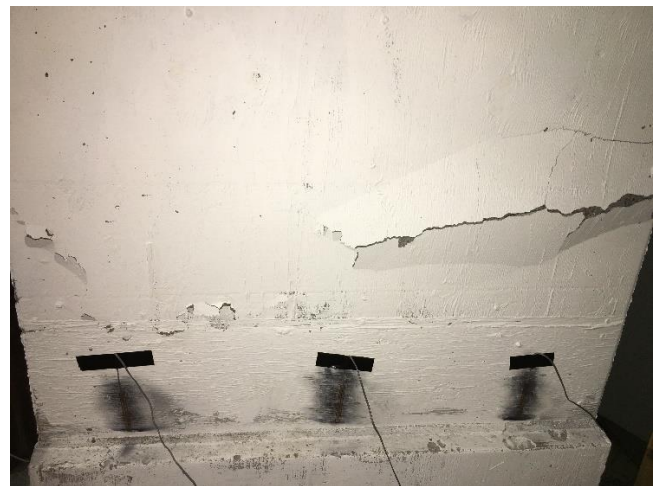
(a) Front side

(b) Rear side

width of the barrier of 900 mm and the height of the applied load over the top surface of the deck slab of 990 mm, the experimental resisting moment is calculated as 200.89 kN.m/m. This experimental resisting moment at the barrier-deck junction is greater than the CHBDC design value of 102 kN.m/m at the barrier-deck slab junction (CSA, 2006). This leads to a factor of safety of 1.97 in the design of the TL-5 barrier wall at exterior location when it is rigidly connected to non-deformable concrete deck slab as listed in Table 4.14. It should be noted that the diagonal shear crack propagated through the barrier thickness to the back side of the barrier causing concrete plugging and spalling as depicted in Figure 4.29.

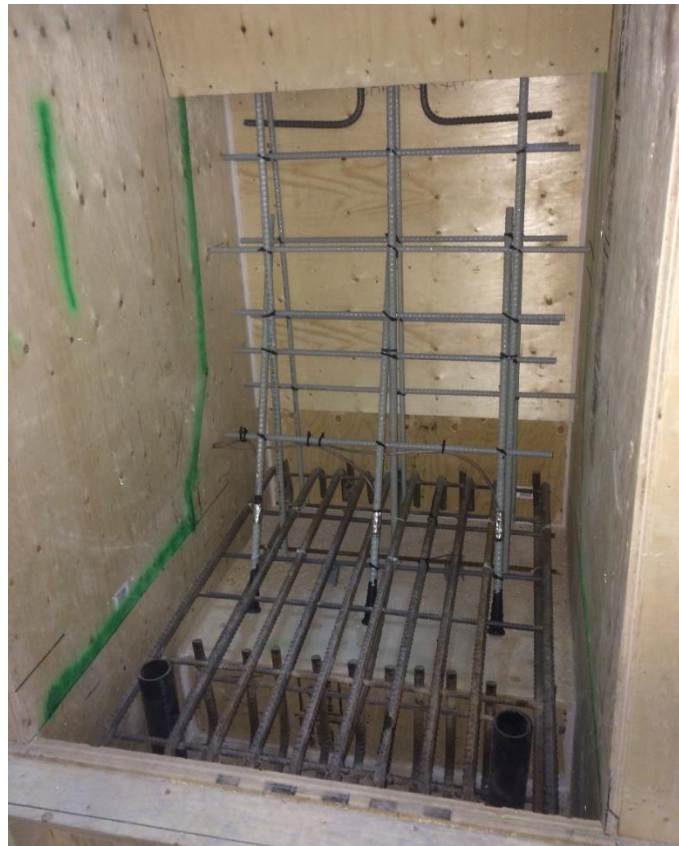
Figure 4.30: Barrier B-3 bar detailing prior to casting

Figure 4.30 shows the arrangement of reinforcement in the barrier specimen B-3 before casting. Figures 4.31 through 4.33 show different views of the crack pattern of the tested barrier specimen. In this specimen, the first visible flexural crack was observed at the intersection of the tapered portions of the front side of the barrier wall as well as at the barrier-deck junction and at the deck slab fixed end at 80 kN and 60 kN jacking load, respectively. These flexural cracks penetrated further at a higher load, along with other flexural cracks in the deck slab as appeared in Figure 4.31. Although flexural cracks appeared in the barrier wall and the deck slab portion, a sudden diagonal tension crack appeared in the deck slab at a jacking load of 90 kN, respectively. These cracks propagated further till the barrier could not take a jacking load beyond 129.64 kN. Given the width of the barrier of 900 mm and the height of the applied load over the top surface of the deck slab of 990 mm, the experimental resisting moment is calculated as 142.6 kN.m/m. This experimental resisting moment at the barrier deck junction is greater than the CHBDC design value of 83 kN.m/m at the barrier-deck slab junction. This leads to a factor of safety of 1.72 in the design of the TL-5 barrier wall at interior location as listed in Table 4.14.

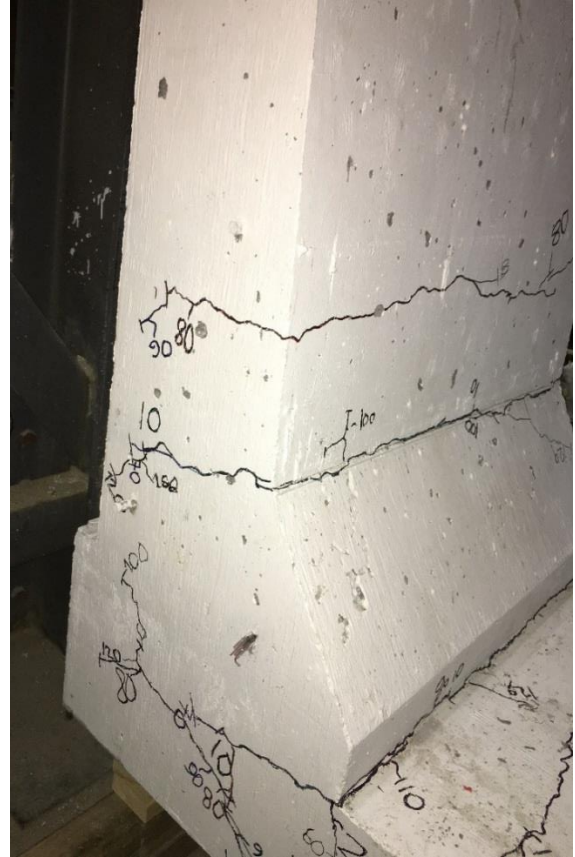
(b) Left side

Figure 4.31: View of crack pattern after failure of the tested specimen B-3

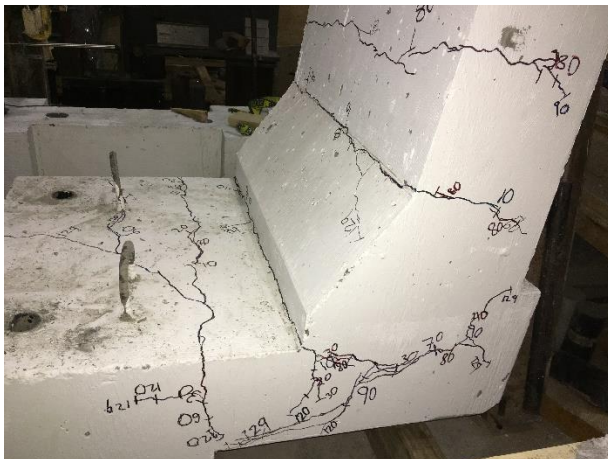
Figure 4.32: Close up view of crack pattern after failure of specimen B-2
