INVESTIGATION ON THE CAPACITY OF TL-5 GFRP-REINFORCED CONCRETE BRIDGE BARRIER-
DECK ANCHORAGE SUBJECTED TO TRANSVERSE VEHICLE IMPACT LOADING

A thesis

Master of Applied Science

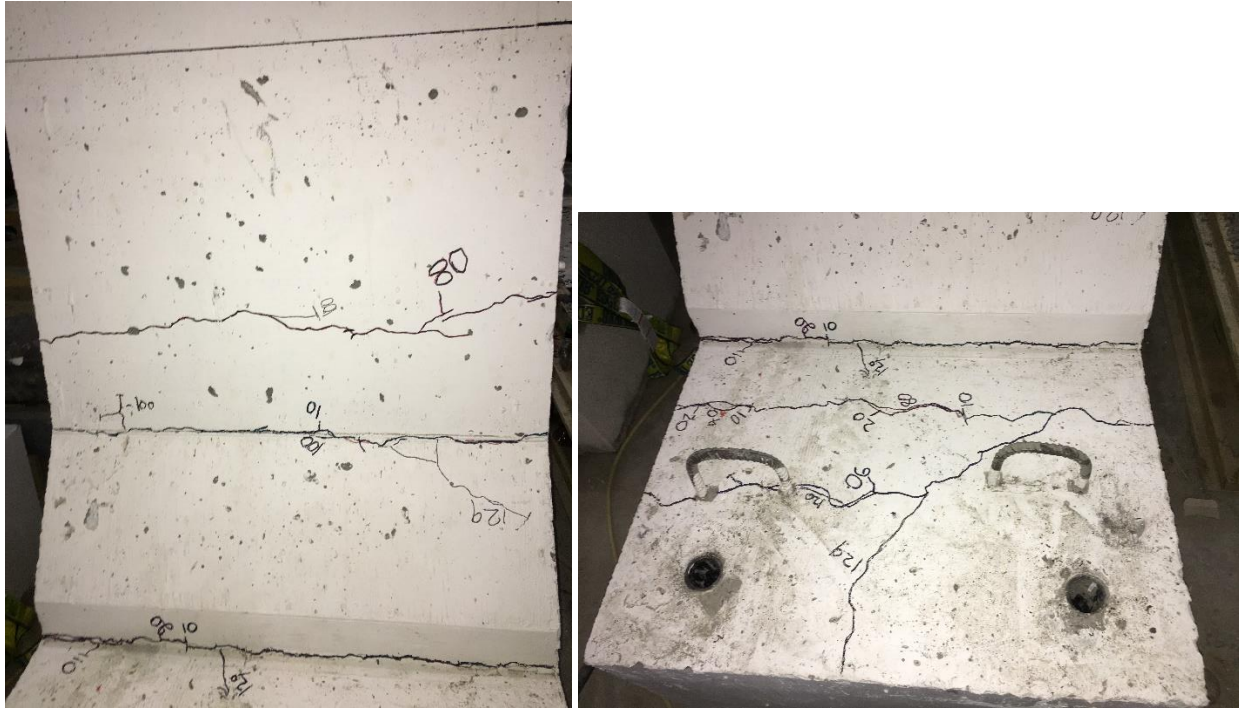
(a) Front face

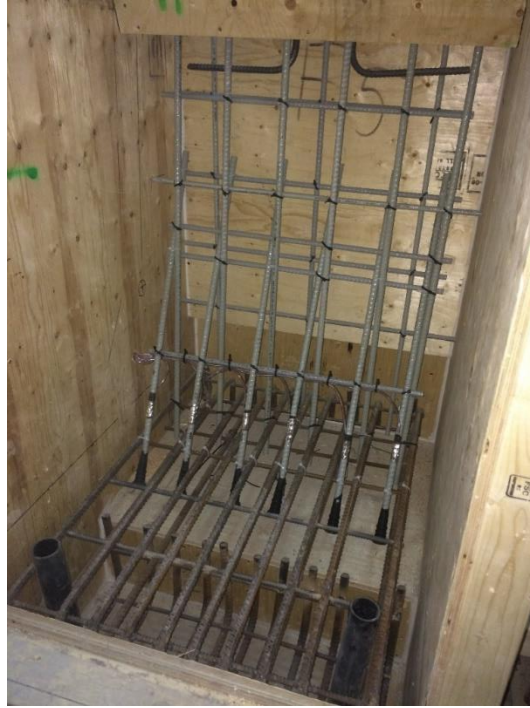
Figure 4.34: Barrier B-4 bar detailing prior to casting

Specimen B-4 represented barrier wall supported over deck slab cantilever at exterior location. Figure 4.4 shows the arrangement of reinforcement in the barrier specimen B-4 before casting. Figures 4.35 through 4.37 show different views of the crack pattern of the tested barrier specimen. In this specimen, the first visible flexural crack was observed at the intersection of the tapered portions of the front side of the barrier wall as well as at the barrier-deck junction and at the deck slab fixed end at 50 kN. These flexural cracks penetrated further at a higher load, along with other flexural cracks in the deck slab as appeared in Figure 4.35. Although flexural cracks appeared in the barrier wall and the deck slab portion, a sudden diagonal tension crack appeared in the deck slab at a jacking load of 90 kN, respectively. These cracks propagated further till the barrier could not take a jacking load beyond 163.41 kN. Given the width of the barrier of 900 mm and the height of the applied load over the top surface of the deck slab of 990 mm, the experimental resisting moment is calculated as 179.75 kN.m/m. This experimental resisting moment at the barrier deck junction is greater than the CHBDC design value of 83 kN.m/m at the barrier-deck slab junction. This leads to a factor of safety of 1.76 in the design of the TL-5 barrier wall at interior location as listed in Table 4.14.

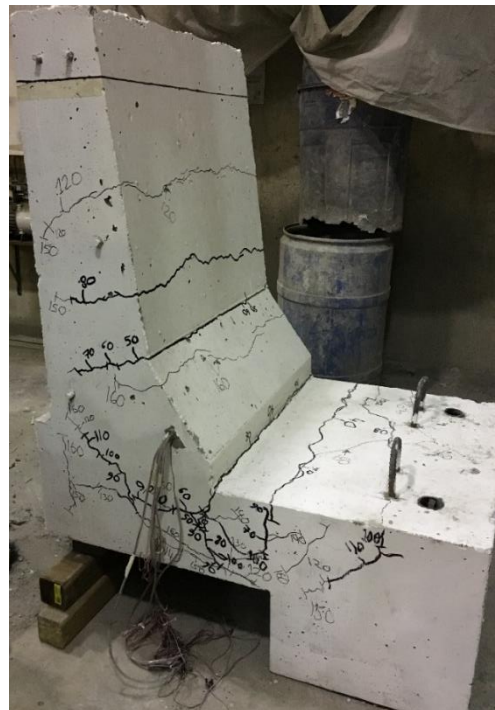
(b) Left side

Figure 4.35: View of crack pattern after failure of the tested specimen B-4

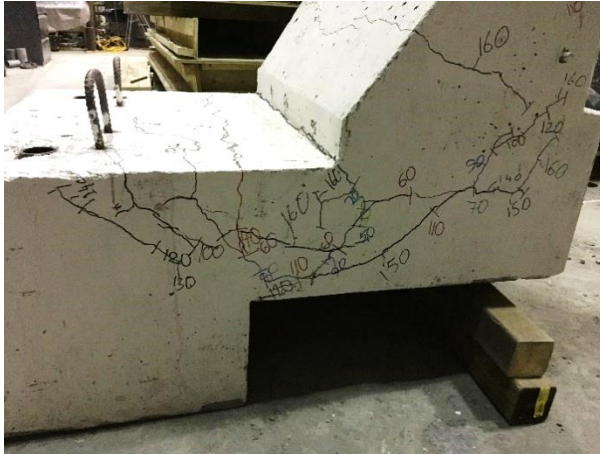
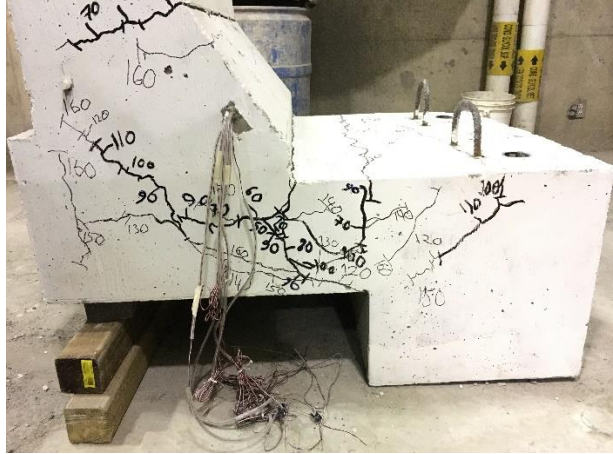
Figure 4.36: Close up view of crack pattern after failure of specimen B-4

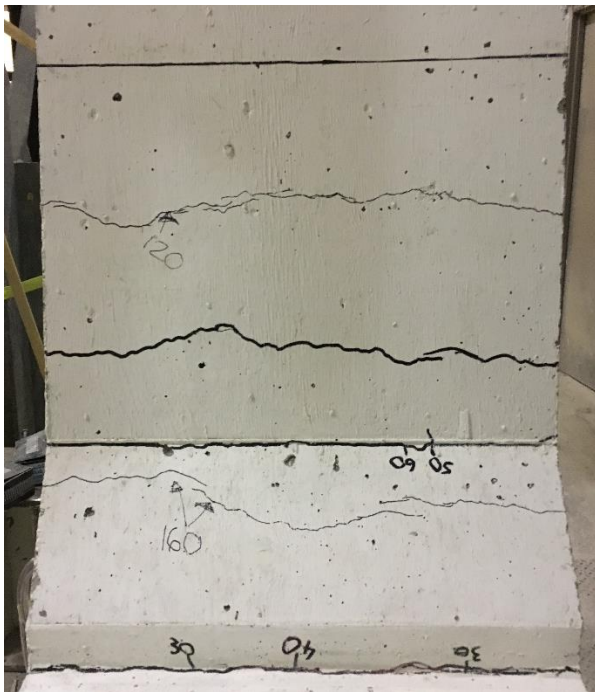
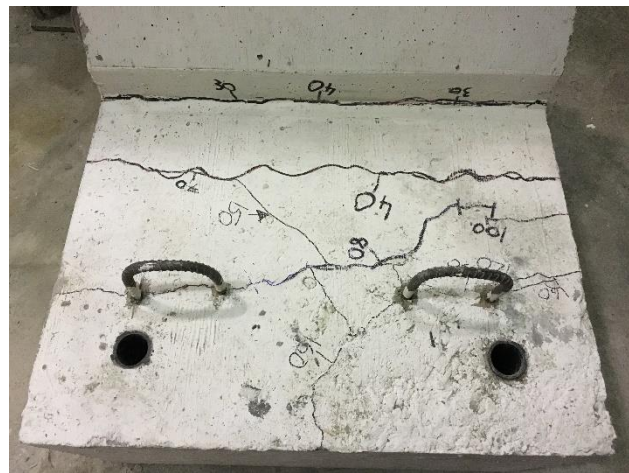
(a) Front face

(b) Deck area

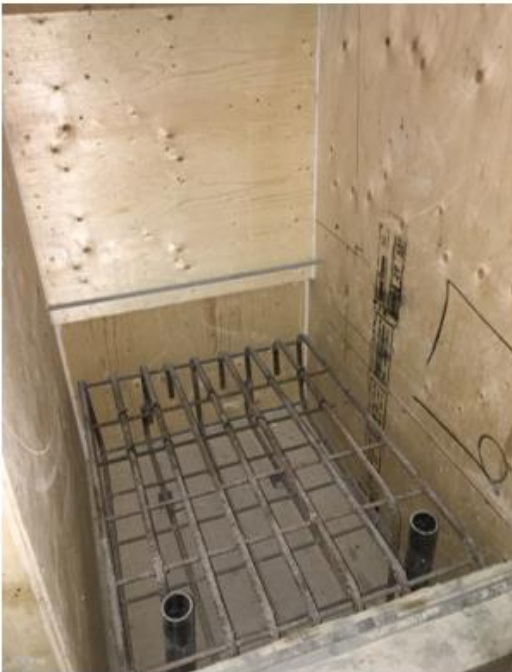
a) Slab prior to casting

represents the case of interior segment of the barrier wall. Figure 4.38 shows the reinforcement details in the barrier and deck before casting. Figures 4.39 through 4.41 show different views of the crack pattern of the tested barrier specimen. In this specimen, the first visible crack was observed in the front side of the barrier wall at barrier-deck junction at 30 kN jacking load, followed by flexural crack at intersection of the two tapered portions of the front face of the barrier wall at 70 kN jacking load. These flexural cracks penetrated through the barrier thickness with increase in the jacking load. However, sudden concrete vertical splitting appeared approximately at the embedded GFRP bar location at a load of 140 kN, followed by signs of concrete breakout close to the end of the embedded bar in the slab at a load of 159 kN. These concrete breakout cracks extended laterally in the slab and towards the back face of the barrier wall at higher loads till the barrier could not absorb jacking load beyond 159.74 kN. Given the width of the barrier of 900 mm and the height of the applied load over the top surface of the deck slab of 990 mm, the experimental resisting moment is calculated as 175.71 kN.m/m. This experimental resisting moment at the barrier deck junction is greater than the CHBDC design value of 83 kN.m/m at the barrier-deck slab. This leads to a factor of safety of 2.12 in the design of the TL-5 barrier wall at interior location when it is rigidly connected to non-deformable concrete deck slab using post-installed, straight-end, GFRP bars as listed in Table 4.14.

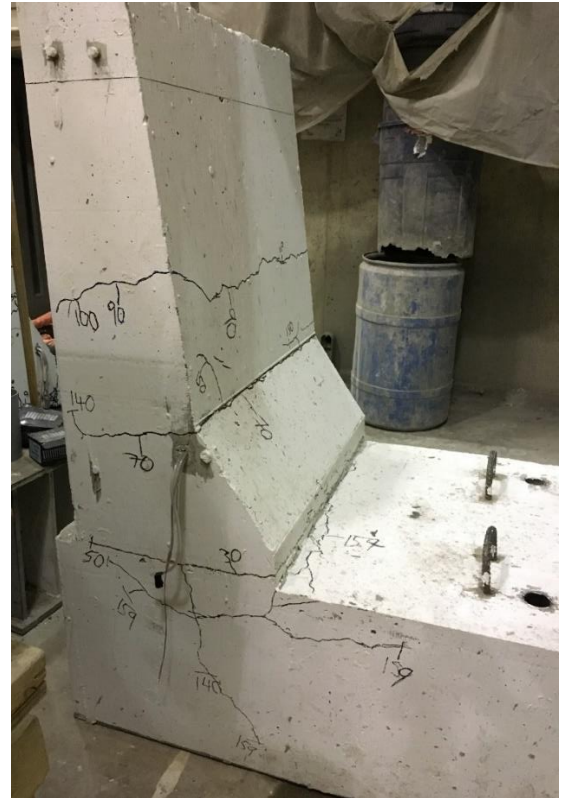
(b) Left side

Figure 4.39: View of crack pattern after failure of the tested specimen B-5

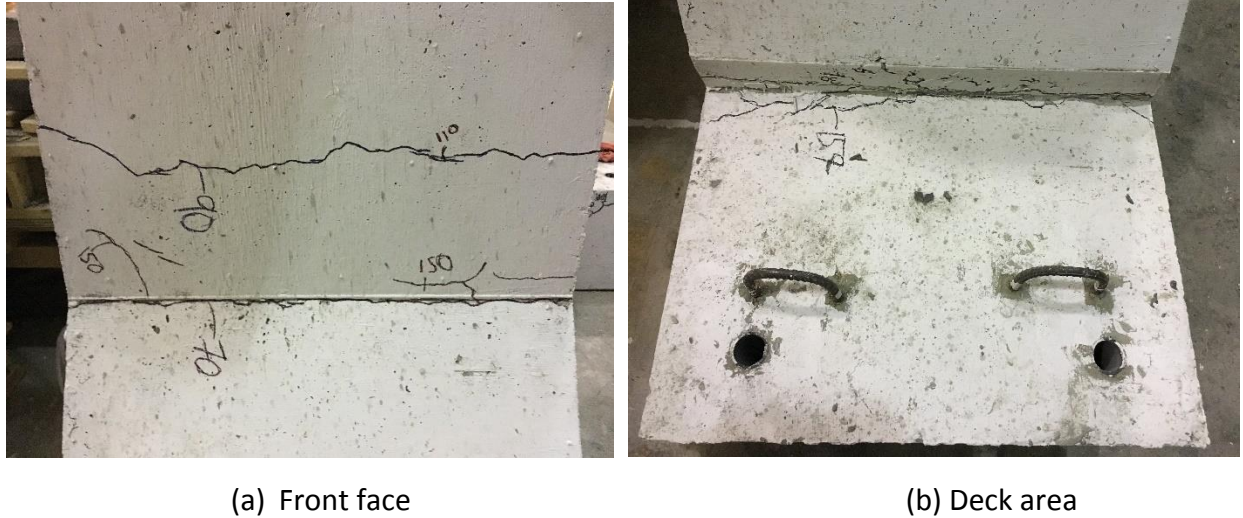
Figure 4.41: View of cracks at front face and deck area of specimen B-5

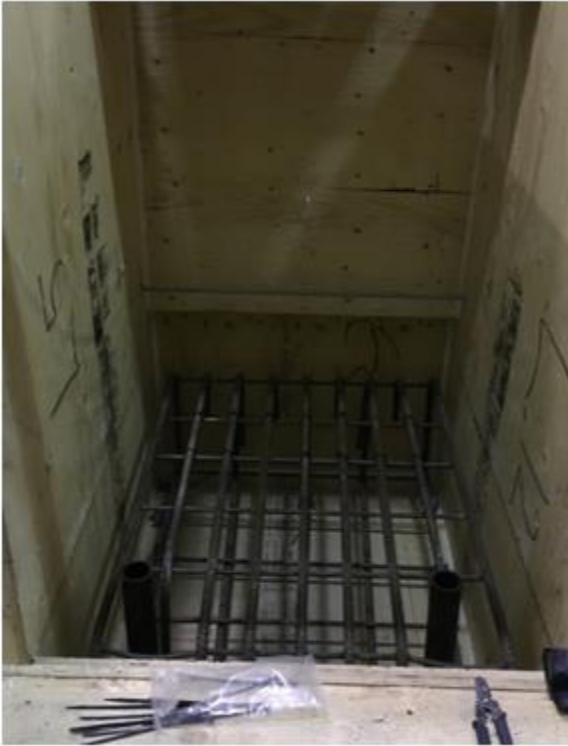
a) Slab reinforcement

Specimen B-6 represents a barrier wall connected to non-deformable concrete slab using post-installed, straight-end, GFRP bars. The amount of vertical reinforcement at the front face represents the case of exterior segment of the barrier wall. Figure 4.42 shows the reinforcement details in the barrier and deck before casting. Figures 4.43 through 4.45 show different views of the crack pattern of the tested barrier specimen. In this specimen, the first visible crack was observed in the front side of the barrier wall at barrier-deck junction at 20 kN jacking load, followed by flexural crack at intersection of the two tapered portions of the front face of the barrier wall at 60 kN jacking load. These flexural cracks penetrated through the barrier thickness with increase in the jacking load. However, sudden shear crack appeared at the middle of top tapered portion of the barrier wall at a load of 180 kN and the specimens could not absorb jacking load beyond 186.74 kN. Given the width of the barrier of 900 mm and the height of the applied load over the top surface of the deck slab of 990 mm, the experimental resisting moment is calculated as 205.41 kN.m/m. This experimental resisting moment at the barrier deck junction is greater than the CHBDC design value of 83 kN.m/m at the barrier-deck slab. This leads to a factor of safety of 2.01 in the design of the TL-5 barrier wall at interior location when it is rigidly connected to non-deformable concrete deck slab using post-installed, straight-end, GFRP bars as listed in Table 4.14.

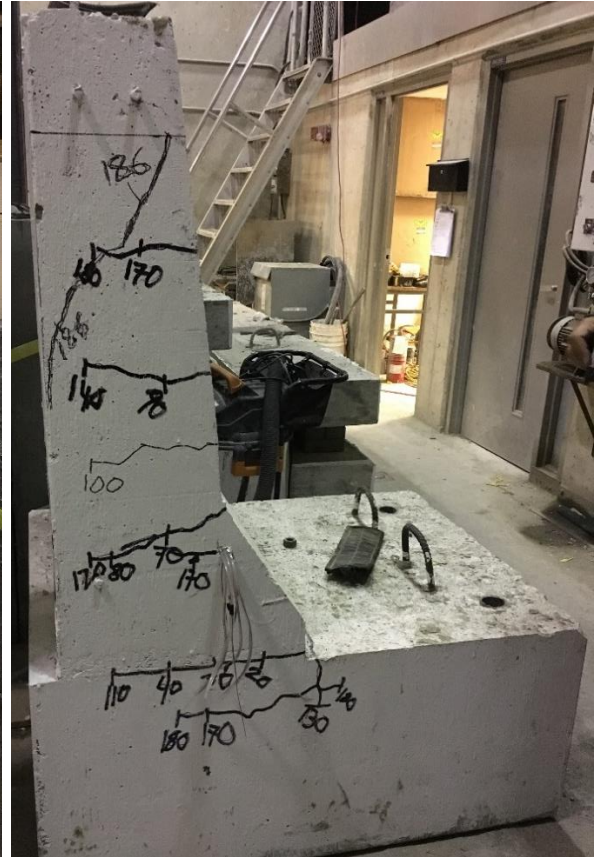
(b) Left side

Figure 4.43: View of crack pattern after failure of the tested specimen B-6

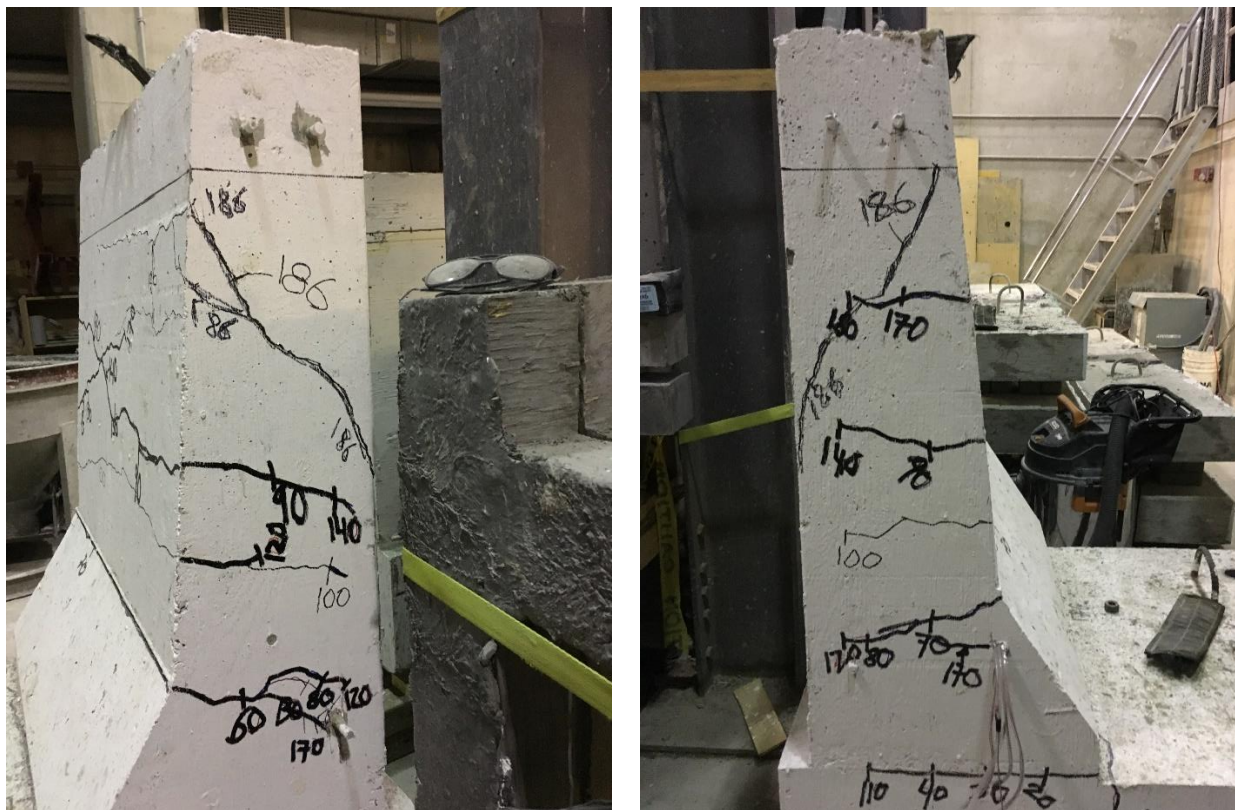
Figure 4.44: Close up view of crack pattern after failure of specimen B-6

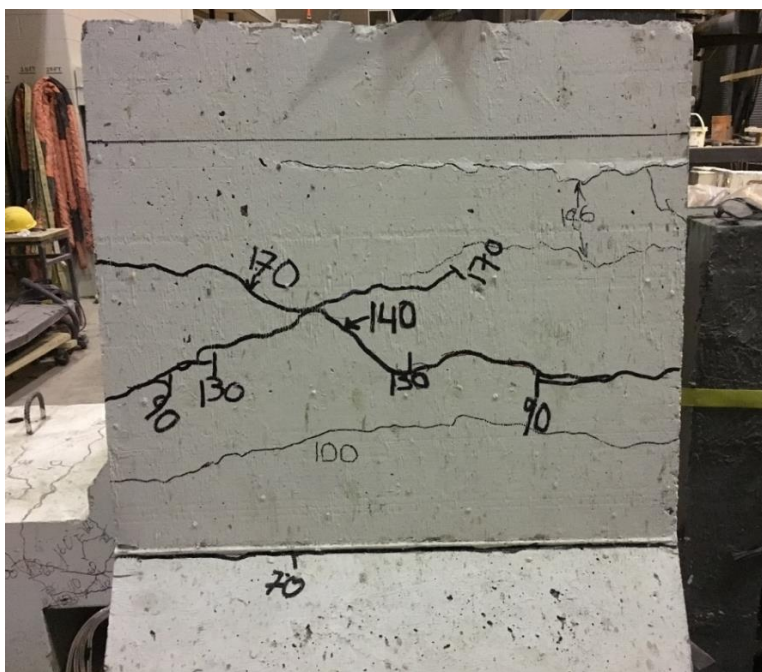
Figure 4.45: View of cracks at front face of specimen B-6

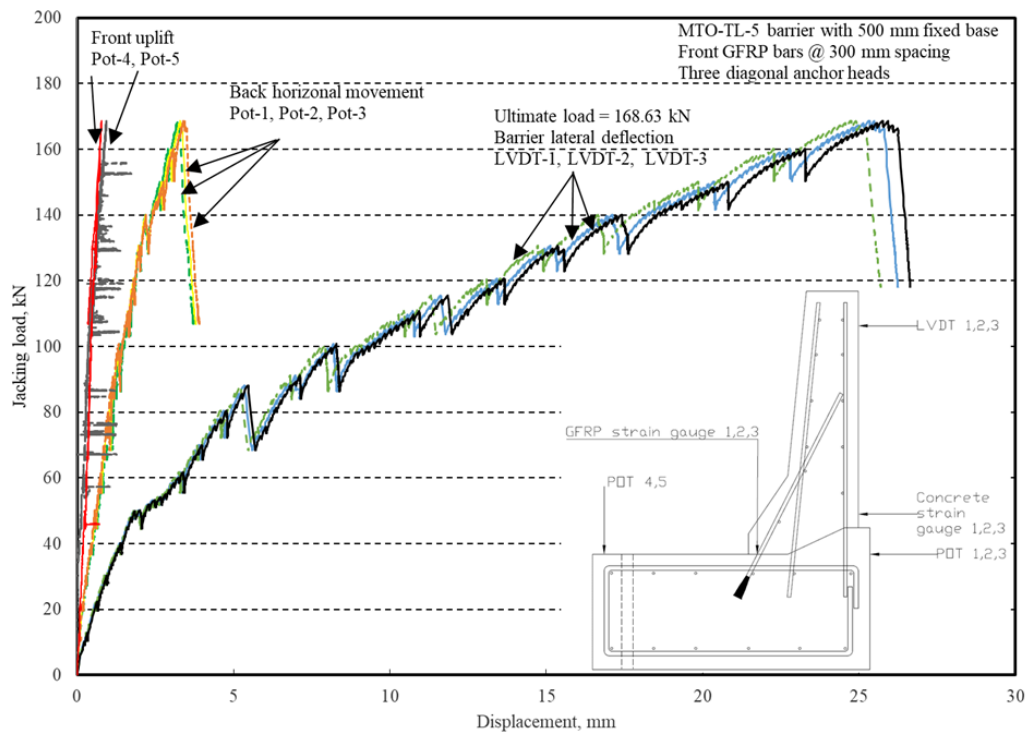
Figure 4.46: Displacement response of Barrier B-1 to increase in static load

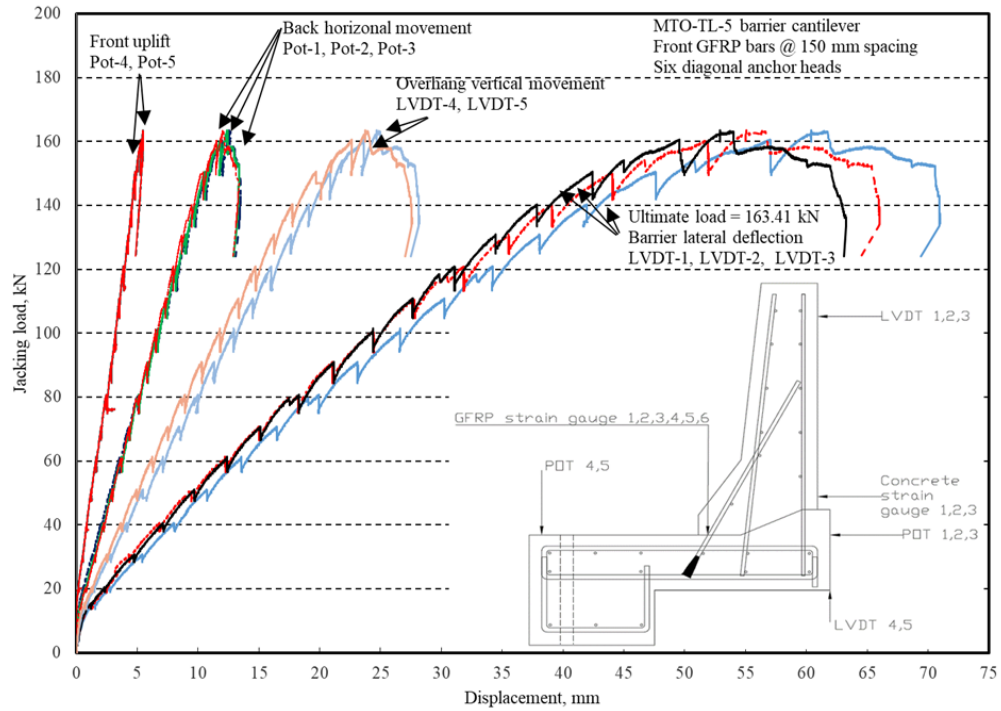
Figure 4.55: Displacement response of Barrier B-4 to increase in static load

It can be observed that the maximum lateral deflection of the barrier wall at failure is 66.76 mm while the vertical deflection of the deck slab cantilever is 27.88 mm. Figure 4.56 depicts the tensile strains in the diagonal GFRP bars at the front face of the barrier. It can be observed that the average strain in the GFRP bars was 6116.32 $\mu\epsilon$ while the ultimate strain of the GFRP bars per the manufacturer's certification sheet is 15,000 $\mu\epsilon$. Figure 4.57 shows the load-concrete strain relationship close to the barrier-deck junction. It can be observed that the average concrete compressive strain at failure was 1083 $\mu\epsilon$ which is far below the ultimate concrete strain at failure of 3500 $\mu\epsilon$. The low GFRP and concrete strain values are attributed to the fact that GFRP-concrete anchorage failure occurred. Table 4.10 summarizes the critical experimental findings obtained from sensors.

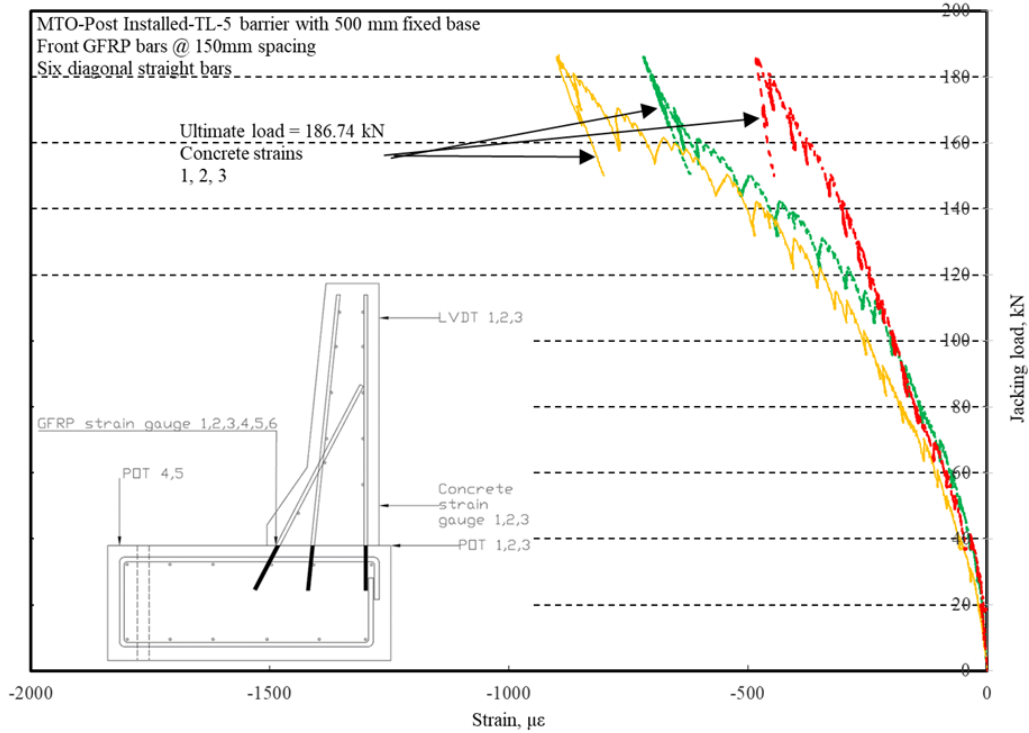
Figure 4.63: Concrete strain response of Barrier B-6 to increase in static load

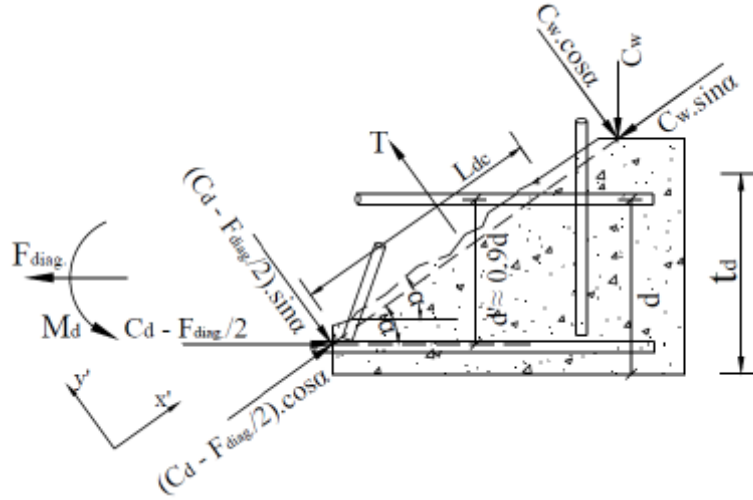
Figure 4.64: Internal forces in the barrier deck-wall junction (Khederzadeh, 2014)

Khederzadeh (2014) conducted cross-sectional analysis of cantilevered barrier specimens to develop formulas to better predict failure of the barrier specimens due to diagonal tension crack in the deck slab cantilever at the barrier-deck junction. The utilized methodology was adopted from Matta and Nanni's research (2009). Khederzadeh (2014) introduced new formulas to eliminate the iterative process proposed by Matta and Nanni while maintaining good correlation between the experimental and analytical results. Khederzadeh (2014) analyzed the internal forces and used diagonal tension crack length and angle data collected from experimental finding to develop the formulas. Figure 4.64 outlines the internal forces that are present in the barrier wall-deck junction. Subsequent to the figure are the formulas used in Khederzadeh (2014) derivation for the new cracking moment to predict failure of the barriers.

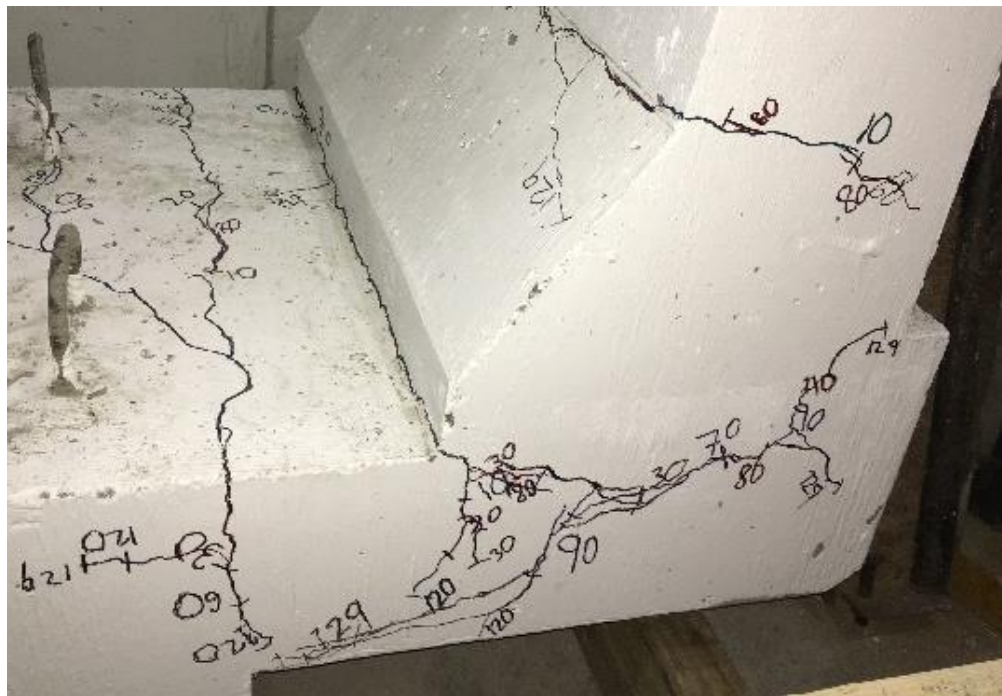
Figure 4.65: Barrier B-3- Interior location cantilever; diagonal cracking is evident in areas and lengths mentioned above

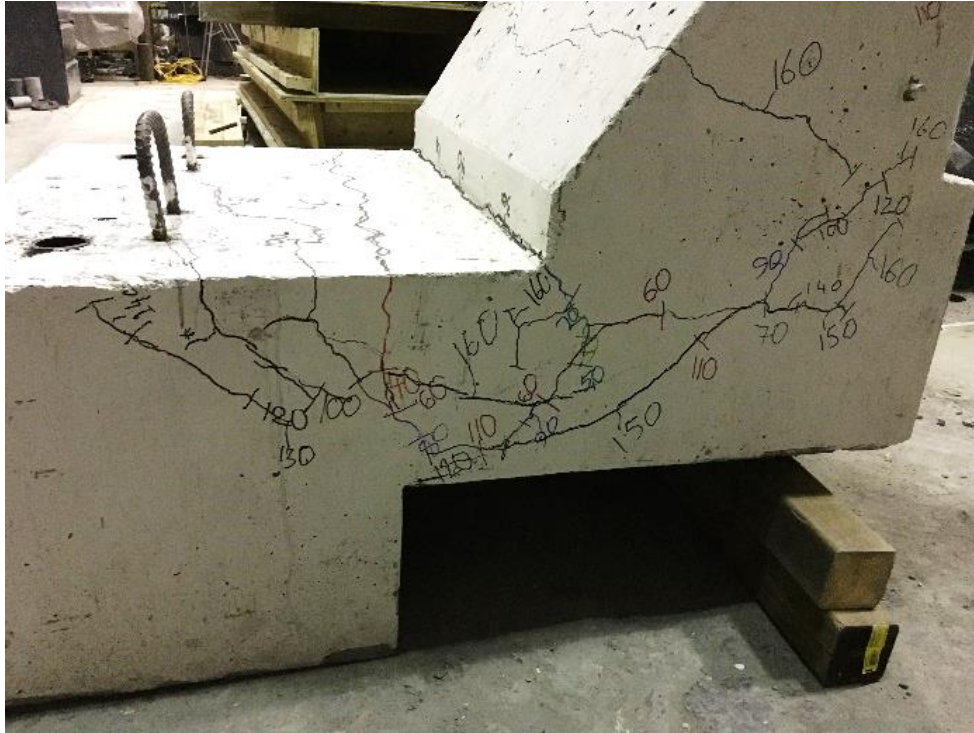
Figure 4.66: Barrier B-4 exterior location; similar diagonal cracking is visible

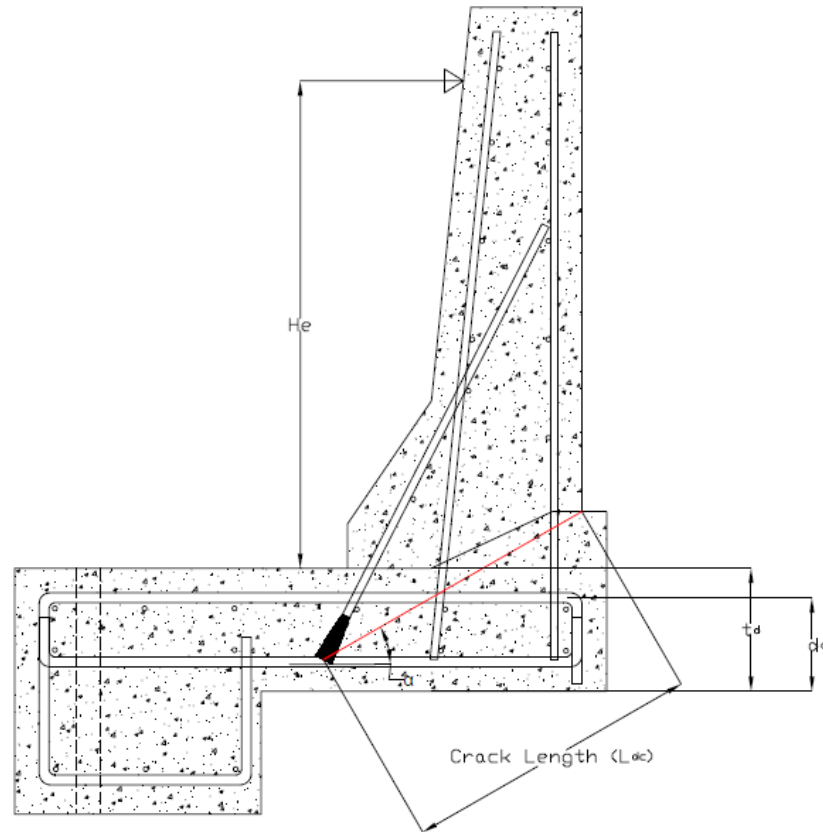
Figure 4.67: Red line outlines the crack length to be used in analysis for this research

When Khederzadeh (2014) calculated the cracking moment, he considered a crack length between the straight vertical bars (on the front face) to the top right corner of longitudinal and vertical bar intersection in the deck, as shown in Figure 4.64. When comparing experimental results achieved in this research, results appear to indicate a crack length propagating from the top right concrete construction joint which extends down to the bottom left, where the anchor-headed bar ends. The experimental crack results are shown in Figures 4.65 and 4.66. Khederzadeh (2014) derivation was used in experimental results obtained in this phase to analyze correlation between the analytical methods vs. experimental. However, crack length and angle was determined analytically without measuring from the tested sample. It should be noted that the angle and crack length were taken from the end of the anchor-headed GFRP bar to the concrete construction joint. This is showcased in Figure 4.68 and 4.69.

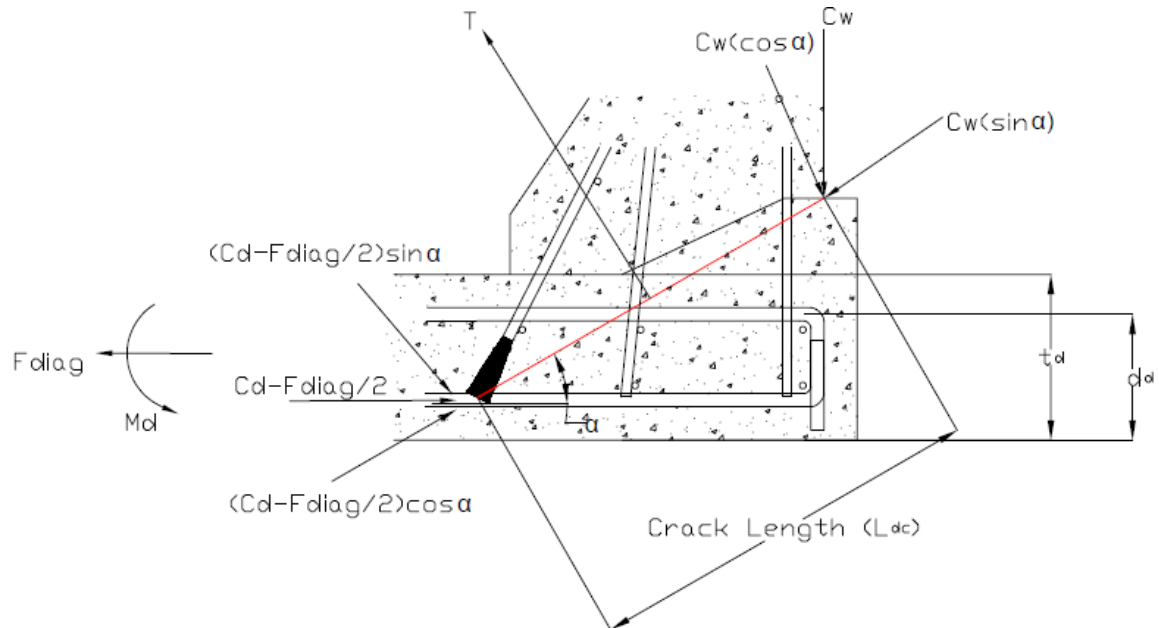
Figure 4.68: A close up of the deck-wall junction along with internal forces

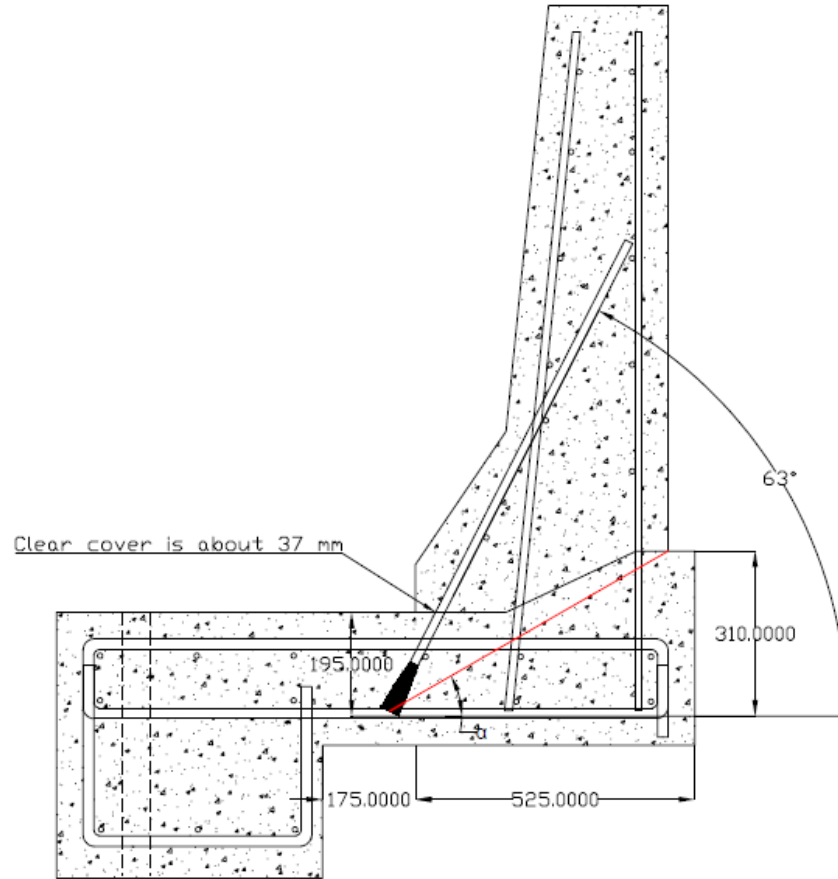
Figure 4.69: Dimensions necessary for crack length calculation

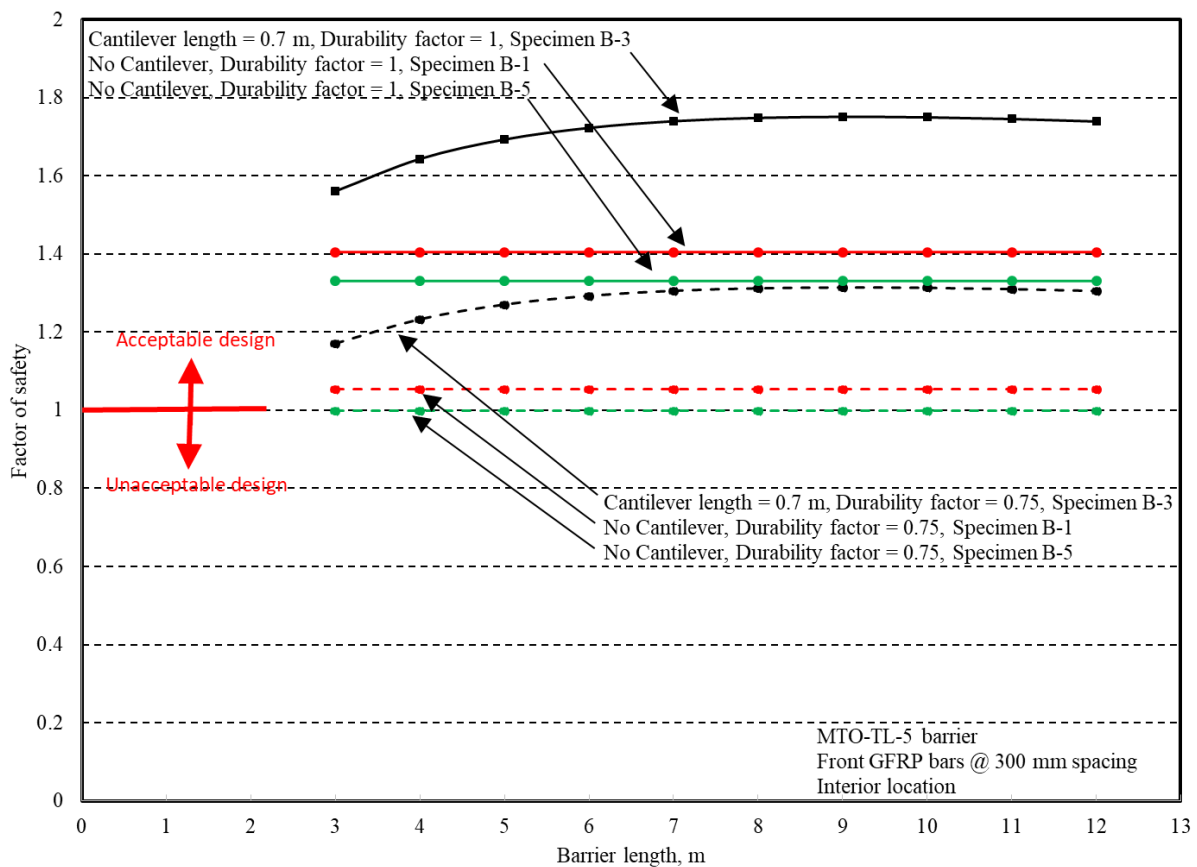
Figure 4.70: Interior loaded barriers factor of safety representation

one may be able to further verify the safety of implementing the proposed barrier-deck junction details in this research. The experimental results were introduced as a ratio over the FEA values obtained from the empirical equation in Table 4.15 to determine whether the ratio is more than or equal to 1 for safe design. It should be noted that a GFRP-concrete durability factor of 0.75 was applied to add to the safety of the barrier design. These results are shown in graphical and table format in Figures 4.70 and 4.71, and Table 4.16. Results show that all factors of safety for design of the barrier-deck junction in this research are more than 1 irrespective of the barrier length. So, it is recommended to use this design for TL-5 barriers. It should be noted that barrier lengths considered in this study were of 3 m or more.
