# Application Of FBG Sensors For Fatigue Monitoring Of Advanced Polymer Matrix Composites

APPLICATION OF FBG SENSORS FOR FATIGUE MONITORING  
OF ADVANCED POLYMER MATRIX COMPOSITES

in partial fulfillment of the  
requirements for the degree of  
Master of Applied Science  
in the Program of  
Aerospace Engineering

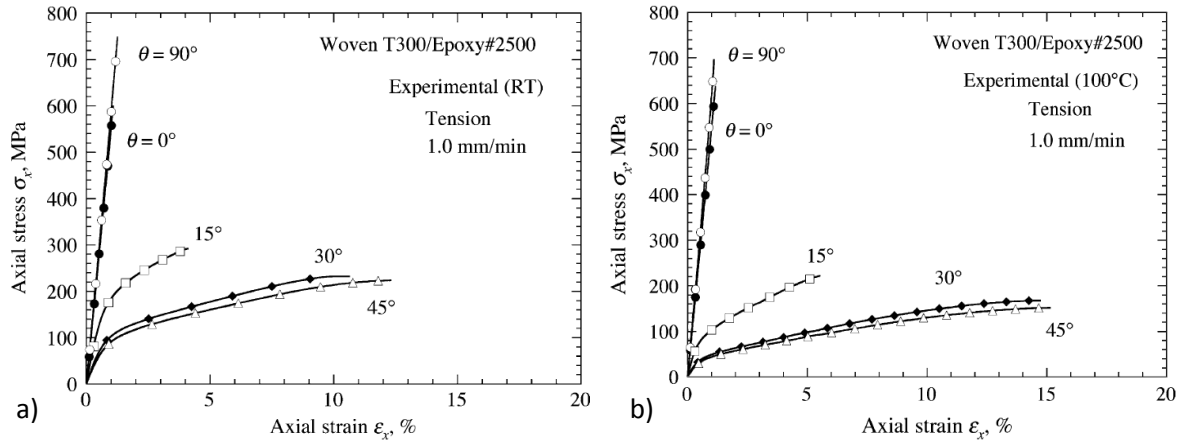
Figure 5: Stress-strain behavior of off-axis woven composites at a) room temperature (RT) and b) 100°C [19].

PMCs, especially those that exhibit matrix-dominated properties, experience a reduction of longitudinal stiffness, ultimate strength and fatigue life at elevated temperatures (ET) [21, 34, 38], refer to Figure 5a and b [19]. A more severe degradation occurs at temperatures near the  $T_g$ . These degradations occur primarily due to the decrease of shear strength and modulus of the matrix, and the weakening of the fiber-matrix bond [5, 6, 9, 19]. Similarly, at ET a matrix becomes more viscoelastic and properties of a PMC become increasing more time-dependent [11, 30, 37, 39].

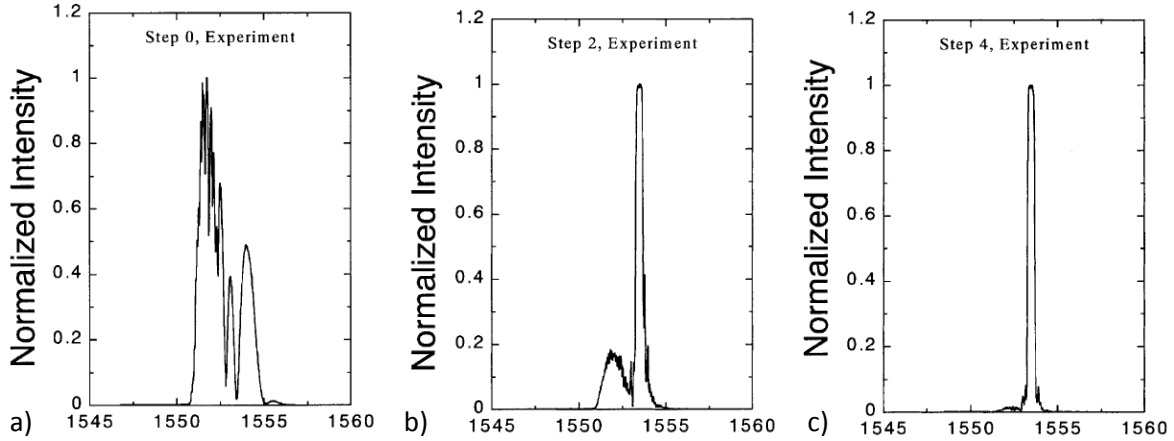
Figure 16: FBG spectra recorded when a) transverse crack had formed, b) delamination initiated and c) delamination became larger than the length of the grating [15].

with the onset of delamination, the spectrum split into two peaks representing the bonded and the delaminated regions. Also, the relative intensity of the two peaks changed as delamination increased. Hence the peak that corresponded to the delaminated portion of the FBG started with a low intensity and significantly increased in intensity as delamination had propagated.

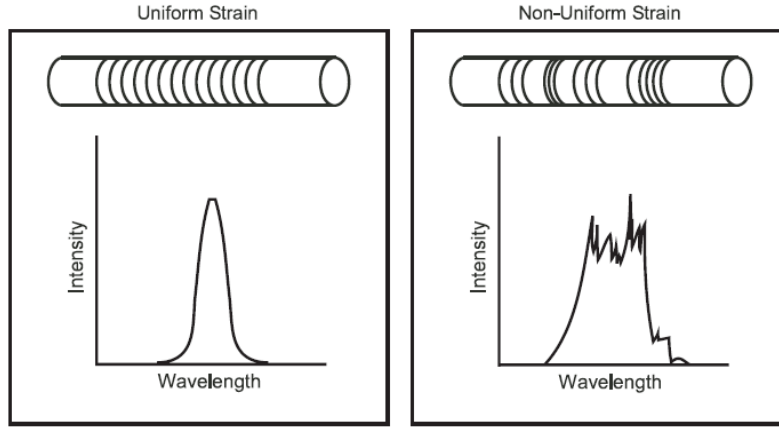
Figure 17: Influence of a non-uniform strain field on the FBG spectrum [16].

Moreover, Takeda *et al.* [16] demonstrated the ability of an FBG embedded into a composite repair patch to monitor debonding of the patch. In this study [17] a clear differentiation was made between the different spectral changes characteristic to the onset and the progression of the different failure mechanism (cracking, debonding). Figure 17, illustrates how the presence of transverse cracks influences the strain distribution in the vicinity of the grating and shows the resultant chirped spectrum. On the other hand, debonding (or delamination) has a more pronounced effect on the spectrum, causing the spectrum to split into two distinctive peaks, each representing the bonded and the debonded regions. Takeda *et al.* [16] also noted that it was possible to define a relationship between the length of the debonded region and the intensities of the two peaks ( $I_A/I_B$ ), where **B** corresponds to bonded and **A** to debonded areas. Figure 18, shows the influence of applied loading on the spectral shift; two possible locations of the debonded region along the length of the grating are considered.

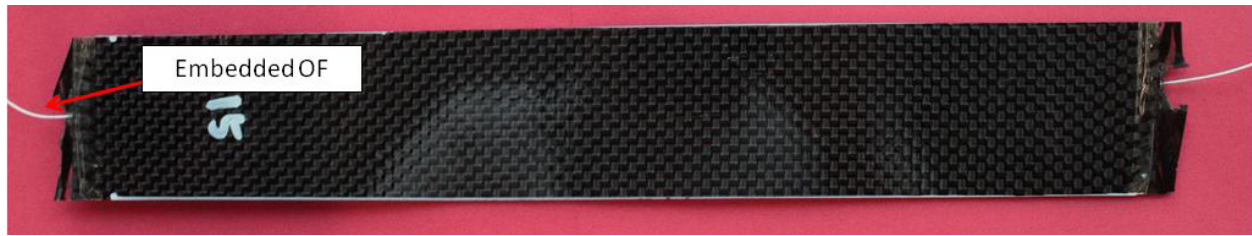
Figure A4: Woven specimen in its original non-damaged state.
