**Evaluation of Critical Factors from Residential Adaptive Reuse Projects
Within the context of Toronto, Ontario**

Major Research Project

Masters of Building Science (MBS.)

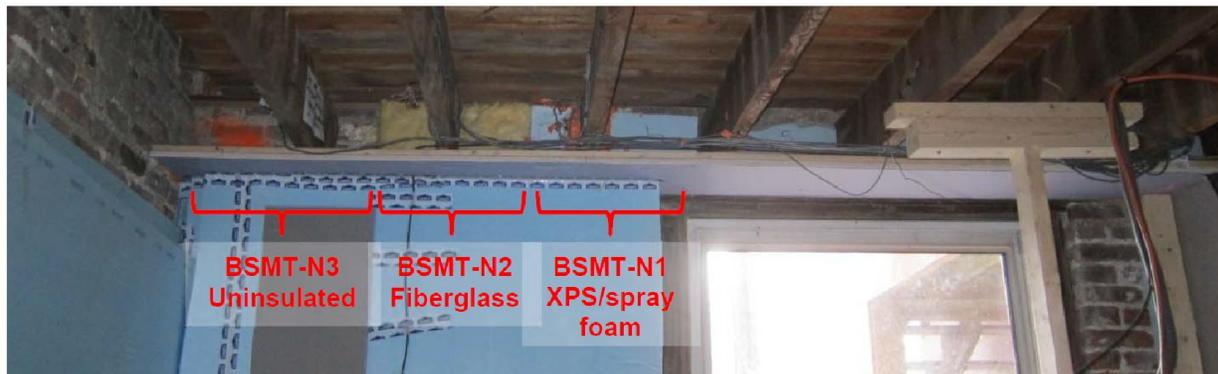
Figure 6: Comparison of Insulation Strategies for Heritage Masonry Buildings (Ueno, Straaten, & Schumacher, 2013)

interior walls of the building were retrofitted with three layers of 2 inches of extruded polystyrene (XPS) insulation adhered to existing masonry with polyurethane adhesive and wood 2x4 framing was installed for mechanical services along with spray foam at the joints (Figure 6). Their findings revealed how the north and east sides of the building displayed higher moisture content inspite of lack of decay within the wood members; south side (solar-heated) demonstrated decent moisture content (10%-13%) thus proving that climatic orientation matters for unheated buildings. Further findings showed reductions in their freeze-thaw cycles by half for uninsulated walls, thus increasing the rate of cooling. After addition of interior heating, it helped in drying up joists (Ueno, Straaten, & Schumacher, 2013).

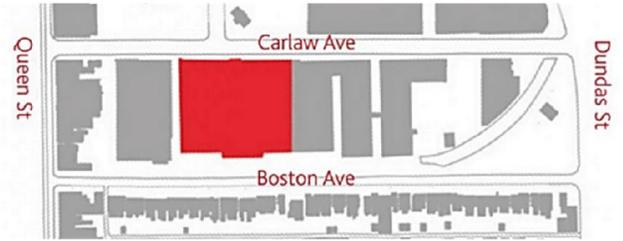
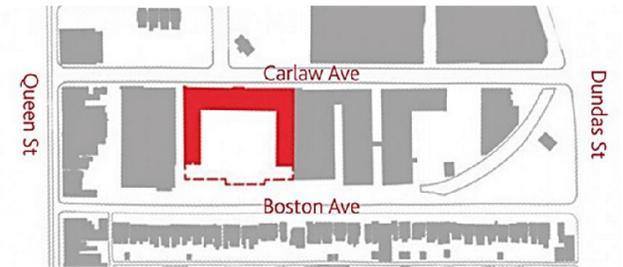
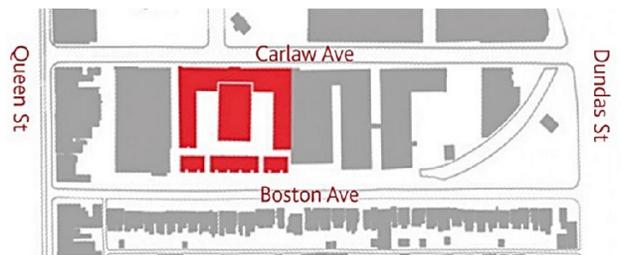
Above: Industrial site before construction

Above: Demolition of the central part

Above: Existing Residential Complex

Figure 14: Design strategies employed in the residential development seen on right (ArchDaily, 2011)

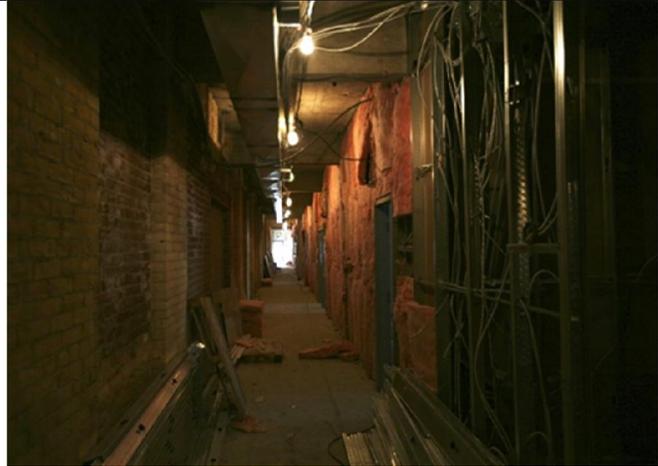
Above: Insulation work at progress

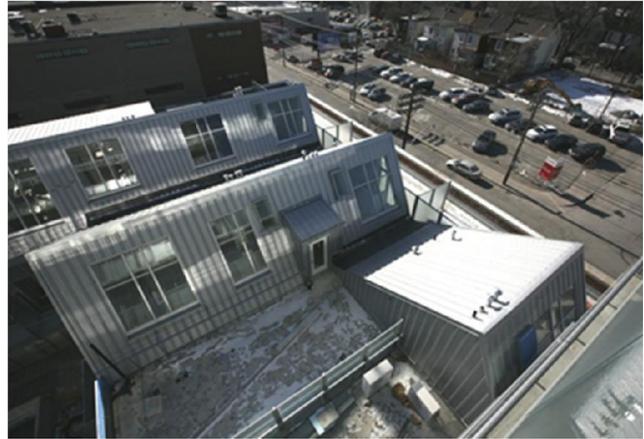
Above: Sawtooth skylights integrated in Lofts

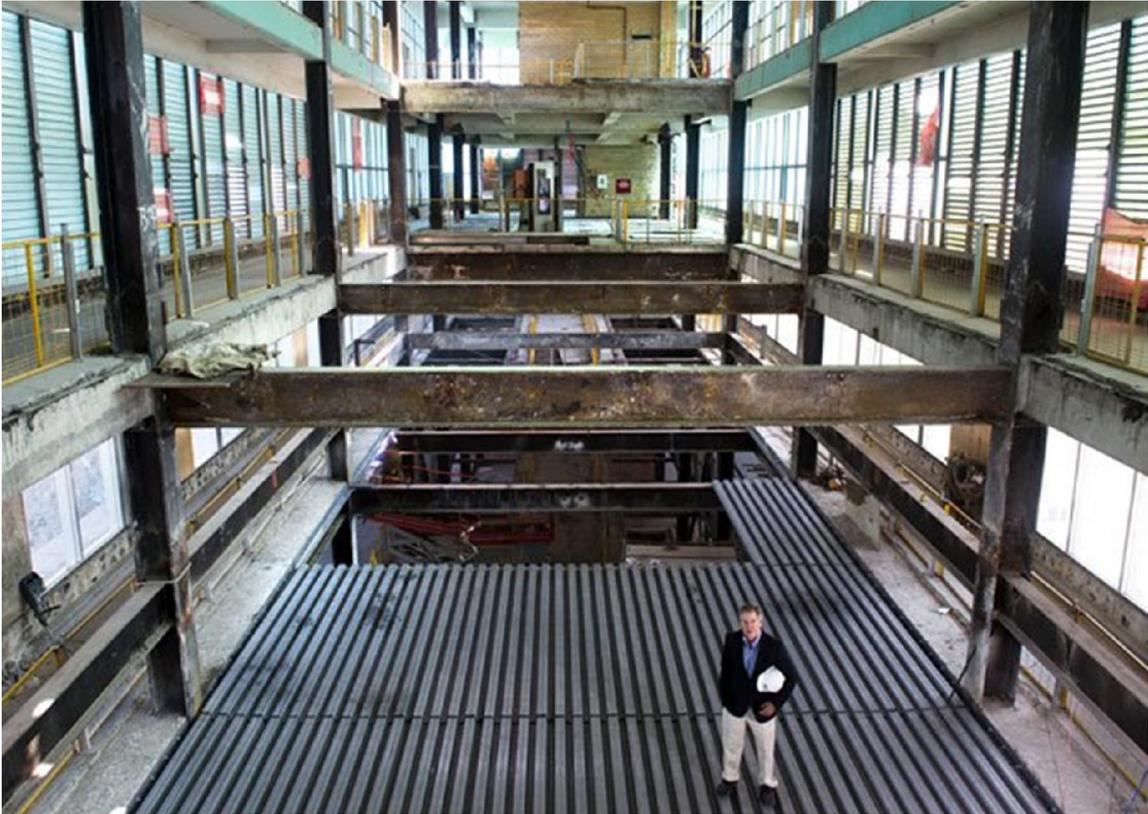
Interior view of former mechanical plant (three floor levels) (Uniacke Breen, 2012)

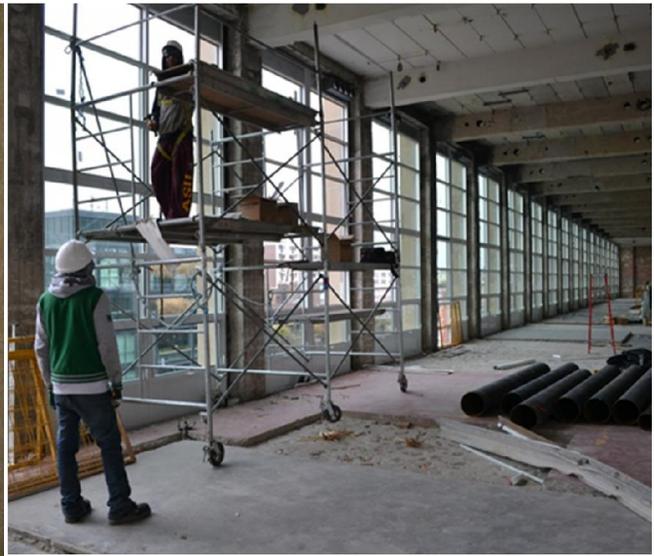
View of massive windows and ceiling height
(4.8m) on the ninth floor levels
