USE OF ADVANCED EMBEDDED PIEZOCERAMIC SENSORS FOR THE NON-DESTRUCTIVE
EVALUATION OF REINFORCED CONCRETE

A thesis presented to Ryerson University
in partial fulfillment of the

MASTERS OF APPLIED SCIENCE

CIVIL ENGINEERING

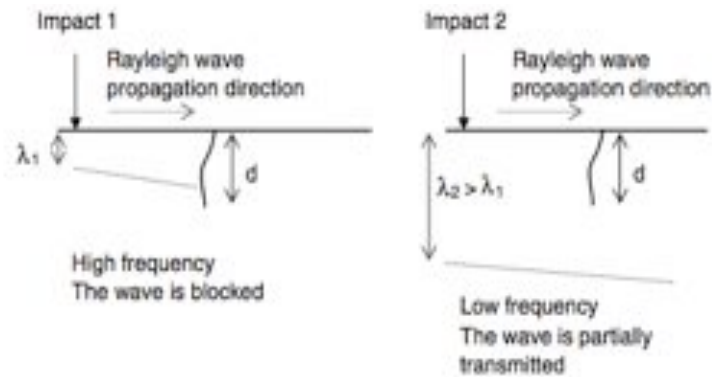
Figure 2.1: Rayleigh Wave Propagation in Determining Cracks (Aggelis & Shiotani, 2007)

The Rayleigh wave is a surface wave that travels in planes normal to the testing surface thus the particles are vibrated perpendicular to the direction of travel. The depth of penetration of Rayleigh waves is directly proportional to the wavelength. This wave mode is very useful for determining the appearance of surface cracking in concrete specimens. Cracks that propagated deeper into the test specimen than the wavelength of the transmitted wave will completely attenuate this wave mode. Thus a receiver placed on the opposite side of the fault from where the stress wave is induced would not sense the disturbance (Aggelis & Shiotani, 2007). Figure 2.1 demonstrated how the Rayleigh wave having a wavelength smaller than the crack depth, would be shadowed by the receiving transducer; whereas if

the wavelength is greater than the depth of the crack the signal will be received by a secondary transducer. This enables to estimate the penetration depth of a surface cracks within a concrete member. Rayleigh waves can be estimated to have a velocity of 55-60% of that of a P-Wave, and are directly proportional to the velocity of the shear wave.

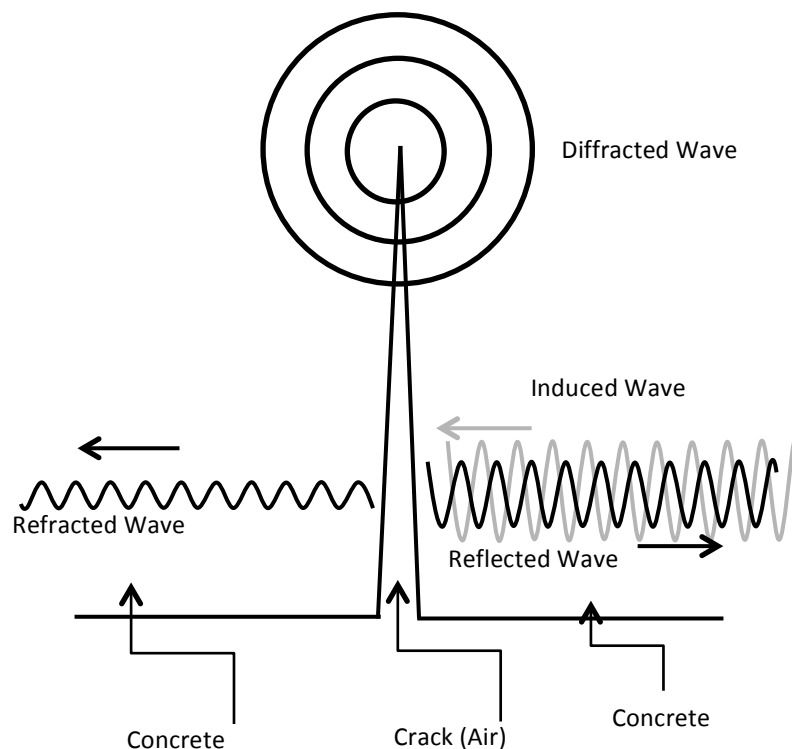
Figure 2.3: Mechanism for Diffraction, Refraction and Reflection of Stress Waves

most important of which is the interaction of a stress wave with a concrete/air interface, or crack location. When a stress wave comes in contact with this interface, the wave is split into two components, a through component, or refracted wave, and a reflected component, as illustrated in Figure 2.3. A third stress wave is created at the edge of the crack opening caused by the diffraction of the incident wave. This diffracted wave travels spherically through the medium centered at the edge of the crack. The amplitudes of these three wave components are fractions of the induced stress wave's amplitude upon incident with the interference.

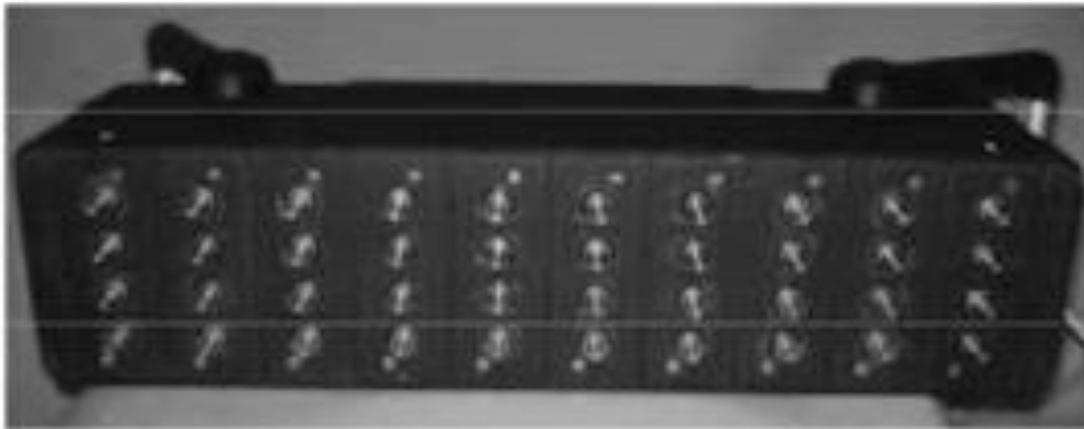
Figure 2.4: MIRA Tomographer's Transducer Array (Germann Instruments, 2010)

The MIRA tomographer is a nondestructive system capable of detecting multiple flaws within a concrete sample, and gives a 3D representation of the internal structure. The system is composed of two components, an antenna array, and a computer. The antenna array is composed of 40 low frequency dry point contact transducers arranged in 10 rows of 4 transducers each, and is presented in Figure 2.4. The antenna array uses the “pitch-catch” method, illustrated in Figure 2.5. These dry contact transducers eliminate the need for a contact medium to the concrete, and are spring loaded to allow the use of the array on very rough surfaces while still providing accurate results.

The antenna itself operates in a very similar fashion to other pitch-catch instruments. The first row of transducers will implement a stress wave into the test element while the other 36 transducers receive the signal. The second cycle would involve the second row of transducers emitting the signal while the remaining 32 probes receive the signal as demonstrated by Figure 2.5. The process is repeated until each of the 9 rows has

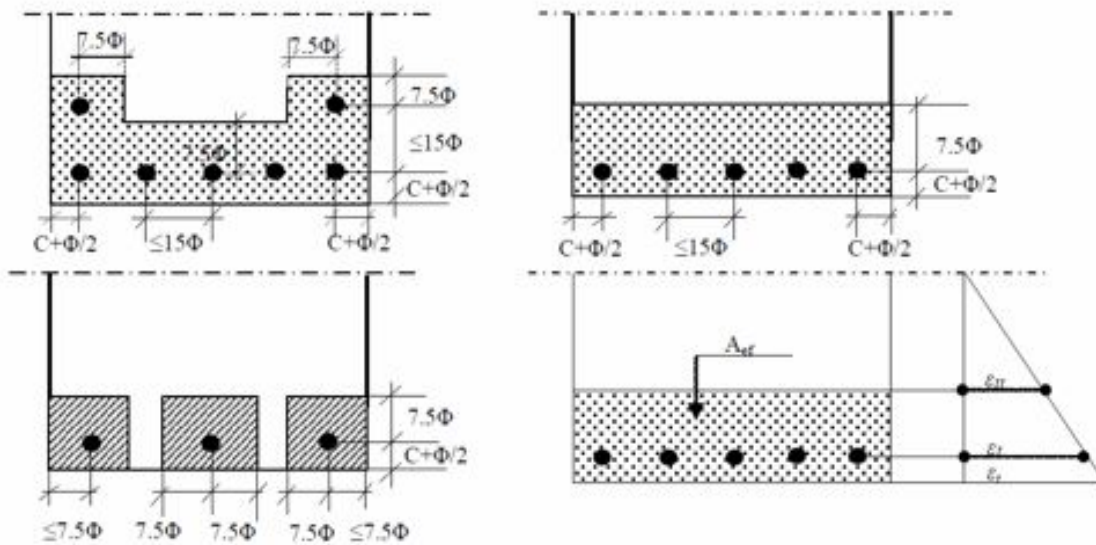
Figure 2.10: Guidelines for Determination of Effective Concrete Area for Calculation of Crack Spacing (Shaded) [NS 3473 E 1992Code]

The provisions provided by the Norwegian Code NS-474E-92 have a different approach for calculating the crack width that accounts for the tensioning stiffening effect. The effective concrete area in accordance to the Norwegian Code NS-474E-92 is presented in Figure 2.10, where Φ represents the diameter of the steel reinforcement. The average crack width (w_m) is calculated using Equation 2.16 where ε_1 is the principle strain of the tensile reinforcement, S_m is the average crack spacing and r is the factor accounting for the tensioning stiffening effect. The r factor is calculated using the stress in the reinforcement at the cracking load (σ_{sr}) and applied load (σ_s). β is the factor taking loading procedure into account, and k_1 is the reinforcement influence factor, taken as 0.4 for ribbed bars. The maximum crack width (w_k) can be calculated using equation 2.17.

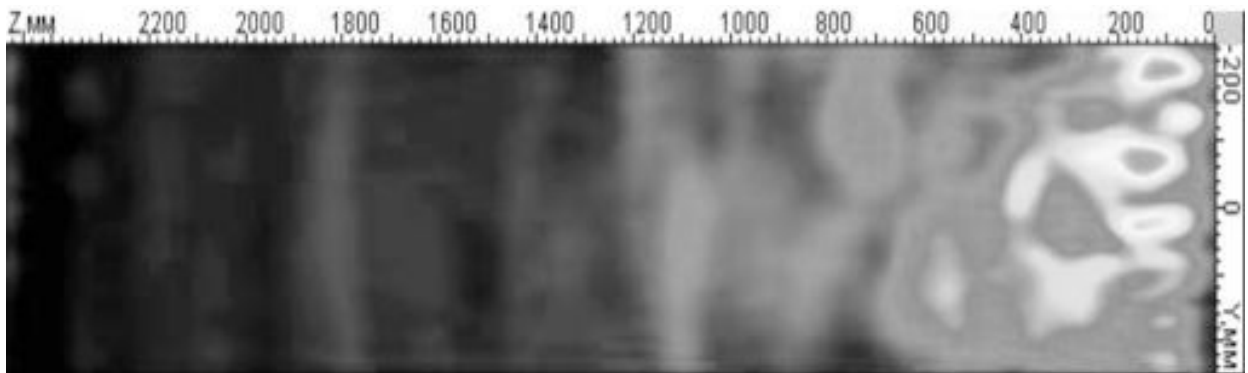
Figure 3.2: 2m deep structural wall MIRA B-scan software output 20 kHz

The image also illustrated a vague representation of reinforcement bars at a depth less than 200 mm. The large wavelength makes it very difficult to get an accurate estimation of the bar size, although the image provides enough information to deduce that the bars are 50 mm apart. The result cannot be confirmed until structural drawings are provided to of the structural floor to verify the result

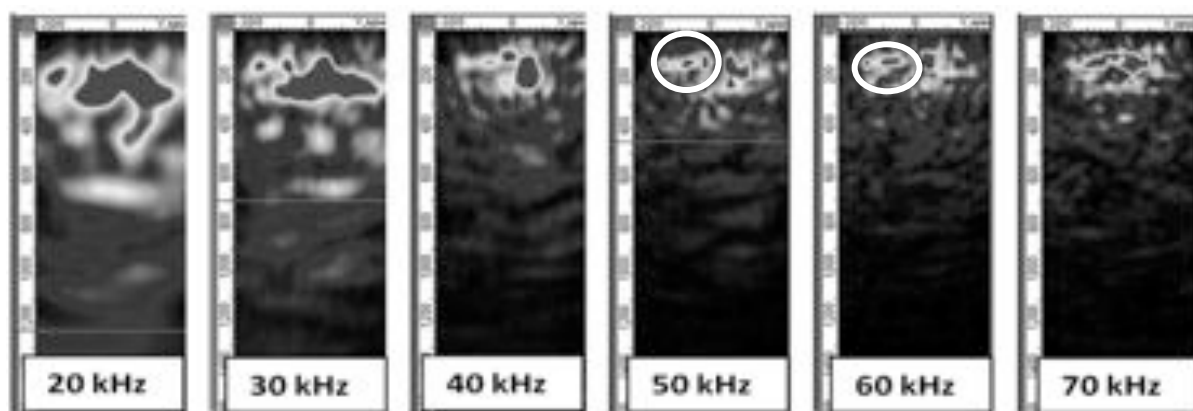
Figure 3.3: Deep structural floor MIRA B-scan software output 20 kHz – 70 kHz

It is presented in Figure 3.3, the depth of penetration of the signal is largely influenced by the frequency used. The higher the frequency the less information was obtained on regions embedded deep within the specimen. At 20 kHz the signal has good penetration well beyond a depth of 1.2 m. The darker the image appears the less signal that is returned to the antenna, this becomes clear with frequencies equal to or greater than 50 kHz, the signal becomes almost insignificant beyond a depth of 800 mm. Although from these higher frequencies we can get a better resolution of the interior, and more accuracy of the depth at which different features are placed within. The smaller wavelength of higher frequencies also helps to identify rather small defects within the slab.

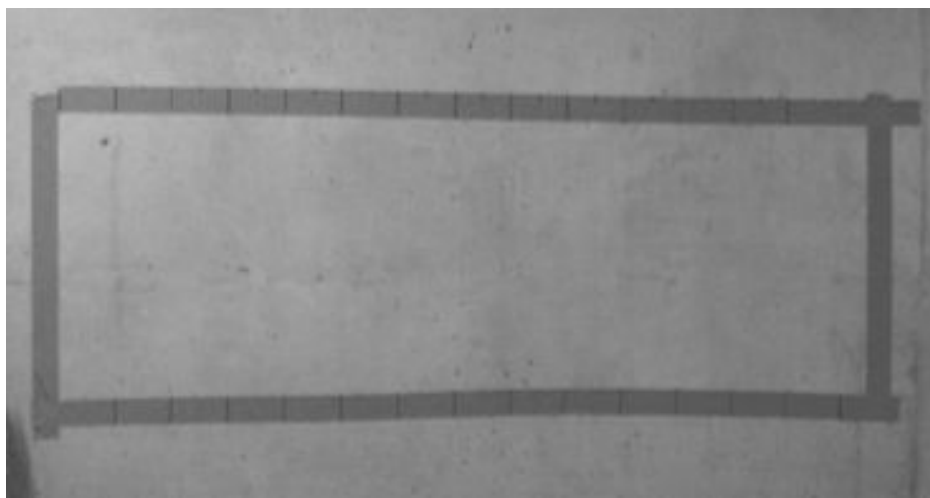
Figure 3.5: Basement Exterior Wall Test Setup

The aim of the test was to verify the MIRA's ability to determine the thickness of the wall and the effects of crack repair on the signal output. The visible repair is over a 200 mm long region on the surface of the wall. To achieve meaningful results an area of 1200 × 500 mm was mapped out over the 300 mm thick wall. The test setup is presented in Figure 3.5. For this test the machine was set to 50 kHz and a step of 100 mm was established and 13 readings were taken.

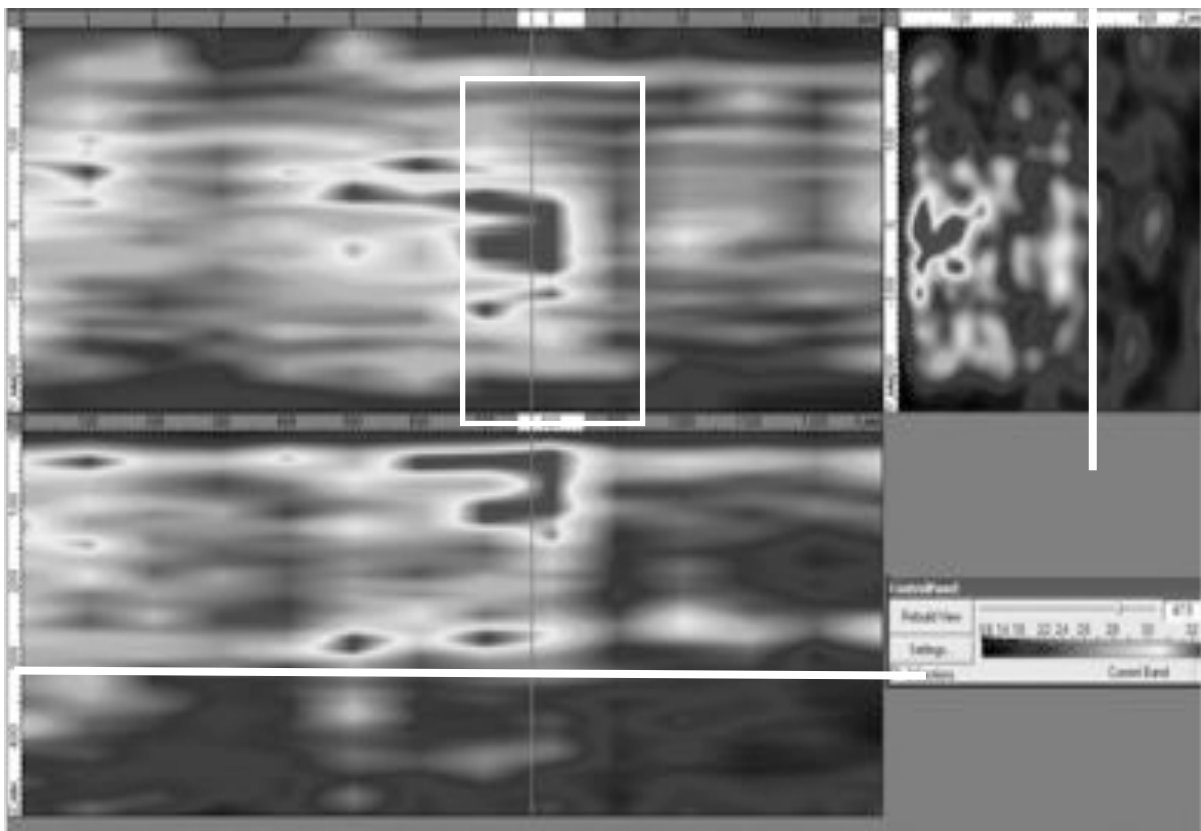
Figure 3.6: Basement Exterior Wall MIRA Software Output 50 kHz

Due to the low frequency used, the damage could not be correctly identified, or correctly positioned, thus a second reading at a higher frequency was taken. The higher frequency would provide a better representation of the top layer. Figure 3.6 also demonstrates that the machine was not calibrated properly, this is illustrated by the 10 equally spaced dots that appear as reinforcement near the top layer of the specimen. These are due to interference from surface waves. This kind of interference is common when the surface of the specimen has many voids and the machine cannot properly calibrate for these. Along with the dots, streaks can be seen on the top left image that would indicate the same problem.

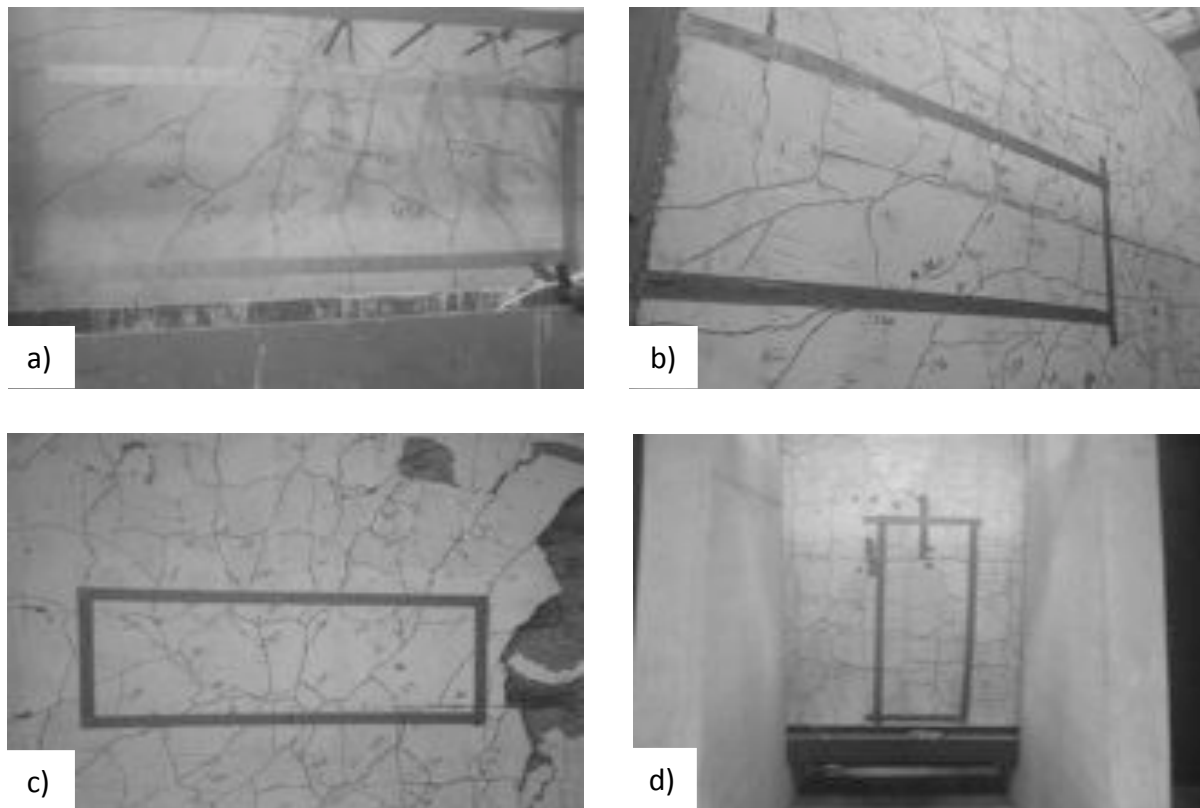
Figure 3.8: Test Surfaces of; (a) Slab 1; (b) Slab 2; (c) Slab 3; (d) Slab 4

Slab 2(HS5) in Figure 3.8b was part one of the slabs that reached its ultimate capacity. The dimensions of the slab are $2650 \times 2650 \times 300$ mm. Due to its size relative to the MIRA tomograph, and the fact that it reached its ultimate capacity, the punching shear crack for this specimen should be clearly visible in the software output. The slab also has T-Headed shear studs, these would stiffen the slab and affect the angle of the punching shear crack, thus making the result different from that of the following two slabs.

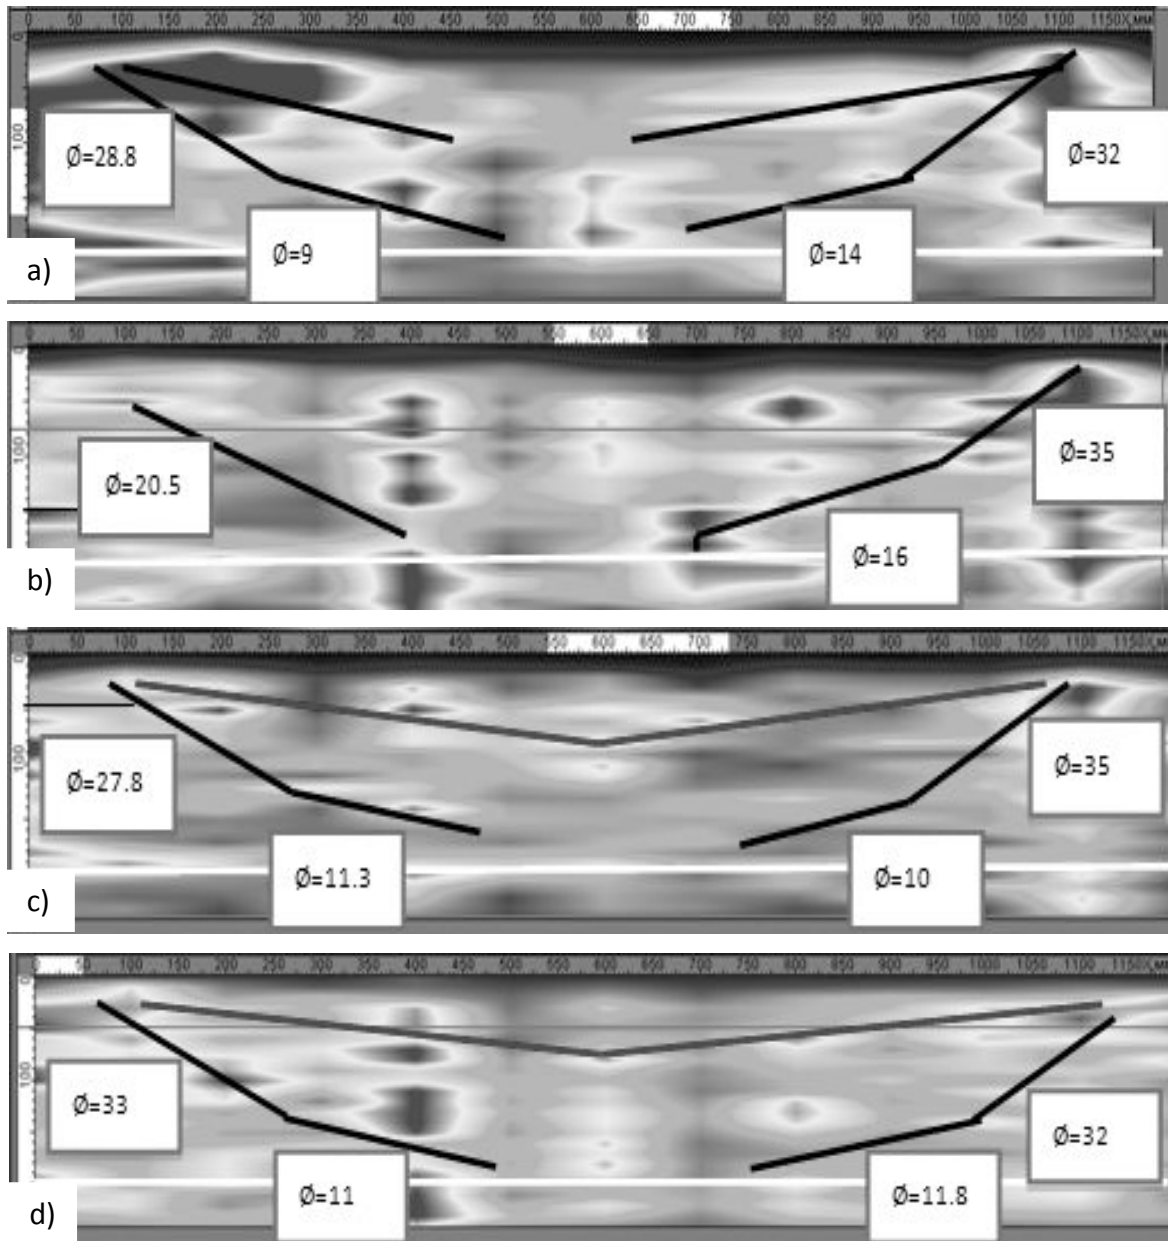
Figure 3.9: Slab 1 D-Scan Image; (a) 40 kHz; (b) 50 kHz; (c) 60 kHz; (d) 70 kHz

the column is estimated at 33.5° and the angle adjacent to the column is estimated to be 13° . Both for the left and right angles, the average of the readings were used to estimate the actual angle.

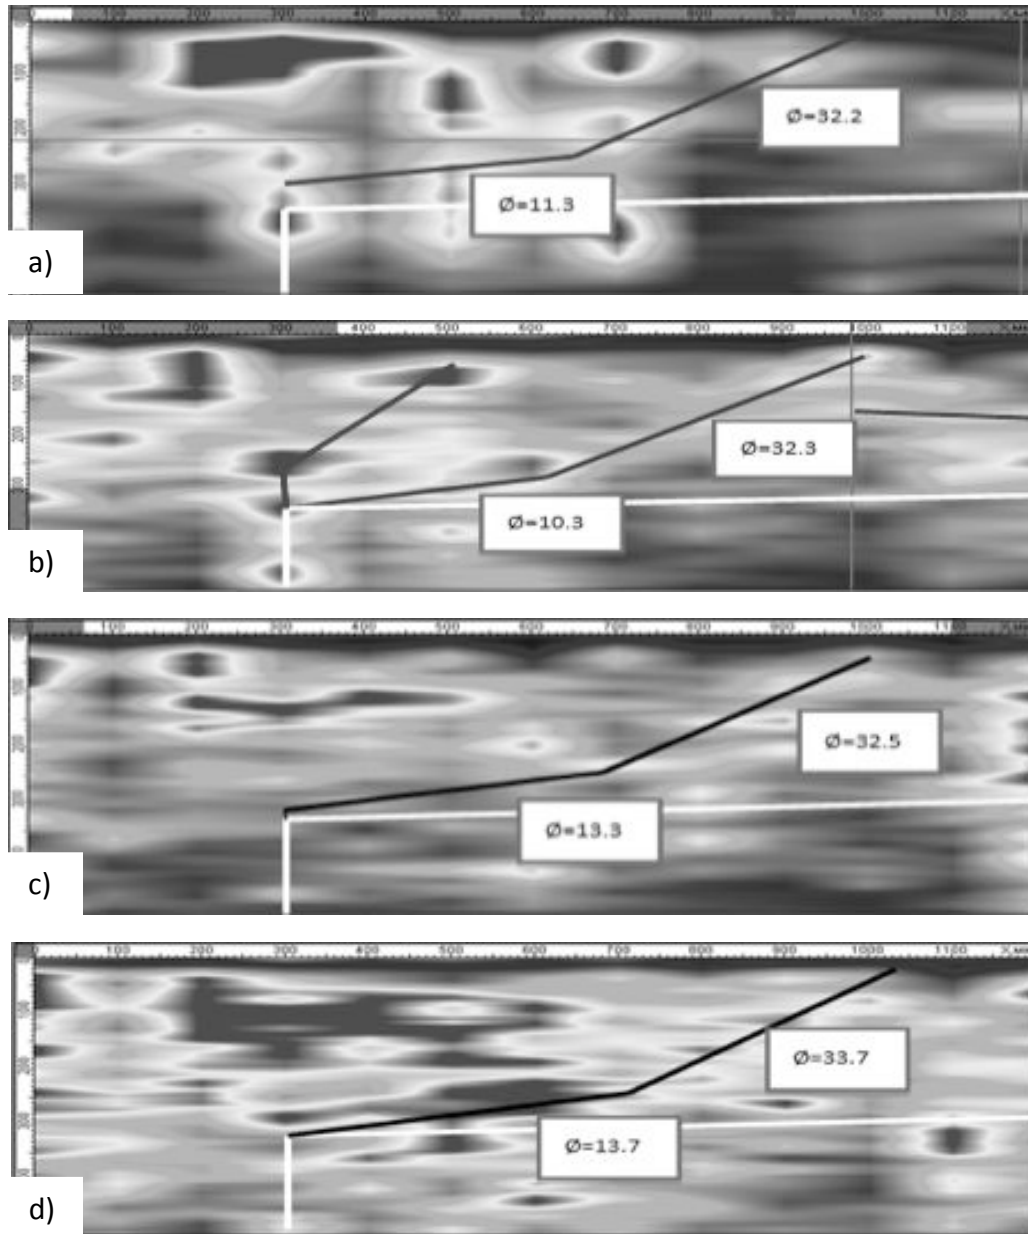
Figure 3.10: Slab 2/HS5 D-Scan Image; (a) 30 kHz; (b) 40 kHz; (c) 50 kHz; (d) 60 kHz

the imperfection and not provide a good measure of the angle. The results that are obtained from Figure 3.10b demonstrate similar results as Figure 3.10d.

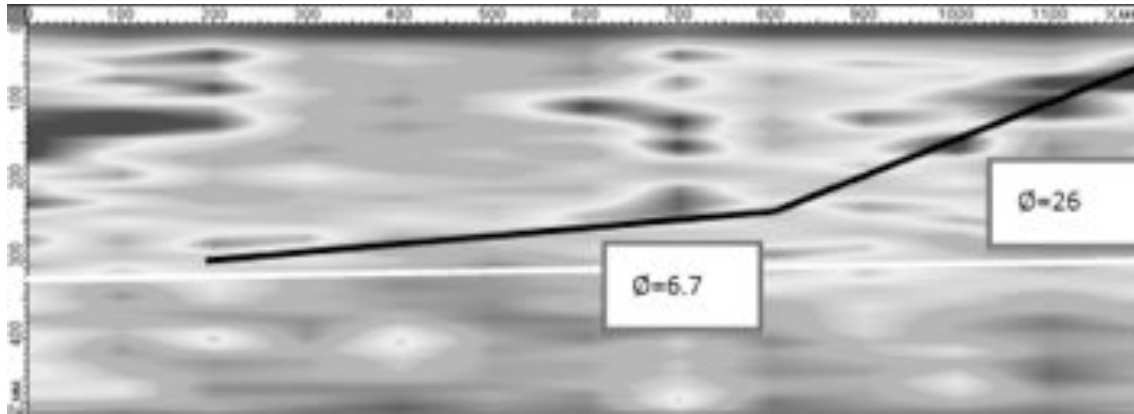
Figure 3.11: Slab 3/HS4 D-Scan Image 50 kHz

The angle of punching shear for the slab was consistent to that of the results obtained from the first two slabs, as there are two angles within the slab. The far angle from the column can be estimated by the MIRA readings to be 26° , and the near angle to be 6.7° . The result would show that the shear studs greatly stiffen the slab as the angle near column is nearly doubled with the shear studs.

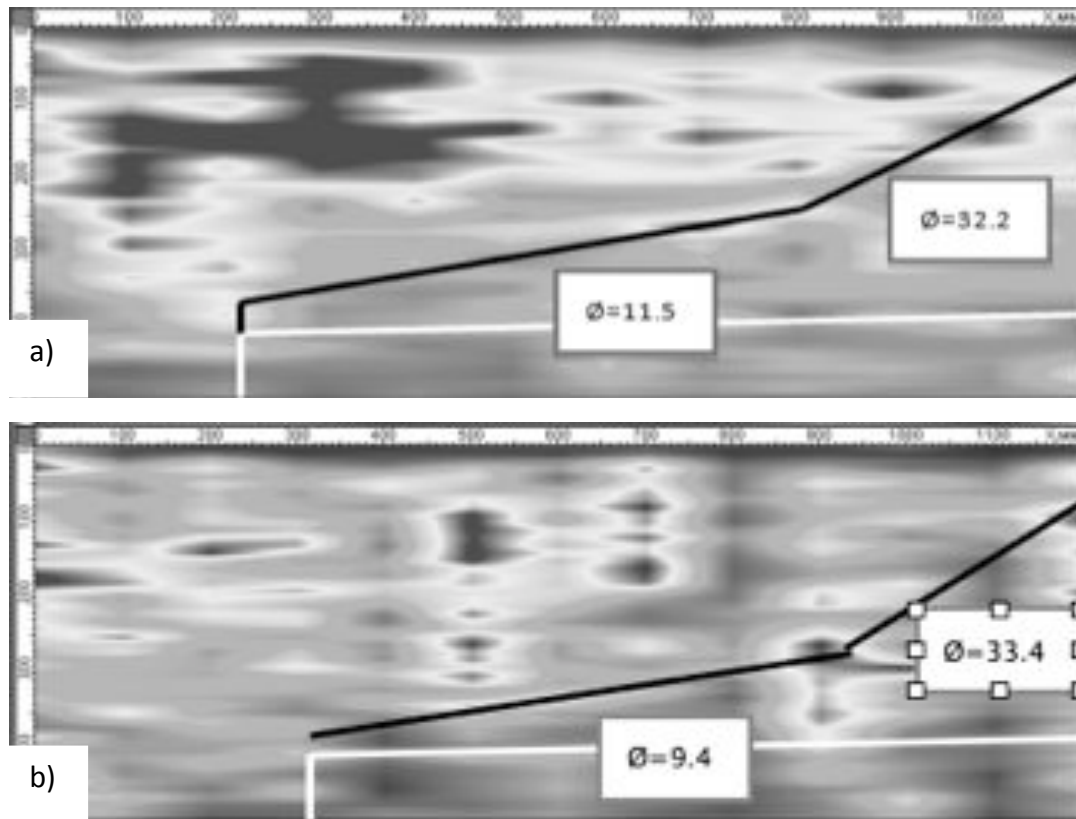
Figure 3.12: Slab 4/HS7 D-Scan Image; (a) 40 kHz; (b) 60 kHz

used to pinpoint the location of the crack. Due to the high level of damage in the first 200 mm of the slab a large amount of signal is reflected back and very minimal signal reaches the punching shear crack. As well, any signal that will reach the shear crack will be reflected back immediately. Thus any reflection that would appear at a distance much greater than 200 mm within the slab would be a reflection coming from the shear crack.

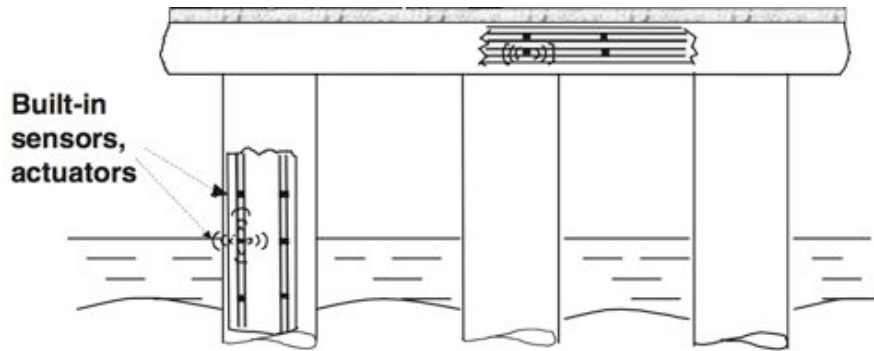
Figure 4.1: Active Non-Destructive Health Monitoring Concept (Wu and Chang, 2006)

The concept of active non-destructive evaluation of reinforced concrete structures is a concept that has been researched for many years. This methodology was first discovered in the literature in a paper by Wu et. al. (2006) and is illustrated in Figure 4.1.

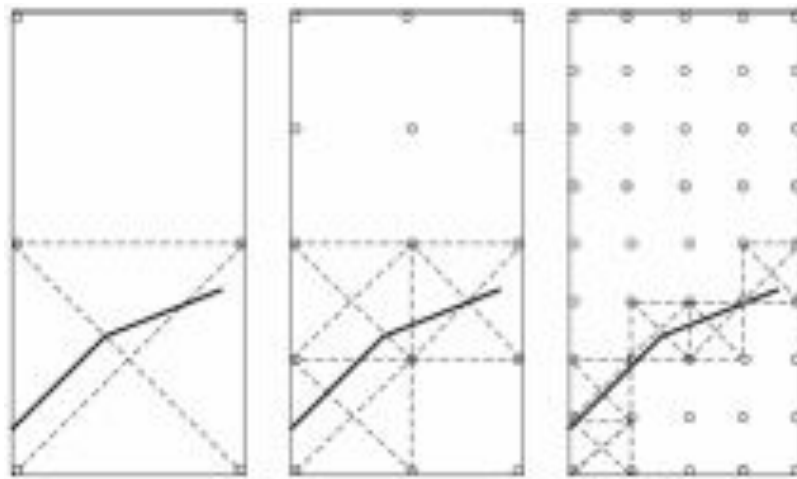
Figure 4.2: Density of Transducer Mesh (Sun and Yan, 2008)

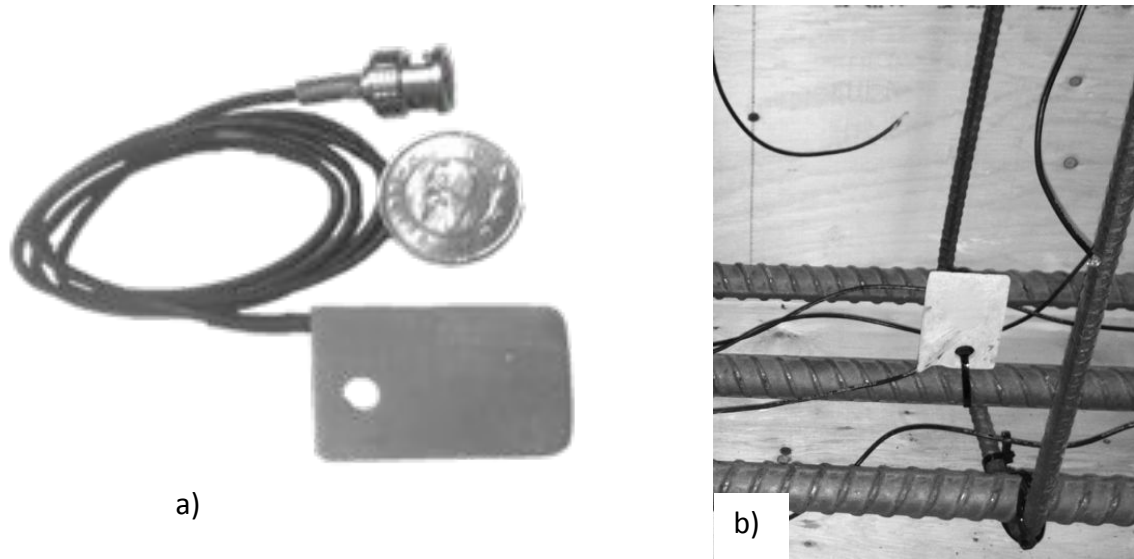
Figure 4.3: Piezoceramic Sensor

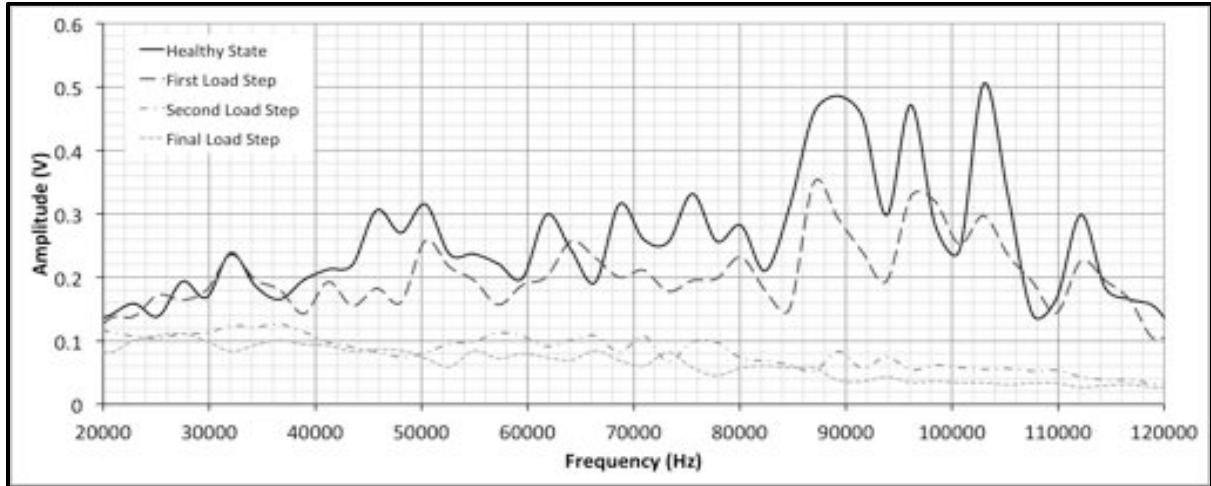
Figure 4.5: Sample Output Data (Health Monitoring)

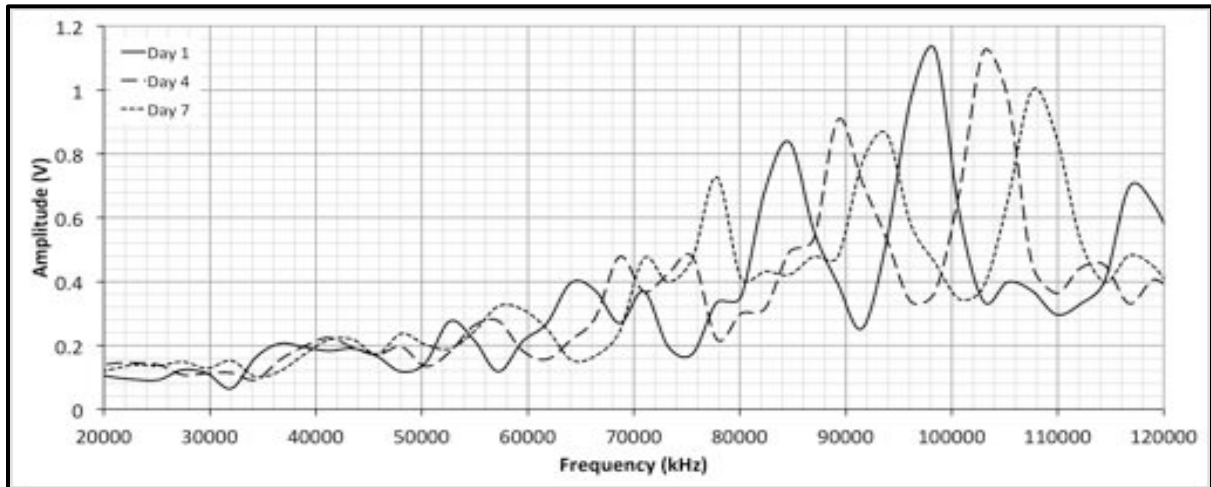
Figure 4.6: Sample Output Data (Early Strength)

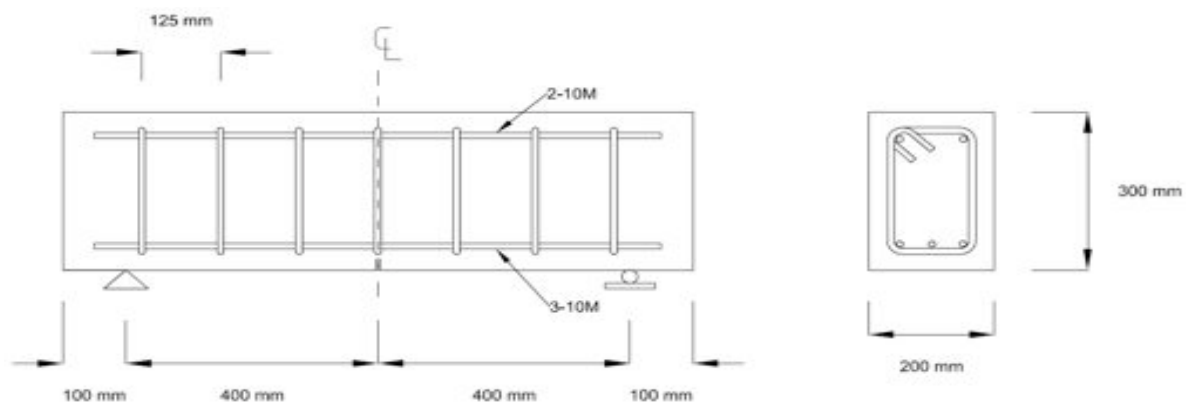
Figure 5.2: Small Scale Beams' Reinforcement Detail

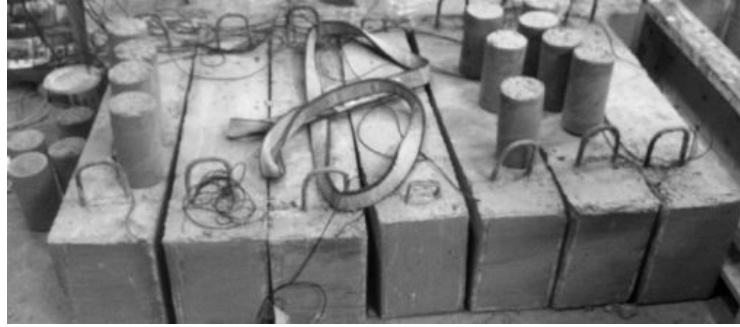
Figure 5.5: Small Scale Beams after De-Molding

The samples were covered with damp burlap for the duration of the first seven days after casting, and sealed underneath a plastic tarp. This would ensure the proper curing of the samples in the critical first seven days. On the seventh day after the concrete reached approximately 80% of its strength, the beams were de-molded and tested. Figure 5.5 illustrates the seven small-scale beams on the day they were de-molded.

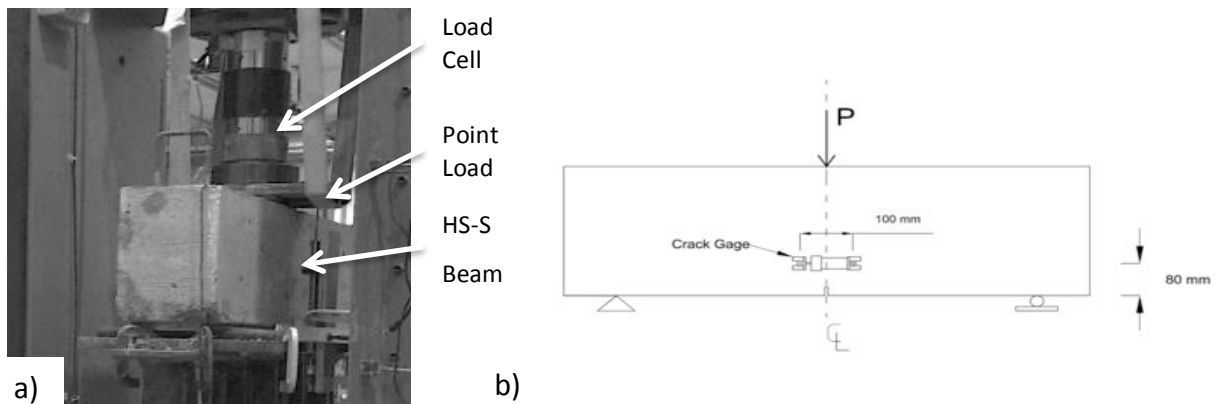
Figure 5.6: Loading Setup (a) Test Setup; (b) Three-Point Load Test Setup, Crack Gauge Location, and Notch Location

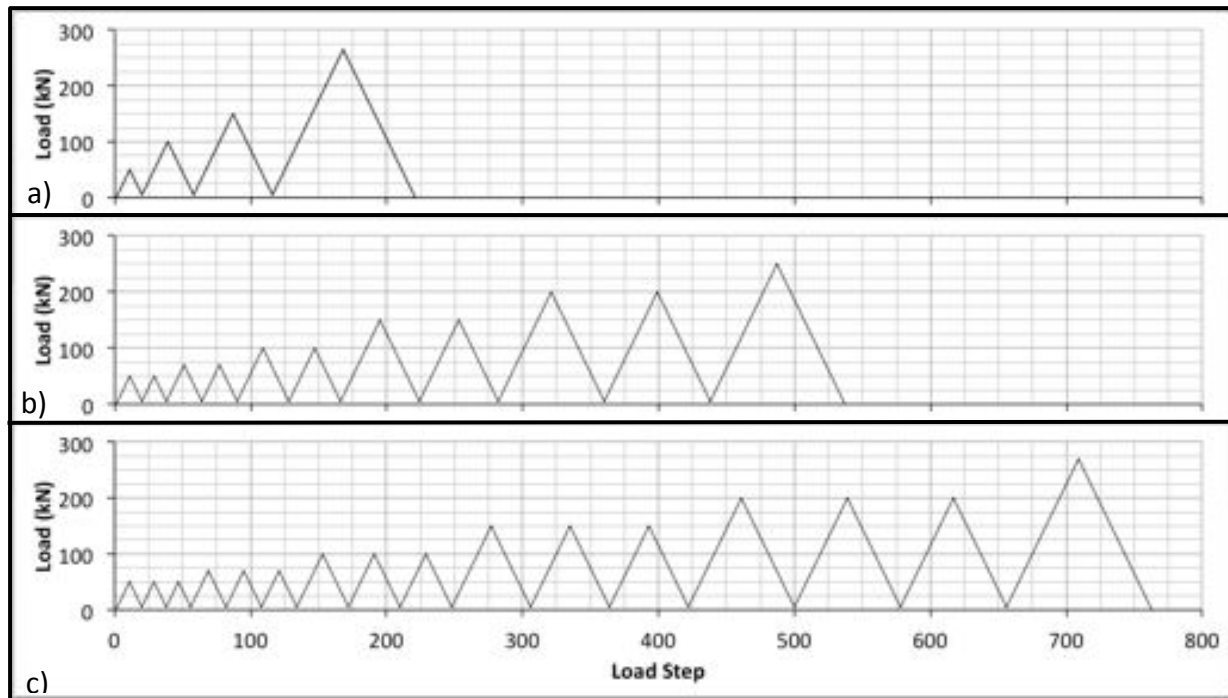
Figure 5.7: Loading Protocol Cyclic Beams (a) HS-S-C-1; (b) HS-S-C-2; (c) HS-S-C-3

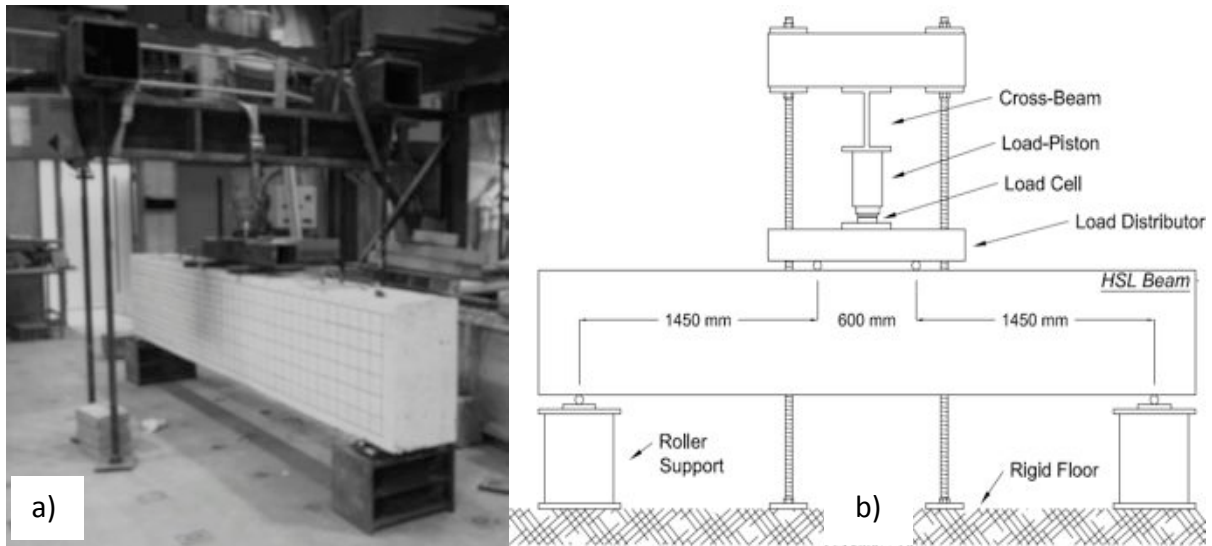
Figure 5.9: Test Setup HS-L-M Beams (a) Loading Setup; (b) Detail of Loading Setup

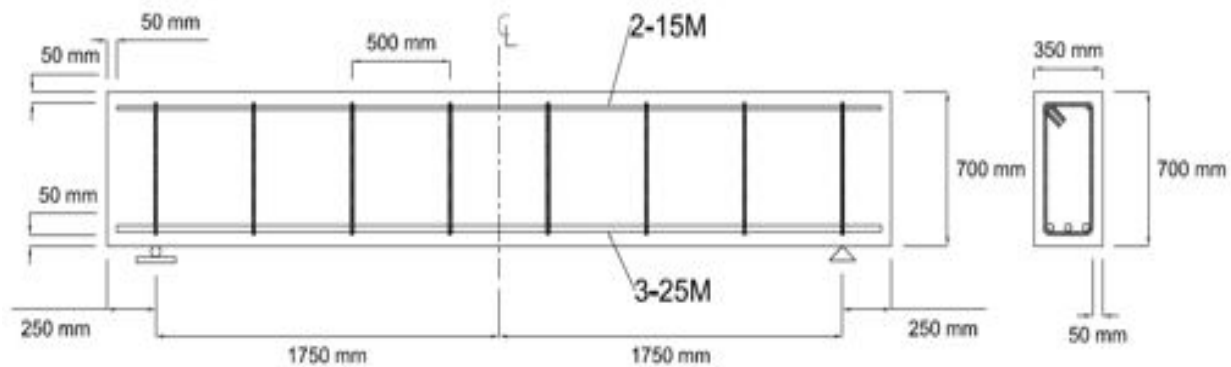
Figure 5.10: HS-L-M-1 Dimension and Reinforcement Detail

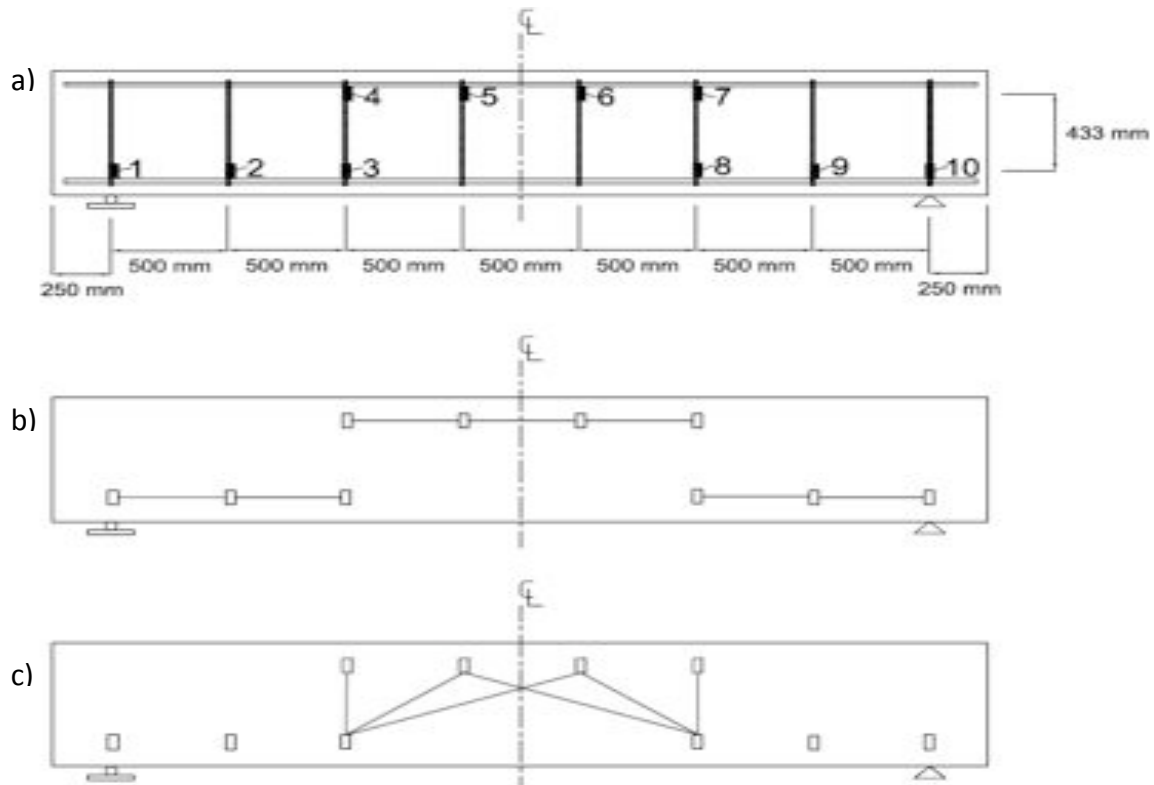
Figure 5.11: Piezo-Sensor Placement (a) Spatial Position of Piezo-Sensor in Beam HS-L-M-1; (b) Signal Paths for Flexural Control; (c) Signal Paths for Shear Control.

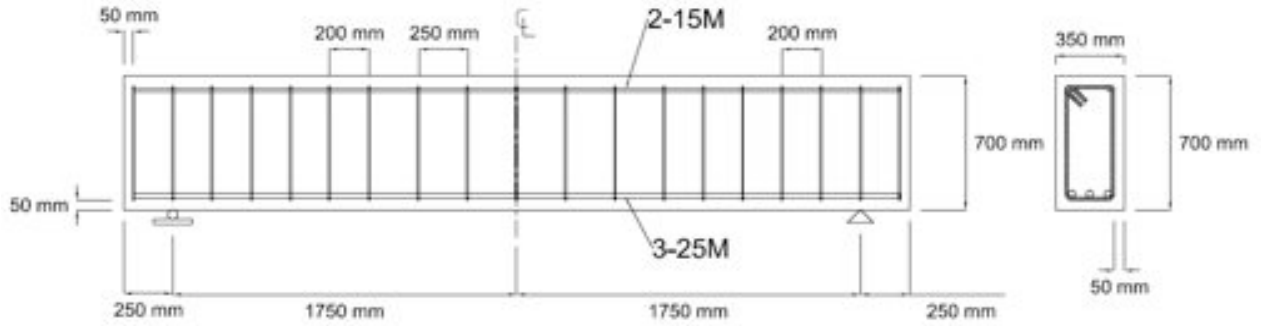
Figure 5.12: HS-L-M-2 Dimension and Reinforcement Detail

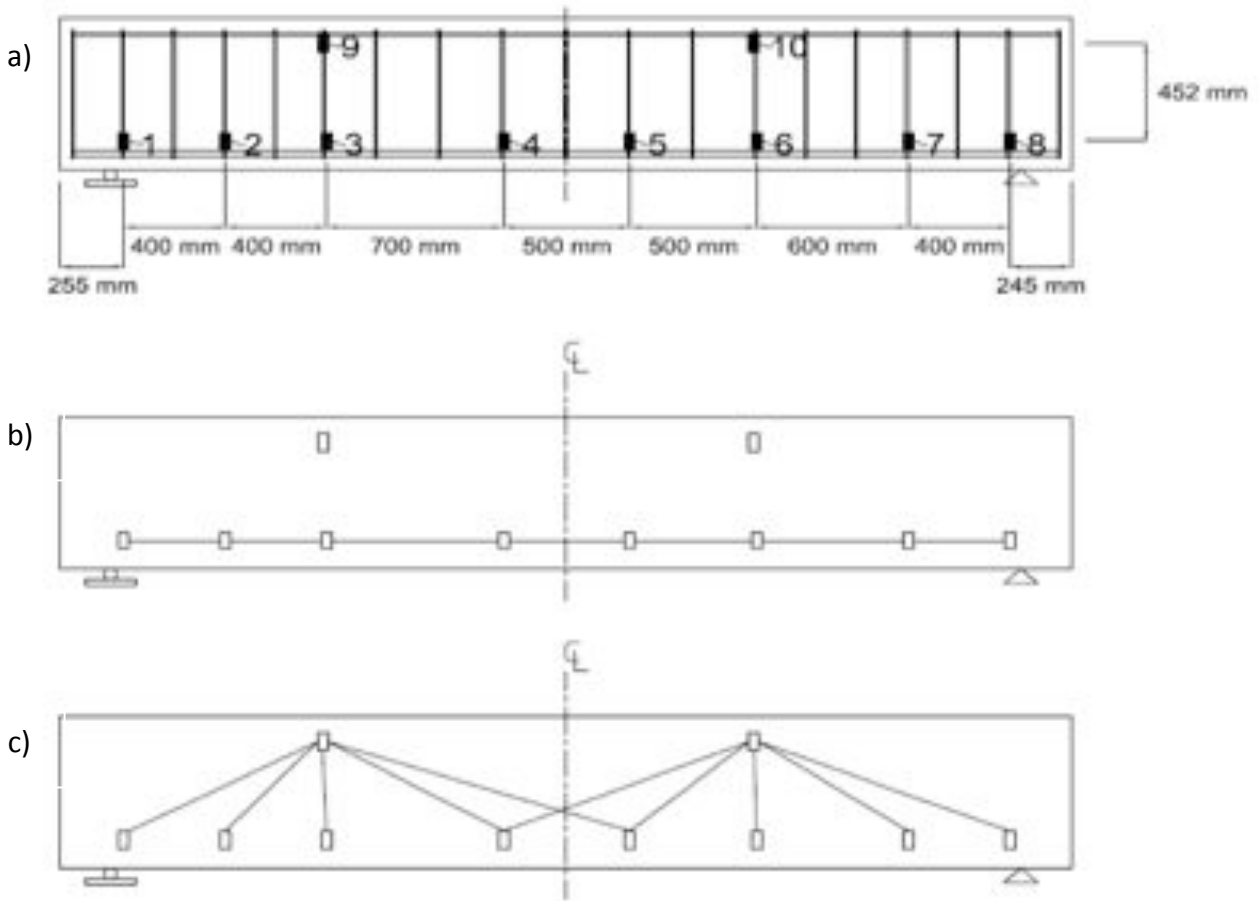
Figure 5.13: Piezo-Sensor Placement (a) Spatial Position of Piezo-Sensor in Beam HS-L-M-2; (b) Signal Paths for Flexural Control; (c) Signal Paths for Shear Control.

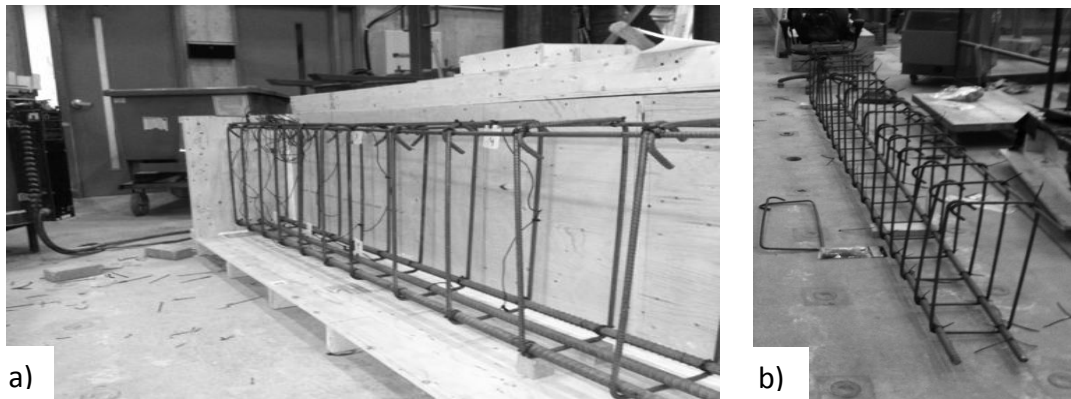
Figure 5.15: Steel Reinforcement Cage for Beam HS-L-M-2 Full-Scale Specimen; (a) Placed in Formwork; (b) Constructed

Steel reinforcement bars of 450 MPa yield strength were used. Prefabricated stirrups comprised the reinforcement cage of each member, and they were attached to the flexural reinforcement using zip-ties. Plastic seats, as to provide the 50 mm clearance with the bottom of the mold and create the clear concrete cover required, supported the three tensile flexural bars in the specimen. Two hangers were also fabricated and implemented

as part of the reinforcement cage. The hangers were placed at the quarter-span of the beam, as to provide a means of transporting the member once it is cast and ready to test. The reinforcement cage for beam HS-L-M-2 is presented in Figure 5.15, as well as Figure 5.14b. The bars used as the tensile flexural reinforcement were 20 M, while the stirrups were made of 10 M bar.

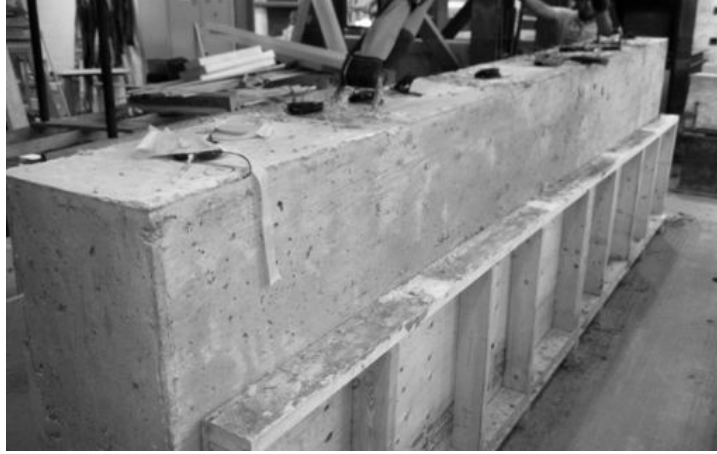
Figure 5.16: Full-Scale Member Demolding

The samples were covered with damp burlap for the duration of the first seven days after casting, and sealed underneath a plastic tarp. This would ensure the proper curing of the samples in the critical first seven days. On the seventh day the beams were de-molded and tested. Figure 5.16 illustrates the full-scale member HS-L-M-2 the day it was demolded.

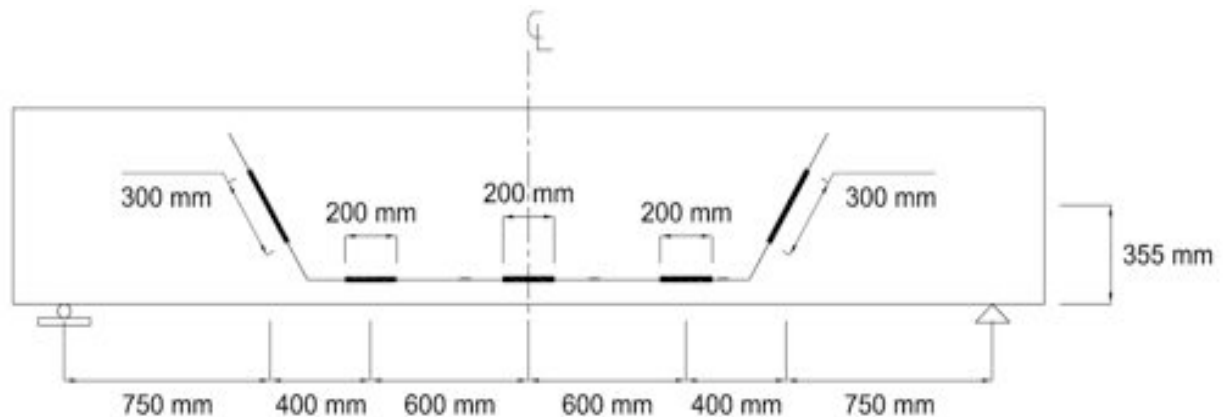
Figure 5.17: FBG Fiber Optic Sensors Spatial Position in the HSL Beam Series

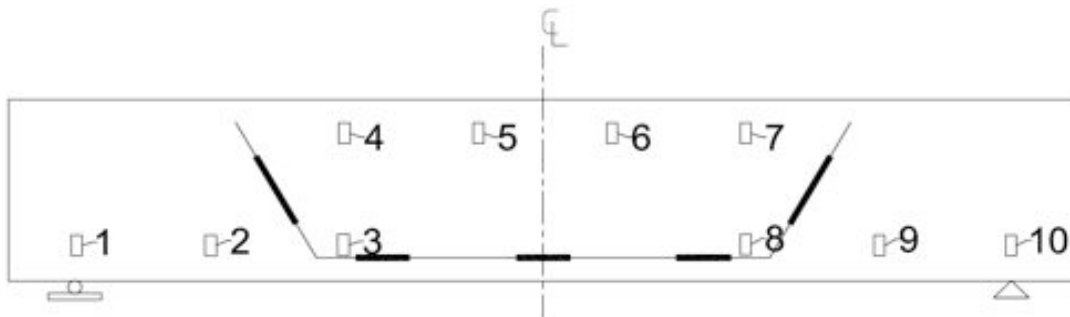
Figure 5.18: Arrangement of FBG Fiber Optic Sensors, and Piezo-Sensors in Beam HS-L-M-1

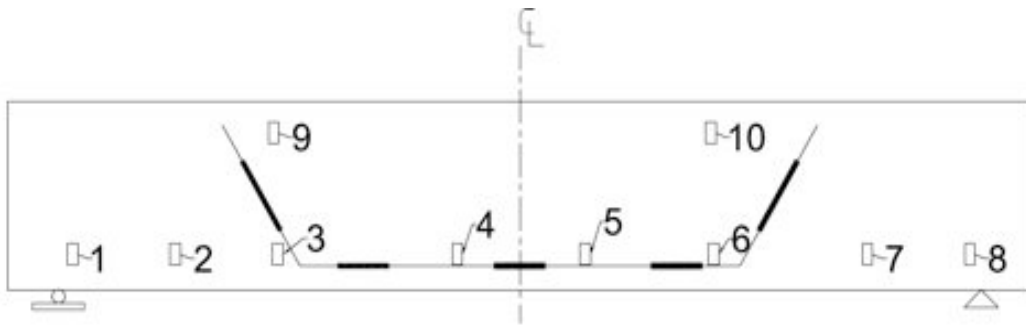
Figure 5.19: Arrangement of FBG Fiber Optic Sensors, and Piezo-Sensors in Beam HS-L-M-2
