USE OF ADVANCED EMBEDDED PIEZOCERAMIC SENSORS FOR THE NON-DESTRUCTIVE
EVALUATION OF REINFORCED CONCRETE

A thesis presented to Ryerson University
in partial fulfillment of the

MASTERS OF APPLIED SCIENCE

CIVIL ENGINEERING

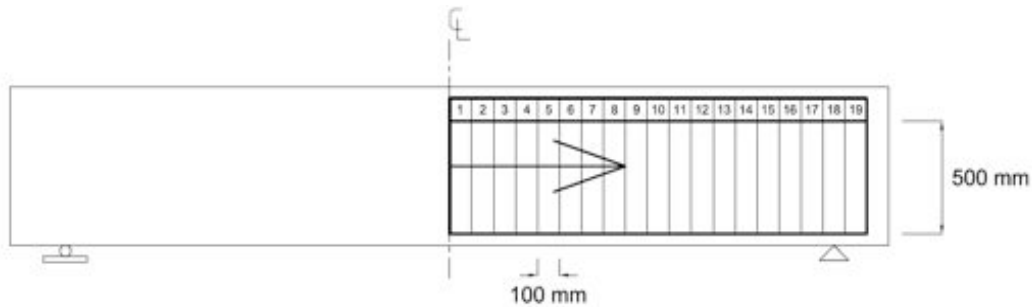
Figure 5.20: Vertical Scan Surface Using the MIRA 3D Tomographer

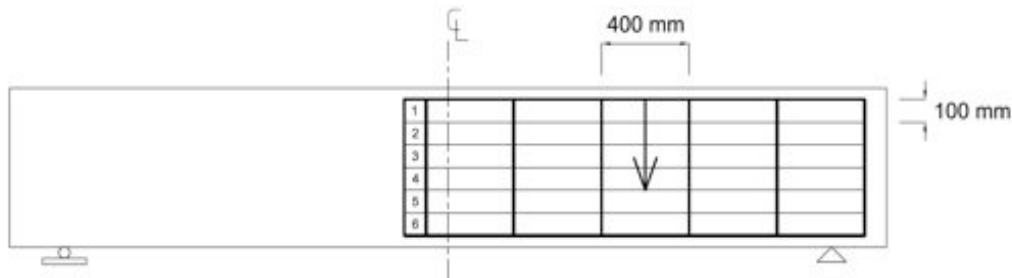
Figure 5.21: Horizontal Scan Surface Using the MIRA 3D Tomographer

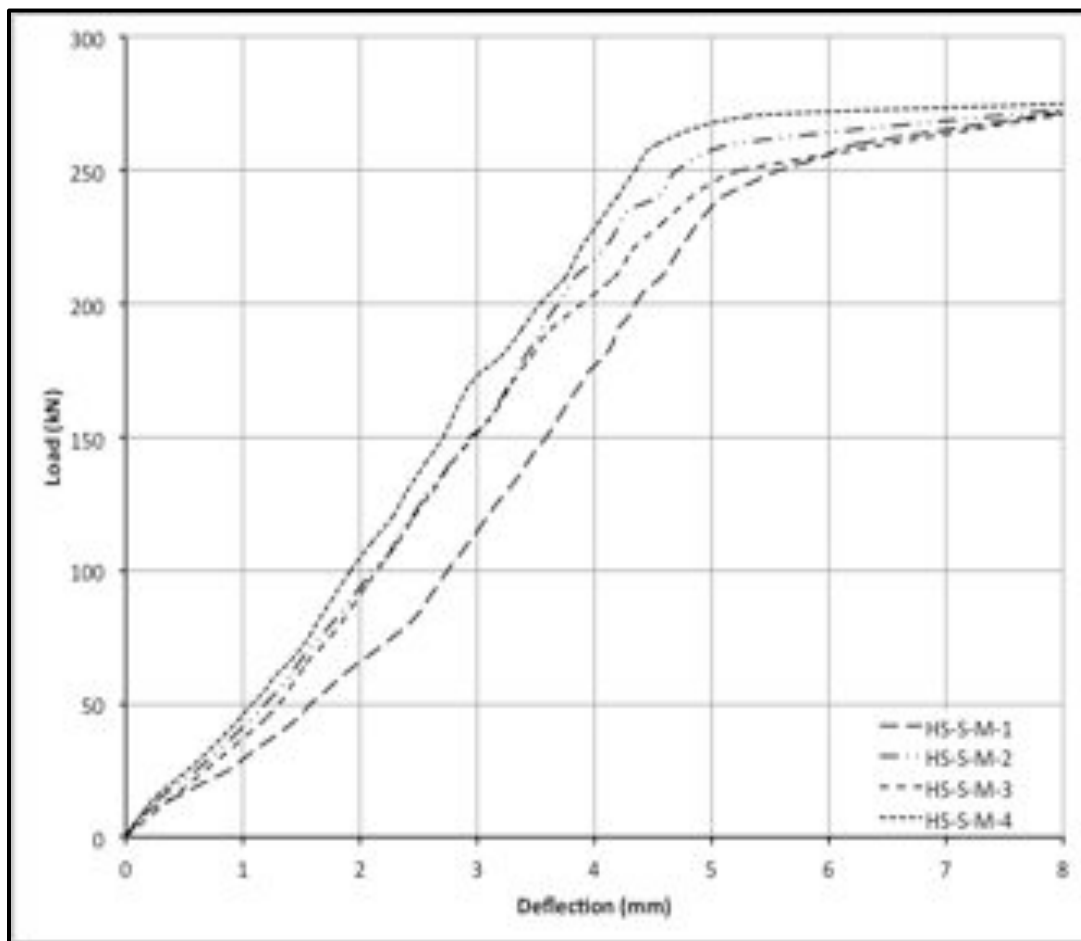
Figure 6.4: Load-Deflection Graphs, Small Scale Monotonically Loaded Members

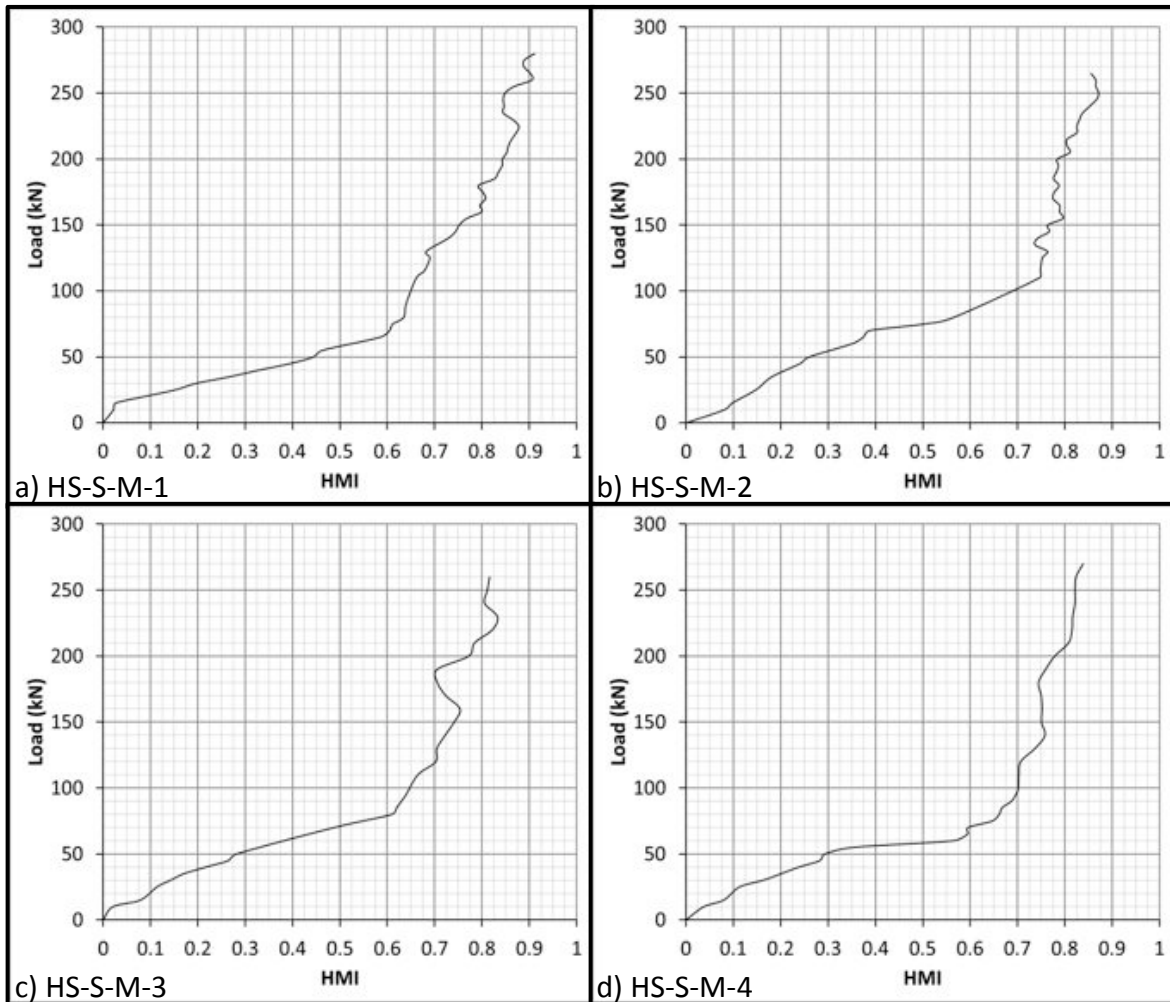
Figure 6.6: Load-HMI Curves, Small Scale Monotonic Loaded Members; (a) HS-S-M-1; (b) HS-S-M-2; (c) HS-S-M-3; (d) HS-S-M-4

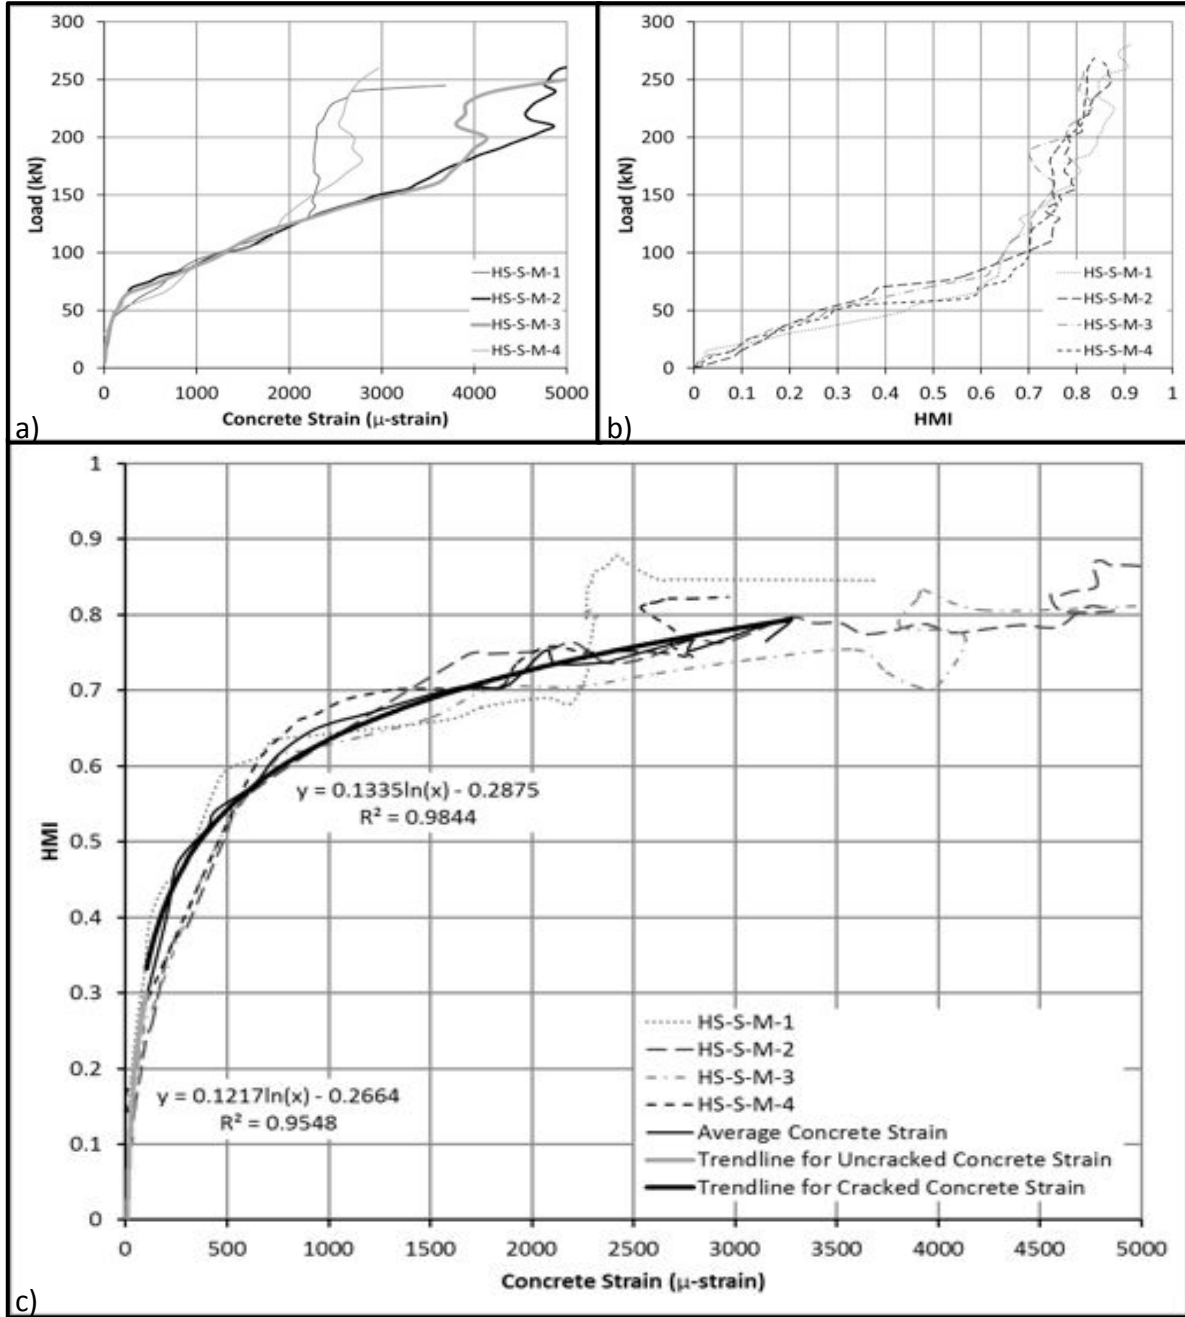
Figure 6.7: Summary Of Small-Scale Results; (a) Load-Strain Reading, Crack Gauges; (b) Load-HMI Readings
(c) Average HMI- Crack Width Relationship

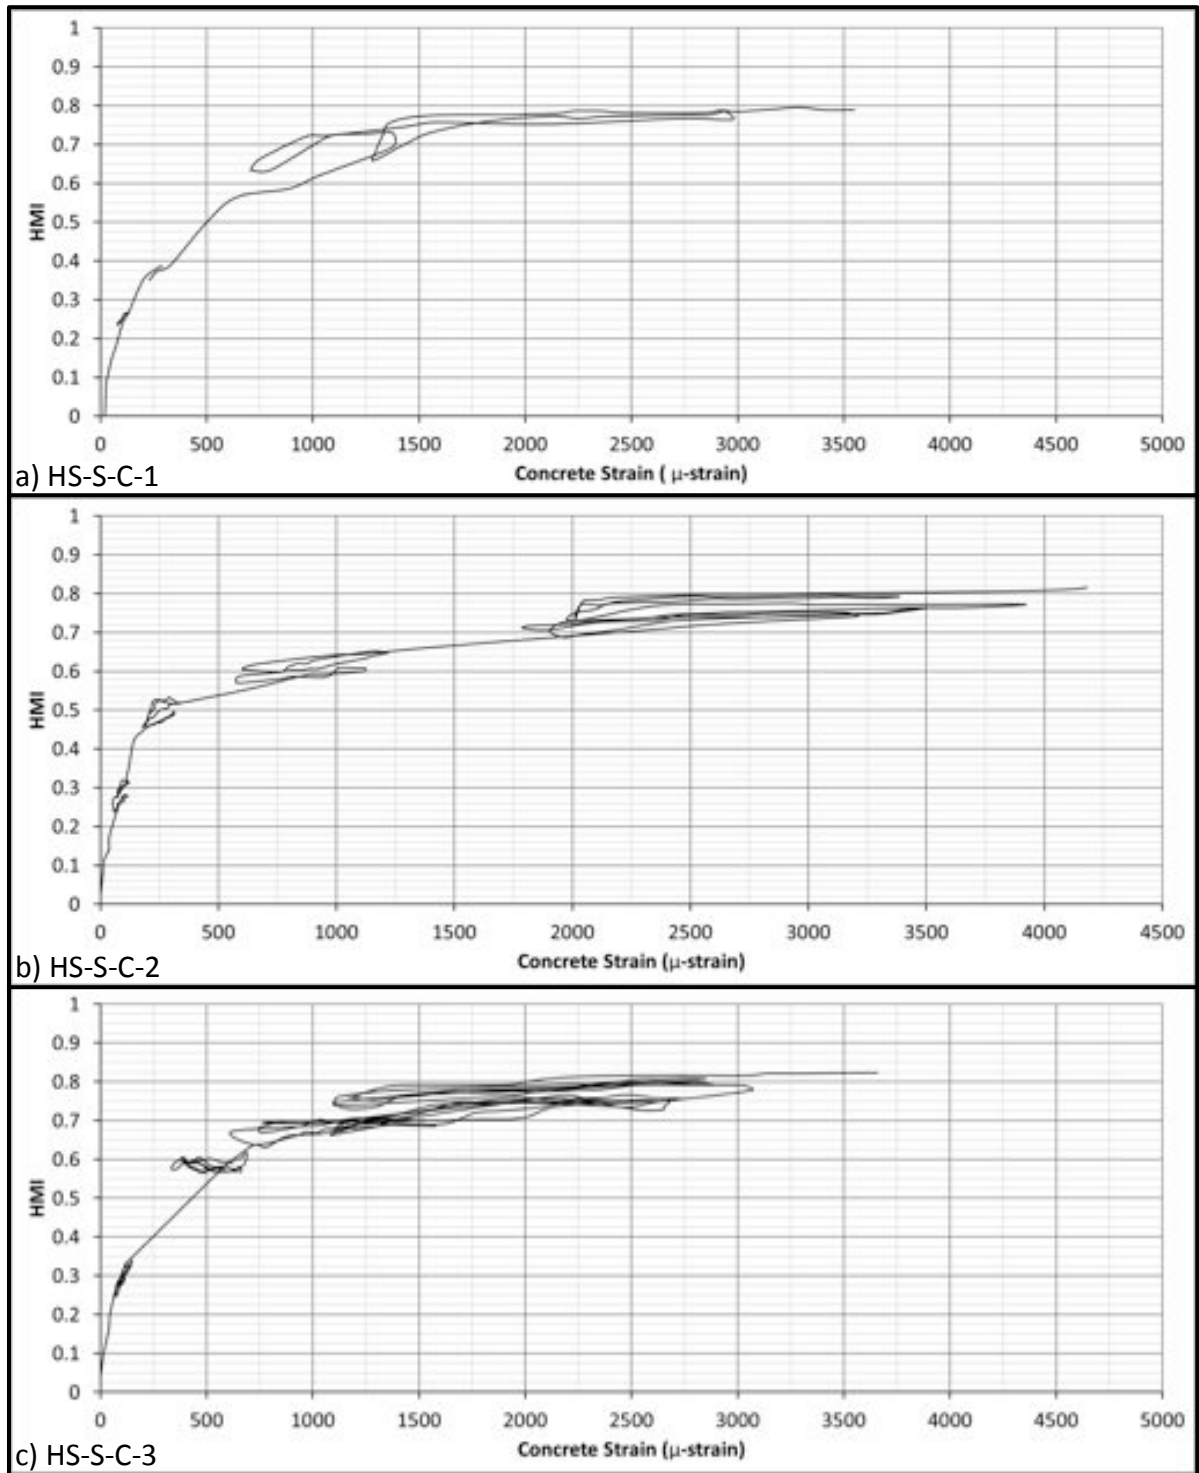
Figure 6.11: HMI-Strain Relationship of Small Scale Cyclically Loaded Beams; (a) HS-S-C-1; (b) HS-S-C-2; (c) HS-S-C-3

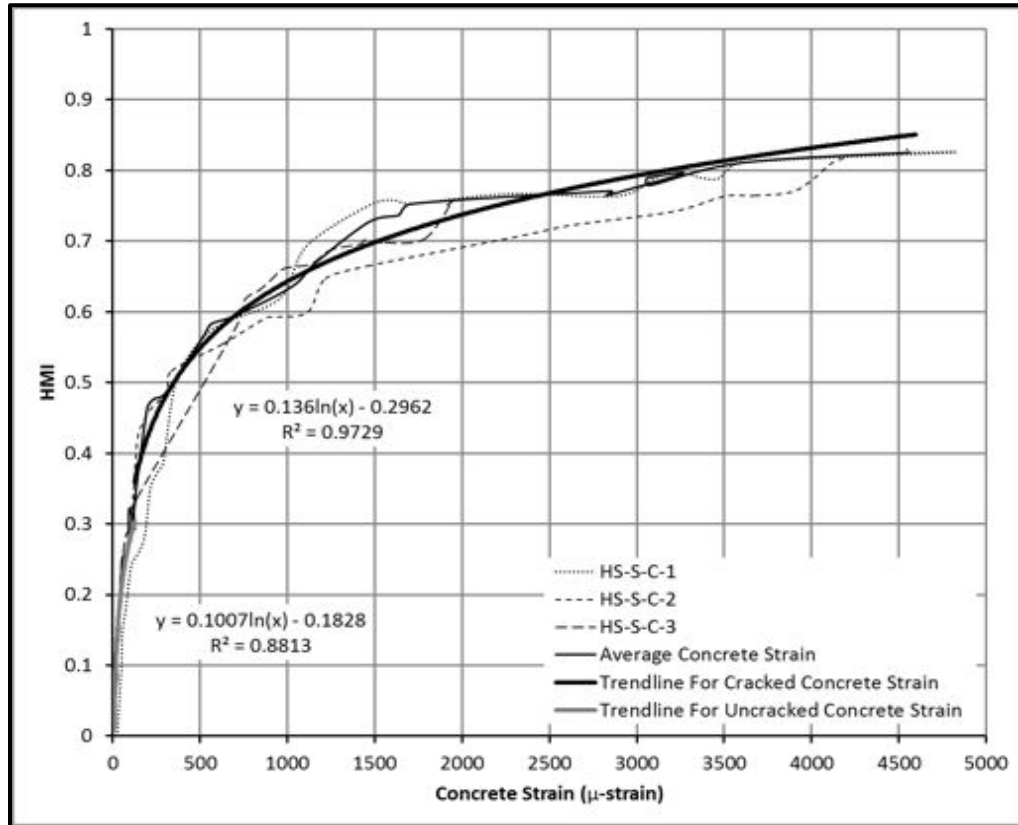
Figure 6.12: Average HMI-Crack Width Relationship as Suggested by Small Scale Cyclically Loaded Beams

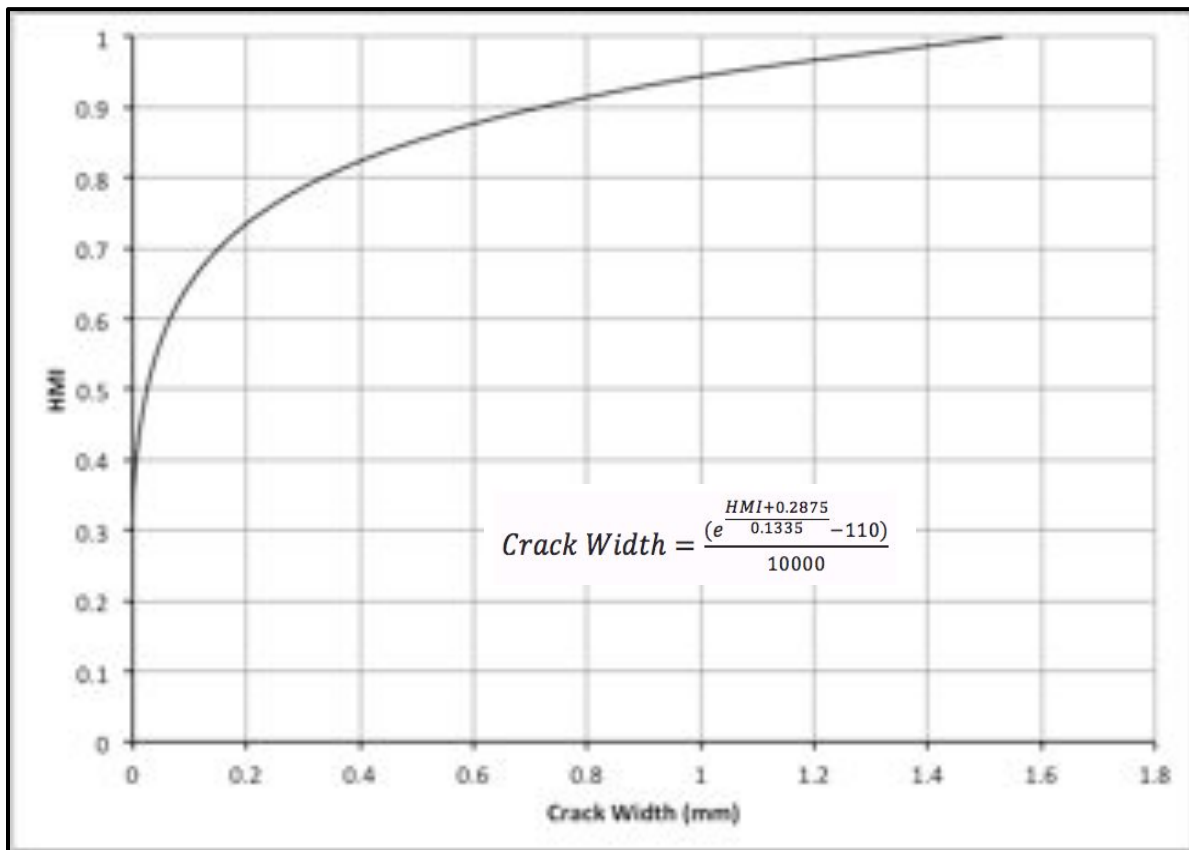
Figure 6.15: Universal HMI-Crack Width Relationship for Piezo-System

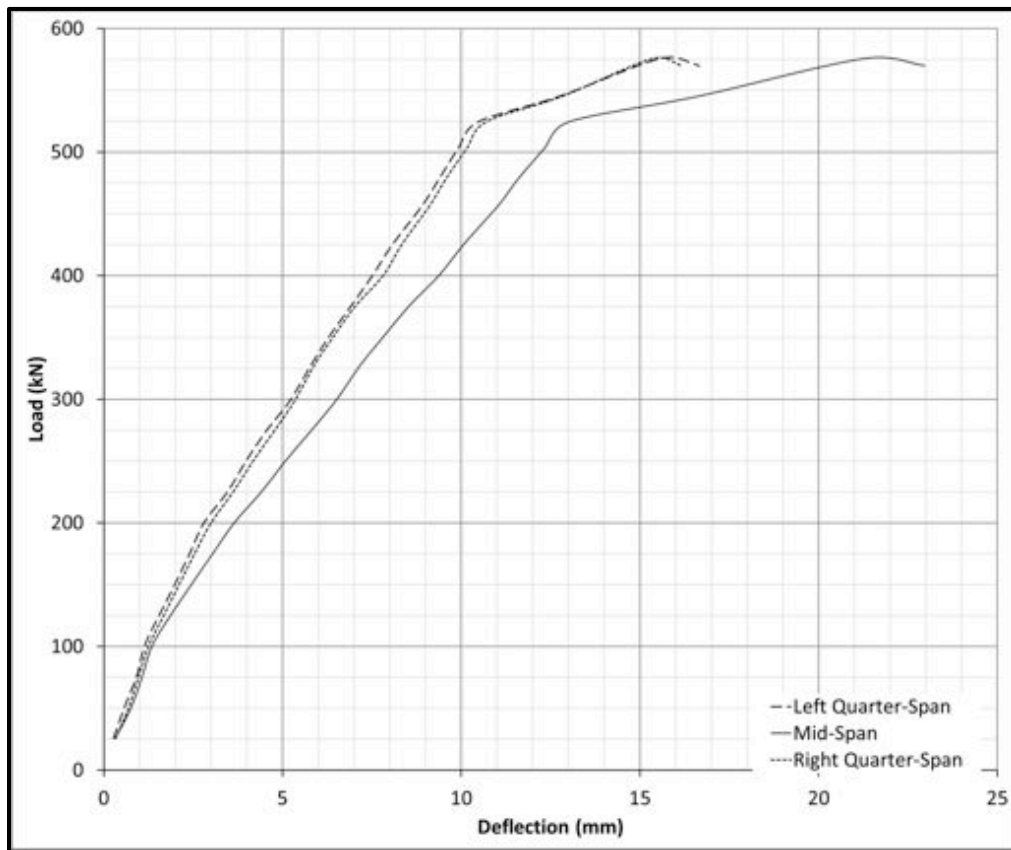
Figure 6.16: Load-Deflection Curve for Beam HS-L-M-1

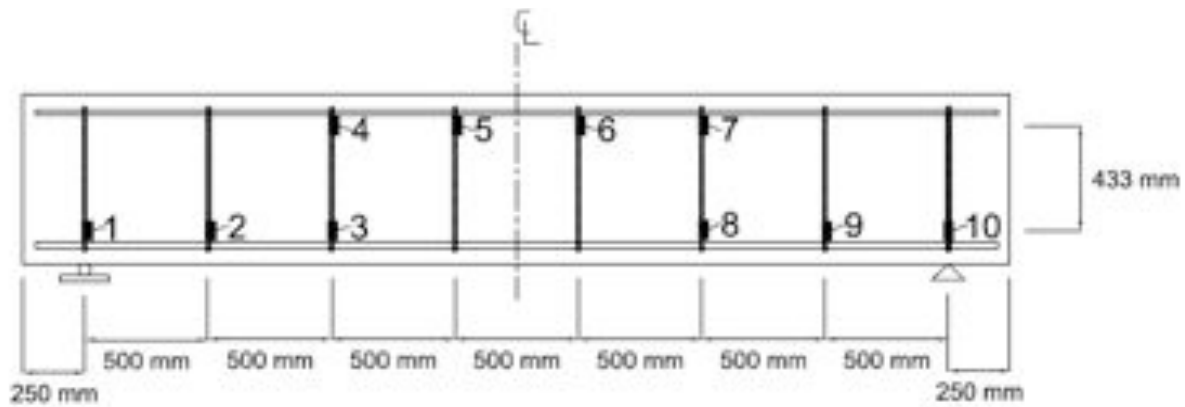
Figure 6.17: Piezo-Sensor Spatial Position

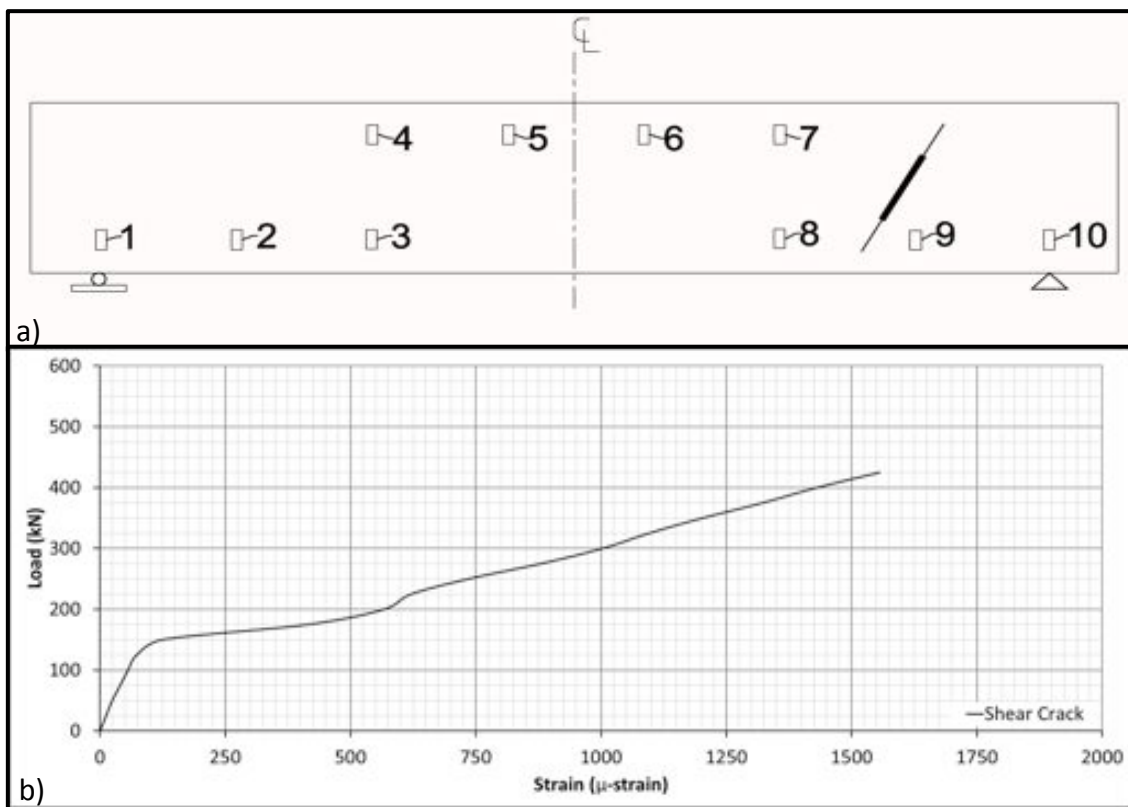
Figure 6.19: FBG Fiber Optic Readings from Beam HS-L-M-1; (a) Location of Working Sensors; (b) Readings Obtained from FBG Sensor

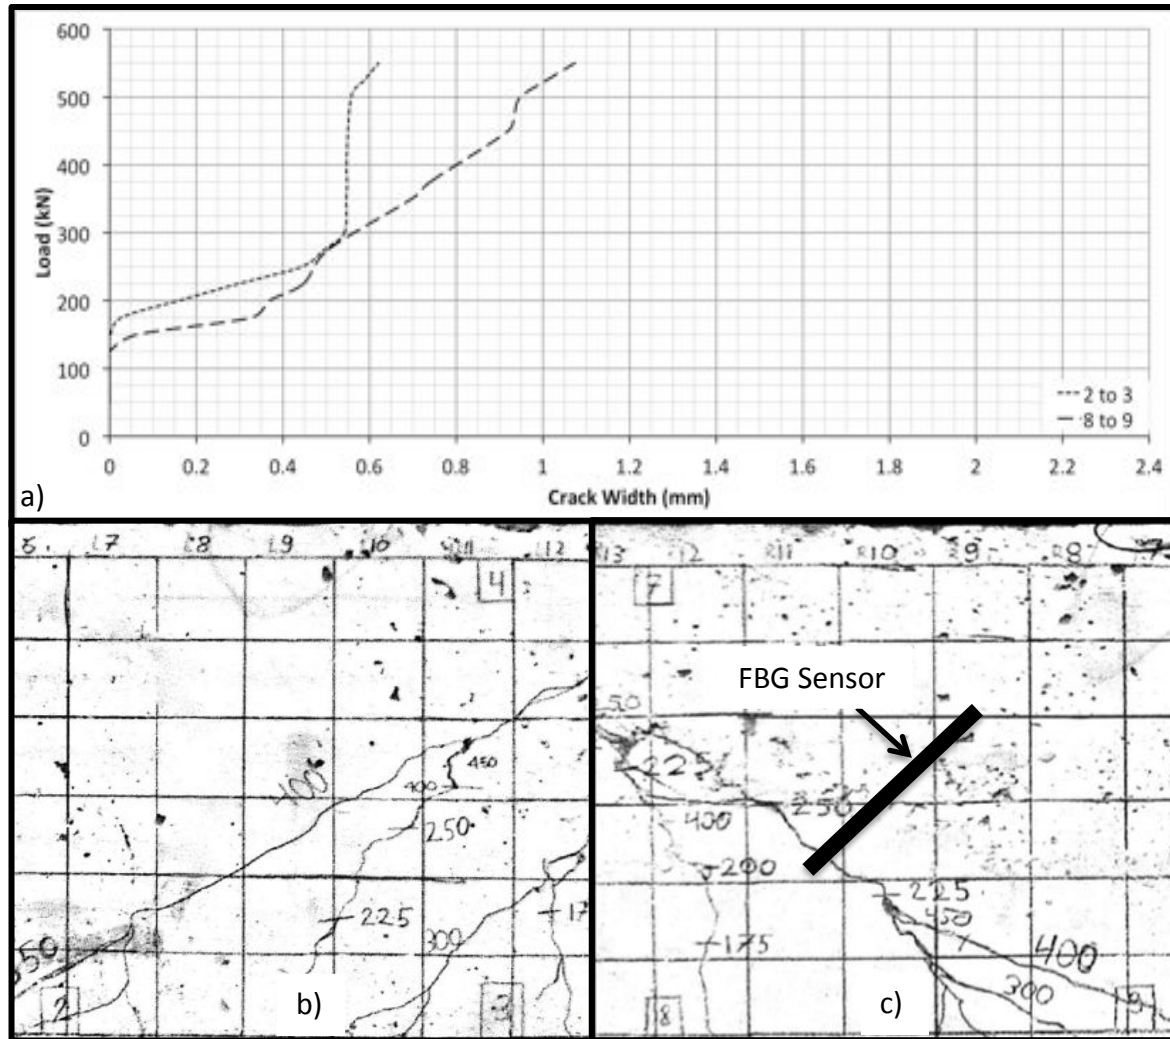
Figure 6.21: Effective Shear Depth Location Behavior for Beam HS-L-M-1; (a) Crack Width Measurements; (b) Cracking Behavior Left Side; (c) Cracking Behavior Right Side

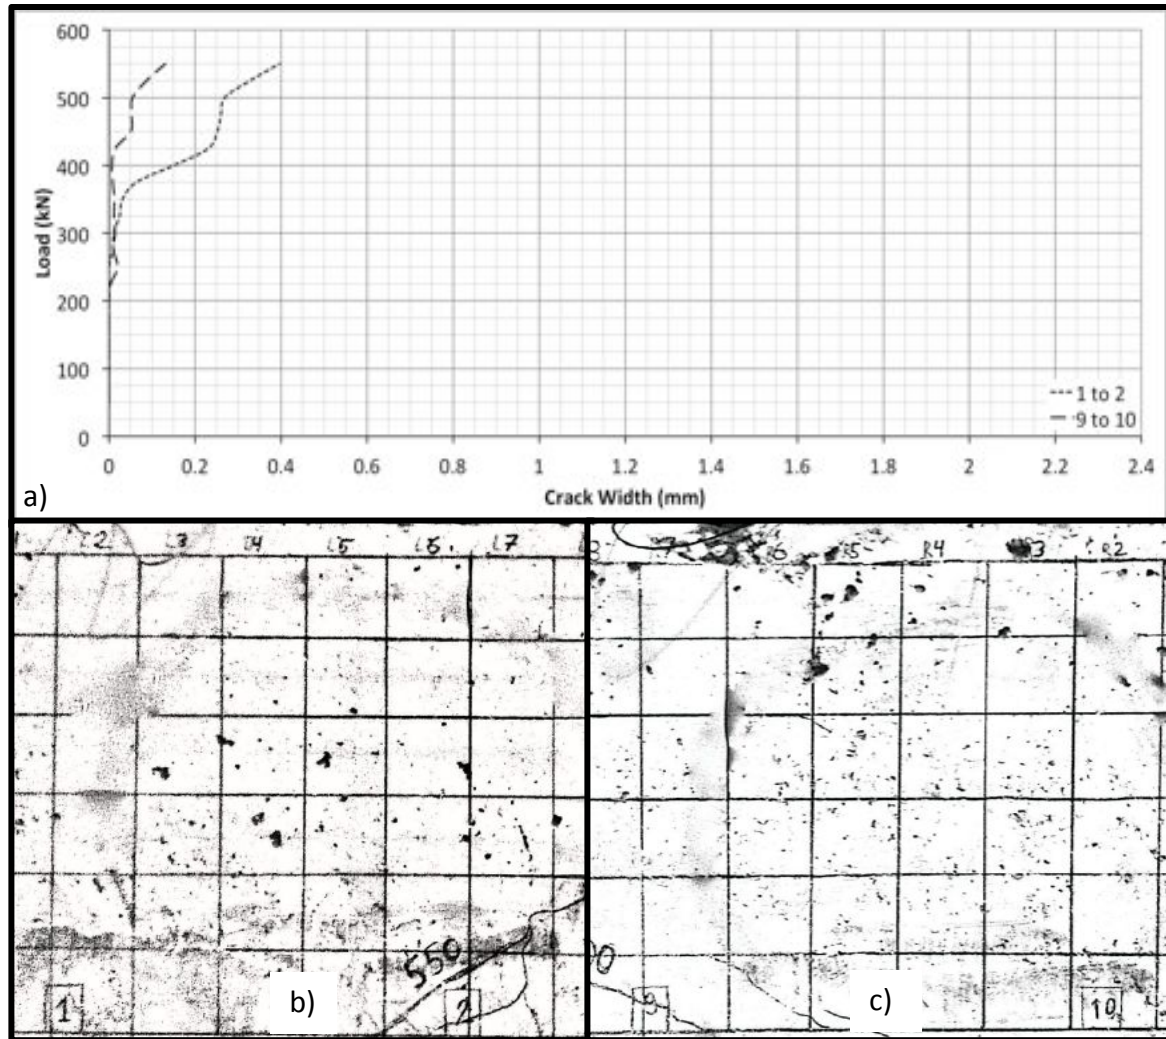
Figure 6.22: Support Location Behavior for Beam HS-L-M-1; (a) Crack Width Measurements; (b) Cracking Behavior Left Side; (c) Cracking Behavior Right Side

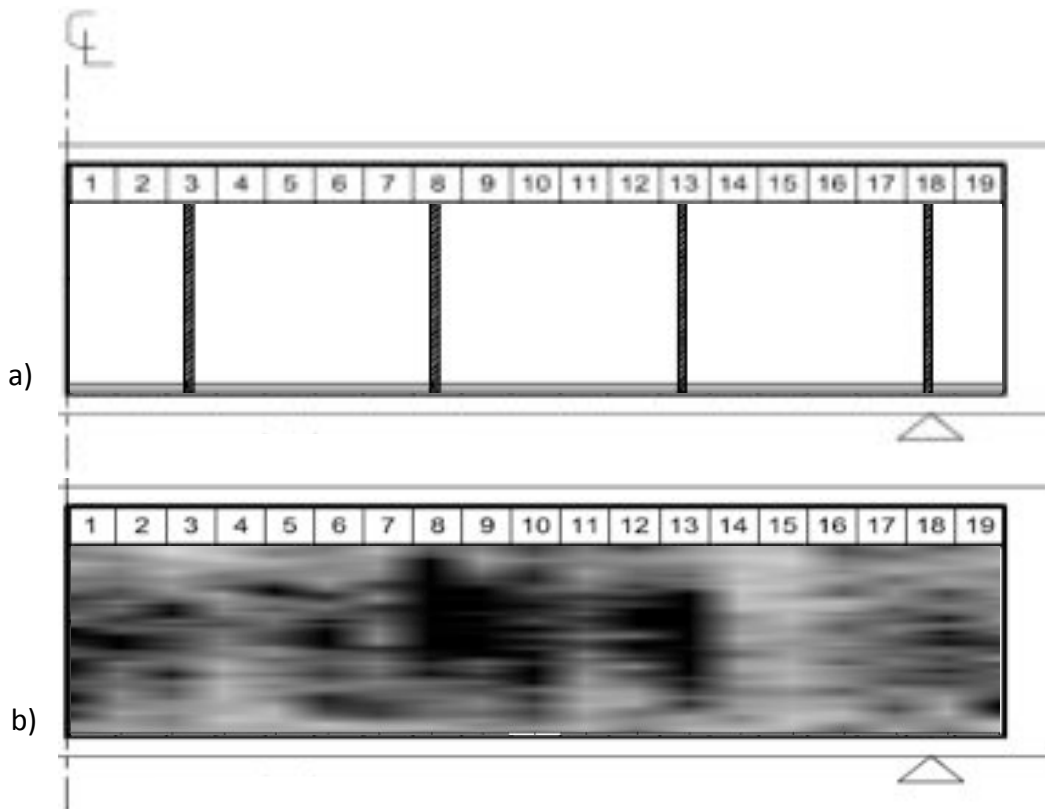
Figure 6.23: Vertical Scan Direction Beam HS-L-M-1 Healthy State; (a) Theoretical Location of Steel Reinforcement; (b) MIRA Software Output

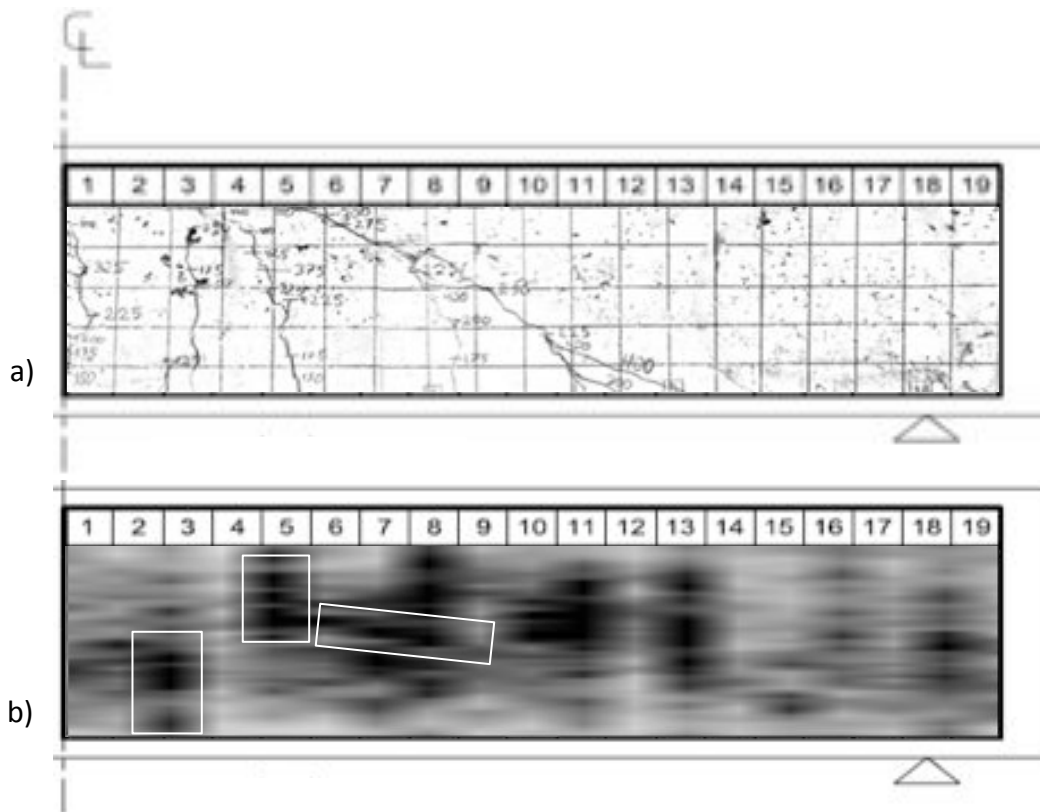
Figure 6.24: Vertical Scan Direction Beam HS-L-M-1 Damaged State; (a) Observed Cracking Pattern on Scanned Surface; (b) MIRA Software Output

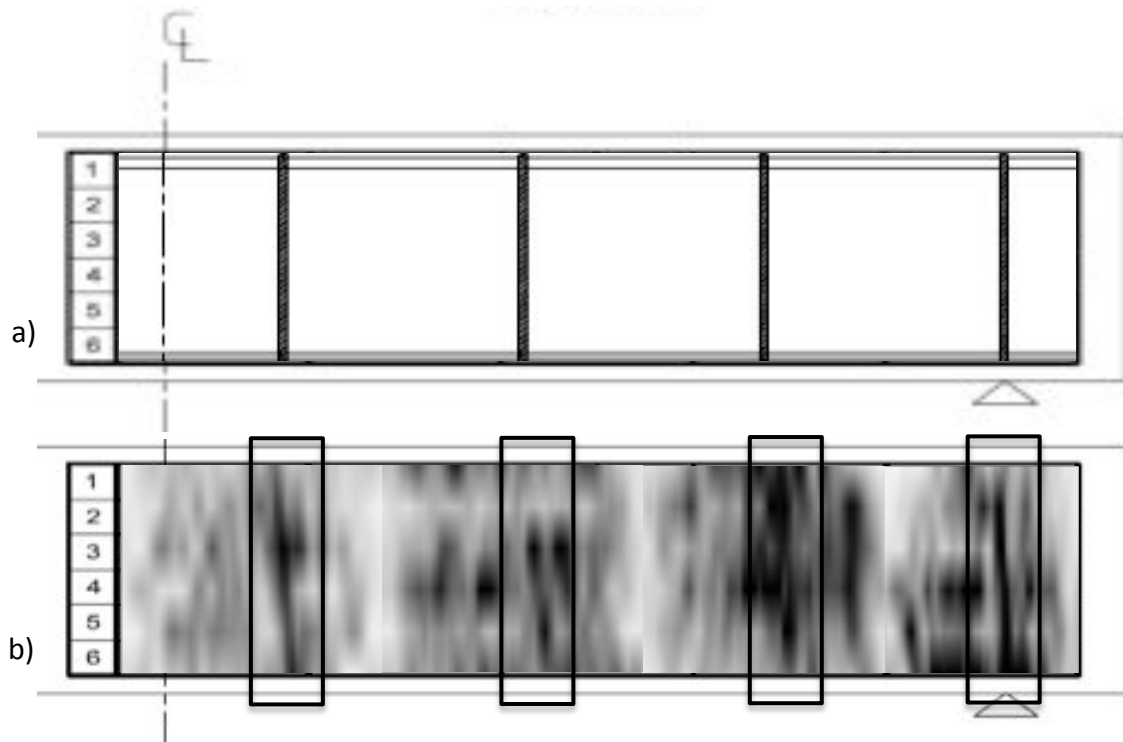
Figure 6.25: Horizontal Scan Direction Beam HS-L-M-1 Healthy State; (a) Theoretical Location of Steel Reinforcement; (b) MIRA Software Output

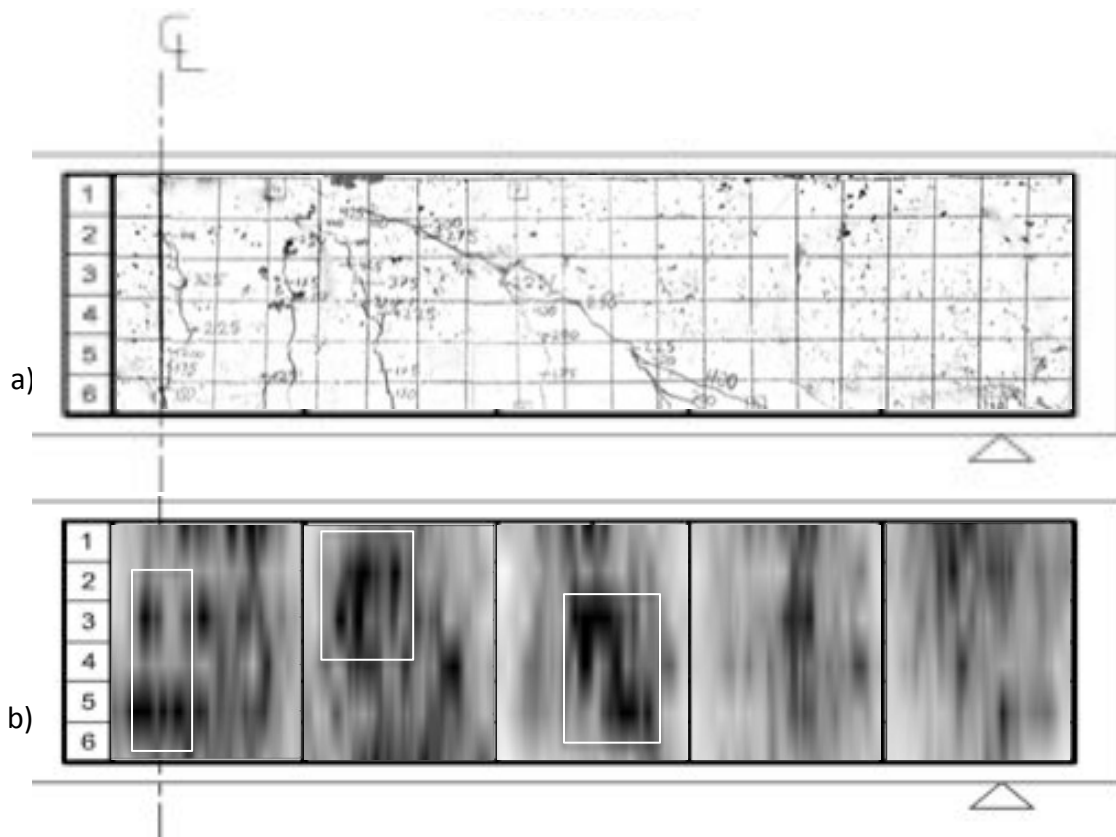
Figure 6.26: Horizontal Scan Direction Beam HS-L-M-1 Damaged State; (a) Observed Cracking Pattern on Scanned Surface; (b) MIRA Software Output

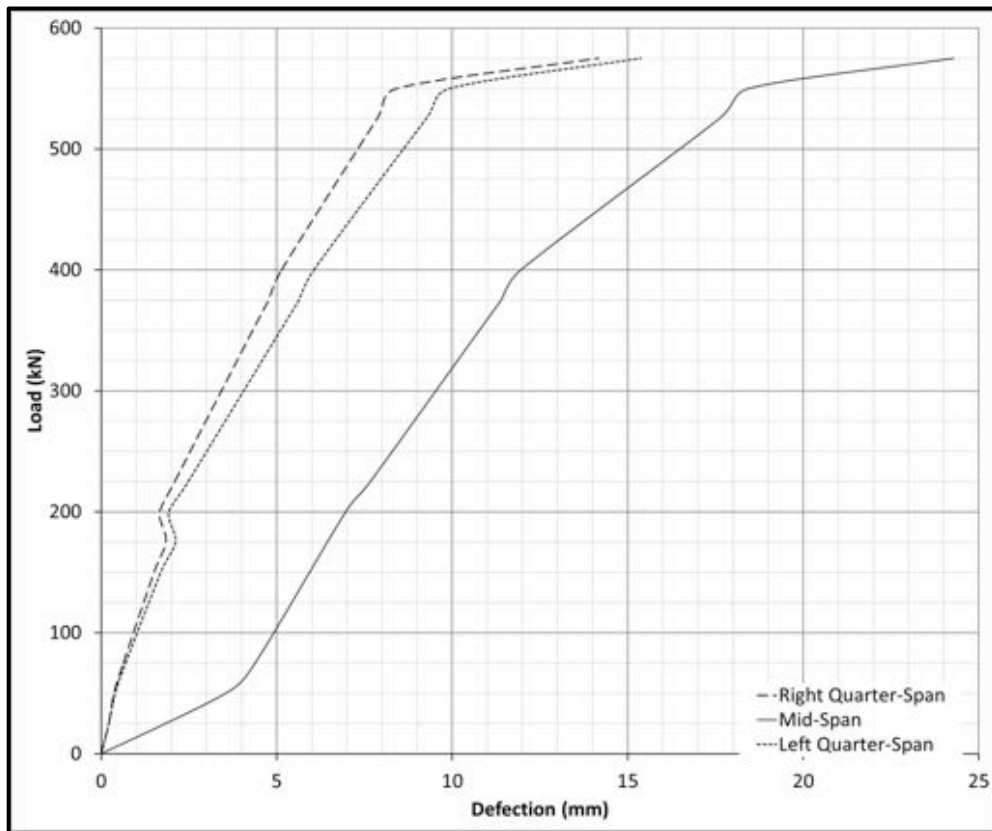
Figure 6.27: Load Deflection Curve Beam HS-L-M-2

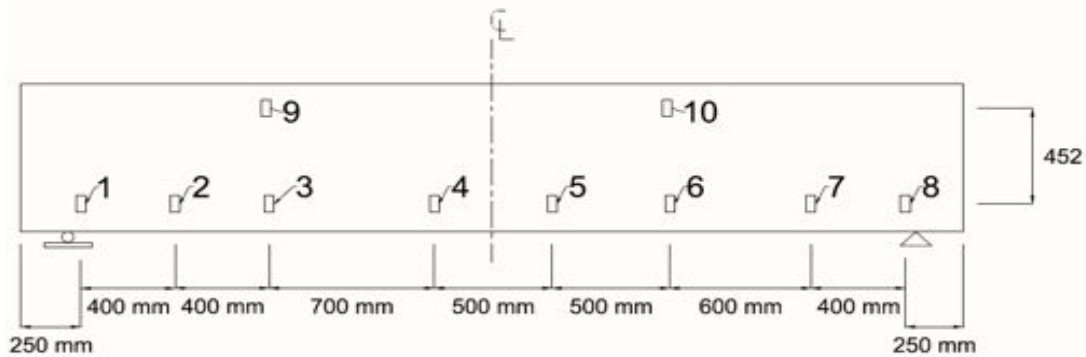
Figure 6.28: Piezo-Sensors Spatial Position in Beam HS-L-M-2

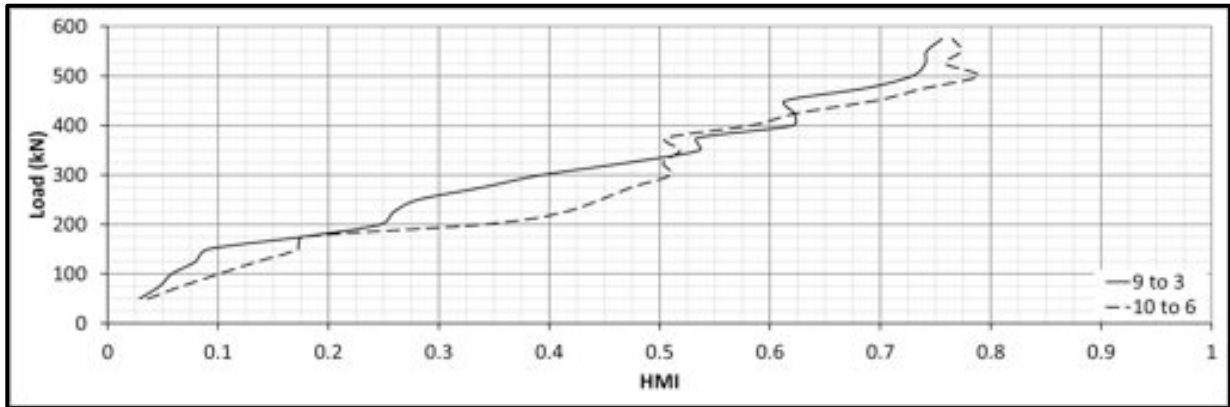
Figure 6.30: Shear Crack Detection

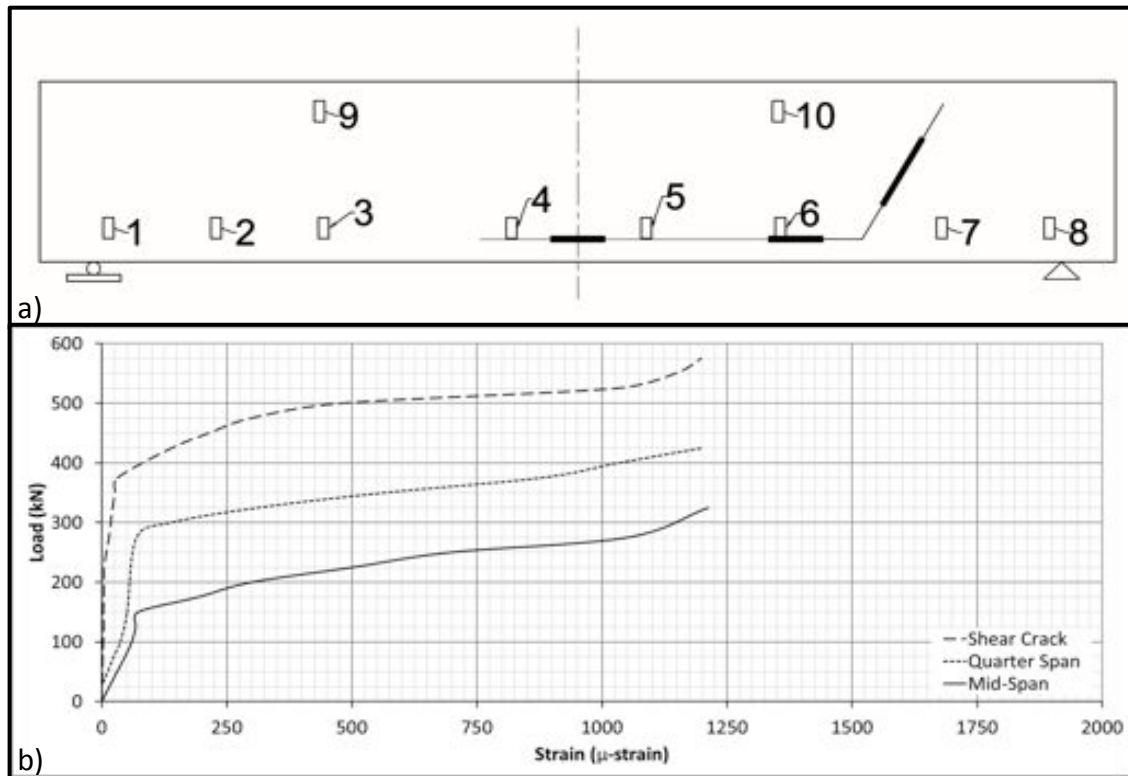
Figure 6.31: FBG fiber optic readings from beam HS-L-M-2; (a) Location of working sensors; (b) Readings obtained from FBG Sensors

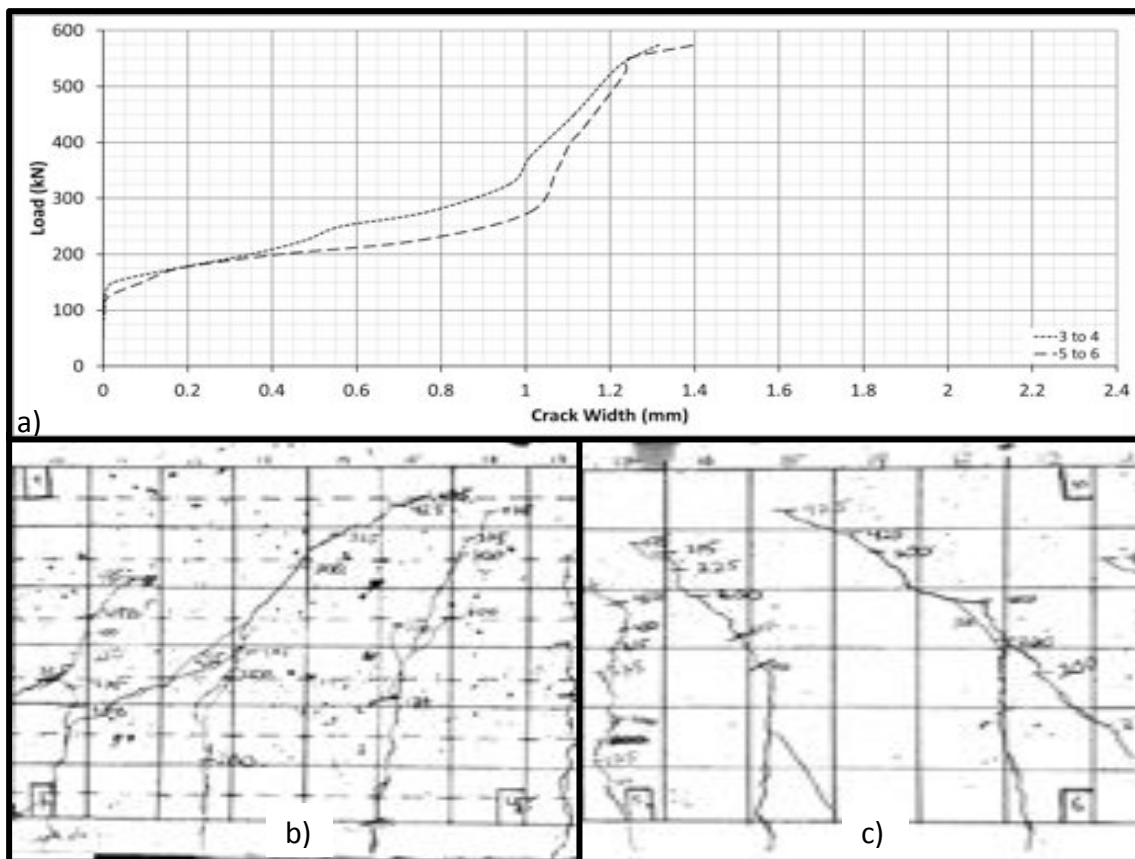
Figure 6.34: Results obtained adjacent to the support region HS-L-M-2; (a) Load-Crack Width Graph as yielded by piezo-sensors; (b) Observed cracking pattern between sensors Pair 9-3, left side of the beam; (c) observed cracking pattern between sensor pair 10-6, right side of the beam

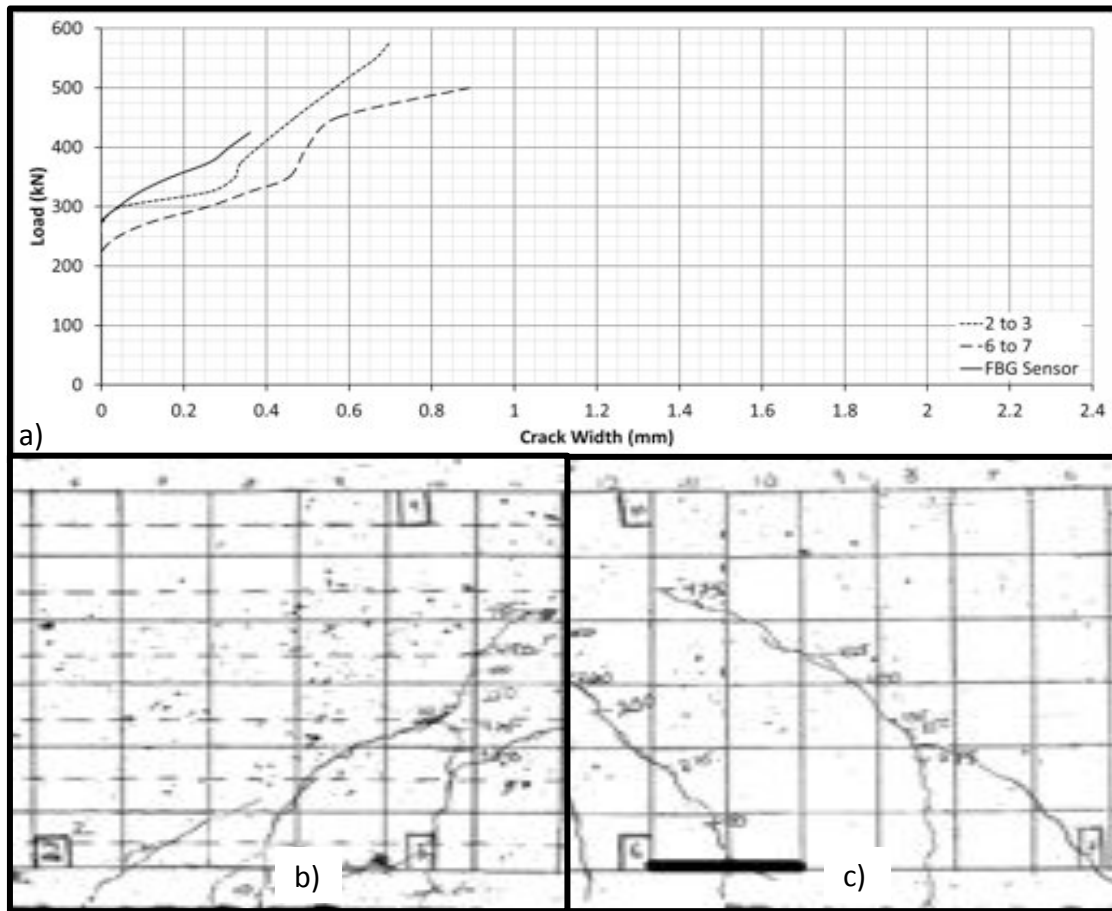
Figure 6.35: Results obtained at d_v from the support of beam HS-L-M-2; (a) Load-Crack Width Graph yielded by Piezo-Sensors and FBG Cable; (b) Observed cracking pattern between sensors Pair 2-3, left side of the beam; (c) Observed cracking pattern between sensor Pair 6-7, right side of the beam

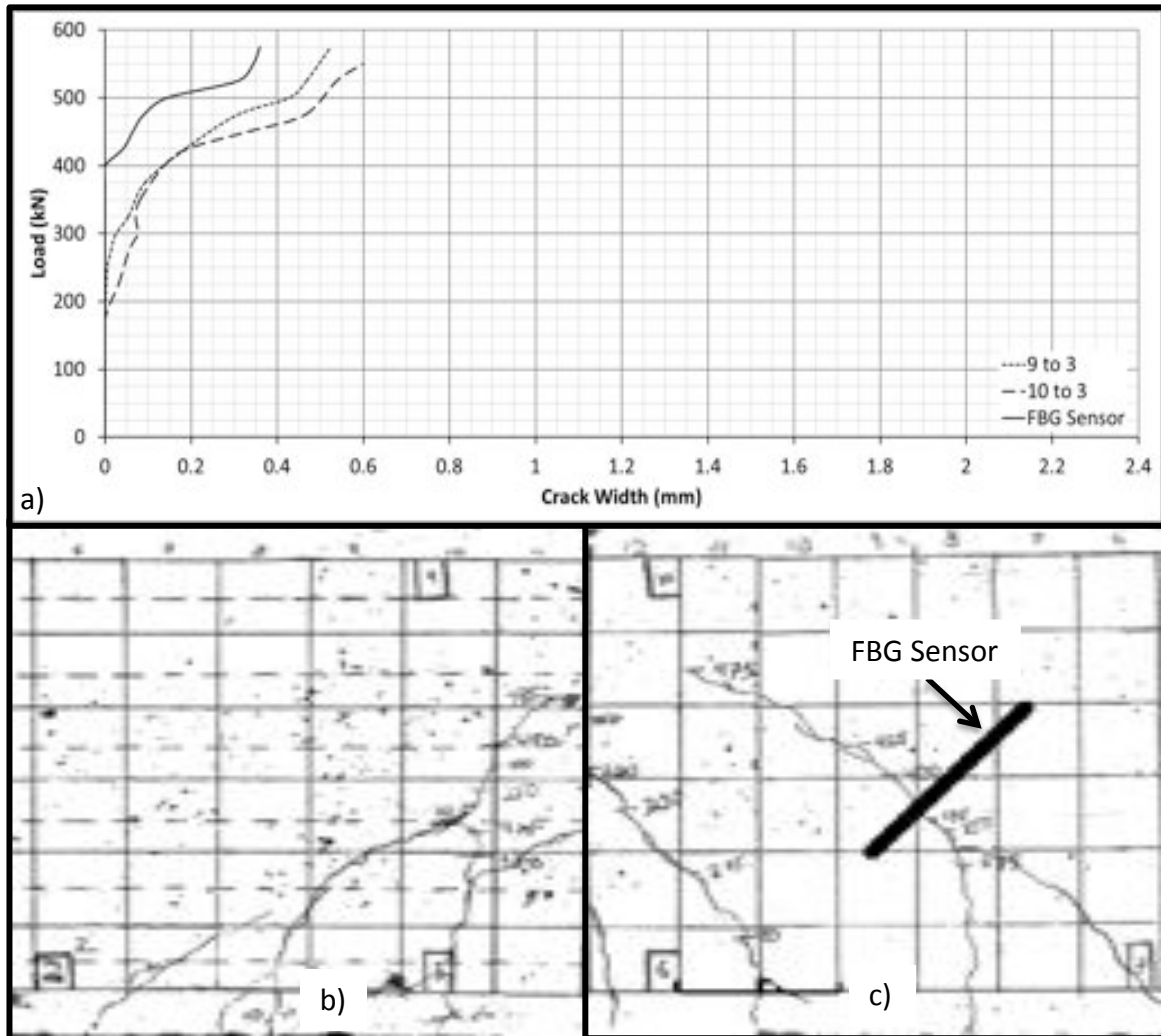
Figure 6.36: Shear Crack width measurements for beam HS-L-M-2; (a) Load-Crack Width Graph yielded by Piezo-Sensors and FBG Cable; (b) Observe cracking pattern between sensors Pair 9-3, left side of the beam; (c) Observed Cracking Pattern Between Sensor Pair 10-6, right side of the beam
