USE OF ADVANCED EMBEDDED PIEZOCERAMIC SENSORS FOR THE NON-DESTRUCTIVE
EVALUATION OF REINFORCED CONCRETE

A thesis presented to Ryerson University
in partial fulfillment of the

MASTERS OF APPLIED SCIENCE

CIVIL ENGINEERING

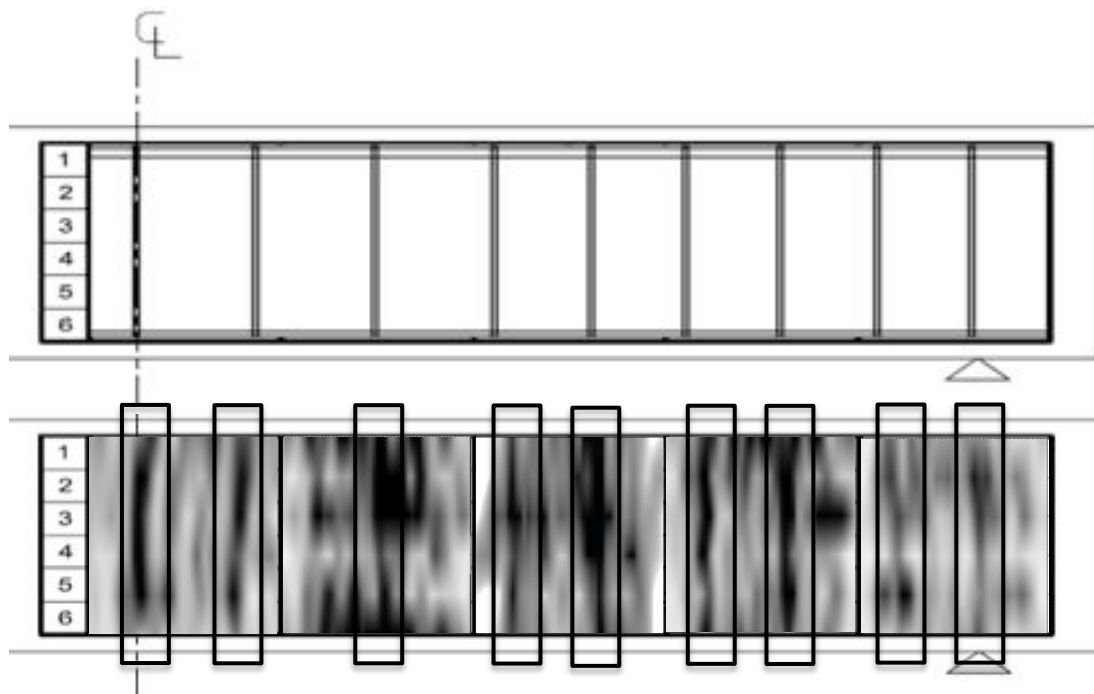
Figure 6.37: Horizontal Scan Direction Beam HS-L-M-2 Healthy State; (a) Theoretical Location of Steel Reinforcement; (b) MIRA Software Output

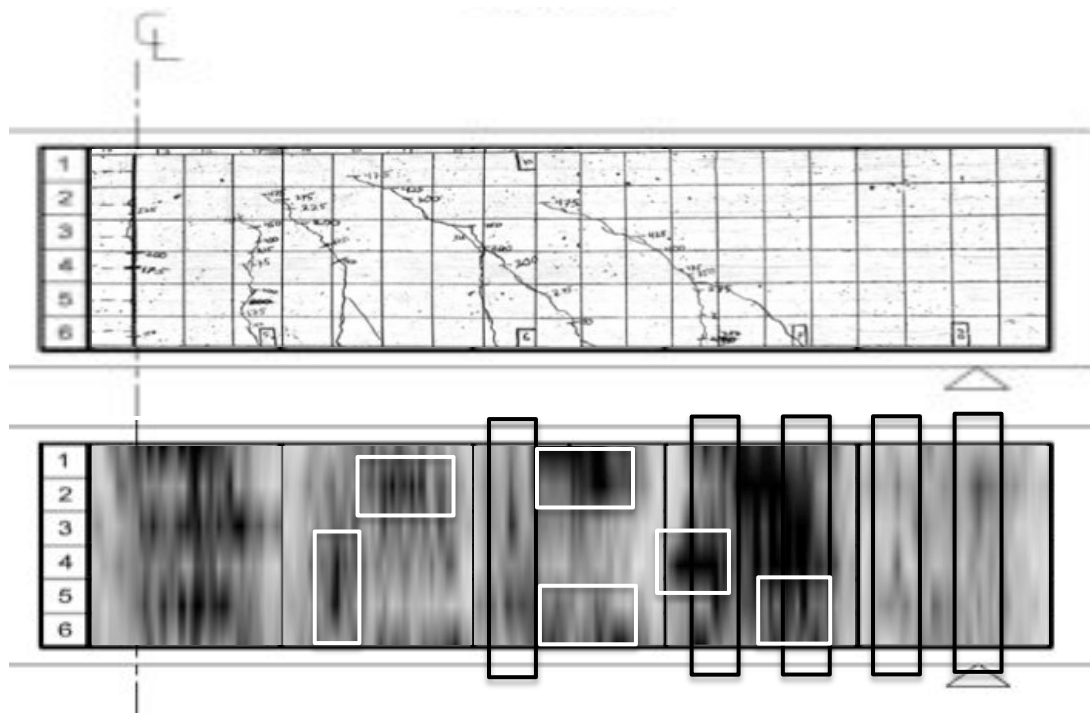
Figure 6.38: Horizontal Scan Direction Beam HS-L-M-2 Damaged State; (a) Observed Cracking Pattern on Scanned Surface; (b) MIRA Software Output
