# Exploring Acoustical Approach for Pre-screening of Window Assemblies Airtightness Level in an Existing Building

A Major Research Project (MRP)

in partial fulfillment of the requirements  
for the degree of Master of Building Science  
in the program of Building Science

Toronto, Ontario, Canada, 2018

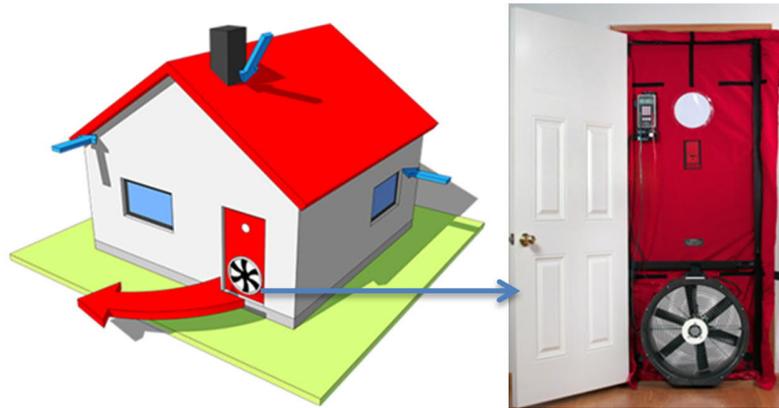
Figure 1 - Blower Door Test: left image (Lambda, 2018), right image (USI Blog, 2018)

After installing the door panel, frame and fan over an opening within the building envelope, such as door or window, and connecting the blower door gauge to the fan, the measurements, such as flow or leakage area, should be taken at increments of 5 to 10 Pa between pressure differences of 10 Pa to 60 Pa (ASTM E779-10, 2010). (Figure 1)

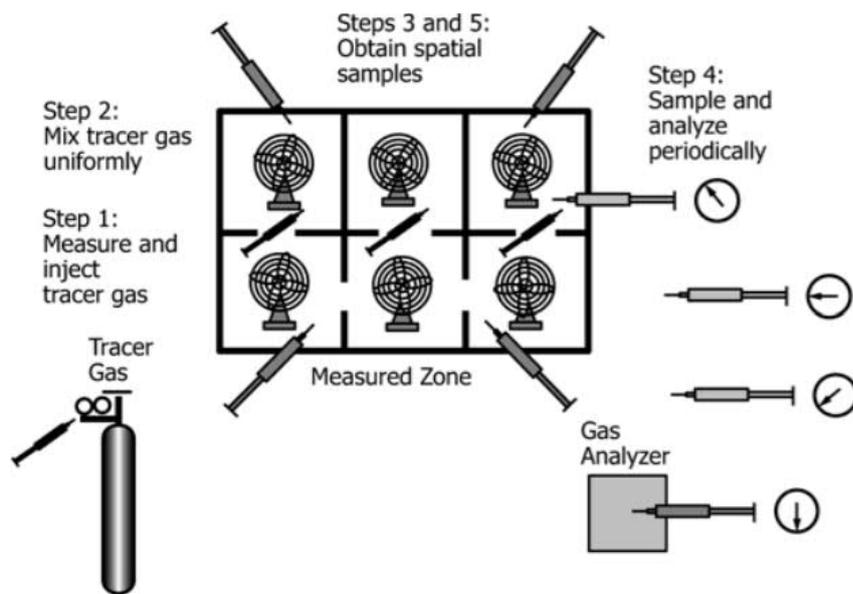
Figure 2 - concentration decay test technique (ASTM E741 , 2011)

By employing concentration decay test method, average air change rate can be estimated. In this method, small amount of tracer gas is distributed uniformly throughout the experimental space. Tracer gas concentration is monitored and measured periodically at certain times. Then, the recorded data is evaluated in order to determine the average air change rate (ASTM E741 , 2011).

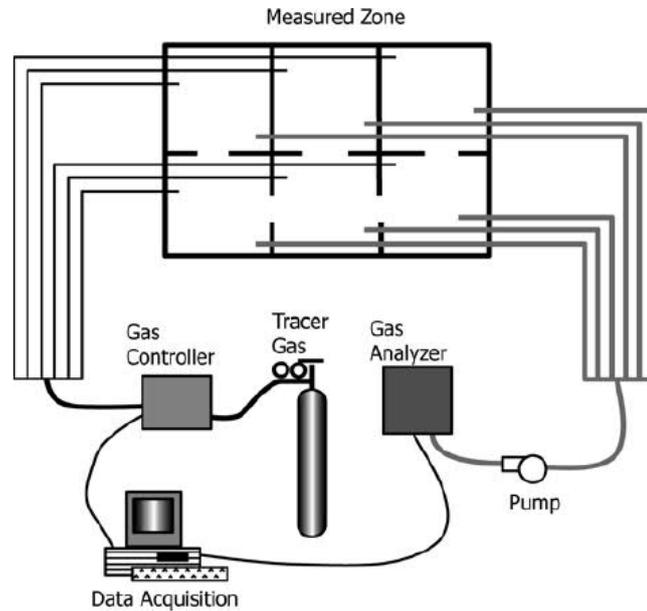
Figure 3- Constant Test Technique (ASTM E741 , 2011)

With the use of constant injection test method, average air change flow can be evaluated. In this method tracer gas is inserted in to experimental space with a constant rate. After the gas is evenly distributed, trace gas concentration is monitored at certain times. Average air flow is determined by analyzing the recorded data (ASTM E741 , 2011). (Figure 3)

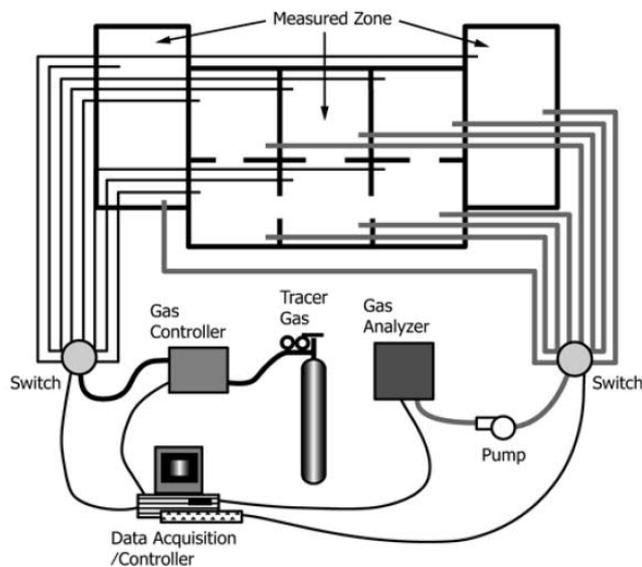
Figure 4 - Constant Concentration Test Technique (ASTME741 , 2011)

In order to calculate air change flow via constant concentration test technique, an automated device is employed to preserve specific uniform tracer gas concentration with measuring the gas concentration regularly and injecting required gas volume. Based on each measurement and the volume of the gas added to the experimental space, air change flow is estimated (ASTM E741 , 2011). (Figure 4)

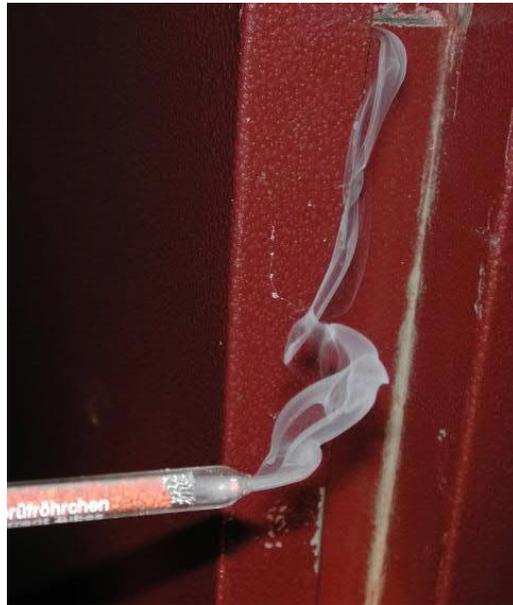
Figure 5 - Tracer Gas Method (InspectAPedia, 2017)

Smoke trace method can also to be used for localizing the air leakage area. This method is described in ASTM E-1186 standard (2017). Due to pressure differentials between inside and outside of building enclosure, air tends to travel through opening and cracks within building enclosure. By placing smoke/theatrical fog sources, which is a device that produces dense vapour which is very much identical to smoke and fog, near the suspected leaking area, within roughly 10 cm, the air infiltration area can be visually localized (ASTM E1186 standard, 2017). (Figure 5)

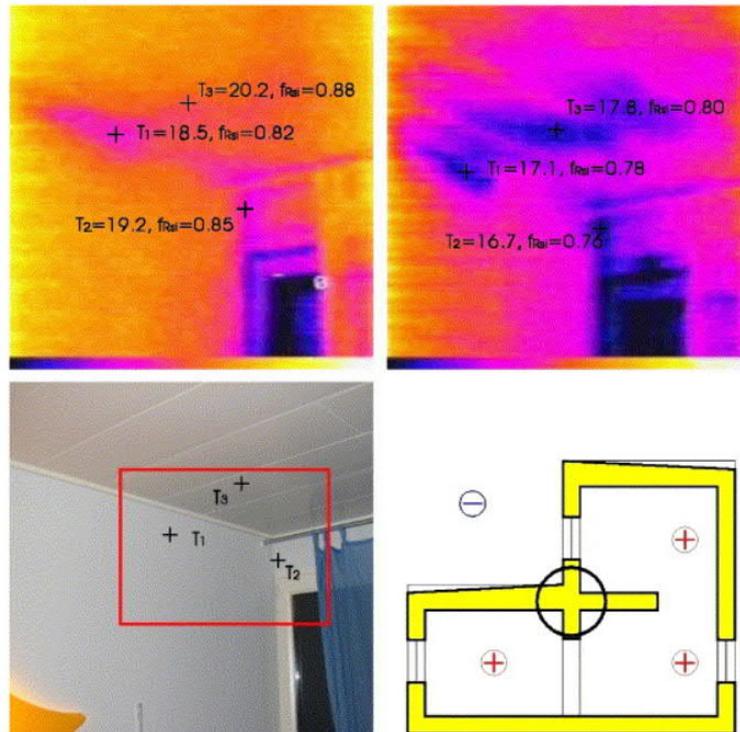
Figure 6 - Upper left: Combined building depressurization and infrared scanning, Upper right: infrared scanning  
(Kalamees T. , 2007)

Kalamees (2007) detected the air leakage locations of a new detached house in Estonia with infrared camera. Then, in order to detect the precise locations of the air leakage, he used the combination of thermal imaging camera technique and blower door fan. The outdoor and indoor temperature difference at the test time measured 20°C. To employ the second method he depressurized the building to 50Pa for 30 minutes. Then, he scanned the interior side of the building to determine the main air infiltration locations. (Figure 6)

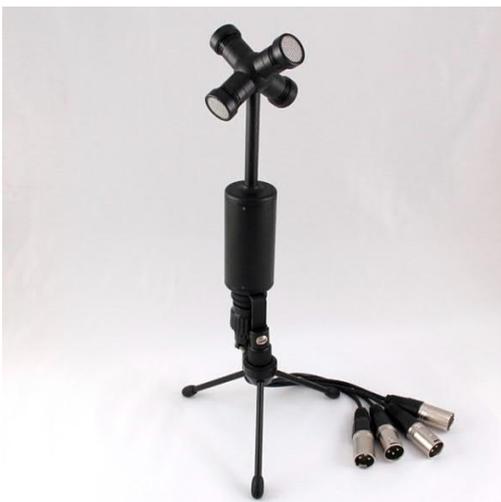
Figure 7 - Ambisonics decomposition (IDIS, 2018)

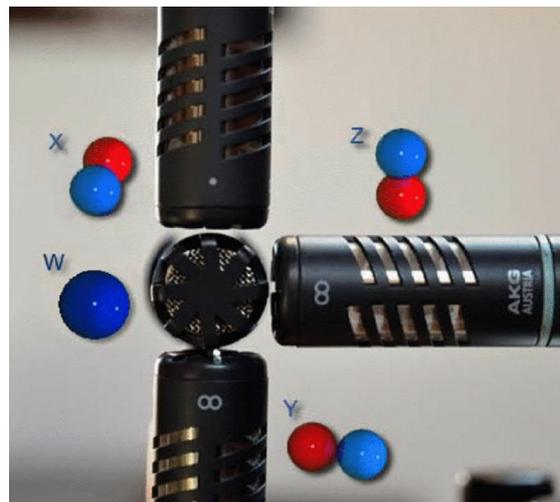
Figure 8 - Ambisonics B-format layout (Ortolani & Uncini, 2016)

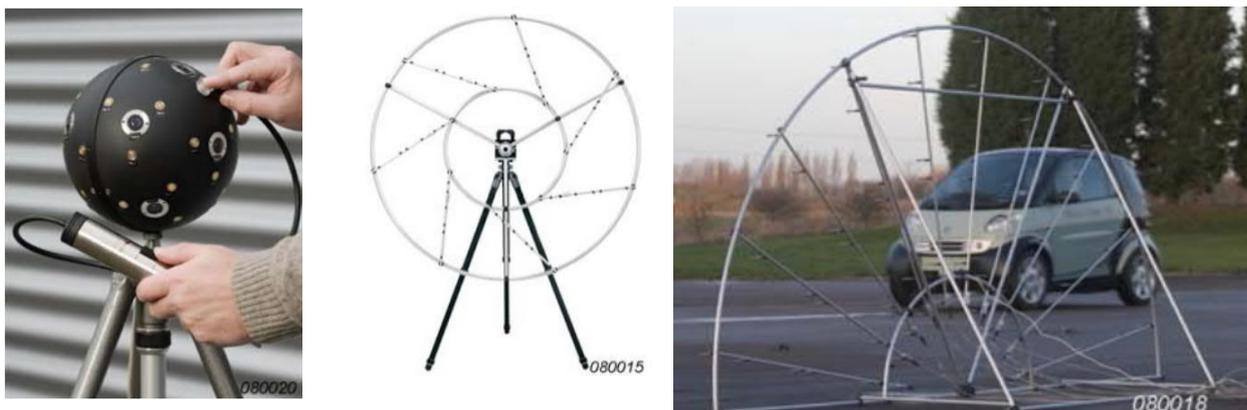
Figure 9 – Samples of microphone arrays used in beamforming technique (Briel & Kjaer, 2018)

Beamforming is a sound processing method. In this method, delays and phase changes of every signal reaching to each transducer are considered to specify the direction of sound source (Martellotta, 2013) (Figure 9). Beamforming not only can be used in sound identification and localization remotely but with some adjustments, it can also be used for nearfield sound source imaging (Cho & Roan, 2009). Raman et al. (2014) used remote acoustic approach to locate leaks out of a window with beamforming technique. Since using beamforming approach cannot quantify the leakage area, employing Nearfield Acoustic Holography (NAH) technique, which has the potential to localize and quantify air infiltration through building envelope, may be the next step in this filed, which was proposed by Raman et al. as a future work.

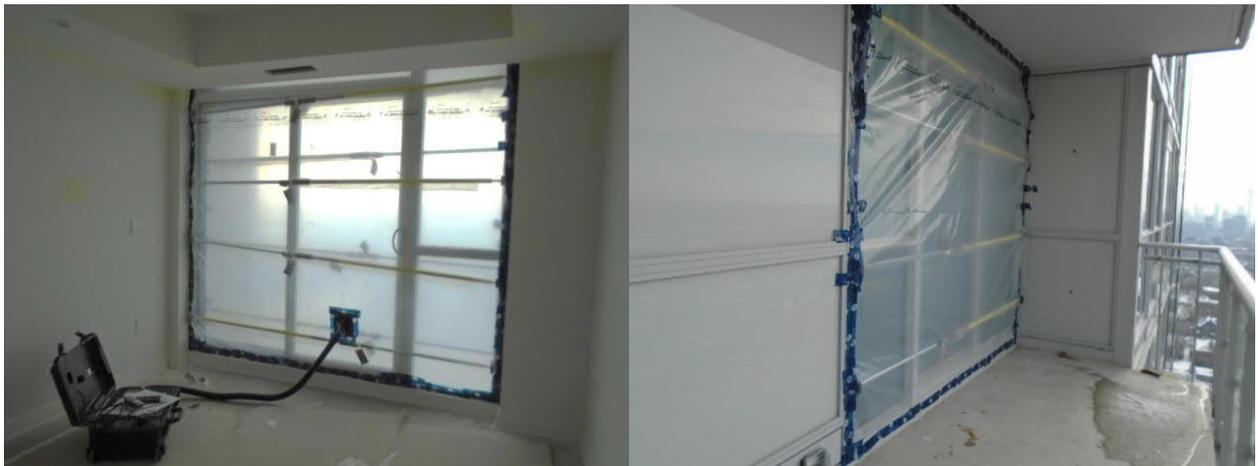
Figure 10 – Air infiltration field test through experimental window assembly set up

During each test both temperature and relative humidity of inside and outside of the building were measured. Speed and direction of wind were also recorded.

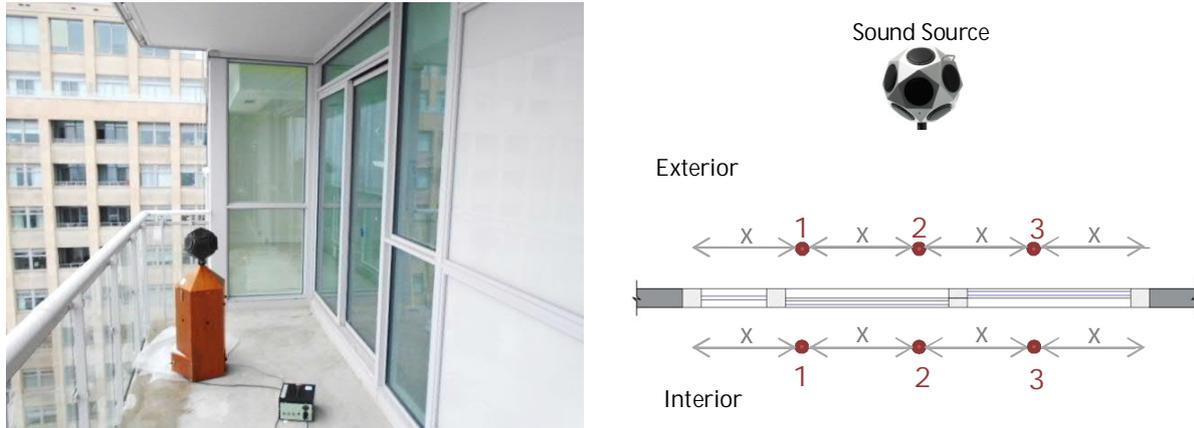
Figure 11 – Sound source location and acoustic measurement points

In order to calculate the sound pressure transmission loss through the window, the average of inside sound pressure was subtracted from the average sound pressure measured outside.

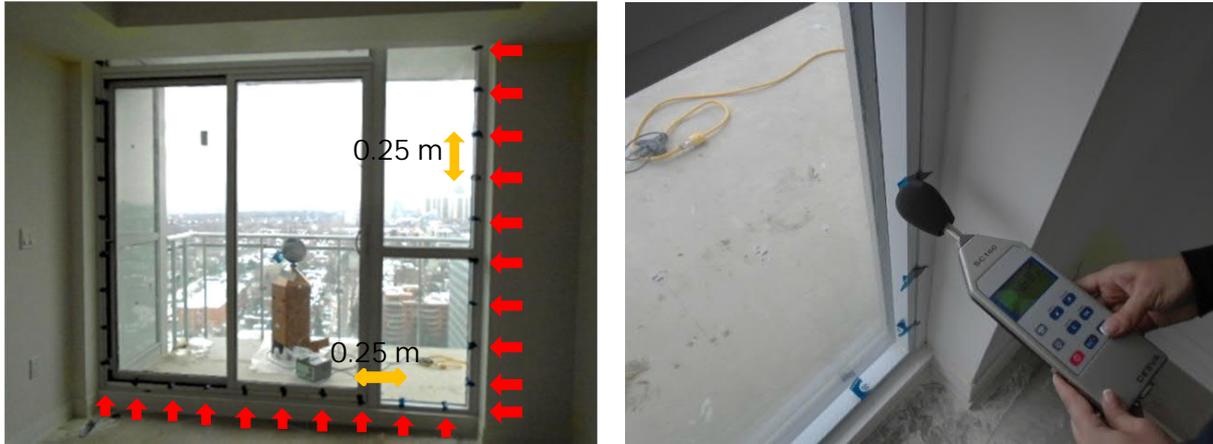
Figure 12- Sound pressure measurements taken in order to identify air leakage locations

In order to explore acoustic air leakage detection method, which is based on standard ASTM E1156 (2017) and was explained on section 2.2.6 of this report, further, it was used to pre-screen the air infiltration locations of the seven experimental window assemblies. A loudspeaker was placed outside and at the center of each window assembly and spaced approximately 1.12 m (4 ft.) far from the specimen at the height of one meter from the floor slab to produce white noise. Since air infiltration through window assemblies mostly happen through window frames and sashes, the Sound level meter was moved over to the interior side of the tested window sashes/frame, by approximately 1 cm from the specimen surface. The sound pressure was recorded every 0.25 m (10 inches) (Figure 12).

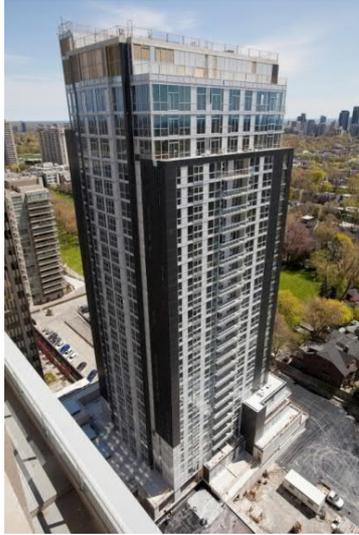
Figure 13 – Overview of 101 St. Clair Avenue West Building (Vandersluis, 2017)

For the purposes of this study, seven randomly selected window assemblies, which are manufactured by Allan Window Technology and installed on a 27 story building located at 101 St. Clair Avenue West, were studied. (Figure 13)

The window assemblies of the building consist of thermally broken aluminum frames and the vision glass, which is double glazed Argon filled with warm spacer along the glass pane premier. The exterior caulking was completed around the perimeter of the experimental window assemblies and the interior drywall was installed.

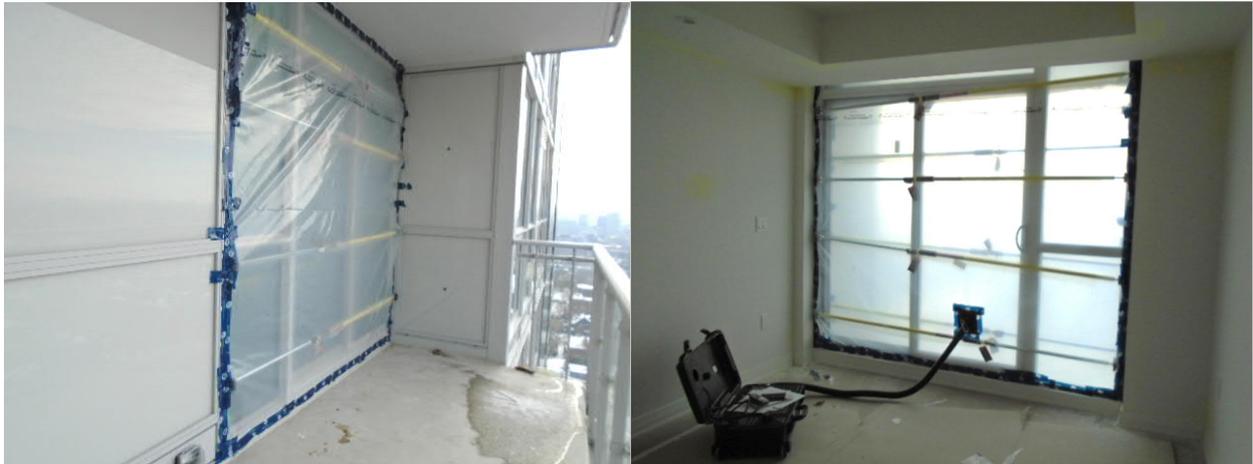
Figure 15 – Left image: Exterior view of window assembly set up, Right image: Interior view of window assembly set up of Location No. 1

Airtightness test was performed based on standard ASTM-E783 as described in section 4.1.1 of this report (Figure 15). The test results and environmental conditions during the test are noted in following table (Table 1).

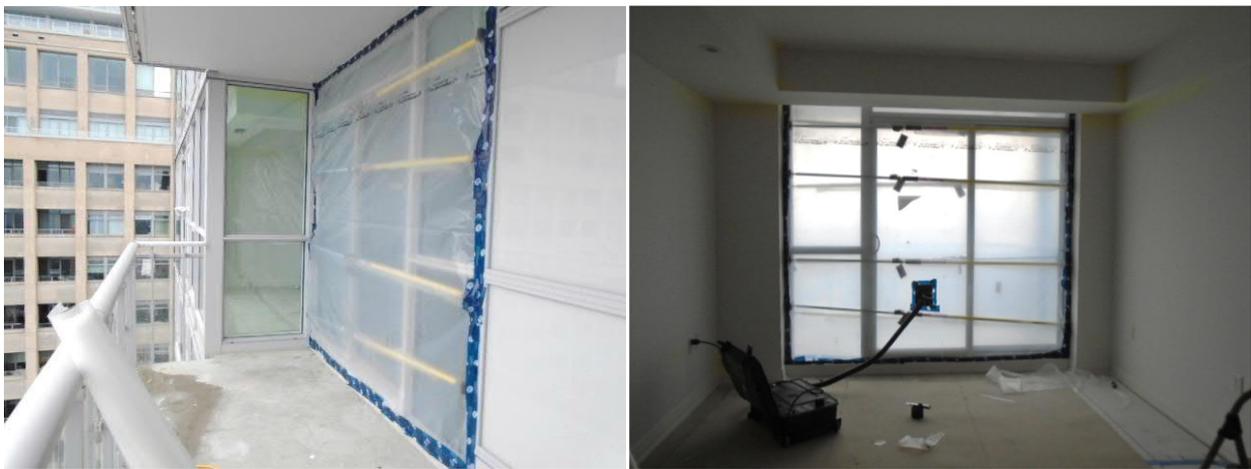
Figure 17 – Left image: Exterior view of window assembly set up, Right image: Interior view of window assembly set up of Location No. 2

Airtightness test was performed based on standard ASTM-E783 as described in the section 4.1.1 of this report (Figure 17). The test results and environmental conditions during the test are noted in flowing table (Table 3).

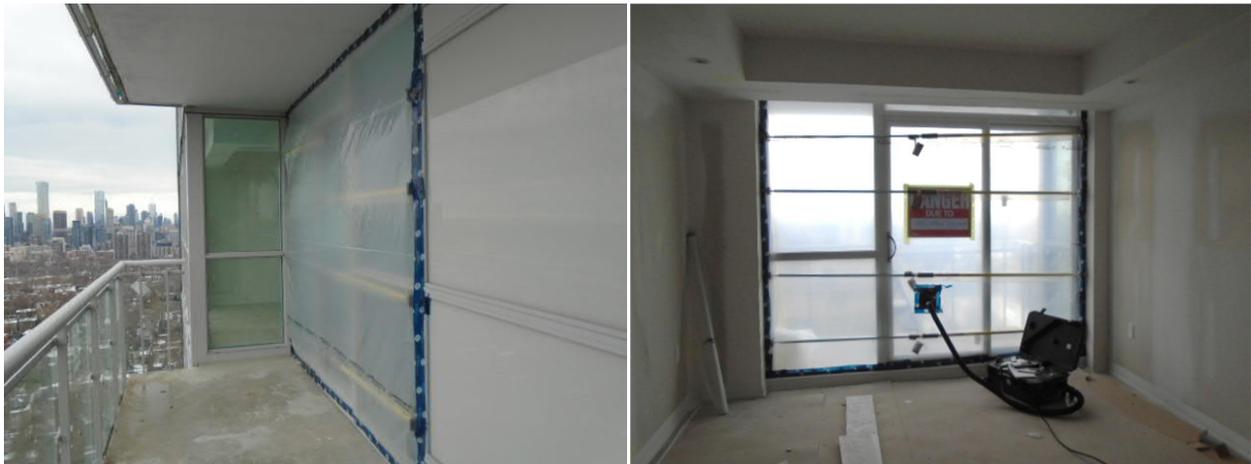
Figure 19 – Left image: Exterior view of window assembly set up, Right image: Interior view of window assembly set up of Location No. 3

Airtightness test was performed based on standard ASTM-E783 as described in the section 4.1.1 of this report (Figure 19). The test results and environmental conditions during the test are noted in following table (Table 5)

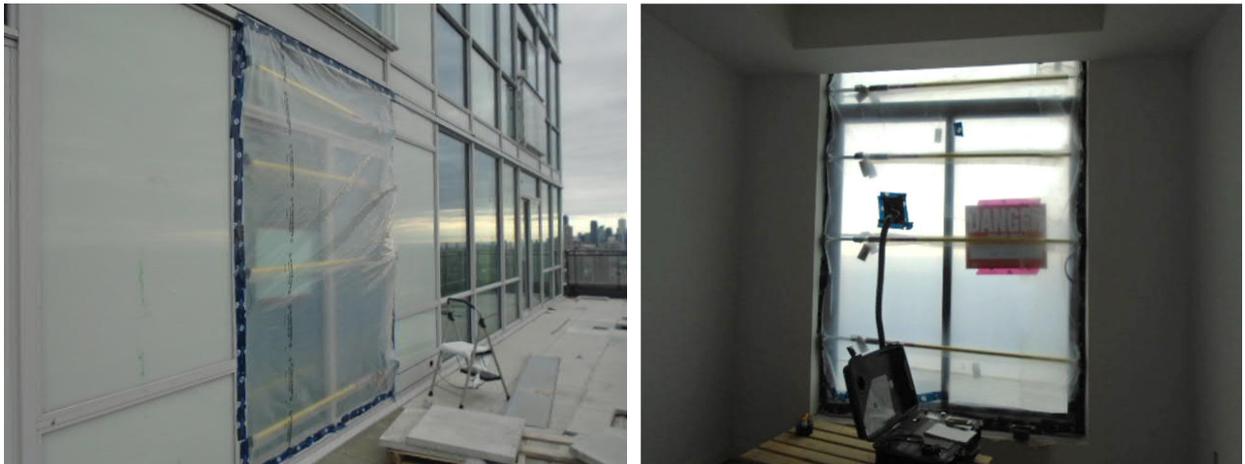
Figure 21 – Left image: Exterior view of window assembly set up, Right image: Interior view of window assembly set up of Location No. 4

Airtightness test was performed based on standard ASTM-E783 as described in section 4.1.1 of this report (Figure 21). The test results and environmental conditions during the test are noted in following table (Table 7)

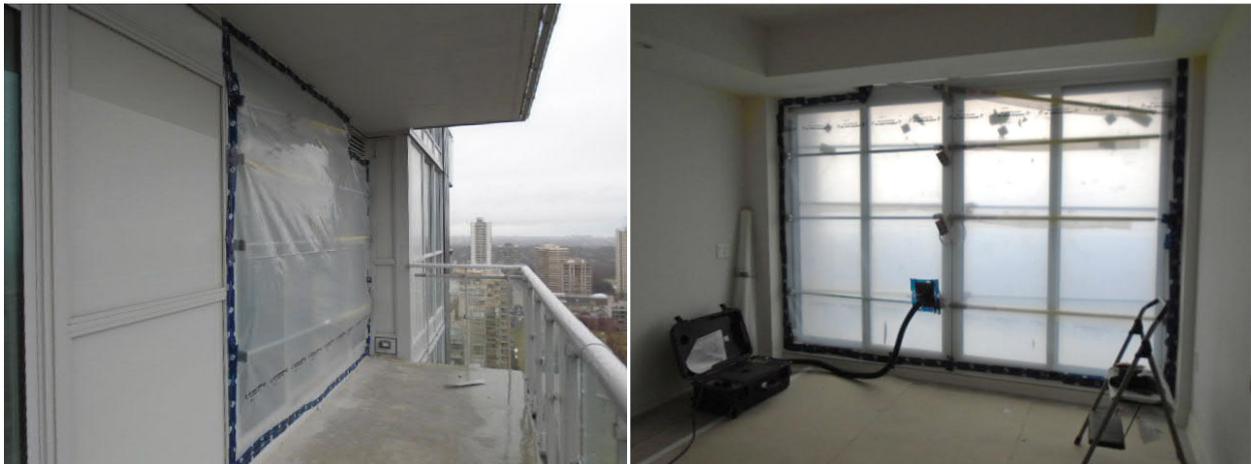
Figure 23 – Left image: Exterior view of window assembly set up, Right image: Interior view of window assembly set up of Location No. 5

Airtightness test was performed based on standard ASTM-E783 as described in section 4.1.1 of this report (Figure 23). The test results and environmental conditions during the test are noted in following table (Table 9).

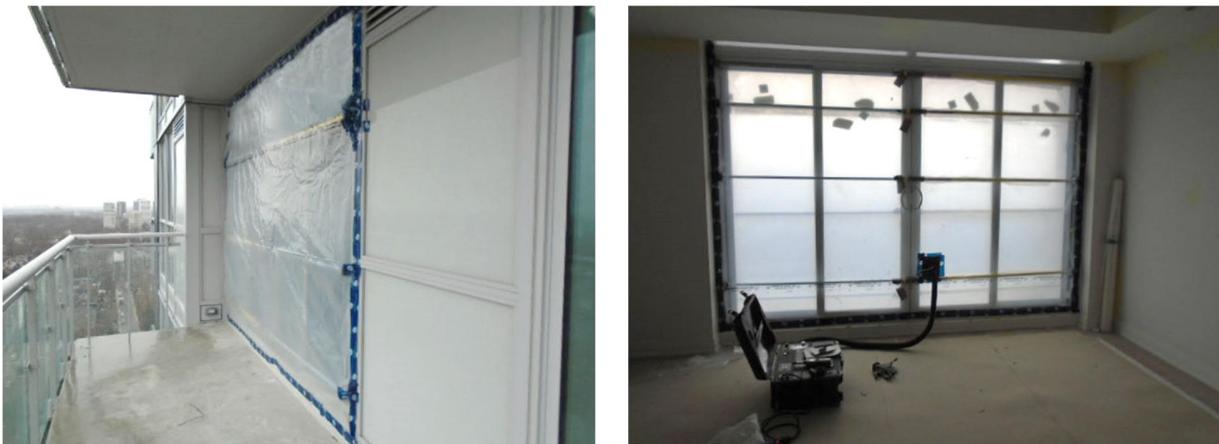
Figure 25 – Left image: Exterior view of window assembly set up, Right image: Interior view of window assembly set up of Location No. 6

Airtightness test was performed based on standard ASTM-E783 as described in the section 4.1.1 of this report (Figure 25). The test results and environmental conditions during the test are noted in following table (Table 11)

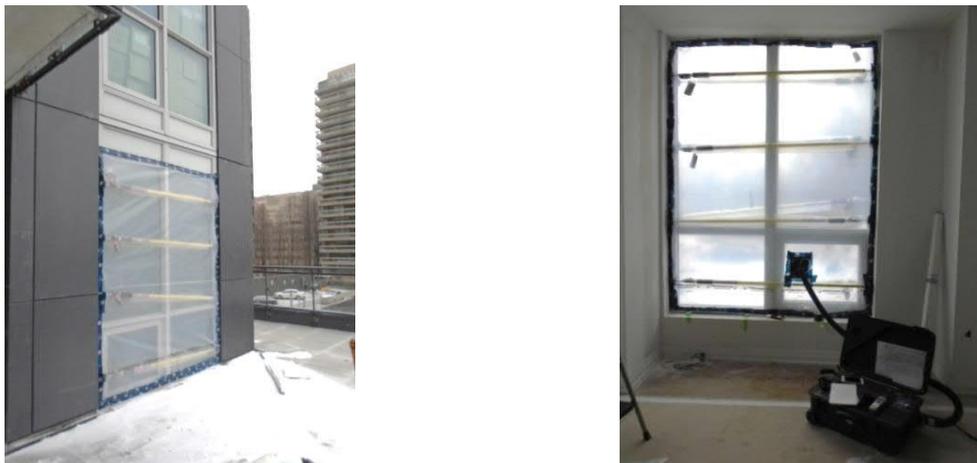
Figure 27 – Left image: Exterior view of window assembly set up, Right image: Interior view of window assembly set up of Location No. 1

Airtightness test was performed based on standard ASTM-E783 as described in the section 4.1.1 of this report (Figure 27). The test results and environmental conditions during the test are noted in the following table (Table 13).

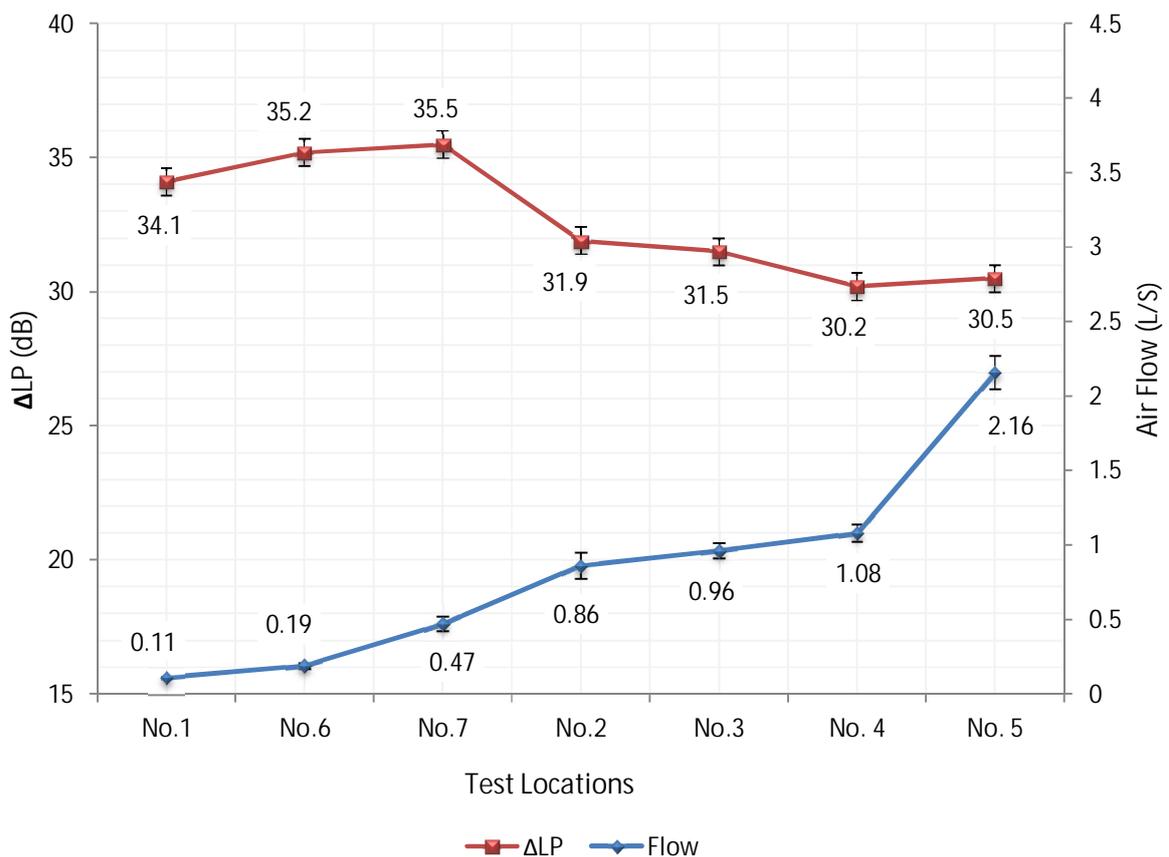
Figure 28 - Relationship between the air flow and the sound transmission pressure loss through the experimental window assemblies

As it can be witnessed Figure 28, while the amount of airflow through the tested specimens rise noticeably and the measurements range from 0.11 L/S to 2.16 L/S, the amount of sound transmission pressure loss through the window assemblies drop gently and sort from 35.5 dB to 30.2 dB.

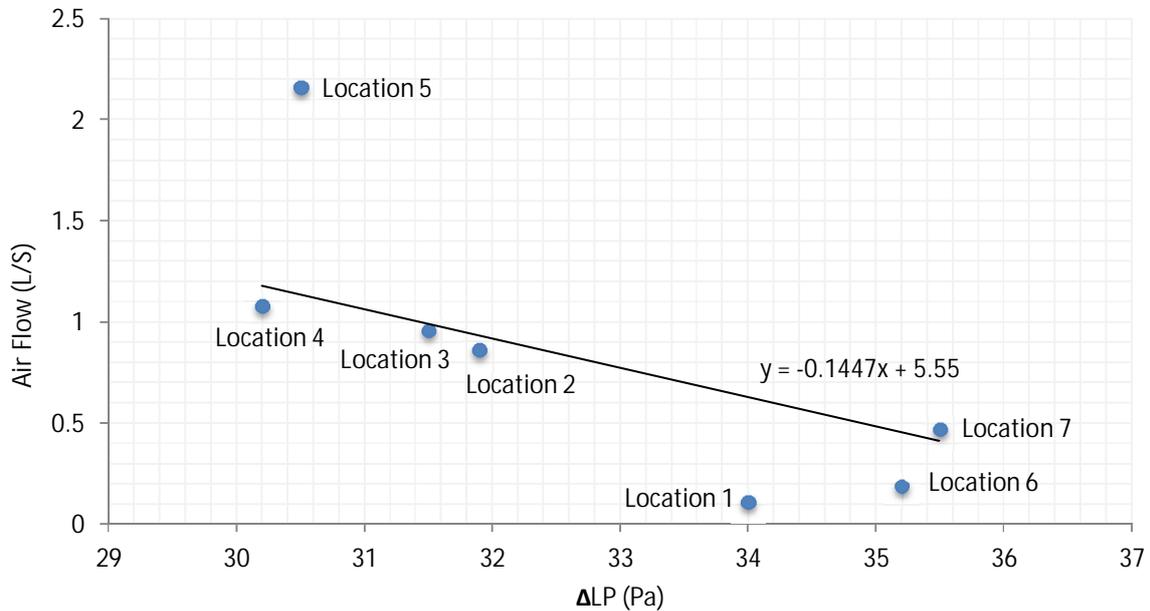
Figure 30- Physical correlation between the air flow and the sound transmission pressure loss (Based on the tests performed on the seven experimental window assemblies)

The following scatted chart also reveals the negative relationship between these two phenomena. The tighter the window assembly, the less sound is transmitted through the window assemblies. (Figure 30)

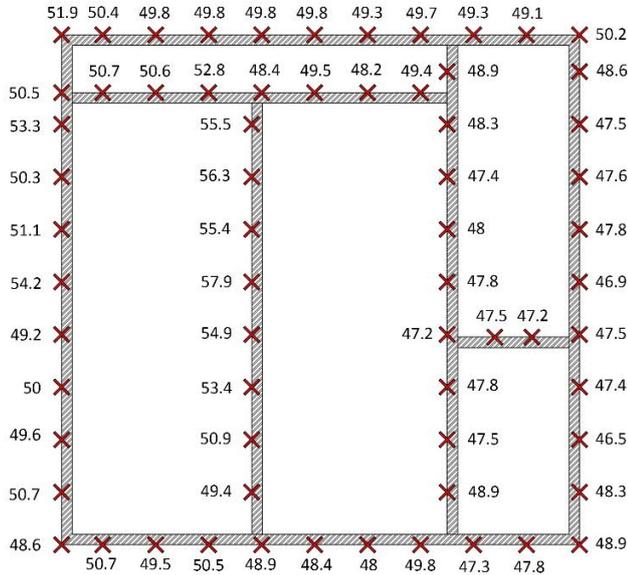
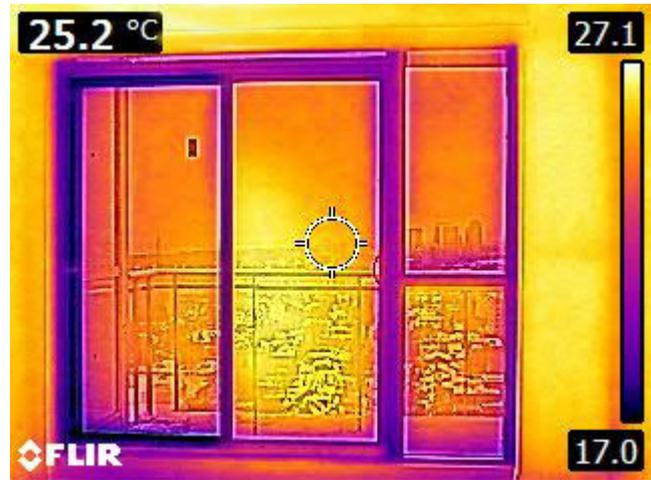
Figure 31 - Test location No. 1 - 22<sup>nd</sup> floor, Suite 2205, Bedroom, Left image: measured sound pressure (dB) of inside of the specimen, Right image: thermal imaging of the experimental window assemblies

window is at the perimeter of the fixed panel of the sliding door due to the surface temperature alteration and the increase in sound pressure.

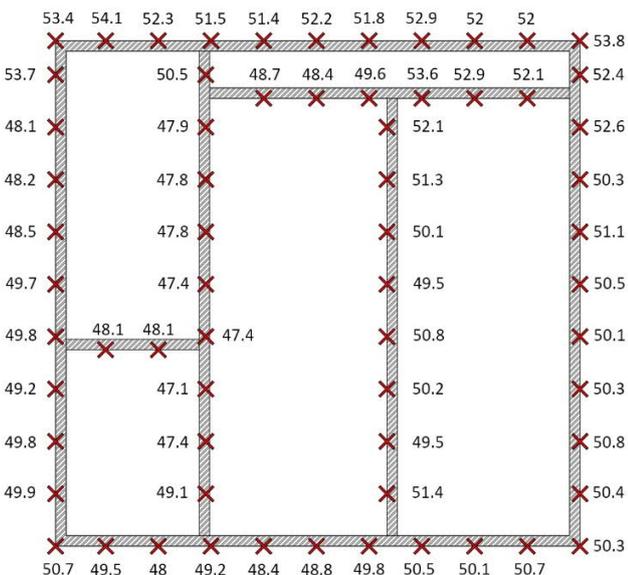
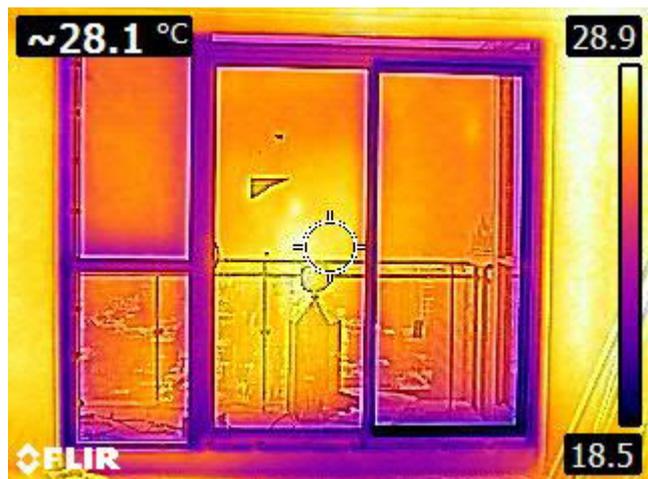
Figure 32 - Test location No. 2 - 22<sup>nd</sup> floor, Suite 2205, Livingroom, Left image: measured sound pressure of inside of the specimen, Right image: thermal imaging of the experimental window assemblies

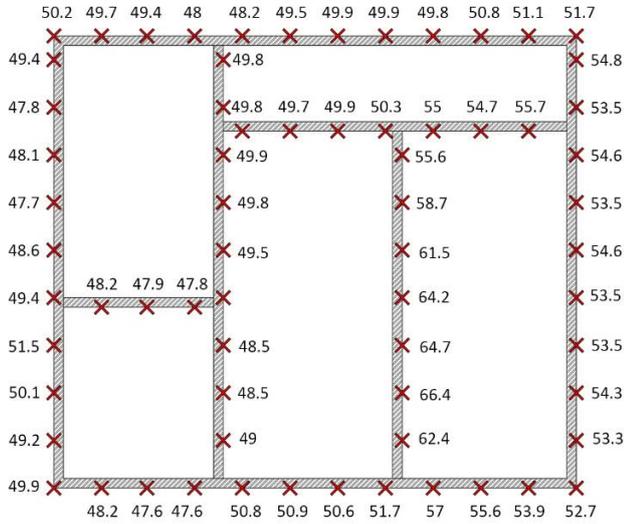
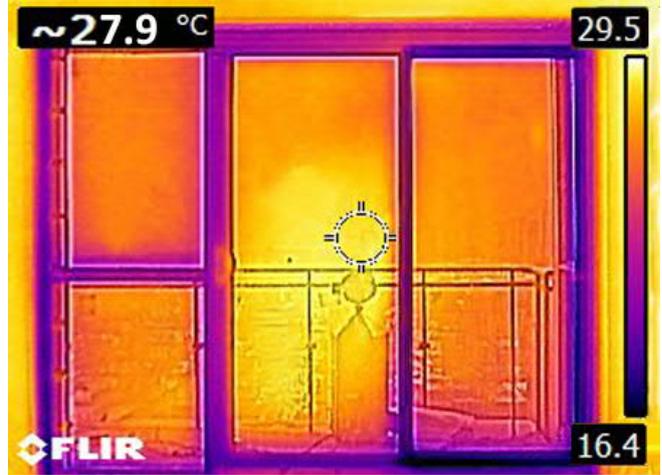
Figure 33 - Test location 3 - 22<sup>nd</sup> floor, Suite 2201, Livingroom, Left image: measured sound pressure of inside of the specimen, Right image: thermal imaging of the experimental window assemblies

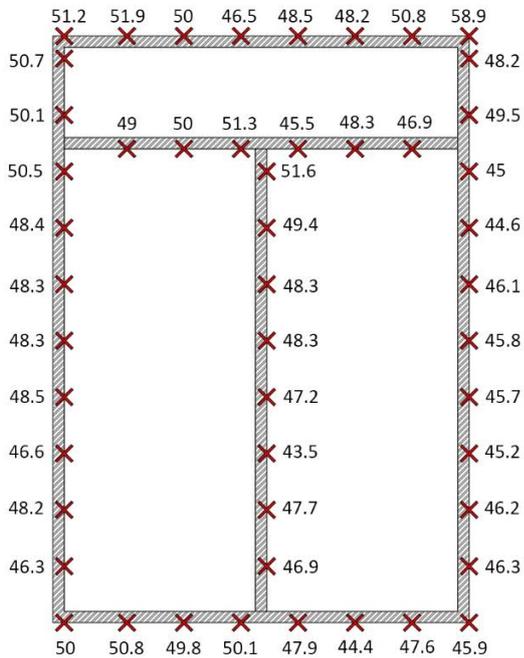
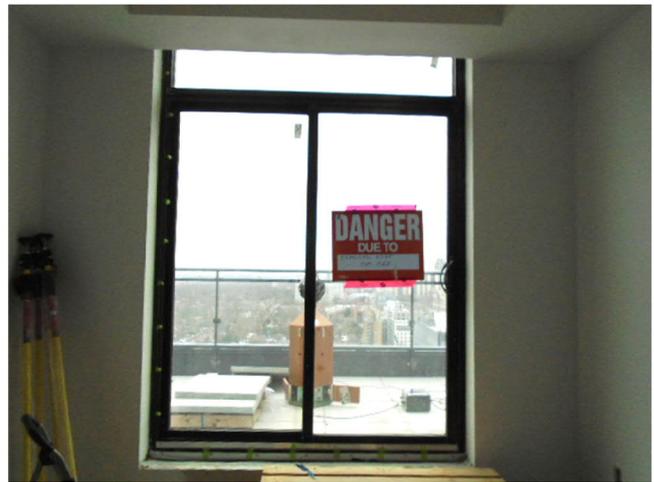
Figure 34- Test location No. 4 - 22<sup>nd</sup> floor, Suite 2402, Family room, Left image: measured sound pressure of inside of the specimen, Right image: view of the experimental window assemblies

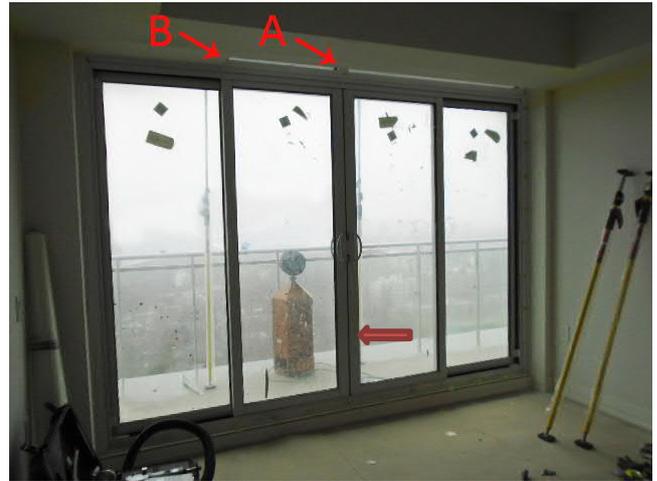
Figure 35 - Test location 5 - 22<sup>nd</sup> floor, Suite 2203, Bedroom, Left image: measured sound pressure of inside of the specimen, Right image: view of the experimental window assembly

1. Location A and B
2. The joint between two slider panels

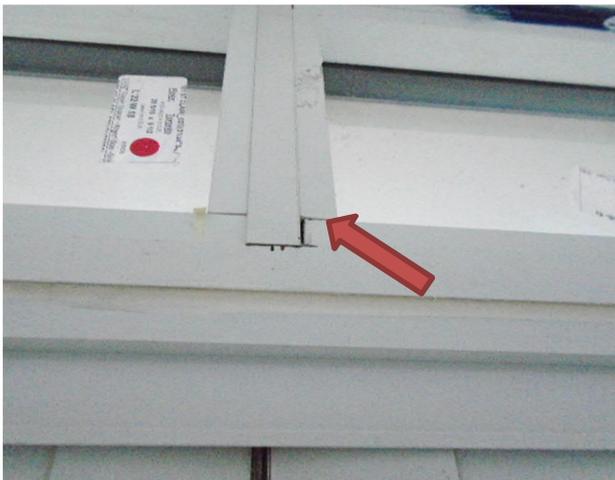
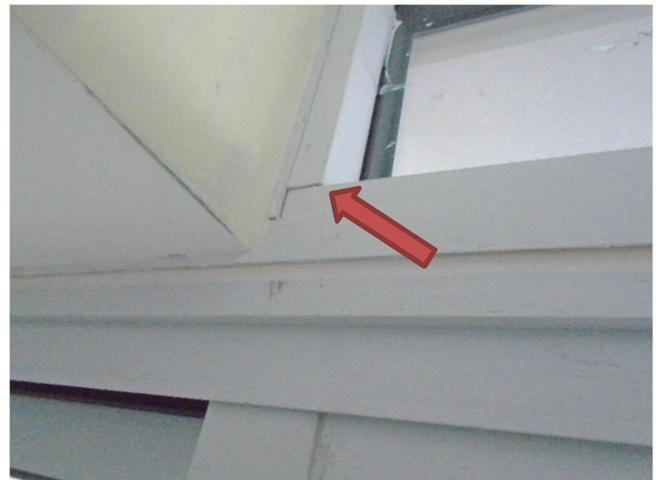
Figure 36 - Test location No. 5 - 22<sup>nd</sup> floor, Suite 2203, Bedroom, Left image: view of point A on tested window assembly, Right image: view of point B on the experimental window assembly

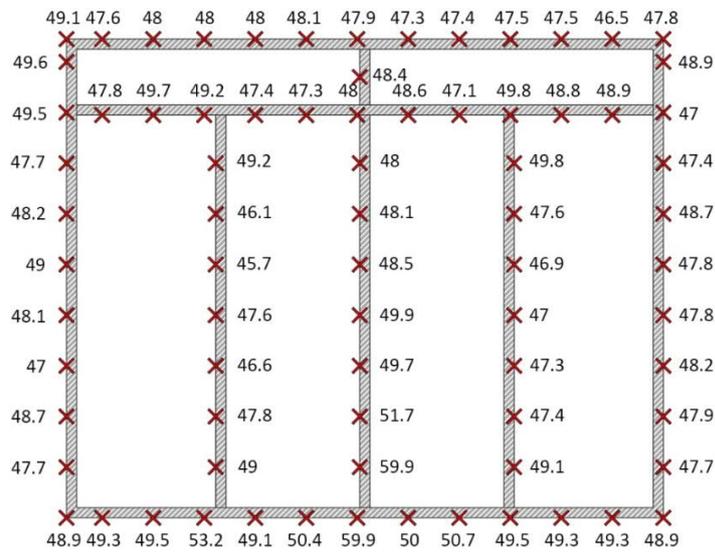
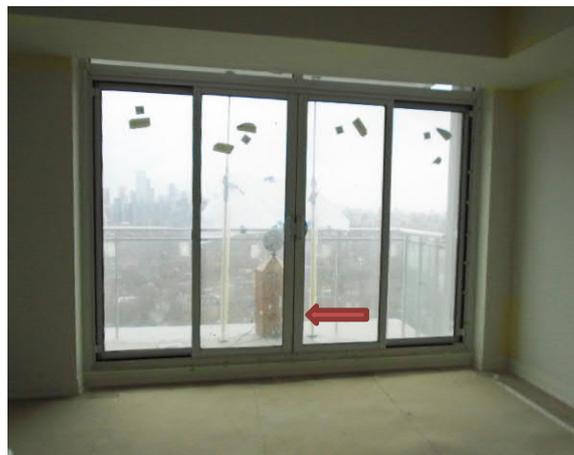
Figure 37 - Test location No. 6 - 22<sup>nd</sup> floor, Suite 2203, Livingroom, Top image: measured sound pressure of inside of the specimen, Bottom image: view of the experimental window assemblies

A raise in measured sound pressure was identified at the joint between two slider panels at the bottom section of the tested window assembly. After visual inspection of the specimen, it appears that these slider panels, as the movable parts of the window assembly, are not perfectly adjusted. This may cause air flow through the experimental window at these locations and cause increase in the recorded sound pressure. (Figure 37)

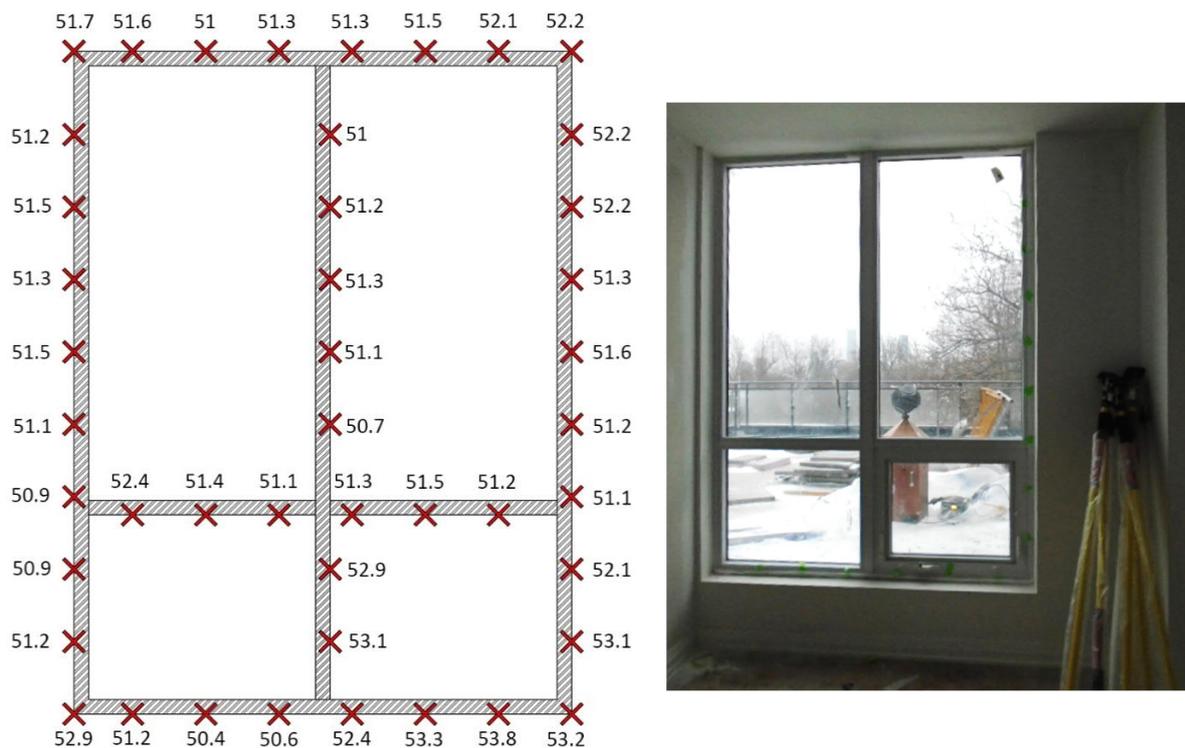
Figure 38- Test location No. 7- 22<sup>nd</sup> floor, Suite 202, Livingroom, Left image: measured sound pressure of inside of the specimen, Right image: view of the experimental window assemblies

At this test location, the noted sound pressure was increased at bottom and sides of the awning window of the specimen. It appears that the rubber gasket installed at this location did not completely prevent the air infiltration through this window. As illustrated on Figure 38, this air flow slightly affected the measured sound pressure.
