DEVELOPMENT OF A TEST METHOD TO EVALUATE DURABILITY OF PAVEMENT JOINTS UNDER  
WINTER CONDITIONS

A thesis

in partial fulfilment of the  
requirements for the degree of  
Master of Applied Science  
in the program of  
Civil Engineering

Toronto, Ontario, Canada, 2019

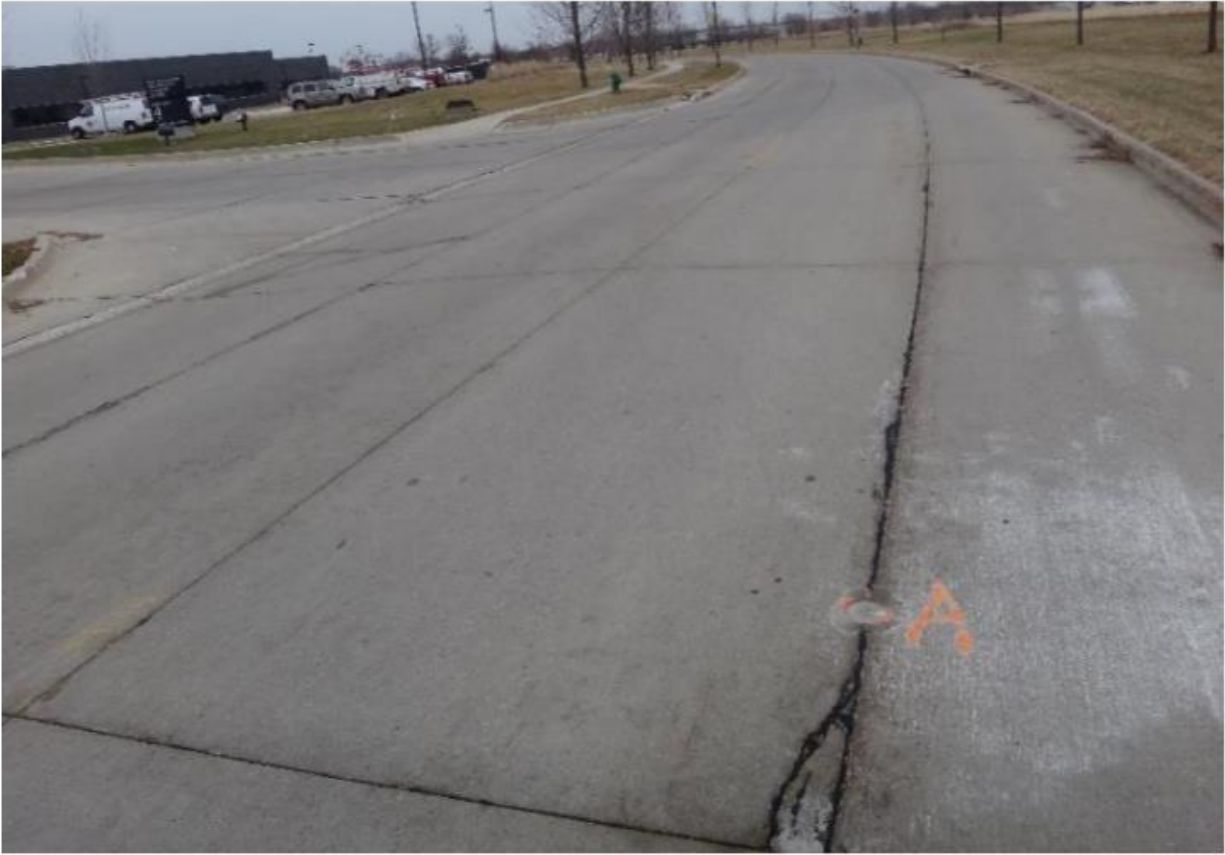
**Figure 2-1 A concrete pavement distressed early in its life cycle (Taylor et al., 2012).**

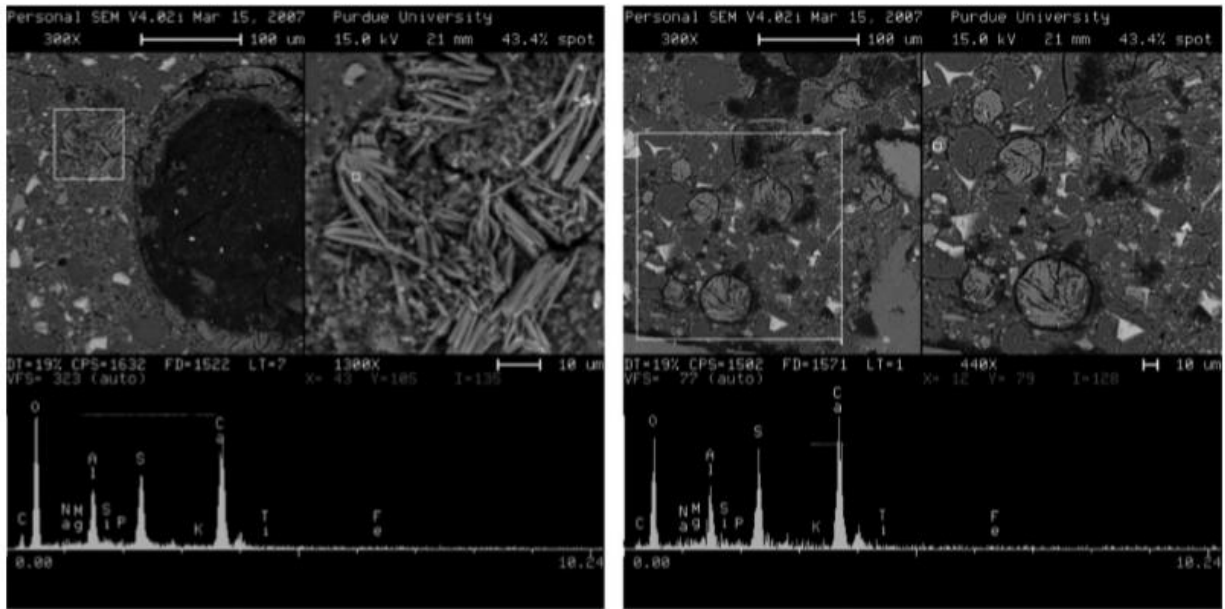
**Figure 2-2 Scanning Electron Microscopy image of damaged concrete core from a longitudinal joint with ettringite filling in the air void (left) and several air voids filled with ettringite (right), (del Mar Arribas- Colon, 2008)**

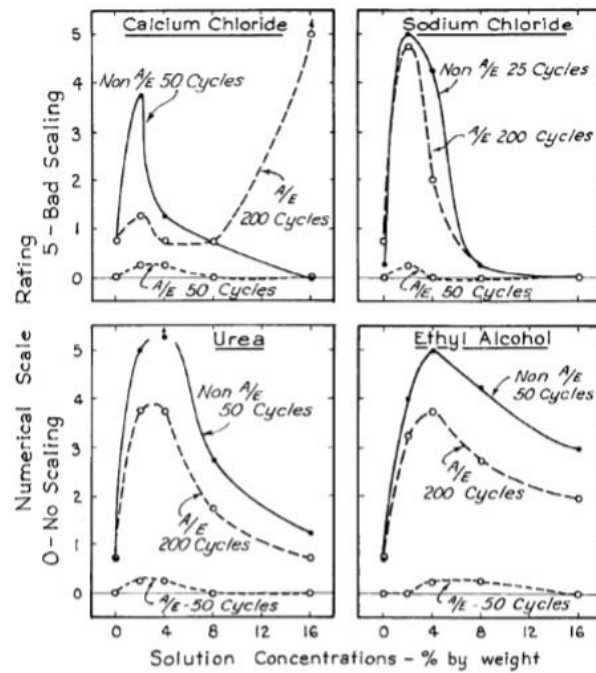
Figure 2-3 Damage from scaling of different solutions and different concentrations on air-entrained and non air-entrained concrete (Verbeck & Klieger, 1957)

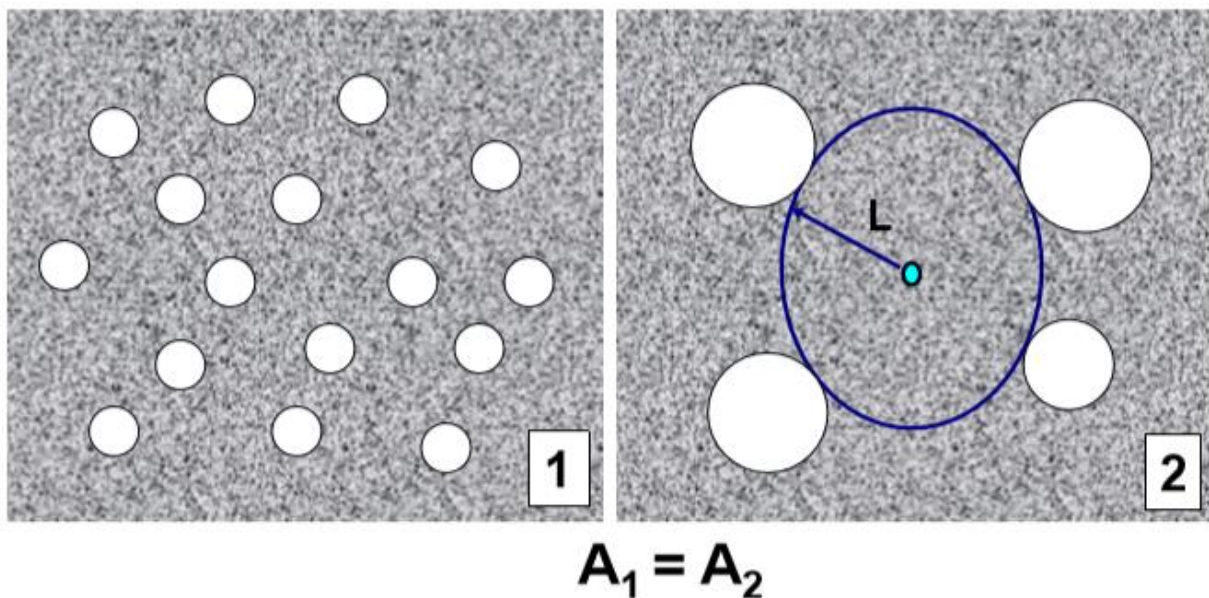
**Figure 2-5** Figure illustrating that if two concretes have the same air content but different sized air voids, that the spacing factor would be different. (Klieger, 1978)

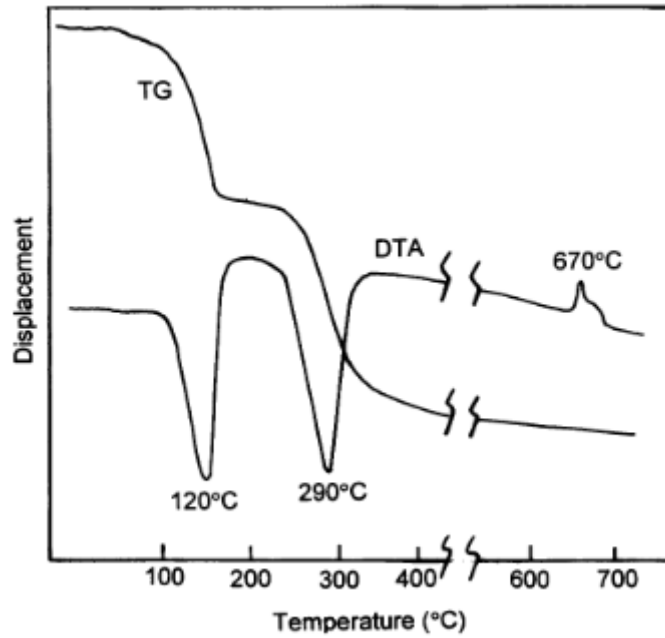
**Figure 2-6 TG and DTA curves for Friedel's salt (Birnin-Yauri & Glasser, 1998).**

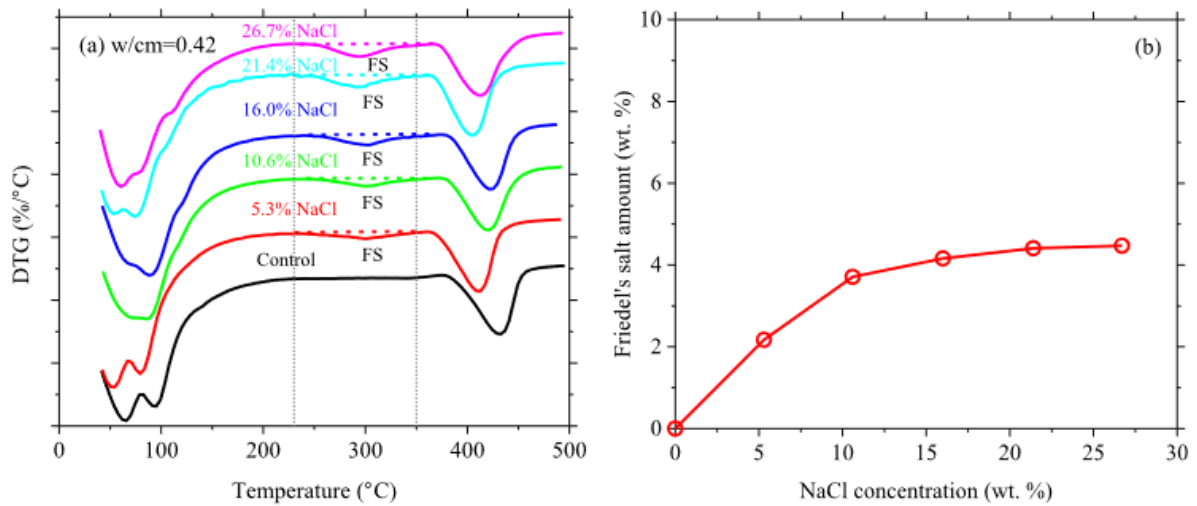
Figure 2-8 (a) DTG curves for cement pastes exposed to different sodium chloride concentrations, and (b) amount of Friedel's salt present given different sodium chloride concentrations (Qiao et al., 2018)

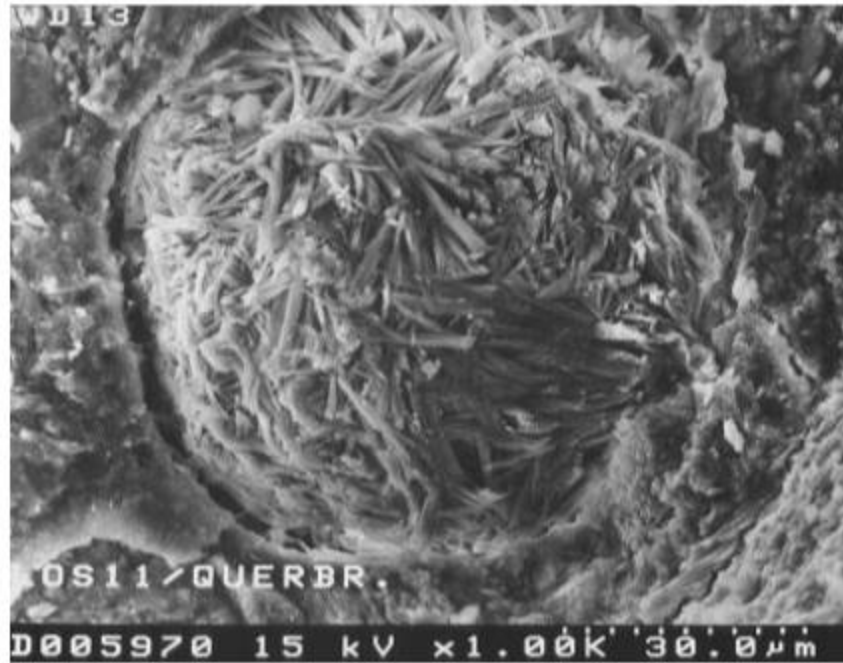
Figure 2-9 An air void in damaged concrete filled with ettringite (Stark & Bollman, 2000)

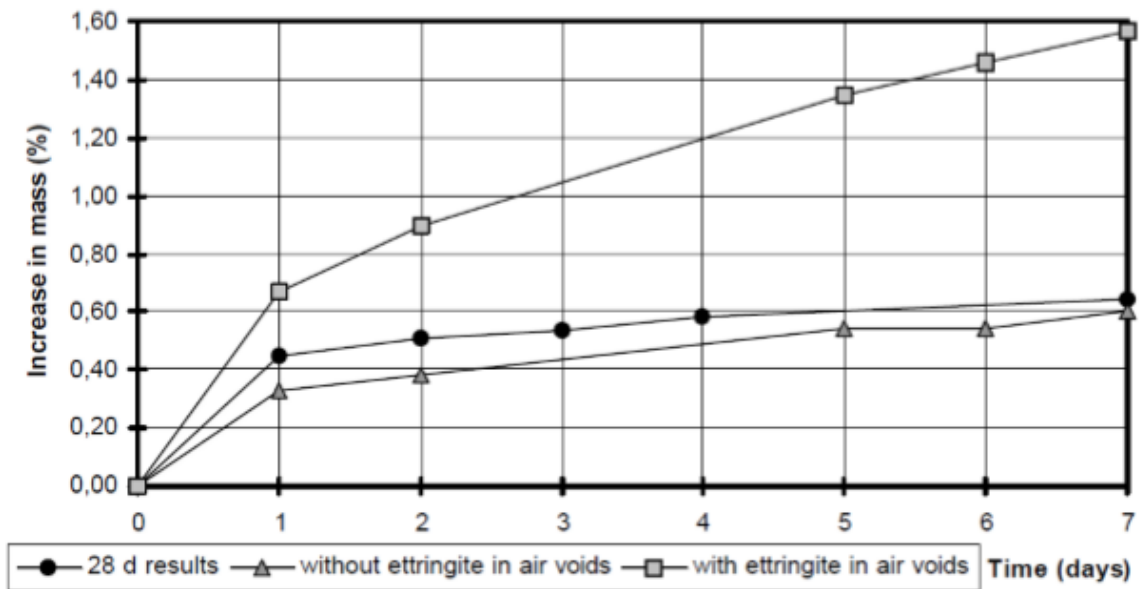
Figure 2-10 Effect of ettringite-filled voids on capillary suction (Stark & Bollman, 2000)

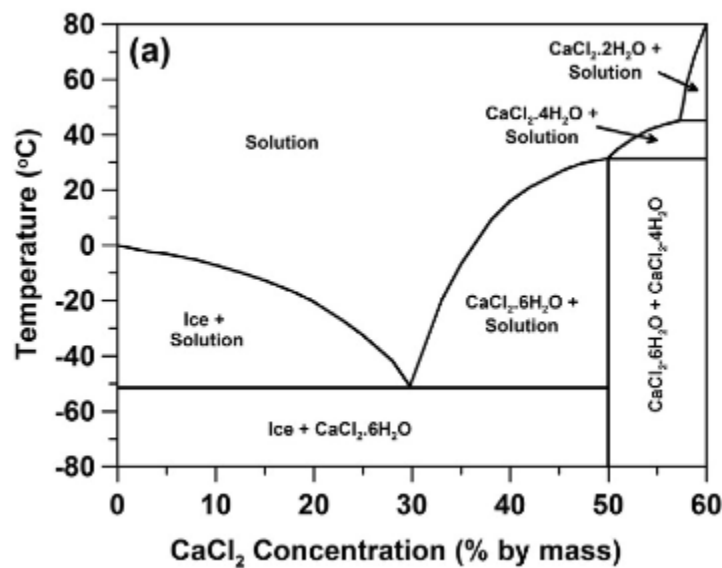
**Figure 2-11 Phase diagram for calcium chloride and water (Farnam et al., 2015b)**

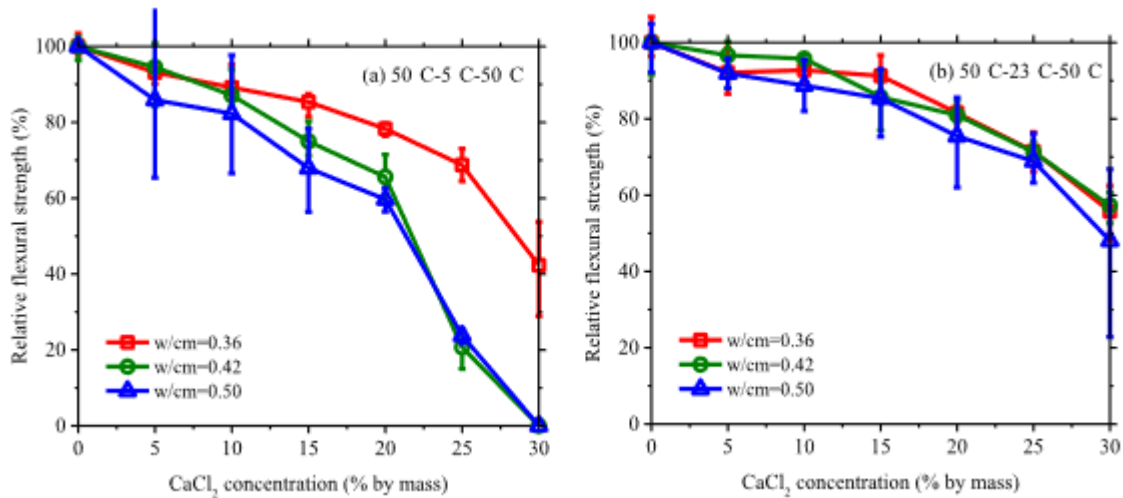
**Figure 2-12 Decreases in flexural strength (relative to control) of pastes exposed to different CaCl<sub>2</sub> concentrations and different temperatures (Qiao et al., 2018b)**

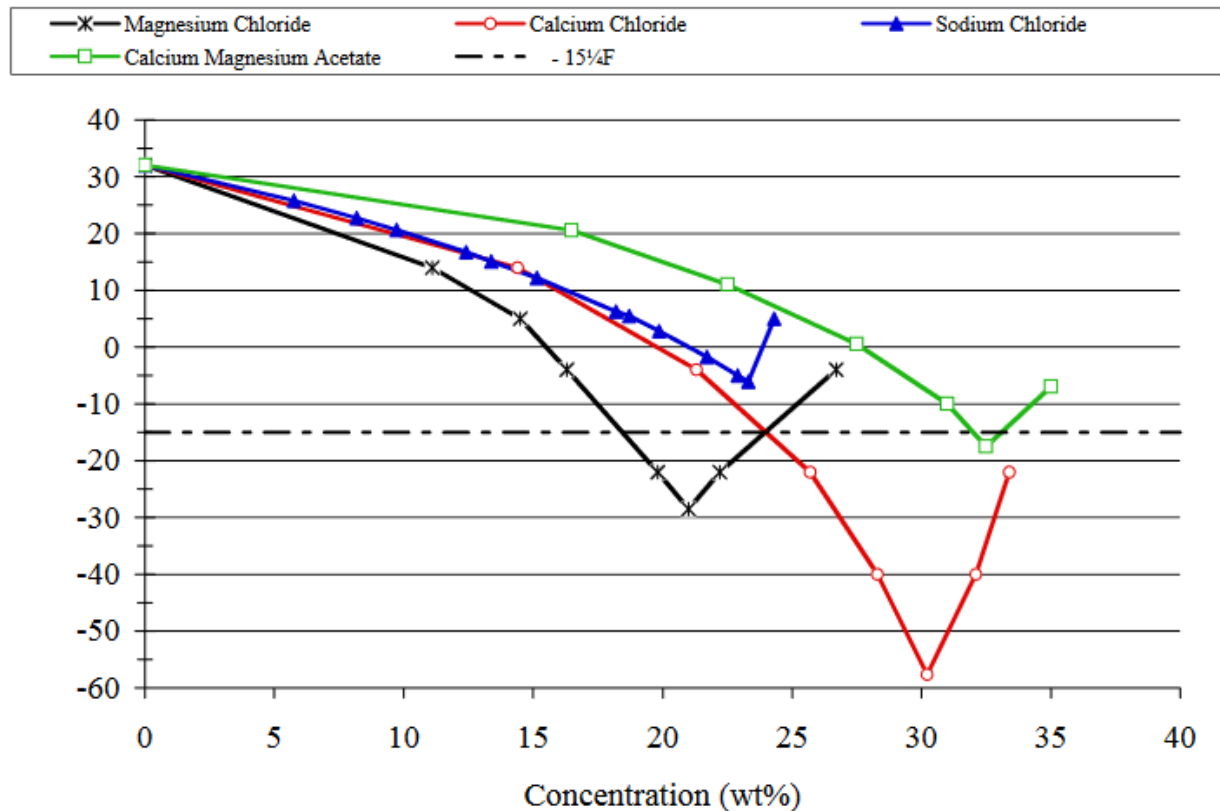
**Figure 2-14 Freezing temperatures (°F) of water with salts at different concentrations (Sutter et al., 2008).**

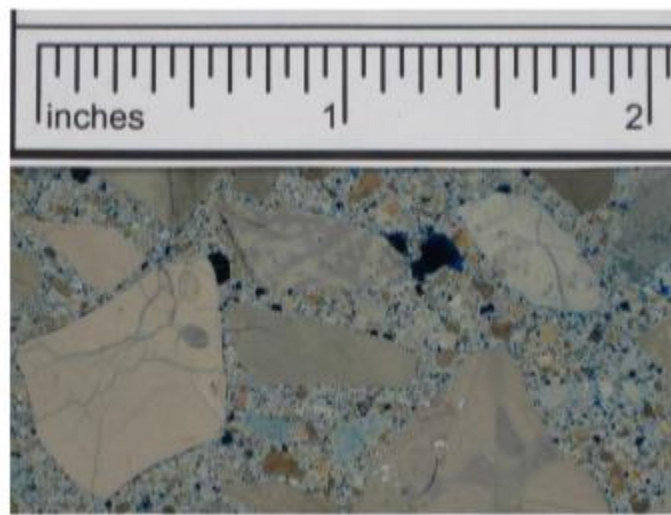
**Figure 2-15 Photo of concrete with cracked aggregate caused by D-cracking of susceptible aggregate caused by freeze-thaw cycles (Alexander & Mindess, 2014)**

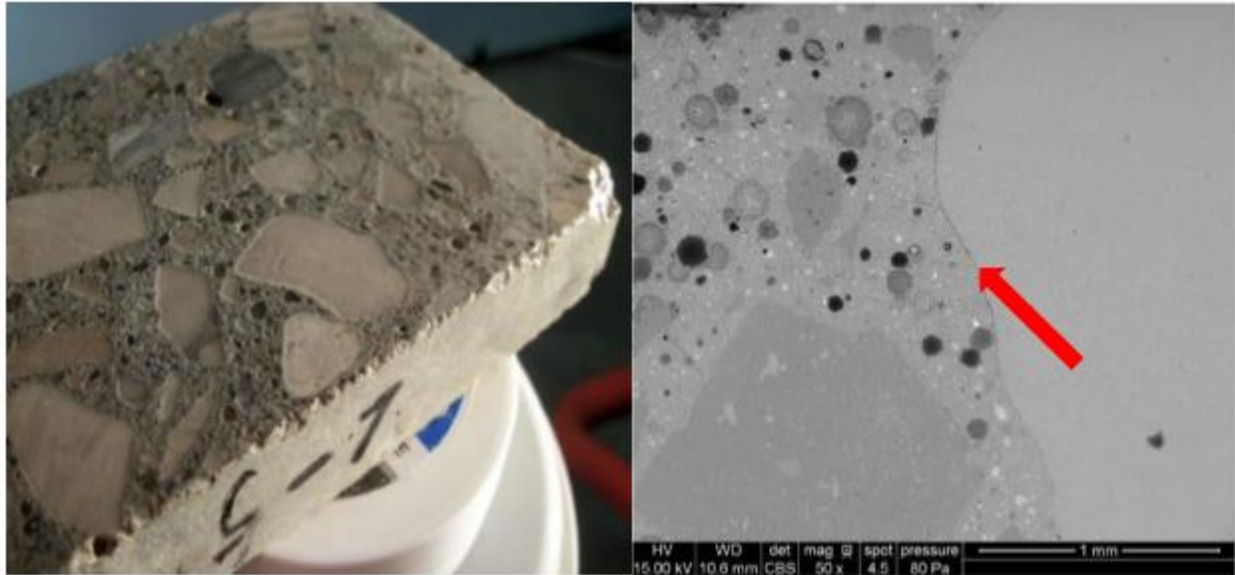
**Figure 2-16 Concrete sample soaked in  $\text{MgCl}_2$  solution for 56 days at 40°F (4.4 °C), with SEM image on the right. The paste expanded and an arrow is pointing to a crack in the SEM image (Taylor et al., 2016)**

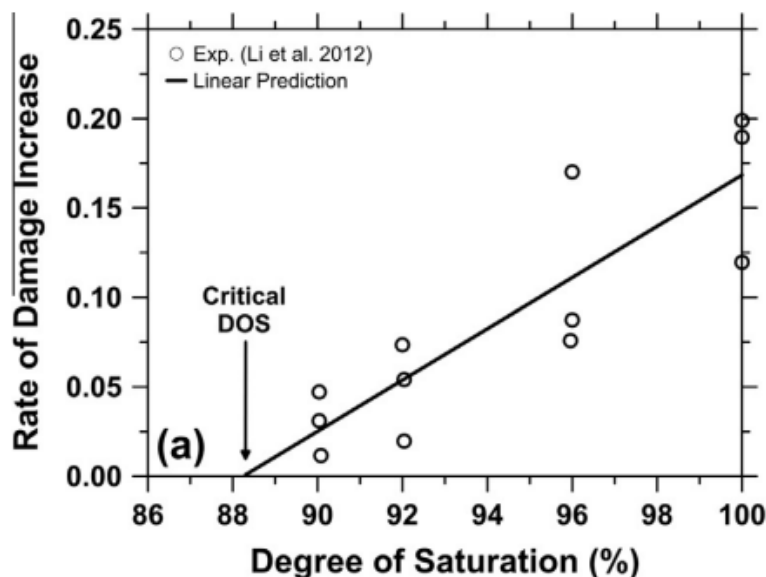
**Figure 2-17 The damage increases from freeze-thaw cycles (measured by decrease of dynamic modulus) with higher degree of saturation of concrete (Farnam et al., 2015c)**

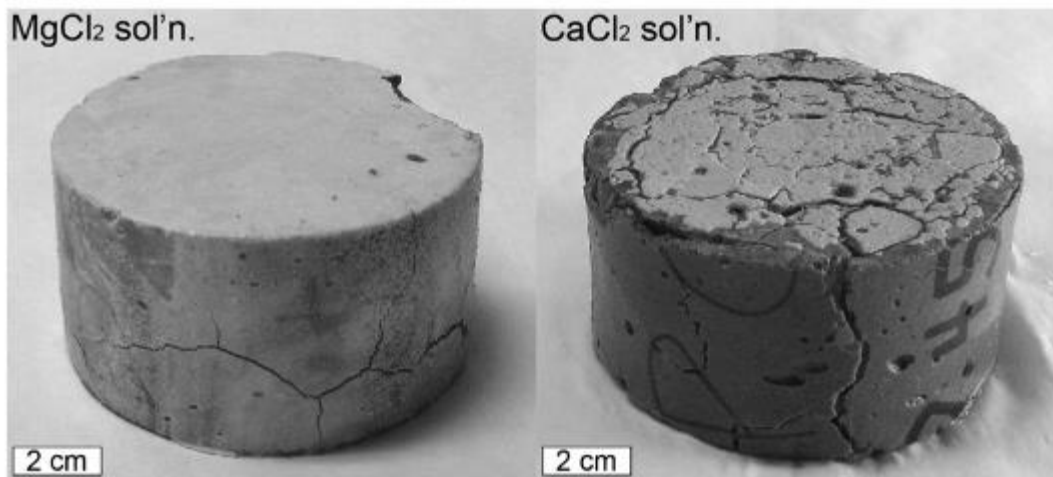
**Figure 2-18 Damage in concrete exposed to 15% MgCl<sub>2</sub> and 17% CaCl<sub>2</sub>, held at 4.4°C for 500 days (Peterson et al., 2013).**

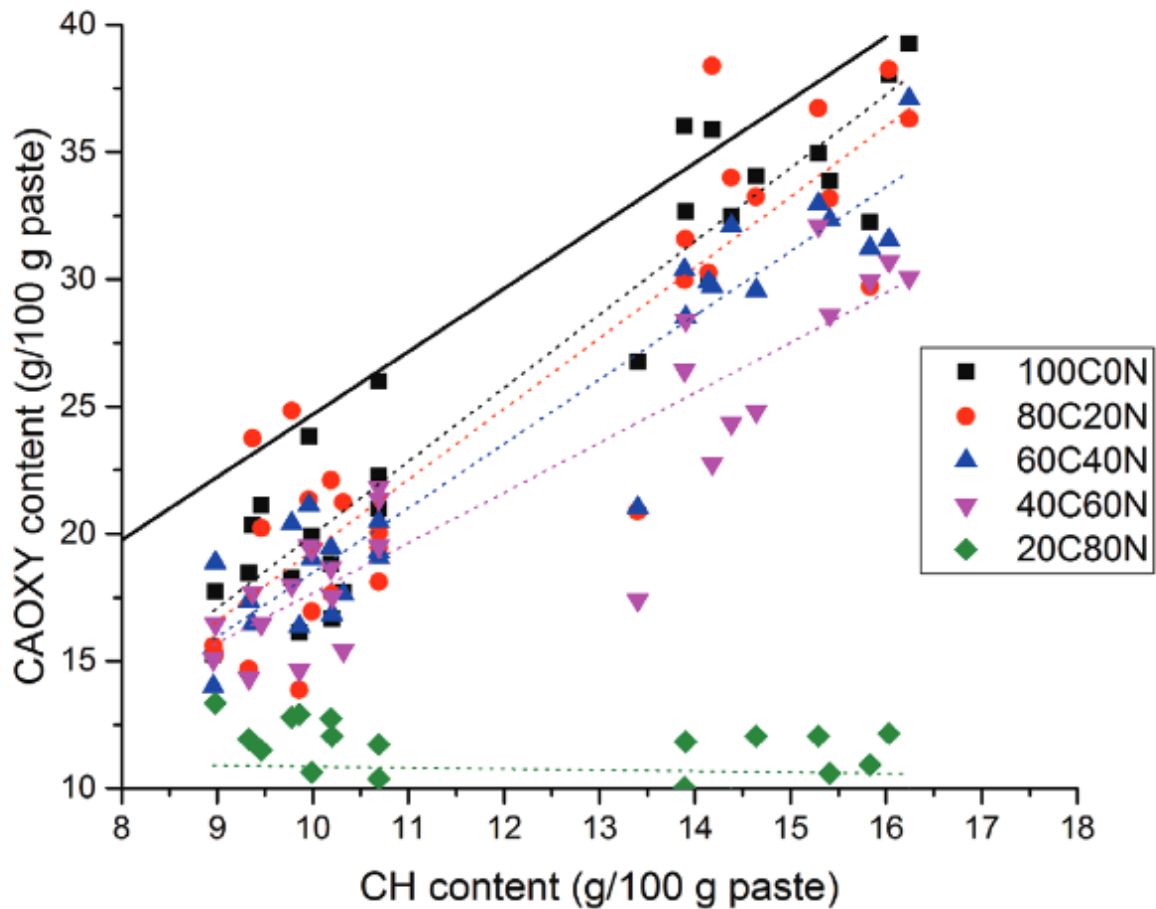
**Figure 2-19 Calcium oxychloride formation for different calcium hydroxide contents of cement paste (Suraneni et al., 2016)**

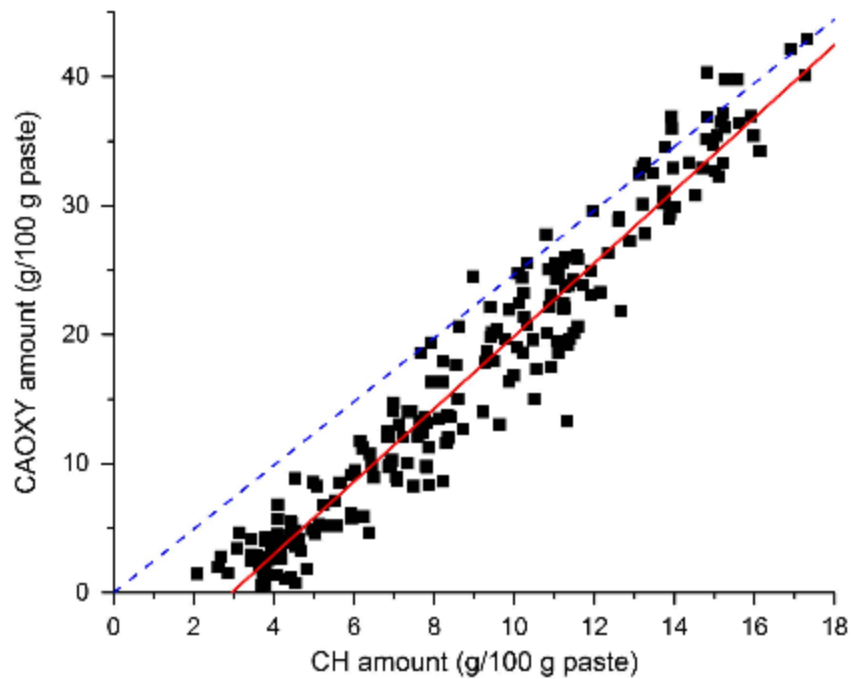
**Figure 2-20 Amount of calcium oxychloride present for pastes with differing amounts of calcium hydroxide present (Suraneni et al., 2018).**

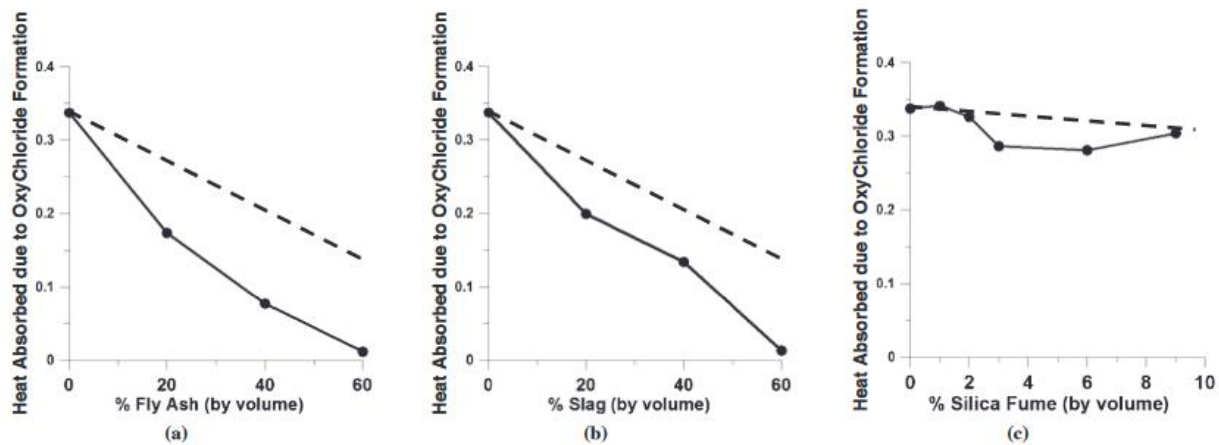
**Figure 2-21 Reduction of calcium oxychloride formation with increasing replacement of cement with SCM (a: fly ash, b: slag, c: silica fume). The dashed line represents the expected drop in calcium oxychloride formation from just dilution of cement, the solid line captures this effect plus the additional reduction of available calcium hydroxide (Monical et al., 2013).**

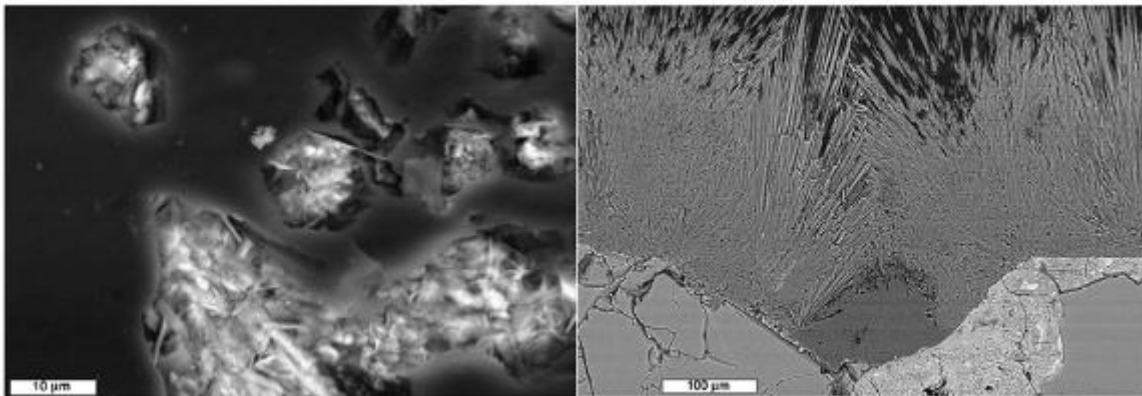
**Figure 2-23 BSE image of calcium oxychloride hydrate,  $\text{CaCl}_2\cdot\text{Ca}(\text{OH})_2\cdot 2\text{H}_2\text{O}$  (left) and magnesium oxychloride hydrate crystals (right) near brucite (Peterson et al., 2013).**

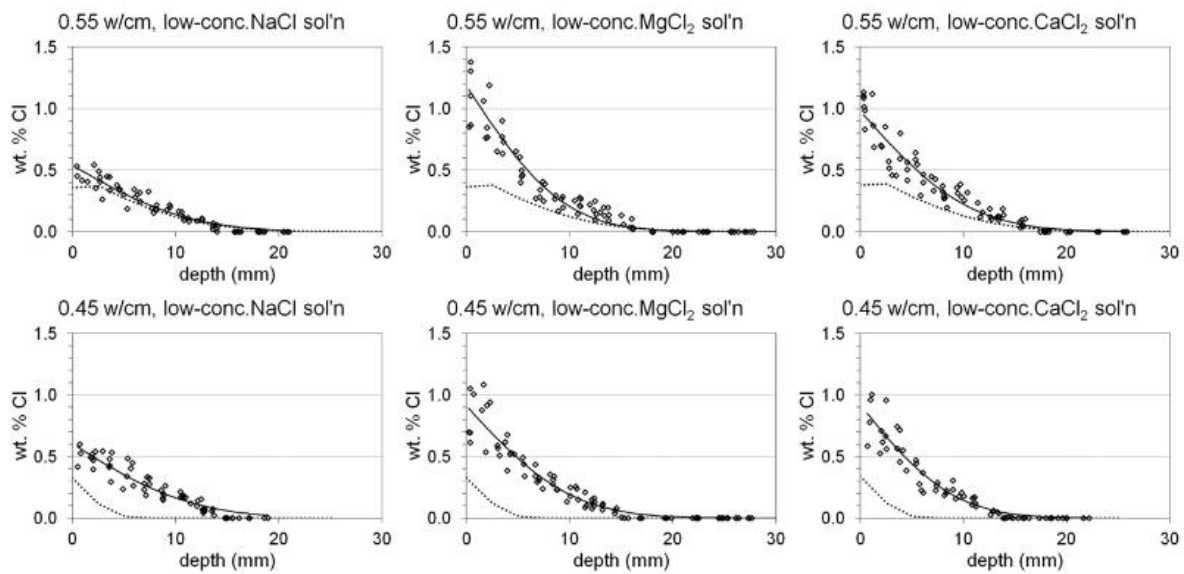
**Figure 2-24 Chloride penetration depth of mortar samples soaked in low concentration (7.3% NaCl, 7.3%  $\text{CaCl}_2$ , 6.2%  $\text{MgCl}_2$ ) salt solutions (Peterson et al., 2013)**

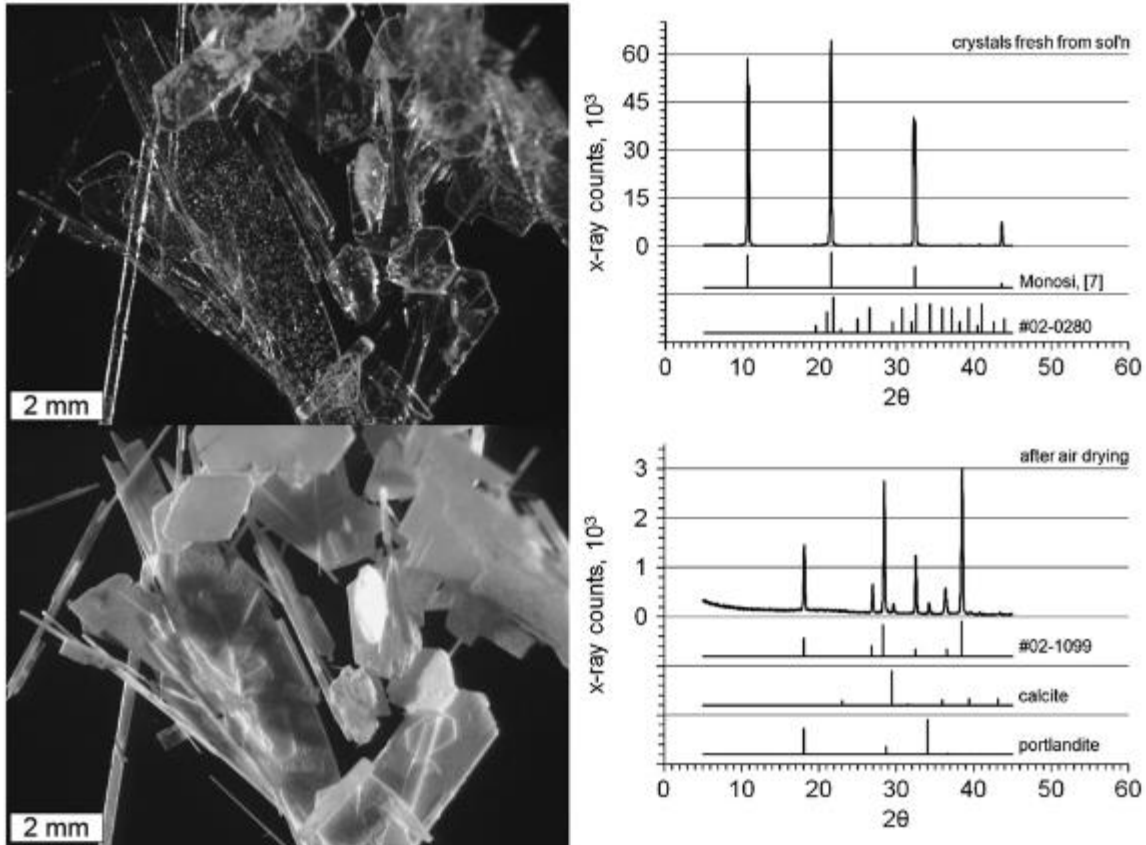
**Figure 2-26 Stereoscopic images and XRD data of the hydrated calcium oxychloride phase (top) and dehydrated calcium oxychloride phases after drying. Some calcite and portlandite were also formed in the drying process (Peterson et al., 2013)**

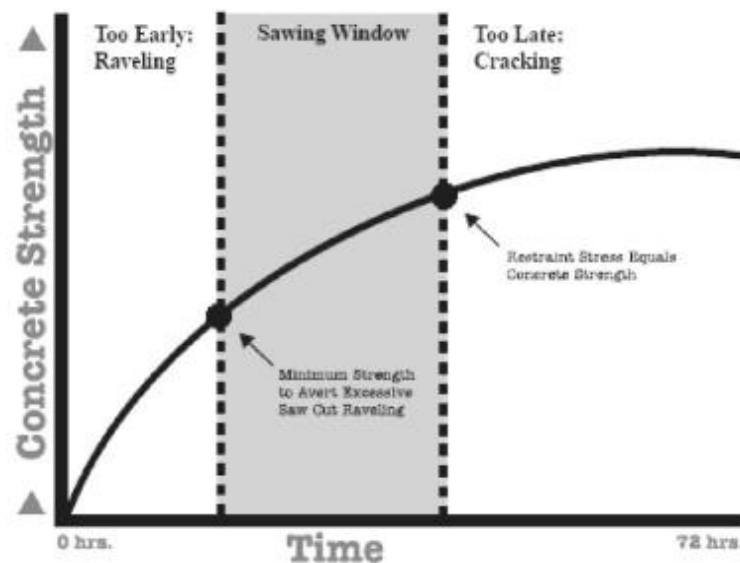
Figure 2-27 The effect of the time of saw cutting on ravelling and cracking (Iowa State University, 2004)

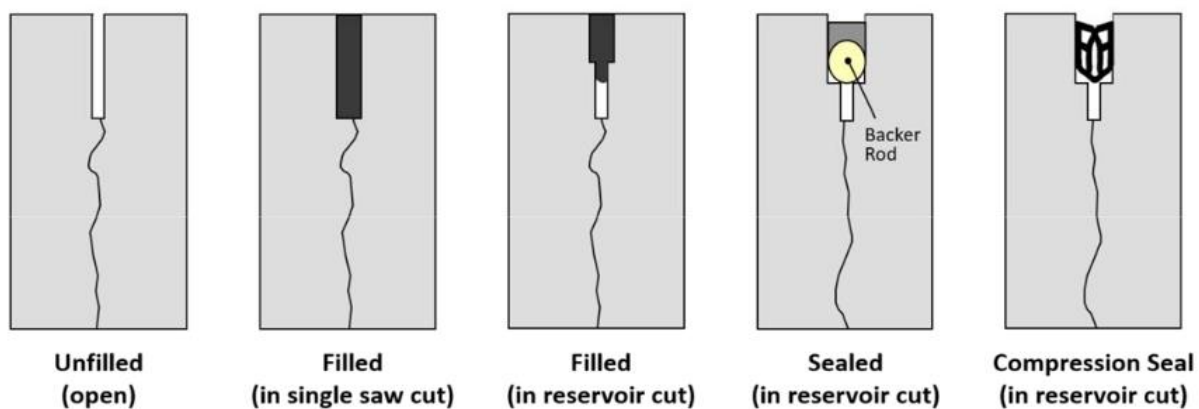
**Figure 2-28 Diagram of different type of joint sealants for joints in concrete pavements (American Concrete Pavement Association, 2018)**

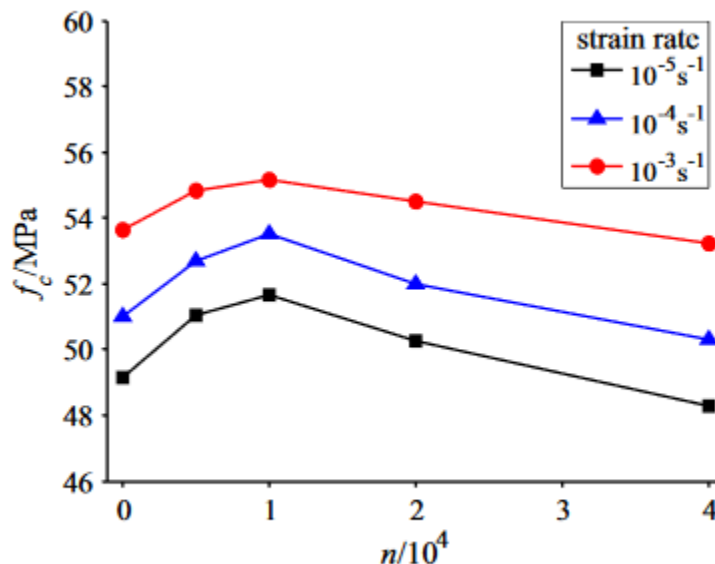
**Figure 2-29 Concrete's compressive strength after having experienced different amounts of fatigue loading cycles (Lu et al., 2017)**

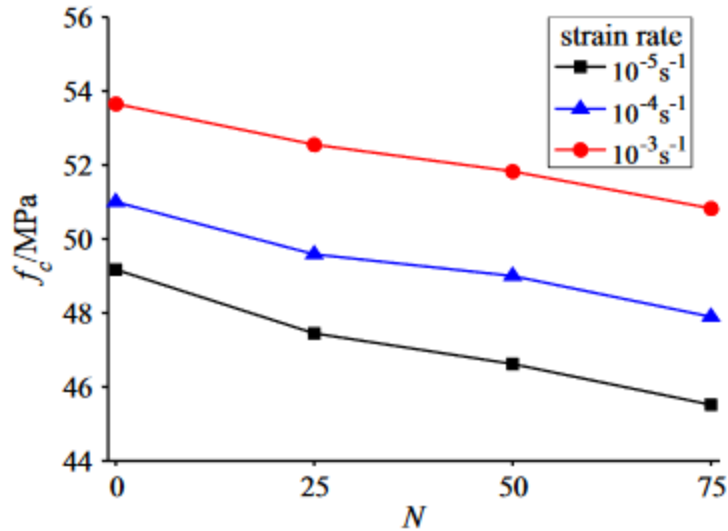
**Figure 2-30 Concrete's compressive strength after undergoing different amounts of freeze-thaw cycles (Lu et al., 2017)**

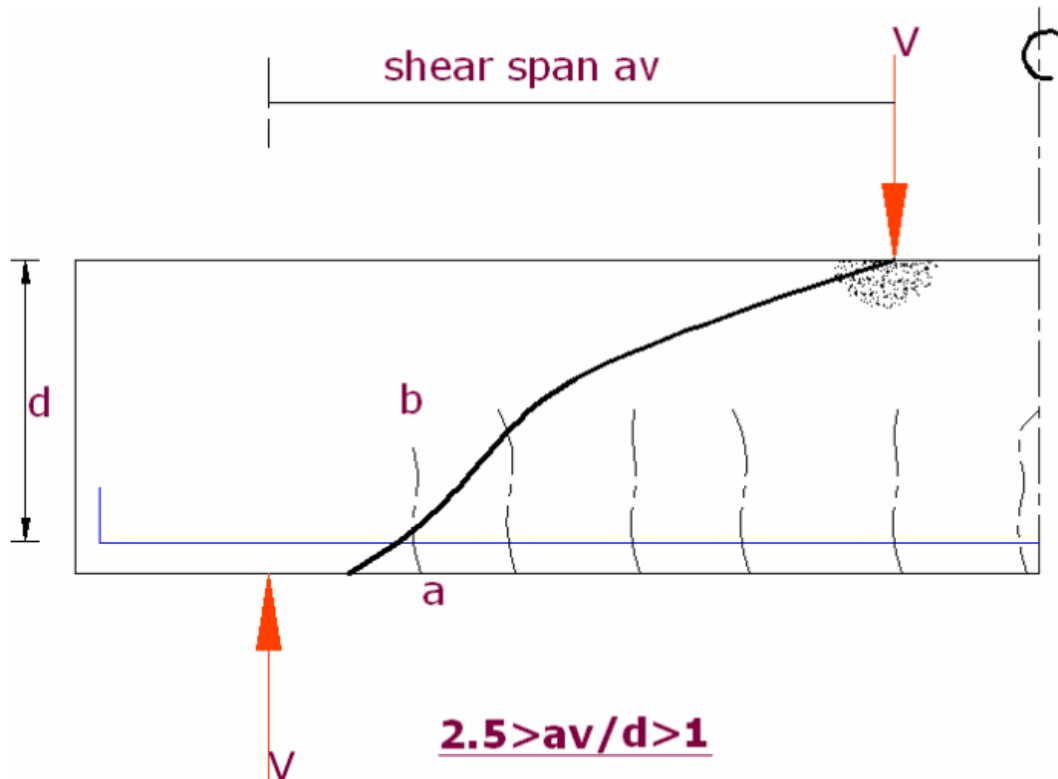
**Figure 2-32 Schematic of shear compression failure in a deep beam, with crushed concrete at the load point (Osman, 2008).**

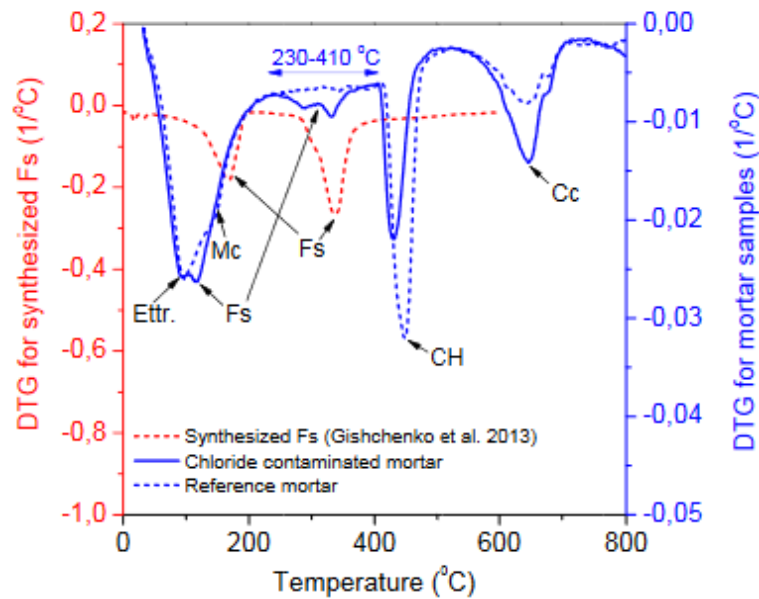
**Figure 2-33 TGA test results showing DTG curves for identifying ettringite and Friedel's salt (Shi et al., 2017).**

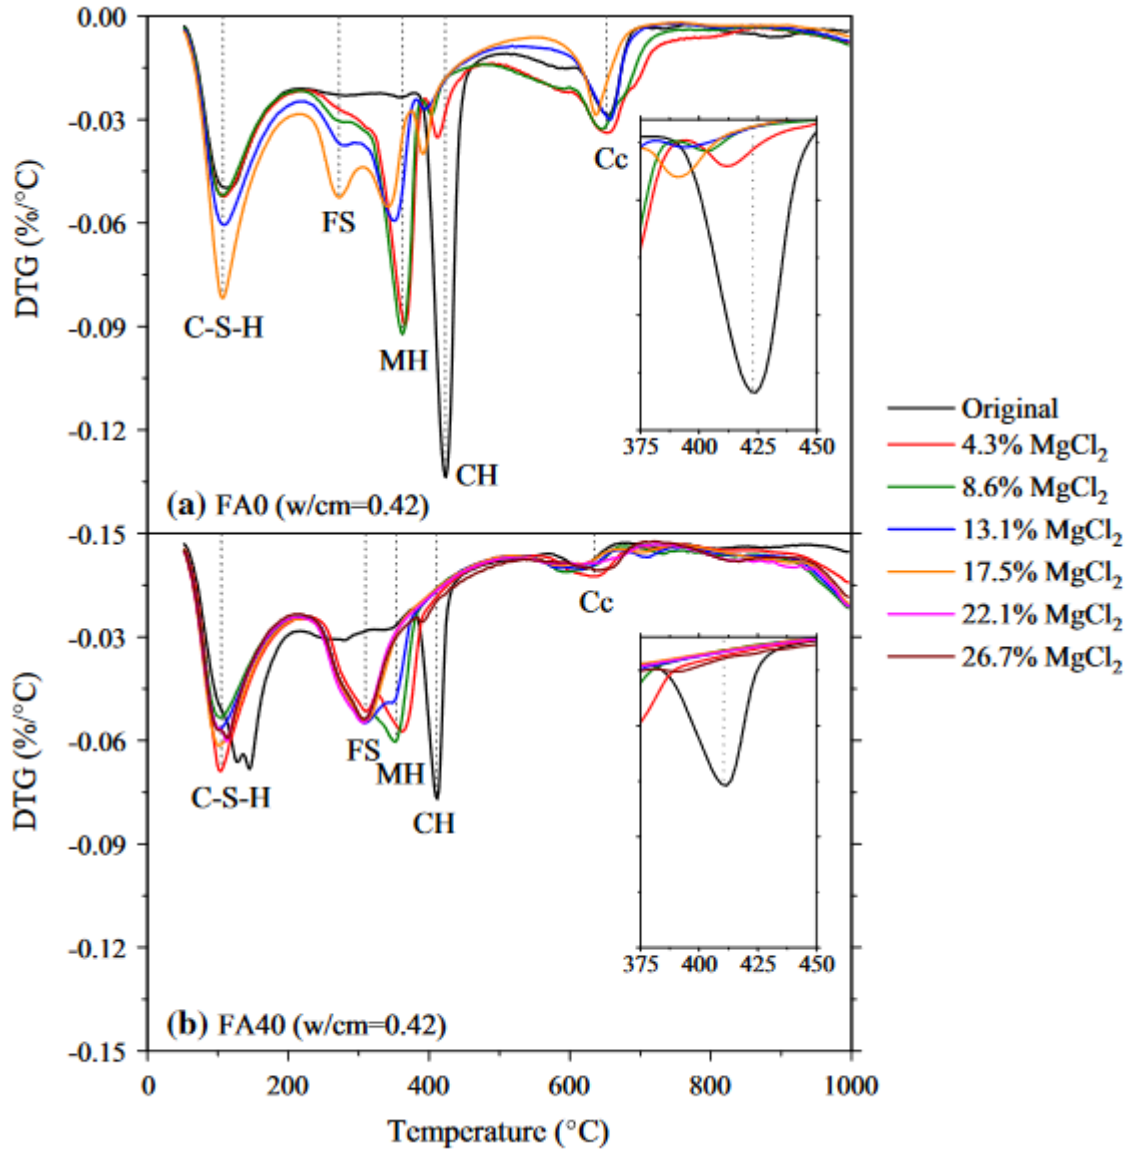
Figure 2-34 DTG curves of concrete exposed to  $\text{MgCl}_2$  solution. CSH: calcium silicate hydrate. MH:  $\text{Mg(OH)}_2$ . CH:  $\text{Ca(OH)}_2$ . FS: Friedel's salt. Cc:  $\text{CaCO}_3$ . (Qiao et al., 2018c)

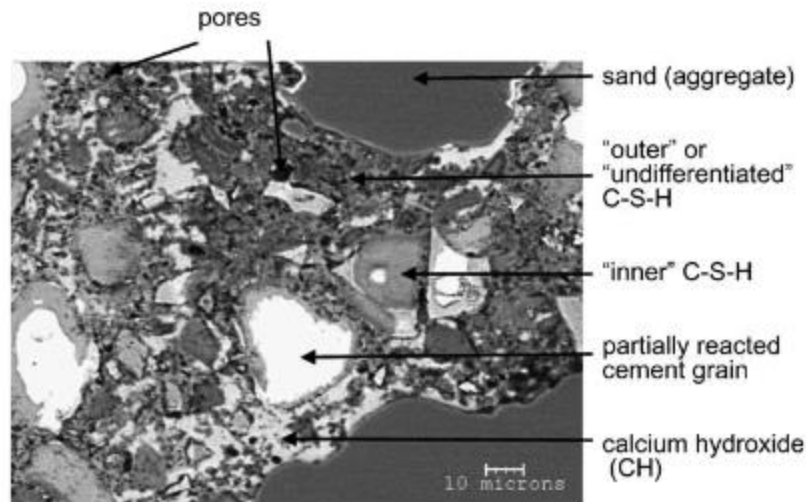
**Figure 2-35 Image of Portland cement mortar from BSE (Scrivener, 2004)**

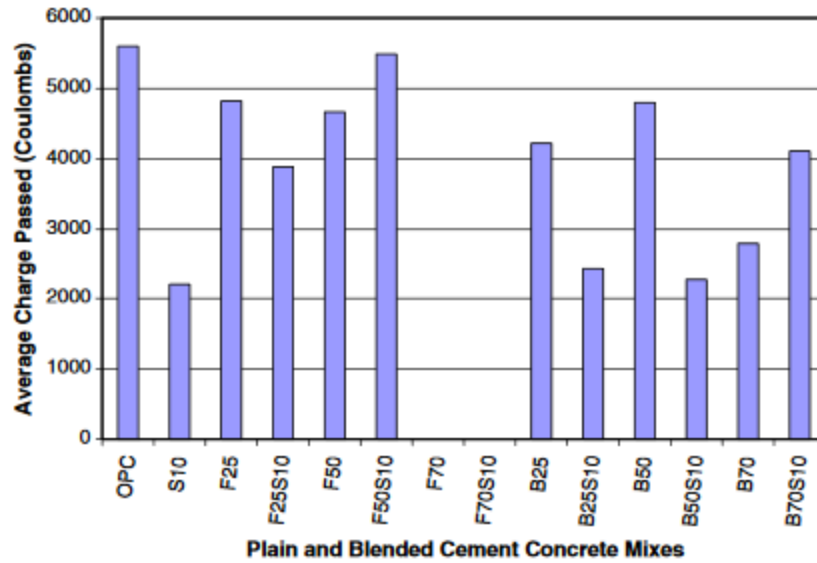
**Figure 2-37 Results of average charge passed during RCPT test of Ordinary Portland Cement (OPC) and other cement blends (F = fly ash, S = silica fume, B = blast furnace slag) (Ahmed et al., 2008)**

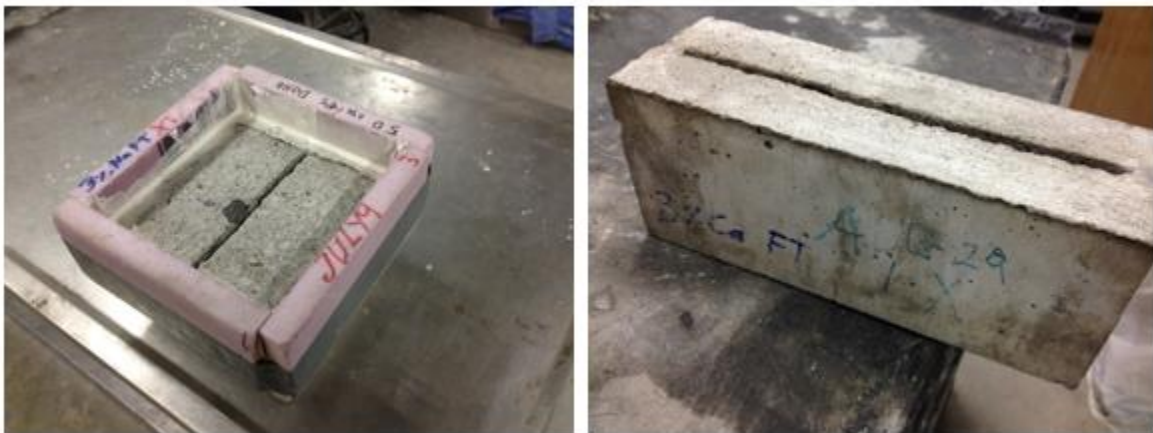
**Figure 3-1 The two types of slabs used in the experiment: square slabs, 200 mm x 200 mm 120 mm (left) and rectangular slabs, 300 mm x 100 mm x 120 mm (right).**

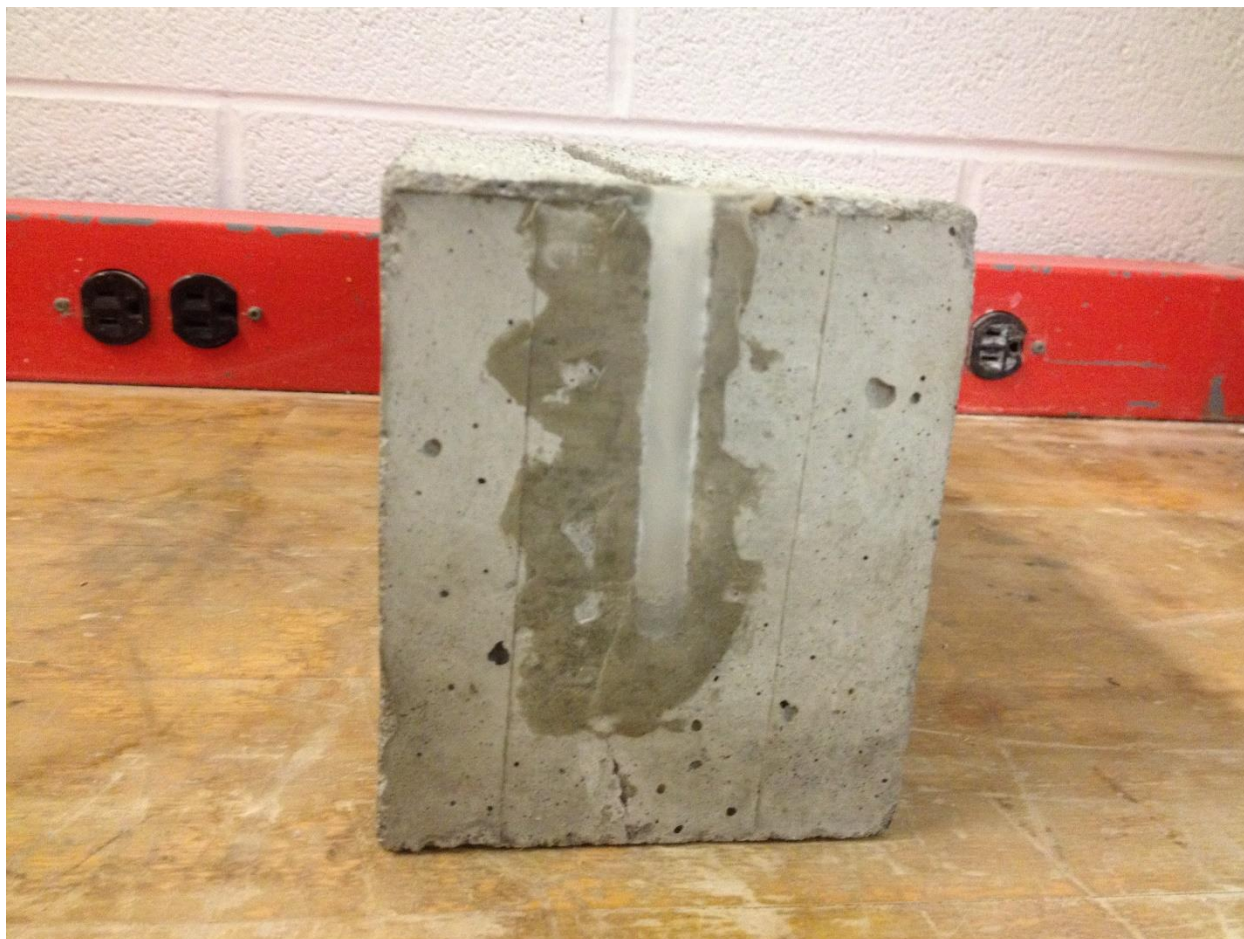
**Figure 3-2 A rectangular slab with a sealed joint to prevent leaking of salt solution.**

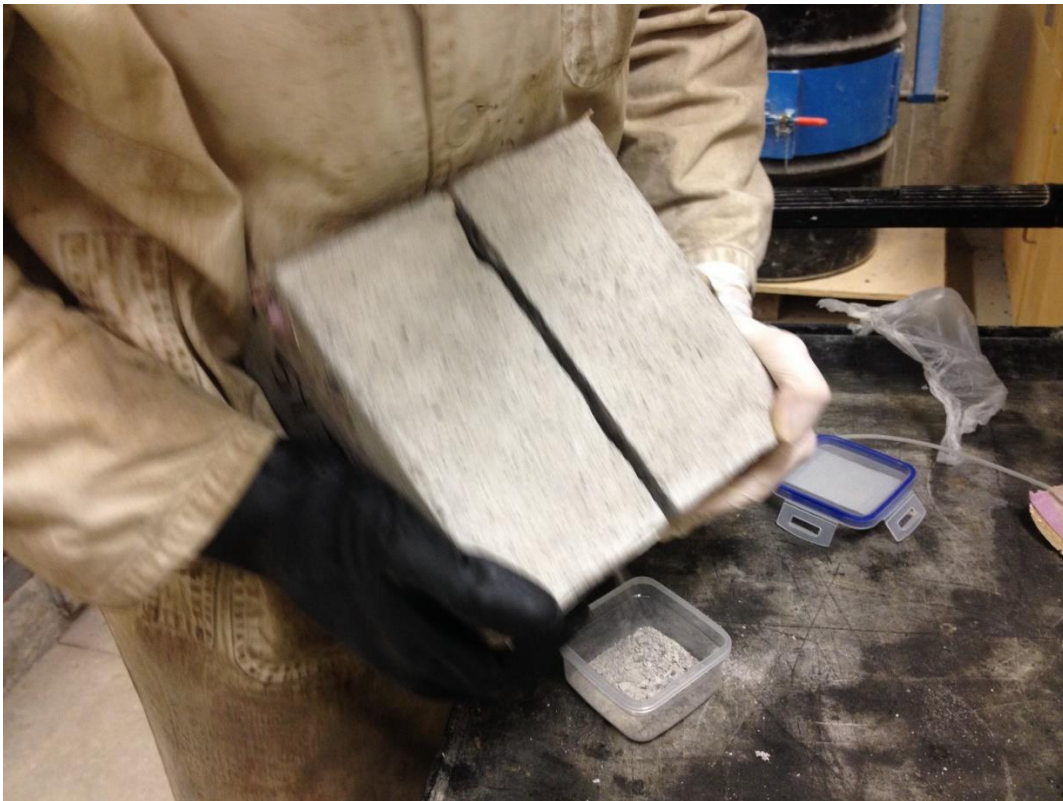
**Figure 3-3 Removing material from inside the joint of a concrete slab and collecting it inside a container.**
