DEVELOPMENT OF A TEST METHOD TO EVALUATE DURABILITY OF PAVEMENT JOINTS UNDER  
WINTER CONDITIONS

A thesis

in partial fulfilment of the  
requirements for the degree of  
Master of Applied Science  
in the program of  
Civil Engineering

Toronto, Ontario, Canada, 2019

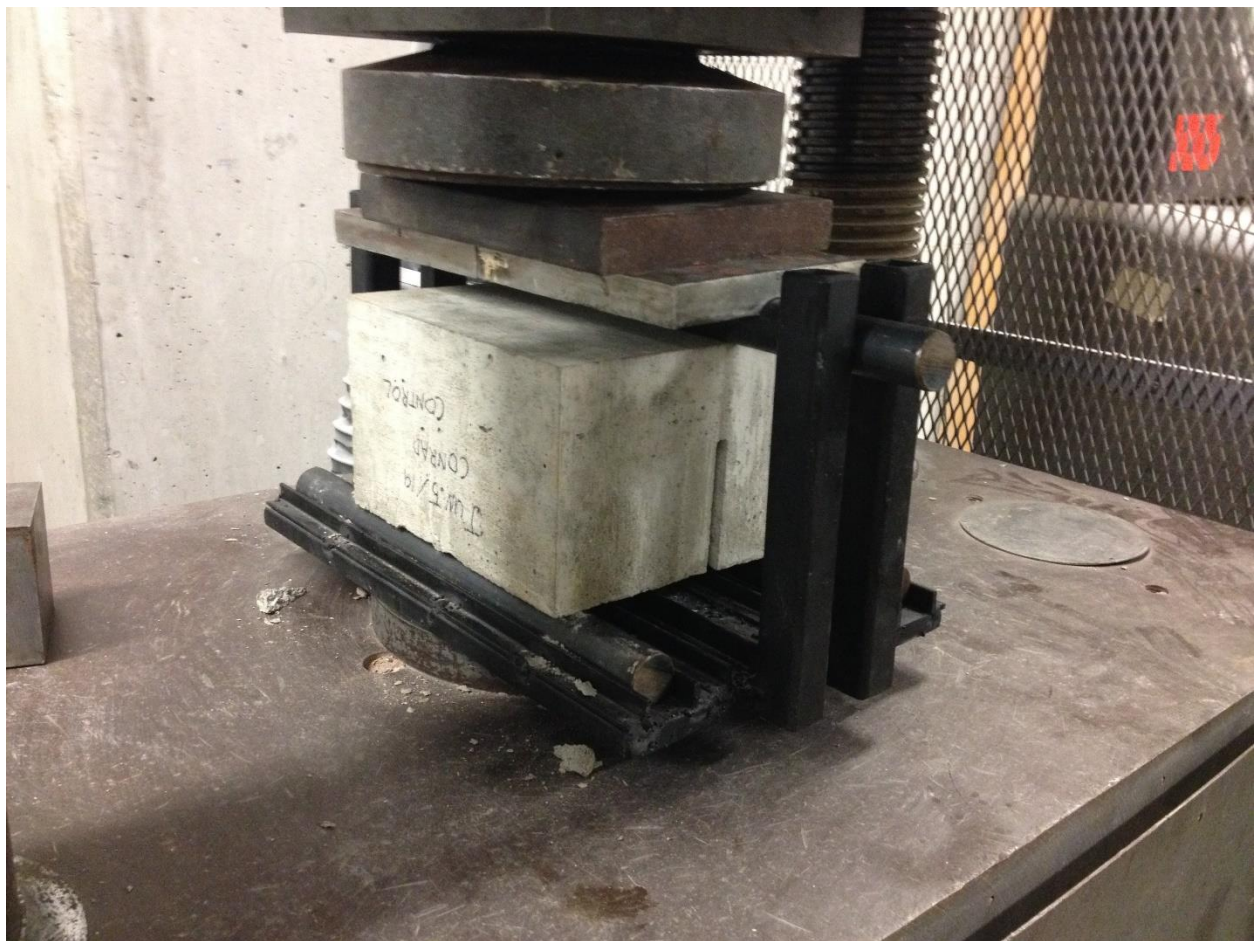
**Figure 3-4 Square slab in the designed loading setup with adjustable rollers to load both the square and the rectangular slabs.**

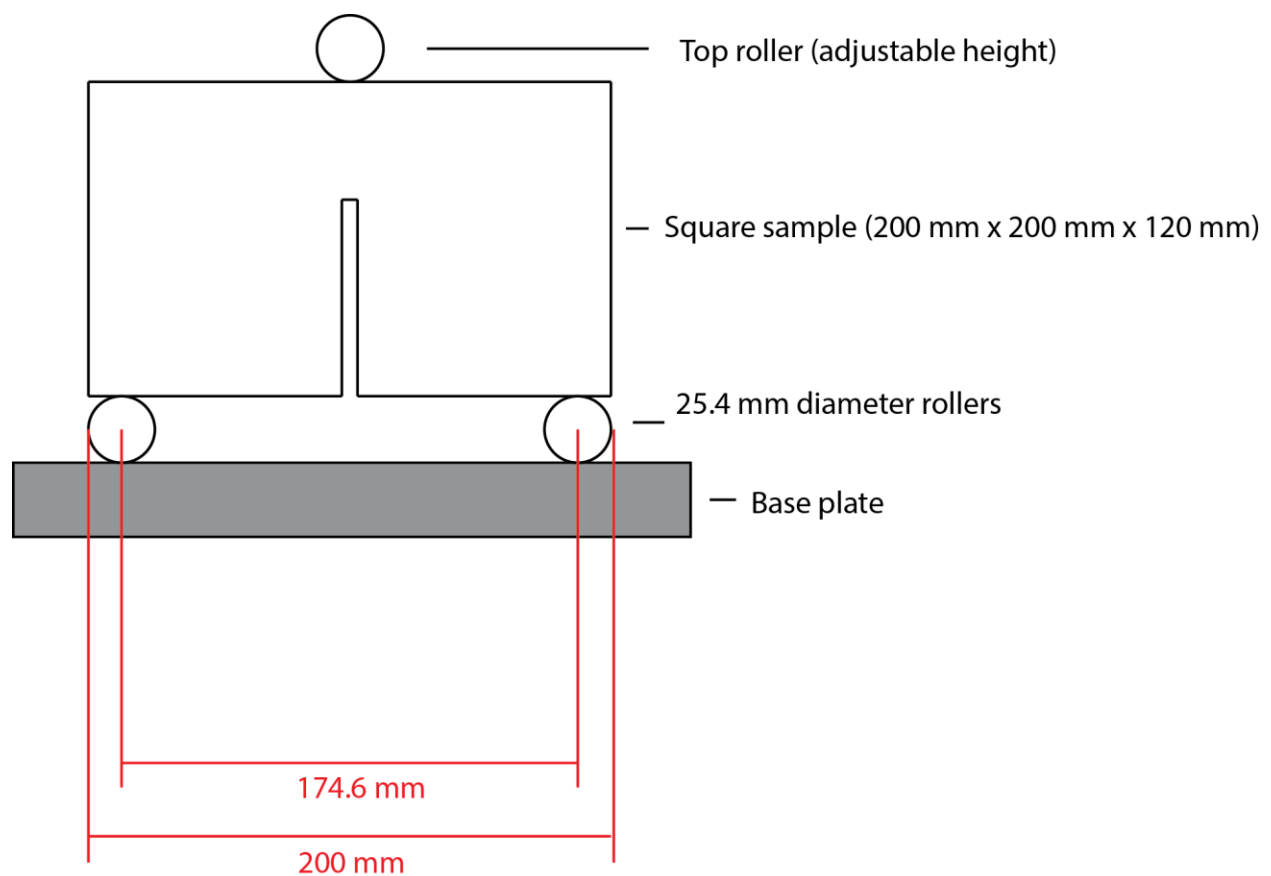
**Figure 3-5 Cross-sectional view of sample loading setup.**

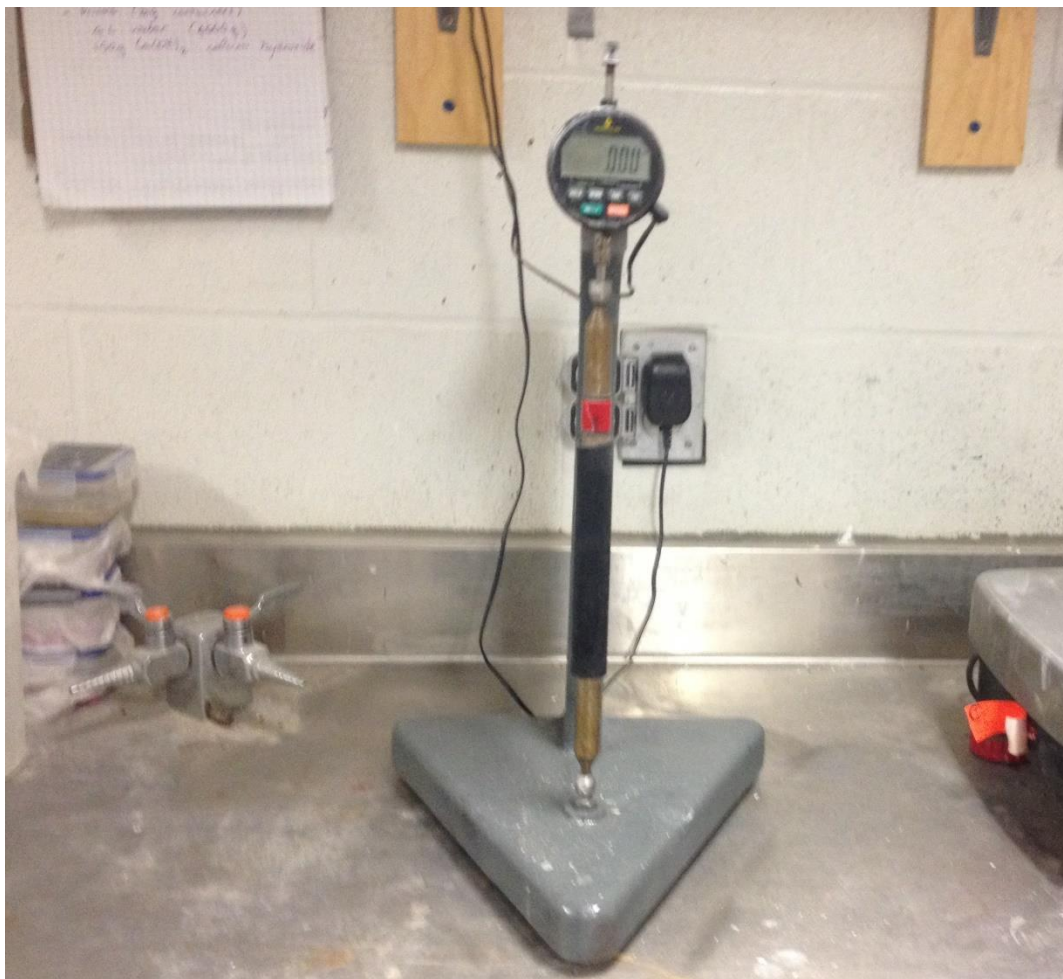
**Figure 3-6 The Humboldt Length Comparator H-3250D with a comparator rod in place, used for measuring length changes of prisms.**

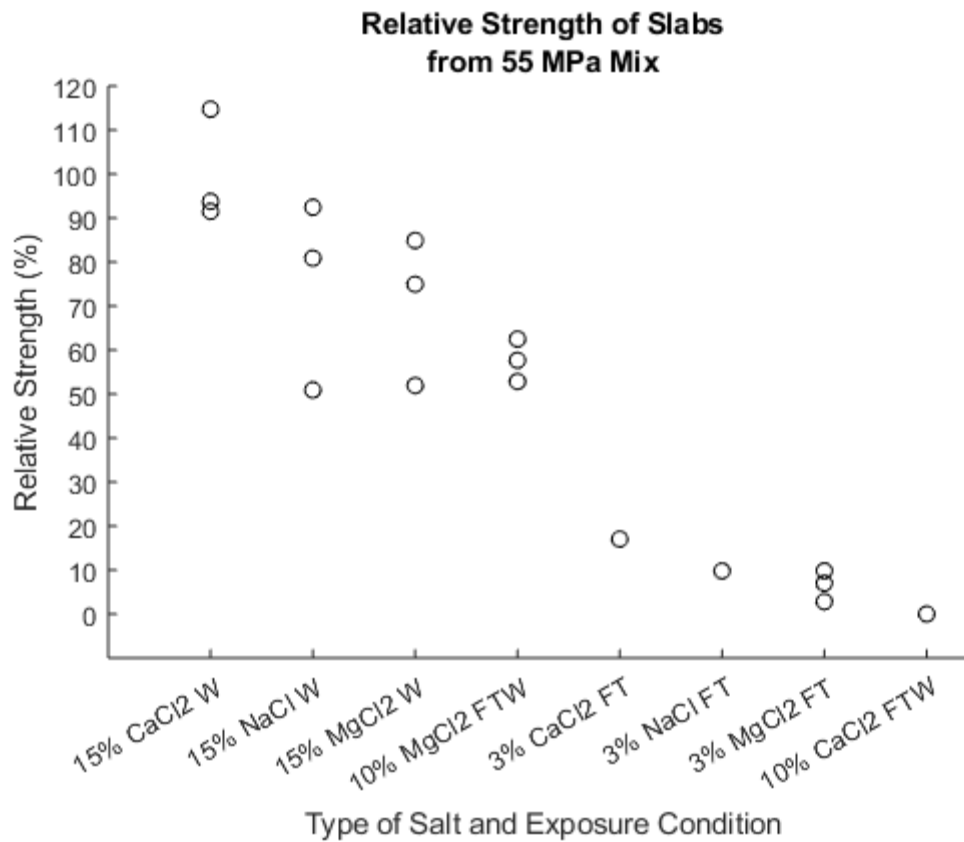
**Figure 4-1 Relative strength of different salt solutions and cyclical exposures for the three different concrete mixes used: (a) the 45 MPa mix, (b) 30 MPa mix, and (c) 55 MPa mix. Each sample consisted of 3 specimens**

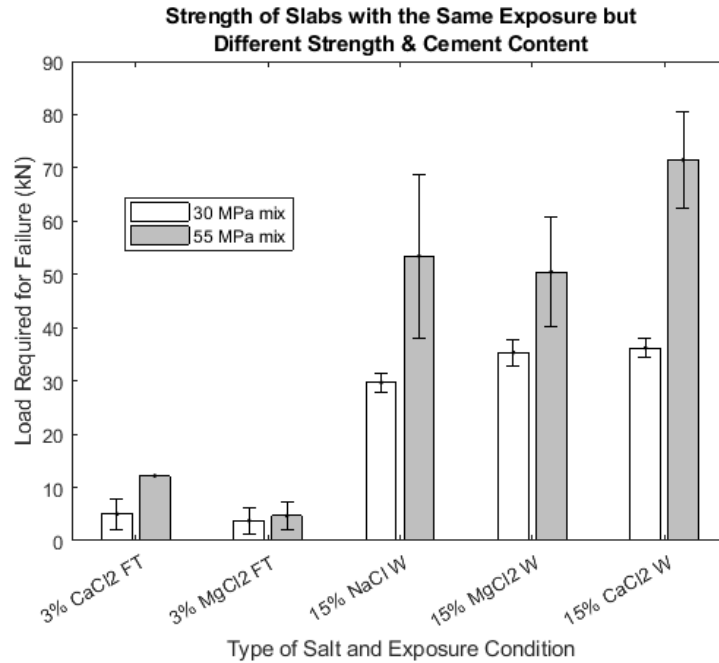
**Figure 4-2 Comparative average strength (of 3 specimens per sample) under the same cyclical exposure but having different cement contents. Error bars represent one standard deviation.**

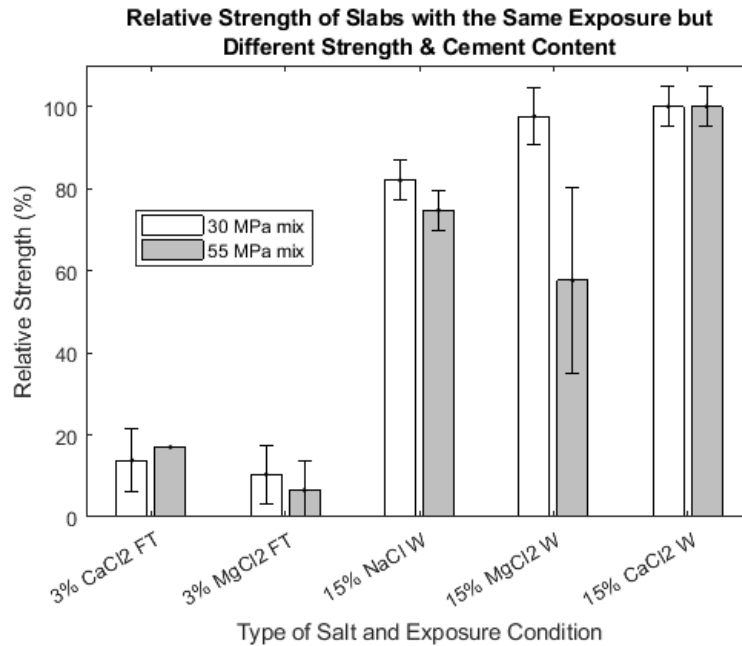
**Figure 4-3 Comparative average strength (of 3 specimens per sample) under the same cyclical exposure but having different cement contents. Error bars represent one standard deviation.**

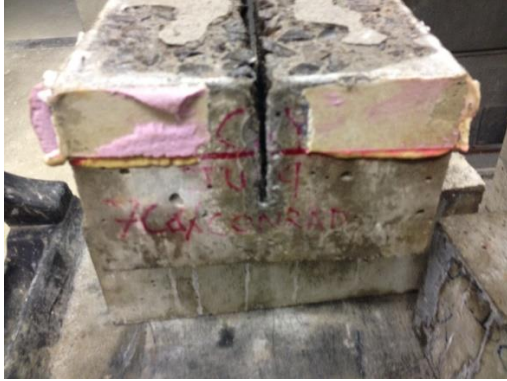
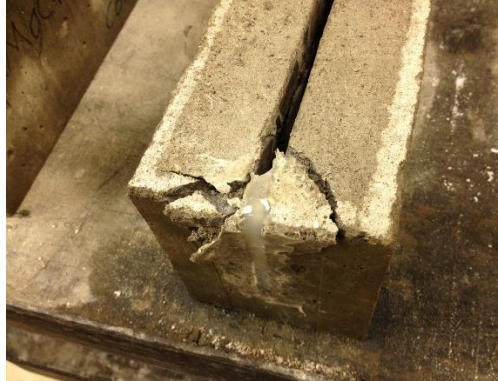
**Table 4-10 Comparisons between 10% CaCl<sub>2</sub> FTW samples of different mixes/ cement contents.**

<b>10% CaCl<sub>2</sub> FTW – 350 kg/m<sup>3</sup> Cement Content (45 MPa Mix)</b>	<b>10% CaCl<sub>2</sub> FTW – 270 kg/m<sup>3</sup> Cement Content (55 MPa Mix)</b>
<b>% Cement replaced with slag</b>	30	0
<b>Sample Strength</b>	13.8 kN	0 kN (sample fell apart before 50 cycles completed)
<b>28-day Compressive Strength of Cylinders with no Exposure</b>	47.2 MPa	53.12 MPa
<b>Picture of Sample after 50 Cycles</b>

Firstly, the difference in the damage observed can be attributed to the difference in cement content, and the presence of slag: less Portland cement and more slag both decrease the damage from CaCl<sub>2</sub> exposure. This is due to less calcium hydroxide in the system due to less Portland cement, and consumption of calcium hydroxide by the reaction of slag.

The results of this experiment gave rise to a very important finding for using bending strength of the tested slabs as a means of evaluating concrete pavement joint deterioration. The recorded strength values for the 55 MPa mix samples was 0, because the samples were so deteriorated that they could not be tested, but the strength of the 45 MPa mix samples was very high, despite evidence of damage and scaling at the surface. This shows that the proposed evaluation

technique is promising at capturing the deterioration of the concrete joints (as it was seen to be in the case with the 55 MPa mix samples). Some damage had taken place in the 45 MPa mix samples, which were more resistant to damage, but their strength was not greatly affected. If more cycles had taken place, more deterioration would have happened, and the test could capture the damage that would happen. Concrete mixes that are more resistant to damage require more exposure. However, the test duration seems appropriate because if the cycles were extended, more damage would take place and it might not have been able to discriminate between different mixes.

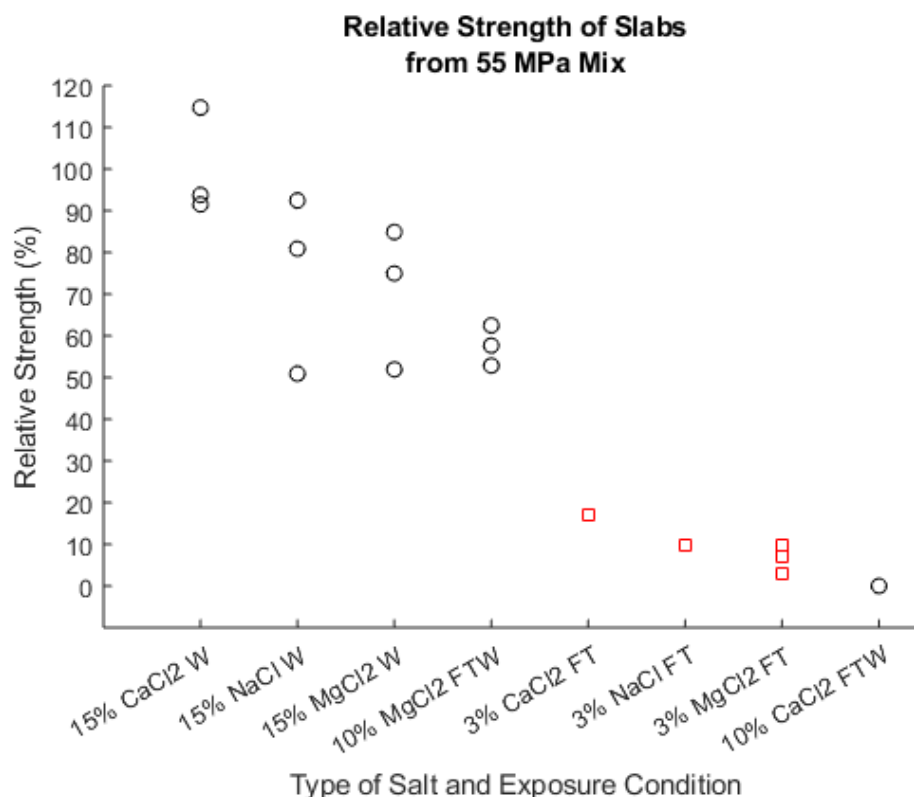
**Figure 4-4 Relative strength of tested samples from (a) the 45 MPa mix, (b) the 30 MPa, and (c) the 55 MPa mix. FT samples are marked as squares.**

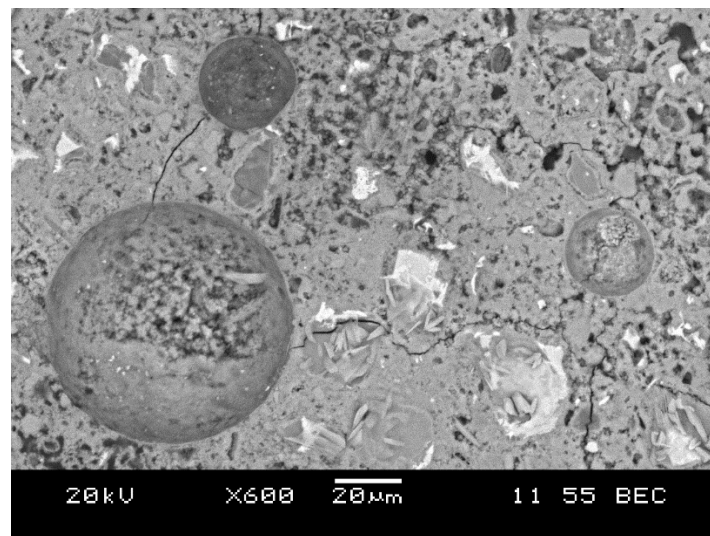
**Figure 4-5 SEM image of 3%  $\text{CaCl}_2$  FT sample with cracks between air voids.**

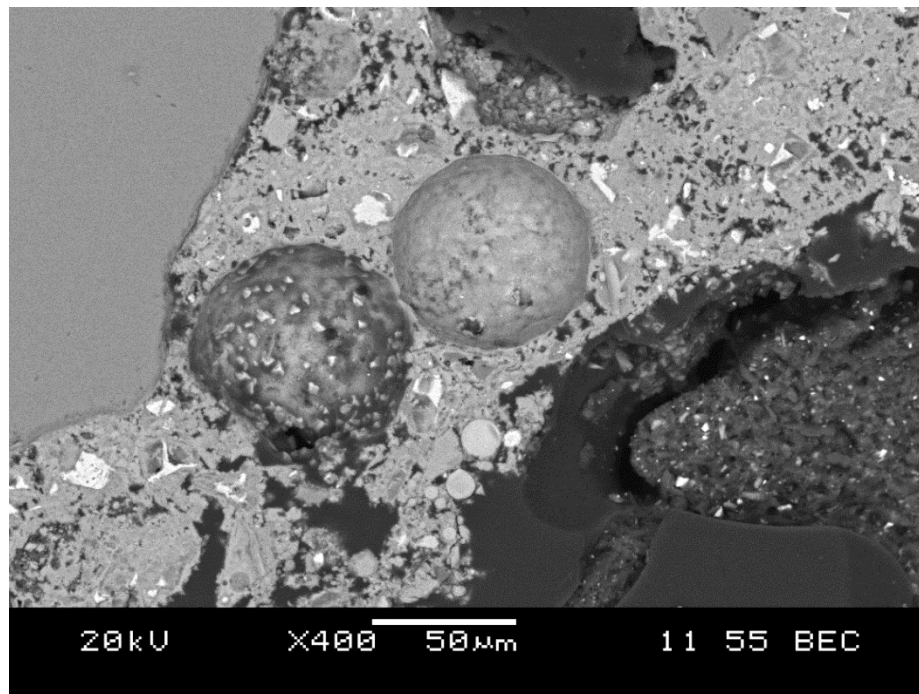
**Figure 4-6 SEM image of undamaged entrained air voids in 3%  $\text{CaCl}_2$  FT sample without any cracks in or around the air voids.**

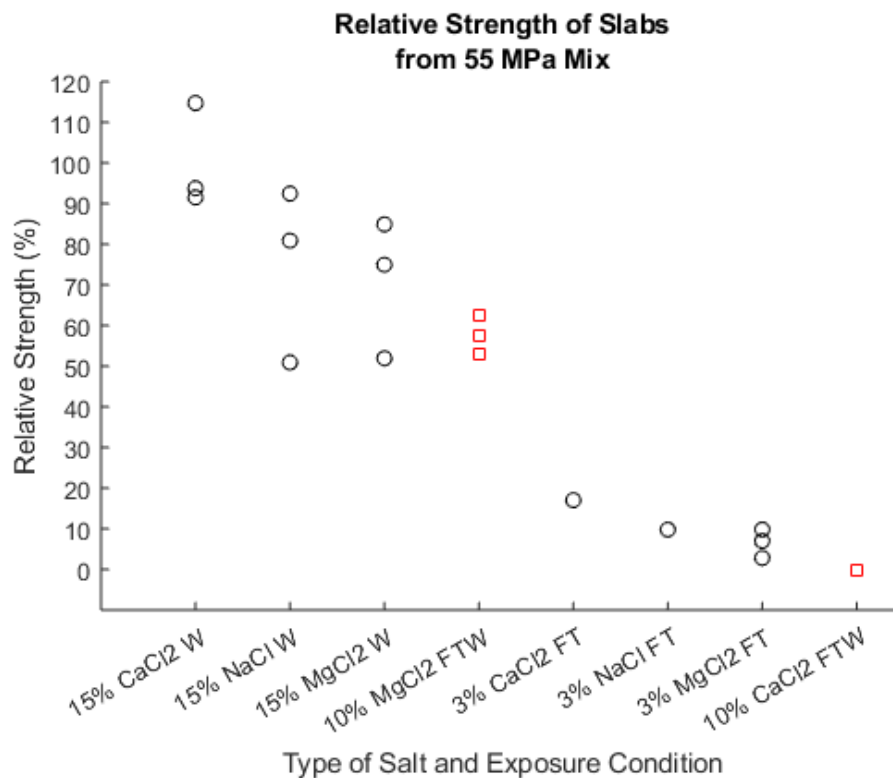
**Figure 4-7 Relative strength of tested samples from (a) 45 MPa mix and (b) 55 MPa mix, with FTW samples marked as squares.**

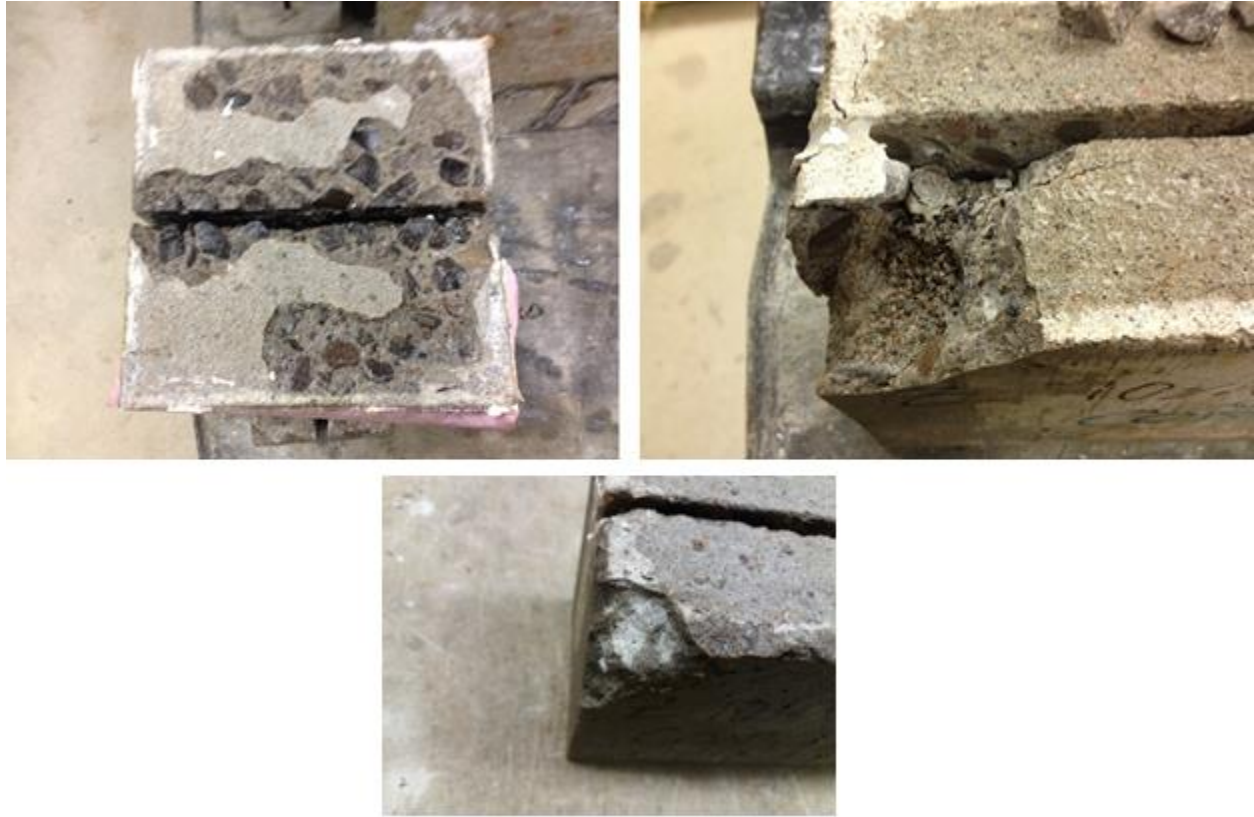
**Figure 4-8 10%  $\text{CaCl}_2$  FTW samples after 50 total cycles, 45 MPa mix (top left) 55 MPa mix (top right), and 55 MPa mix 10%  $\text{MgCl}_2$  FTW (bottom).**

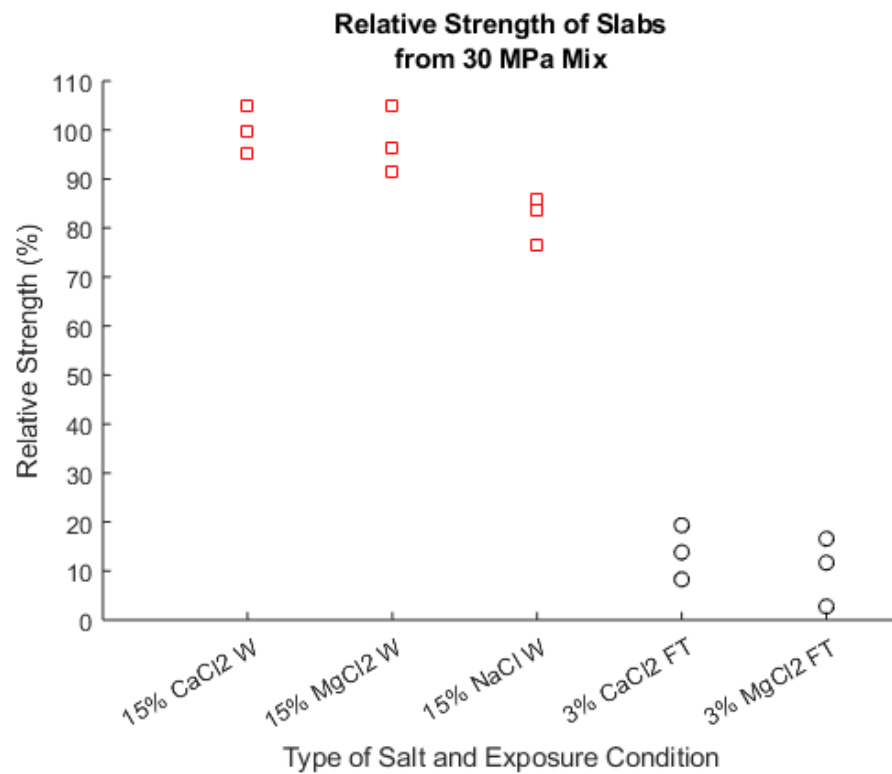
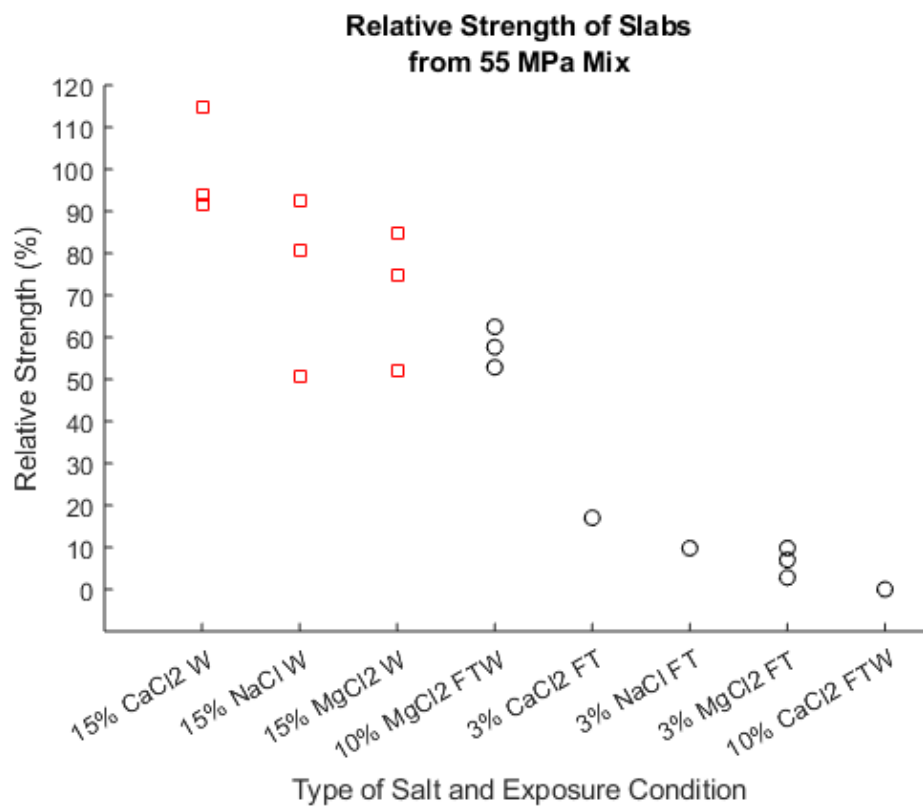
**Figure 4-9 Relative strength of samples from (a) the 35 MPa mix and (b) the 55 MPa mix, with the samples exposed to only wetting marked as squares.**

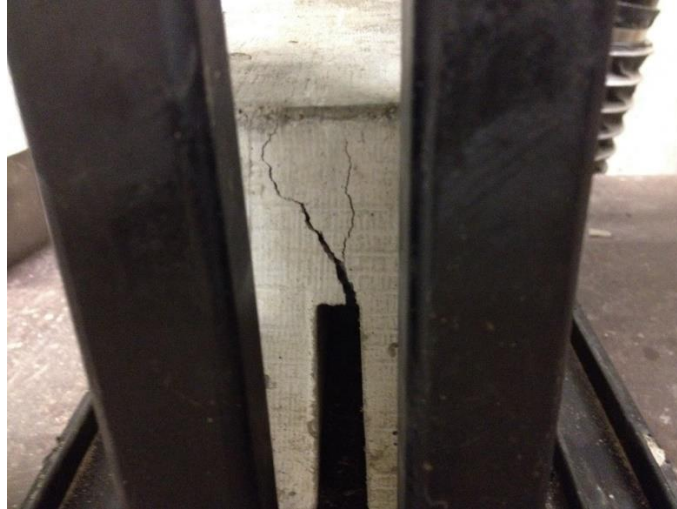
**Figure 4-10 Control slab tested to ultimate failure with rollers, in which the crack that had formed was not confined to the section immediately above the saw cut.**

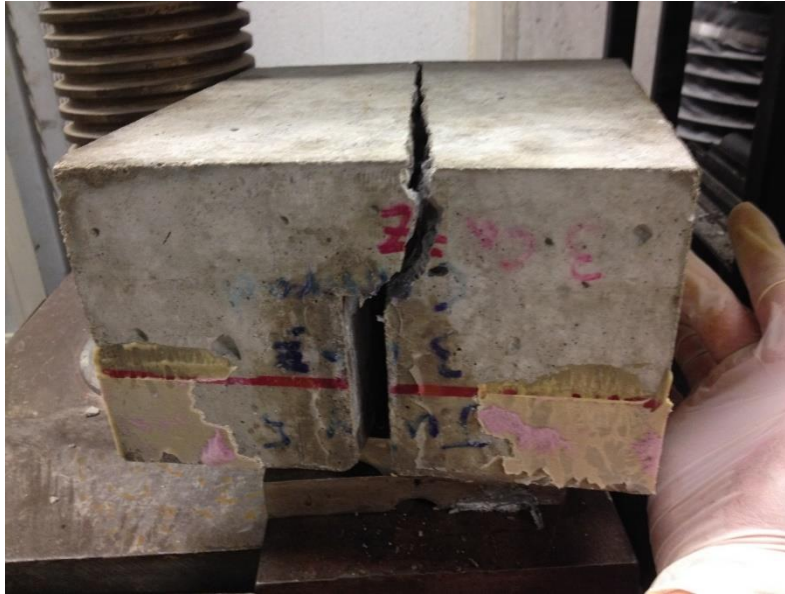
**Figure 4-11 10% CaCl<sub>2</sub> FT sample with the crack extending up and away from the joint rather than staying confined within the area directly above the saw cut.**

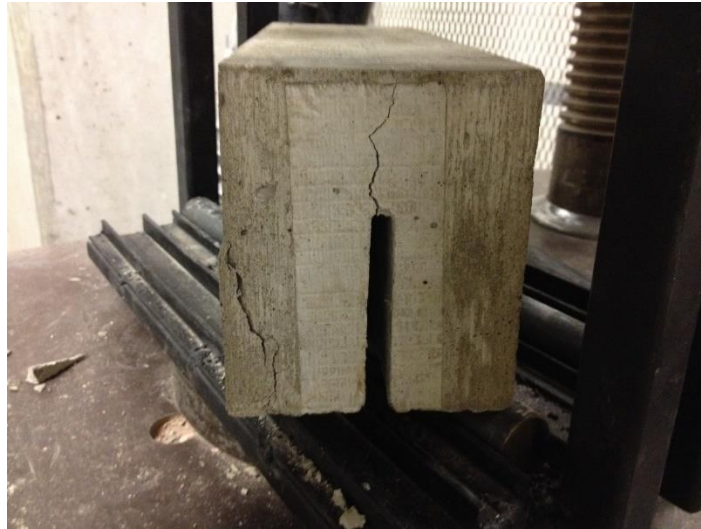
**Figure 4-12 Control slab tested to ultimate failure, which had experienced some cracking above the roller support (left side of the image).**

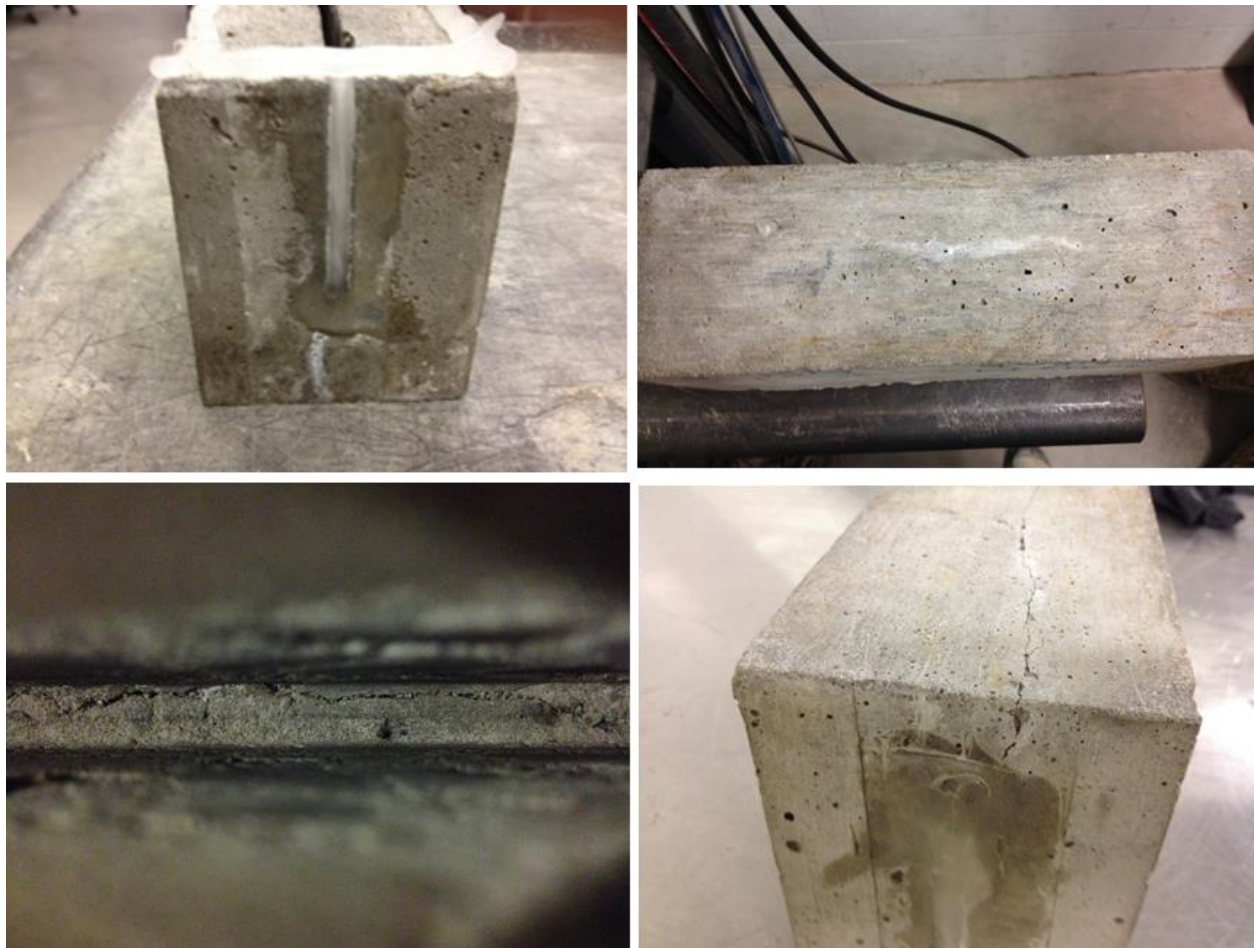
**Figure 4-13 Cracks in and around the joint of slabs exposed to FT before loading. A crack and efflorescence below the joint of a 3%  $\text{CaCl}_2$  FT sample (top left), some efflorescence and a thin crack on the bottom surface of a 3%  $\text{MgCl}_2$  FT sample (top right), cracks inside the joint of a 3%  $\text{CaCl}_2$  sample (bottom left), and a crack visible on the bottom surface of a slab connecting to the saw cut of a 3%  $\text{CaCl}_2$  sample (bottom right).**

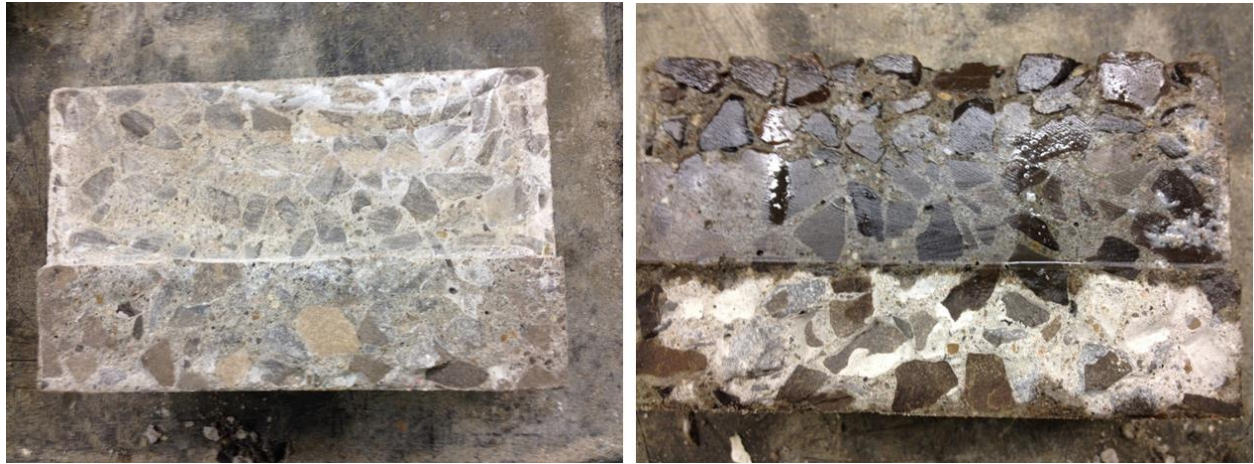
**Figure 4-14 A view inside the joint (after loading) of the 10% NaCl FTW ( $\text{H}_2\text{O}$ ) sample (left) and the 10%  $\text{CaCl}_2$  FTW sample (right), both from the 45 MPa mix.**

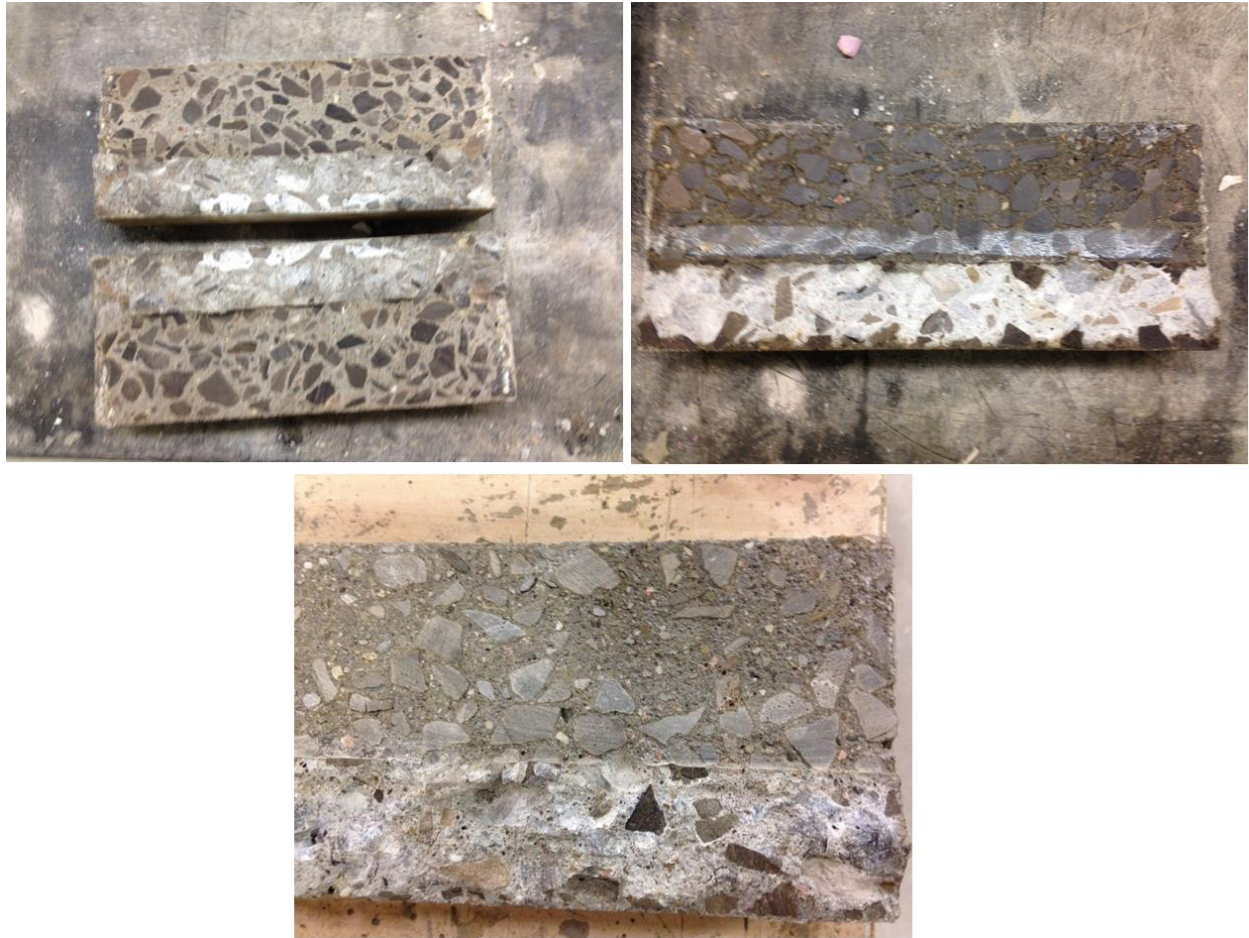
**Figure 4-15 Inside the joints of different samples after loading: 15% NaCl W (top left), 15% MgCl<sub>2</sub> W (top right), and 3% MgCl<sub>2</sub> FT (bottom).**

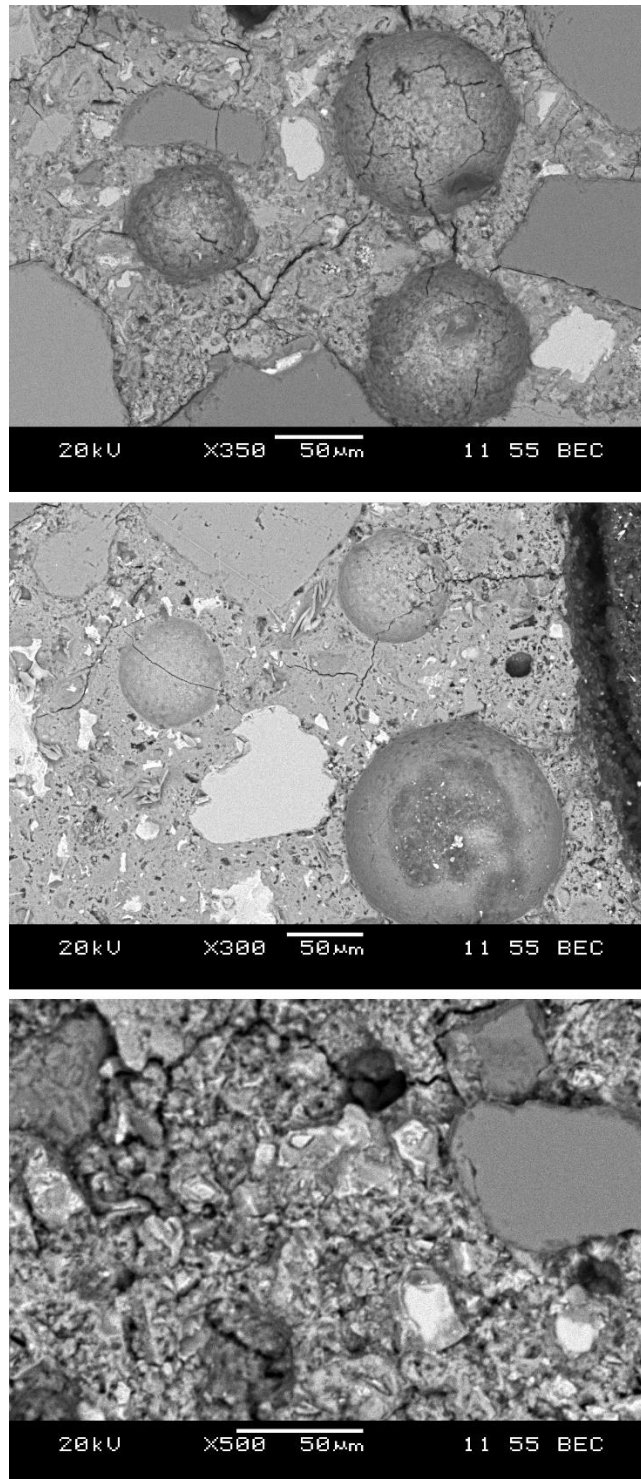
Figure 4-16 SEM images showing differences in paste of samples exposed to different salt solutions, from top to bottom: 3% NaCl FT, 3% CaCl<sub>2</sub> FT, and 3% MgCl<sub>2</sub> FT.

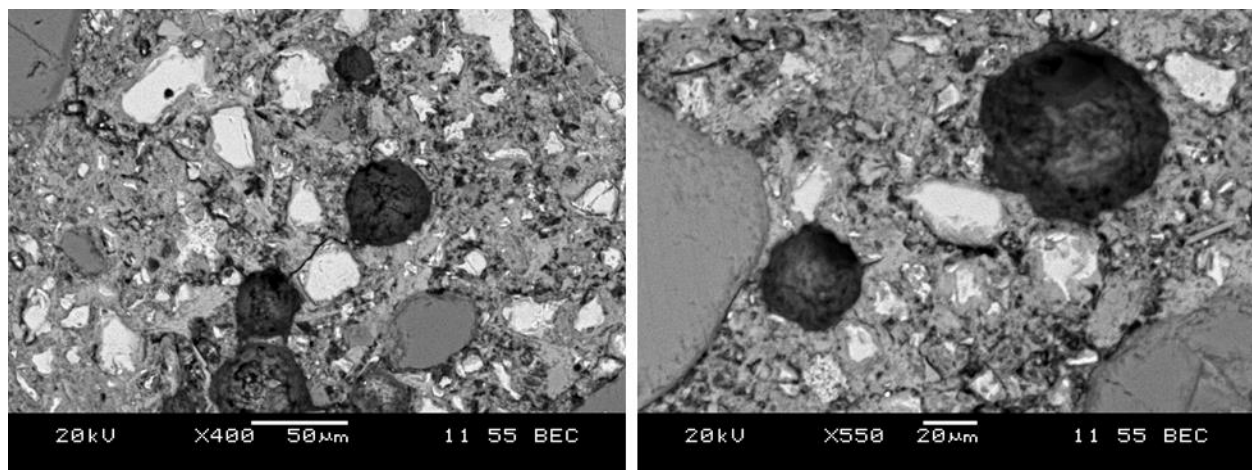
**Figure 4-17 SEM images of a sample exposed to 3%  $\text{MgCl}_2$  FT with a crack present between entrained air voids (left) and entrained air voids without a connecting crack (right).**

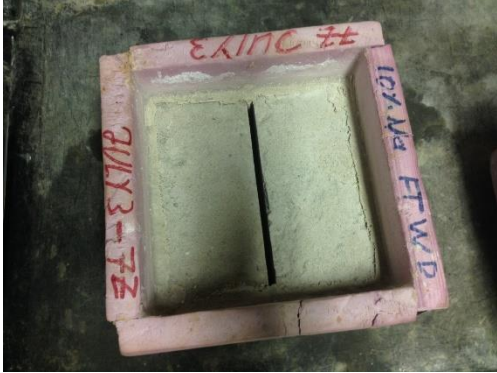
<p>Little/ no surface scaling, no damage along the joint. (Example: 10% NaCl FTW, 45 MPa mix)</p>
2

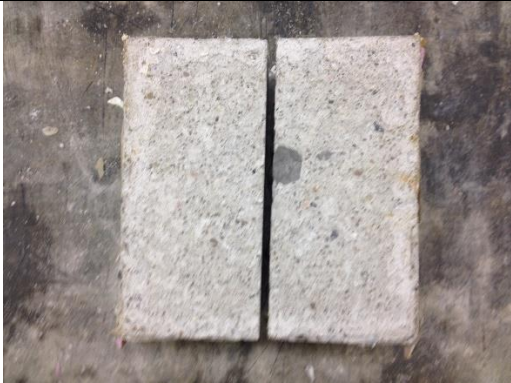
<p>Some scaling/ damage around the joint, some paste missing, no aggregate missing. (Example: 3% NaCl FT, 45 MPa mix)</p>
3

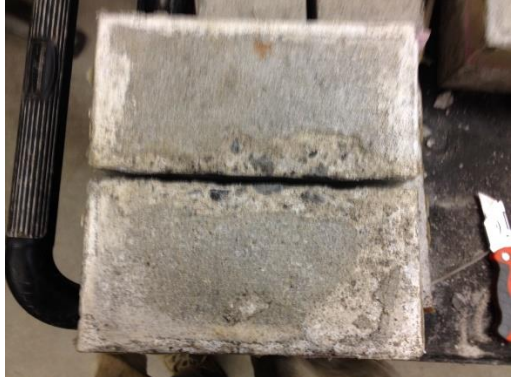
<p>Some scaling/ minor spalling around the joint, little to no aggregate missing. (Example: 10% <math>\text{CaCl}_2</math> FTW, 45 MPa mix)</p>

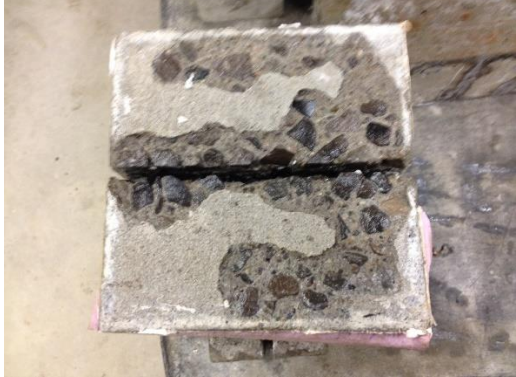
<p>Some spalling around the joint, most aggregate exposed, some aggregate missing. (Example: 10% CaCl<sub>2</sub> FTW, 45 MPa mix)</p>
5

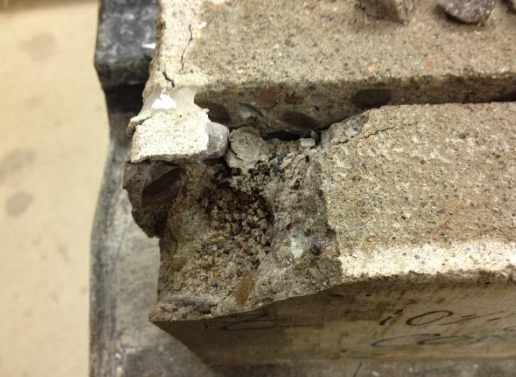
<p>Excessive spalling, large masses of concrete cracking off starting from the joint. (Example: 10% CaCl<sub>2</sub> FTW, 55 MPa mix)</p>

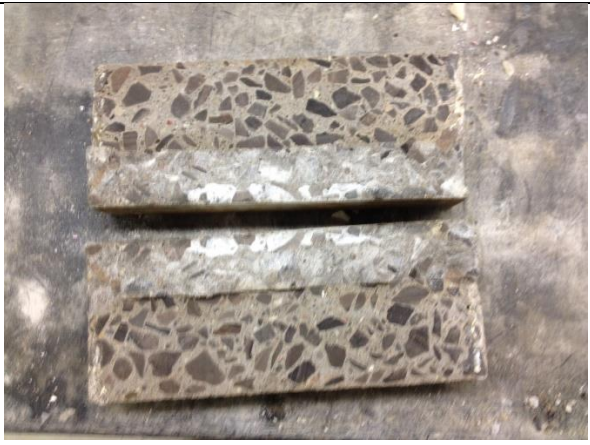
<p>No visible damage. (Example: 3% NaCl FT, 30 MPa mix)</p>
2

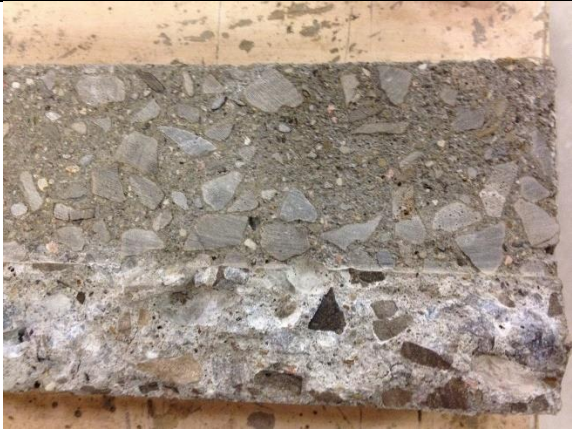
<p>Slight visible damage or discolouration/ recessed paste. (Example: 3% MgCl<sub>2</sub> FT, 55 MPa mix)</p>
3

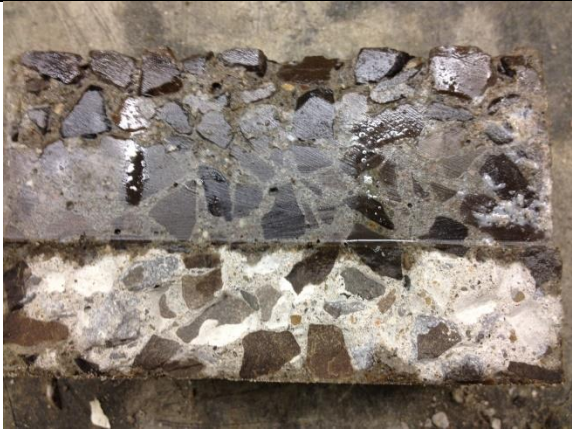
<p>Discolouration and/ or recessed paste with visible damage/ spalling. (Example: 10% CaCl<sub>2</sub> FTW, 45 MPa mix)</p>

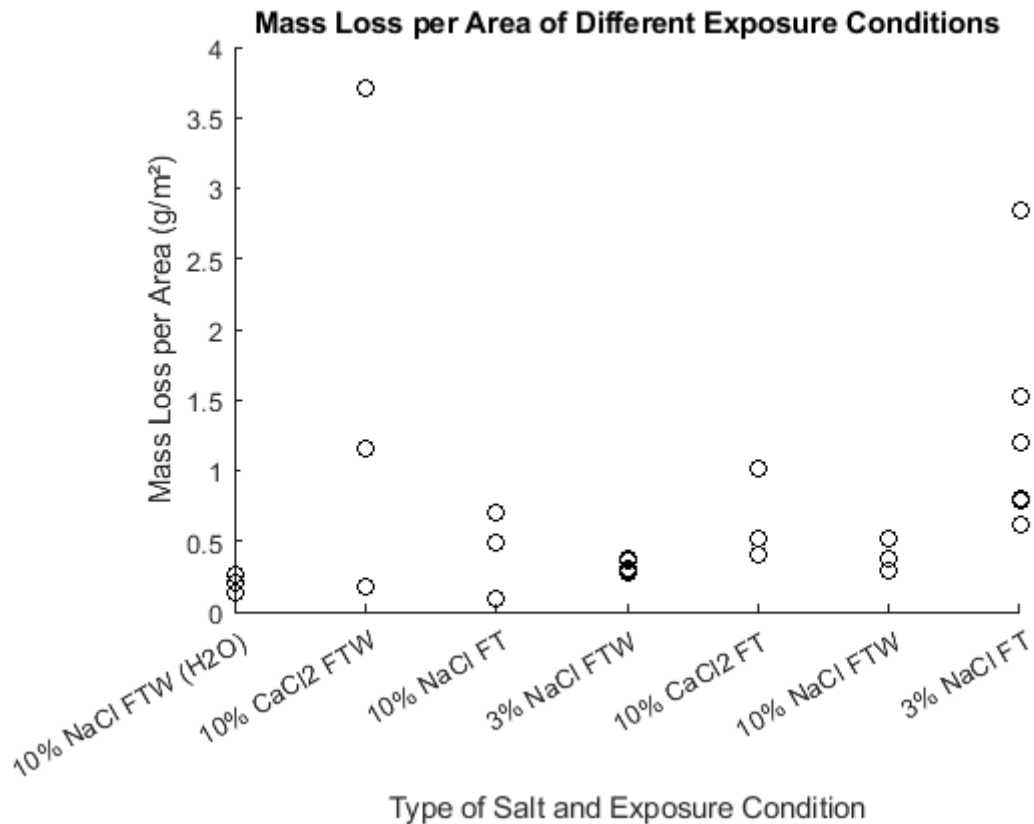
**Figure 4-18 Average mass loss (g/ m<sup>2</sup>) of the different conditions that slabs underwent.**

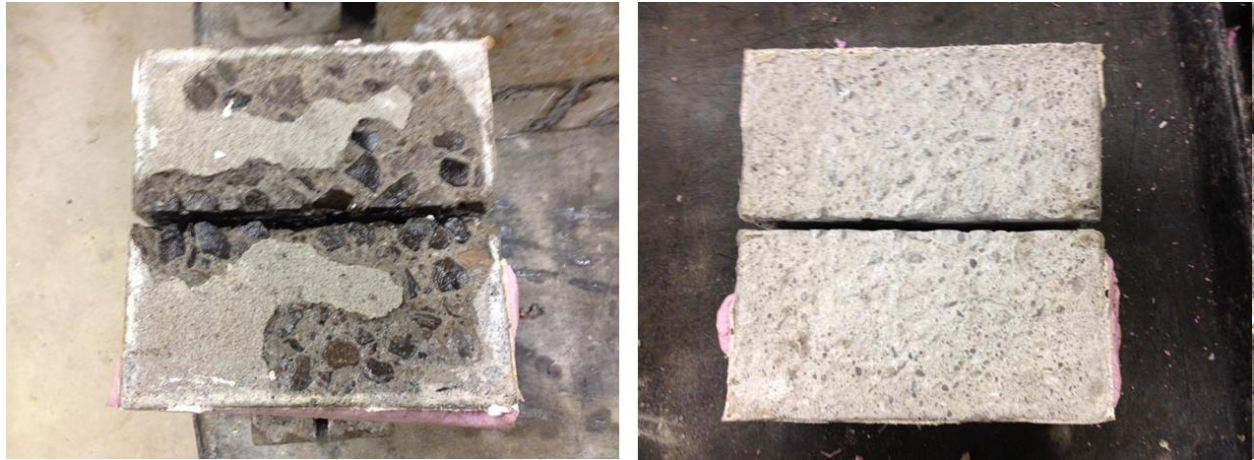
**Figure 4-19 Comparison of the slabs with the most mass loss from surface scaling: 10%  $\text{CaCl}_2$  FTW (1.68 g/m<sup>2</sup> mass loss) with spalling around the joint and surface scaling (left) and 3% NaCl FT (1.30 g/m<sup>2</sup> mass loss) with mostly surface scaling (right).**

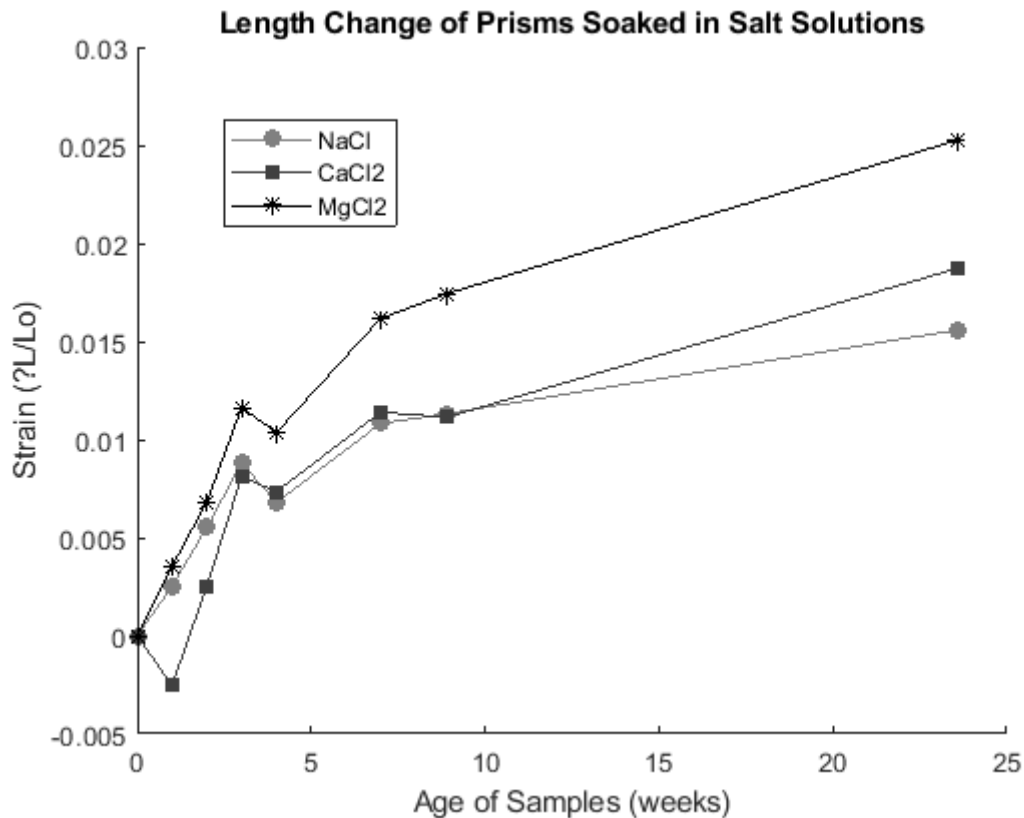
**Figure 4-20 Average strain (change in length divided by initial length) for concrete prisms exposed to 15% salt solutions at room temperature.**
