Environmental And Age-Related Deterioration Of Concrete Median Barriers

ENVIRONMENTAL AND AGE-RELATED DETERIORATION OF CONCRETE MEDIAN BARRIERS

A thesis presented to Ryerson University

Master of Applied Science
in the program of
Civil Engineering

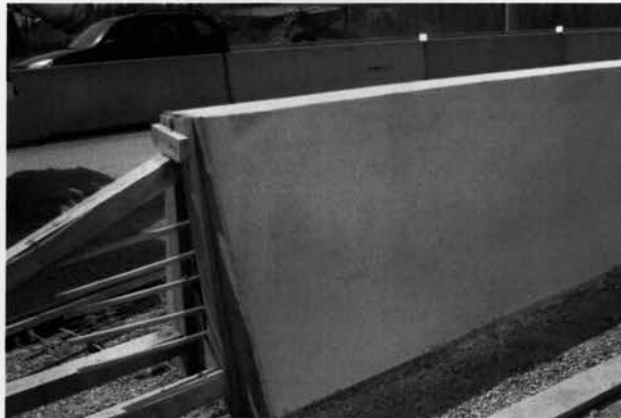
Figure 2.8: Construction Joint

Construction joint was done at the beginning of the slip formed barrier wall, as shown in Figure 2.8. Construction joint means the surface where two successive placements of concrete meet or where new concrete is placed against old concrete. As per Ontario Provincial Standard Specifications, for tall wall concrete barrier, five epoxy coated 25 mm diameter reinforcing bars of 1m long should be placed, with 500 mm on each side of the joint. The location of the bars should be in such a way that all bars should be placed in centerline, with the first bar placed at 150 mm from top, and the remaining equally spaced at 150 mm below it. However, in the site as seen in Figure 2.8, the first reinforcement bar is not placed as per specification. Based on the following observations, it is recommended to improve the construction practices while performing slip forming operations, with main emphasis on consolidation and curing practices.

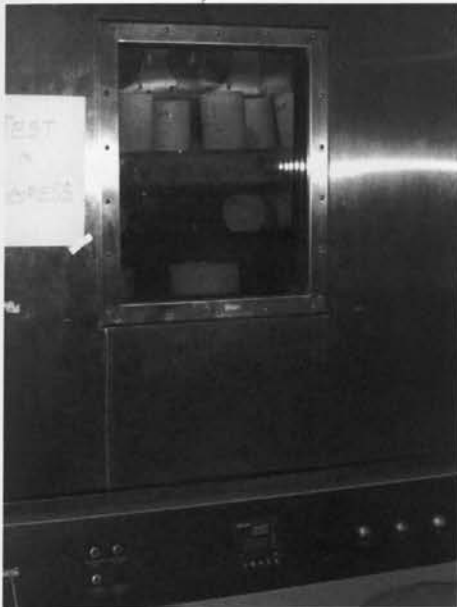
Figure 3.7: Samples in Environmental Chamber

- ✓ Y samples were cured for 28 days and exposed to temperature variation from -50°C to $+50^{\circ}\text{C}$ in “Wet” condition. Samples after 28 days of curing were immersed in a pail of water and kept in an environmental chamber. Chamber controlled the temperature cyclically, completing one cycle from $-50^{\circ}\text{C} \rightarrow +50^{\circ}\text{C} \rightarrow -50^{\circ}\text{C}$ linearly.
