Deterioration Caused By Sulfide-Bearing Aggregates: Performance Test Development

**DETERIORATION CAUSED BY SULFIDE-BEARING AGGREGATES:
PERFORMANCE TEST DEVELOPMENT**

in partial fulfillment of the
requirements for the degree of
Master of Applied Science
in the Program of
Civil Engineering

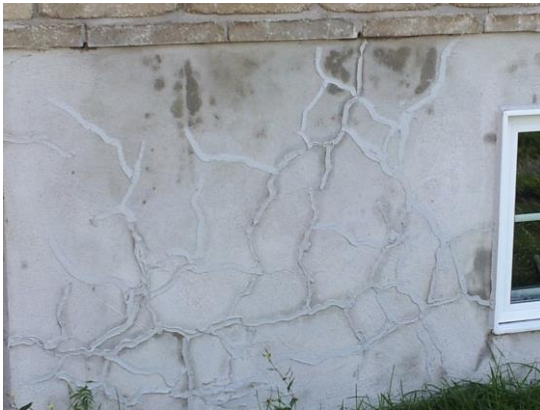
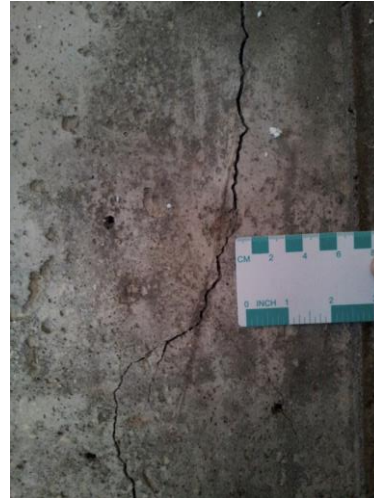
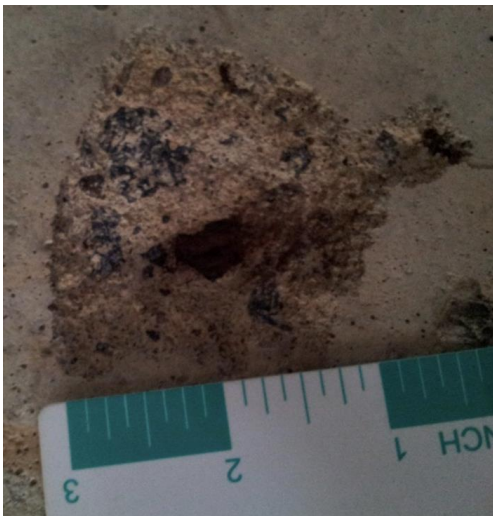
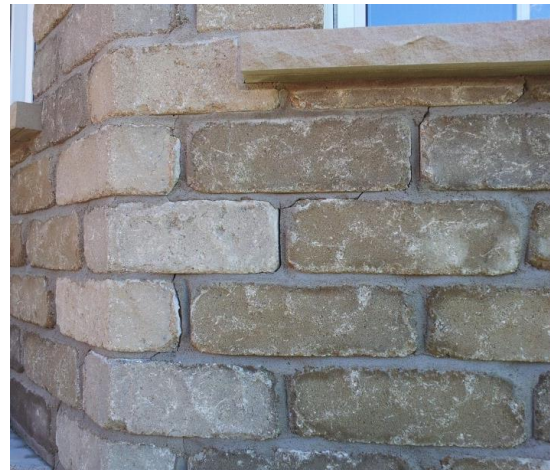
Figure 1.1.1: Pictures of damaged concrete foundations in Quebec, Canada

In recent years, a rapid concrete deterioration has been observed in a few housing developments in the Trios-Rivières area in Quebec, Canada. Detrimental cracking was seen after just 3 to 5 years of construction and crack widths up to 5mm wide were observed in the interior of the foundation walls, as seen in Figure 1.1.1-B).

Map cracking in foundation

Interior crack in foundation

Pop-out with yellowish staining

Cracked masonry caused by foundation expansion

immediate remedial actions. This distressed concrete is the point of reference for all testing in this study, and will be referred to as “the foundations” from here forward. Yellowish staining, map cracking, and pop-outs were observed on the surface of the foundation walls, shown in Figure 1.1.1. Sealer was used to fill the cracks in A). Also, some exposed coarse aggregate particles showed rust (iron oxyhydroxides) on their surface, seen in Figure 1.1.1-C). A crack is seen in the masonry in Figure 1.1.1-D) that was thought to be caused by expansion of the foundation. Concrete removed from the foundations was examined using petrographic techniques, the results of which are discussed by Duchesne and Fournier. Also, concrete taken from the foundations was examined further by Rodrigues et al.. A summary of the results of these 2 papers is discussed in the following section. Damage and expansion caused by oxidation of iron sulfide minerals has been observed in other cases, but it occurred at a much slower rate and was not detrimental to the structure. Since the case in Quebec occurred over such a short period of time this problem is now of great importance to the concrete industry in Canada. There is currently very little information available on the exact reaction mechanism causing this severe damage.

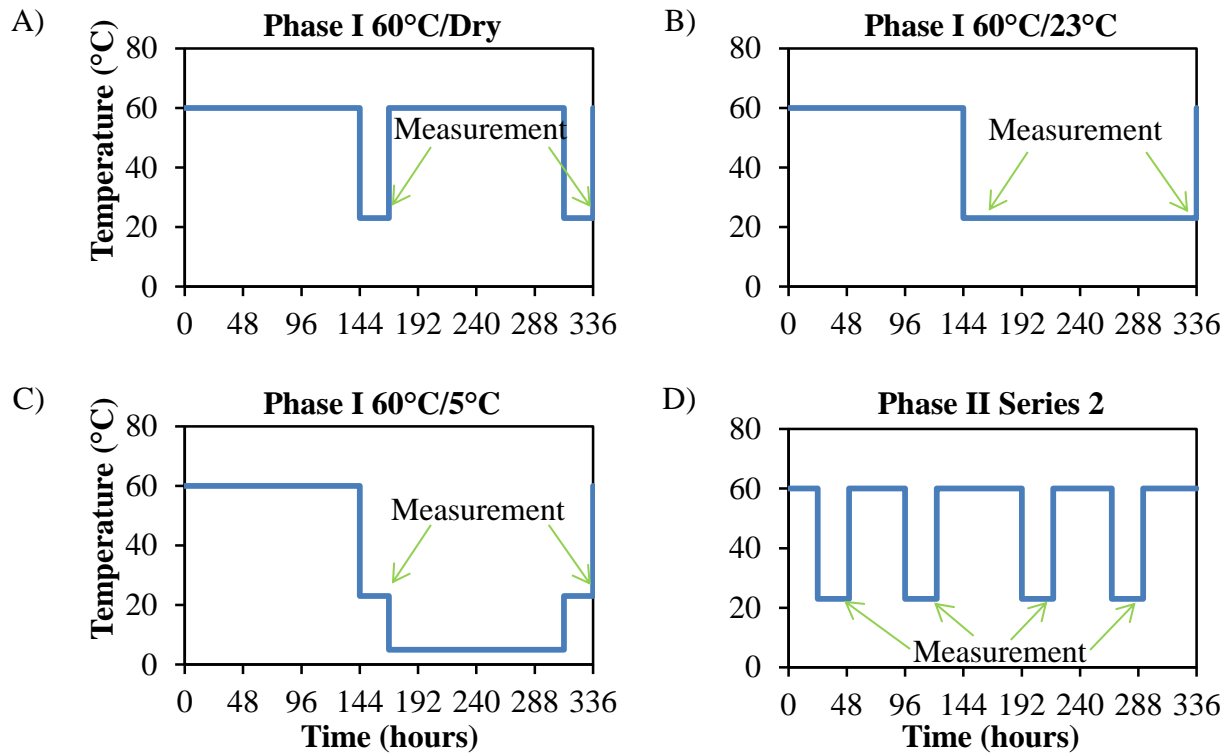
Figure 3.3.1: Heat cycle schematics for different testing regimes over 14-days – Samples were soaked in solution (lime or bleach) while at temperatures of 5°C or 23°C, except A) Phase I 60°C/Dry

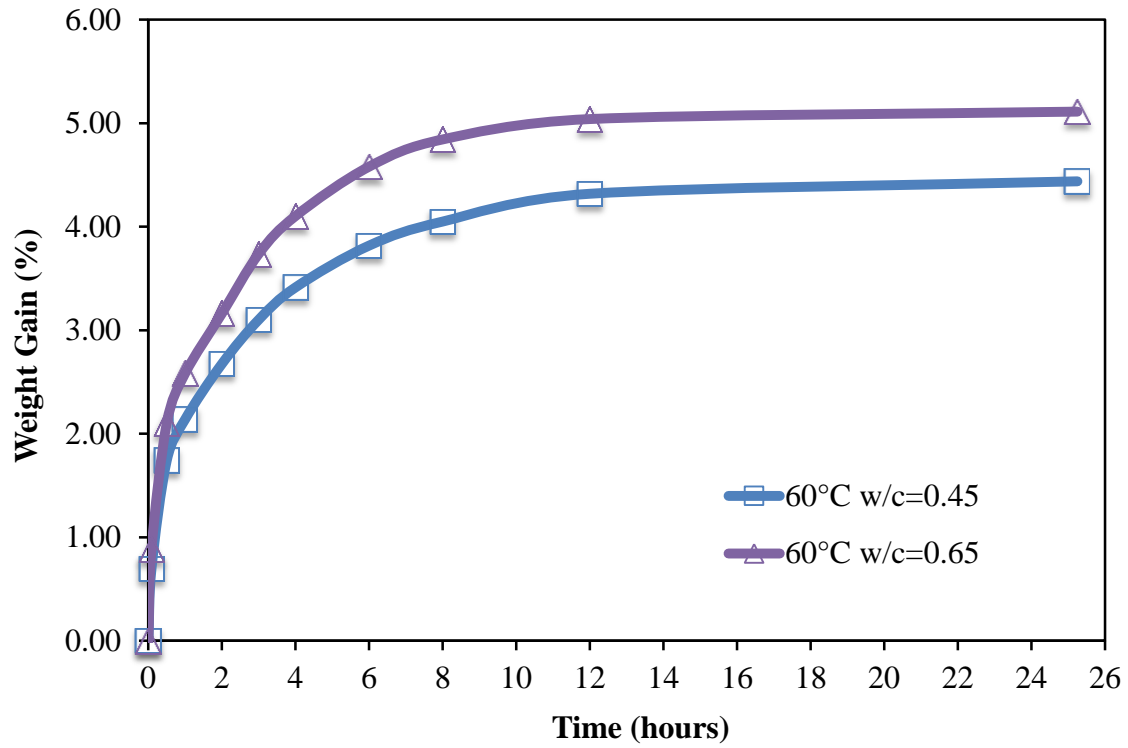
Figure 4.1.1: Absorption of 76x76x256mm prisms with water over 24-hours

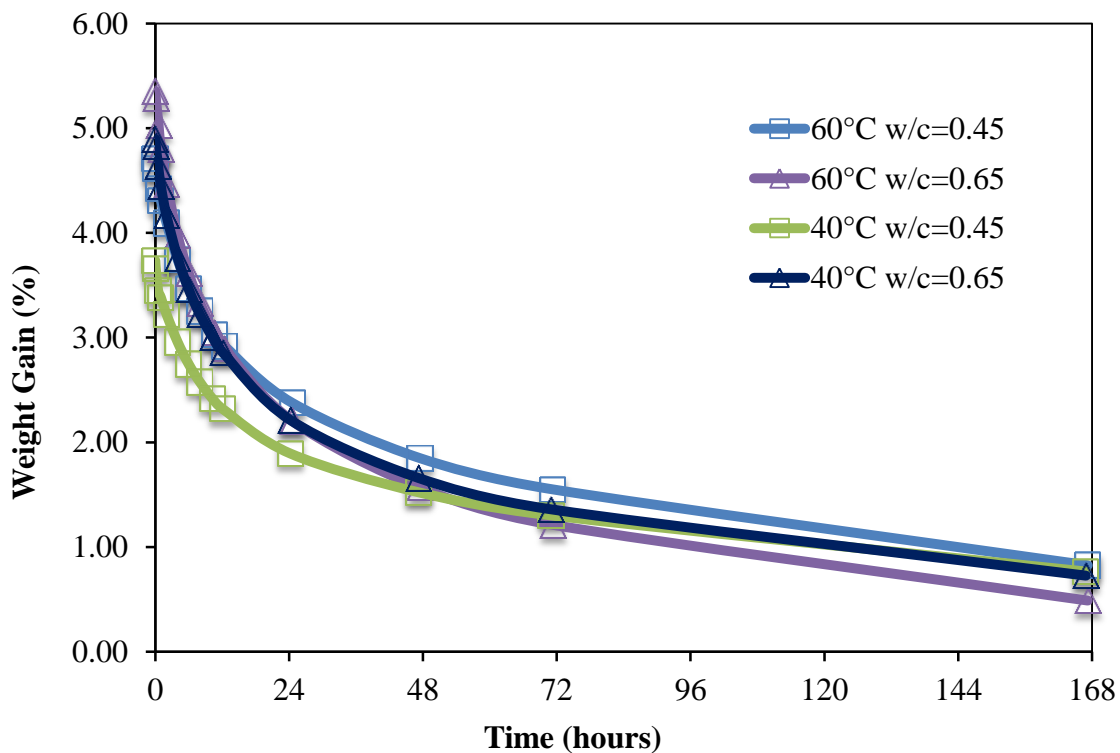
Figure 4.1.4: Drying of 76x76x256mm prisms over 7-days

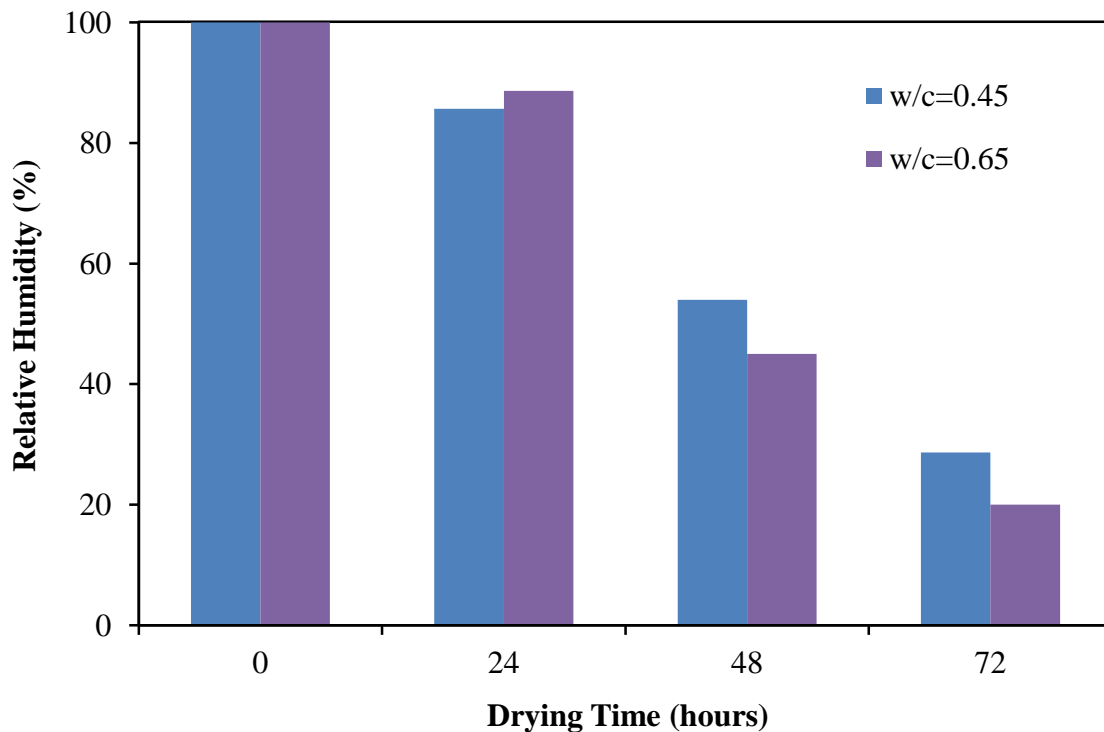
Figure 4.1.5: Relative humidity values for drying at 60°C over 72-hours

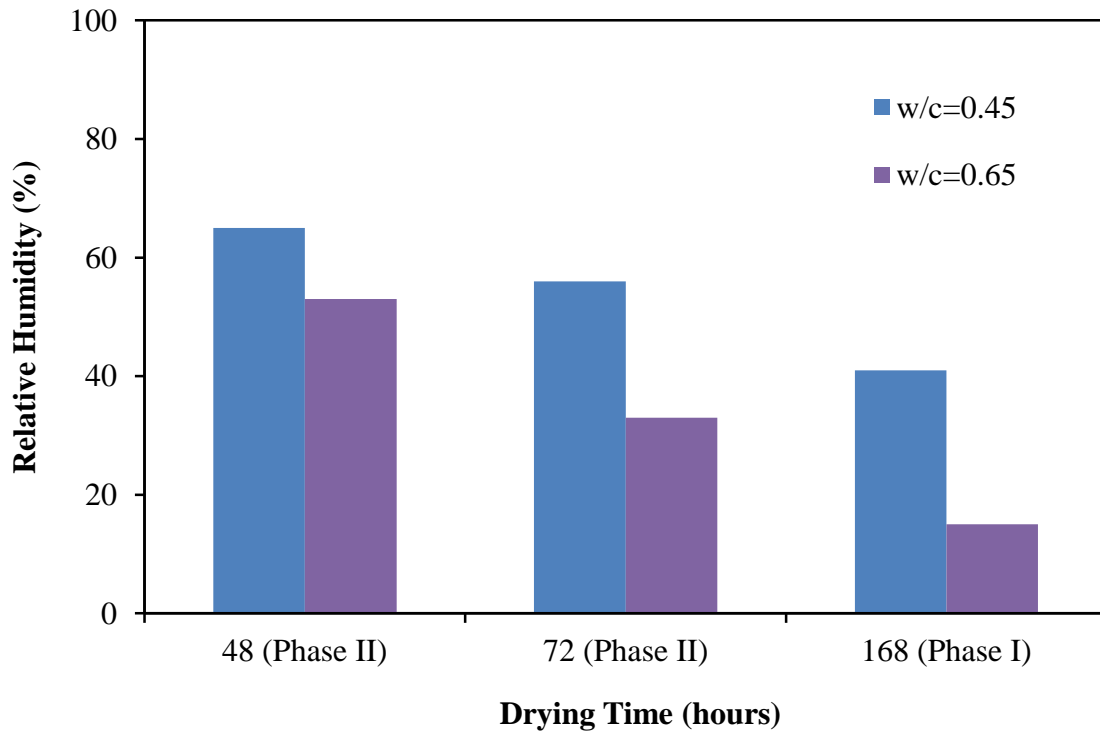
Figure 4.1.6: Equilibrium relative humidity values after 28-days of testing, all drying was at 60°C; RH measurements were taken adjacent to respective testing measurement, at the time of dry readings after stabilization for 24-hours

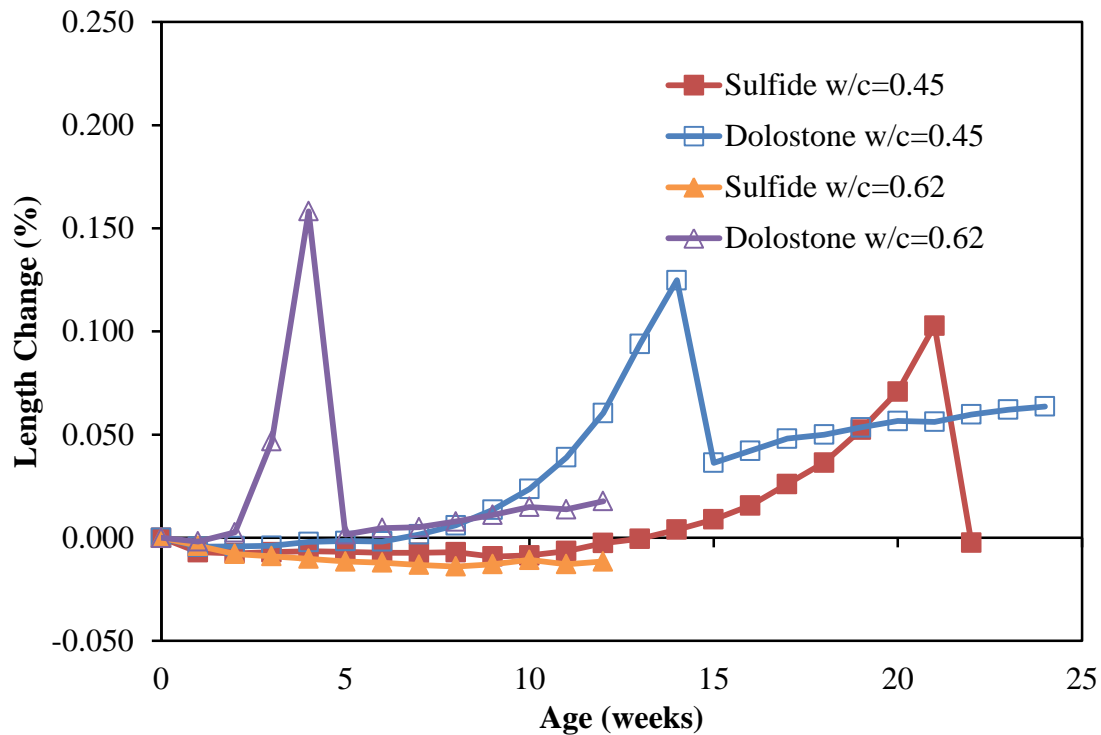
Figure 4.2.1: Phase I results from 1 heating/cooling cycle per week to 150°C/23°C and no wetting cycles; samples were measured after 24-hours stabilization at 23°C

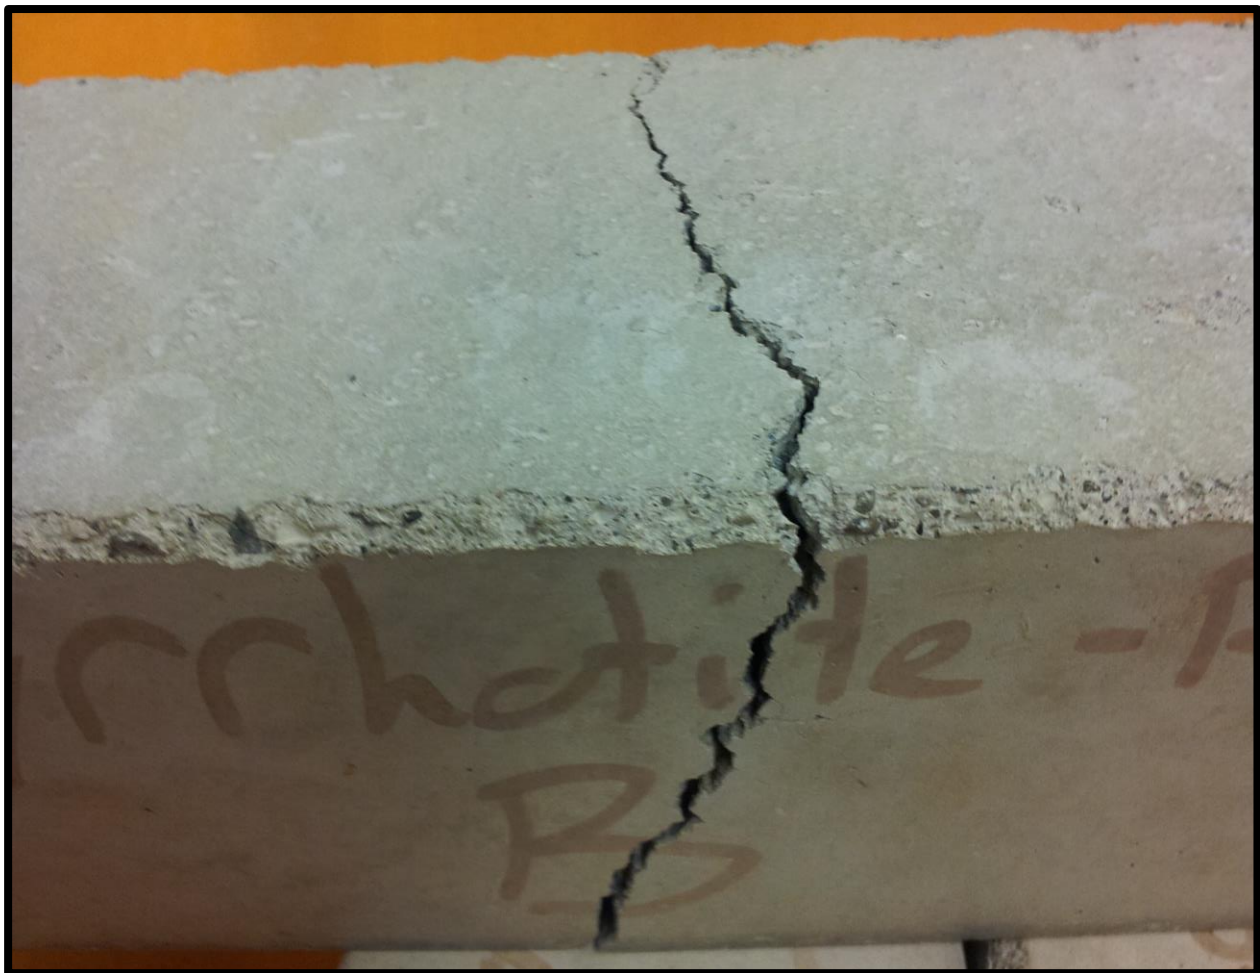
Figure 4.2.2: Image of Phase I Sulfide-0.45 sample tested under dry conditions with hot/cold cycles of 150°C/23°C

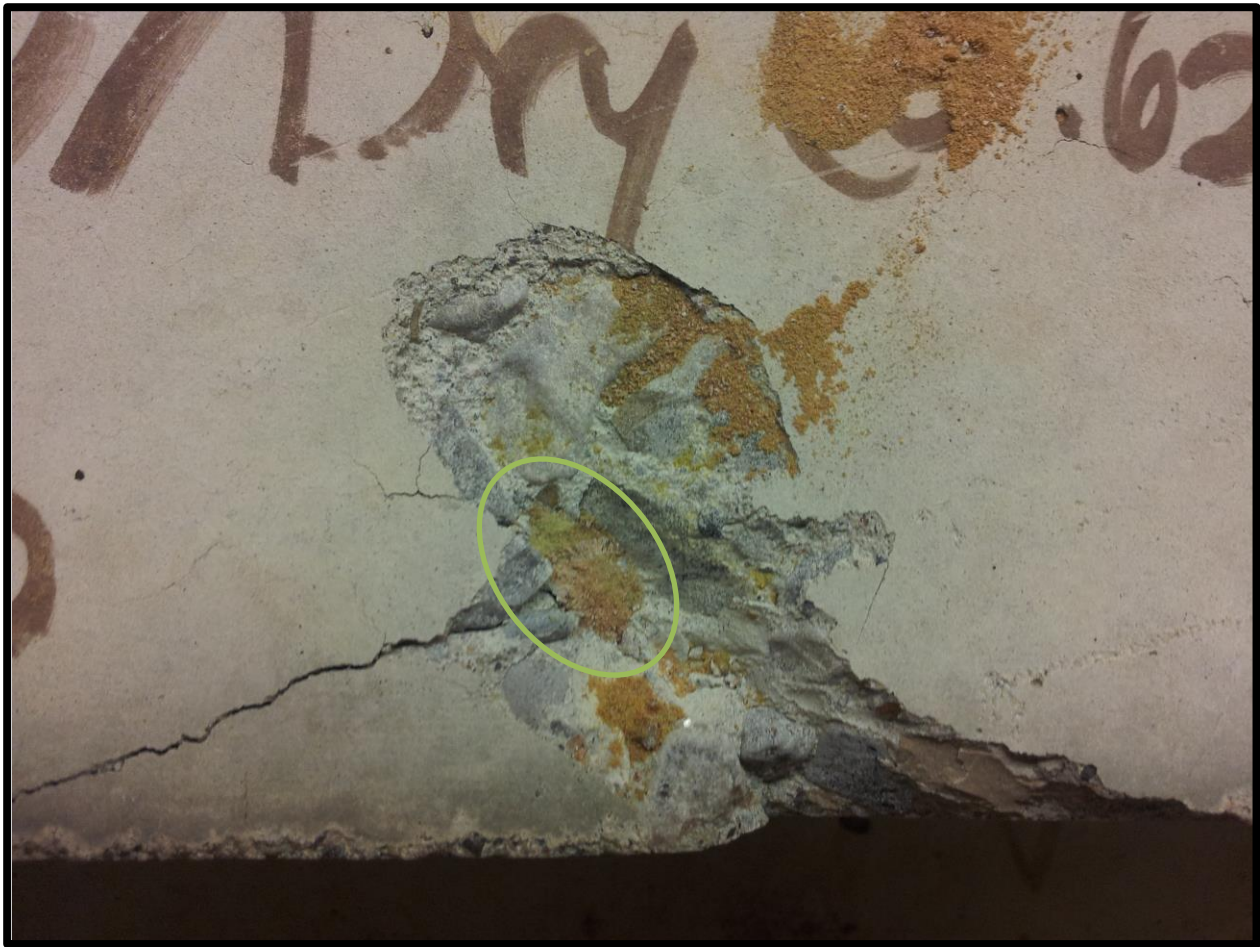
Figure 4.2.3: Image of Phase I Dolostone-0.62 specimen tested under dry conditions with hot/cold cycles of 150°C/23°C

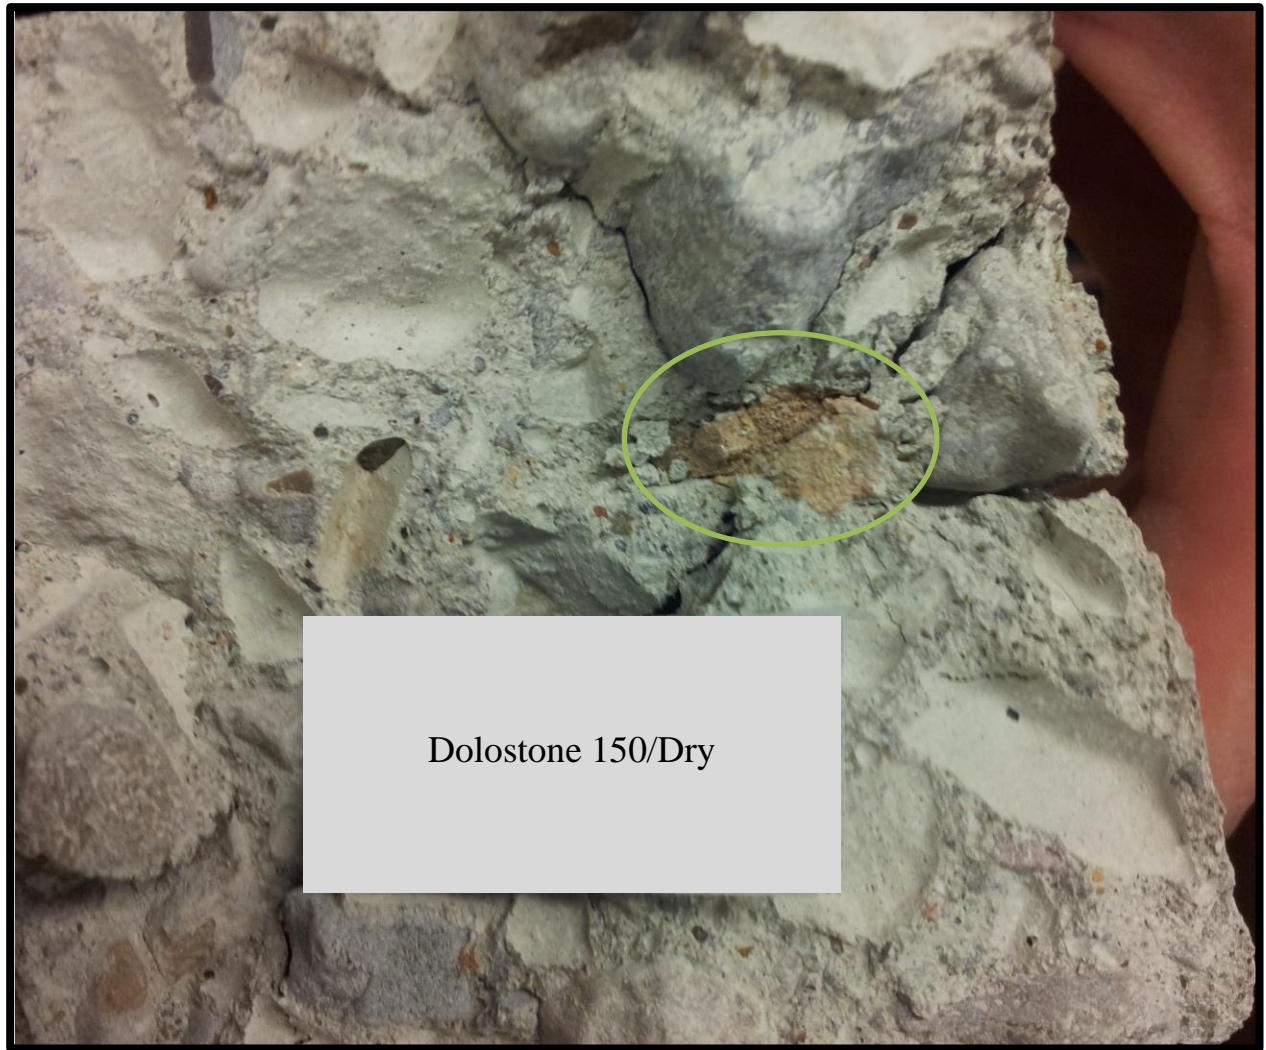
Figure 4.2.4: Image of fractured Phase I Dolostone-0.62 specimen tested under dry conditions with hot/cold cycles of 150°C/23°

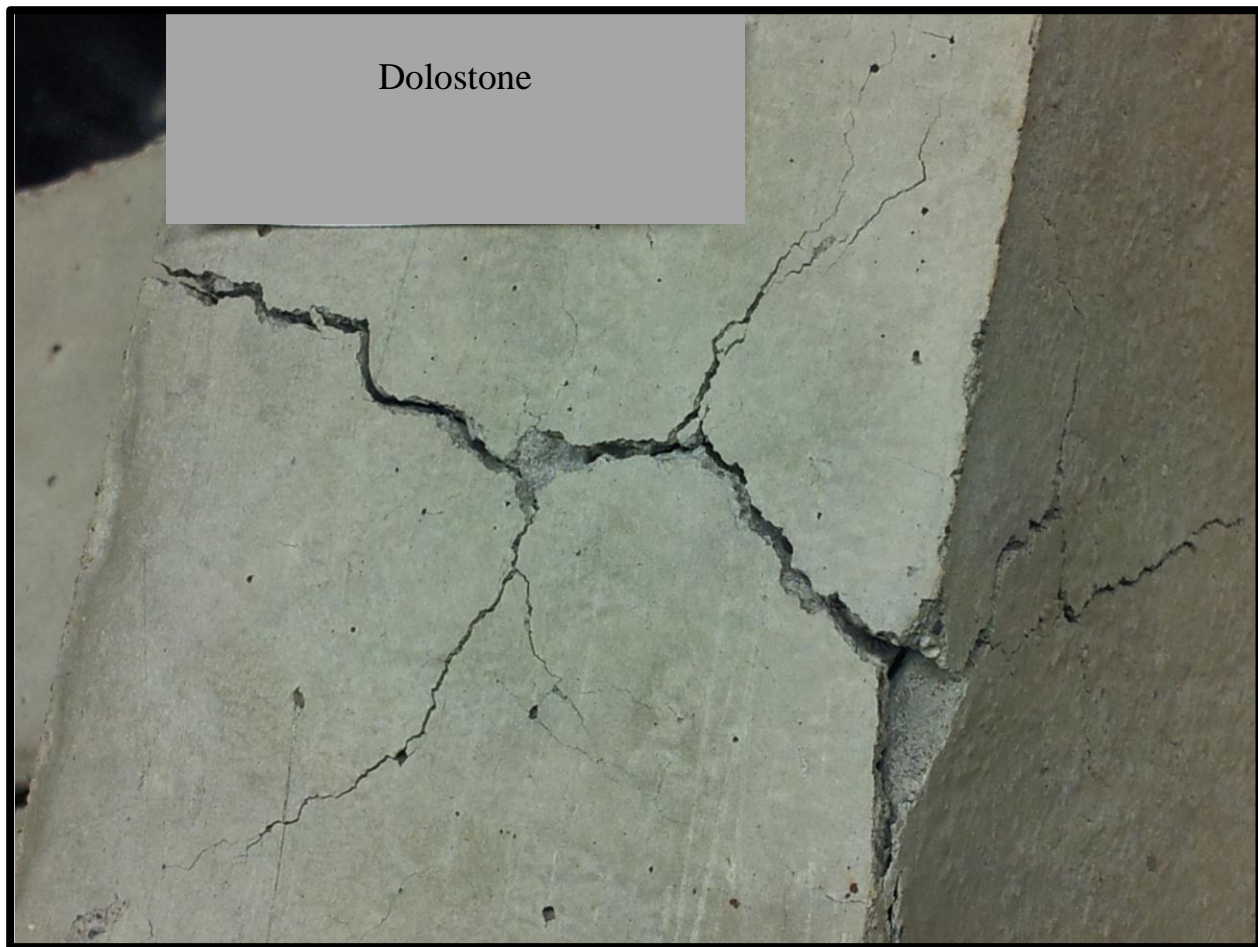
Figure 4.2.5: Image of severely cracked Phase I Dolostone-0.45 sample tested under dry conditions with hot/cold cycles of 150°C/23°C

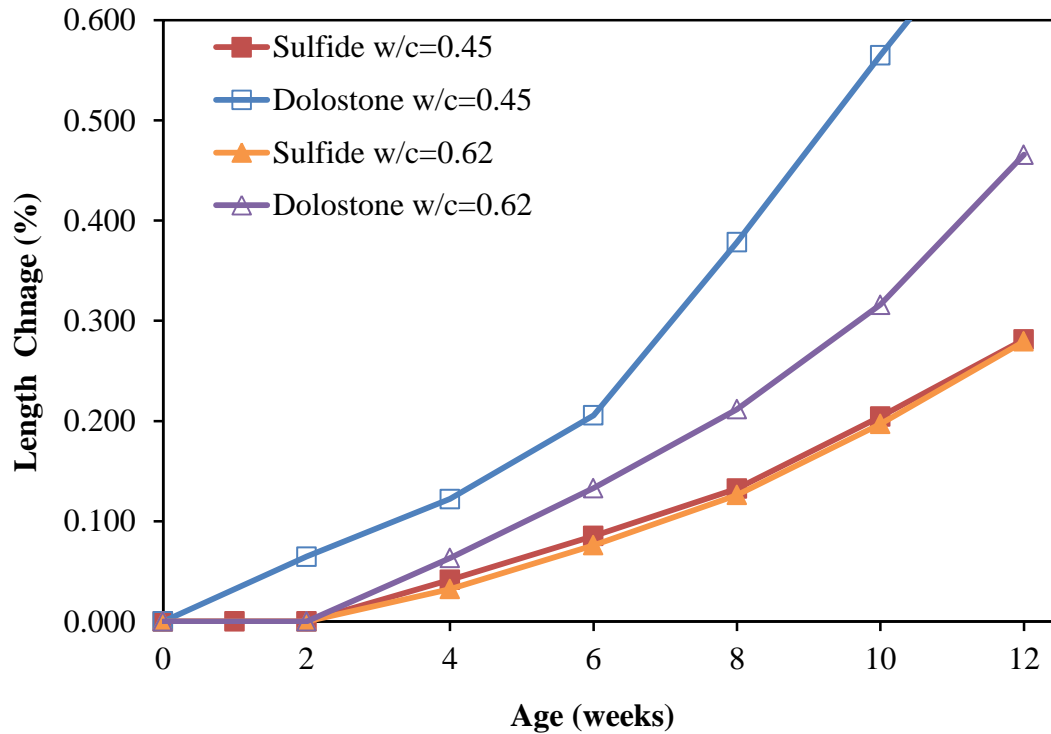
Figure 4.2.6: Phase I results from heating/drying to 150°C for 7-days and soaking cycles at 23°C for 7-days; thus 2 wet/dry cycles per 28-days were experienced

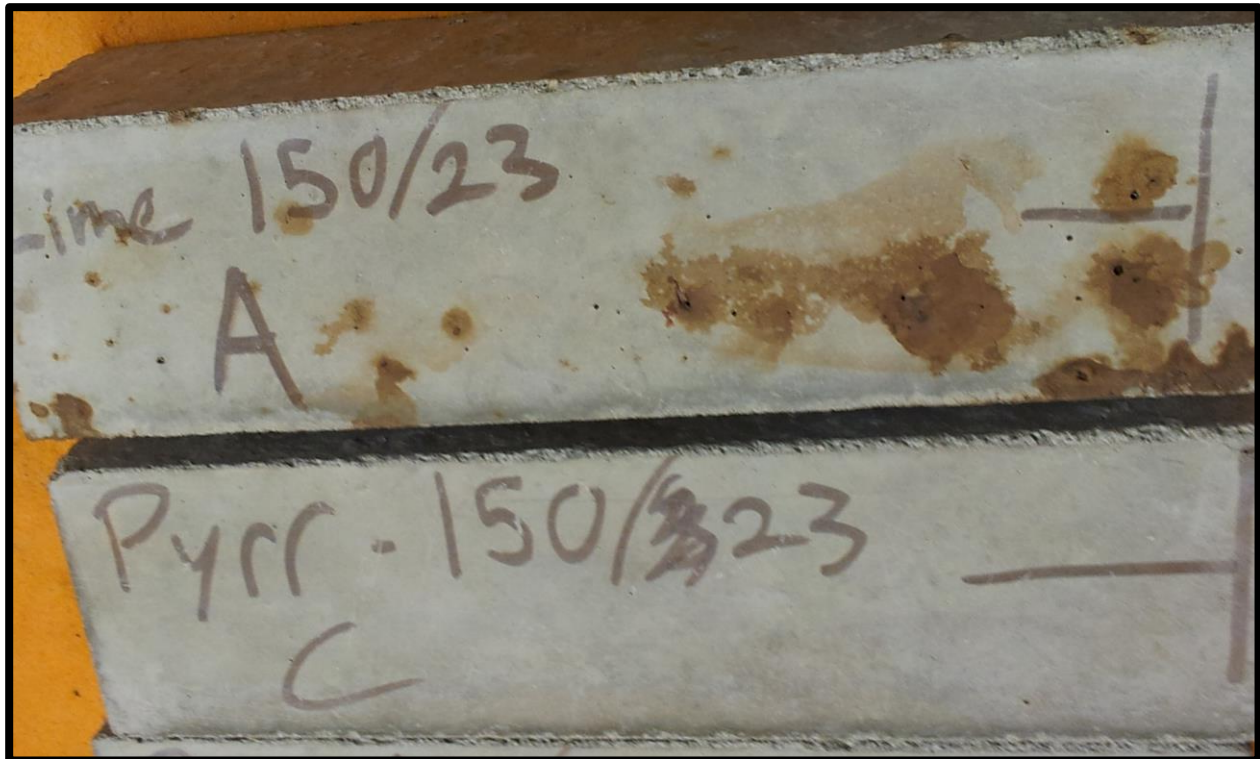
Figure 4.2.7: Image of Phase I samples with w/c of 0.45 tested with 7-days heating/drying at 150°C and soaking at 23°C, the Dolostone sample with staining is shown on top, and the Sulfide sample is below

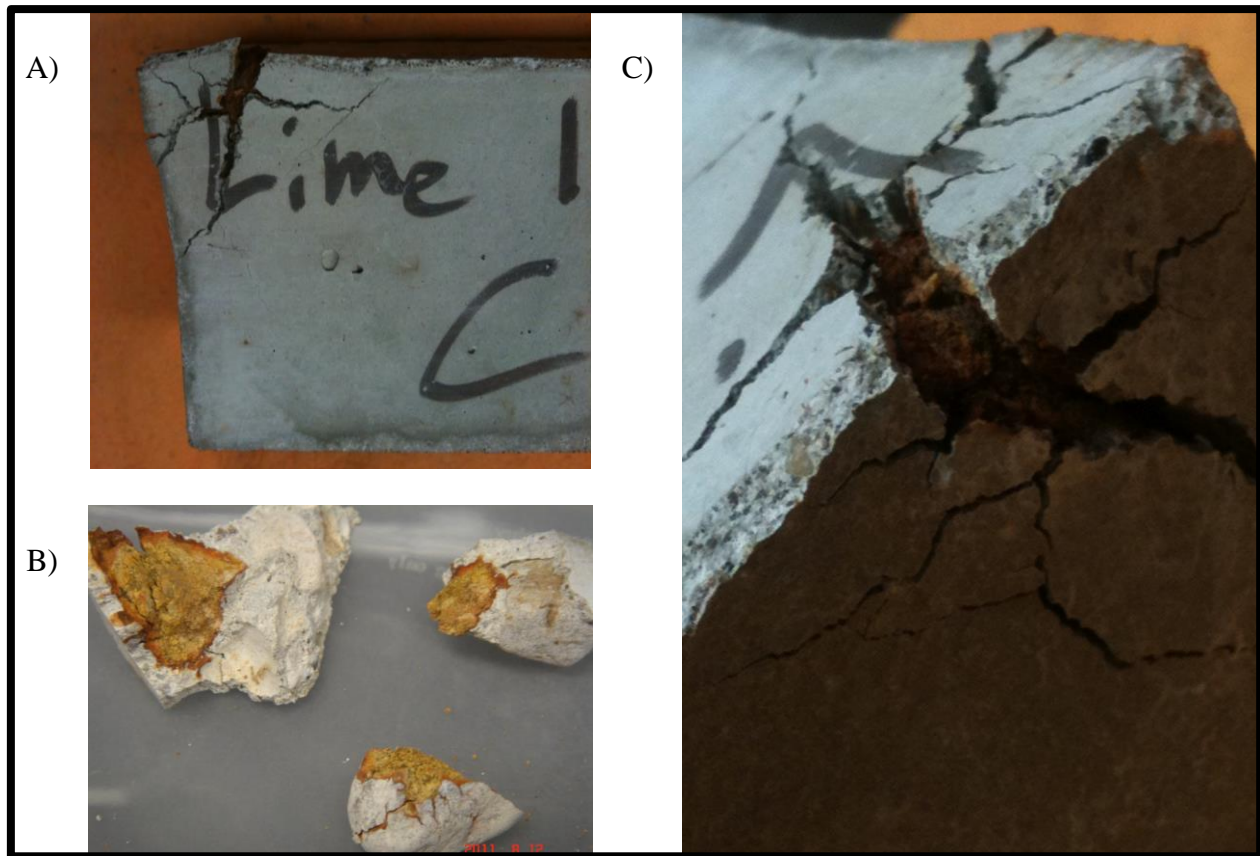
Figure 4.2.8: Images of fractured specimen from Phase I Dolostone-0.45 sample tested with 7-day heating/drying at 150°C and 7-day soaking at 23°C; fractured concrete sample shown in A) and C), removed aggregate particle causing fracture shown in B)

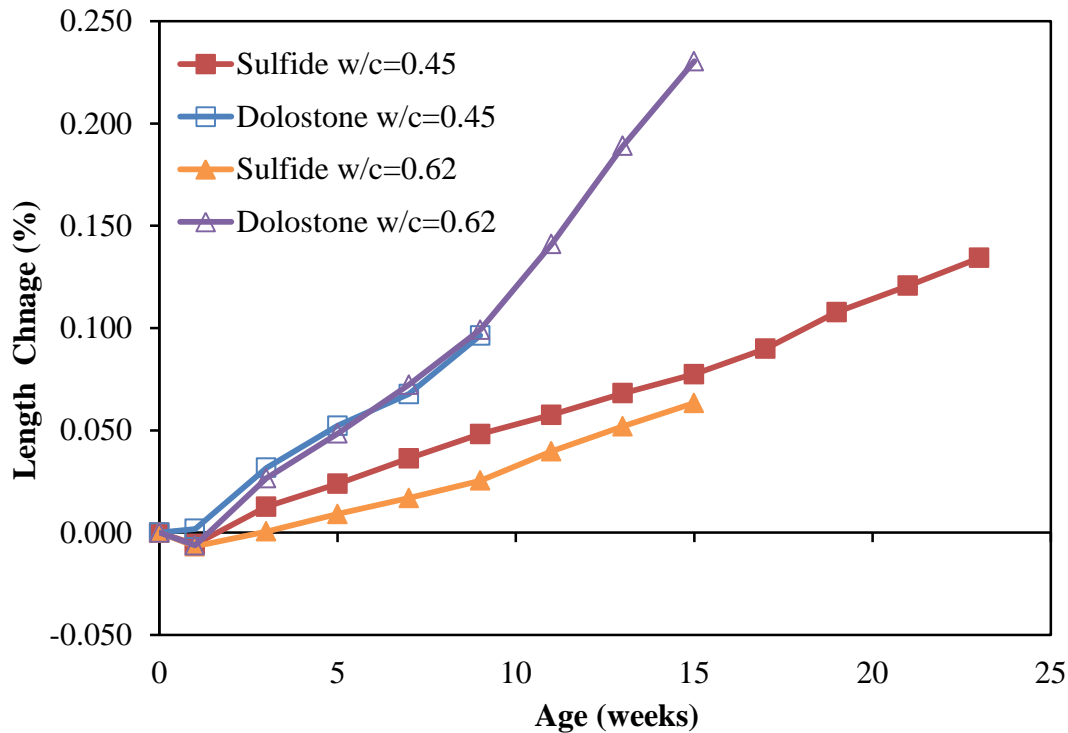
Figure 4.2.9: Phase I results from 7-days heating/drying to 150°C and 7-days soaking cycles at 5°C, thus 2 wet/dry cycles per 28-days was experienced

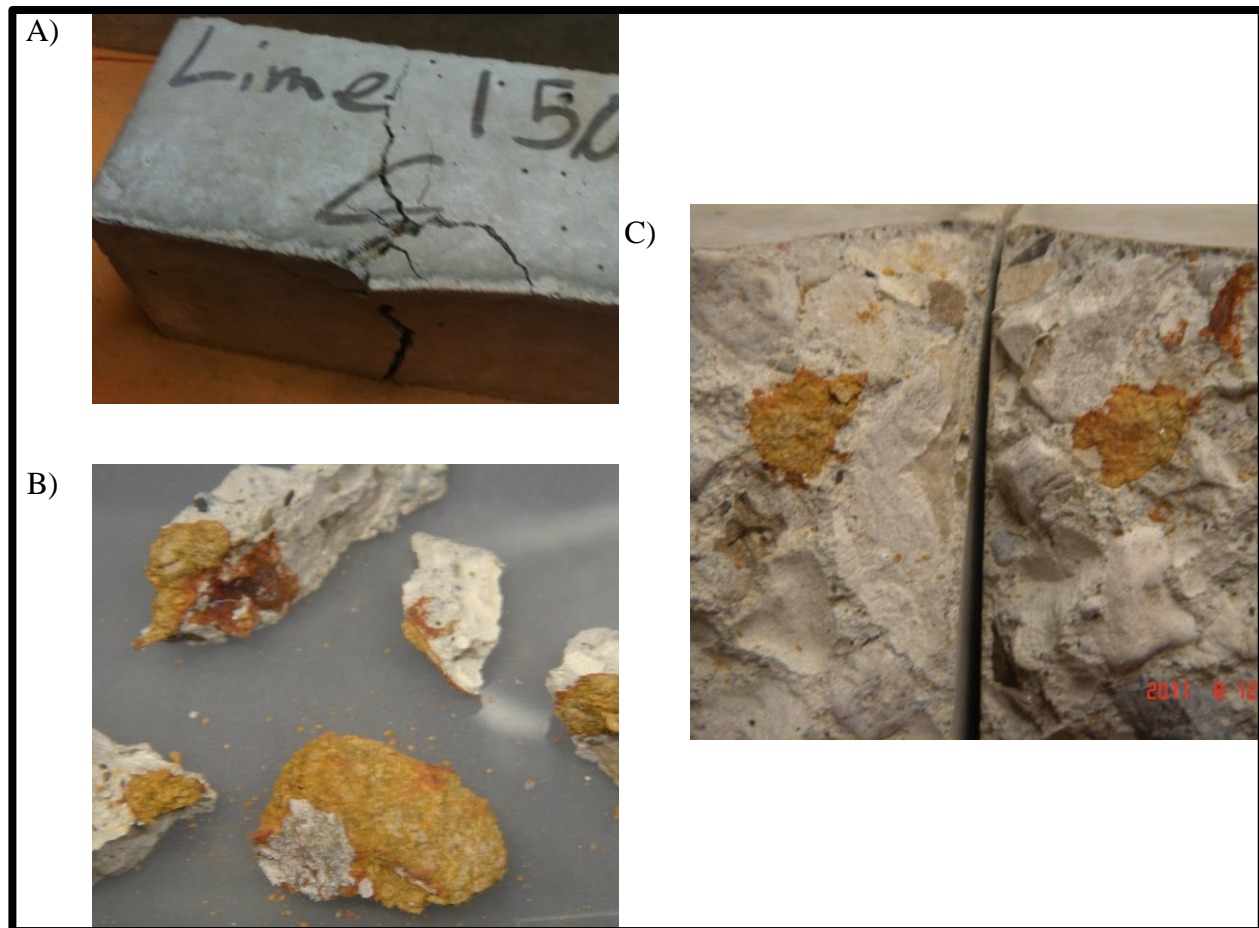
Figure 4.2.10: Images of fractured specimen from Phase I Dolostone-0.45 sample tested with 7-days heating/drying at 150°C with 7-days soaking at 5°C; fractured concrete sample shown in A) and C), removed aggregate particle causing fracture shown in B)

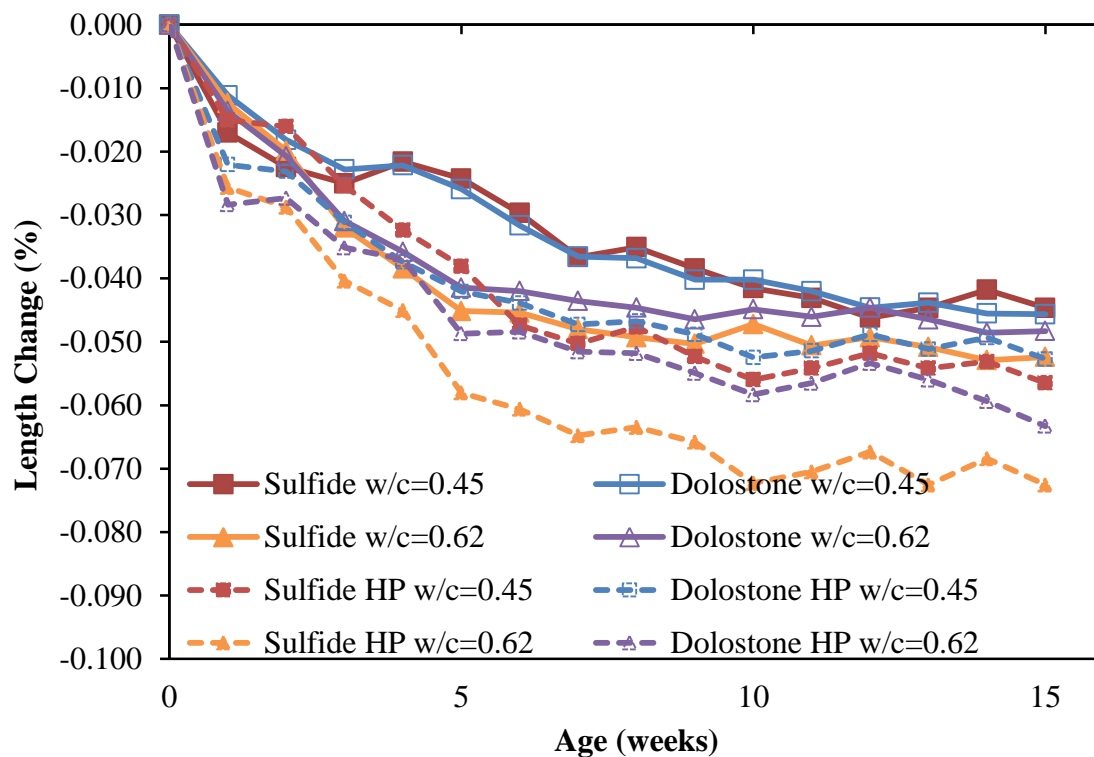
Figure 4.2.11: Phase I results from heating/cooling cycles to 60°C/23°C and no wetting cycles

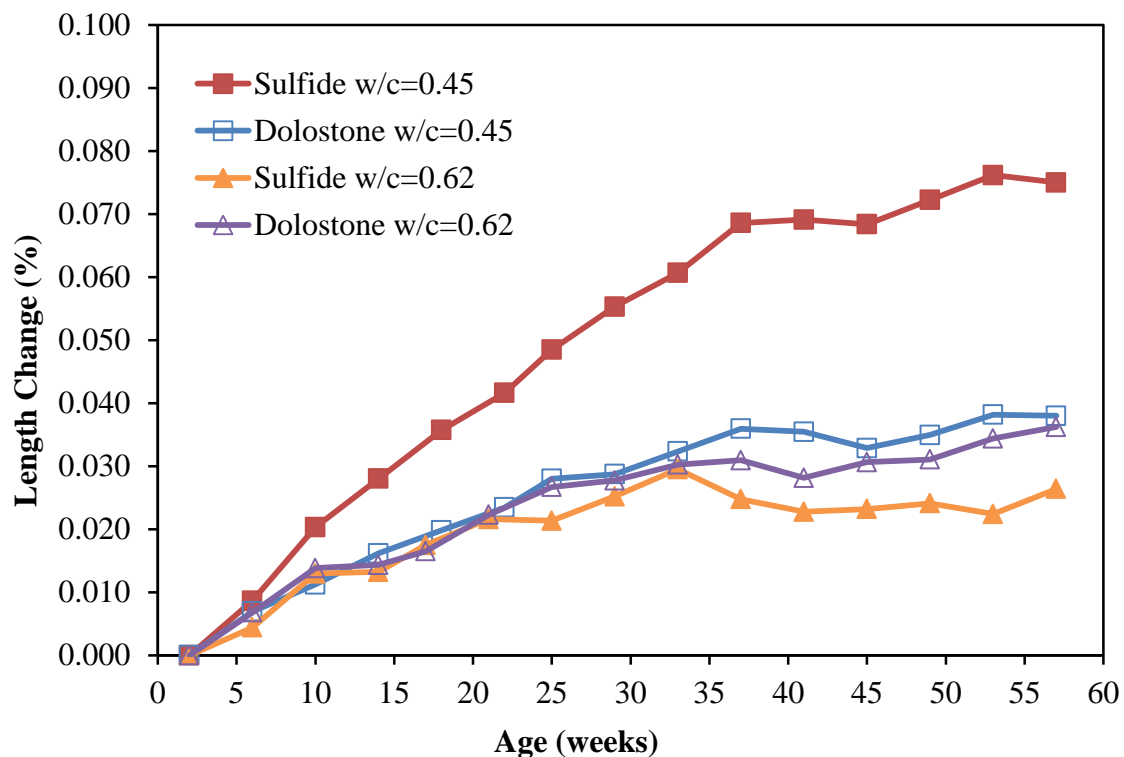
Figure 4.2.12: Phase I results from heating/drying to 60°C for 7-days and soaking cycles at 23°C for 7-days; thus 2 wet/dry cycles per 28-days were experienced

Figure 4.2.29: Side-by-side comparison of Phase I testing with 7-days soaking at 23°C from Figure 4.2.12 and 7-days soaking at 23°C from Figure 4.2.28; tested with 7-days drying at 60°C

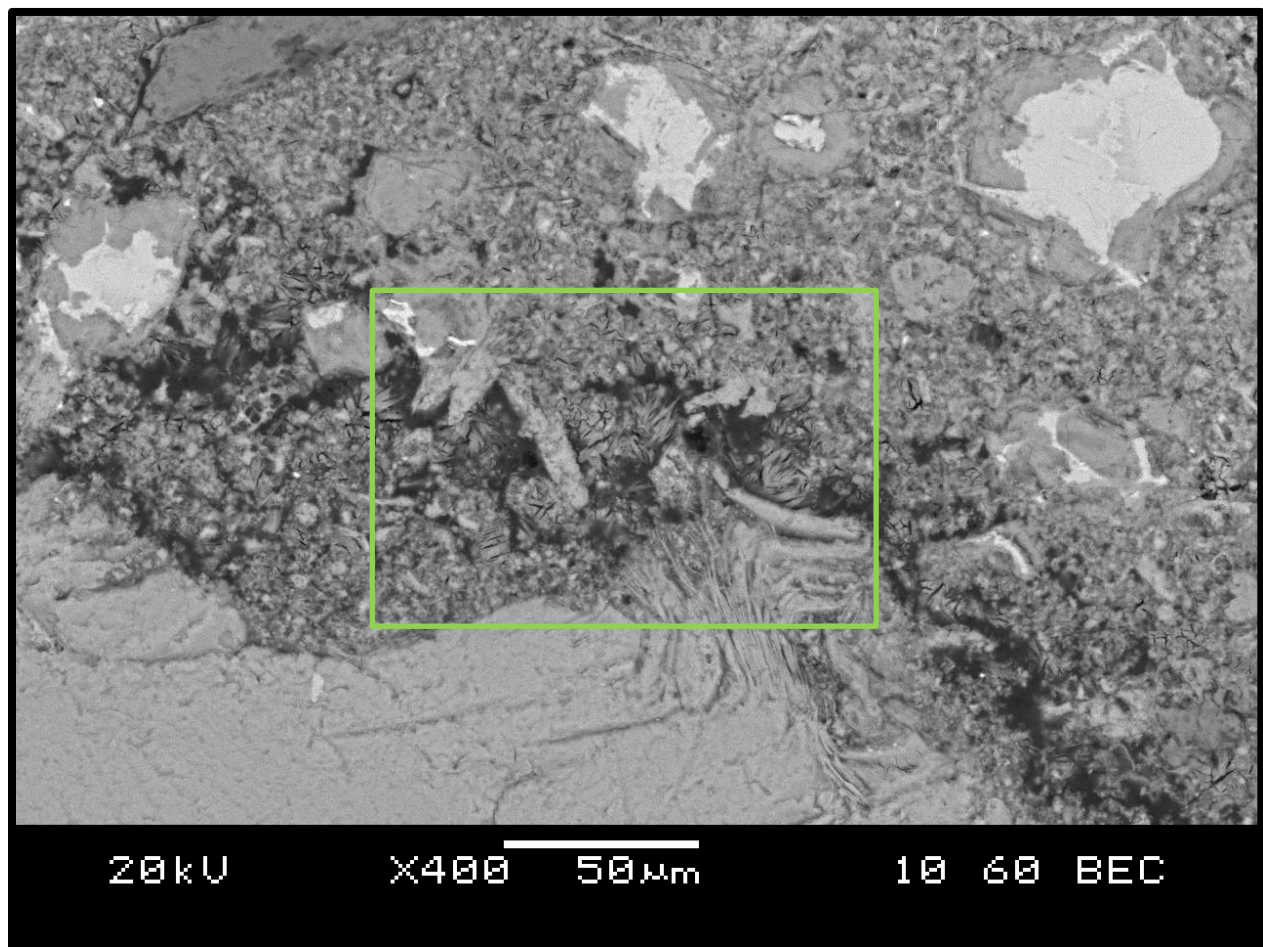
Figure 4.2.13: SEM image of Phase I Sulfide-0.45 sample showing ettringite in paste at 57-weeks of testing; made with Sulfide aggregate, 0.65 w/c, and tested with 7-days drying at 60°C and 7-days soaking at 23°C

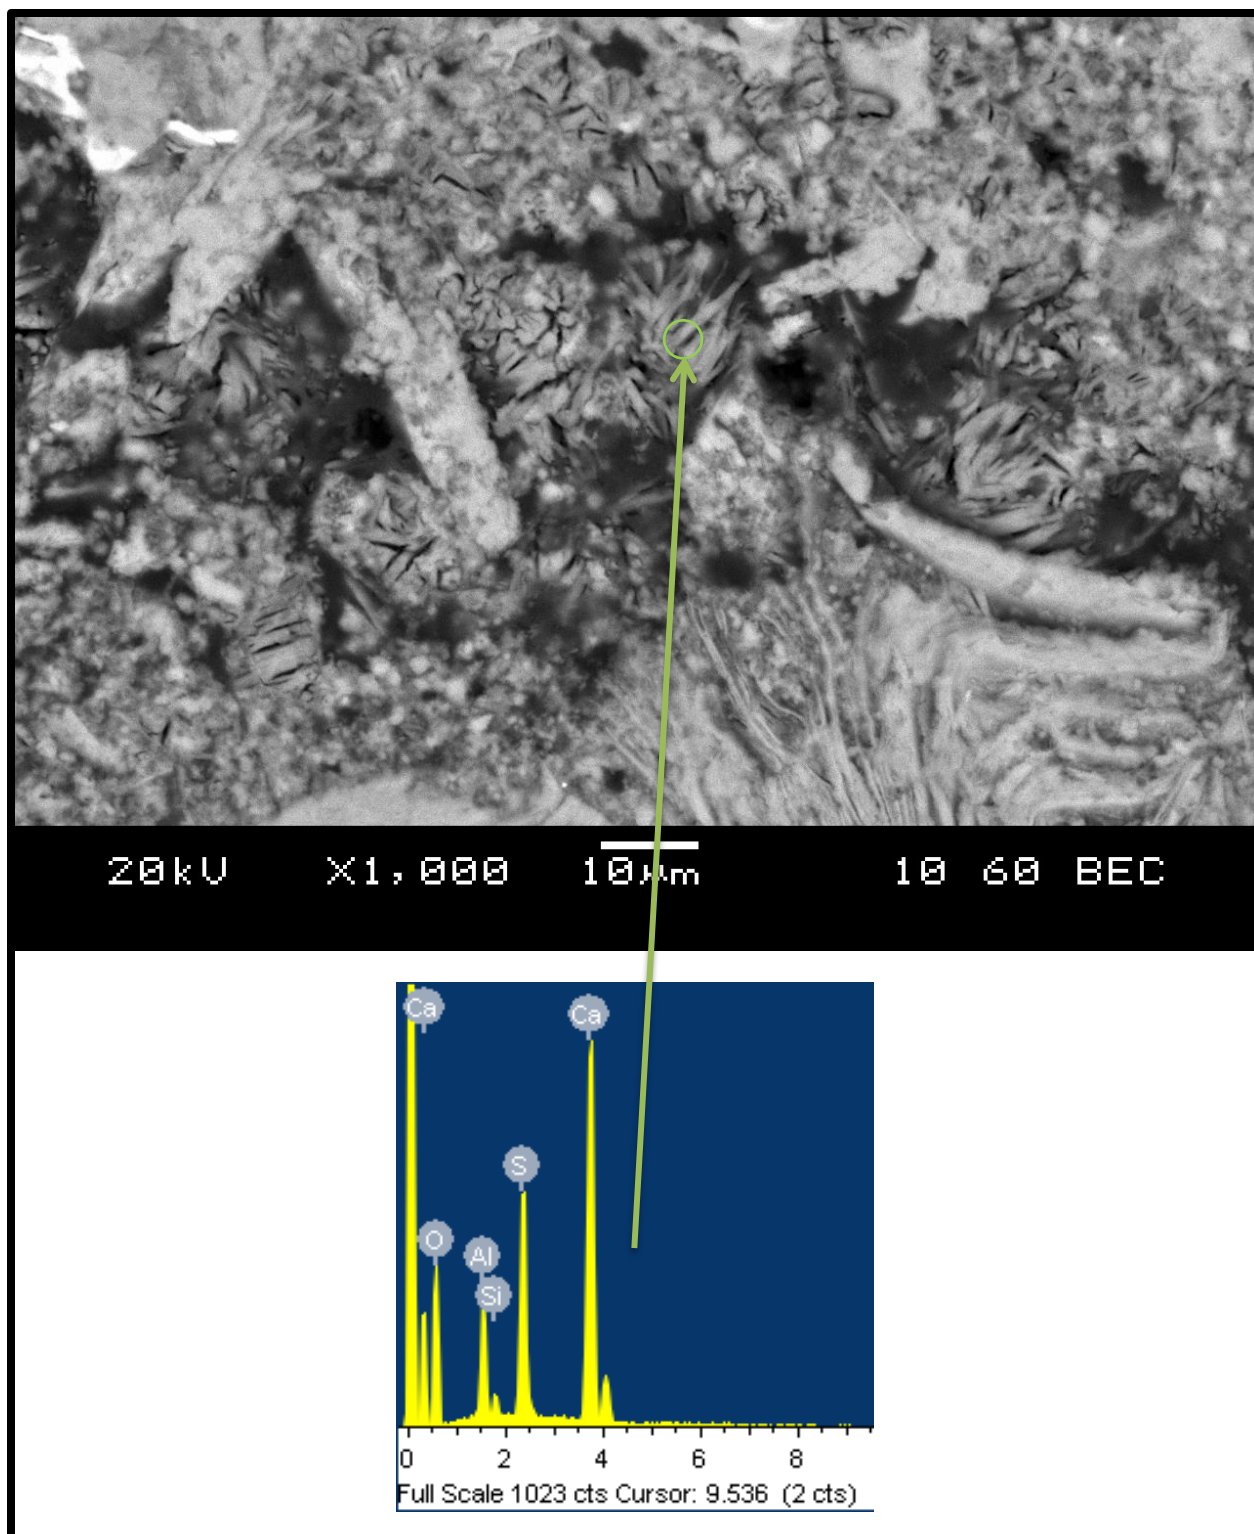
Figure 4.2.14: SEM image and EDS analysis of Phase I Sulfide-0.45 sample showing condensed ettringite at 57-weeks of testing; made with Sulfide aggregate, 0.65 w/c, and tested with 7-days drying at 60°C and 7-days soaking at 23°C
