Deterioration Caused By Sulfide-Bearing Aggregates: Performance Test Development

**DETERIORATION CAUSED BY SULFIDE-BEARING AGGREGATES:
PERFORMANCE TEST DEVELOPMENT**

in partial fulfillment of the
requirements for the degree of
Master of Applied Science
in the Program of
Civil Engineering

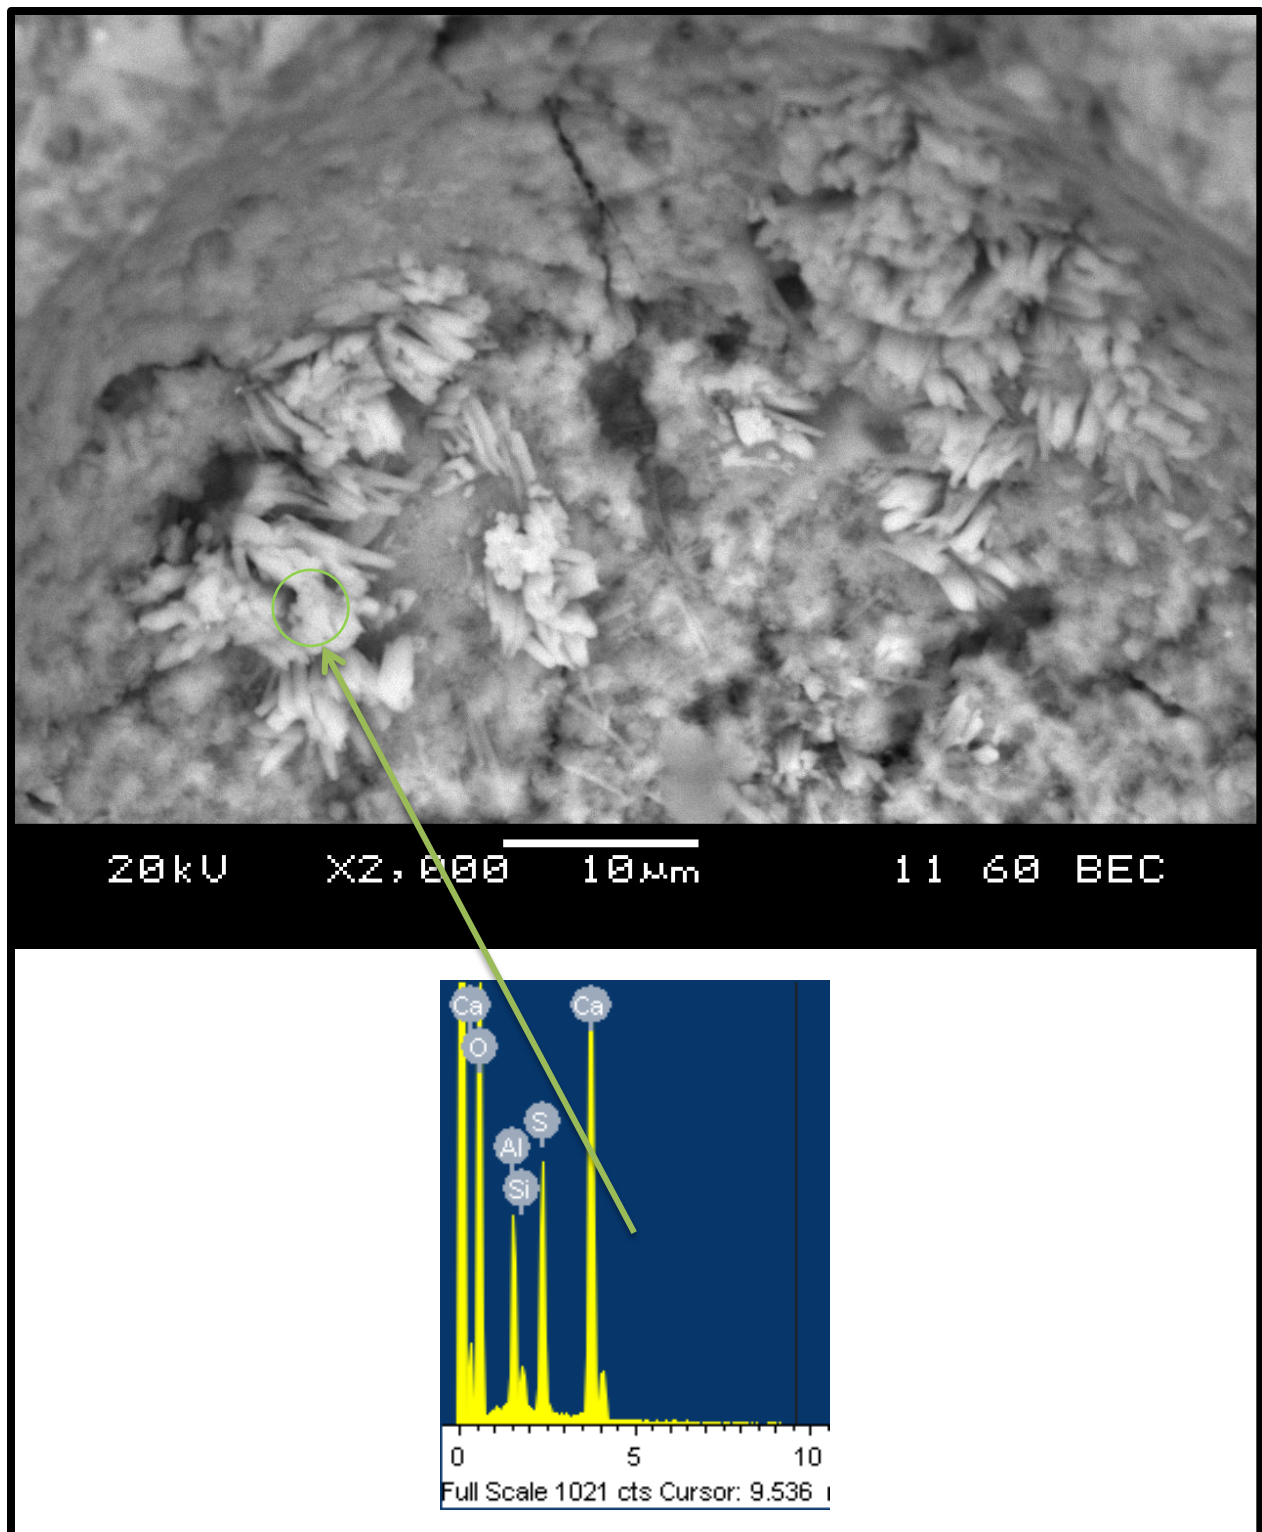
Figure 4.2.15: SEM image and EDS analysis of Phase I Sulfide-0.45 sample showing ettringite crystals in an air void at 57-weeks of testing; made with Sulfide aggregate, 0.65 w/c, and tested with 7-days drying at 60°C and 7-days soaking at 23°C

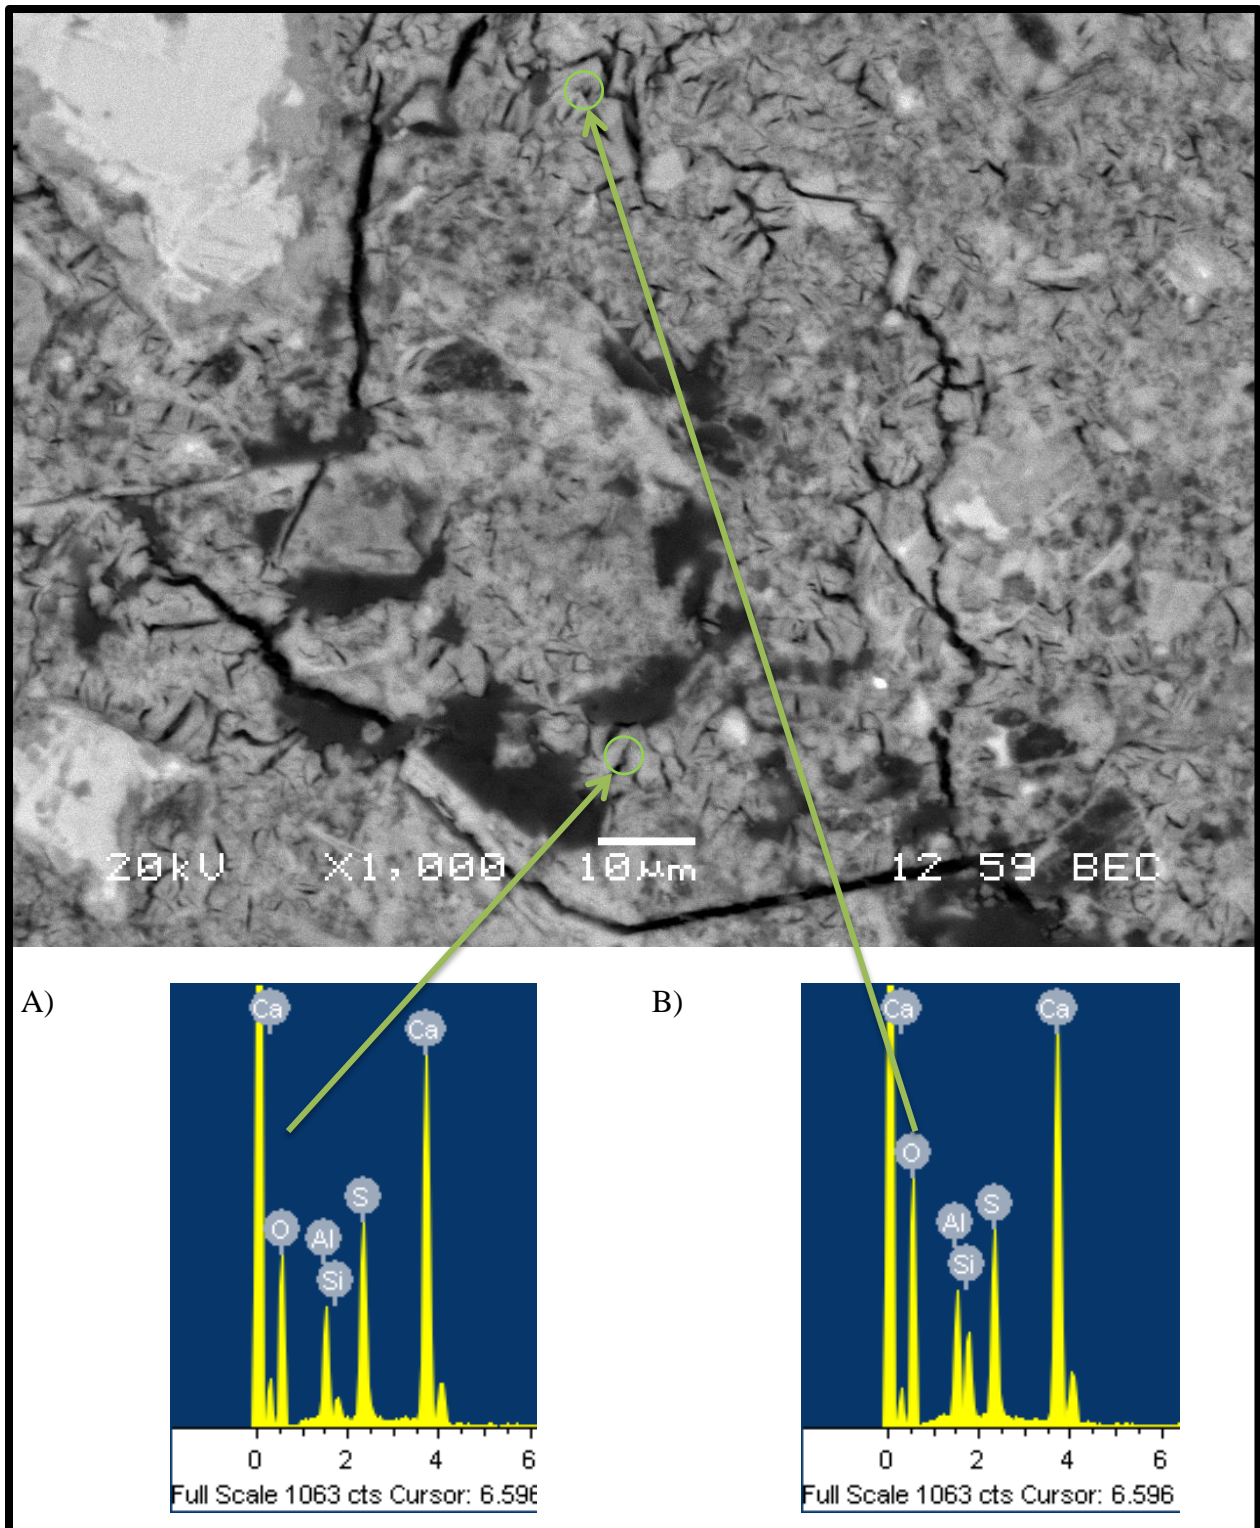
Figure 4.2.17: SEM image and EDS analysis of I-S60/23 showing condensed ettringite within the cement matrix; made with Sulfide aggregate, 0.65 w/c, and tested with 7-days drying at 60°C and 7-days soaking at 23°C

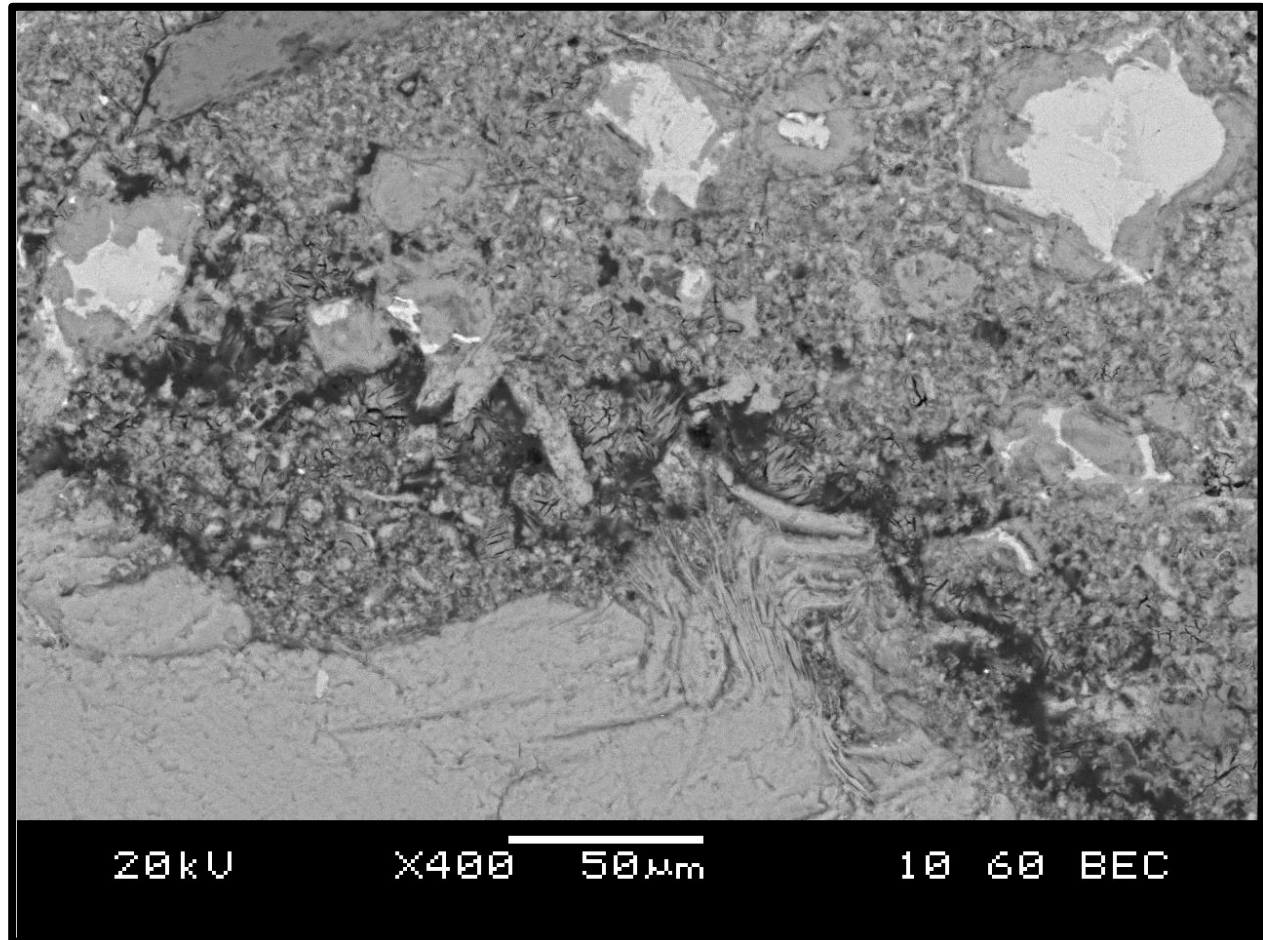
Figure 4.2.19: SEM image of I-S60/23 showing iron interaction with paste; made with Sulfide aggregate, 0.65 w/c, and tested with 7-days drying at 60°C and 7-days soaking at 23°C

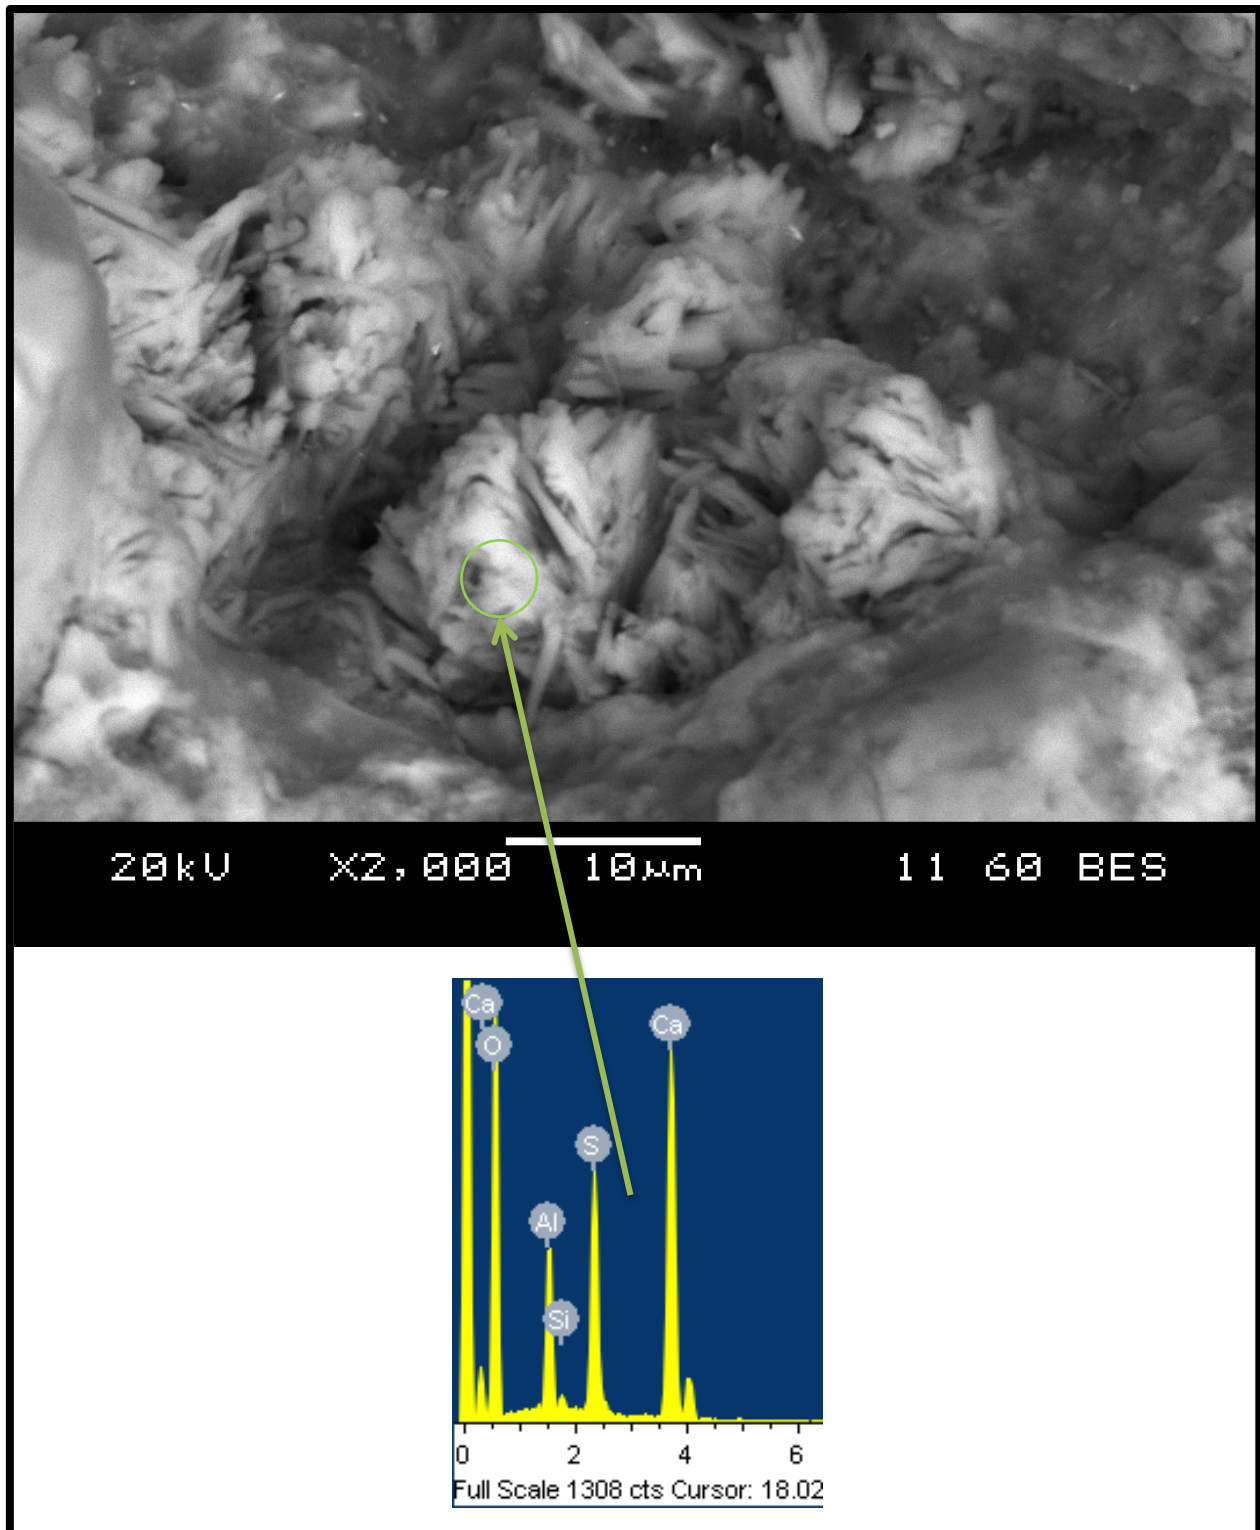
Figure 4.2.25: SEM image and EDS analysis of I-D60/23 showing ettringite crystals in an air void; made with Dolostone aggregate, 0.65 w/c, and tested with 7-days drying at 60°C and 7-days soaking at 23°C

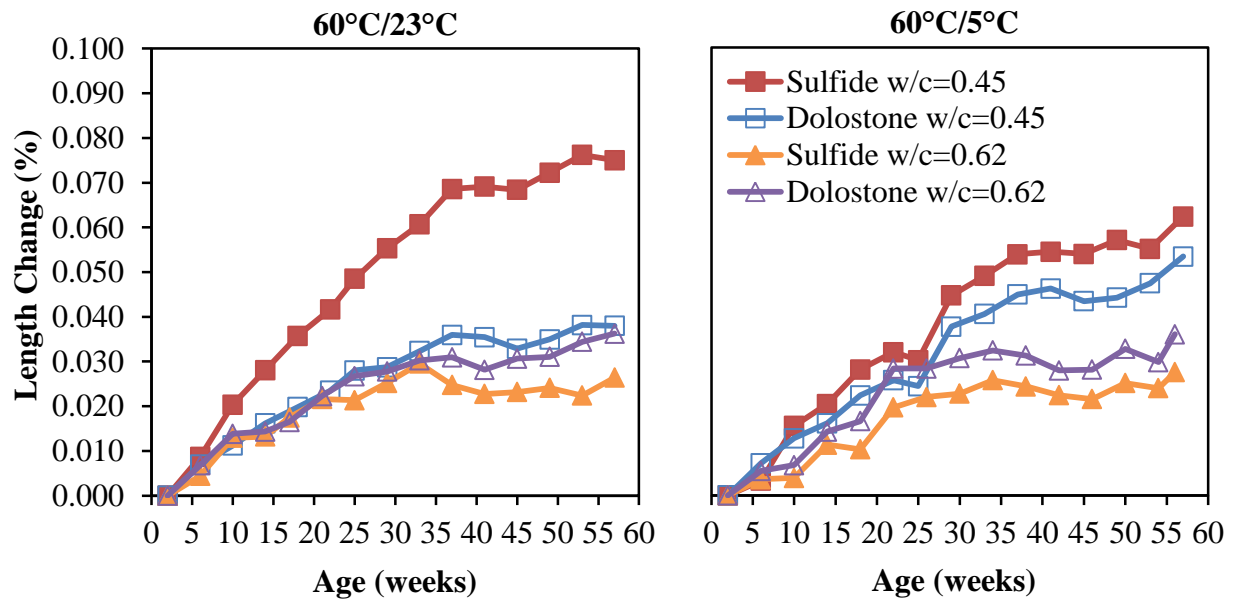
Figure 4.2.29: Side-by-side comparison of Phase I testing with 7-days soaking at 23°C from Figure 4.2.12 and 7-days soaking at 23°C from Figure 4.2.28; tested with 7-days drying at 60°C

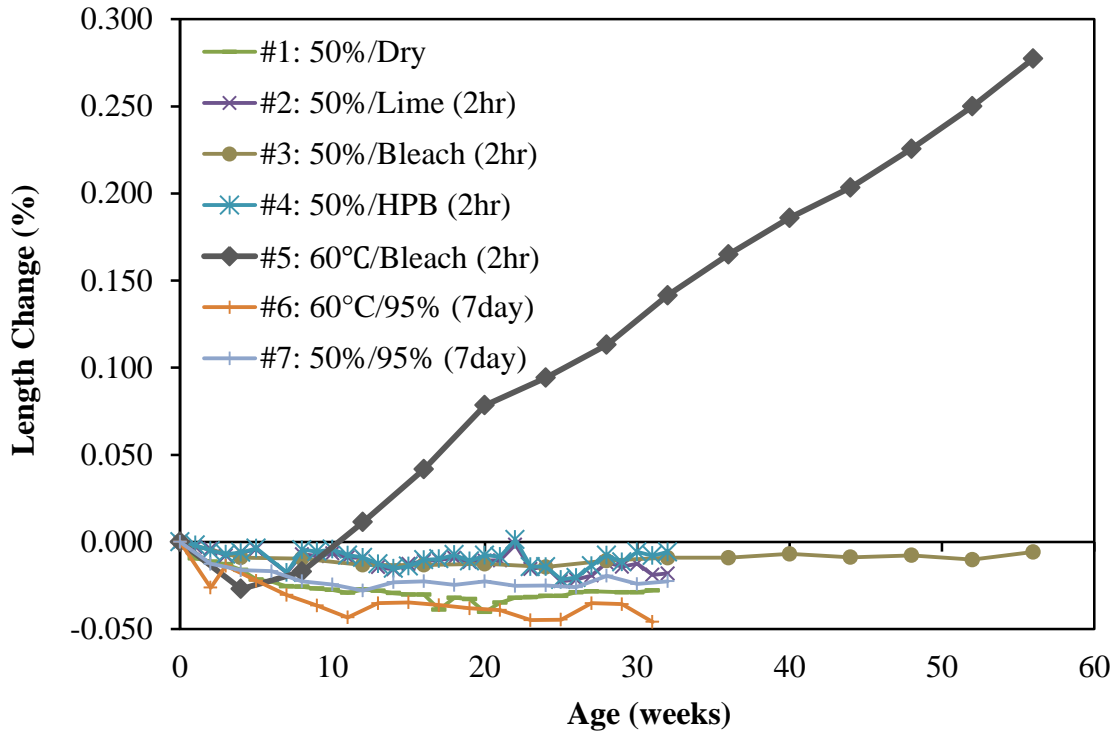
Figure 4.3.1: Phase II Series 1 results for sulphide aggregate with w/c of 0.65; all soaking was at 23°C after 24-hours stabilization

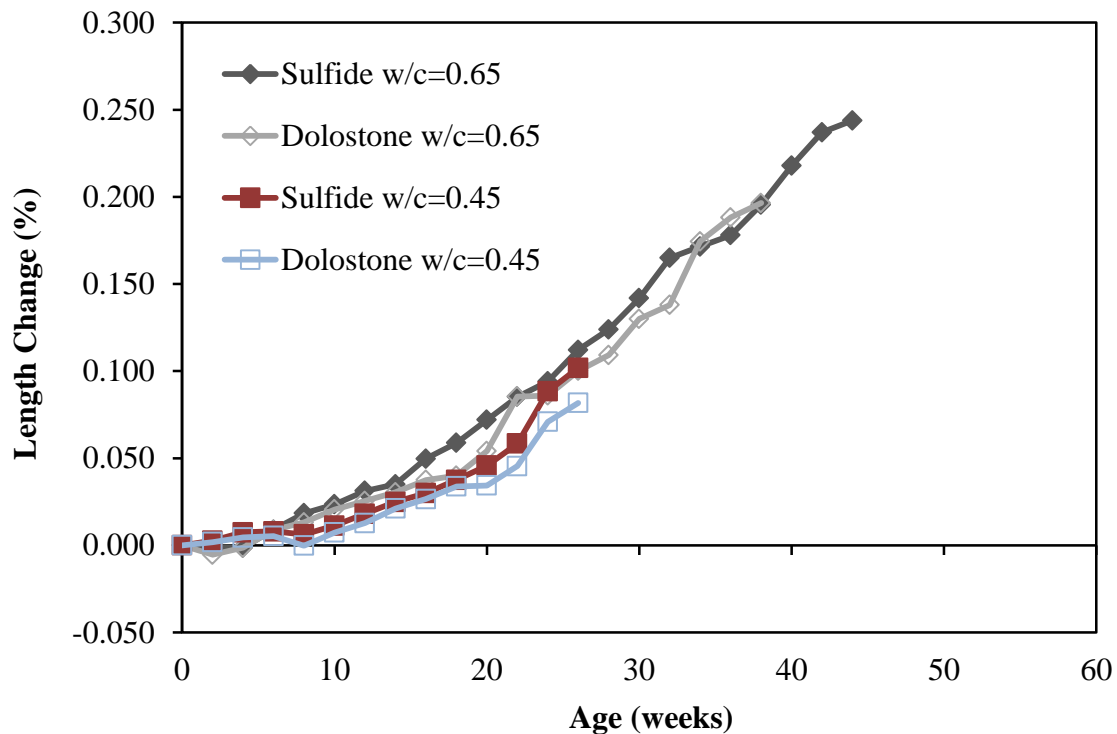
Figure 4.3.3: Phase II Series 2 Results; all samples tested with drying at 60°C and 2-hours soaking in bleach at 23°C twice a week

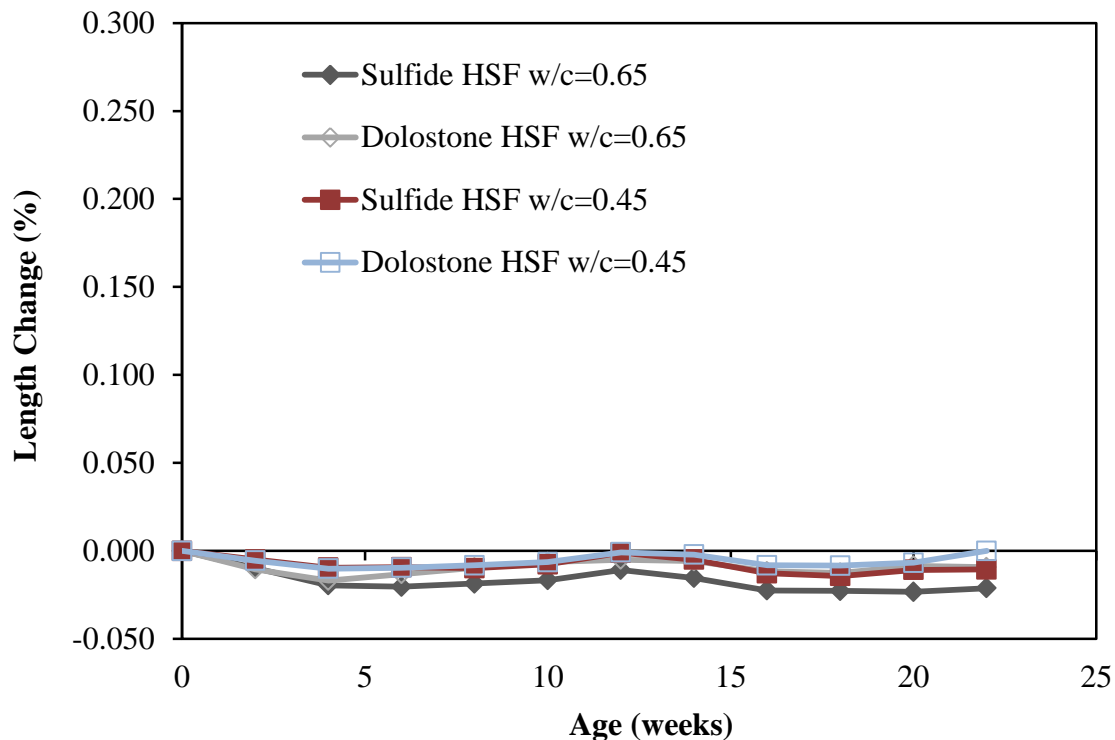
Figure 4.3.4: Phase II Series 2 Results; all samples made with HSF cement and tested with drying at 60°C and 2-hours soaking in bleach at 23°C twice a week

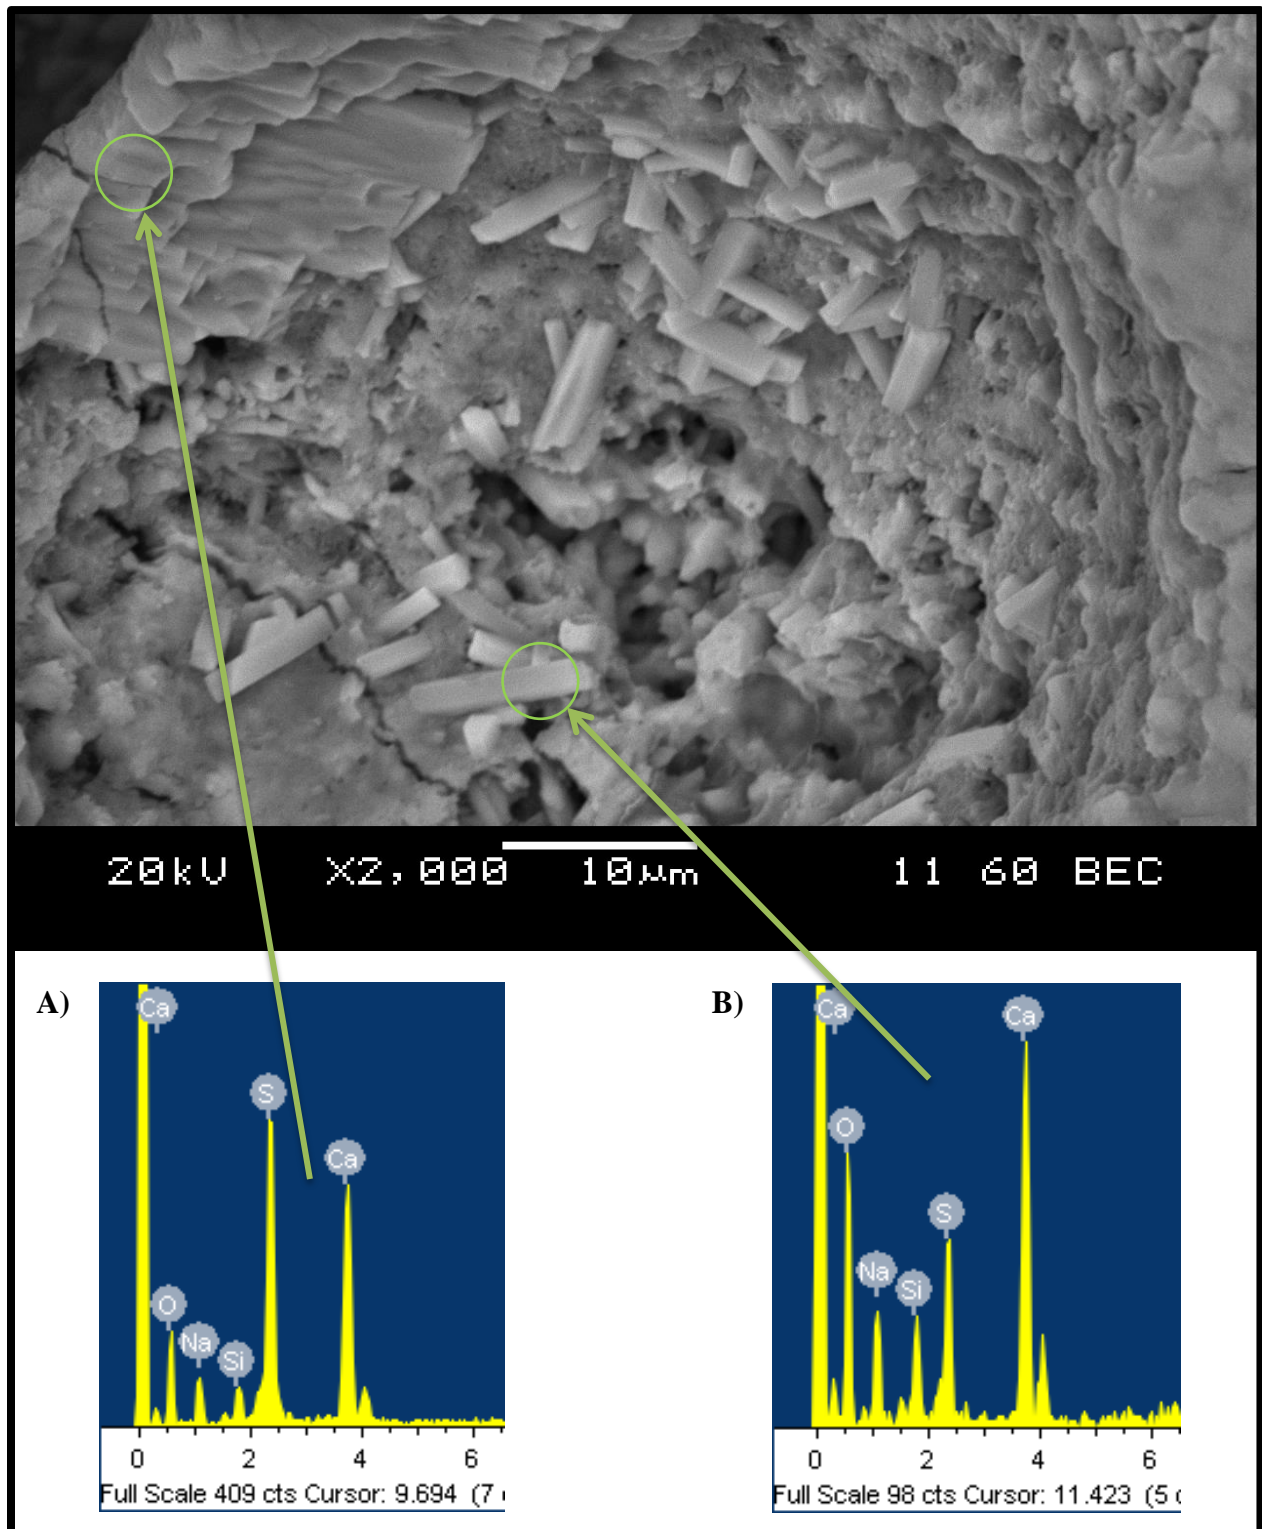
Figure 4.3.7: SEM image and EDS analysis for II-S60A showing gypsum crystals; made with Sulfide coarse aggregate, w/c of 0.65, and tested with drying at 60°C and 2-hours soaking in bleach at 23°C twice a week

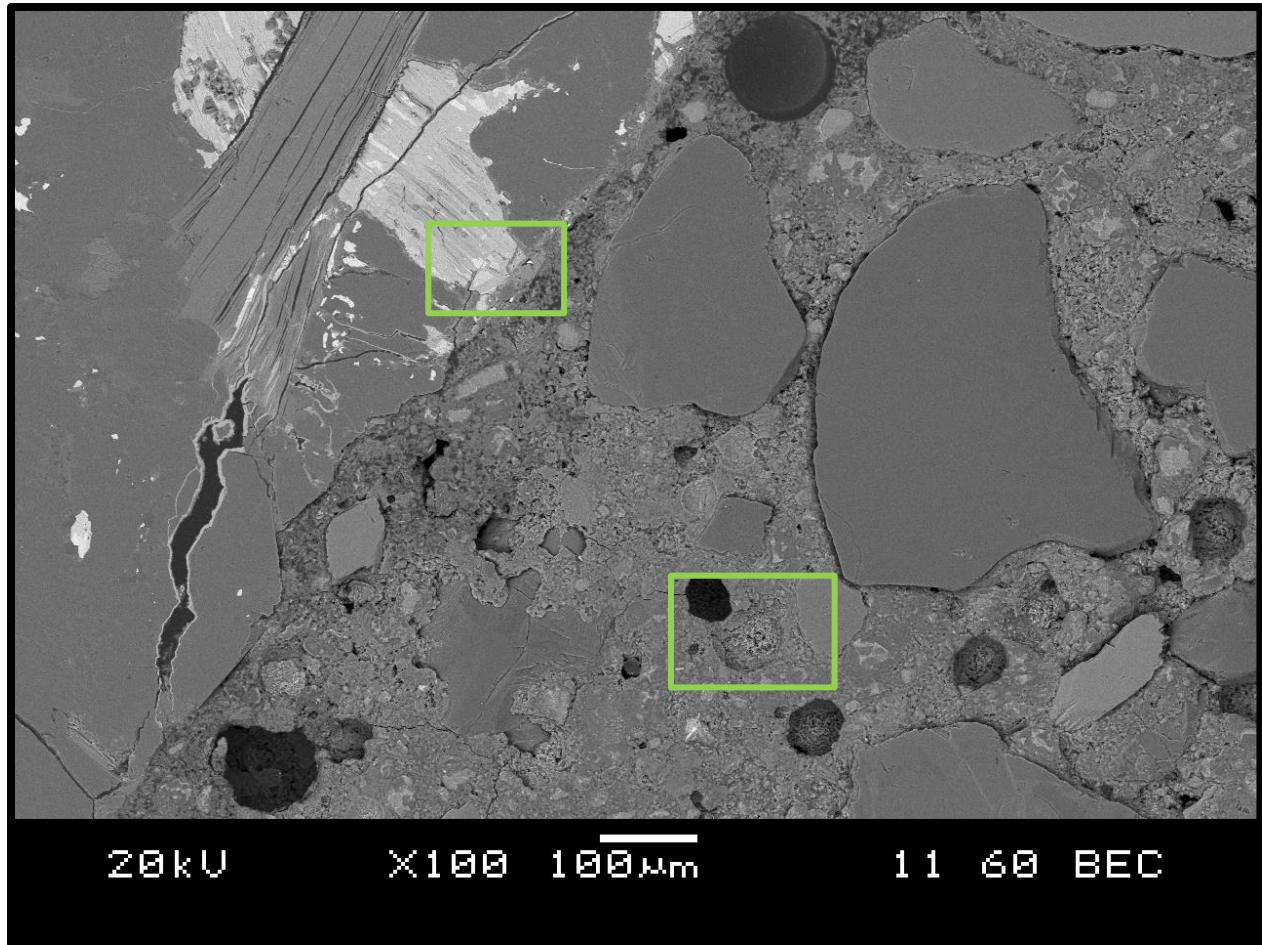
Figure 4.3.9: SEM image for II-S60A showing large analysis area; made with Sulfide coarse aggregate, w/c of 0.65, and tested with drying at 60°C and 2-hours soaking in bleach at 23°C twice a week

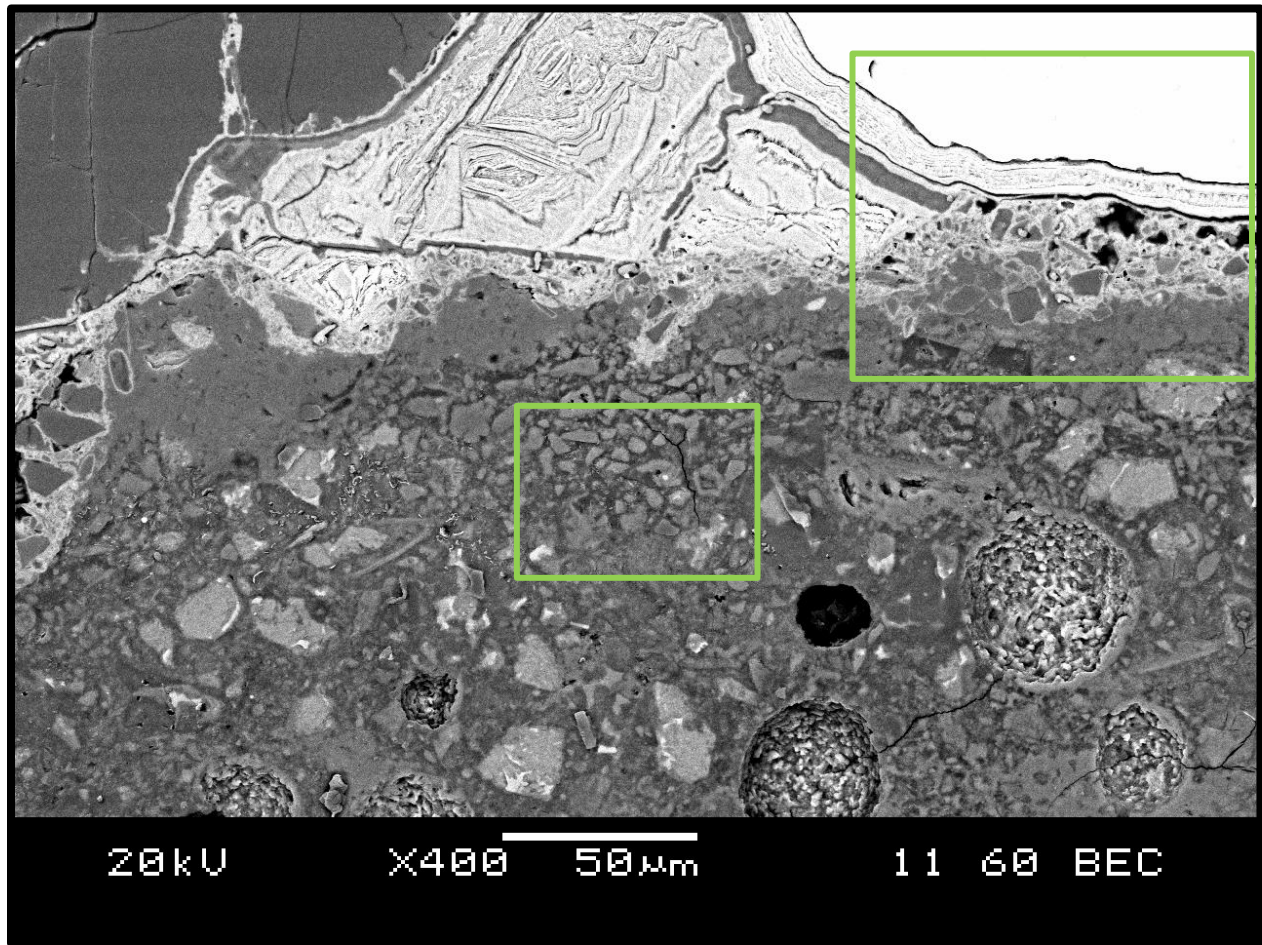
Figure 4.3.10: SEM image and EDS analysis for II-S60A showing gypsum and large area; made with Sulfide coarse aggregate, w/c of 0.65, and tested with drying at 60°C and 2-hours soaking in bleach at 23°C twice a week

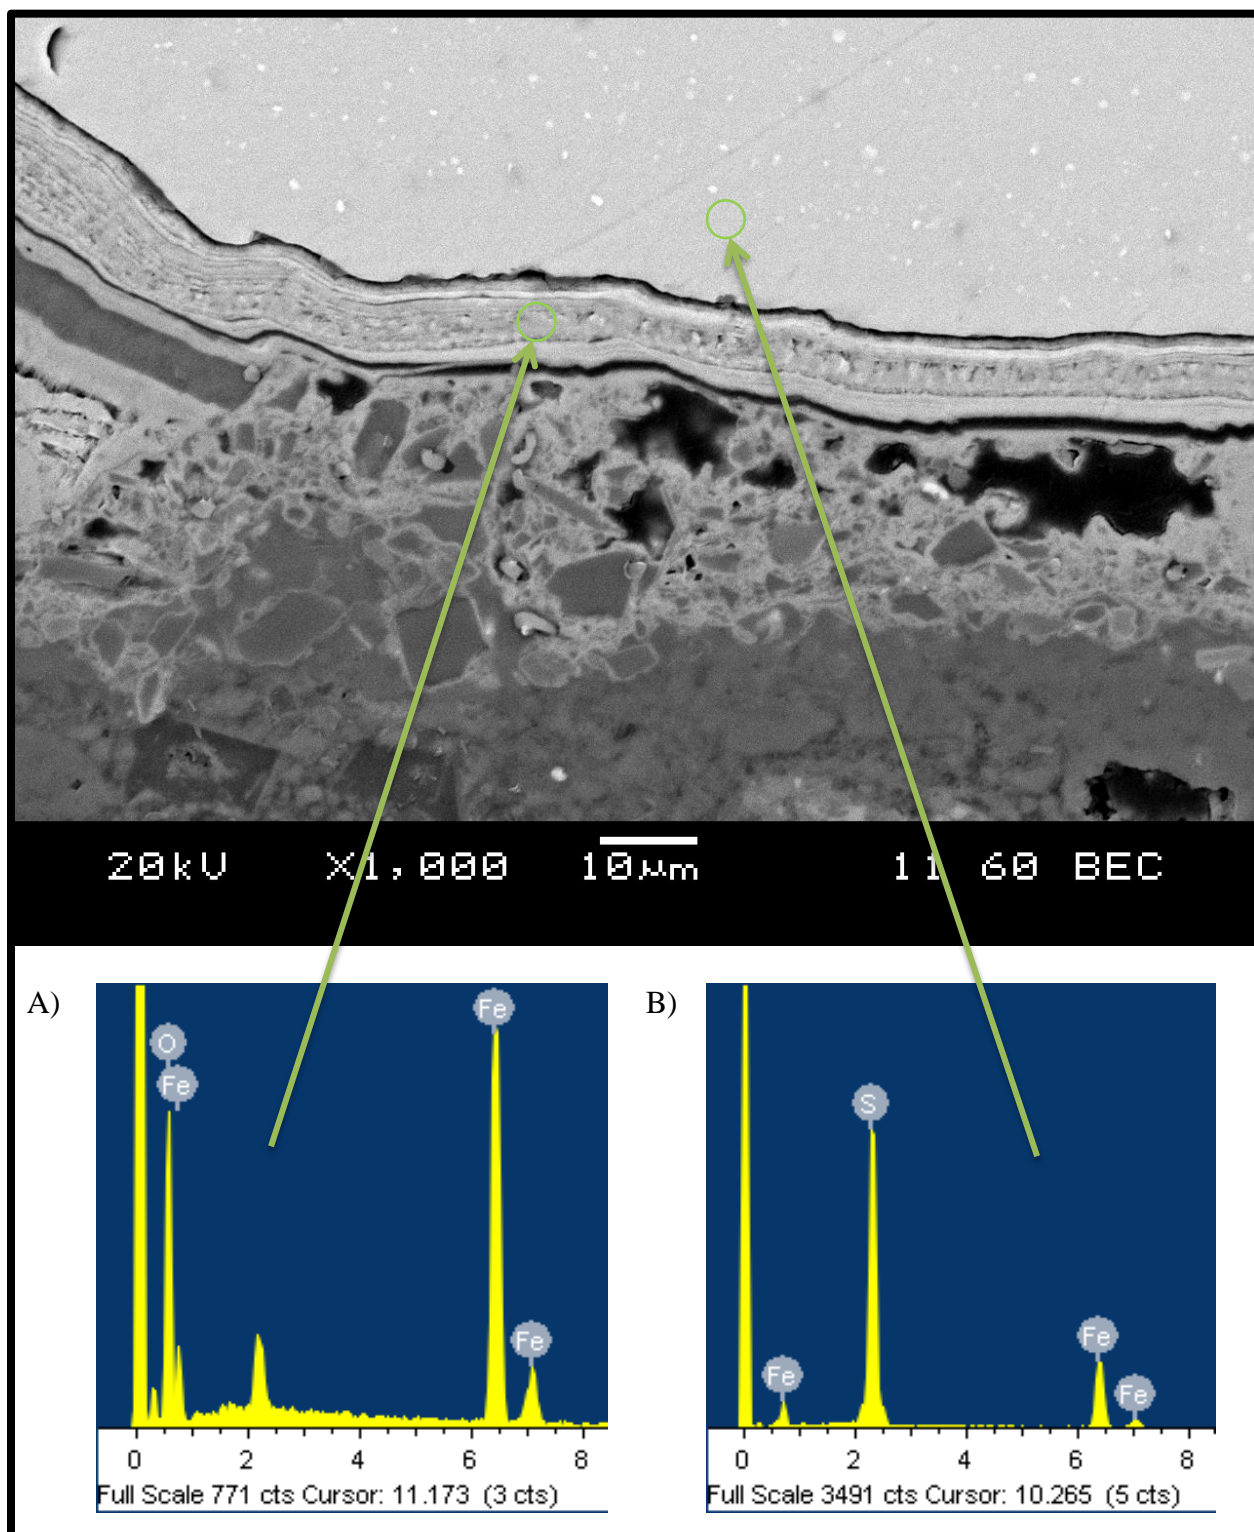
Figure 4.3.11: SEM image and EDS analysis for II-S60A showing oxidized pyrrhotite; made with Sulfide coarse aggregate, w/c of 0.65, and tested with drying at 60°C and 2-hours soaking in bleach at 23°C twice a week

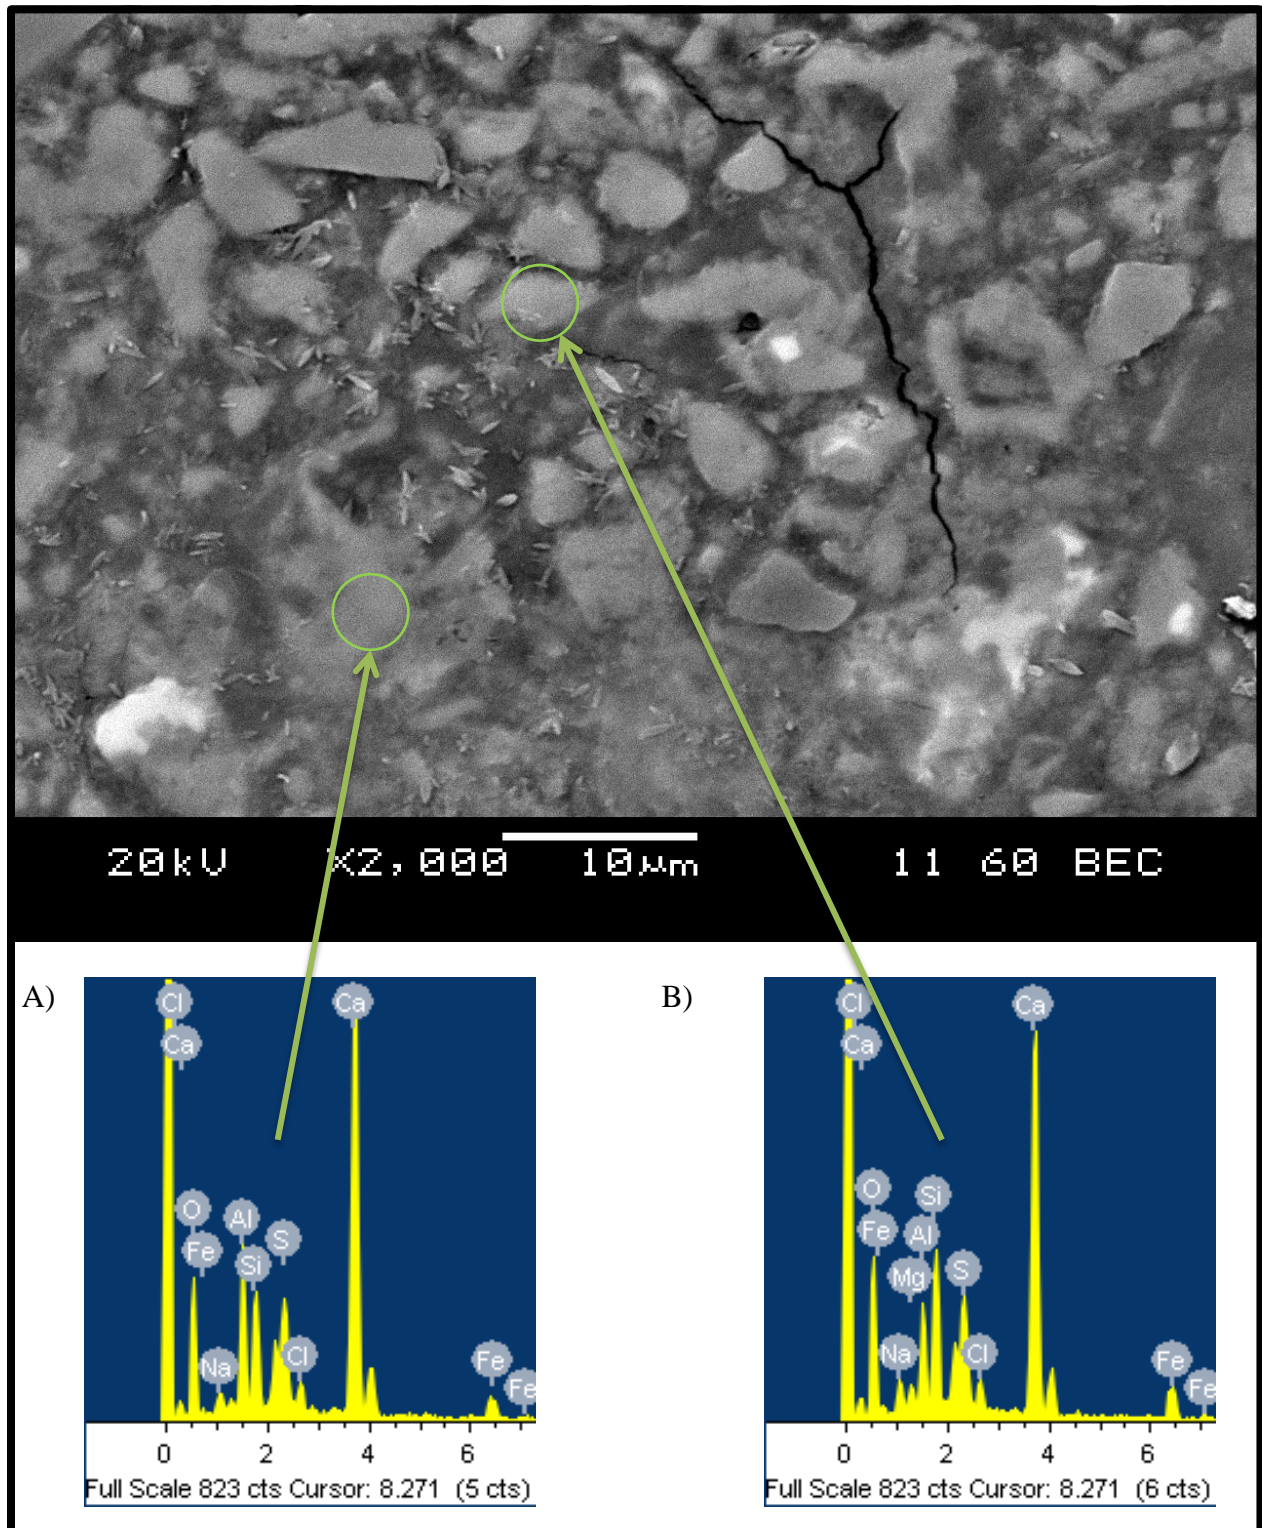
Figure 4.3.15: SEM image and EDS analysis for II-S60A showing presence of sulfur; made with Sulfide coarse aggregate, w/c of 0.65, and tested with drying at 60°C and 2-hours soaking in bleach at 23°C twice a week

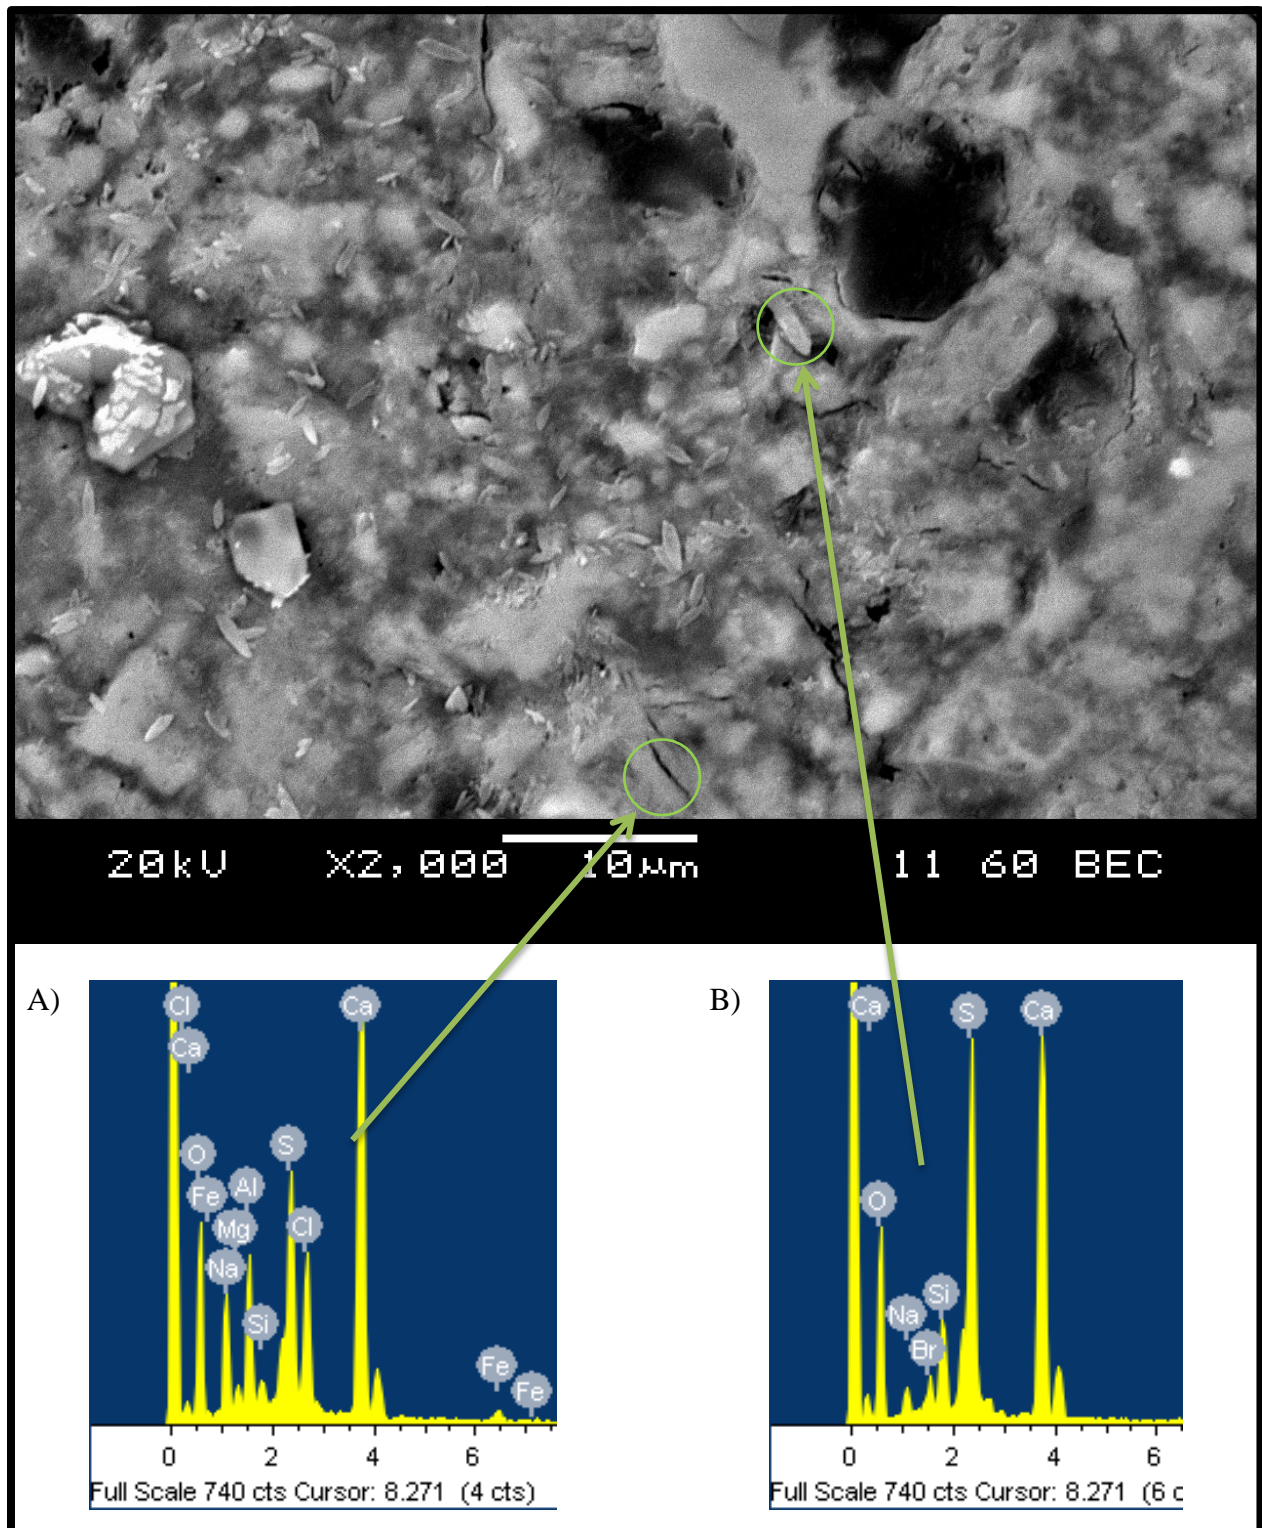
Figure 4.3.16: SEM image and EDS analysis for II-S60A showing gypsum and Friedel's salt; made with Sulfide coarse aggregate, w/c of 0.65, and tested with drying at 60°C and 2-hours soaking in bleach at 23°C twice a week

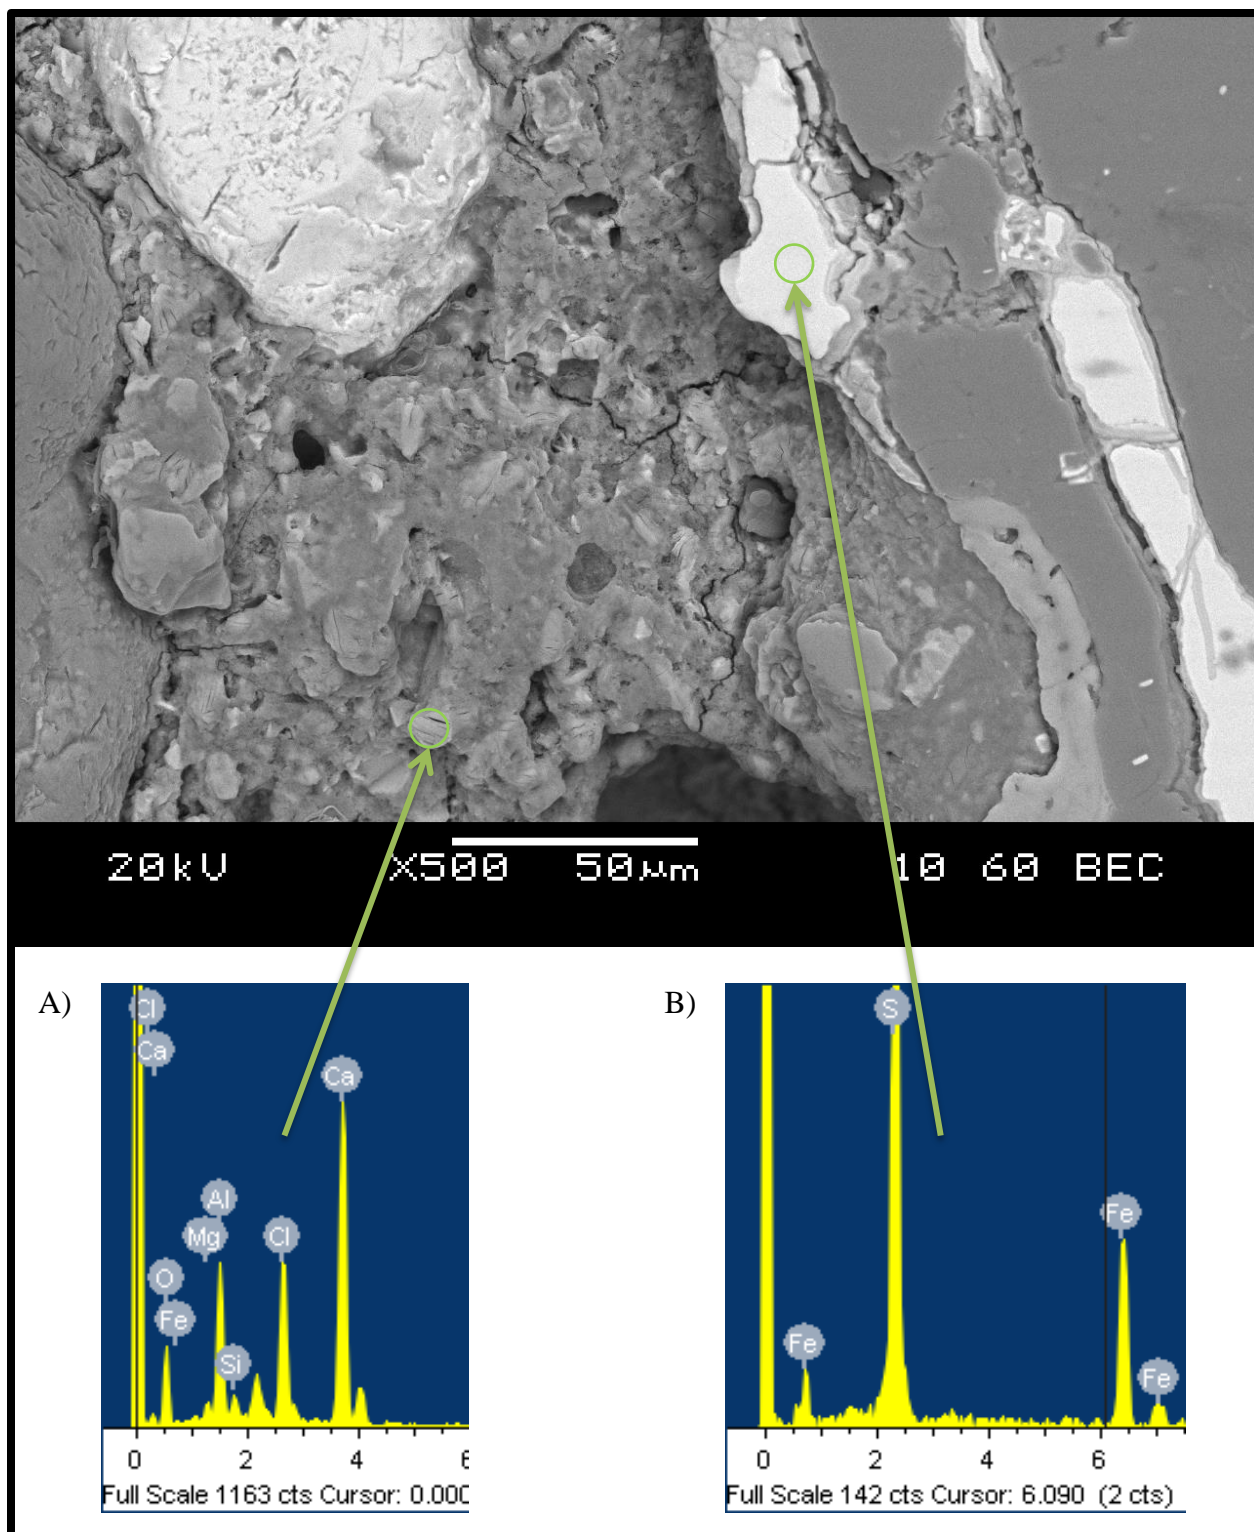
Figure 4.3.17: SEM image and EDS analysis for II-S60A showing Friedel's salt; made with Sulfide coarse aggregate, w/c of 0.65, and tested with drying at 60°C and 2-hours soaking in bleach at 23°C twice a week
