Deterioration Caused By Sulfide-Bearing Aggregates: Performance Test Development

**DETERIORATION CAUSED BY SULFIDE-BEARING AGGREGATES:
PERFORMANCE TEST DEVELOPMENT**

in partial fulfillment of the
requirements for the degree of
Master of Applied Science
in the Program of
Civil Engineering

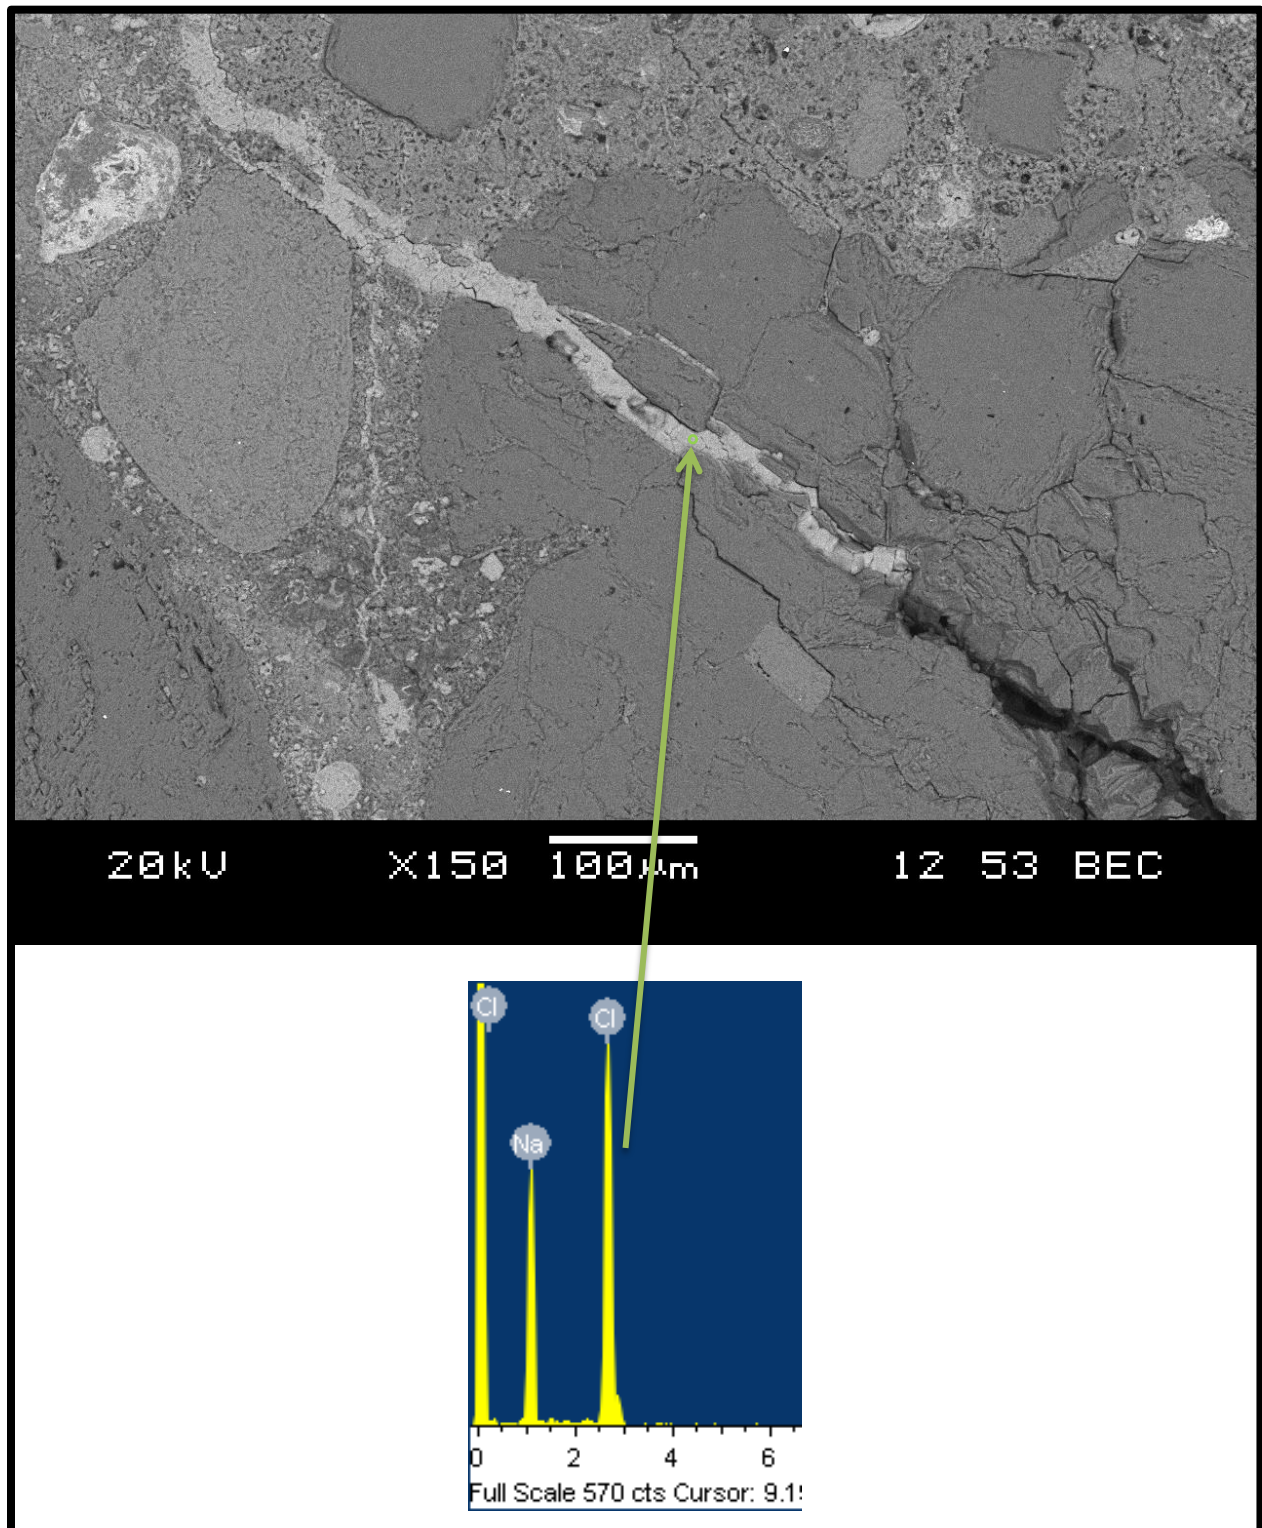
Figure 4.3.21: SEM image and EDS analysis for II-S60B showing NaCl salts in crack; made with Sulfide coarse aggregate, w/c of 0.65, and tested with drying at 60°C and 2-hours soaking in bleach at 23°C twice a week

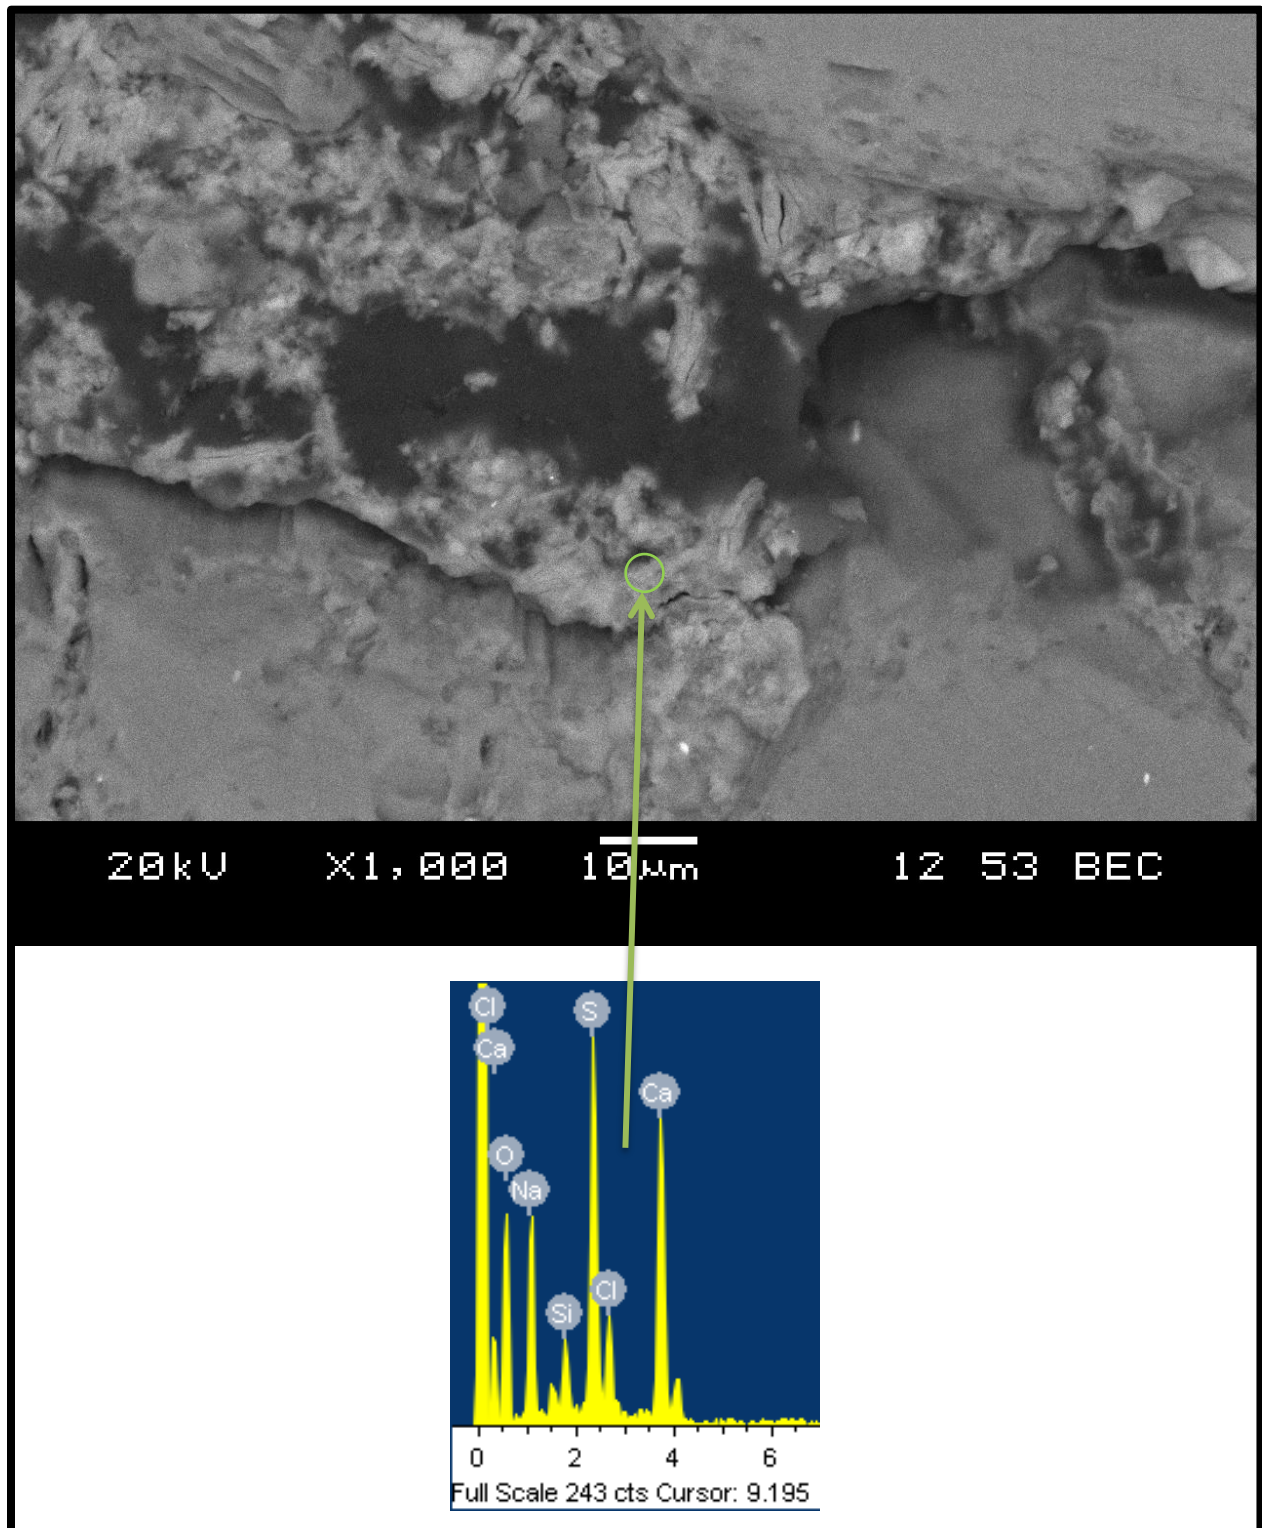
Figure 4.3.22: SEM image and EDS analysis for II-S60B showing gypsum in ITZ; made with Sulfide coarse aggregate, w/c of 0.65, and tested with drying at 60°C and 2-hours soaking in bleach at 23°C twice a week

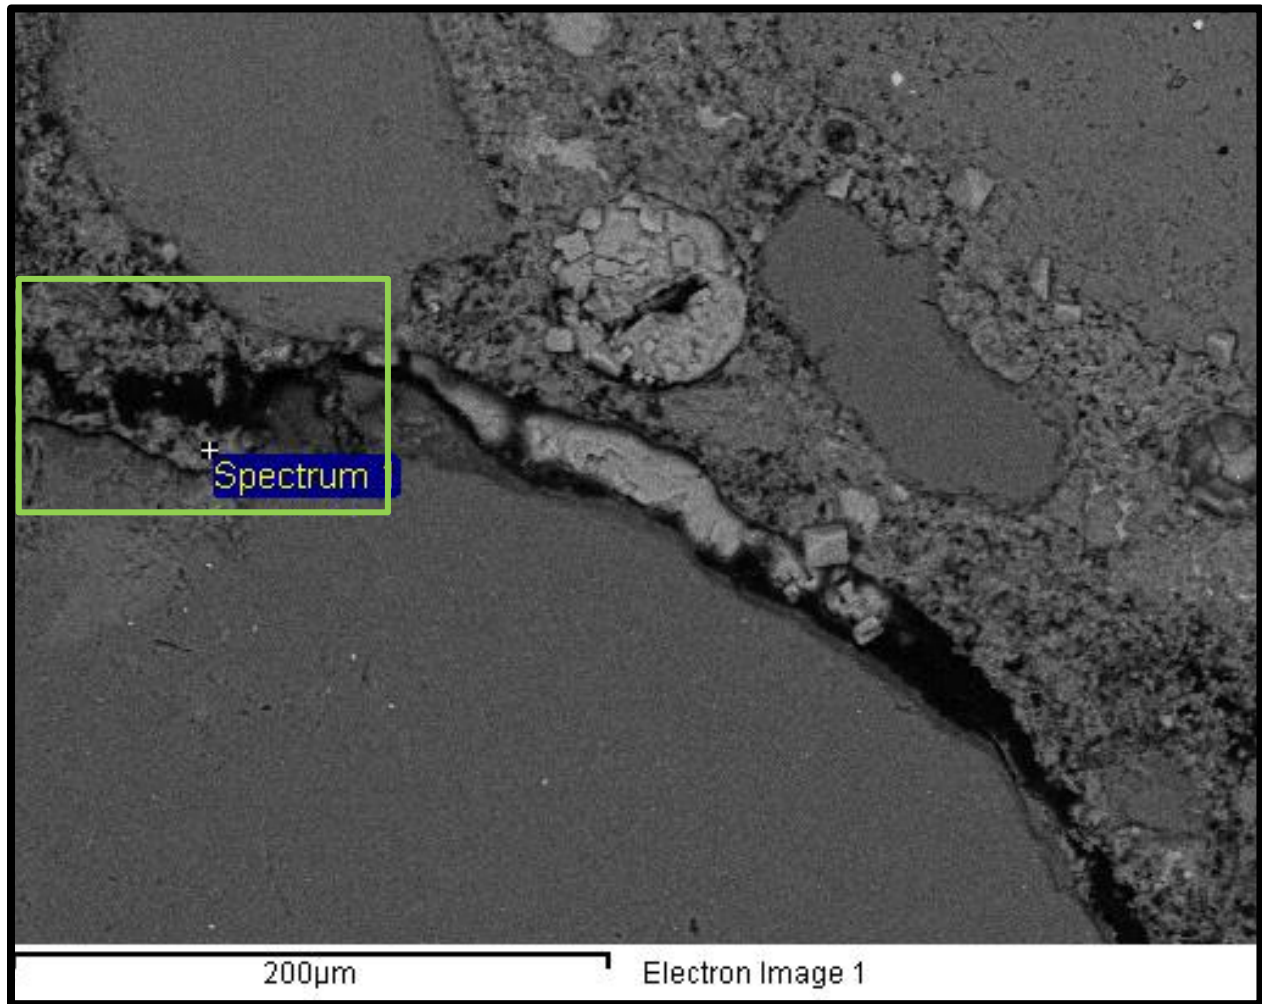
Figure 4.3.23: SEM image for II-S60B showing NaCl salts in crack; made with Sulfide coarse aggregate, w/c of 0.65, and tested with drying at 60°C and 2-hours soaking in bleach at 23°C twice a week

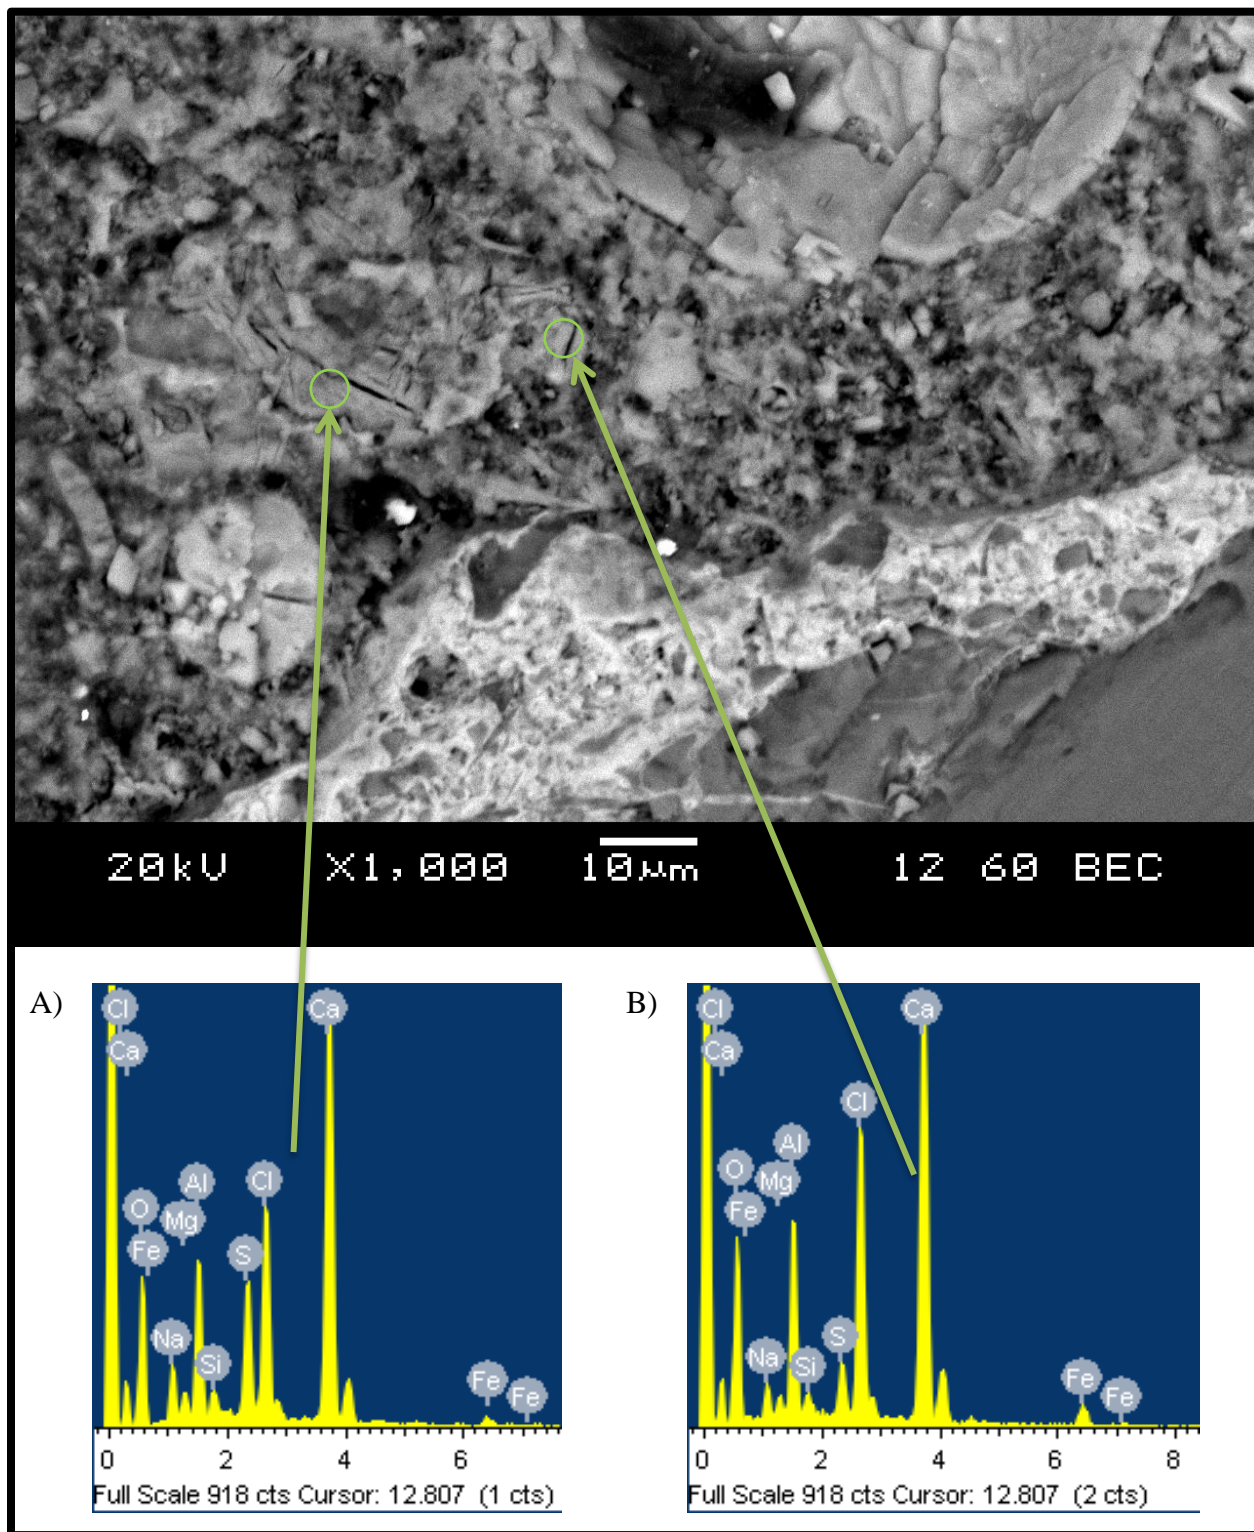
Figure 4.3.24: SEM image and EDS analysis for II-S60B showing Friedel's salt; made with Sulfide coarse aggregate, w/c of 0.65, and tested with drying at 60°C and 2-hours soaking in bleach at 23°C twice a week

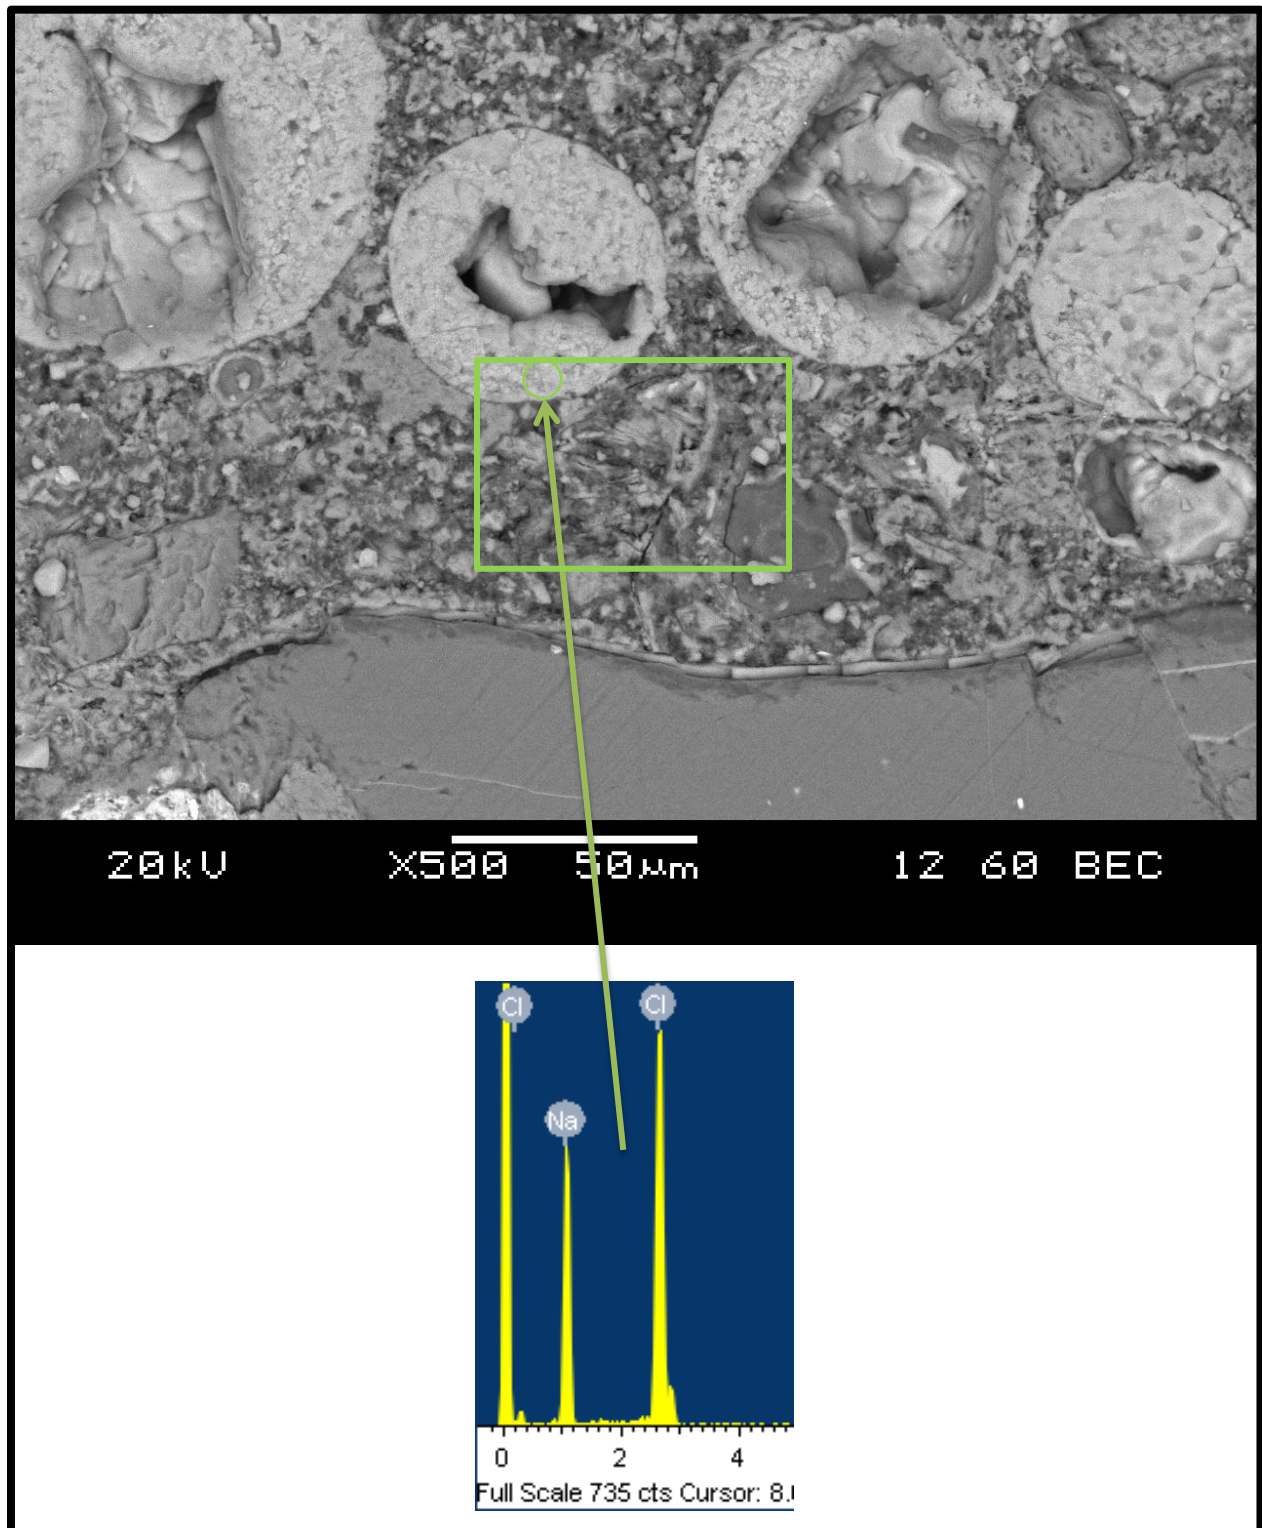
Figure 4.3.26: SEM image and EDS analysis for II-S60B showing NaCl salt; made with Sulfide coarse aggregate, w/c of 0.65, and tested with drying at 60°C and 2-hours soaking in bleach at 23°C twice a week

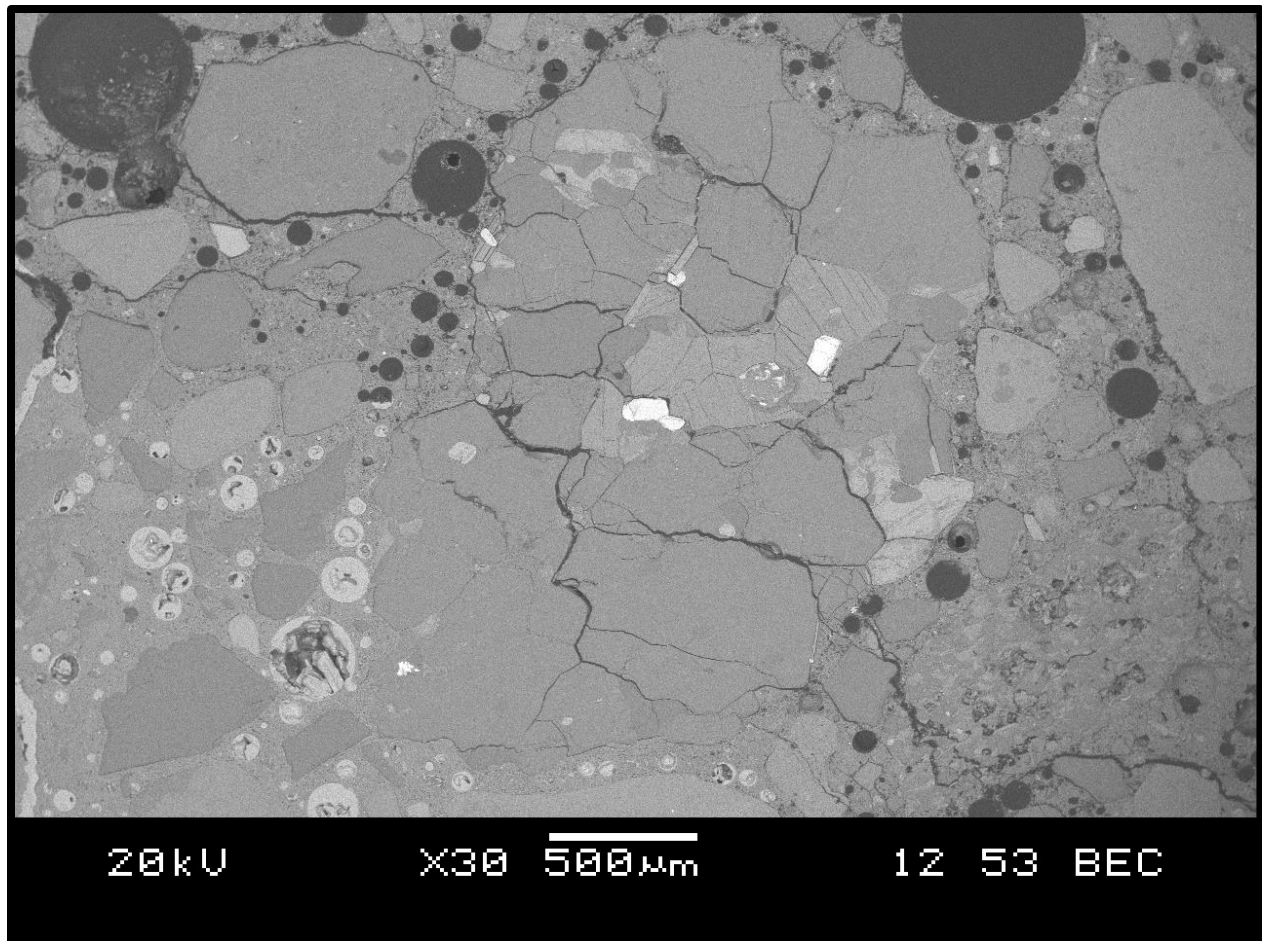
Figure 4.3.27: SEM image of II-S60B showing severe cracking in an aggregate particle; made with Sulfide coarse aggregate, w/c of 0.65, and tested with drying at 60°C and 2-hours soaking in bleach at 23°C twice a week

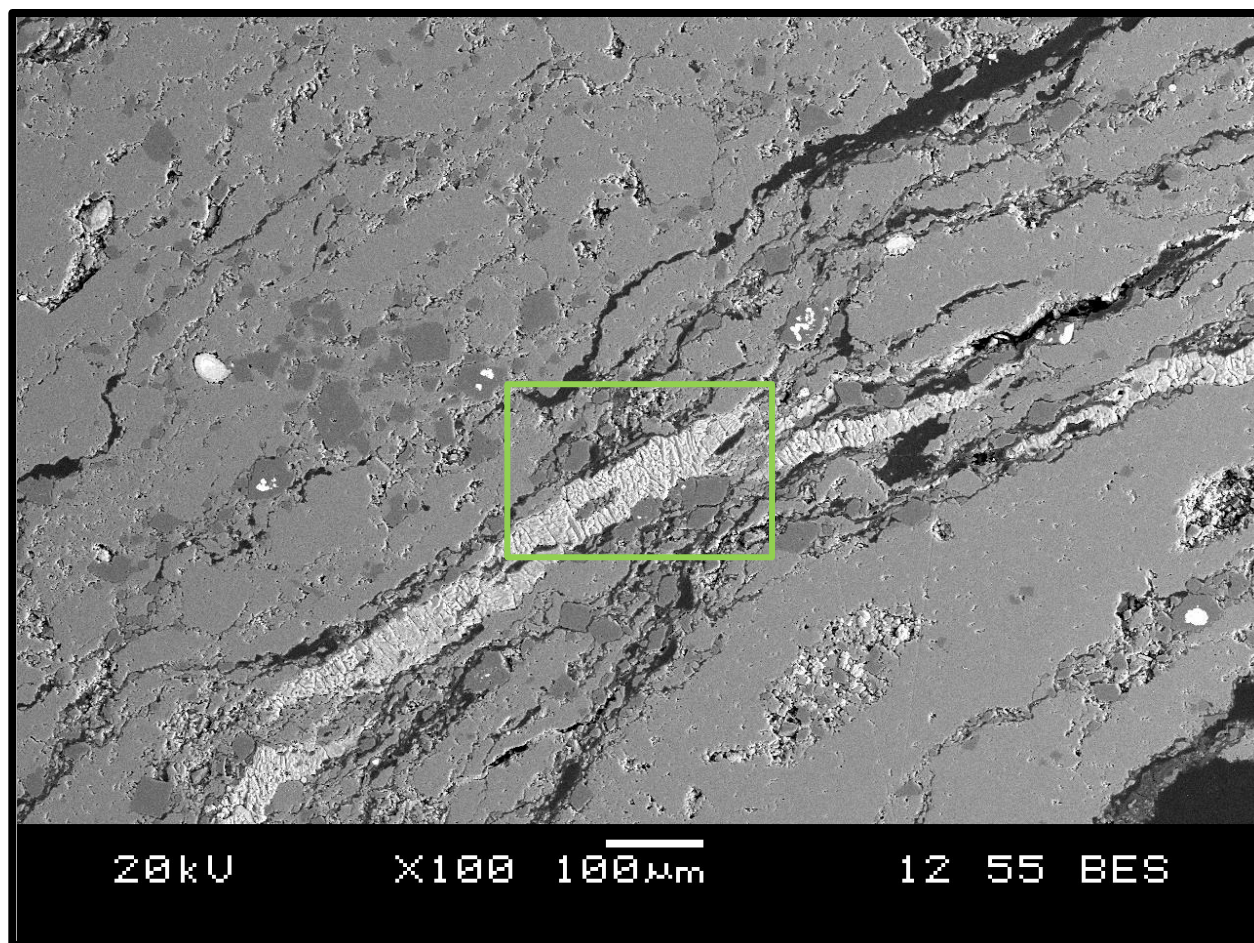
Figure 4.3.28 SEM image and EDS analysis for II-D60A showing NaCl salt in coarse aggregate; made with Dolostone coarse aggregate, w/c of 0.65, and tested with drying at 60°C and 2-hours soaking in bleach at 23°C twice a week

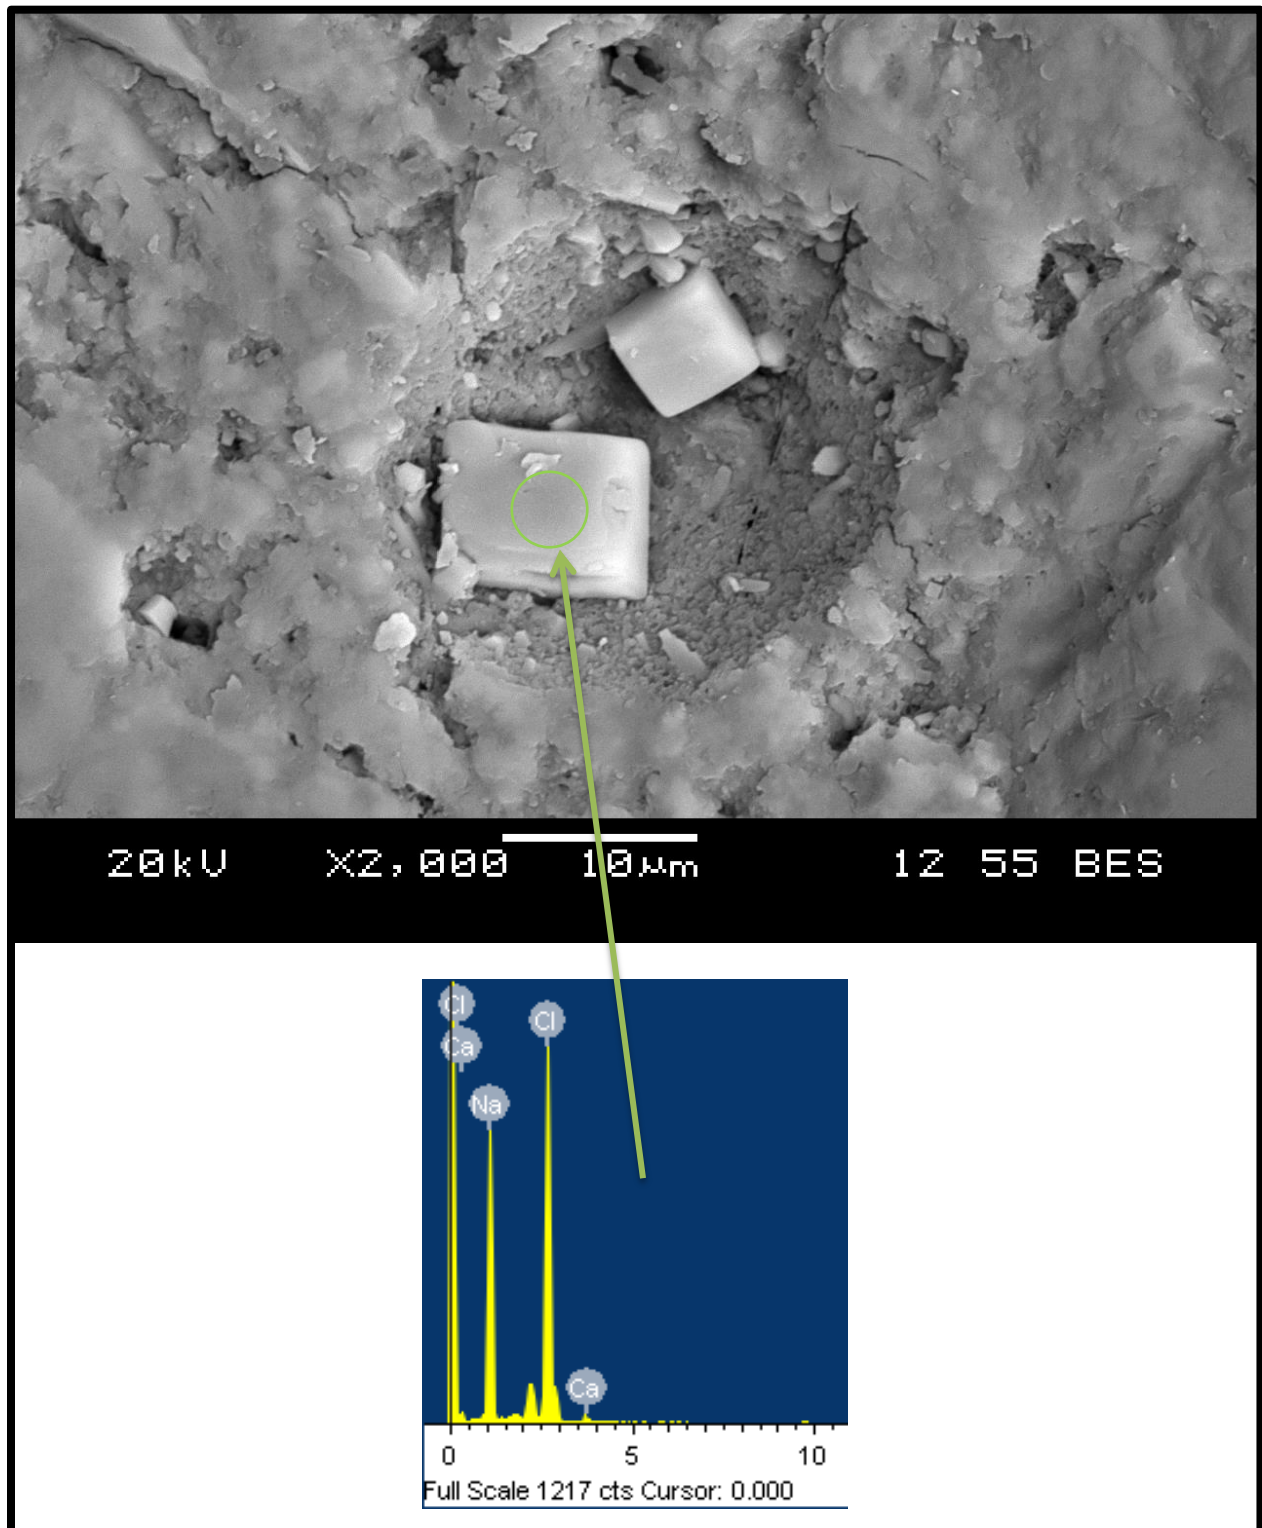
Figure 4.3.30: SEM image and EDS analysis for II-D60A showing cubic NaCl salt crystal in air void; made with Dolostone coarse aggregate, w/c of 0.65, and tested with drying at 60°C and 2-hours soaking in bleach at 23°C twice a week

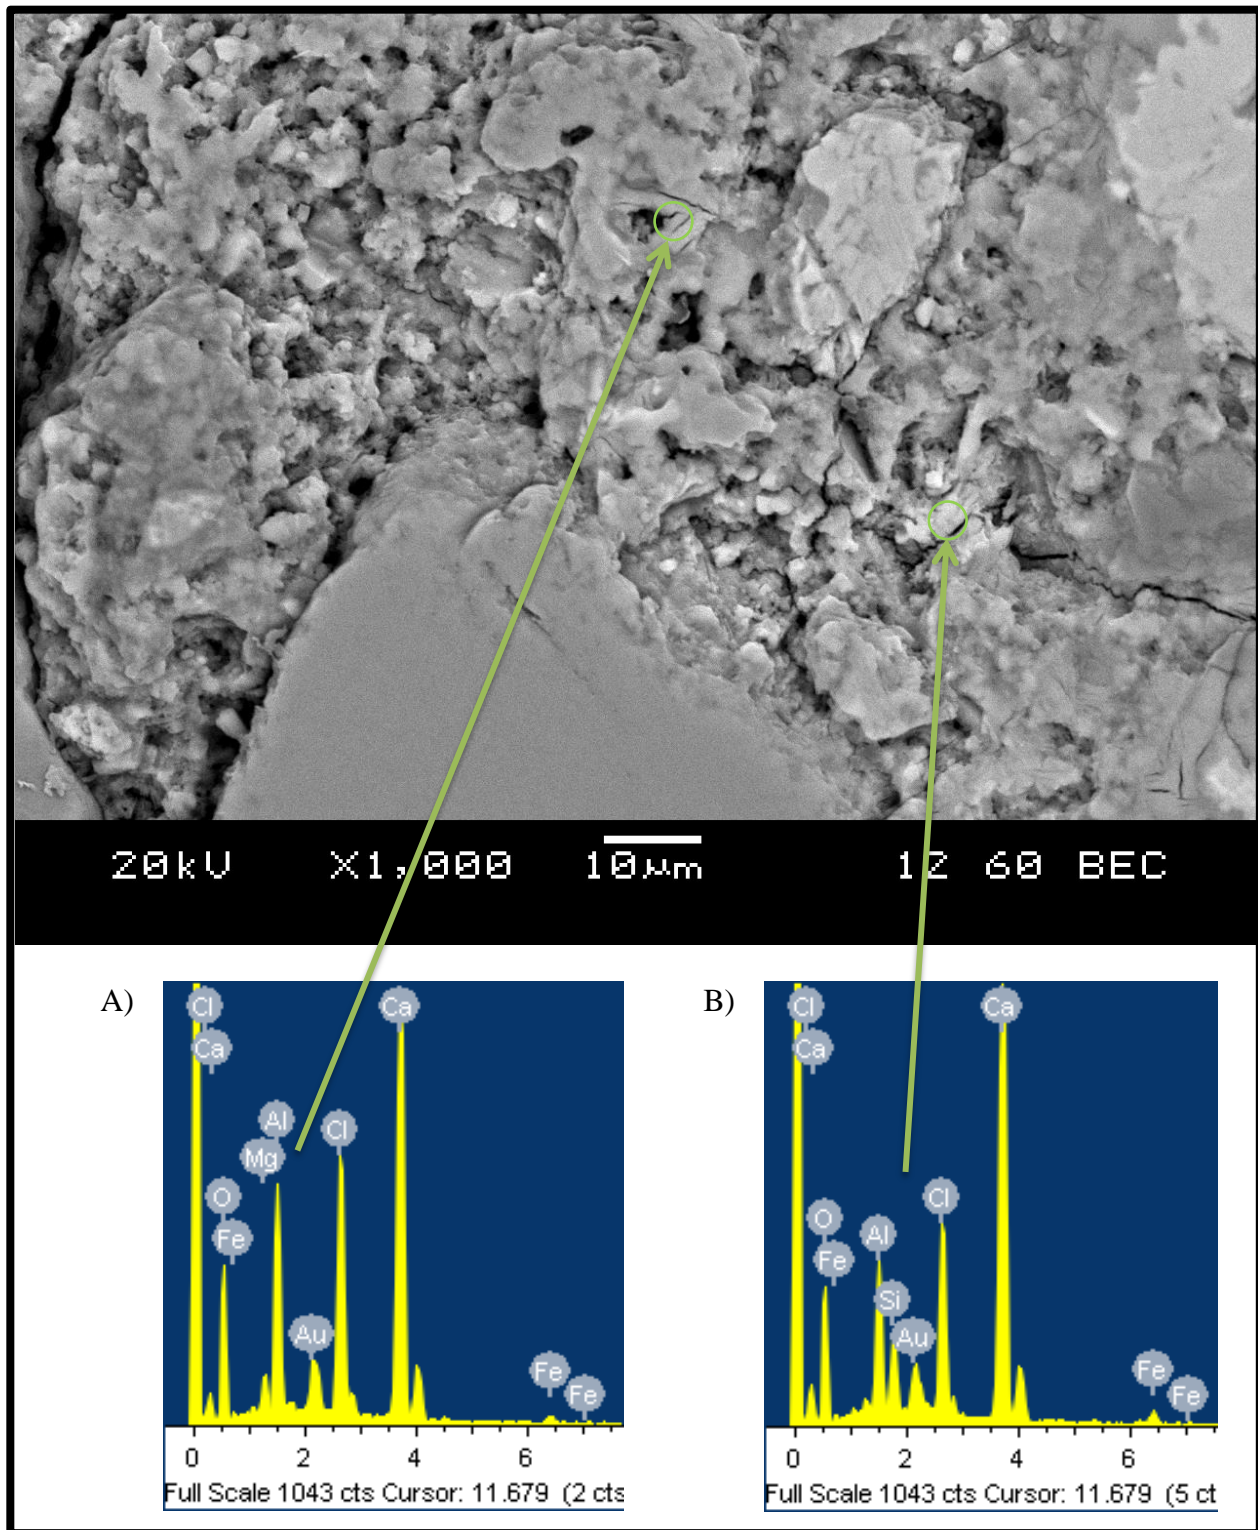
Figure 4.3.31: SEM image and EDS analysis for II-D60A showing Friedel's salt; made with Dolostone coarse aggregate, w/c of 0.65, and tested with drying at 60°C and 2-hours soaking in bleach at 23°C twice a week

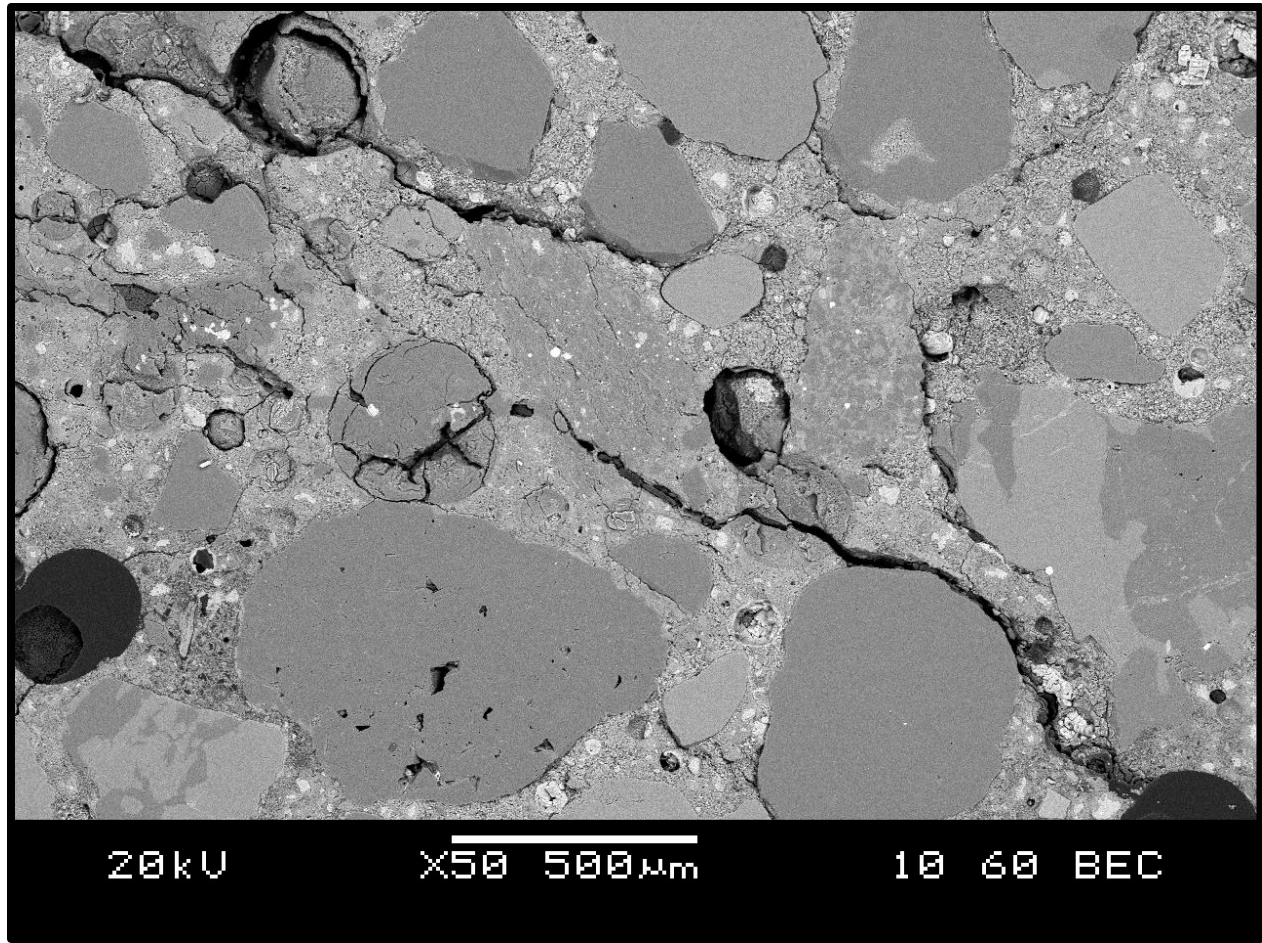
Figure 4.3.32: SEM image of II-D60A showing severe cracking; made with Dolostone coarse aggregate, w/c of 0.65, and tested with drying at 60°C and 2-hours soaking in bleach at 23°C twice a week

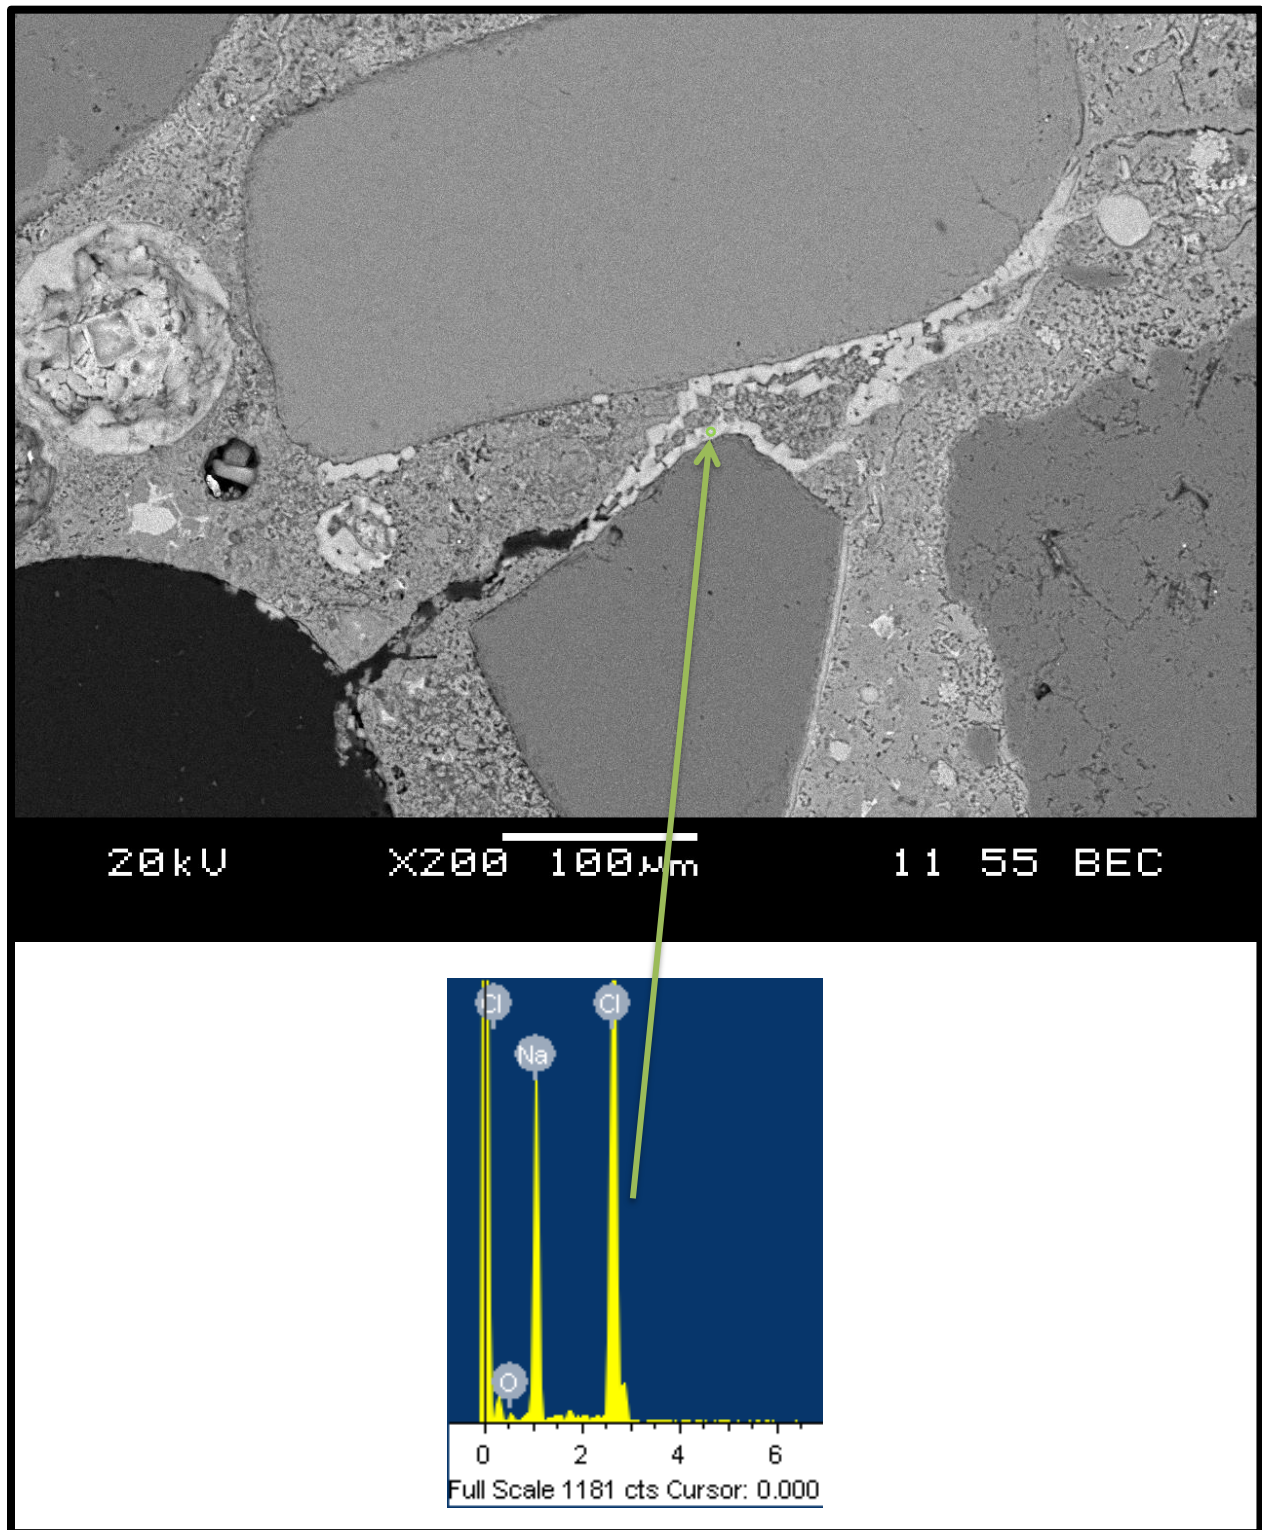
Figure 4.3.33: SEM image and EDS for II-D60B showing NaCl salt; made with Dolostone coarse aggregate, w/c of 0.65, and tested with drying at 60°C and 2-hours soaking in bleach at 23°C twice a week

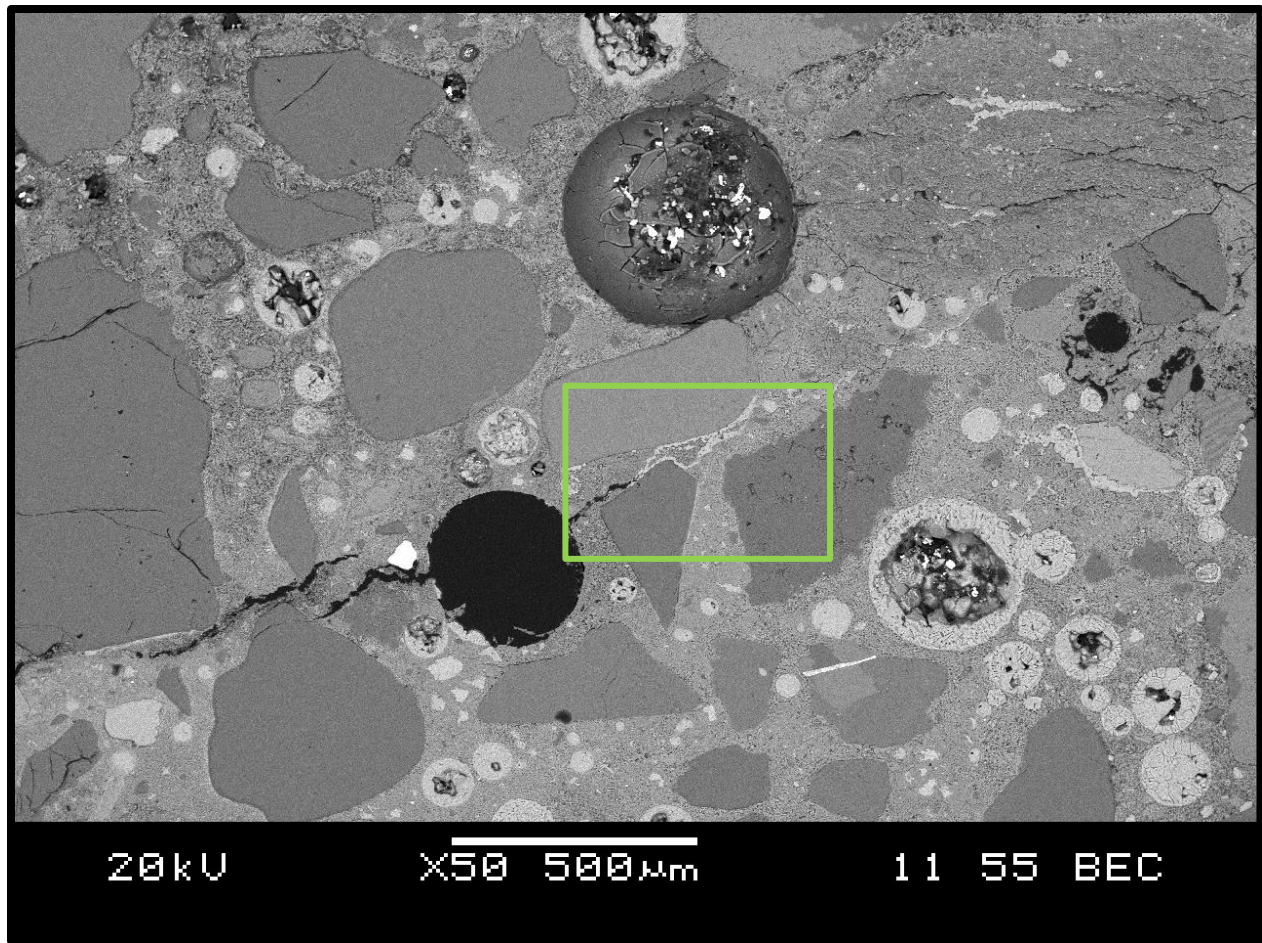
Figure 4.3.34: SEM image of II-D60B showing large cracks filled with NaCl salt; made with Dolostone coarse aggregate, w/c of 0.65, and tested with drying at 60°C and 2-hours soaking in bleach at 23°C twice a week

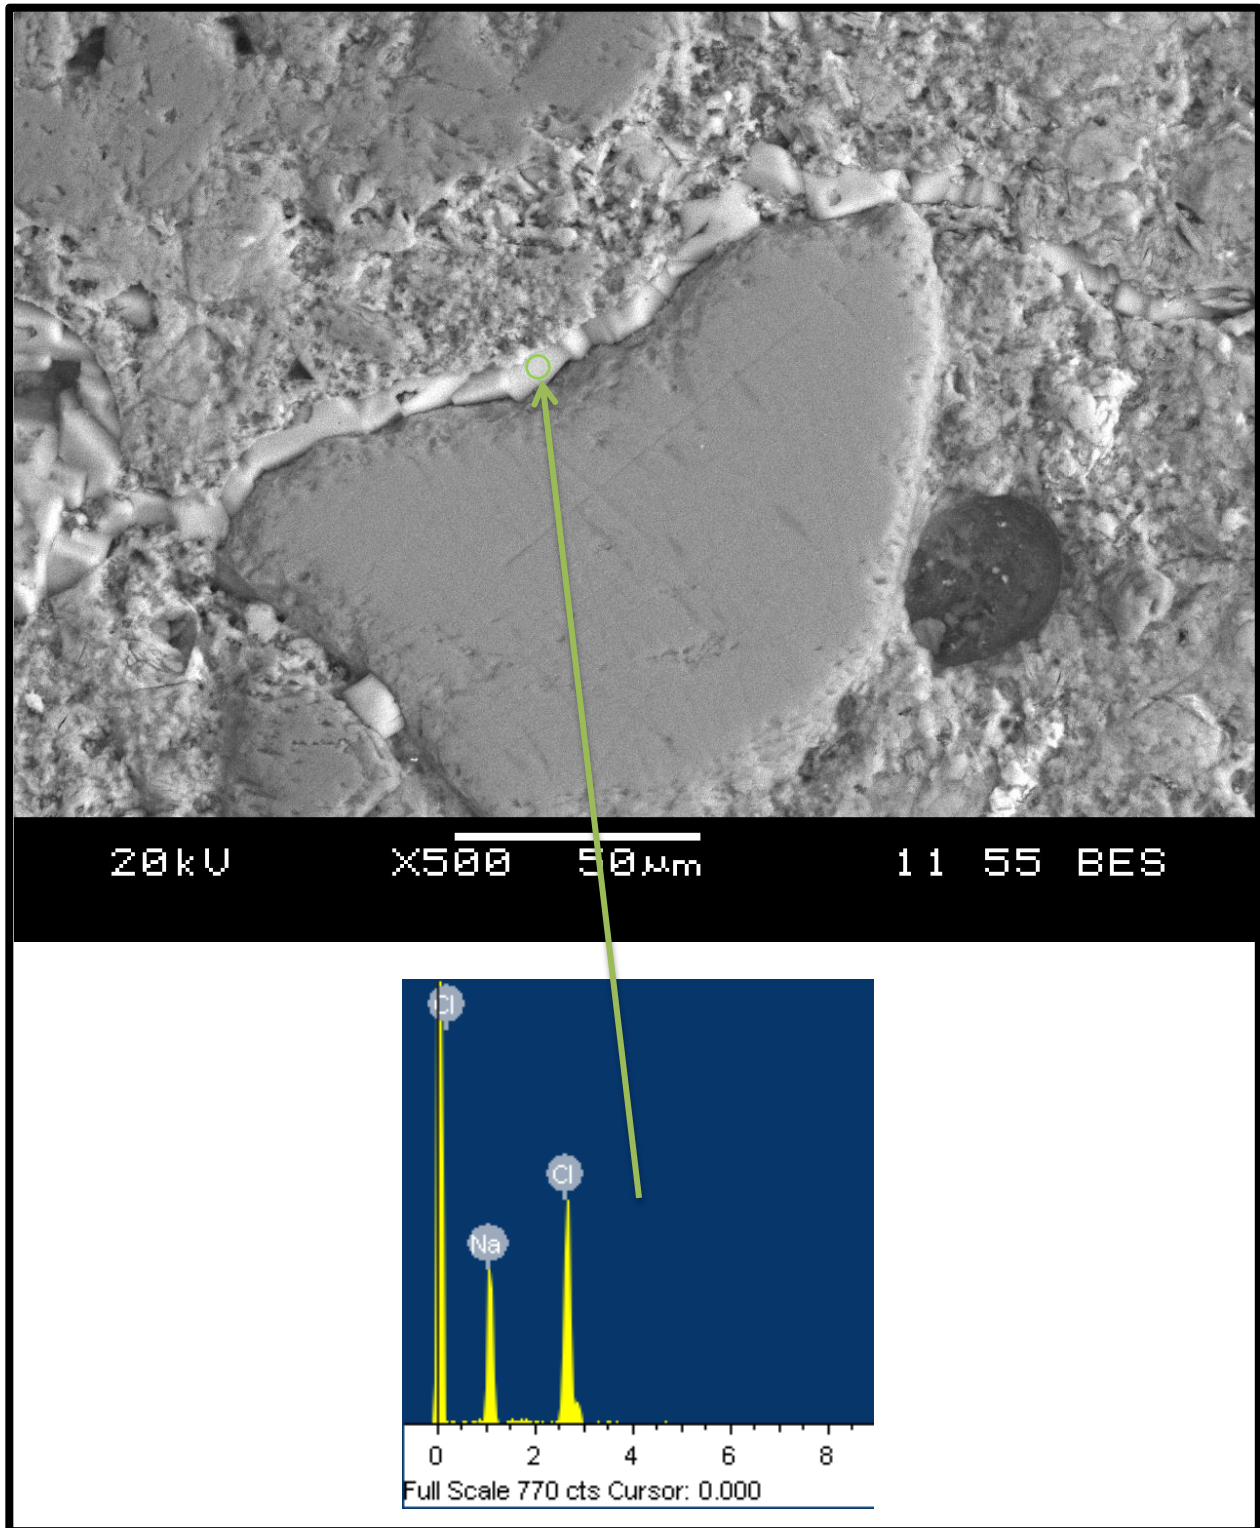
Figure 4.3.35: SEM image of II-D60B showing large crack in ITZ filled with NaCl salt; made with Dolostone coarse aggregate, w/c of 0.65, and tested with drying at 60°C and 2-hours soaking in bleach at 23°C twice a week
