Deterioration Caused By Sulfide-Bearing Aggregates: Performance Test Development

**DETERIORATION CAUSED BY SULFIDE-BEARING AGGREGATES:
PERFORMANCE TEST DEVELOPMENT**

in partial fulfillment of the
requirements for the degree of
Master of Applied Science
in the Program of
Civil Engineering

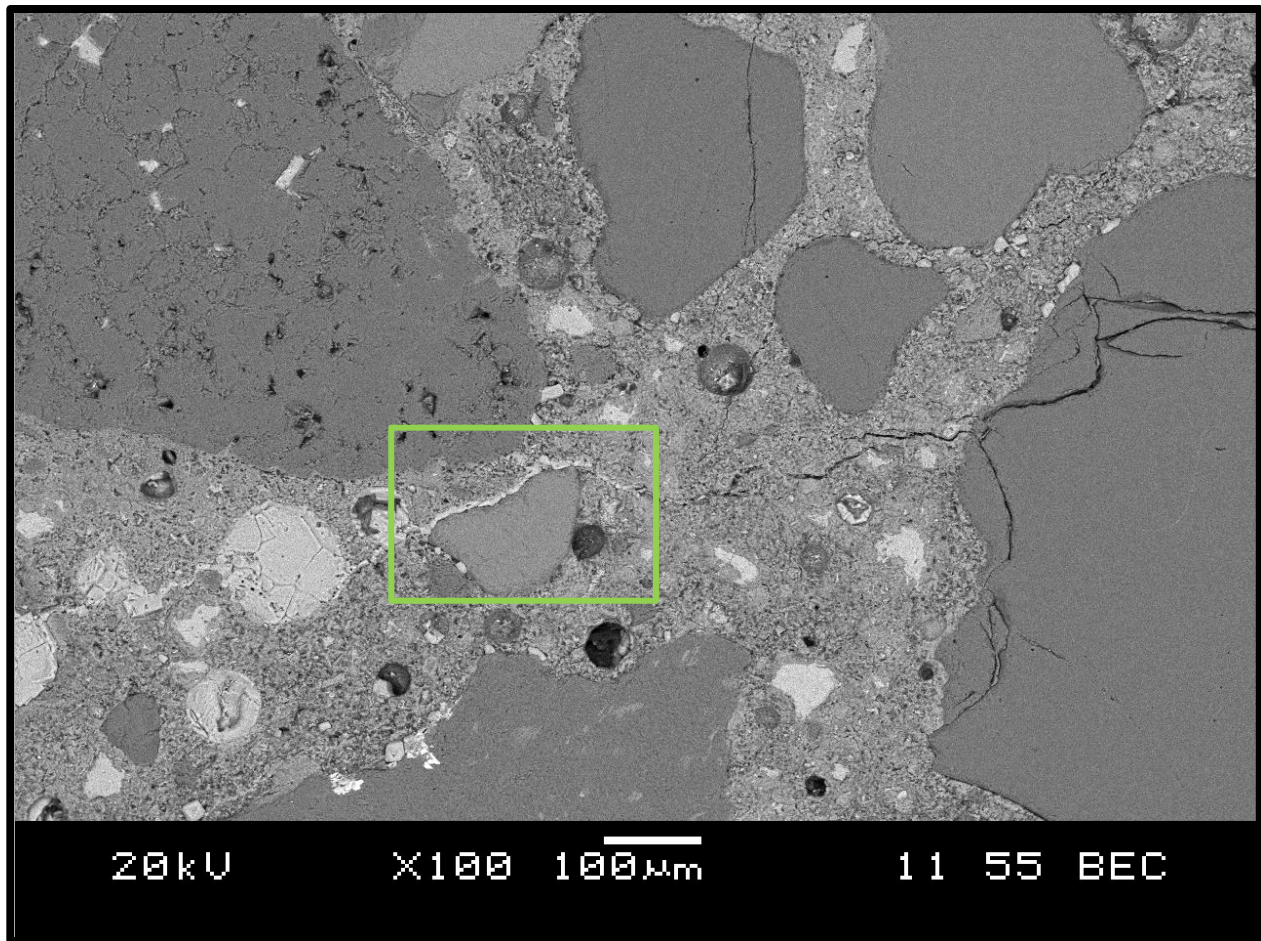
Figure 4.3.36: SEM image of II-D60B showing large cracks filled with NaCl salt; made with Dolostone coarse aggregate, w/c of 0.65, and tested with drying at 60°C and 2-hours soaking in bleach at 23°C twice a week

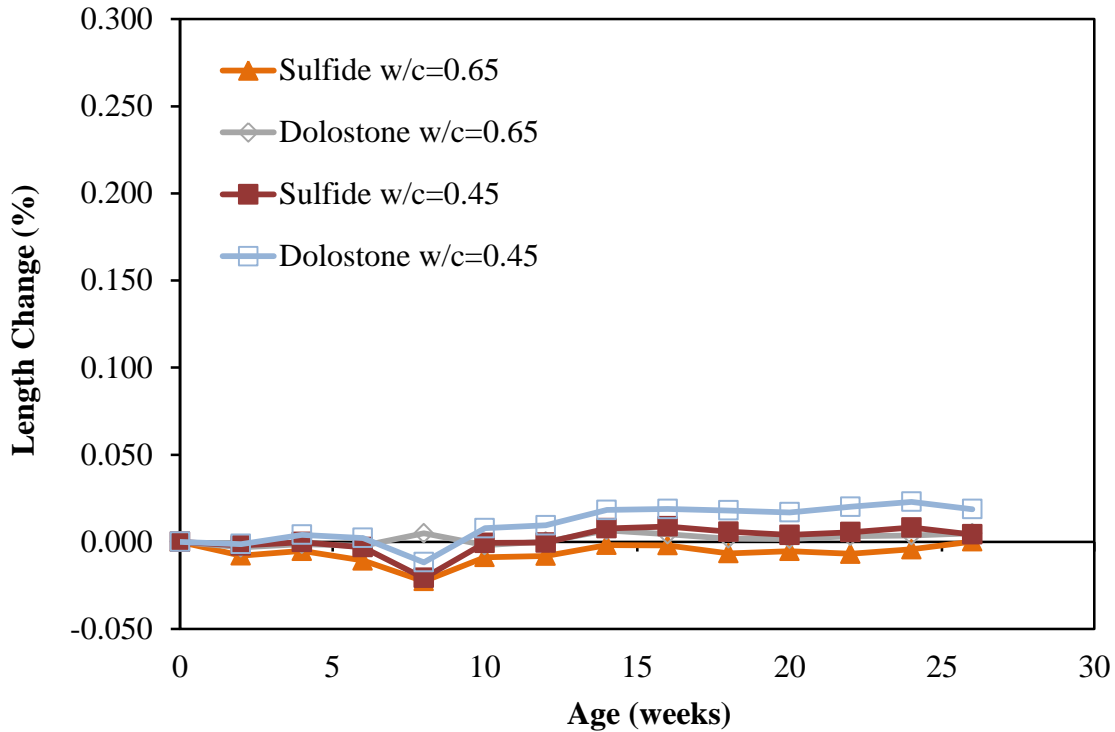
**Figure 4.3.37: Phase II Series 2 Results; all samples were soaked in lime solution for 2-hours at 23°C twice a week, with drying at 60°C**

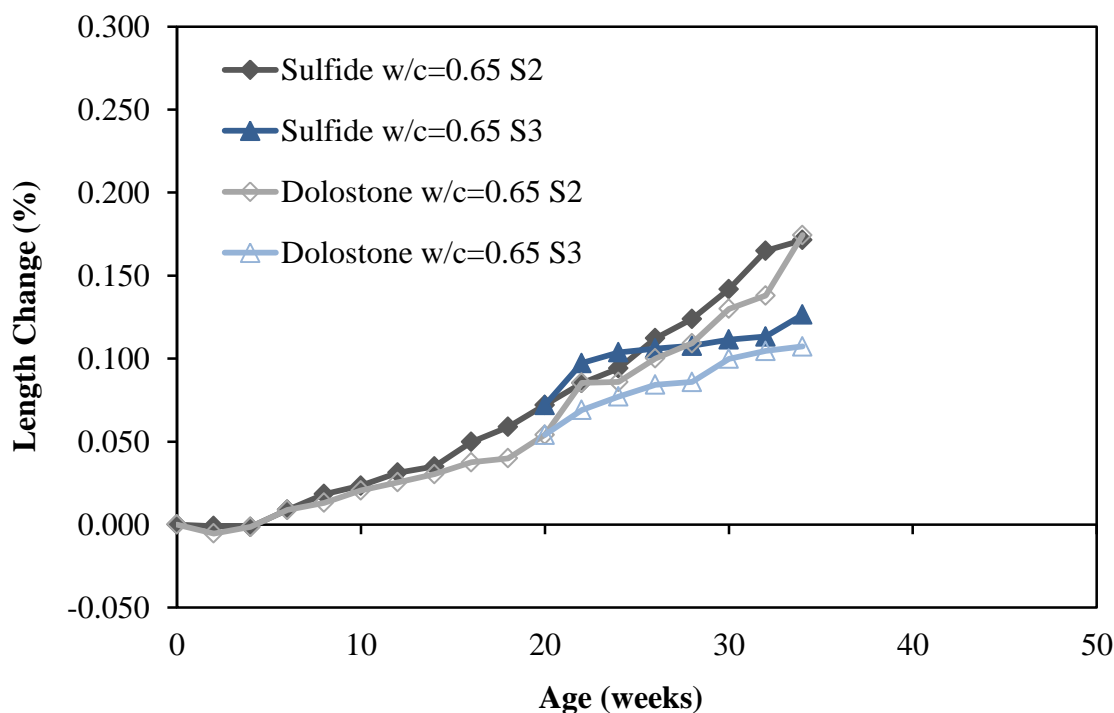
Figure 4.3.38: Phase II Series 3 results; after Series 2 exposure, samples soaked in lime solution at 5°C for 7-days, with hot/cold cycles to 23°C/5°C

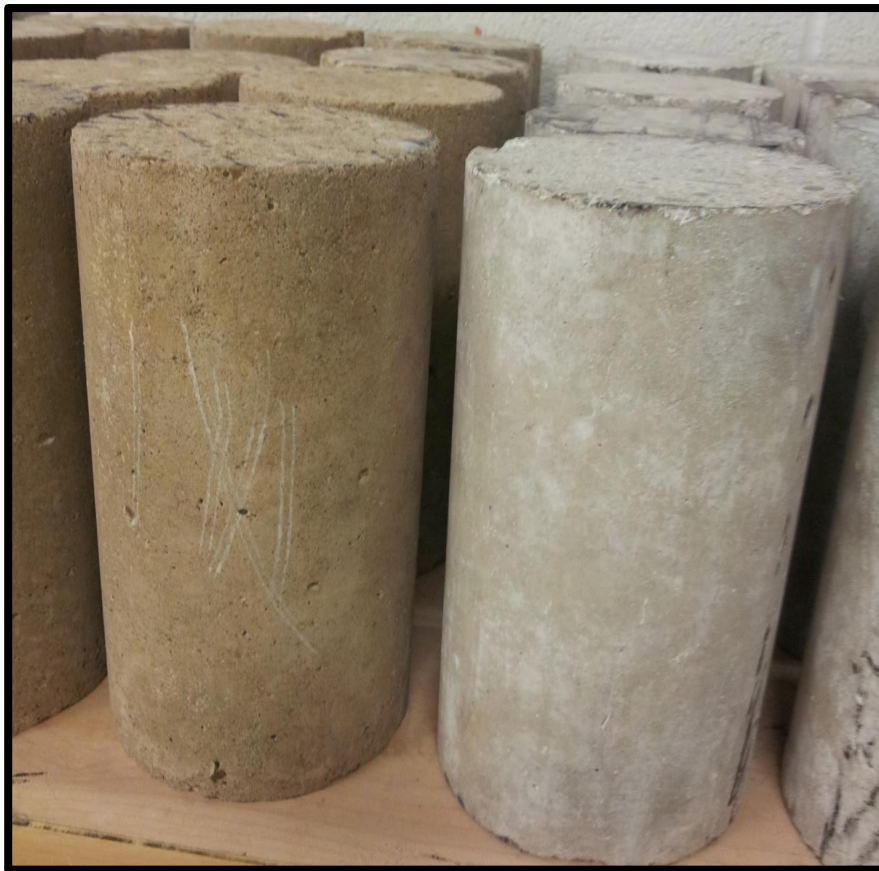
It was suspected that that the bleach affected the concrete in other ways than providing oxygen to the aggregates. This was apparent by the yellowish staining of the concrete that was observed, an example of which is shown in Figure 4.6.1. Both sets of cylinders were tested under Phase III exposure cycles. The sample on the left had soaking in bleach, while the sample on the right had soaking in lime solution, in Figure 4.6.1.

Figure 4.6.1: Cylinders tested under Phase III conditions, bleach soaked on left, lime solution soaked on the right; all samples have $w/c=0.65$, were tested with 24-hour soaking at 23°C twice a week, and 24-hours heating/drying to 60°C twice a week

When inspecting this figure carefully, scratches can be seen on the bleach cylinder shown; this was done with a key, to see how deep the staining penetrated. It was observed that the staining
