Current bridge deck rehabilitation practices : use and effectiveness

CURRENT BRIDGE DECK REHABILITATION PRACTICES: USE AND EFFECTIVENESS

In partial fulfillment of the
Requirements for the degree of
Master of Applied Science
in the program of
Civil Engineering

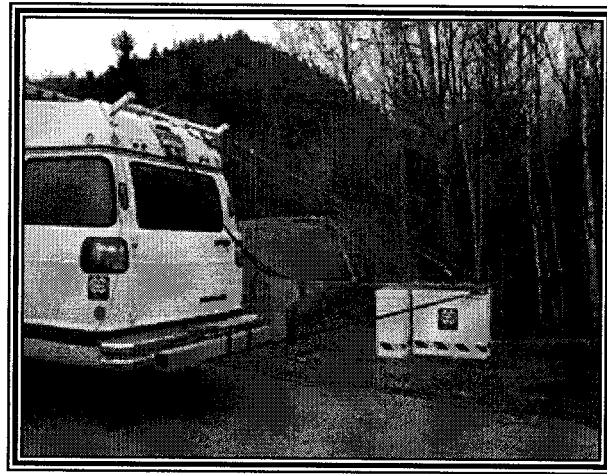
Figure 2.9 Air coupled GPR System

Air coupled systems are ideally suited for bridge inspections because they minimize traffic disruptions. Air coupled systems are mounted on vehicles as shown in Figure 2.9. These antennas emit signals into the structure and they have the ability to retrieve data readings from the deck slabs. When these tests are conducted it usually takes several longitudinal passes over the bridge deck for the radar antennae to completely emit signal throughout the entire deck surface. Each antennae pass is normally 2 to 3 feet in width (Daniels, 1996). This technique gathers a high volume of data acquisition in a short period of time, with minimized traffic flow obstructions.

GPR can emit and retrieve electromagnetic waves at depth of 500 mm or more. It primarily depends on the antenna used and the concrete type (Popel et al., 1995).

Different antennas emit and record different ranges of frequencies. High frequencies antennas result in high resolution data, but they have low penetration depth. Low frequency antennas have greater penetration depths; however they have lower resolutions (Hugenschmidt, 2002). Many GPR systems used today have antennas with frequency ranging from approximately 50 MHz to 1.5GHz. For bridge inspections, usually antennas with frequencies above 1 GHz are used (Daniels, 1996).

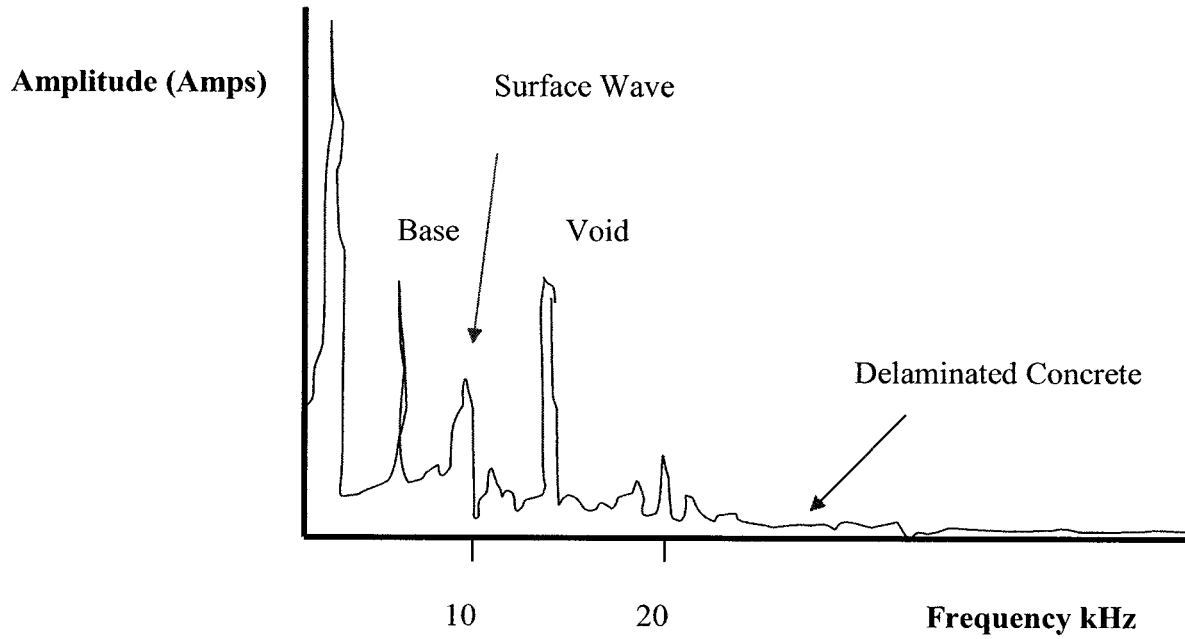
Figure 2.16 Frequency Spectrum Obtained after Impact with Hammer

A spectral analysis using a Fourier transform algorithm such as a fast Fourier transform (FFT) is performed on the reflected P waves to determine the internal characteristics of the concrete at that particular location (Scott et al., 2002). The FFT analysis converts the time domain signal into a frequency domain function. A typical frequency (f) domain spectrum is shown in the Figure 2.16. This spectrum is evaluated to determine the location of discontinuities or to determine the thickness (T) of the material.

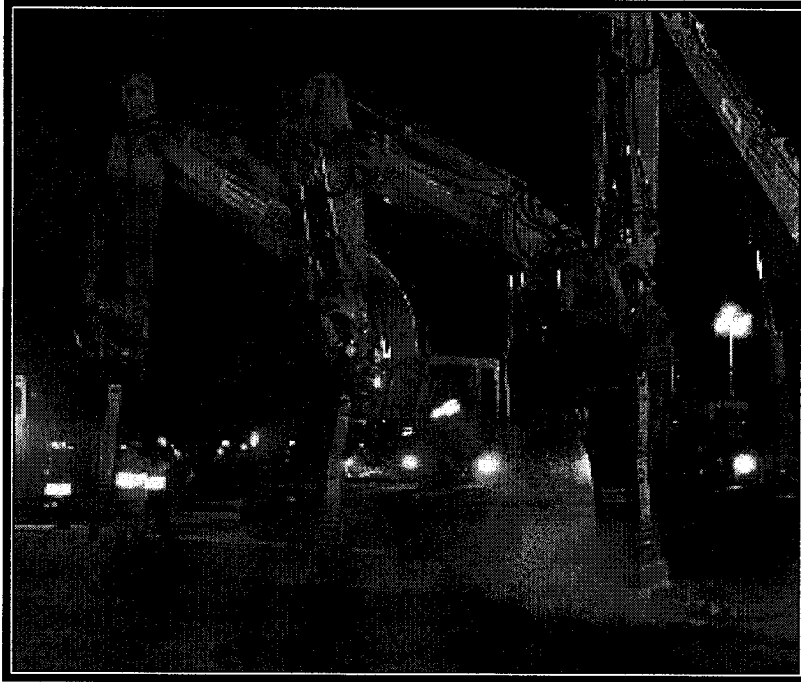
Figure 3.6 Machine Mounted Hydraulic Hammers

For this type of removal technique, there are usually two types of machine-mounted demolition attachment; hydraulic hammer and crushers. Hydraulic hammers are vehicle mounted on excavators, backhoe-loader and skid steer loader as shown in Figure 3.6. They are rated in terms of impact energy measured in Joules. The vehicle mounted breaker tool design is similar to that of the hand-held breaker except that they are mechanically operated and considerably larger.
