An Investigation on the Critical Degree of Saturation of Half Brick Samples via the Frost  
Dilatometry Methodology

A Major Research Project

Master of Building Science

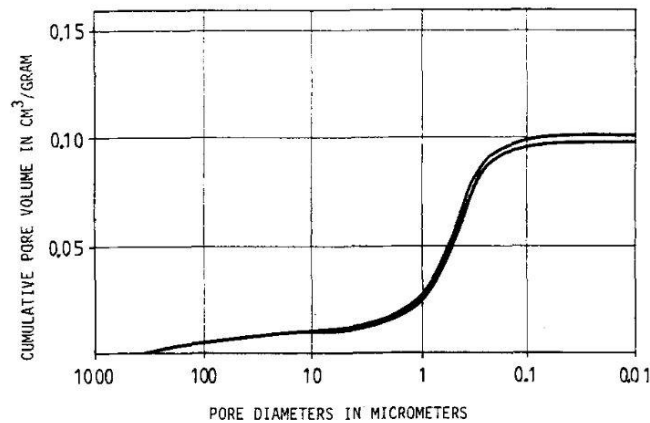
FIGURE 2-3: PORE SIZE DISTRIBUTION IN A GIVEN TEST SPECIMEN (MAAGE, 1984)

the bulk specific density, the absolute specific density, and the porosity can be calculated” (see Figure 2-3 & Figure 2-4) (Maage, 1984, p. 347).

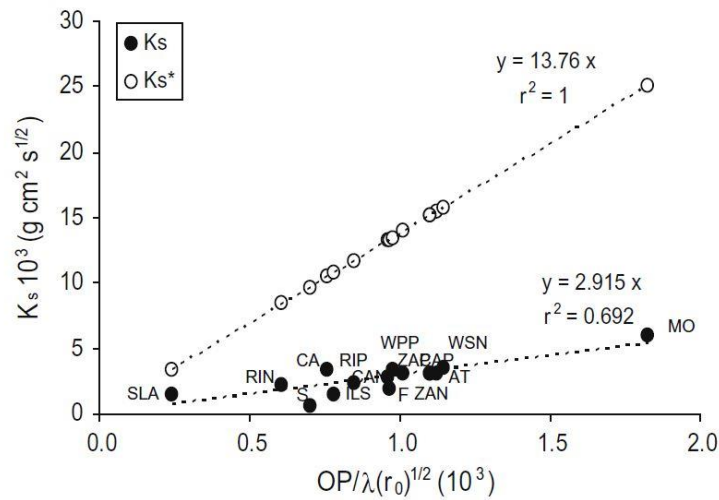
FIGURE 2-7: THE RELATIONSHIP BETWEEN  $K_s$ , PORE TORTUOSITY FACTOR AND PORE RADIUS OF THE DIFFERENT BRICKS SAMPLES (WHILE THE POROSITY REMAINS THE SAME) (RAIMONDO ET AL., 2009).

It can be seen from Figure 2-7 that increasing the mean pore radius and decreasing the pore tortuosity factor at the same level of porosity (of the different test samples) has the effect of reducing the capillary coefficient,  $K_s$ .

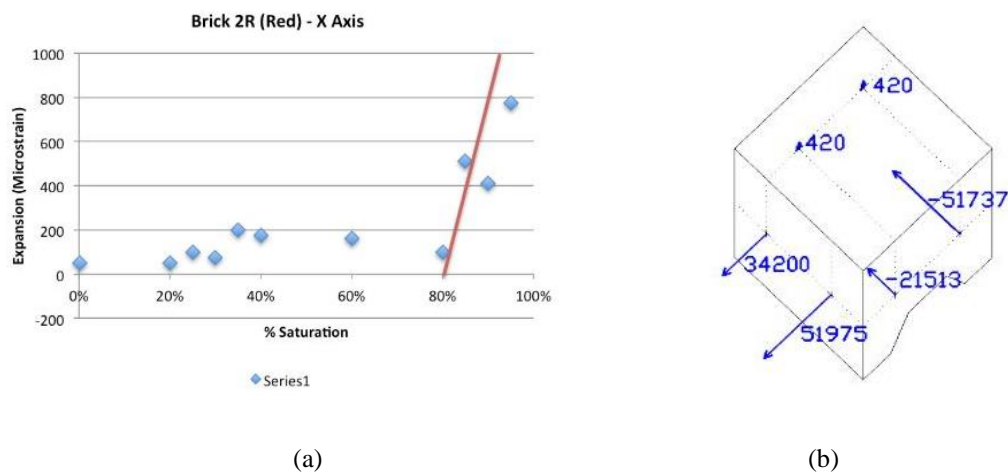
FIGURE 2-16: (A) THE STRAINS VS MOISTUTRE CONTENT (% VACUUM SATURATION) GRAPH FOR A BRICK SPECIMEN (ALONG THE X AXIS). (B) THE EXPANSION AND SHRINKAGE STRAINS SEEN AT THE X AND Y AXES FOR THE HALF BRICK SAMPLE (WILLIAMS, 2015)

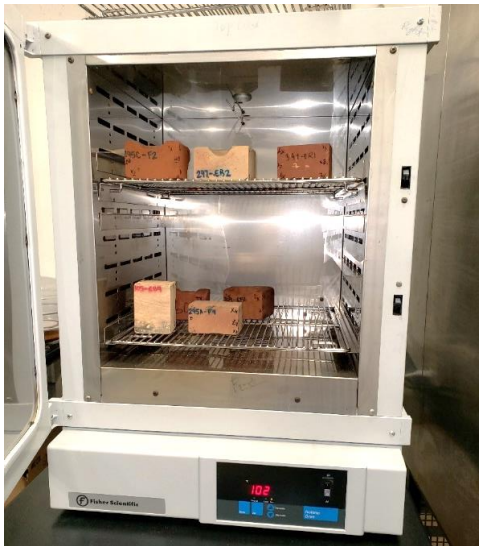
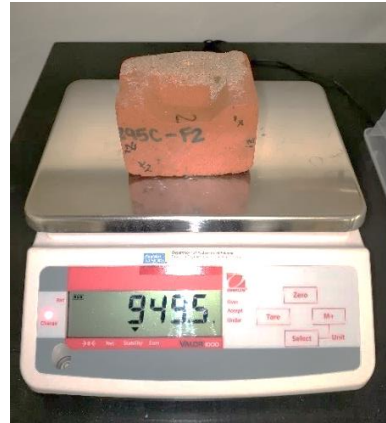
FIGURE 4-3: (A) THE BRICK SAMPLES WERE DRIED IN THE LABORATORY OVEN AT 105°C FOR 24 HOURS. (B) THE SAMPLES WERE WEIGHED ON THE WEIGHING SCALE. (C) THE BRICK SAMPLES WERE SET ASIDE TO COOL IN A DESICCATING VESSEL.

In general accordance to ASTM C67/67M-19, the brick samples were dried at a temperature of 105°C in the laboratory oven (Fisher Scientific – Laboratory Instrument). The drying time was kept at 24 hours, whereby the bricks were weighed on a mass scale (OHAUS) every two hours to monitor changes in mass. Once it was established that there was no change in mass higher than 0.2% of the mass recorded earlier, the brick samples were taken out of the oven and set aside to

cool. They were kept inside a desiccator at room temperature to prevent them from absorbing moisture from the environment (see Figure 4-3).

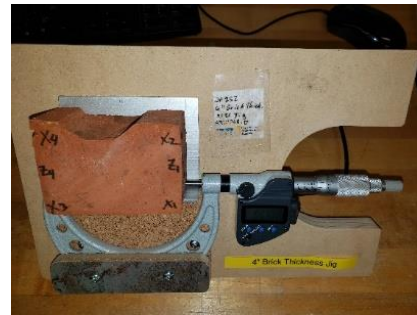
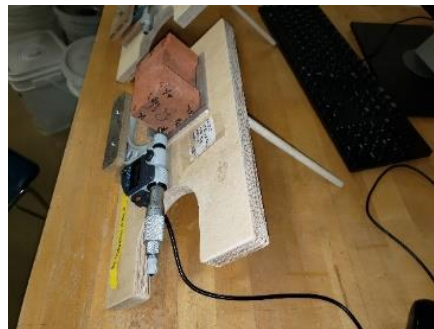
FIGURE 4-4: (A) TO (C) MICROMETER JIGS FOR THE INCH AND ELECTRONIC MICROMETER, WHEREBY THEY ARE ELEVATED FROM THE HORIZONTAL TO ENABLE PERFECTLY ALIGNED MEASUREMENTS

For accurate measurements, micrometer jigs that were inclined to the horizontal were developed (see Figure 4-5). This way, the brick samples could sit perfectly aligned on the resting platform next to the spindle, thereby ensuring a degree of precision in measurements. The spindle was positioned to take measurements at the same point along the different axes, whereby the sample was rotated in 180° after each measurement. It is noteworthy that care was taken to ensure that the spindle did not wear away any brick surface during the measurements.

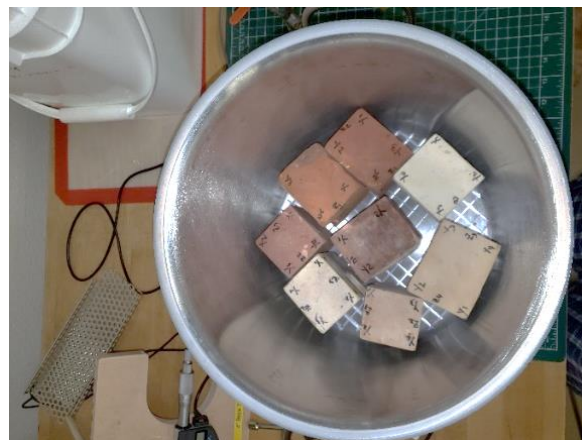
FIGURE 4-7: THE TEST SAMPLES WERE PLACED ON A LEVELLING RACK INSIDE THE DESICCATOR VESSEL. THEY WERE ARRANGED IN AN ORDER TO ENSURE THAT ALL OF THEM COULD BE VACUUM SATURATED AT THE SAME TIME.

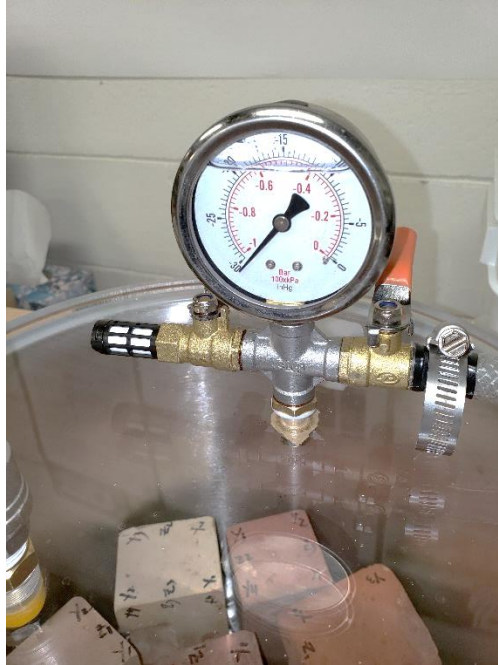
FIGURE 4-8: THE BRICK SAMPLES WERE SUBJECTED TO A VACUUM INSIDE THE VESSEL, WHEREBY THE GAUGE HERE INDICATED THE PRESSURE INSIDE TO BE -1ATM (~30 INHG).

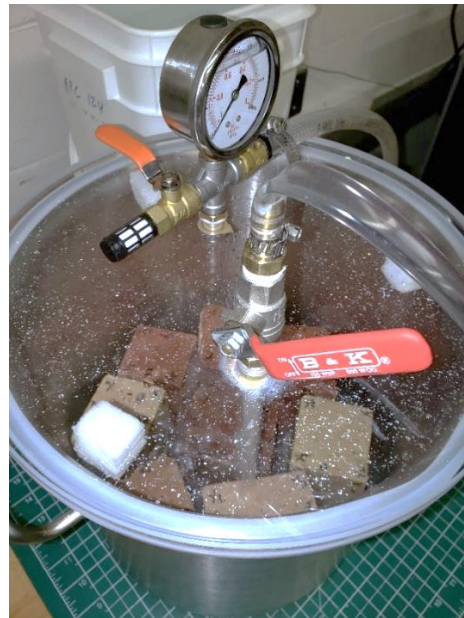
FIGURE 4-9: ONCE THE RIGHT LEVEL OF VACUUM PRESSURE WAS REACHED (I.E. 0ATM OR -30INHG), THE VALVE CONNECTING THE RESERVOIR TO THE DESICCATOR VESSEL WAS OPEN ALLOWING IT BE FILLED WITH DISTILLED WATER

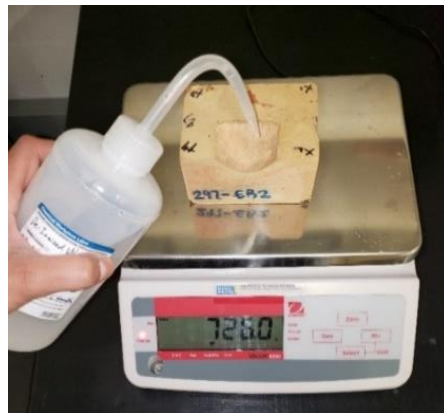
FIGURE 4-10: A DROPPER WAS USED TO APPLY DISTILLED WATER ON THE BRICK SAMPLE, ALL THE WHILE METICULOUSLY MONITORING THE CHANGE IN MASS

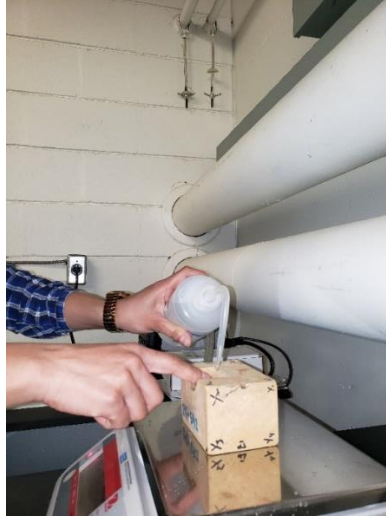
FIGURE 4-11: THE TECHNIQUE OF REAPPLYING MOISTURE SUCH THAT IT IS EVENLY DISTRIBUTED IN THE BRICK SPECIMEN

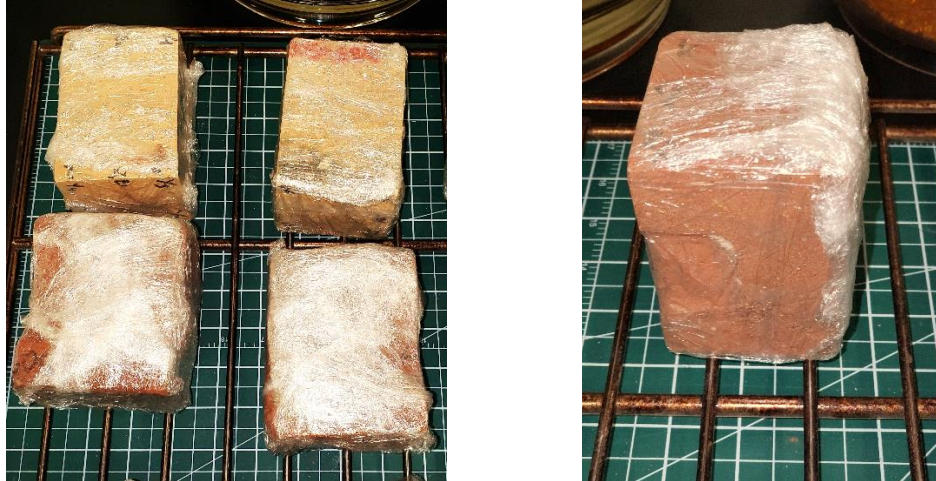
FIGURE 4-12: THE BRICK SAMPLES HAVE BEEN TIGHTLY WRAPPED IN TWO LAYERS OF CLING FILM

Once the bricks reached their target mass, either through drying or by the reapplication of additional moisture on the surface, they were tightly wrapped in cling film. The film was basically a vapor impermeable material, which restricted the egress of moisture in the form of water vapor out of the brick sample (see Figure 4-12). According to Straube et al. (2010), careful attention needs to be put in reducing “the air space between the surface of the specimen and the sealant material” (p. 5). The brick samples were then left for about 18 hours to let the moisture redistribute in the brick samples. Depending upon the A-value of the considered samples, the time required to allow all of the moisture to redistribute within the material could be as long as 72 hours (Straube et al., 2010). After a period of about 48 hours, length measurements of the brick samples were taken again. The brick sample was carefully removed from the cling film and re-weighed. Any differences in the dimensions and mass were hence recorded. The brick samples were then re-wrapped in the cling film, to prevent further loss of moisture from the specimen.

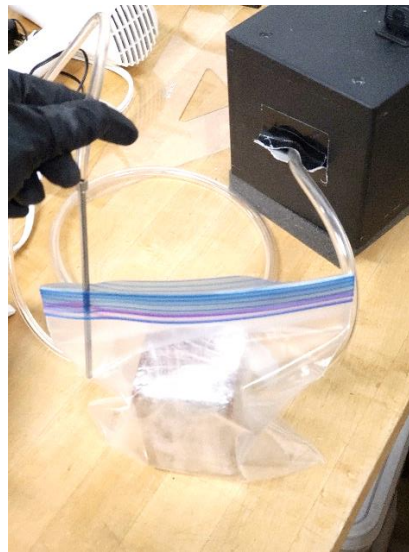
FIGURE 4-13: AIR WAS REMOVED FROM INSIDE THE ZIPLOCK BAG USING A MODIFIED ‘VACUUM CLEANER’.

The cling-film wrapped brick samples were then placed in a waterproof Ziplock bag, and the air inside was removed using a modified ‘vacuum cleaner’ (see Figure 4-13). This was done with the purpose to remove air pockets inside the Ziplock bag that would have otherwise had an insulating effect resulting in a non-uniform distribution of temperature in the sample upon immersion in the refrigerant bath.

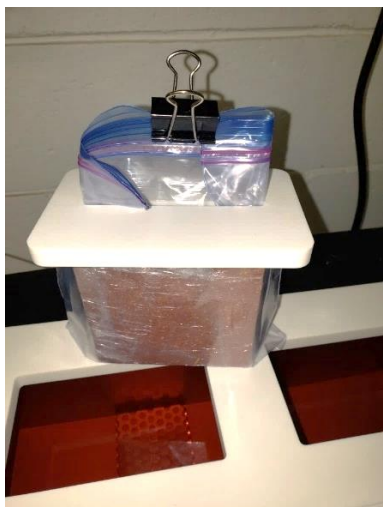
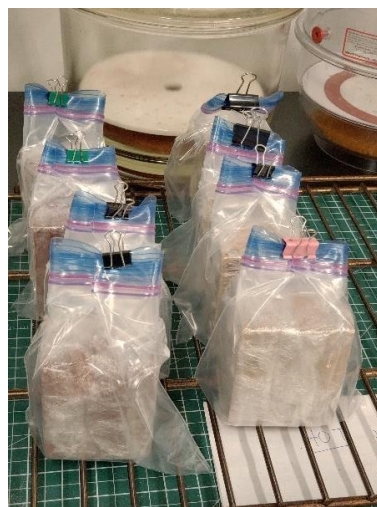
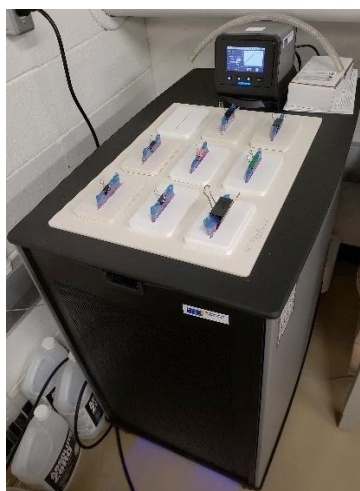
FIGURE 4-14: (A) TO (C) THE SAMPLES WERE PLACED INSIDE ZIPLOCK BAGS AND IMMERSED IN THE BATH

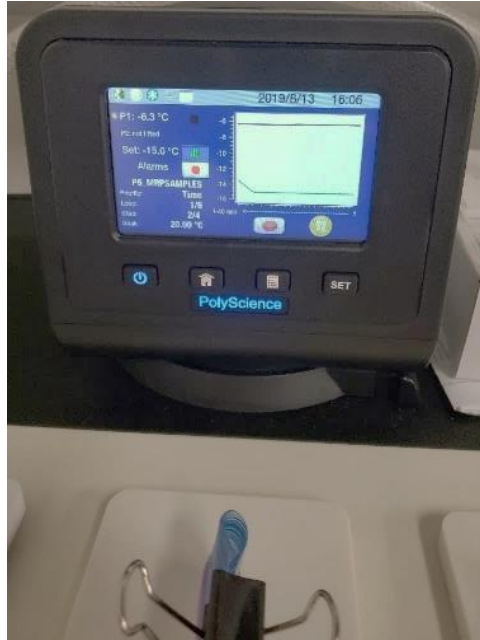
FIGURE 4-15: THE PROGRAM FOR THE FREEZE-THAW CYCLES IS BEING RUN AS SEEN ON THE CONTROLLER'S SCREEN.

The samples in the Ziplock bag were carefully placed inside the refrigerant bath, wherein the machine (PolyScience) was programmed via the controller to run six freeze-thaw cycles from 20°C to -15°C. It is noteworthy that the refrigerant in the machine was in a circulating motion due to the machine pump that was constantly running, thereby helping to evenly distribution of temperature required for the cycles (see Figure 4-15).

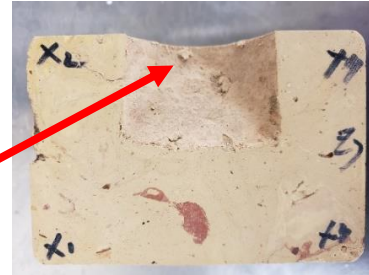
(b) Sample type 297-EB2

FIGURE 4-19: (A) – (B) A CRACK IS SEEN ON SAMPLE TYPE 60, WHEREAS FLAKING ON THE SURFACE OF SAMPLE TYPE 297-EB2 AFTER THE FIFTH SET OF FREEZE THAW CYCLES

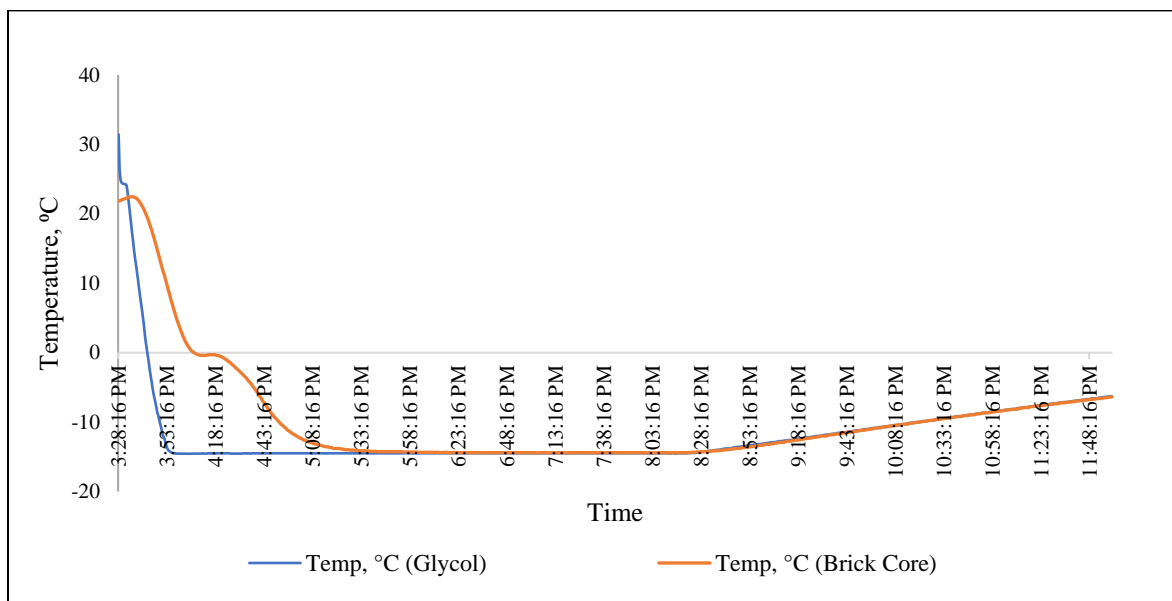
FIGURE 6-1: THE CORE OF THE BRICK TAKES ABOUT TWO HOURS TO REACH THE SAME TEMPERATURE AS THE BATH (FOR COOLING AT -15°C)
