THE INFLUENCE OF CAVITY VENTILATION ON THE PERFORMANCE OF BRICK VENEER PANELS WHEN  
EXPOSED TO WIND DRIVEN RAIN: AN EXPERIMENTAL ANALYSIS

A Major Research Project  
presented to Ryerson University

in partial fulfillment of the  
requirements for the degree of  
Master of Building Science  
in the Program of  
Building Science

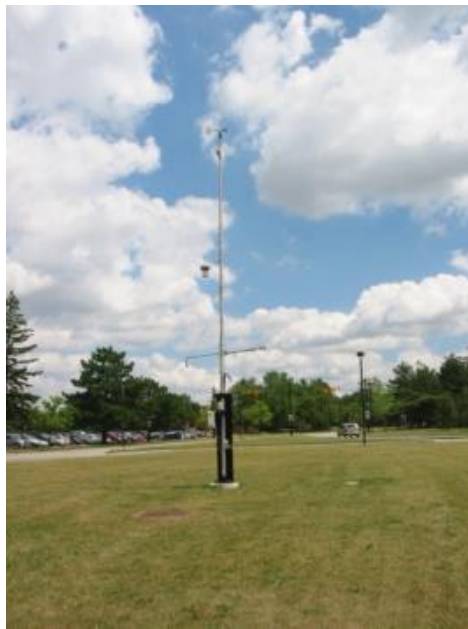
The coordinates and elevation of the weather station are 43.7753N 79.5100W and 198m respectively. It is located to the North of downtown Toronto at York University. It is managed by the ESSE (Department of Earth Space Science and Engineering). The station monitored a number of climatic conditions such as air temperature, wind speed, horizontal rainfall, and snow depth. The two datasets used in this investigation are wind speed and horizontal rainfall. Figure 1 shows the station and its immediate surroundings.

*Figure 1 – ESSE weather station with immediate surroundings. There are no buildings in the immediate area to affect measurements*

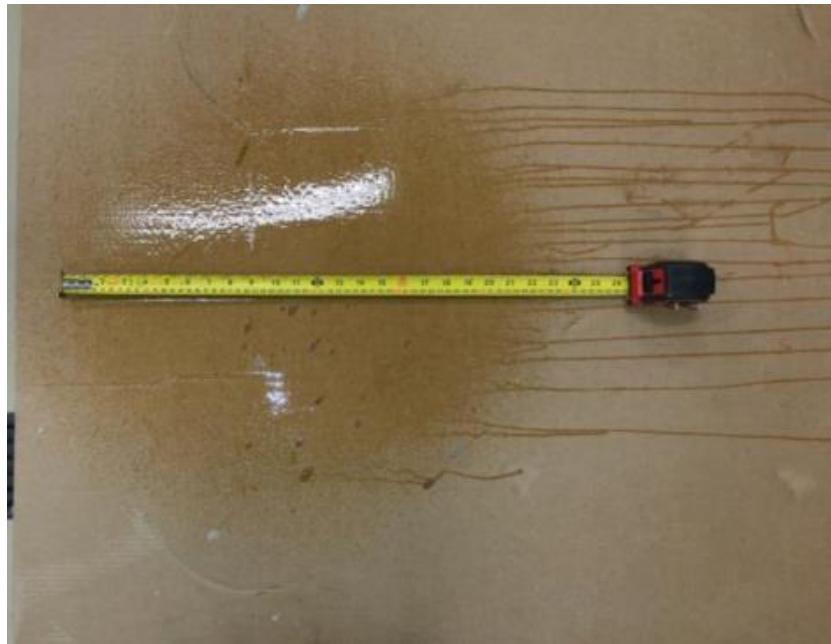
The header and feeder hose connections were press fitted. A heat gun was used to temporarily enlarge the PVC hose and make connections easier. A hot air gun was used to straighten the hose. The misting heads were tested to examine their spread pattern. A typical spread at 30 cm is shown in FIGURE 2.

*Figure 2 – spread pattern from Lee Valley misting head at 30 cm, 25 PSI*

This pattern was used to determine the number of misting heads required to provide an even spread of water to the wall specimen area. Twelve misting heads were chosen to provide the coverage. All joints on the distribution side were sealed with silicone waterproof sealant.

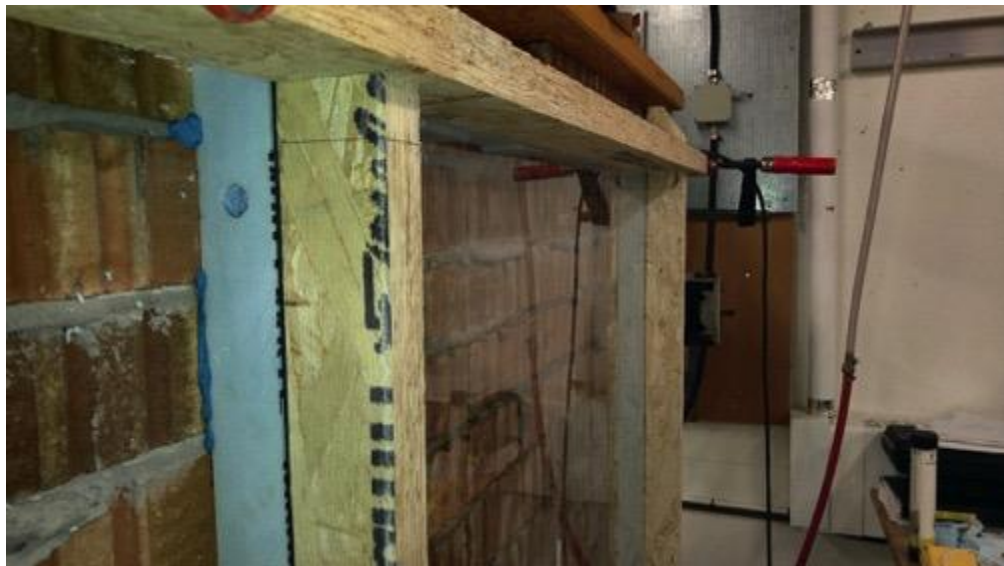
A modular unit was constructed to provide an airtight chamber at the back of the wall to simulate a cavity. A sheet of acrylic glass was cut to 1.10 x 1.10 m and screwed to a 2" x 4" notched wood frame. 50 mm thick Styrofoam™ insulation was adhered to the perimeter of the glass with doubled sided foam tape. The insulation provided the air space gap between the acrylic sheet and the back of the wall specimen. The frame was clamped to the wall to provide the seal. Each wall surface had to be prepped before clamping as mortar droppings hindered to ability to create an air seal. The full sheet minus the width of the foam perimeter resulted in a 1.06 x 1.06 m sheet of acrylic which is the same dimension as the wall which is exposed to water. The bottom piece of insulation was removed as mock tests showed water collecting on the bottom insulation rather than falling to the cloths. The exterior perimeter was sealed with adhesive putty. The cavity frame and sealing can be seen in Figure 3.

*Figure 3 – Cavity frame with putty adhesive acting as an air seal. Note the eyehole punched through the insulation, this was used for air velocity measurements.*

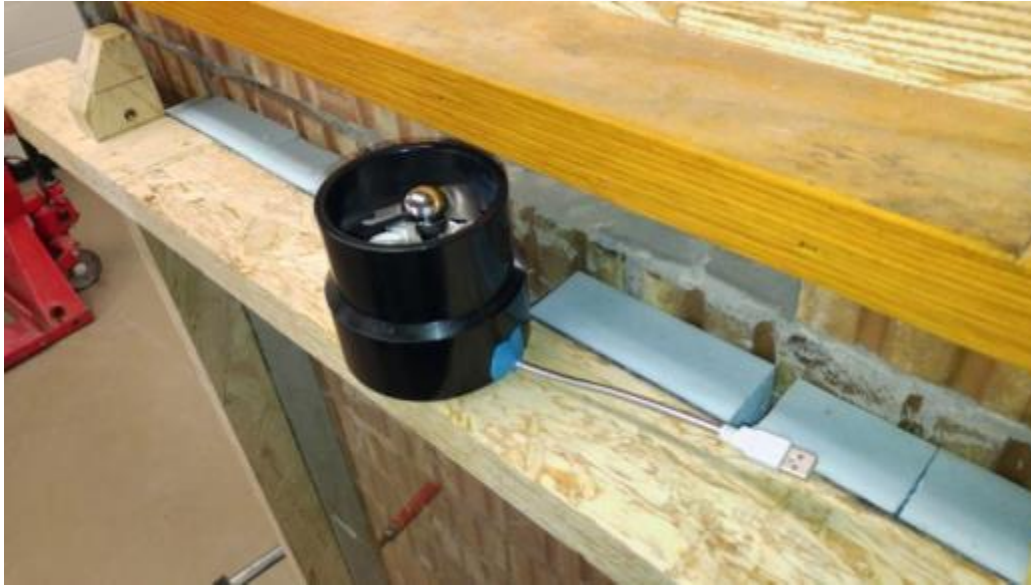
Ventilation air was simulated by introducing air at lab conditions through a small opening at the top of the cavity. This opening was cut to 1.5 cm x 5 cm. A small USB powered fan was placed and centered within a 101mm diameter PVC pipe fitting. This unit was placed overtop the top vent with the fan positioned to blow air at the ceiling, thus creating air suction out of the cavity. See FIGURE 4 below.

*Figure 4 – Components of suction system used to simulate ventilation air*

A small hole was drilled into the side of the PVC pipe to feed through the USB power cord. The hole was sealed with putty adhesive.

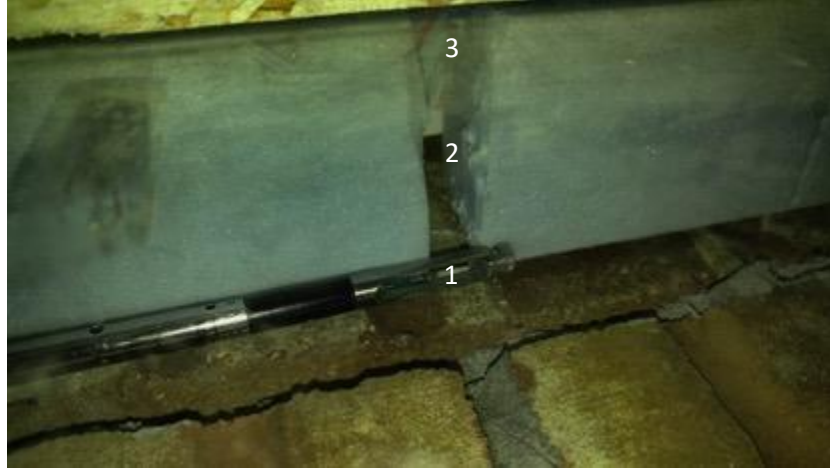
A hot-wire anemometer was used to measure the air speed at the exit vent. Figure 6 shows locations where measurements were taken. The instrument used was the VelociCalc Air Velocity Meter Model 9515 by TSI™. The device has a velocity range of (0 to 20 m/s) with an accuracy of  $\pm 0.025$  m/s or 5%, whichever is greater.

*Figure 6 – Hot-wire anemometer probe at position closest to backside of wall specimen. Three measurements taken at vent opening and an average used for ACH calculations.*

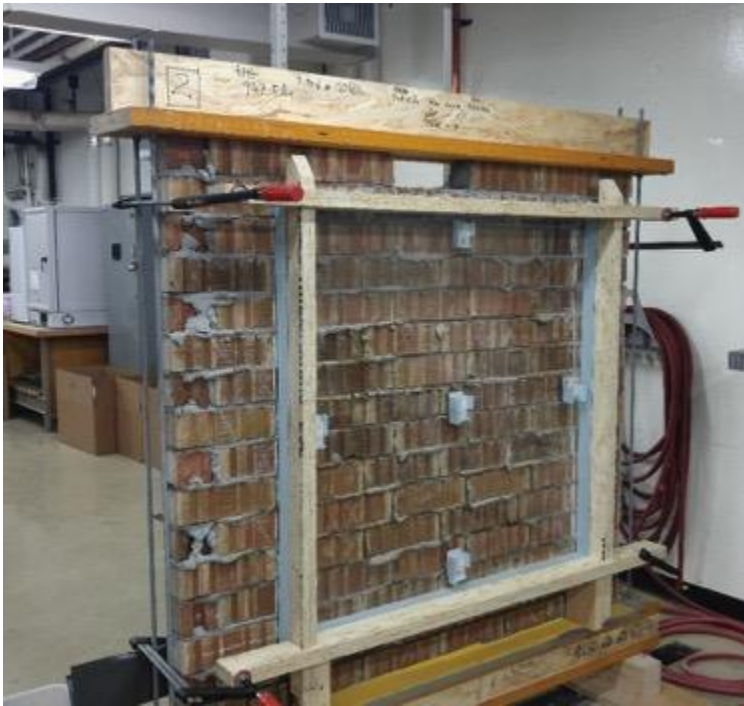
*Figure 8 – Wall specimen with cavity chamber*

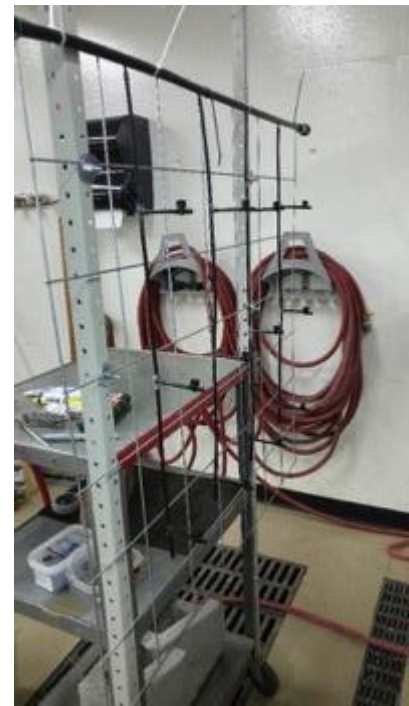
*Figure 7 – Water delivery grid*

The test set up includes the wall specimen with cavity chamber attached on the rear, and the water distribution grid.

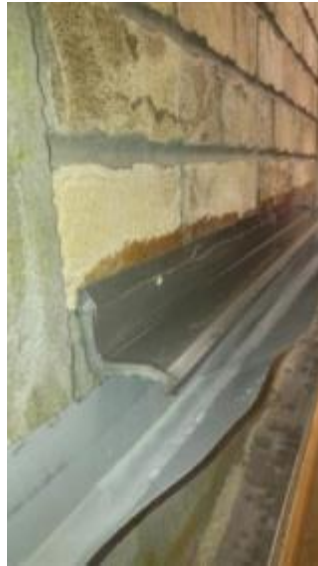
The amount of water applied to the wall was theoretically 125 L over the test period. Metal flashing was installed at the bottom of the exterior face of each wall to direct water that was not absorbed or deflected by the brick wall. The flashing was attached to the wall specimen at three locations with

anchors and masonry screws. Waterproof silicone was used to seal the upper lip of flashing to the wall. This is depicted in Figure 10.

*Figure 10 – Flashing and trough showing drainage path of deflected water*

The water flowed off the flashing into a trough which drained to a bucket. The bucket was weighed to determine the amount of water which drained off the exterior side of the wall.

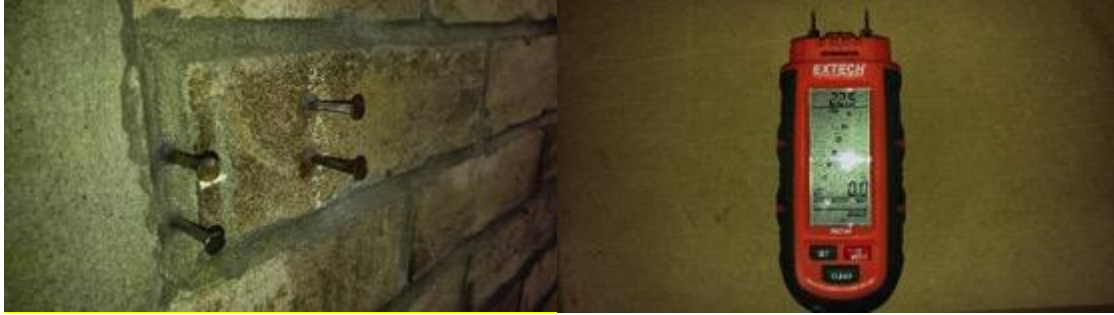
Moisture content of various construction materials can be difficult to measure. Different devices yield varying results. An electrical resistance moisture meter (Extech MO230) was used to measure moisture content in brick and mortar independently. Two pins were placed on the material and electrical conductivity was measured between the two pins. The inherent disadvantage of this unit is the moisture content is read only on the surface. In situ data was preferred for this experiment as it would give a more accurate representation of moisture profile in the wall. To combat this problem, holes were drilled to the center of each wall specimen. Masonry nails were then tapped into the holes, which essentially acted as extension probes for the contact pins. For example, wall type C would have nails driven 45mm in depth, equal to half the total depth of the brick. The holes were then sealed with waterproof silicone sealant to stop water from entering the hole. This can be seen in Figure 11.

*Figure 11 – Typical installation of moisture meter pins shown on left. Extech MO230 Moisture meter shown on right*

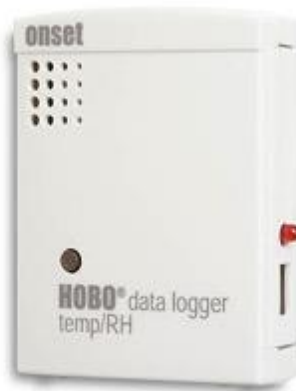
Air temperature and RH was monitored for both lab and cavity conditions. The data loggers used for measurement were six Onset HOBO U10-003 Internal RH/Temp units. These units were attached to the cavity glass panel with double-sided tape. Styrofoam was used to shield the units from possible water damage. The units were programmed to record conditions at 30-second intervals. They were placed at the same locations as the moisture content readings were taken, however in the cavity, on the reverse side of the wall. One logger was placed on a desk within 6 feet of the wall to measure lab conditions.

*Figure 13 - Image courtesy of Onset Corporation™*

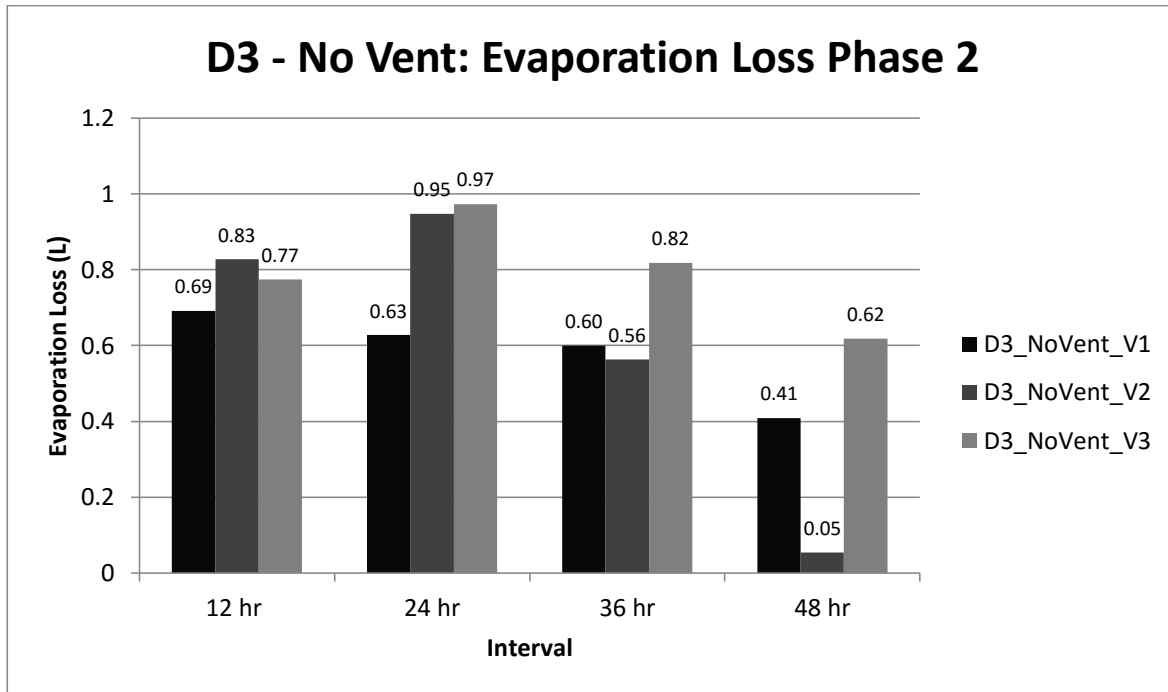
Figure 15 – D3, no ventilation, evaporation loss during phase 2

Tests V2 and V3 show the largest amount of evaporation occurred between the 12 hour and 24 hour time points. This trend did not occur during the first test (V1).

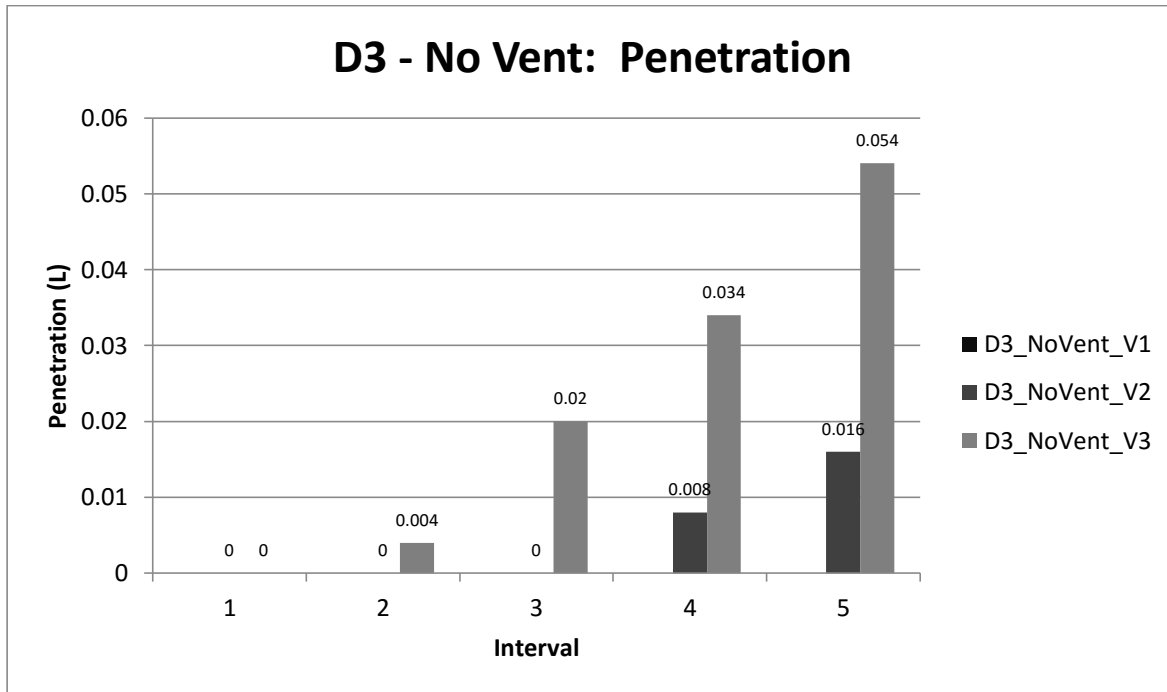
Figure 16 – D3, no ventilation, penetration

The quantity of water penetration was measured by weighing moisture absorbent cloths before and after each wetting cycle. The first test, (D3\_NoVent\_V1) had no penetration which could be measured through this technique. Water was observed to be penetrating through the brick during the first test cycle of wetting, but it travelled down the length of the wall and was reabsorbed by brick outside the testing area before it could be collected by the moisture absorbent cloths. This event occurred during each wetting cycle of test D3\_NoVent\_V1. As the walls became damp, more water penetrated the brick veneer, resulting in more bulk water collected at the base of the cavity chamber. The larger amounts of water became quantifiable. The results clearly show an increase of water penetration in consecutive tests.

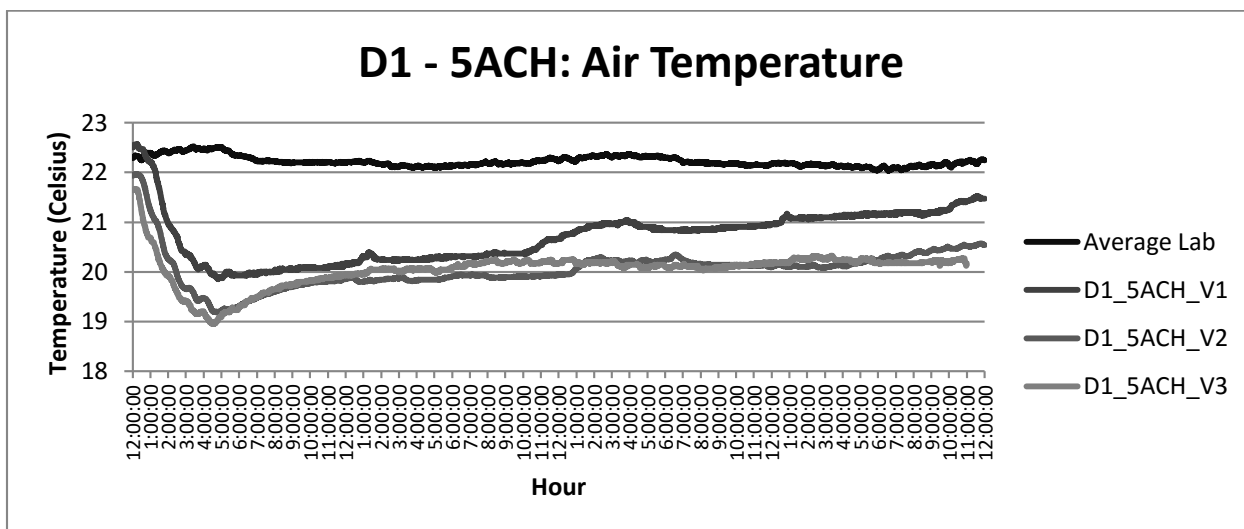
Figure 26 – D1, 5 ACH, air temperature

Air temperature within the cavity was lowest during the wetting phase in test V3. The first tests V1 and V2 resulted in similar temperature profiles throughout the length of the test. The number of degrees in temperature drop during each test was approximately the same, however the initial temperatures differed which appeared to influence warming of the cavity throughout the remainder of the test. Overall, V1 data showed the quickest increase in temperature during phase two of the experiment.

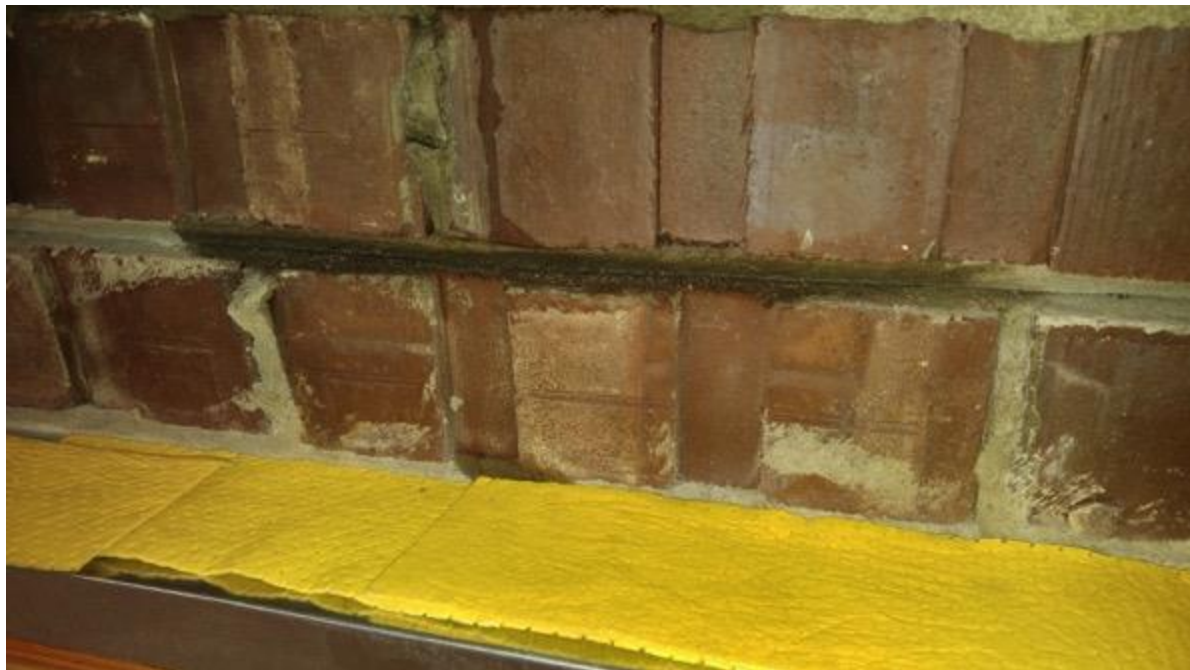
- i) Water accumulated on the mortar droppings or in raked mortar joints instead of draining to the bottom of the wall.
- ii) Water drained downward, outside the test area and collected on raked mortar joints where the water was re-absorbed into the bricks which were not exposure to the simulated WDR. This is exemplified in Figure 57.

*Figure 57 – Photograph showing water accumulating on a raked mortar joint, outside the test area.*

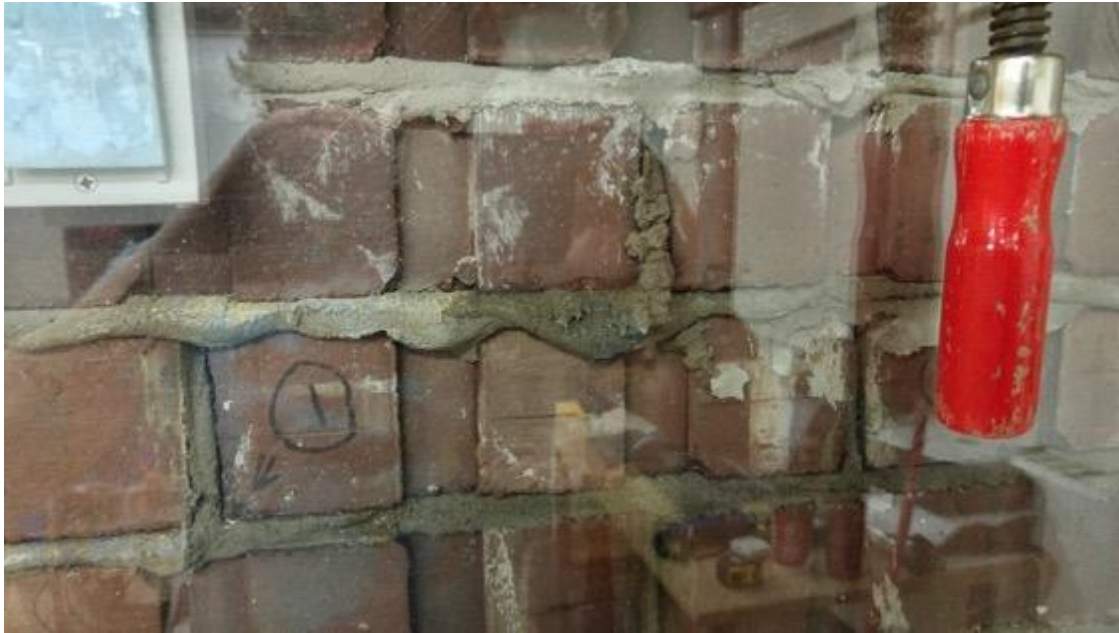
chamber. This moisture could not be measured without removing the cavity chamber. An example of the accumulation can be seen in Figure 58.

*Figure 58 – Photograph showing moisture accumulation on mortar droppings.*

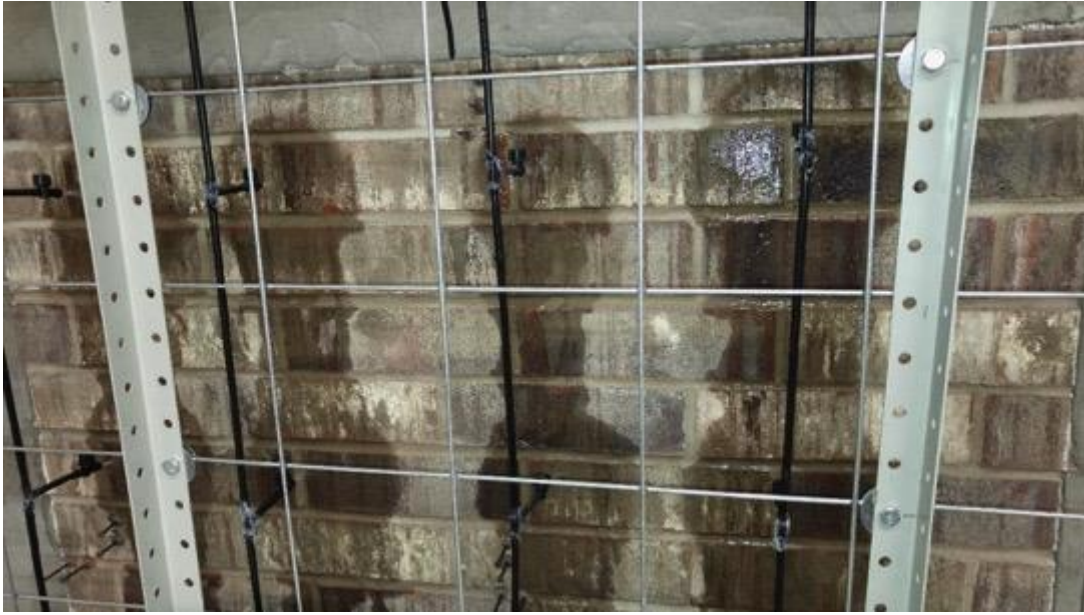
The original design of the water distribution grid was to use twelve misting heads positioned 30 cm from the wall to provide sufficient coverage. The spread of the misting heads is dependent on the amount of available water flow. Initial mock tests showed this was not possible with the equipment because too much water was being delivered to the wall specimen for the desired spread pattern. As a result, the flow had reduced, therefore reducing the diameter of the spread pattern. This resulted in an uneven distribution of water should the delivery grid stay stationary. Figure 59 shows the actual spread pattern which was used in the investigation.

*Figure 59 – Photograph showing the actual spread pattern used in the investigation*

This spread pattern required the investigator to shift the water delivery grid throughout the 15 minute wetting cycles to provide an even distribution. The grid was shifted twice, moving left to right, during each wetting interval for a total of five minutes in each position. Without this technique, a significant portion of the wall would not be exposed to the simulated WDR. The only test which did not receive this treatment was D3\_NoVent\_V1. The effect of this can be seen in the absorption results as the subsequent test in that series (V2) absorbed more water.
