**COMPARISON BETWEEN SATELLITE IMAGE ANALYSIS  
AND SITE DATA FOR MONITORING TRAIL ROAD  
LANDFILL SITE**

**Presented to Ryerson University  
In Partial Fulfillment of the  
Requirements for the Degree of  
Master of Applied Science  
In the Program of  
Civil Engineering**

**Toronto, Ontario, Canada 2010**

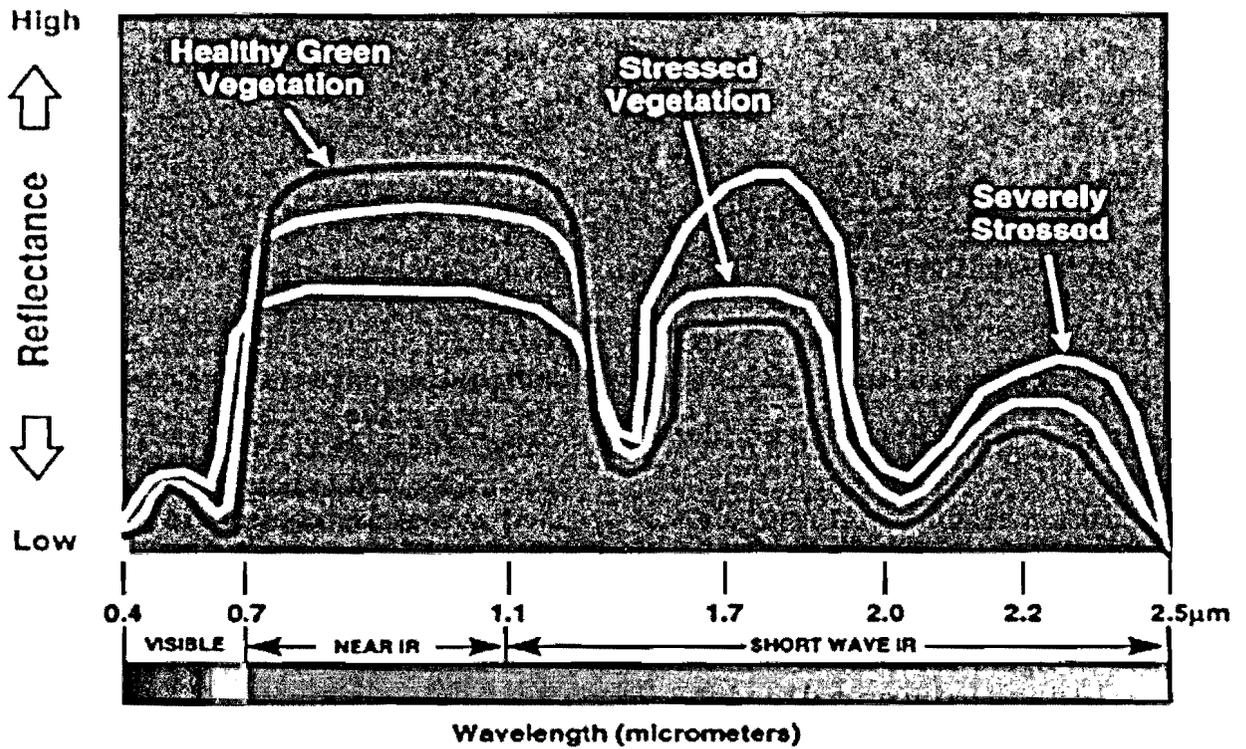
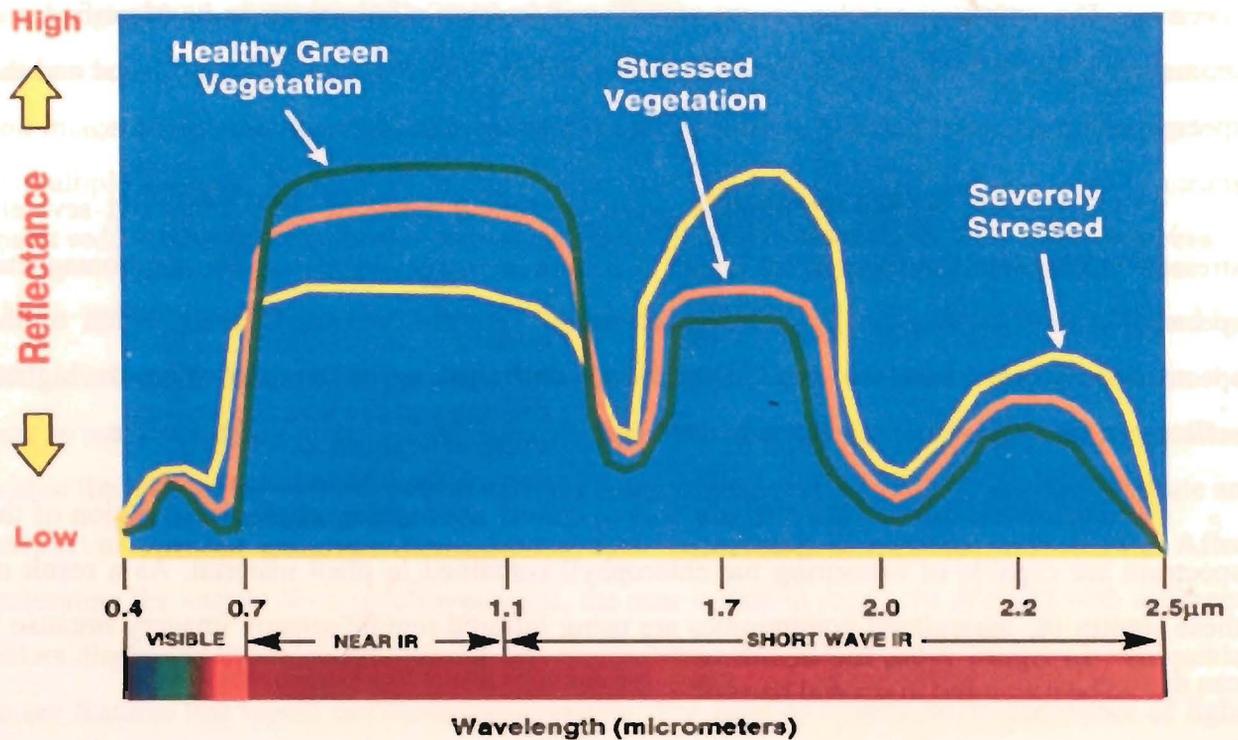
Figure 3.1 - Spectral Reflectance of Vegetation vs. Different Wavelengths

Studies show that sensors that are able to collect data in the near-infrared region of the spectrum are capable of measuring the chlorophyll contained in plant material. As a result of these studies the agricultural communities are using infrared remote sensing imagery because it can distinguish crop stress before the human eye can detect it (Kusanagi, 2000).

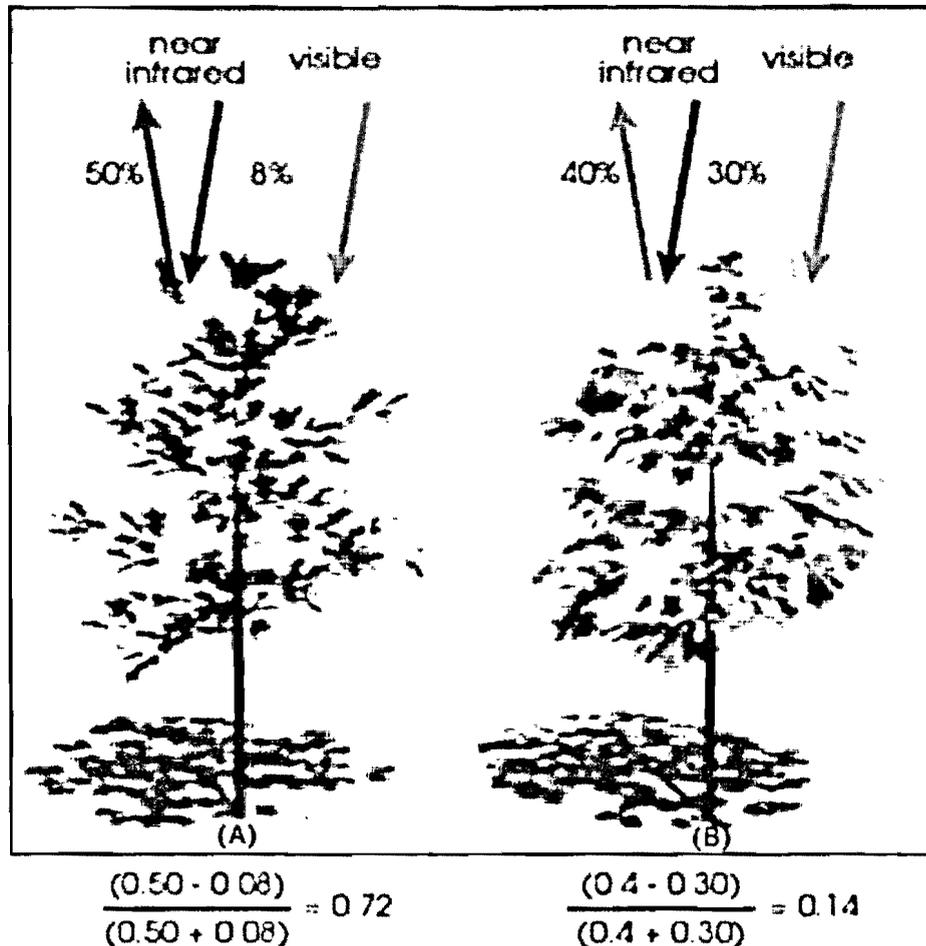
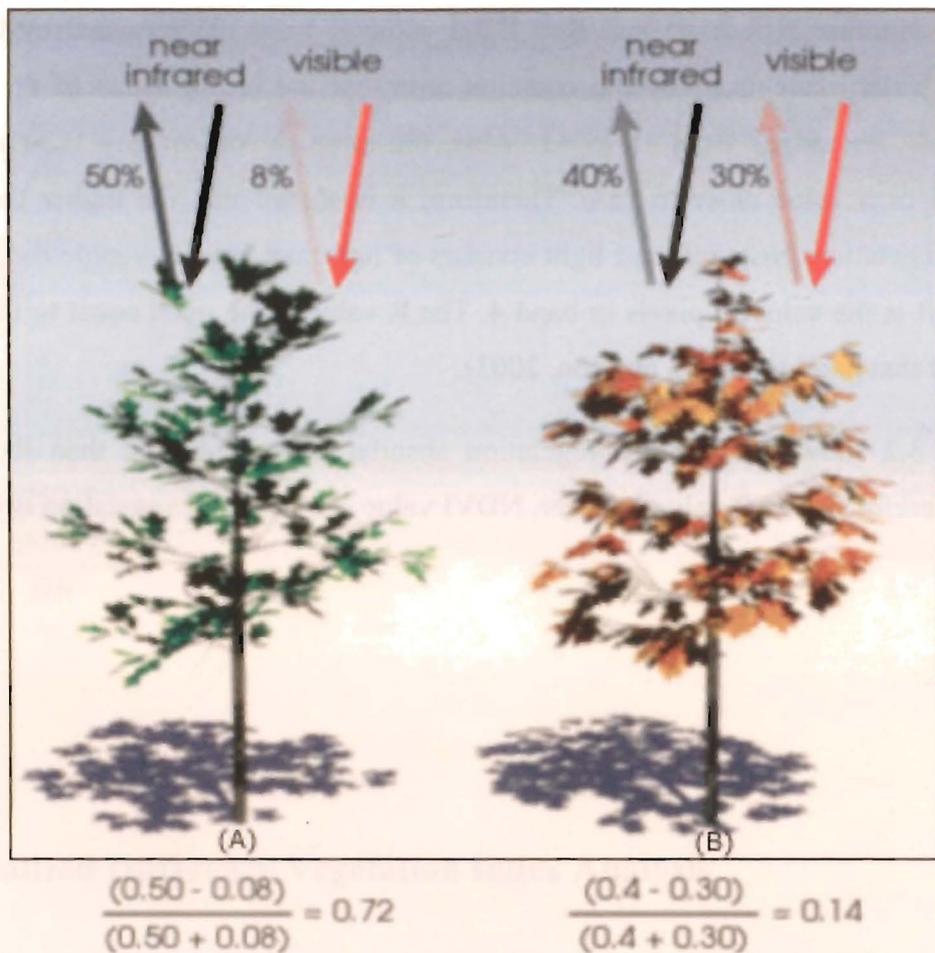
Figure 3.2 – NDVI Calculation

(A) The healthy vegetation absorbs more Red light than (B) the unhealthy or stressed vegetation

Figure 3.2 show that healthy vegetation absorbs more Red light than the unhealthy vegetation. Therefore when R value is lower, NDVI value is higher and vegetation is healthier.

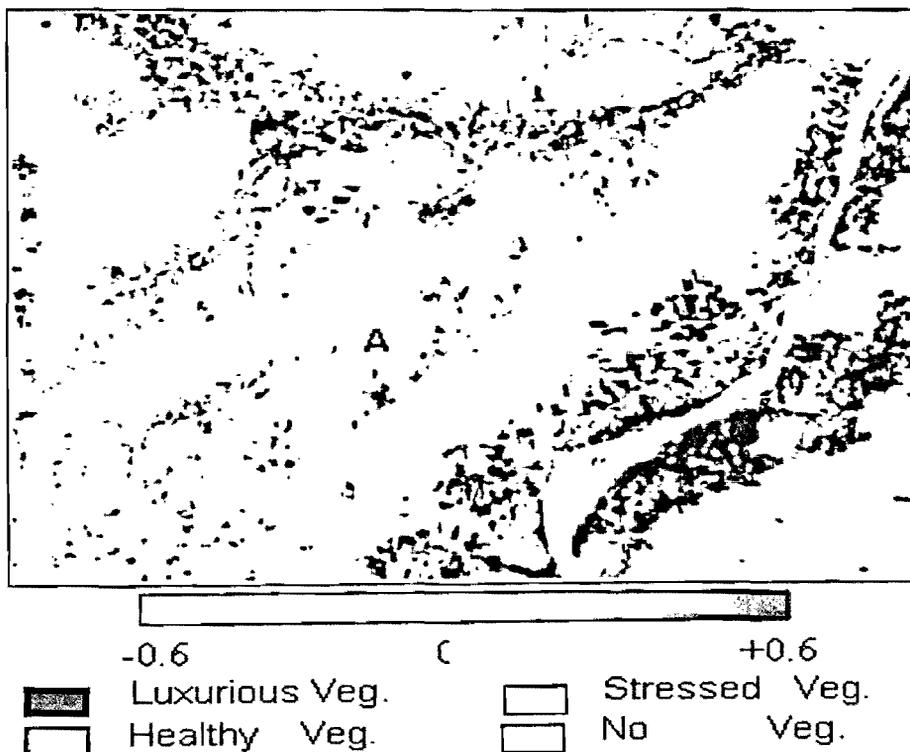
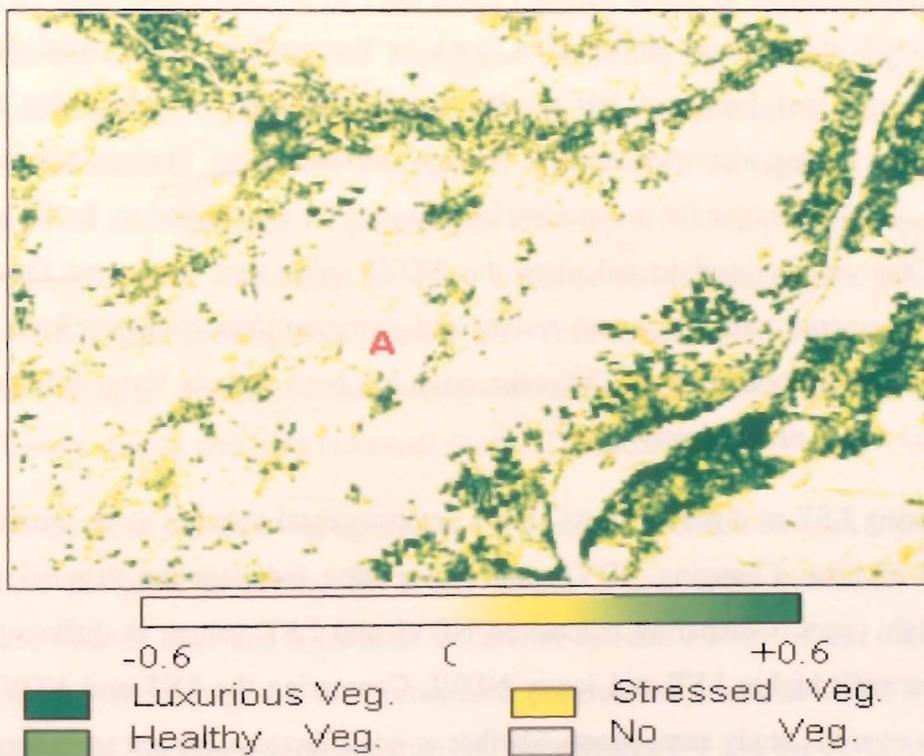
Figure 3.3 - The intensity of NDVI value

Figure 3.3 has been classified into four classes: Luxurious vegetation, Healthy vegetation, Stressed vegetation, and Areas with No vegetation. It can be observed that the areas close to the river channels have a good concentration of Luxurious and healthy vegetation when compared to the rest of the area.

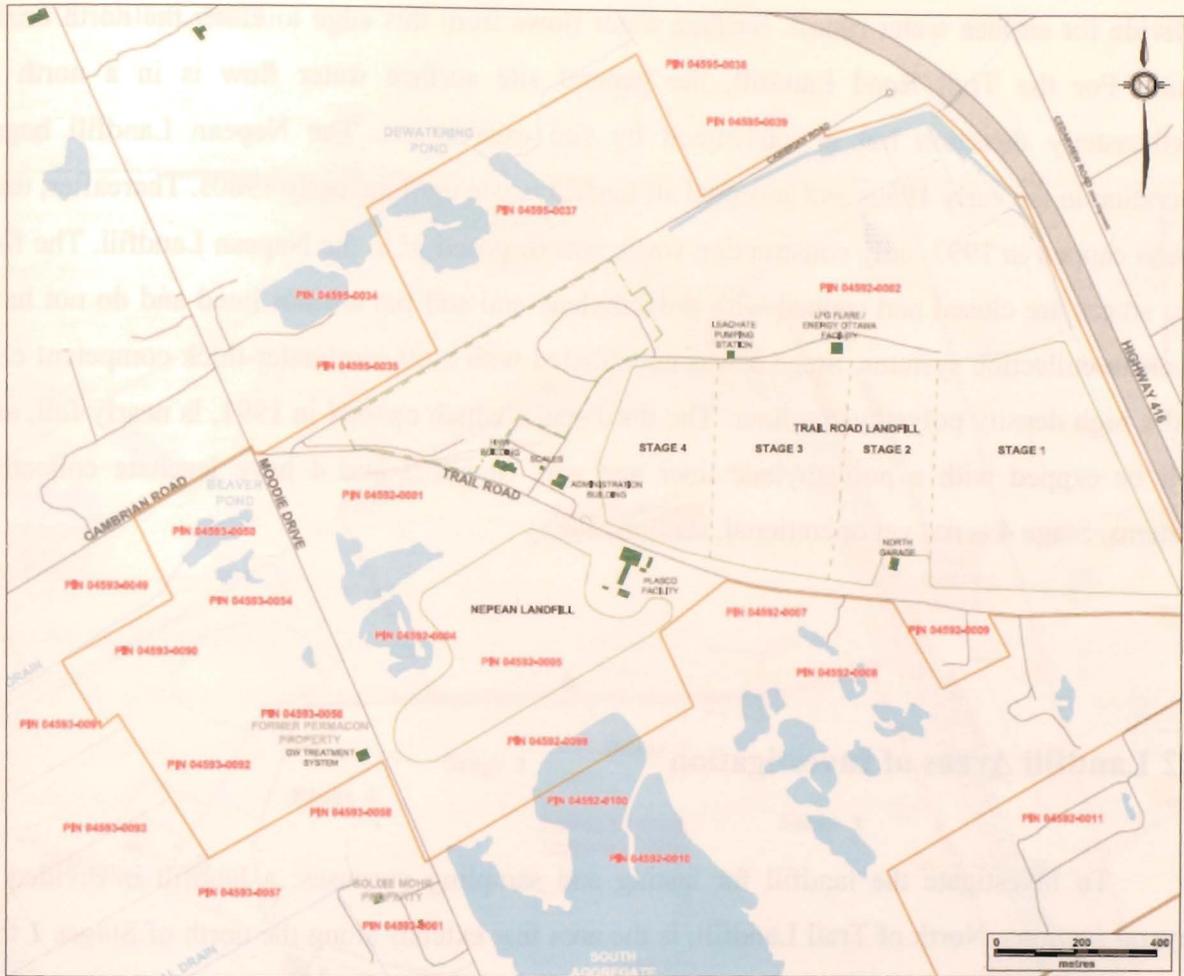
Figure 4.2- Landfill General Area

The surrounding area of the landfill is covered by grasslands and light forests. Running tangent to the eastern side of Trail Road Landfill is Highway 416. The southern side is bordered by a Lesser Road, Trail Road, which also borders the northeastern side of the Nepean Landfill which is located southwest of the Trail Road Landfill. Moodie Drive runs along the western boundary of the Nepean Landfill. The south end of the entire site is bordered by Barnsdale Road, and Cambrian Road runs northeast through the northern boundary of the site, but is not immediately adjacent to the landfills, as shown in Figure 4.1. Figure 4.2 shows the location of different landfill's stages. (Dillon, 2007)

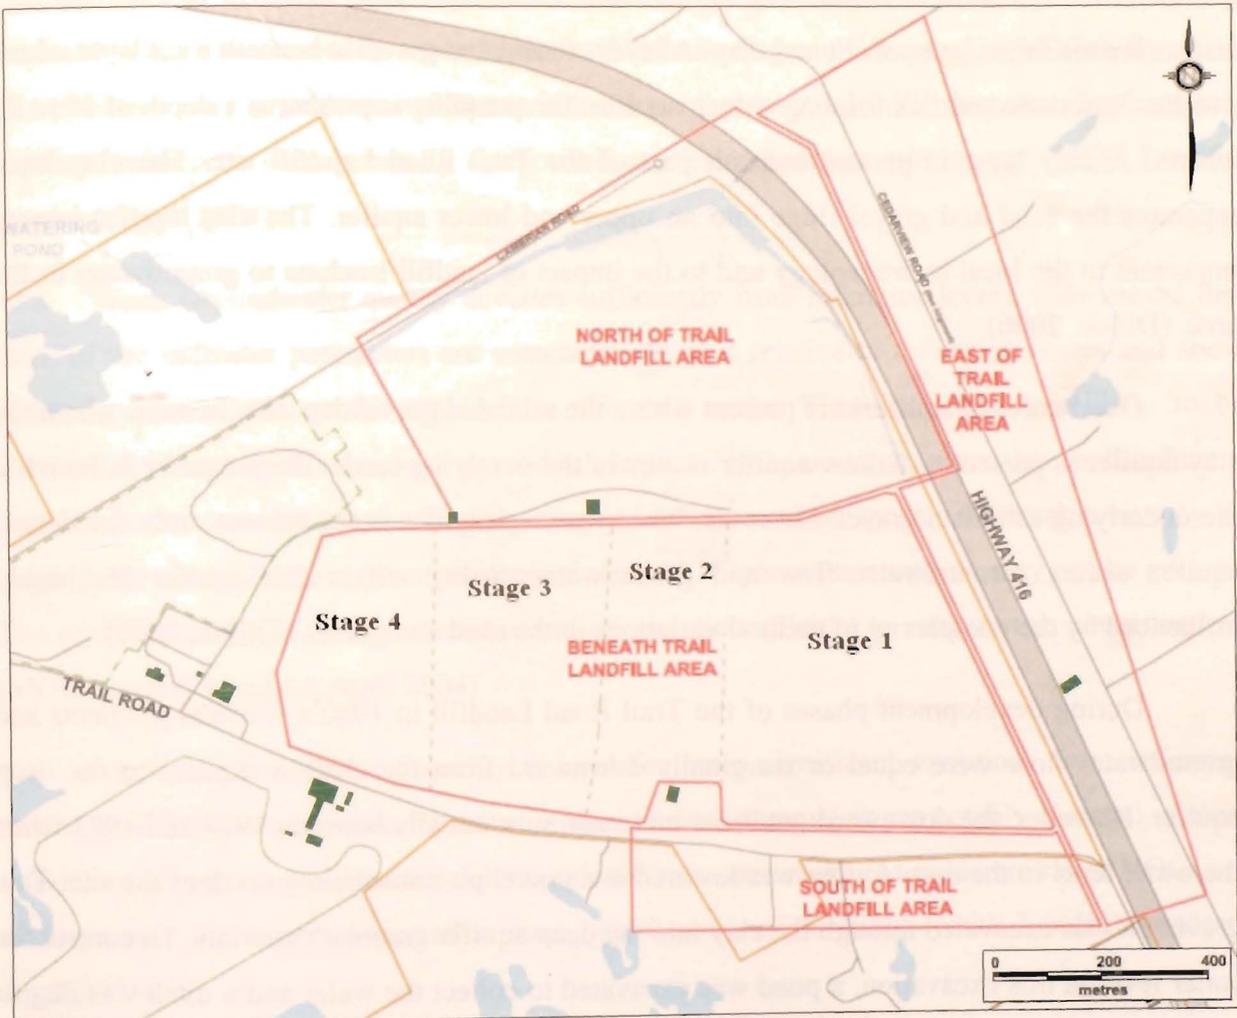
Figure 4.3- Landfill Stages

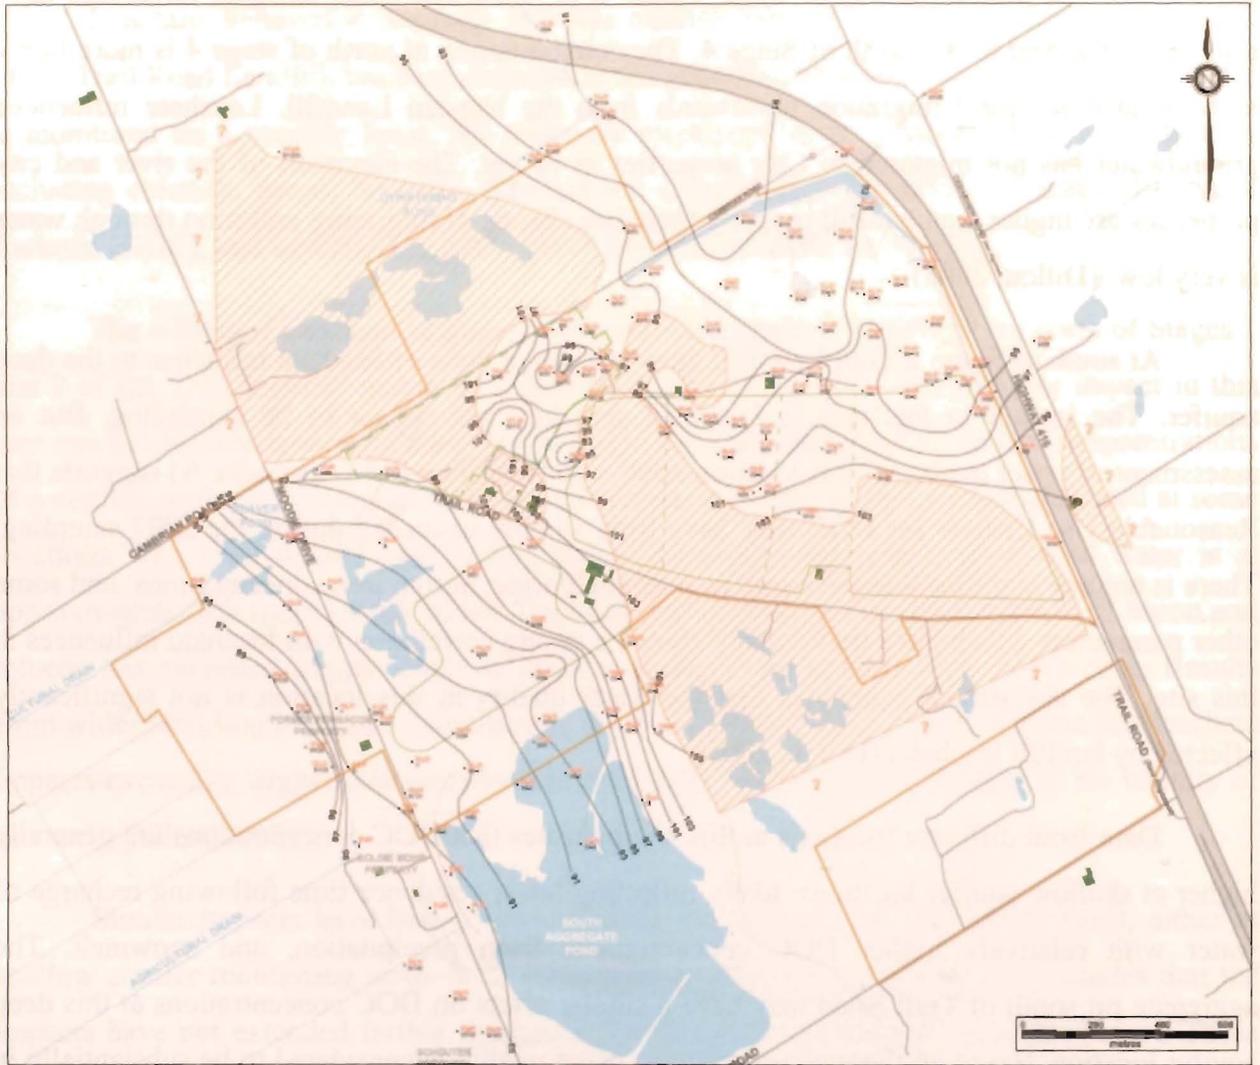
Figure 4.4- Elevations of the Landfill and the Surroundings Area

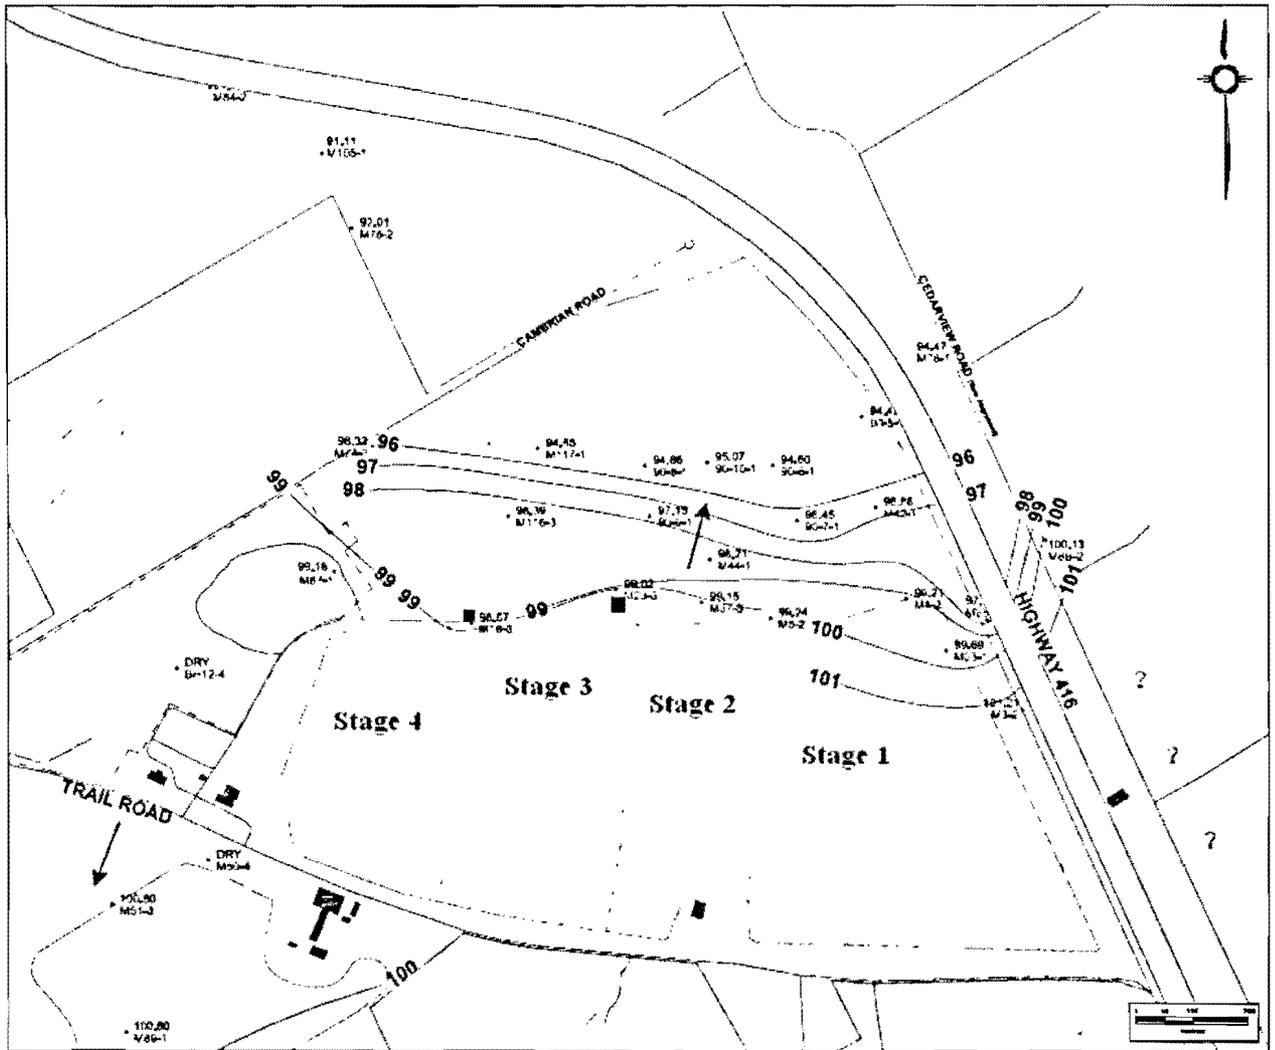
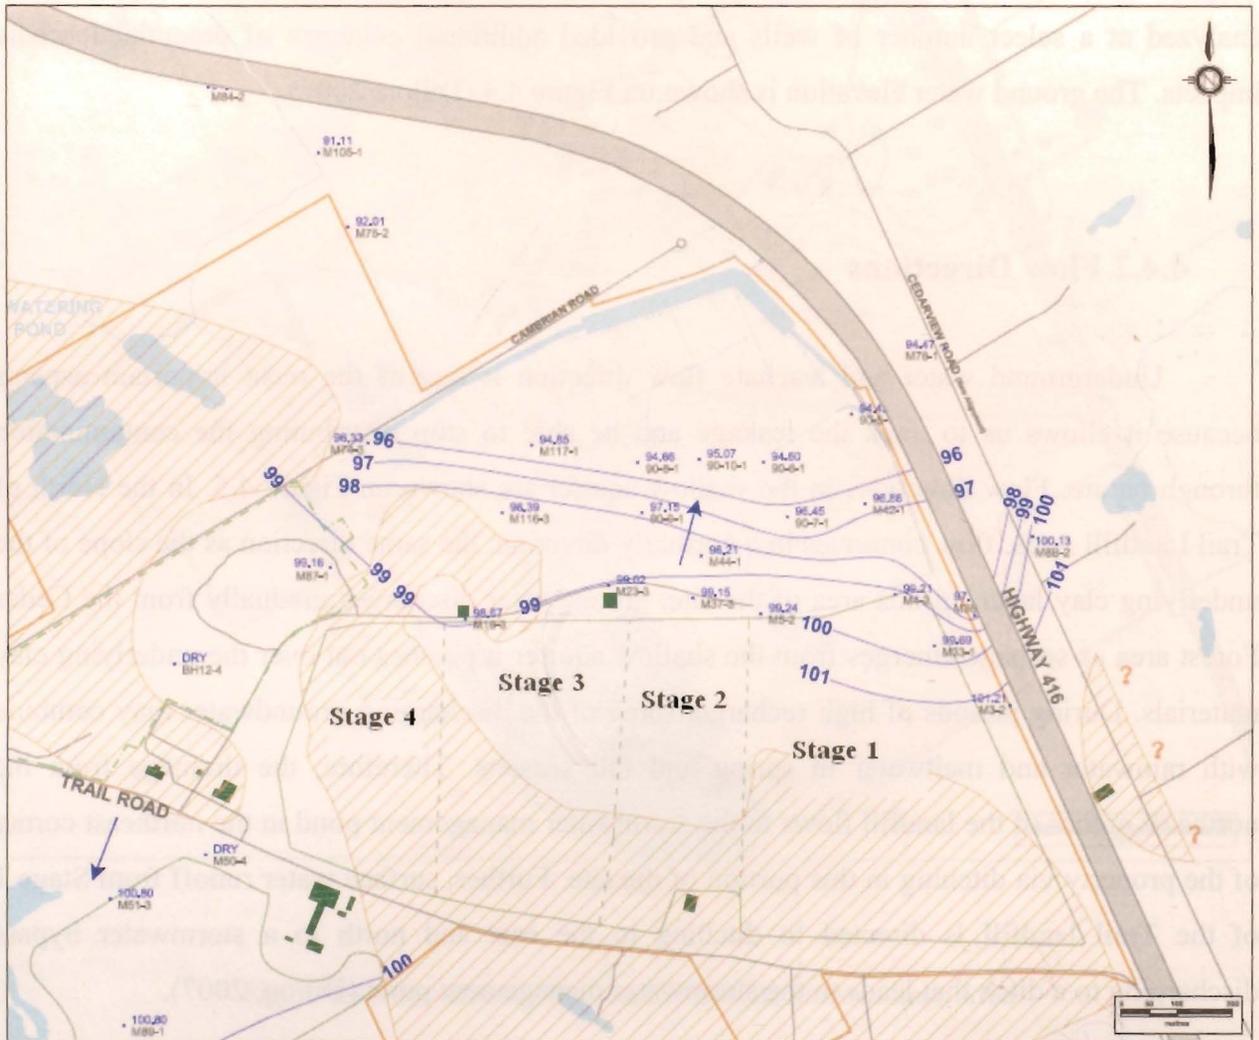
Figure 4.5 - Flow Directions from the Trail Road Landfill

Underground water and leachate flow direction is one of the most important aspects because it allows us to track the leakage and be able to stop distributing the contamination through nature. Flow directions in the shallow aquifer are shown on Figure 4.5. In the North of Trail Landfill Area, flow continues in a northerly direction, the same direction as the slope of the underlying clay layer. In this area of the site, groundwater discharges gradually from the Cedar Forest area as seepage emerges from the shallow aquifer it pinches out over the underlying clay materials. During periods of high recharge, some of the discharging groundwater may combine with rainwater and meltwater in spring and fall seasons. Therefore, the drainage from the northeast corner of the landfill flows to the stormwater management pond in the northeast corner of the property via ditching in this portion of the site. Further, surface water runoff from Stage 1 of the Trail landfill is directed to ditching to the east and north to a stormwater bypass discharging to a ditch that leads to the stormwater management pond (Dillon, 2007).

or draining to the deep aquifer where the clay pinches out. Flow from the far western corner of the property is southwest across Trail Road towards the Nepean Landfill (Dillon, 2006).

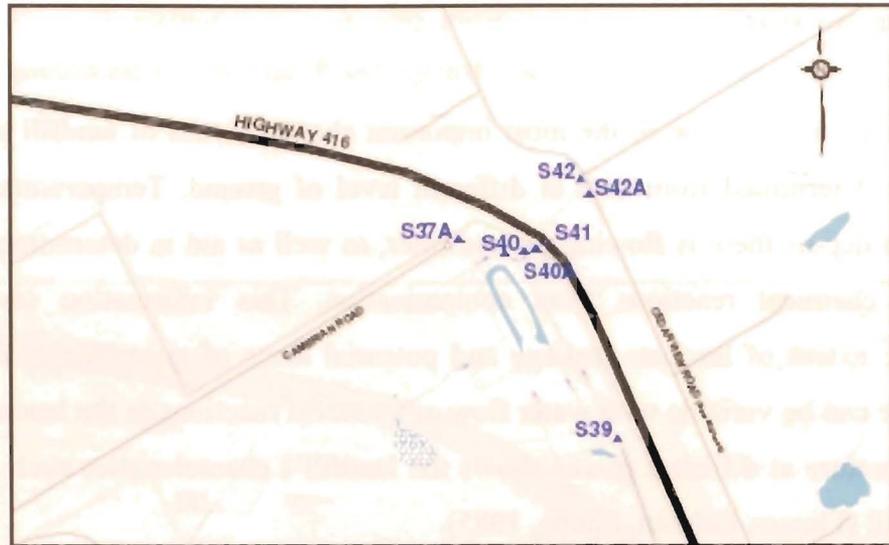
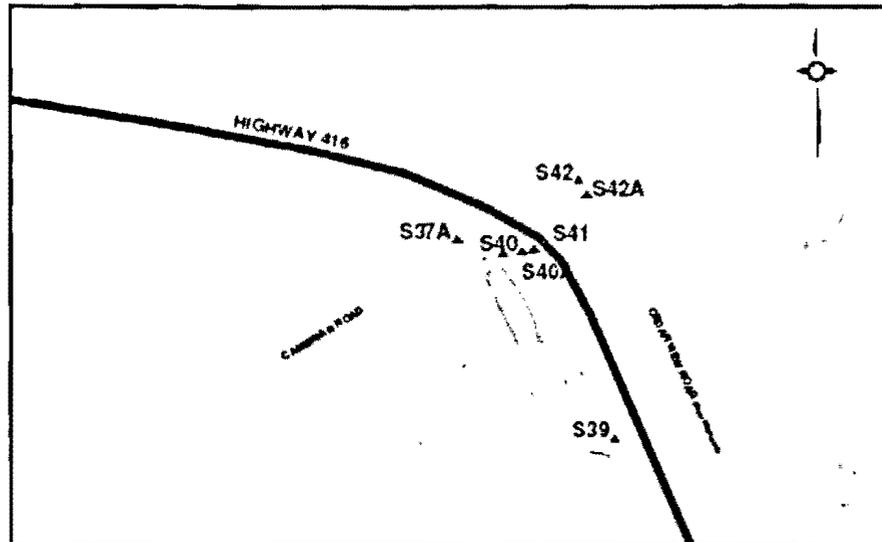
Figure 4.6 – Locations of Surface Monitoring Stations

Surface water drainage from the Trail Road Landfill is directed to the stormwater management pond at the northeast corner of the site. From there, surface water flows eastward under Highway 416 and then continues northward via roadside ditches along Cedarview Road, ultimately discharging to the Jack River. Surface water flowing in this system consists primarily of surface runoff, but may also include a component of shallow aquifer groundwater discharge. No exceedances of surface water trigger concentrations were obtained at any stations that have been set up at the discharge points from the site. The locations of the monitoring stations are shown on Figure 4.6.

Because of the exceedances of groundwater boron and toluene in the Cedar Forest area surface water samples have been taken at all locations of visible surface water discharge from the forest. Elevated iron and total phosphorus levels are generally considered unrelated to the landfill, although, in the case of iron, leachate influences may be a contributing factor at some locations.

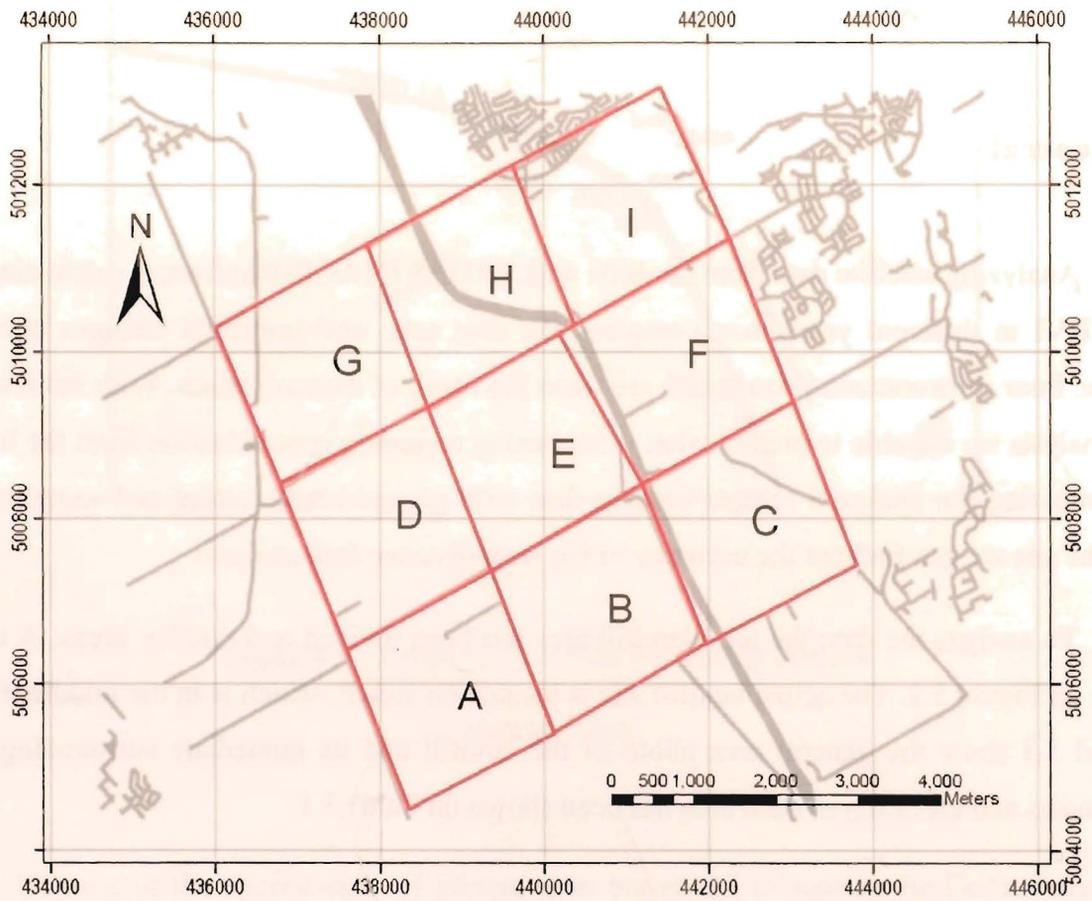
Figure 5.1 - General Study Area Divided Tiles

To analyze the data the total landfill area has been divided to 9 smaller areas: A to I, as shown on Figure 5.1. The actual landfill site is located on area E, which is in the middle. Figures 5.2 and 5.3 show the general area photo of the landfill and its immediate surroundings. The coordinates and elevation of each area has been shown on Table 5.1.

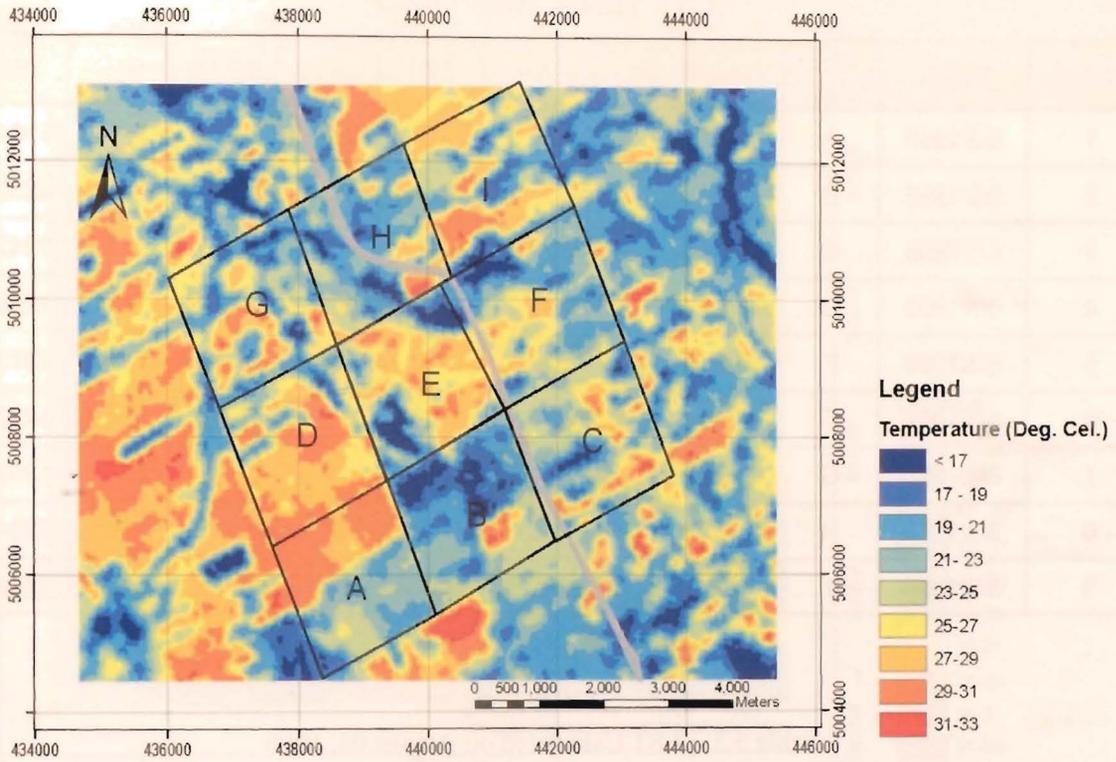
Figure 5.4 - LST on May 29, 1992

Figure 5.4 displays the LST calculated for year 1992 with ERDAS IMAGINE software. As the color indicates, ground surface temperature is between 12 and 32 degree Celsius. The image was taken on May 29, 1992. The external temperature recorded for the daytime of that date was within the range of 8 to 12 degree Celsius. Further, the vegetation has a significant influence on surface temperature. In spring time there are lots of movement on the ground surface, such as animals, insects and vegetation. They all cause heat which in turn can have small effects on surface temperature in the area.

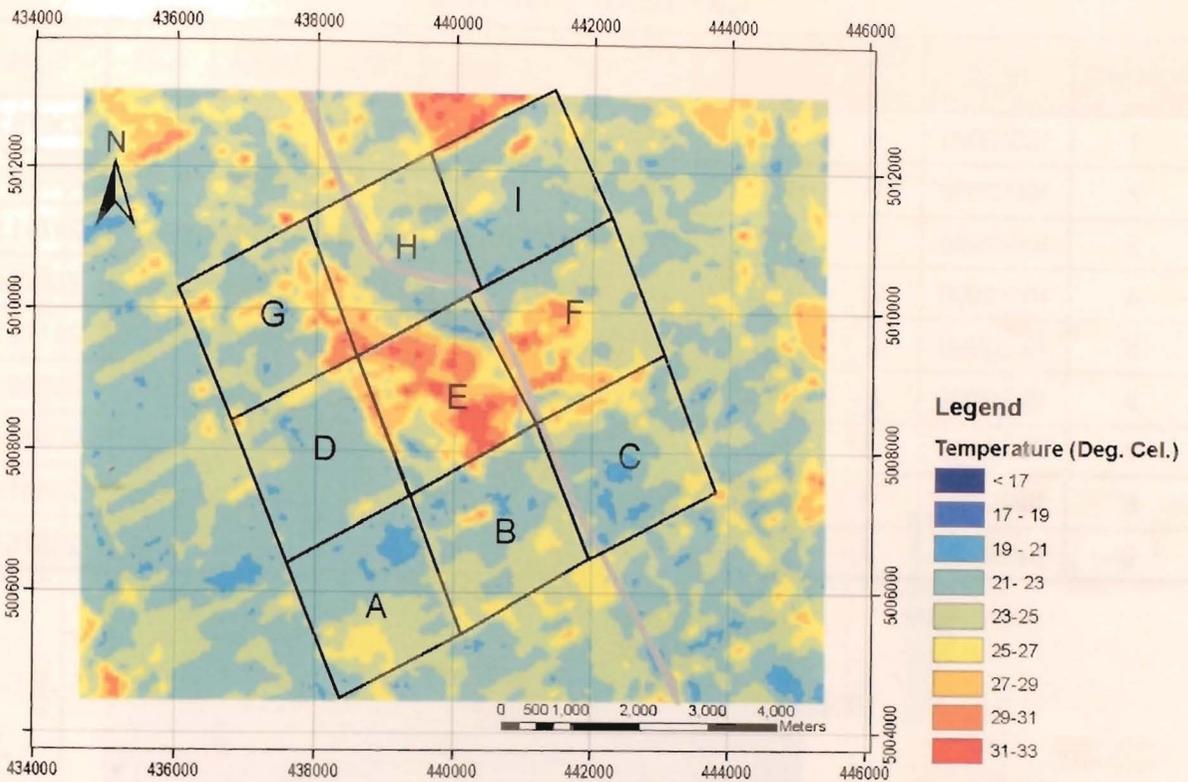
Figure 5.5 – LST on August 03, 1998

The highest LST indicated at this time was on the north side of area E, at 25.7 degrees Celsius, which is located directly on the landfill site. Additionally, the highest standard deviation is also accrued in area E amidst the landfill itself. The highest average LST value surface temperature also occurs at area E, at 19 degrees Celsius. Table 5.4 shows the summary of LST calculated for all nine divided areas at October 2000. LST values calculated for year 2000 indicates that the minimum and maximum LST value, highest average LST value, and standard deviation value all occurred in area E in the areas that are used for the landfill. This might be one of the negative effects of a landfill upon environment. These negative results could be caused by leachate leakage and contamination from the landfill.

Figure 5.5 shows the calculated LST on August 1998. As the color of the legend indicates, the LST value calculated for this date is between 20 and 32 degrees Celsius. This image was acquired during the summer, and the weather temperature range was between 22 and 26 degrees Celsius. There shall be other likely causes to influence the LST values.

The highest LST value captured at West side of area F at 31.9 degrees Celsius, an area that is very close to the landfill's location. All areas have approximately the same range of low temperature at 20 to 21 degrees Celsius. The highest standard deviation calculated at area E, the landfill area itself, with significant differentiation from the other areas. The highest average LST belongs to area E as well, with 27.1 degrees Celsius. Table 5.3 shows the summary of LST calculated for each of the areas in July 1998. The high average indicates that most of the LST values are relatively higher than normal LST values. The minimum LST of all areas is in the same range, between 20 and 21 degrees Celsius.

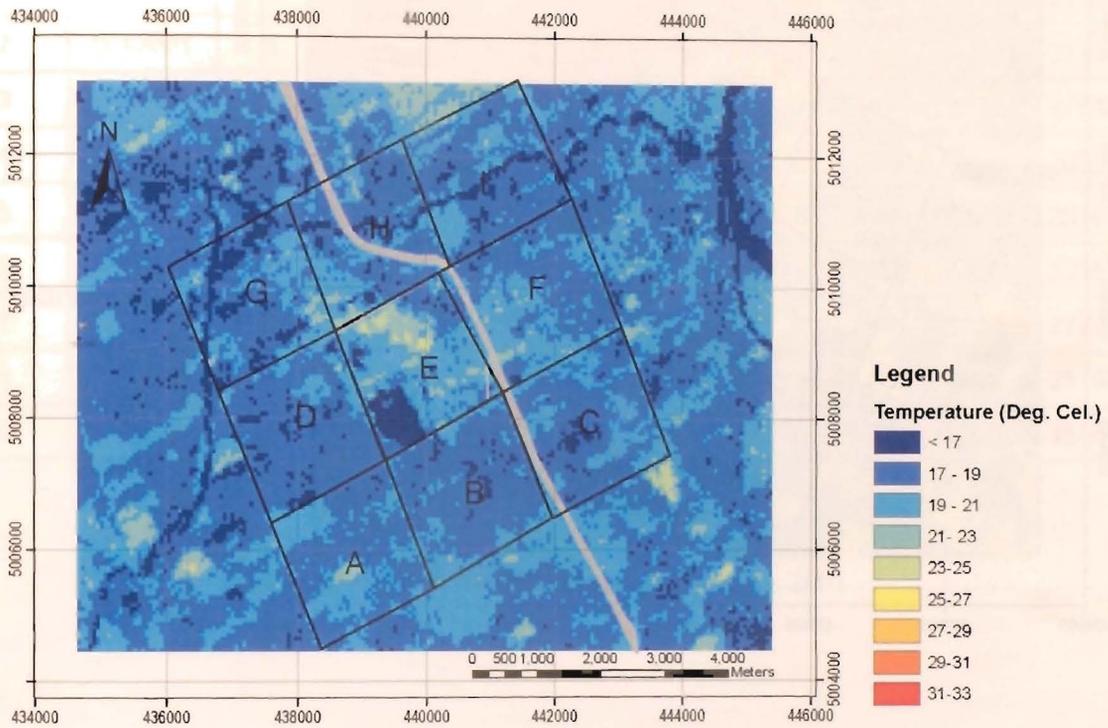
Figure 5.6 - LST on October 02, 2000

Figure 5.6 displays the LST values calculated with ERDAS IMAGINE software in October 2000. This figure indicates that the general temperature is lower than the previous figures. The temperature range is between 12 and 25 degrees Celsius. This image was taken in October 2000 (during autumn) and the external temperature is usually in range of 13 to 17 degrees Celsius. Further, the vegetation which influences LST is almost dead in this season. The activities of animals and plants are less than in spring and summer, and thus the lower LST is to be expected.

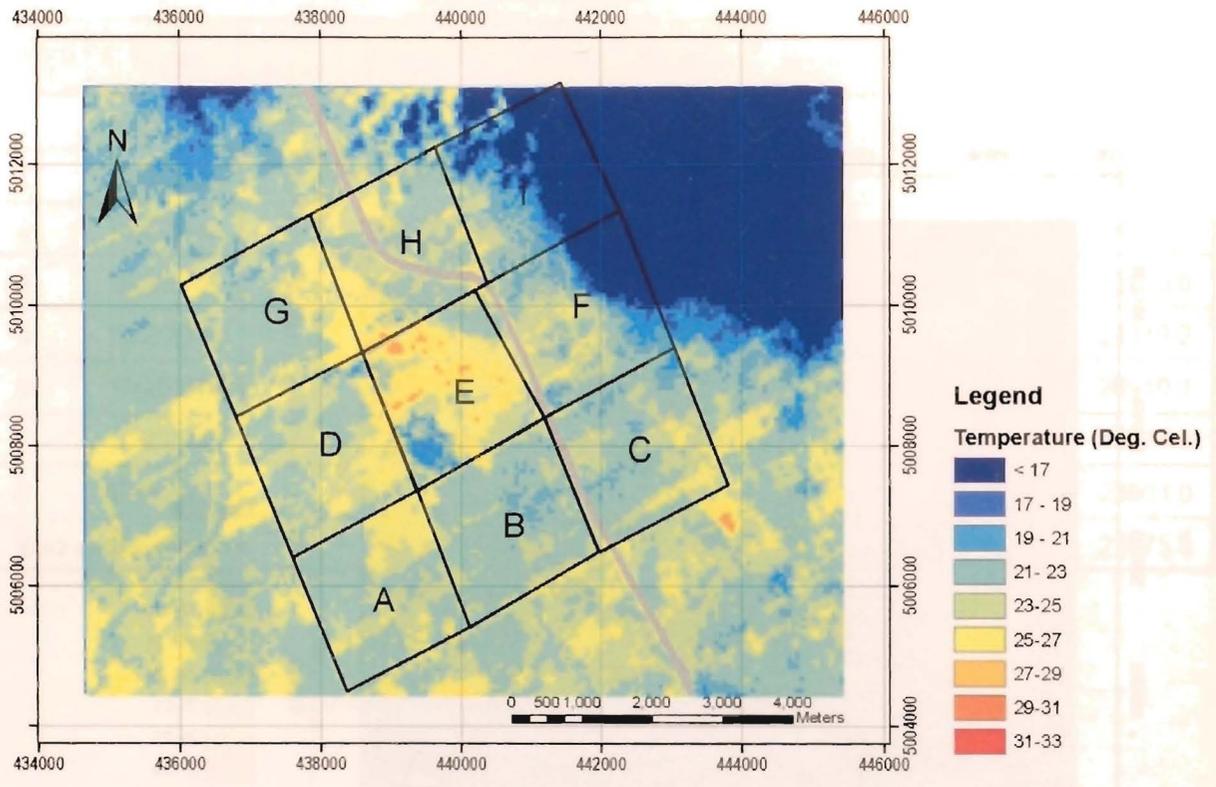
Figure 5.7 – LST on September 03, 2001

Figure 5.7 shows the LST of the area collected on September 2001. The range of the LST is between -14 and 28 degrees Celsius. This image was taken during the Fall season, and the external temperature is commonly within the range of 17 to 23 degrees Celsius. Additionally, the activities of micro organism, animals and plants are less than in the spring and summer months, so therefore the lower temperature can be expected. The highest LST occurred at the north and centre of area E, at 28.2 degrees Celsius overtop of the landfill site. The highest average LST also accrued at area E, with 23.1 degrees Celsius. The reason for the -14 degrees Celsius LST at I area is unknown, and it may be a software error. The highest standard division is 8.9 degrees Celsius, which indicates unusual LST values in area F. Table 5.5 shows the summary of surface temperature calculated for all nine divided areas during September 2001.

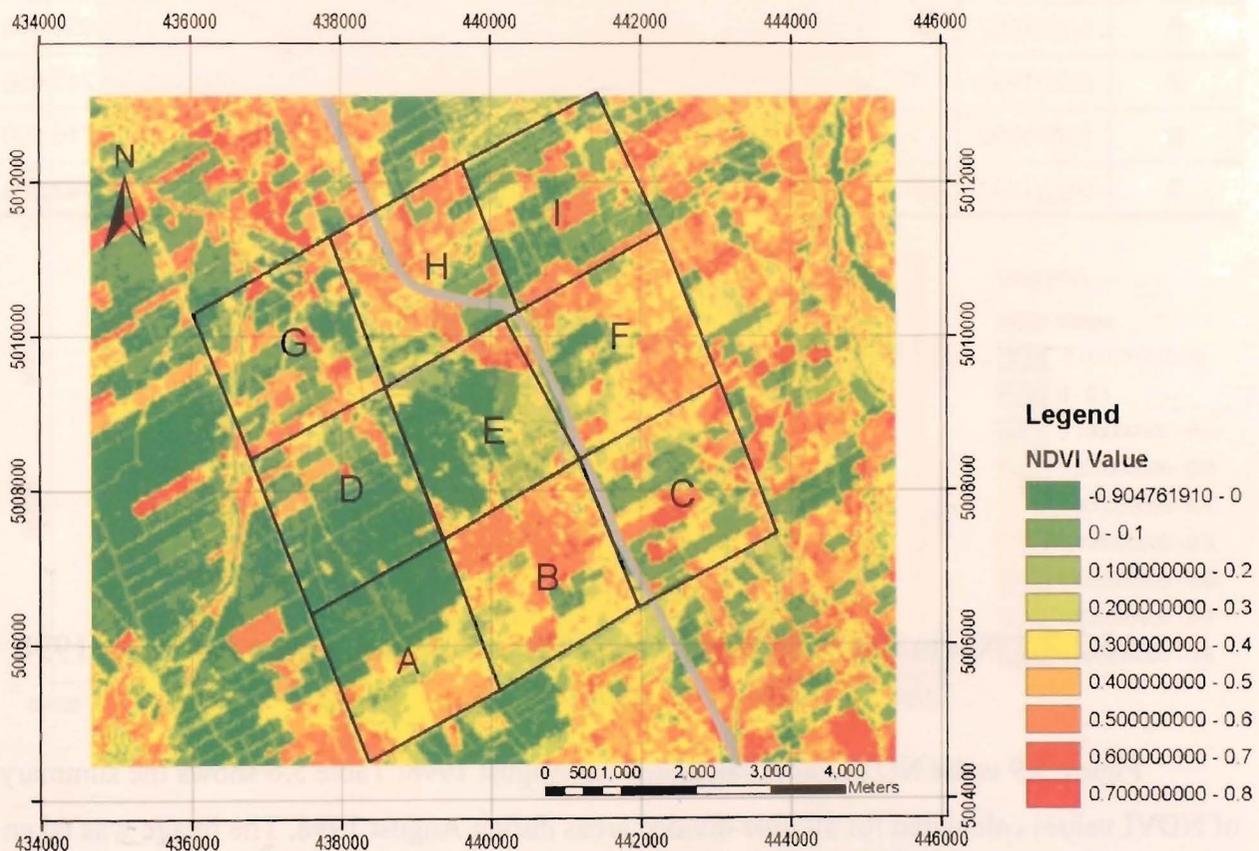
taken during the spring, when the vegetation has started growing new leaves and branches. The lowest NDVI, which is the unhealthiest vegetation, occurred in area E, amidst the landfill site, with a NDVI value of -0.4. Figure 5.8 shows that the lowest NDVI values calculated at stage 3 and 4 of Trial Road landfill, and all of the Nepean Landfill. However, the lowest NDVI average happened in area D with a value of 0.1. This average value means that the vegetations are in normal condition within the general area.

Figure 5.8 - Calculated NDVI Values on May 29, 1992

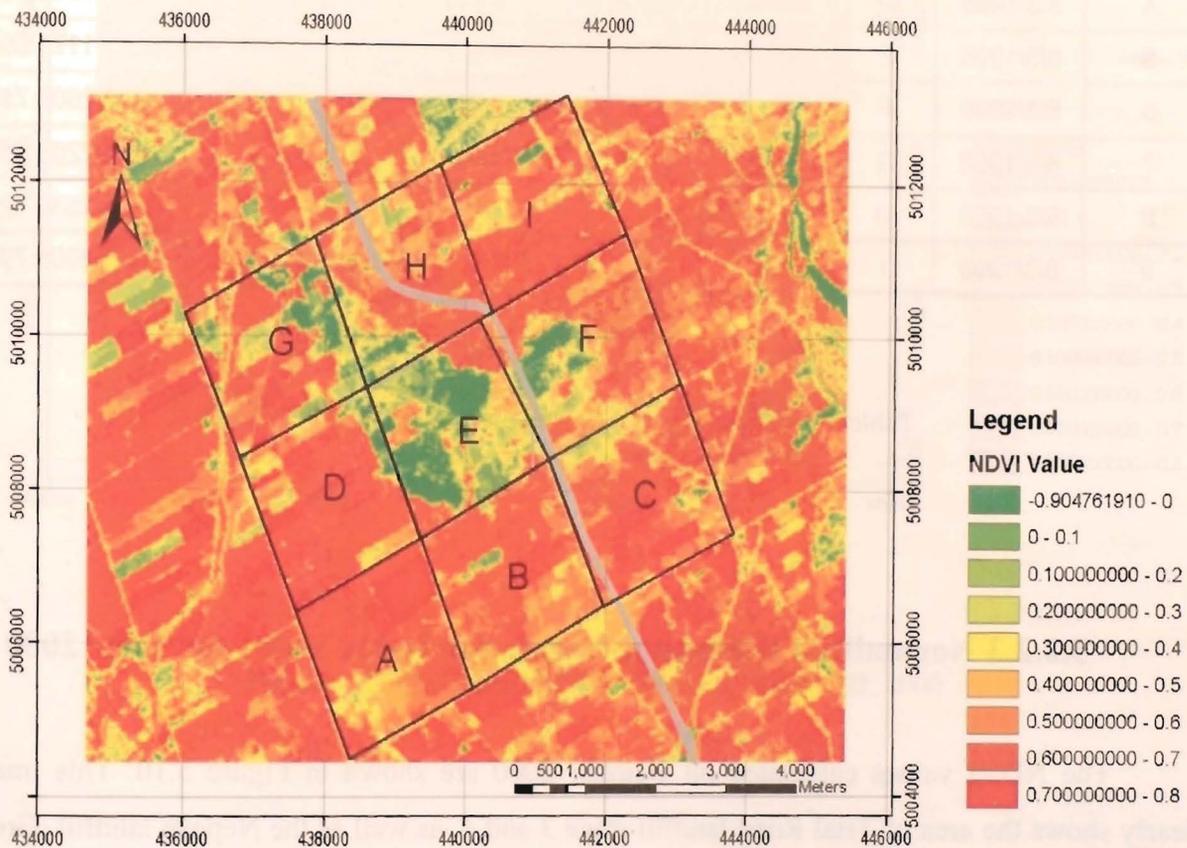
that was recorded in area E is higher than zero, which means that the vegetation is still within healthy NDVI range for the whole area.

Figure 5.9 - Calculated NDVI Values on August 03, 1998

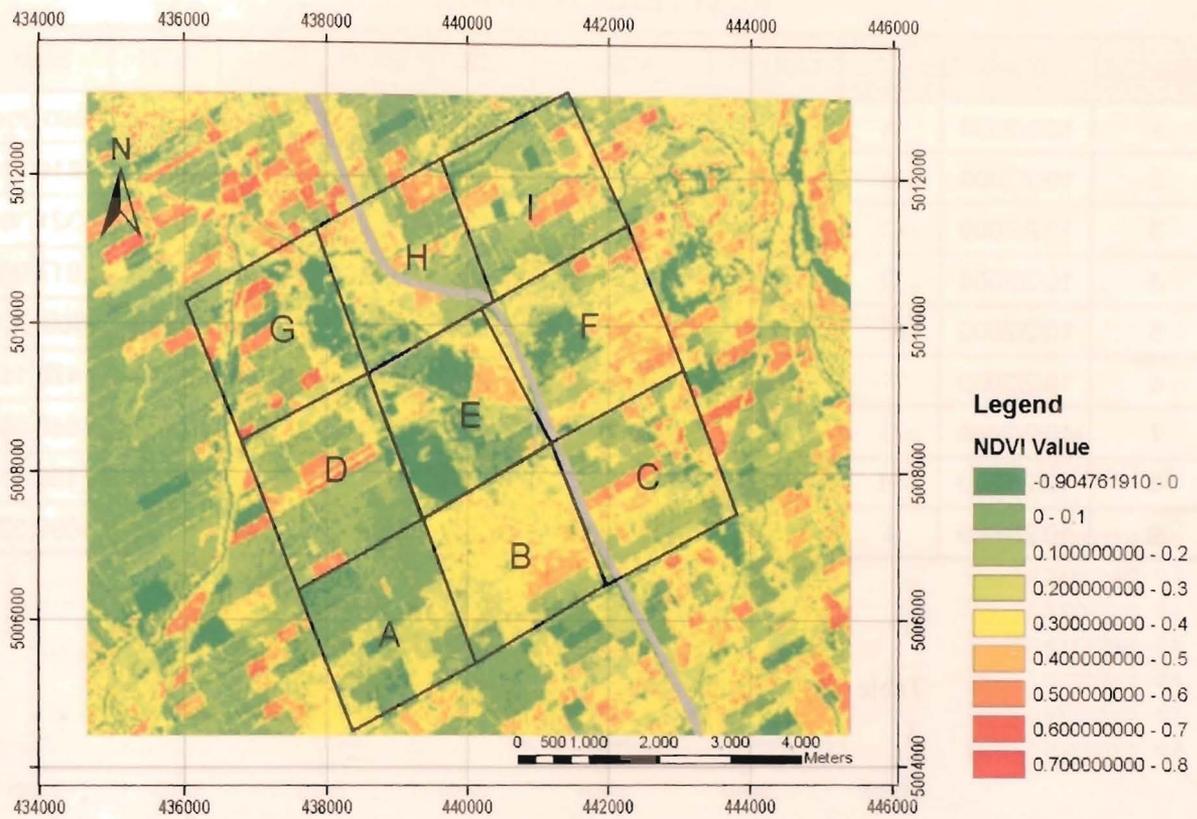
Figure 5.10 - Calculated NDVI Values on October 02, 2000

The NDVI values calculated on October 2000 are shown in Figure 5.10. This image clearly shows the area of Trial Road landfill stage 3 and 4, as well as the Nepean landfill. Green color in Figure 5.10 shows the landfill and its area have a low NDVI value. The general calculated NDVI for the entire area is low. One of the reasons for this might be the Fall season. All the vegetation is usually in their final stage of life. The range of the NDVI value is between -0.5 and 0.6. The lowest NDVI, indicating the least healthy vegetation, occurred in area E at value of -0.5. Although the lowest mean NDVI occurred at area A, still the worst vegetation area is the landfill site within area E. The minimum average value is still higher than zero, indicating that the vegetation is generally in normal health levels.
