**COMPARISON BETWEEN SATELLITE IMAGE ANALYSIS  
AND SITE DATA FOR MONITORING TRAIL ROAD  
LANDFILL SITE**

**Presented to Ryerson University  
In Partial Fulfillment of the  
Requirements for the Degree of  
Master of Applied Science  
In the Program of  
Civil Engineering**

**Toronto, Ontario, Canada 2010**

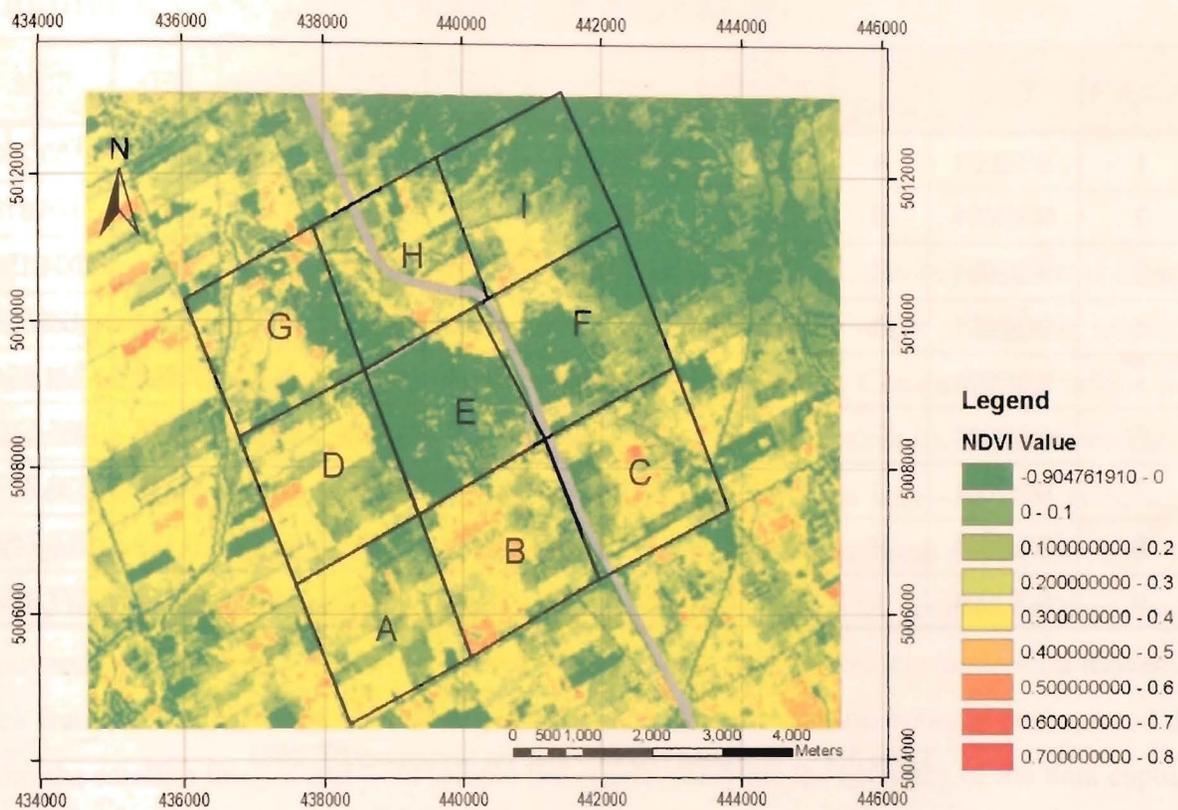
Figure 5.11 - Calculated NDVI Values on September 03, 2001

The NDVI value calculated on September 2001 is displayed in Figure 5.11. This image visually illustrates the conditions of the vegetation at the landfill site. It is quite clear that the calculated NDVI value of the landfill is in the negative range. The low NDVI values indicate that the vegetation within the landfill area is not in a healthy condition. The general calculated NDVI values are also in low range. All the vegetation is almost at their final stages of life during the Fall season. The range of the NDVI value is between -0.7 and 0.6. The lowest NDVI value, displaying the least healthy vegetation, occurred at area E, with value of -0.68, throughout the landfill site. The lowest mean clearly occurred at area E, with a NDVI value of -0.05.

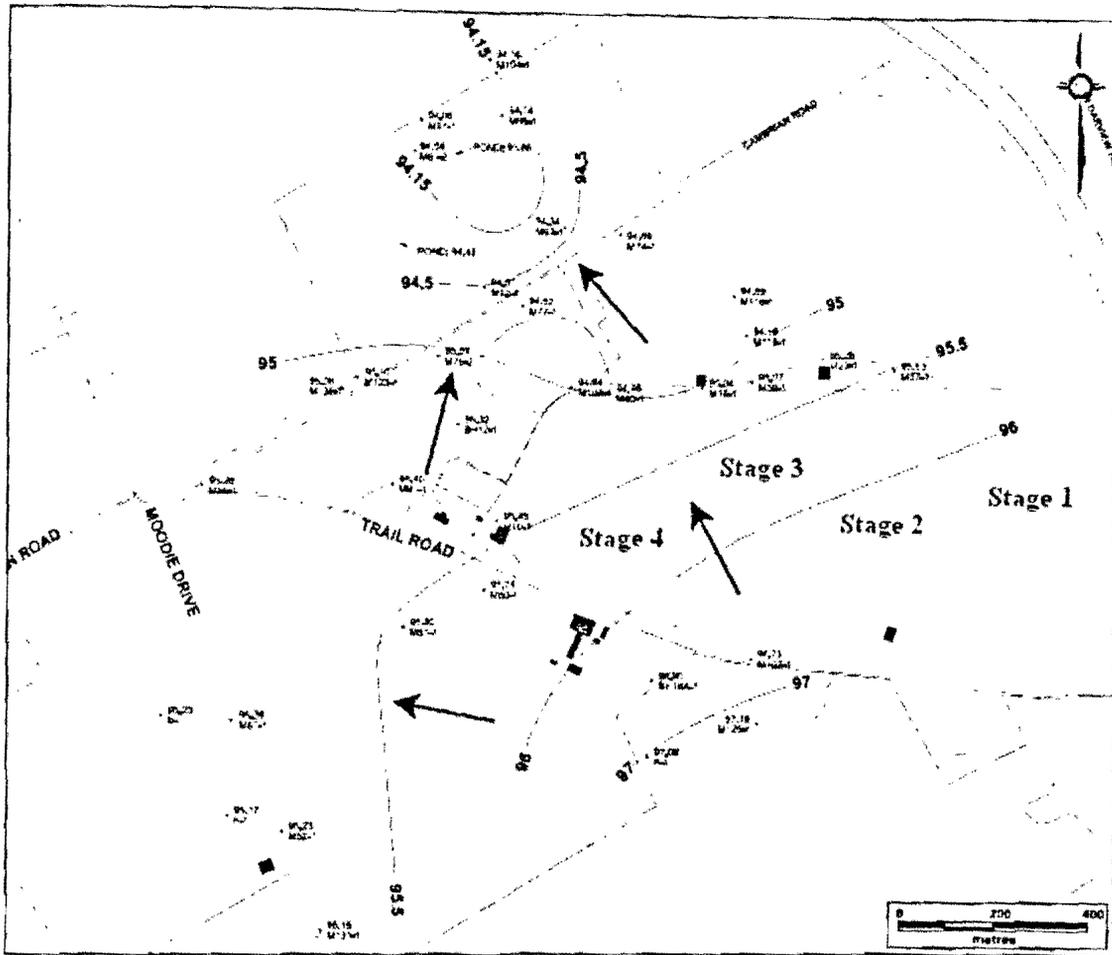
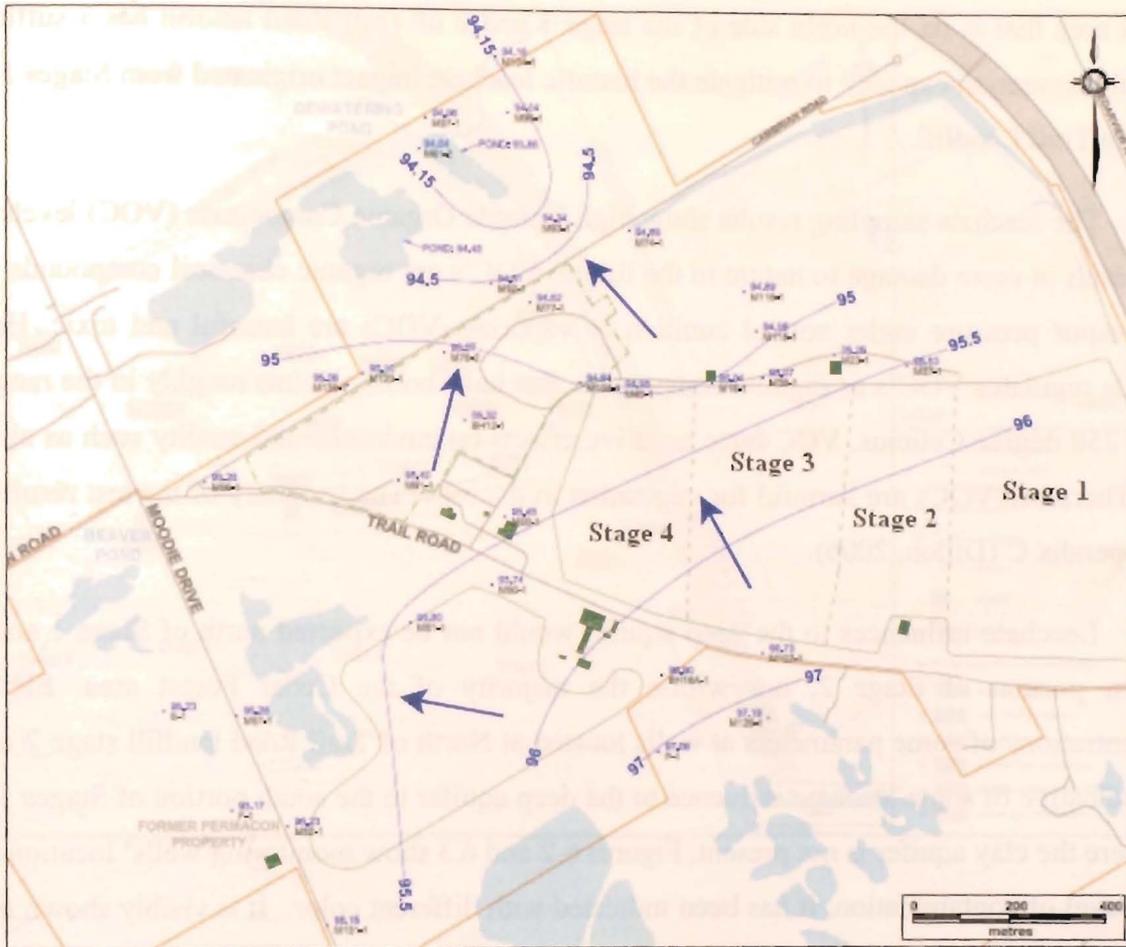
Figure 6.1 - Landfill Flow Directions

North of Trail Road landfill is located at northern margin of Stages 1, 2, 3 and 4 of the Trail Road Landfill up to Highway 416 and Cambrian Road, which has been shown in Figure 4.3. Leachate influences to the groundwater at the site generally occur to the north of the landfill area with respect to groundwater flow. Off-site migration of groundwater might be influenced by leachate from the landfill. Although the groundwater migration northwards in the shallow aquifer is limited, because the aquifer pinches out through the Cedar Forest area. Figure 6.1 shows the ground water movements clearly, the ground water movement indicates the direction of leachate and contamination expansion. It is noted that the clay aquifer underlies the northern portions of Stages 1 and 2, therefore leachate influences to the deep aquifer in this area would only be expected within the western portions of the discussion area, since groundwater flows in a west to northwest direction towards the Dewatering Pond (Dillon, 2006).

The general pattern of the groundwater flow is in the north to north west direction. To capture the impact of leachate upon the groundwater migrating beyond the site boundaries, samples were taken from outside of the landfill. The results of this sampling were very similar. Elevated concentrations of boron and toluene were observed at 90-7-1, located at north of Trail Road landfill stage 1 or north east of area E. This location was found to be isolated and the Cedar

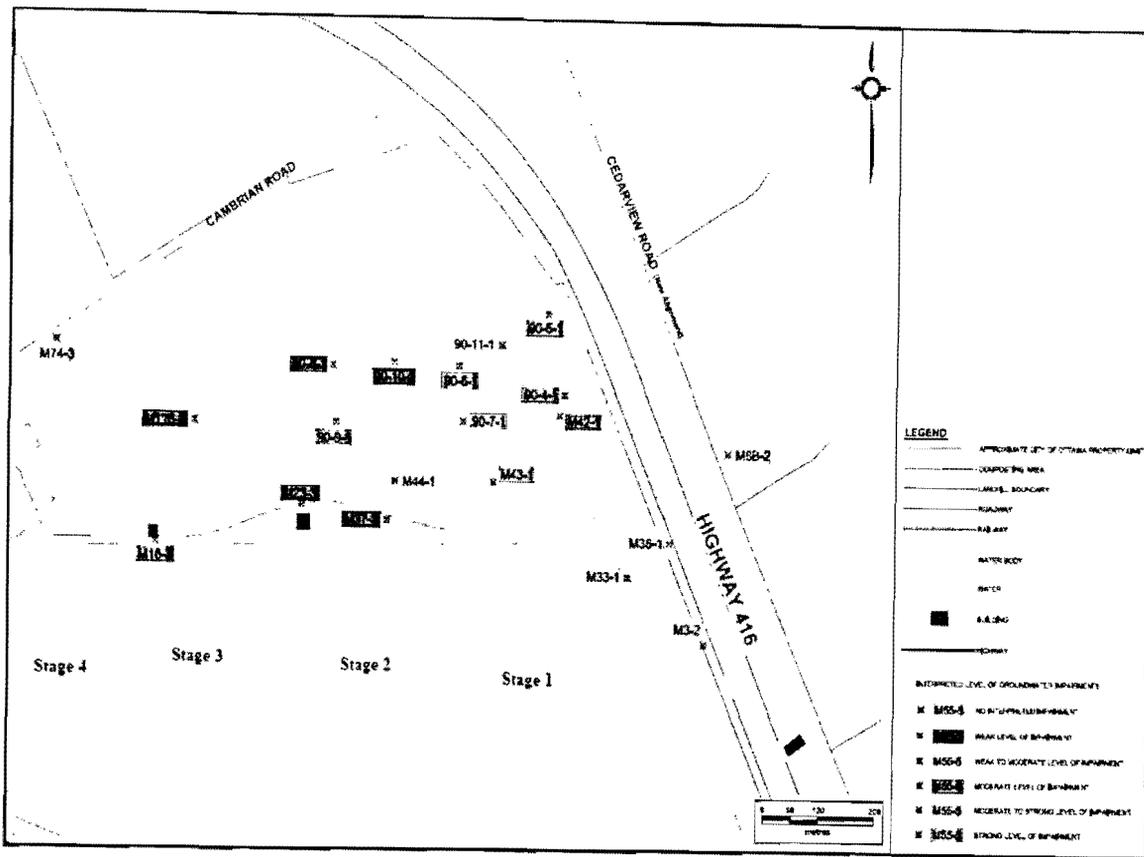
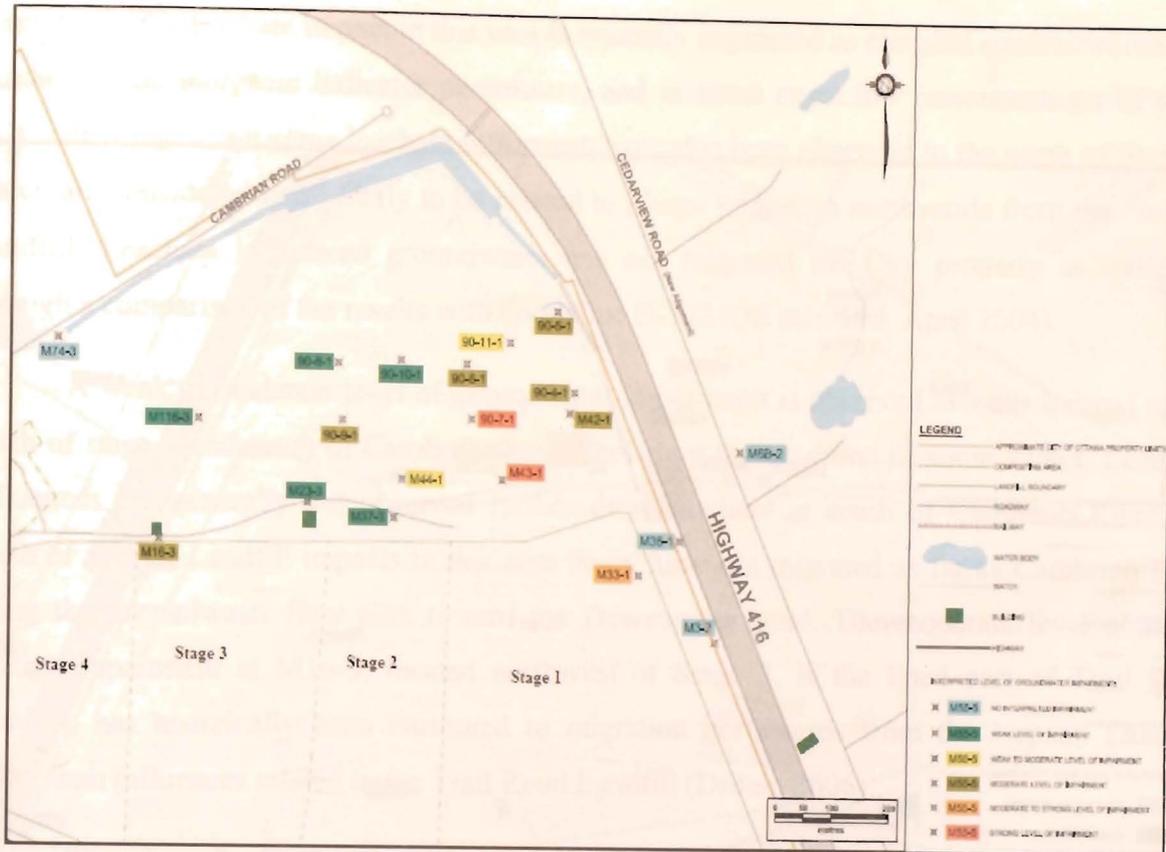
Figure 6.2 – Locations of Monitoring Wells at North Part of the Trail Road Landfill

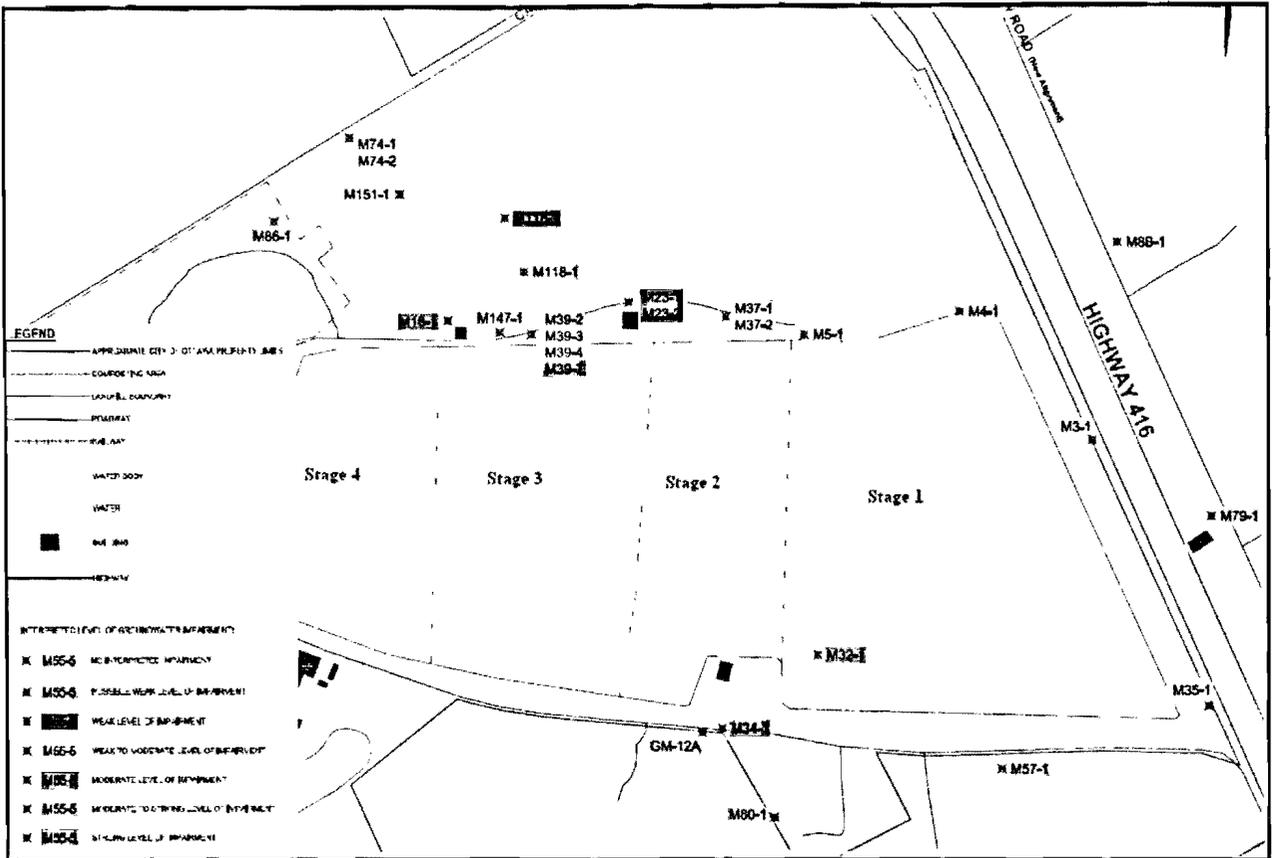
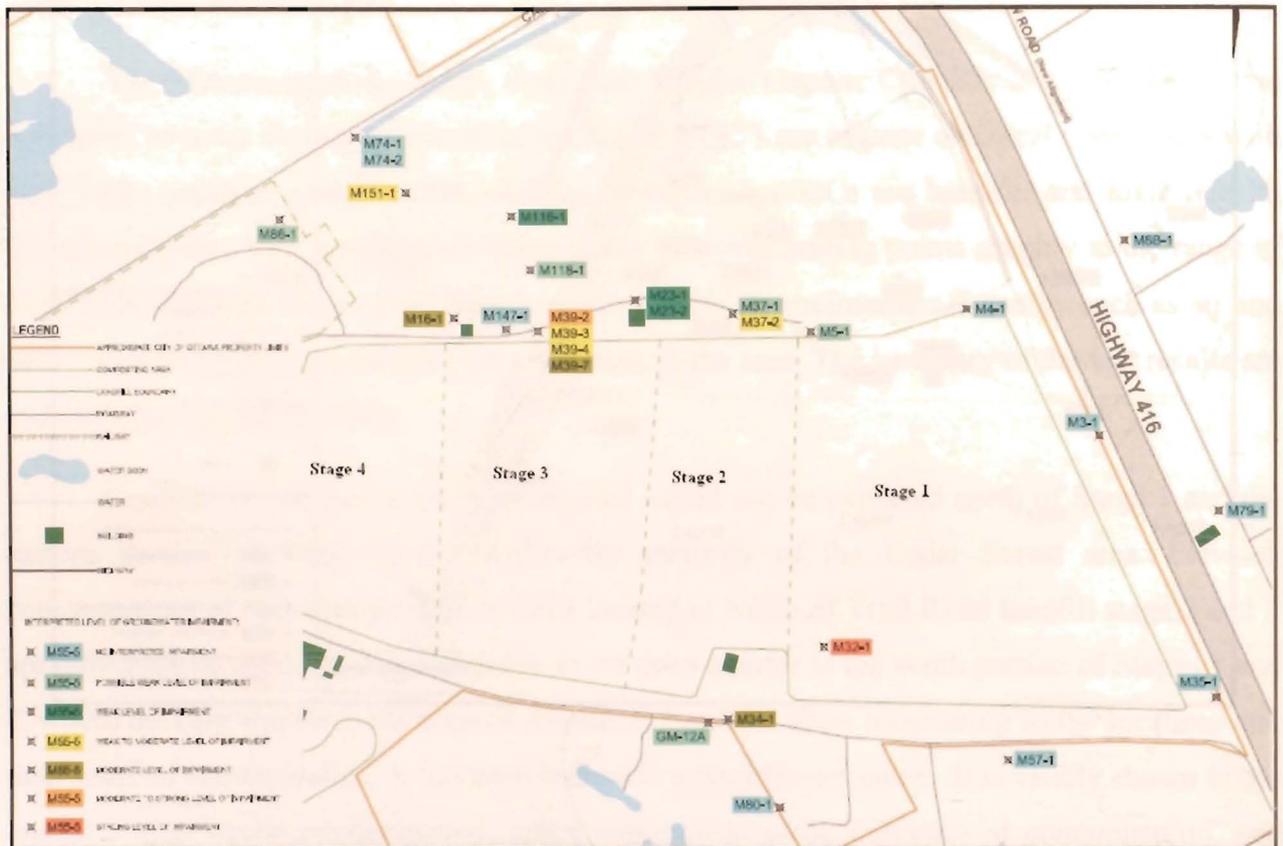
Figure 6.3 – Locations of Monitoring Wells at North and South Part of Trail Road Landfill

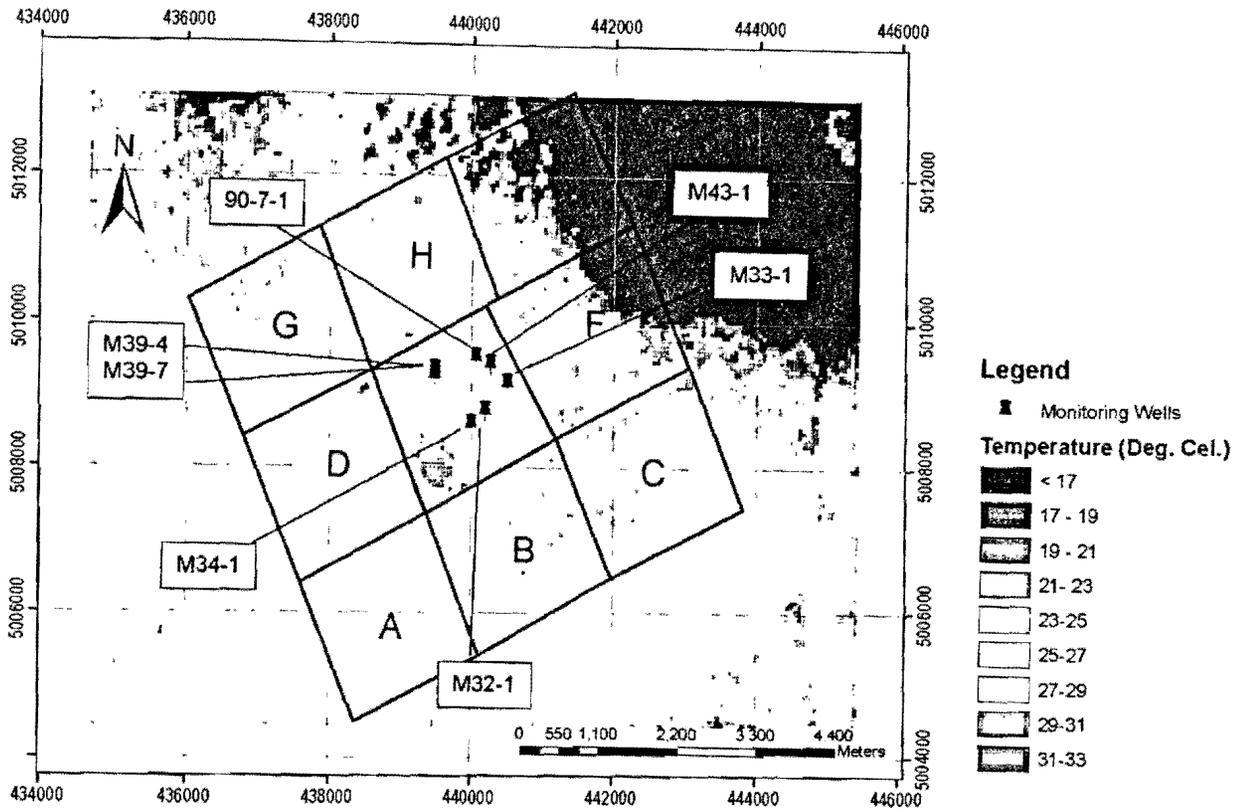
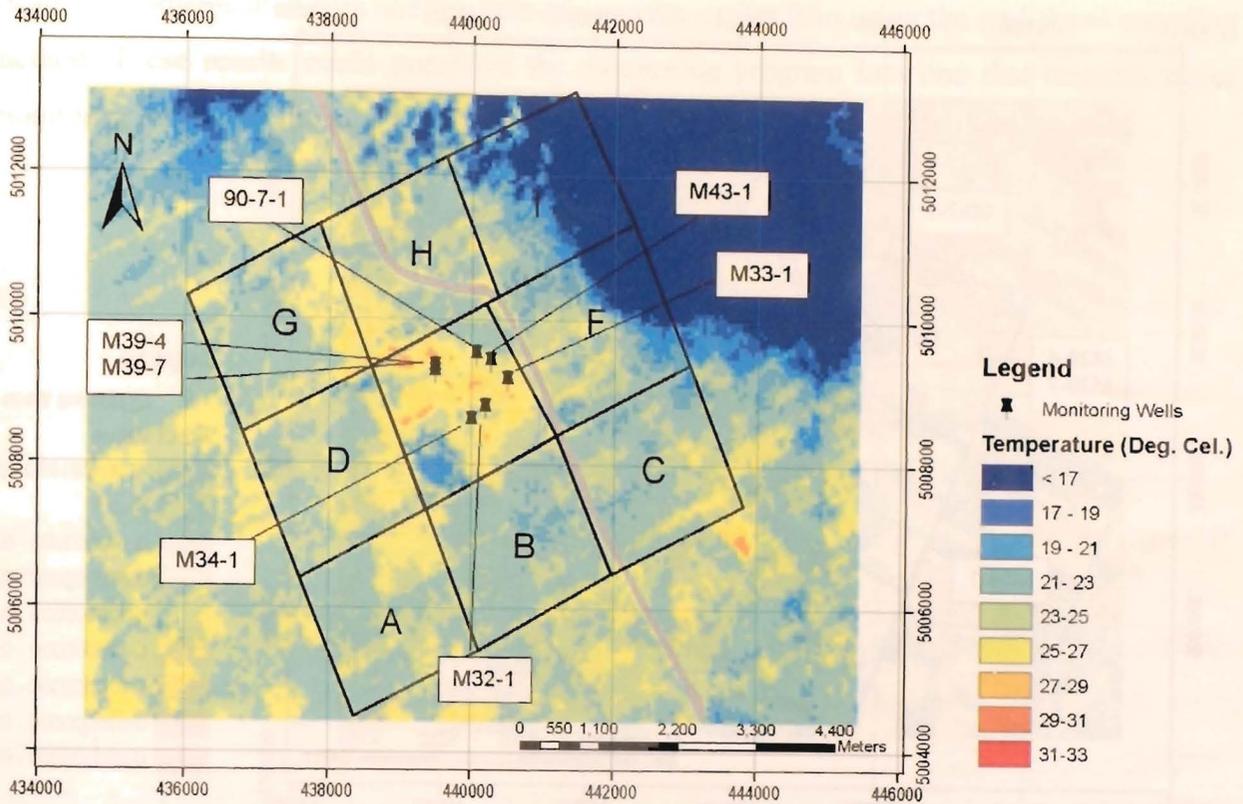
Figure 6.4 – LST Calculated During September 2001 and Locations of Monitoring Wells

At Trail Road landfill study area both data analysis results show the same locations, which is northwest and southwest of the Cedar Forest area in the north part of Trail Road landfill, that is north and northeast of area E. Figures 6.4 and 6.5 show the well locations on LST and NDVI values calculated from 2001. The combination of these two methods explains the reasons for low NDVI value and high LST. The same combinations of two methods over a period of time will explain the results of the contamination and its movement.

The Following Figures combine the results captured from the two methods of collection during 2001 at the Trail Road landfill study area. Comparing different years of data analysis from both methods indicates increasing levels and movement of contamination.

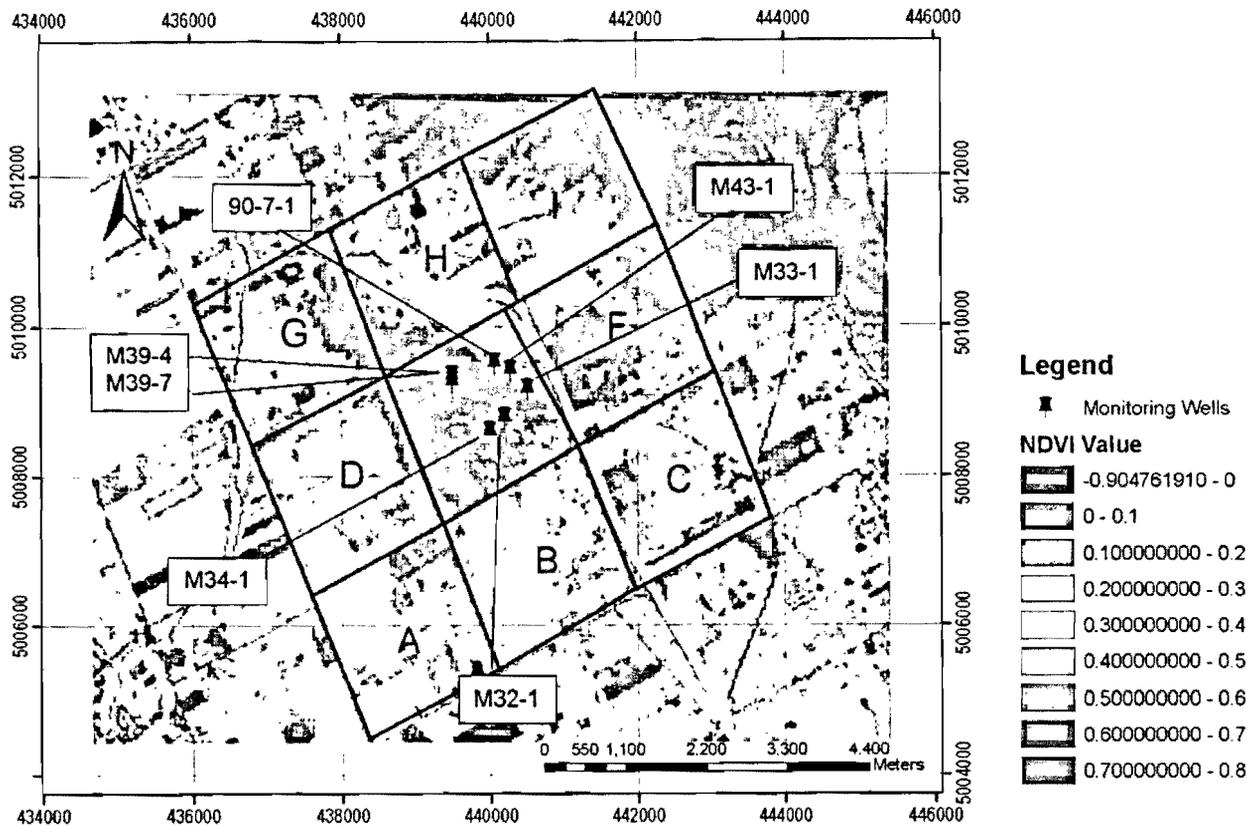
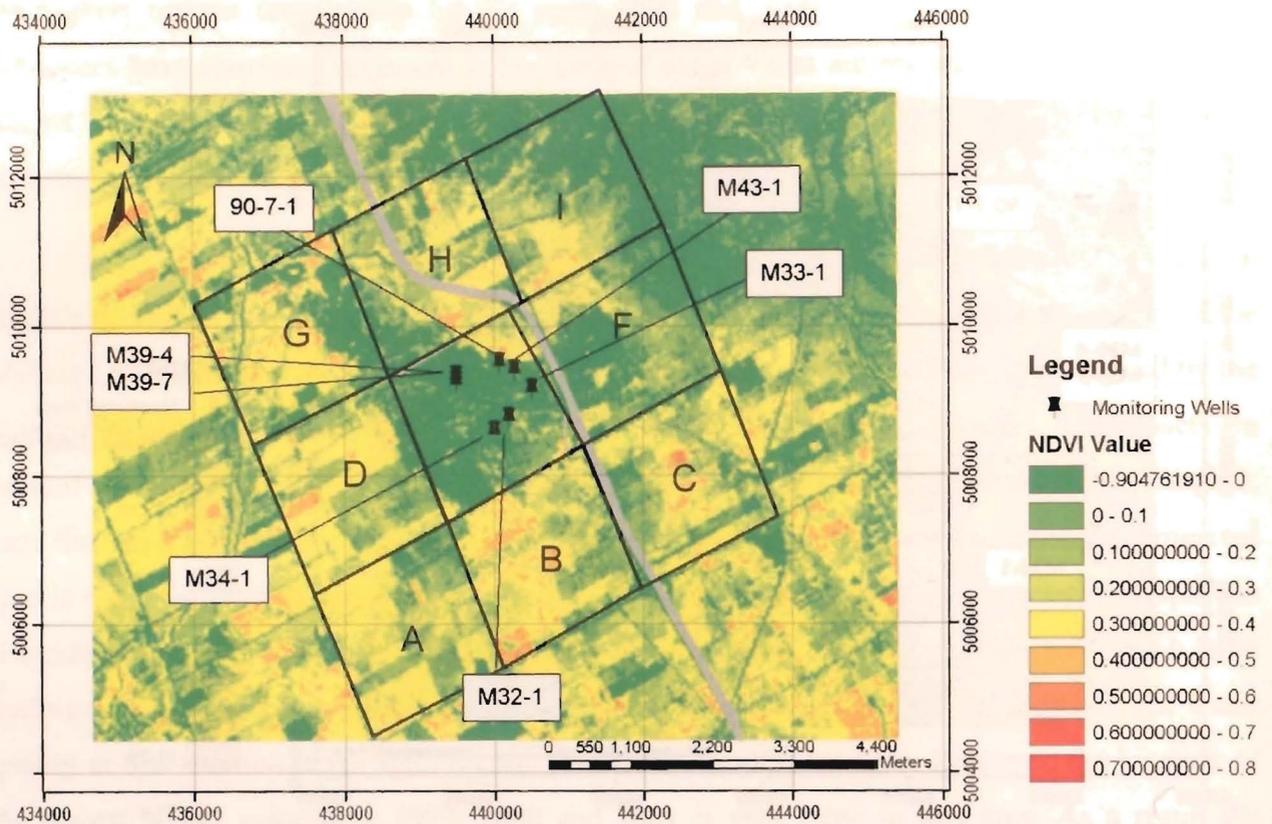
Figure 6.5 – NDVI Calculated During September 2001 and Locations of Monitoring Wells

LST analysis at different years indicates that the LST of the landfill and its surrounding area are higher than other areas, which means LST captured at area E is higher than all the other areas. NDVI value comparison between different years indicates that the landfill's NDVI value is lower, and decreasing over the years. Figure 6.4 shows the location of the most contaminated monitoring wells on LST calculated during 2001. Figure 6.4 shows that all contaminated areas are located on high LST locations. Also, Figure 6.5 confirms that more contaminated monitoring wells are located on low NDVI value areas. Therefore, as a result of this comparison; combining remote sensing and satellite analysis methods with site testing and sampling methods could
