Structural Health Monitoring of the Rebecca Street (William Anderson) Bridge

A thesis
presented to Ryerson University
in partial fulfillment of the
requirements for the degree of
Master of Engineering
in the Program of
Civil Engineering

Toronto, Ontario, Canada, 2015
© Canon Shafieyan 2015

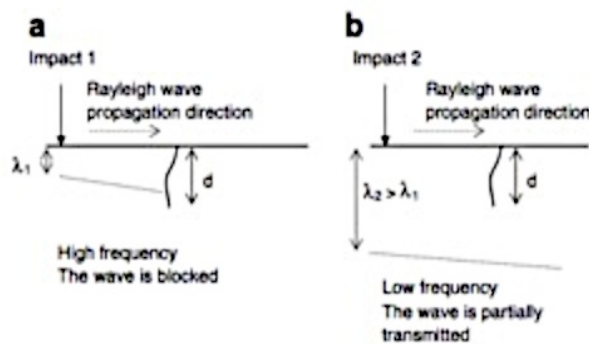
Figure 2.1 – Rayleigh Wave Propagation in Determining Cracks (Aggelis and Shiotani, 2007)

The Rayleigh wave (R-Wave) is a surface wave, which travels in planes normal to the testing surface. The particles are vibrated normal to the direction of travel, thus making these waves useful in determining surface anomalies such as cracking. The depth of wave penetration is directly proportional to the wavelength. Any crack that spreads deeper into the test specimen than the wavelength of the transmitted wave would completely diminish the transmitted wave from a receiver placed on the opposite side of this crack (Aggelis and Shiotani, 2007). Figure 2.1a) illustrates how a wave with a smaller wavelength than the depth of the crack is blocked, with no transmission across the crack. Conversely, Figure 2.1b) illustrates how a wave transmits across when the wavelength is greater than the crack depth. Therefore, with this transmission, engineers can estimate the penetration depth of a given crack. The Rayleigh wave velocity is approximately 55-60% of the velocity of a pressure wave (P-Wave).

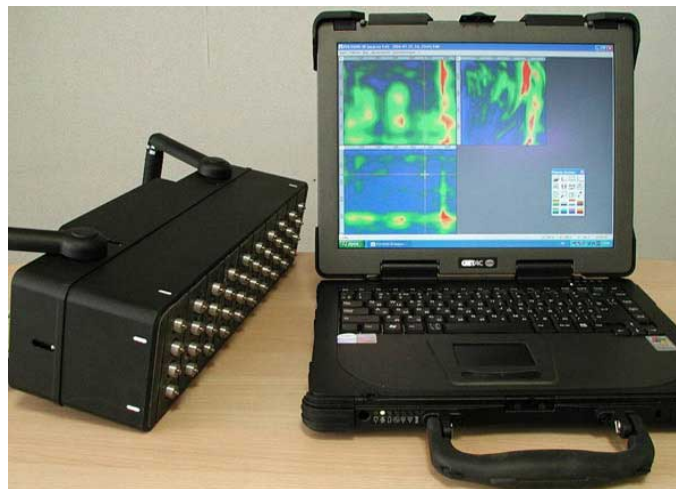
Figure 2.2 – MIRA 3D Shear Wave Tomographer Aparatus (Hoegh et al., 2012)

The MIRA 3D shear wave tomographer shown in Figure 2.2 is a non-destructive testing apparatus that utilizes 40 dry-point contact transducers that emit shear waves into the concrete member.

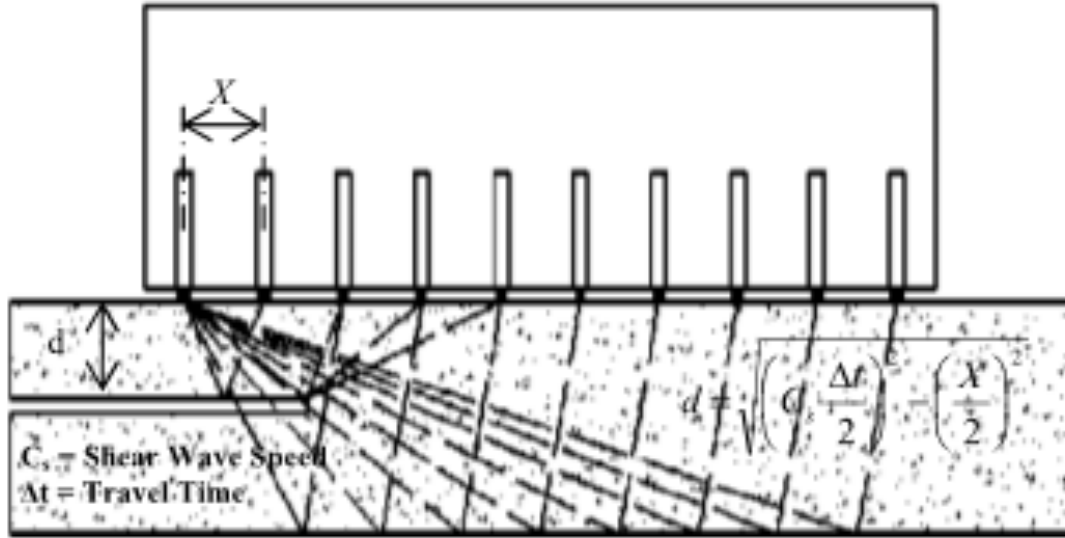
Figure 2.3 – Shear Wave Firing Sequence (Germann Instruments, 2014)

next row sends a stress-wave, while the remaining 32 transducers receive the signal. The process is repeated until each of the nine rows of transducers have emitted stress-waves. The complete data acquisition, data processing, and data transfer takes less than 3 seconds.

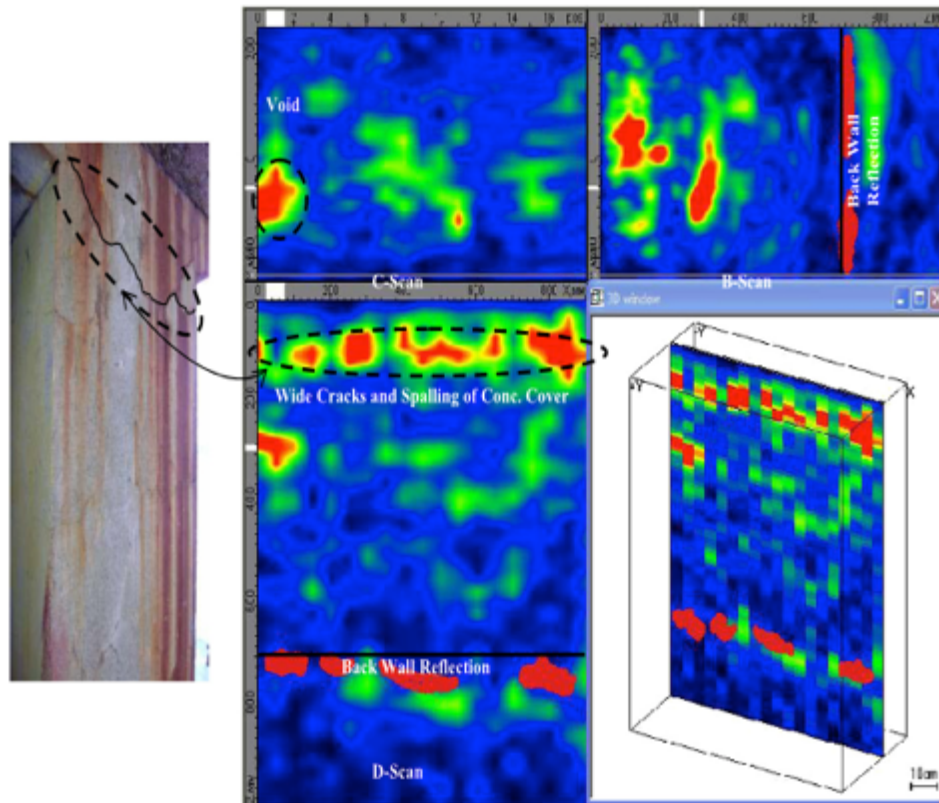
Figure 2.6 – Scan Results Indicating Cracks and Spalling (Dawood and Marzouk, 2011)

The MIRA 3D shear wave tomographer has been applied successfully to detect various defects. The anomalies will show as different colors based on their density characteristics as shown in Figure 2.6. The reflected image provides information such as:

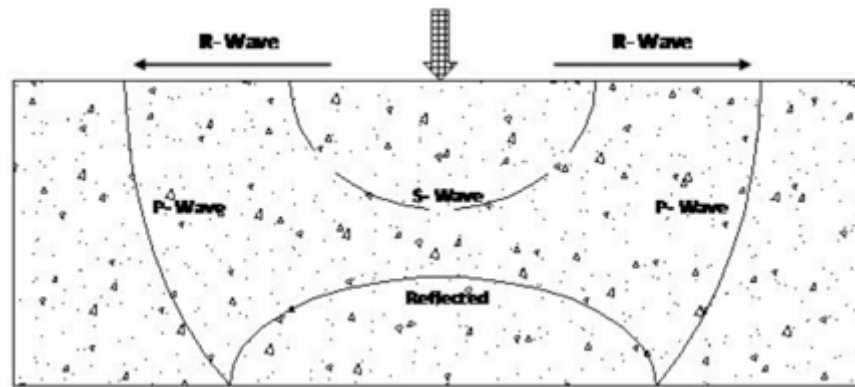
Figure 2.8 – Stress Waves Caused by Impact at a Point on the Surface of a Concrete Plate (Sansalone and Streett, 1997)

the surface as a Rayleigh (R) waves (Sansalone and Streett, 1997). The P- and S-waves propagate into the medium along spherical wave fronts, as shown in Figure 2.8. These waves are reflected by internal cracks, voids and external boundaries of the structure.

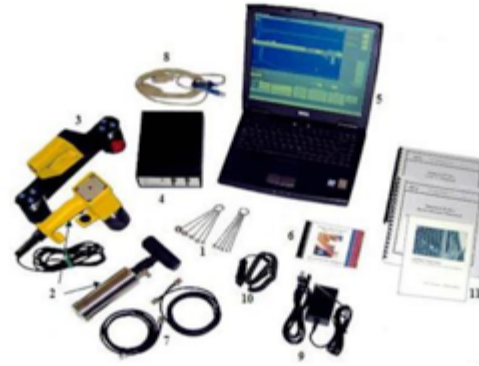
Figure 2.9 – A Typical Impact-Echo Test System (Impact-Echo Instruments, 2001)

A typical impact-echo test system is shown in Figure 2.9. The use of the equipment is dependent on the application, such as surface wave speed measurements, thickness measurements, or detection of flaws. Steel balls are often used as an impact source since the contact time can be changed by changing the diameter of the ball (Goldsmith, 1965). Grease-like material is often used to provide appropriate coupling between the transducer and the testing surface. In addition, the distance between the transducers is important in accurately measuring the flaw depth with the suggested spacing being 0.2 to 0.5 of the flaw depth (Carino and Sansalone, 1986) or less than 40% of the member depth (Sansalone, 1997).

Basic test set-up for a direct P-wave speed measurement

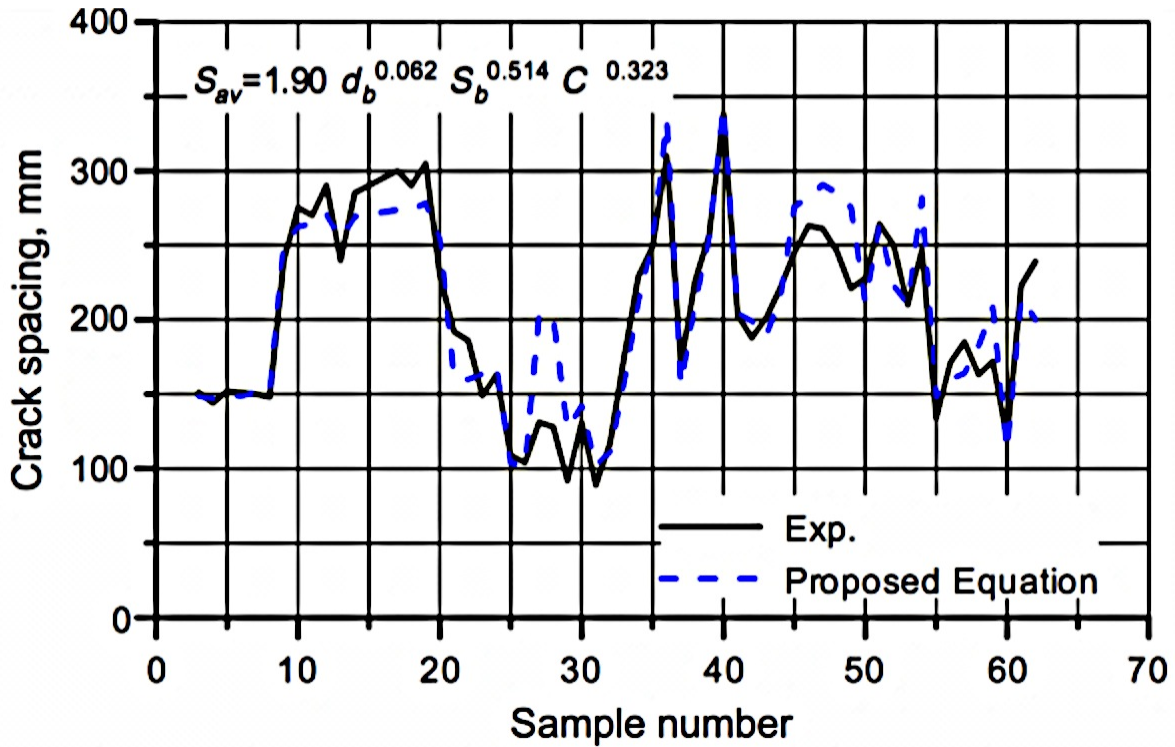
Figure 3.2 – Comparison Between Crack Spacing From Experimental Results and Proposed Equation (Elshafey et al., 2013)

Equation 3.2 was validated based on its comparison to experimental results. Figure 3.2 illustrates the accuracy of the equation due to its similarity to experimental results. In addition, Equation 3.2 proved to be more accurate than other existing equations (CSA-2004, NS-1992, EC2-2004, CEB-FIP-1990, and ACI 224R-01). Figures 3.3 to 3.7 compare the various code prescribed equations to the experimental results.

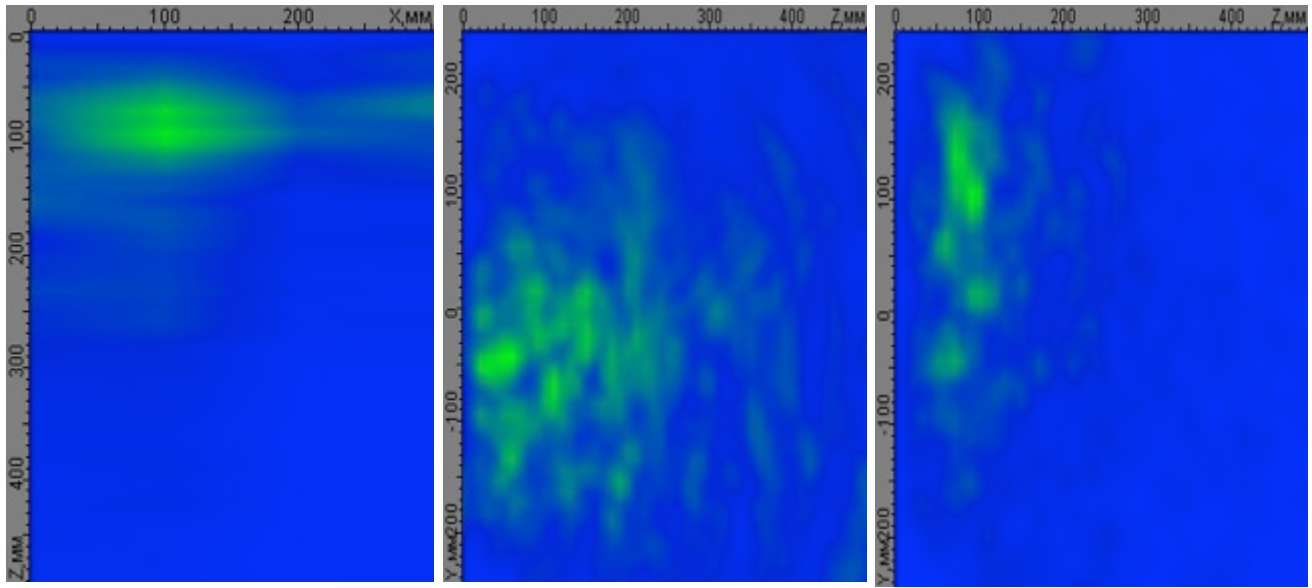
The west abutment was scanned at various locations to determine the overall structural condition. The scans were carried out at a frequency of 50 Hz and a calibrated wave velocity of 2,487 m/s. Although minor cracks were visually noted, the MIRA shear wave scans indicated no deterioration present. The scan shown in Figure 4.1 suggests the abutment is in good structural condition, and no structural defects are present. Since no deterioration is present at a fairly low frequency of 50 Hz, it can be concluded that the member only has minor aesthetic issues as noted in the visual inspection (Figure 4.2), and has no structural defects.

Figure 4.1 – C-Scan (left), B-Scan (middle), and D-Scan (right) of the West Abutment Indicating No Deterioration

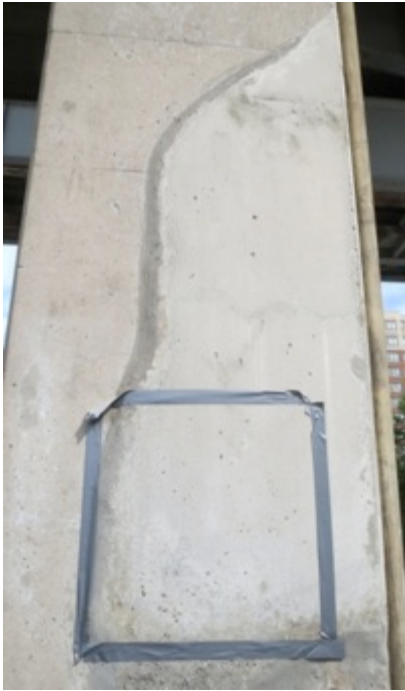
Figure 4.3 – Pier 2-1 Scan Outline

Pier 2-1 was scanned on the North-South face (Figure 4.3), with an initial frequency of 50 Hz. The wave velocity was calibrated to 2,449 m/s for this pier, which will be utilized in the latter portions of this report to compute the dynamic modulus of elasticity. The shear wave scan was done over a patched portion of the pier, and the resulted 3D image indicated a high presence of inconsistencies (Figure 4.4.). However, to overcome this, the MIRA was adjusted to a frequency of 70 Hz, to provide a clearer image of the member (Figure 4.5). The image indicates the presence of potential voids concentrated at around 100 mm – 250 mm from the face of the support. However, to isolate the findings further, an additional scan was carried out at 100 Hz (Figure 4.6). The high degree of red present in the first two scans is highly due to the MIRA detecting the patched portion of member. However, the higher frequency scan clears up the image, highlighting potential voids present as a result of reinforcement corrosion. This conclusion is evident by the voids present in a line as noted in the B, C, and D-scans. However, the small voids present are not severe at this point, but should be considered in future analysis of pier 2-1. The comparison of the B-scans (50 Hz, 70 Hz, and 100 Hz) is illustrated in Figure 4.7, which illustrates how the frequency adjustment isolates the deterioration. Although the voids noted in the 100 Hz scan are small in size, to make a conclusive decision, additional scans should be carried out at different elevations over the member to provide insight of the overall structural condition.

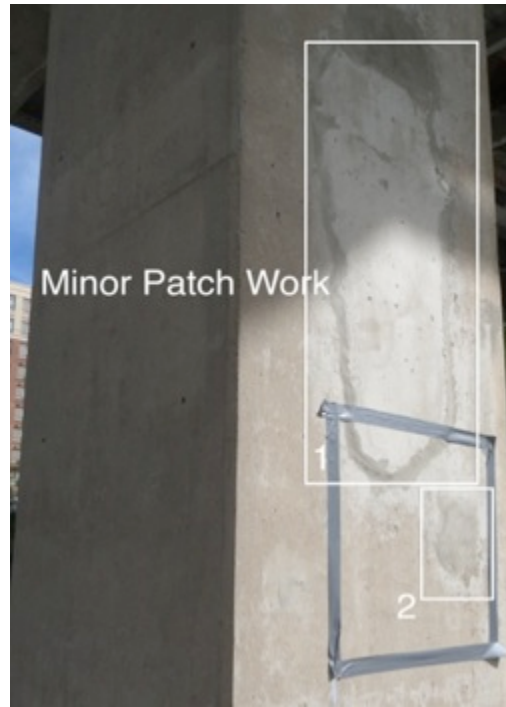
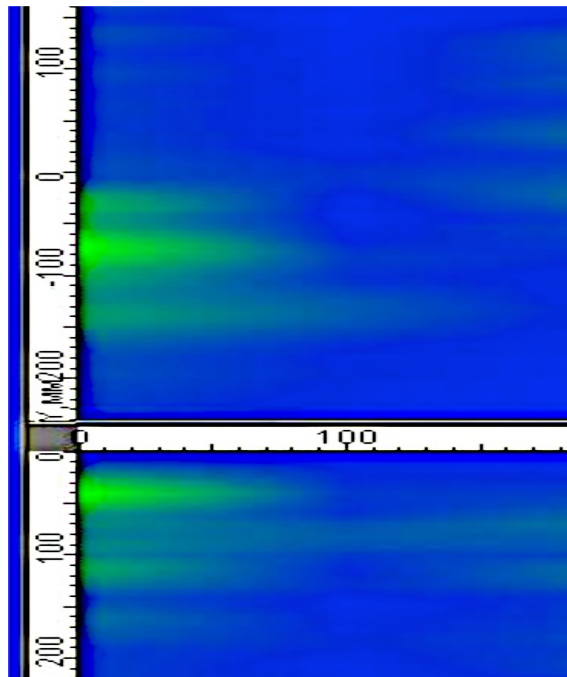
Piers 2-2 and pier 2-3 were both scanned at a frequency of 50 Hz and a calibrated wave velocity of 2,561 m/s and 2,394 m/s respectively. Both piers were scanned on the North-South face. Figures 4.8 and 4.9 illustrate the resulting scans, which indicate no void presence. Since no structural defects were noted during visual inspections either, it is assumed that the remaining portions of these members are in good structural condition as well, and no further analysis of these members is required.

Figure 4.8 - Pier 2-2 Scan Outline and Results

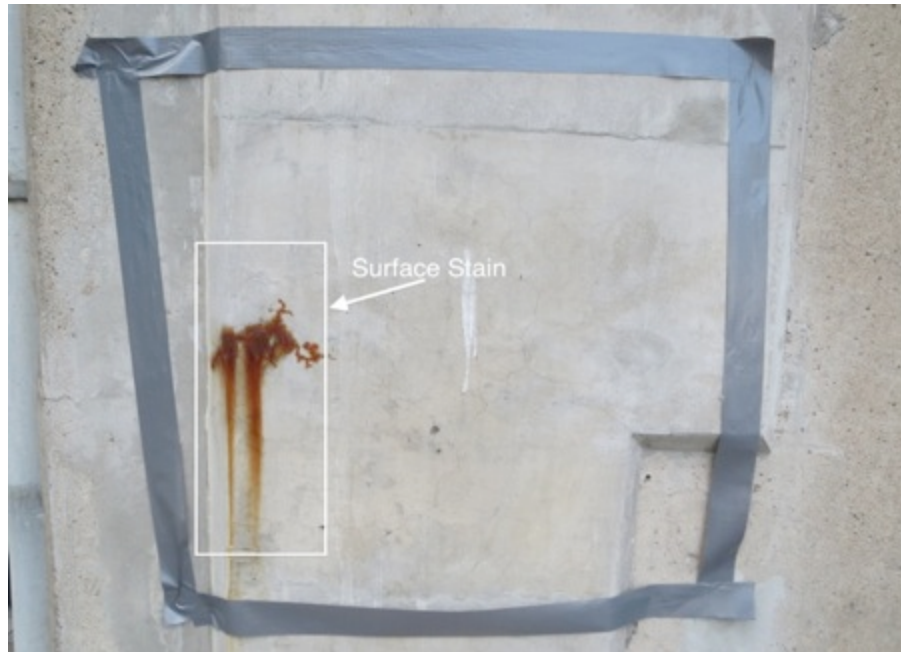
Pier 2-4 was scanned on the South-North face with a frequency of 50 Hz and a calibrated wave velocity of 2,515 m/s. Visual inspections of the member indicated a high degree of patching and distinct surface stains as shown in Figure 4.10. The scan shown in Figure 4.11 indicates two voids present at around 85 mm and 100 mm from the face of the support (boxed in white). The C-scan indicates that the voids could be due to reinforcement corrosion since they align with other reinforcements present (yellow circle). The voids present in the MIRA shear wave scan line up with the surface stain, which supports the assumption that the voids are due to reinforcement corrosion. Although there are lots of patched portions on this member, the deterioration indicated by the scan is minimal and requires no immediate attention.

Figure 4.10 - Pier 2-4 Scan Outline Indicating a Small Surface Stain

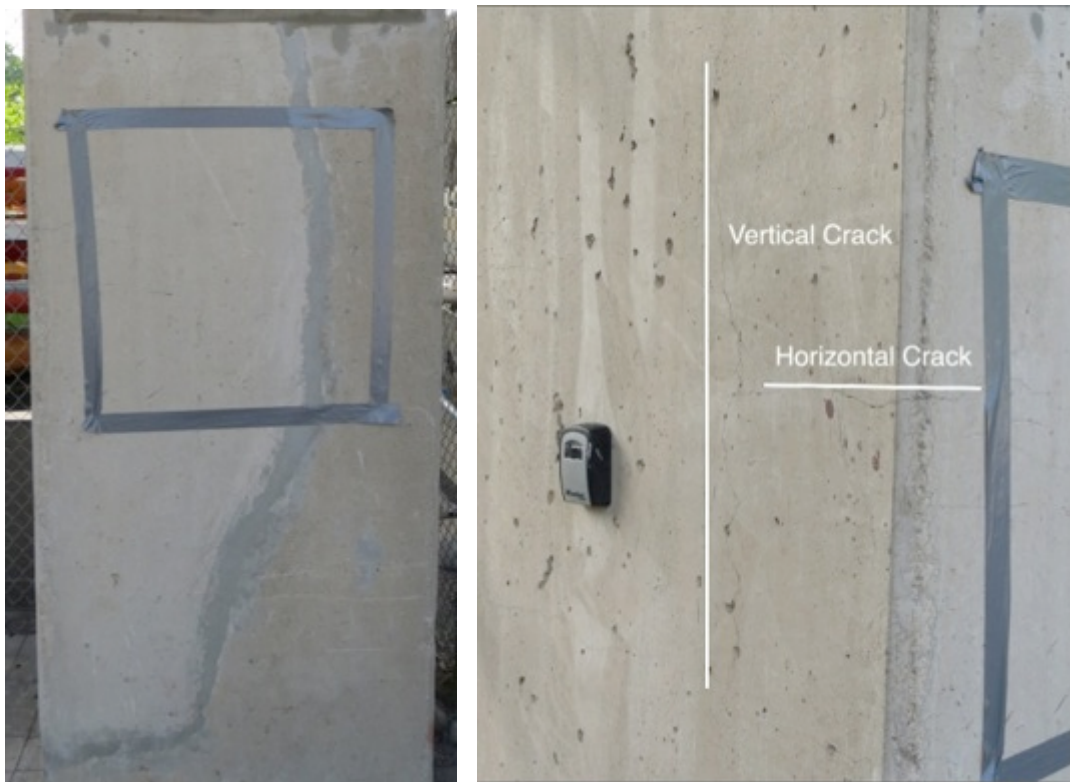
Figure 4.12 - Pier 3-3 Scan Outline

Piers 3-1 and 3-2 were fenced off by the rowing storage facility, and thus were not accessible for scanning. Pier 3-3 was scanned at an initial frequency of 50 Hz and a calibrated wave velocity of 2,435 m/s. Visual inspections indicated various cracks, as shown in Figure 4.12. The pier was subsequently scanned on the South-North, with the initial results shown in Figure 4.13, which demonstrate inconclusive results. The large presence of inconsistencies is due to the MIRA detecting the patched section, and does not provide any valuable information regarding the member's structural condition. Thus, the frequency was adjusted to 70 Hz to provide a clearer image as shown in Figure 4.14. From the scan results the presence of voids concentrated between 70 mm and 200 mm can be observed. In addition, voids can be observed at around 280 mm from the face of the support. Although the scan indicates the presence of small voids, there is a section with a cluster of voids. A frequency adjustment was carried out to obtain a scan at 100 Hz, with the results shown in Figure 4.15. The 100 Hz B-scan shows clear and distinct regions with voids present around the reinforcement level. The B-scan indicates a potential void cluster at around 140 mm from the face of the support. The high degree of patching at the lower levels of the pier raises some concerns regarding the overall structural condition of this member. Thus, to make a conclusive statement, more scans should be carried out at higher elevations to provide insight of the overall structural condition of this member.

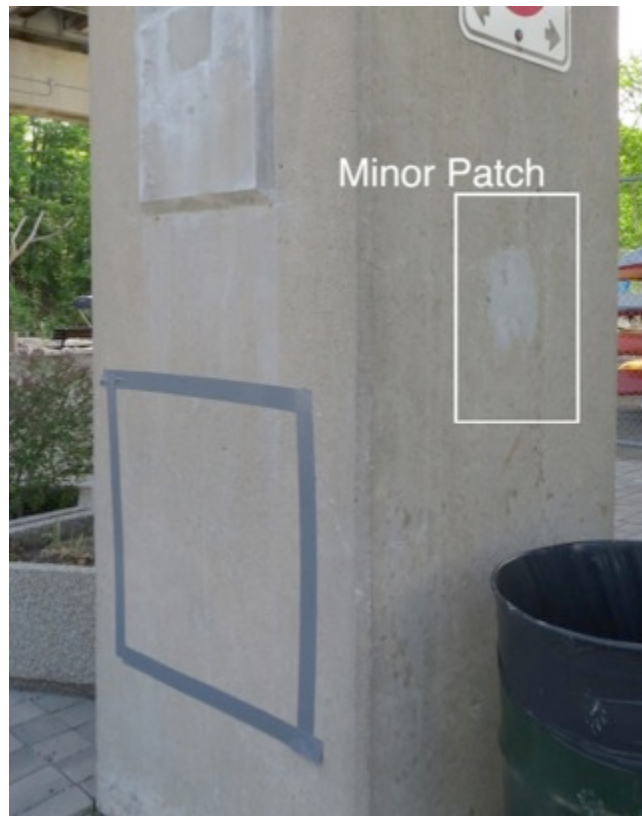
Figure 4.16 - Pier 3-4 Scan Outline

Pier 3-4 was scanned on the South-North (shown in Figure 4.16) face with a frequency of 100 Hz, and a calibrated velocity of 2,483 m/s. The scan indicated minimal signs of deterioration as shown in Figure 4.17 and the visual inspection of the member raised no alarms, thus it is presumed the member is in good structural condition and requires no further attention.

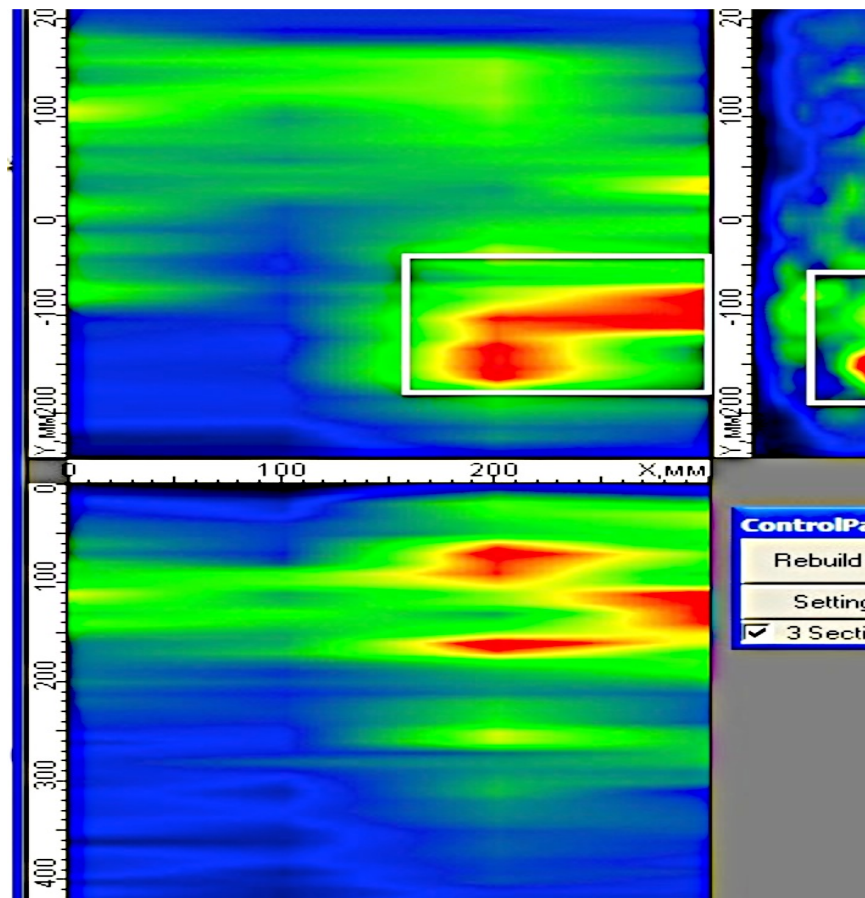
Pier 5-1 was scanned at calibrated wave velocity of 2,397 m/s and a frequency of 50 Hz on the North-South face. Figure 4.18 shows the shear wave scan results, which indicates the presence of voids (boxed). The B-scan for pier 5-1 indicates the presence of 3 distinct voids at 60, 75, and 160 mm from the face of the support respectively. The D-scan shows reflections of apparent reinforcements, with voids aligned with the reinforcements, indicating potential corrosion and deterioration around the rebar's. Although the visual inspection did not indicate the presence of any deterioration, the shear wave scan indicates voids in close proximity to each other. These voids could grow in size in the future, resulting in large-scale deterioration. Thus, a more detailed evaluation of this member should be undertaken, with scans at higher elevations to provide better insight of the overall structural condition of this pier.

Figure 4.18 - Pier 5-1 Scan Results Indicating Void Presence and Void Formation

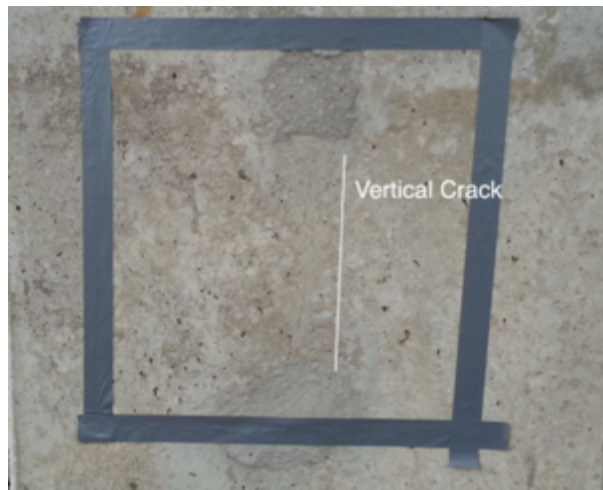
Pier 5-3 was scanned at a frequency of 50 Hz with a calibrated wave velocity of 2,489 m/s on the East-West face. Minor vertical cracks were noted during initial visual inspections as shown in Figure 4.20. The shear wave scan results shown in Figure 4.21 indicate large-scale voids present between 70 mm and 140 mm from the face of the support, with some surface deterioration at around 30 mm to 50 mm from the face of the support. The C-scan and D-scan results indicate the deterioration could be due to reinforcement corrosion as well as concrete deterioration. The clear image in the B-scan and distinct void regions in the C and D-scans indicate that no frequency adjustment is required. The large-scale voids present should trigger further analysis of the remaining portions of the pier to analyze the overall structural condition of the pier 5-3 in order to allocate appropriate maintenance actions.

Figure 4.20 - Pier 5-3 Scan Outline and Presence of a Vertical Crack on the Scan Face

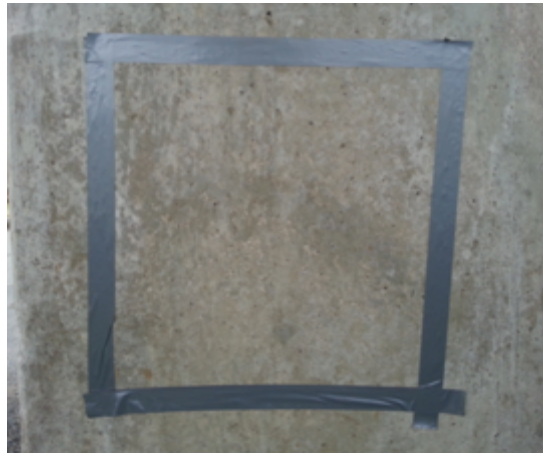
Figure 4.22 - Pier 5-4 Scan Outline

Pier 5-4 was scanned at a frequency of 50 Hz and a calibrated wave velocity of 2,402 m/s on the East-West face as shown in Figure 4.22. The voids (circled) on the B-scan and C-scan indicate minor reinforcement corrosion, which seem to be isolated and small in nature as shown in Figure 4.23. In addition, the reinforcement corrosion appears to be isolated to the surface, with only minor voids detected at deeper levels. Although the voids are minimal in size, they could result in large-scale delamination and cracks as a result of their alignment and proximity to the surface. Although the overall visual inspection and scan results indicate that the member is in good structural condition, the pier should be monitored in more detail to analyze the overall structural condition.

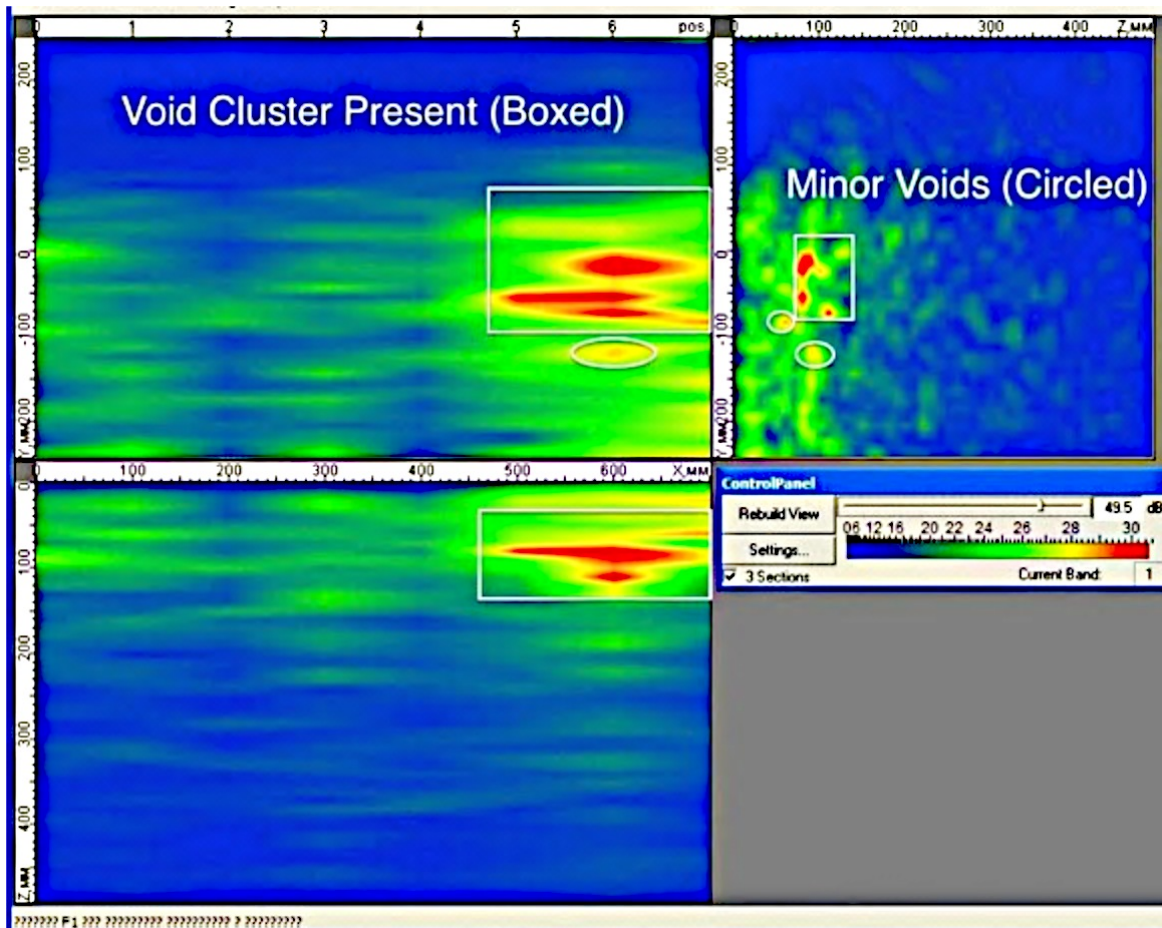
Pier 6-1 was scanned at a frequency of 100 Hz and a calibrated wave velocity of 2,494 m/s on West-East face. The visual inspection of the member indicated some minor patching, and potential surface stains, thus the shear wave scan was carried out on that face. The shear wave scan results shown in Figure 4.24 indicate some void clusters (boxed) and some minor voids (circled). The overall member indicated extensive patching, with some visible surface cracks present. In addition, the scan results indicate the voids are aligned, potentially forming a crack as a result of reinforcement corrosion. The voids are concentrated at around 100 mm from the face of the support (west face). Although, additional scans are recommended at higher elevations, the scan results and visual inspection do not raise any alarms regarding the structural adequacy of this member. However, pier 6-1 should be monitored carefully to study the potential development of cracking in order to provide timely maintenance.

Figure 4.24 - Pier 6-1 Scan Results Indicating Void Clusters and Minor Voids Present

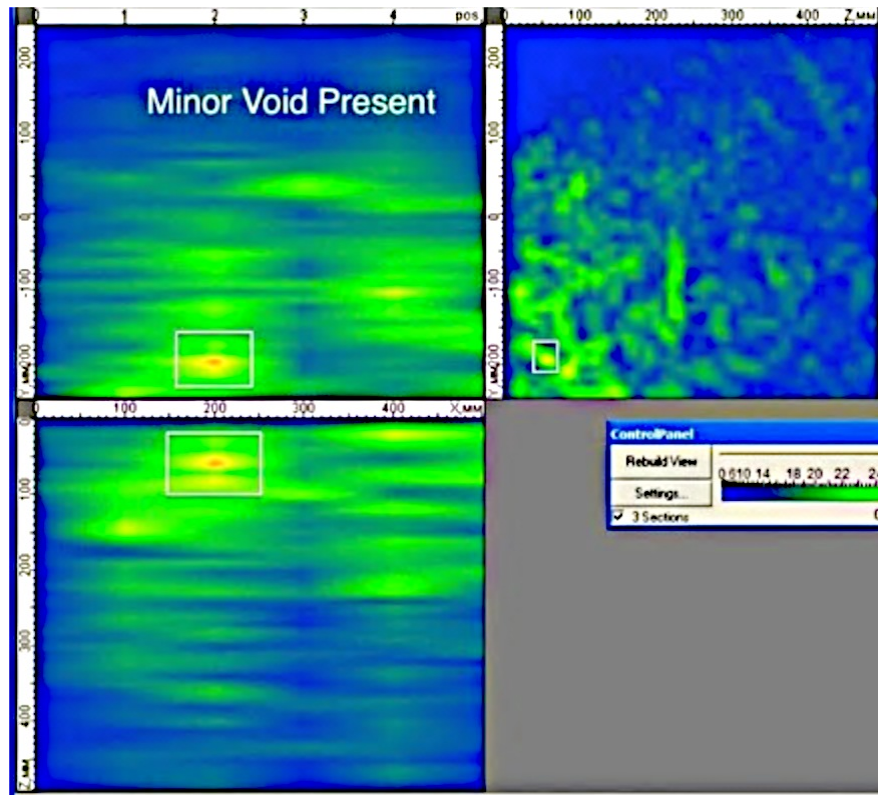
Pier 6-2 was scanned at a frequency of 100 Hz and a calibrated wave velocity of 2,539 m/s on North-South face. The visual inspection of the member indicated some patched sections along the member, but no surface deterioration was noted. The shear wave scan results shown in Figure 4.25 indicate some minor voids (boxed) at around 60 mm from the north face of the support. However, the overall scan and visual inspection raised no alarms, and no further analysis of this member is required.

Figure 4.25 - Pier 6-2 Scan Results Indicating Minor Voids Present

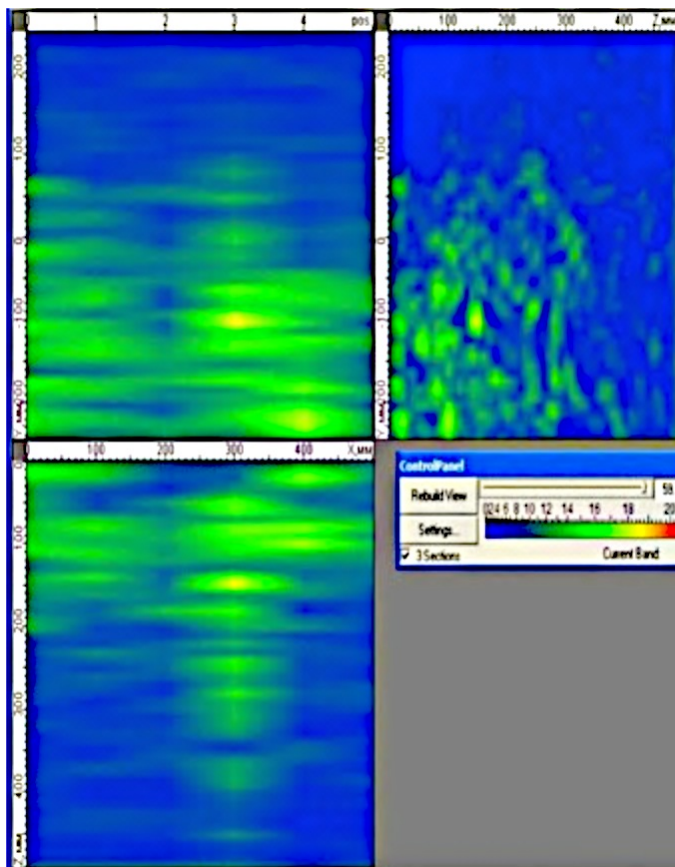
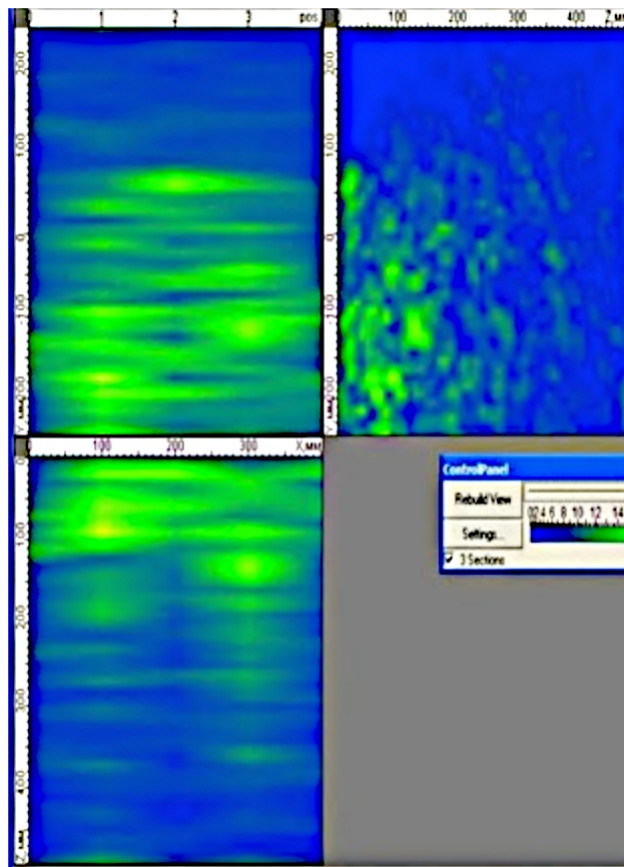
Piers 6-3 and 6-4 were scanned at 50 Hz and a calibrated velocity of 2,470 and 2,474 m/s on the North-South and South-North face respectively. The shear wave scan results are shown in Figure 4.26 and 4.27 indicate no voids present. In addition, the visual inspection of the members did not indicate any deterioration. Thus, piers 6-3 and 6-4 require no further analysis.

Figure 4.26 - Pier 6-3 Scan Results

Figure 4.27 – Pier 6-4 Scan Results

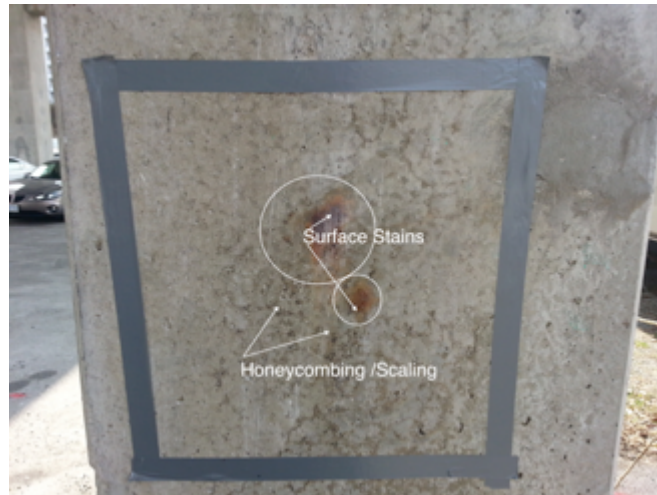
Pier 7-1 was scanned at a frequency of 50 Hz and a calibrated wave velocity of 2,444 m/s on the South-North face. Initial visual inspections indicated the presence of surface stains, honeycombing and scaling at various portions of the pier as shown in Figure 4.28. The initial scan shown in Figure 4.29 illustrates the large-scale deterioration in pier 7-1, at around 75 mm from the south face of the pier. The deterioration could be due to delamination of the concrete or cracking as a result of reinforcement corrosion. The deterioration in the C-scan and D-scan indicate that the deterioration could be along the reinforcements close to the face of the support. The clear scan images suggest that a frequency adjustment is not necessary. The cluster of voids present is bound to cause future problems in this member and appropriate maintenance action should be undertaken as soon as possible. However, prior to undertaking any maintenance actions, the pier should be scanned at higher elevations in order to analyze the overall structural condition of the member.

Figure 4.28 – Pier 7-1 Scan Outline with Surface Stains, Honeycombing and Scaling Present

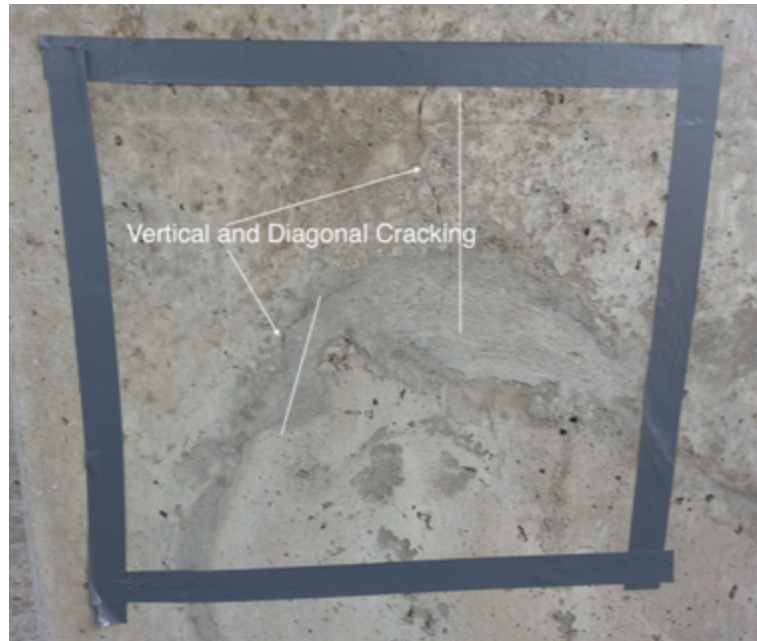
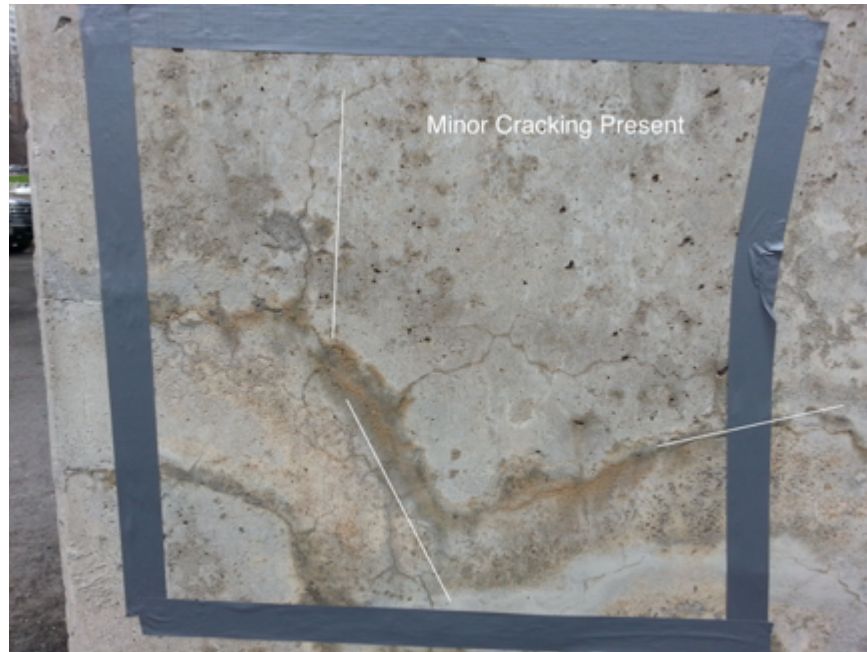
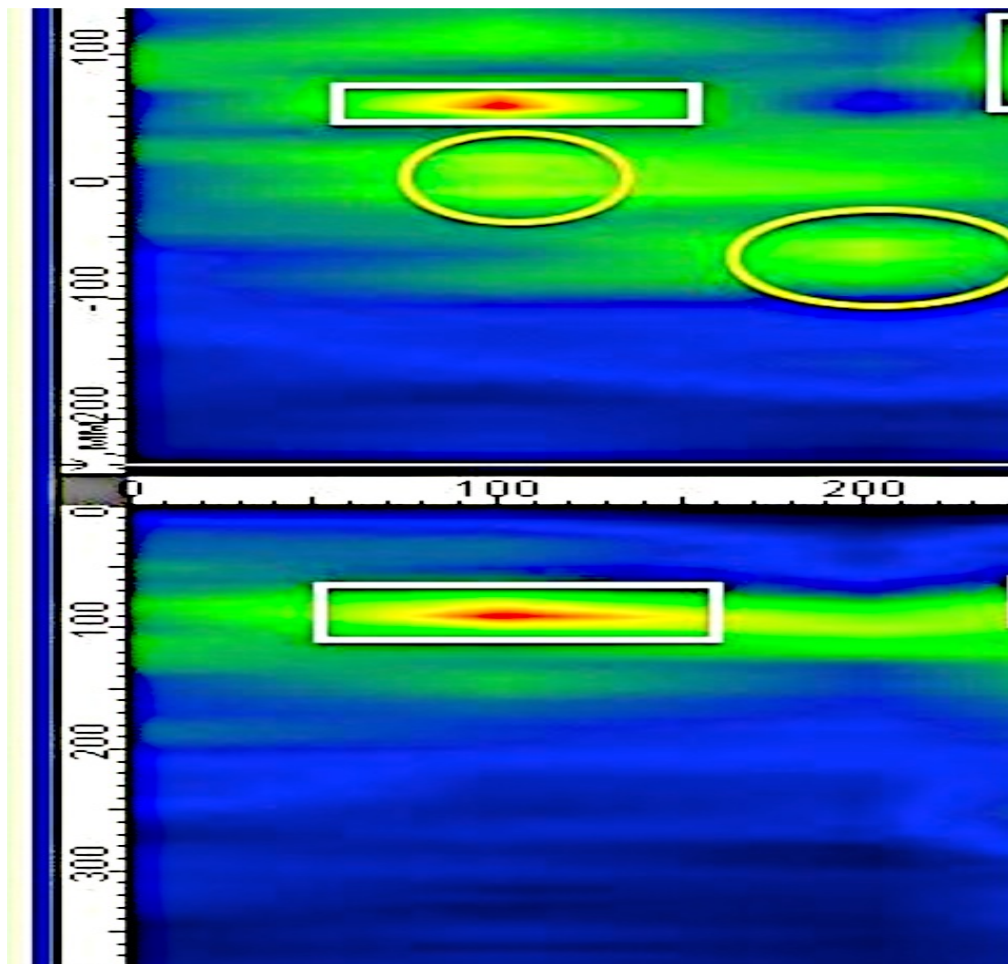
Piers 7-2 and 7-4 were both scanned at a frequency of 50 Hz and a calibrated wave velocity of 2,421 m/s and 2,403 m/s on the East-West face respectively. The shear wave scans shown in Figures 4.31 and 4.33 show minimal signs of deterioration, with only minor voids present. The visual inspection of both members indicated minor vertical and diagonal cracks as shown in Figure 4.30 and 4.32. The small nature of voids noted in the MIRA scans and minor visual anomalies indicate that piers 7-2 and 7-4 are in good structural condition and no immediate action is required.

Figure 4.30 - Pier 7-2 Scan Outline with Vertical and Diagonal Cracks Present on the Scan Face

Figure 4.31 - Pier 7-2 Scan Results Indicating Minor Voids Present

Figure 4.32 - Pier 7-4 Scan Outline with Minor Cracks Noted

Figure 4.33 - Pier 7-4 Scan Results Indicating Minor Voids Present
