**EXPERIMENTAL STUDY ON THE STRENGTH OF TL-5 CONCRETE BRIDGE  
BARRIER REINFORCED WITH STAINLESS STEEL BARS**

An MRP  
presented to Ryerson University

in partial fulfillment of the  
requirements for the degree of  
Master of Engineering  
in the program of  
Civil Engineering

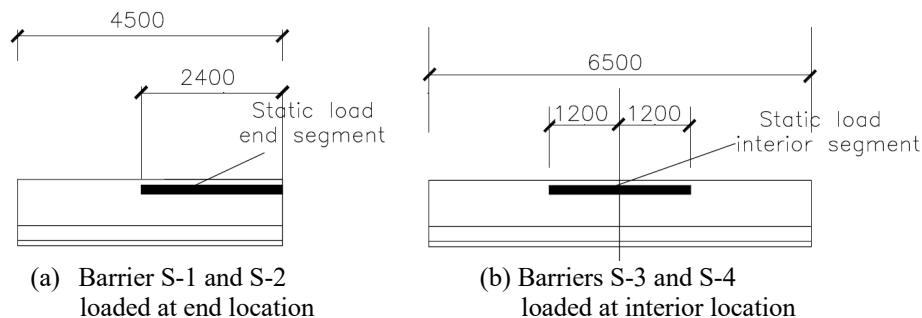
Figure 1.1 Visual schematics of barrier length and load location for the four TL-5 specimens

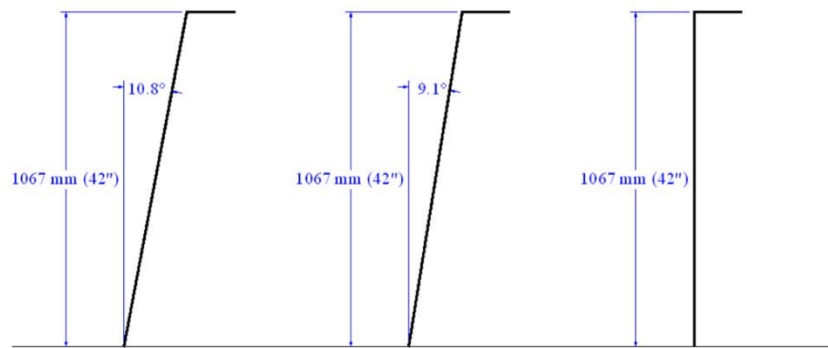
Figure 2.3 Popular industry standard constant-sloped barriers  
(Rosenbaugh et al., 2007)

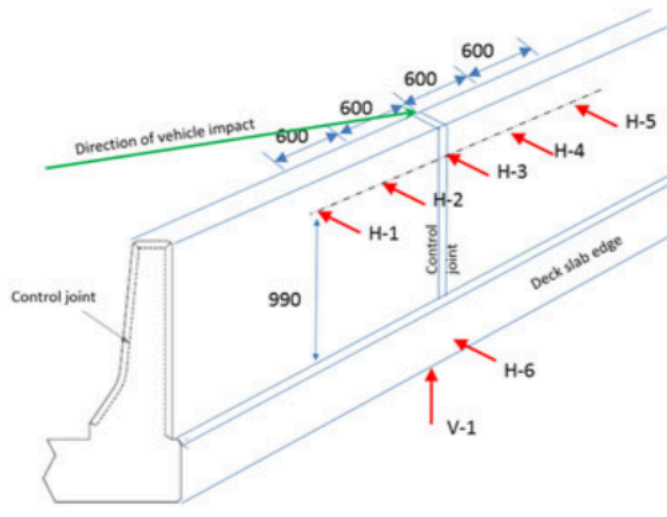
Figure 2.5 TL-5 barrier crash test schematic (Sennah and Hedjazi, 2018)

In Figure 2.5, H-1 to H-6 represent six LVDT sensors which measure the horizontal displacement of the barrier wall, while V-1 represents and LVDT sensor which measures the vertical deflection of the deck slab cantilever. The control joints were included while casting the barrier wall in accordance with the MTO to reduce shrinkage cracks. The crash test conclude that vehicle did not penetrate or go over the barrier wall. The safety aspect of the impact passed as a result of no detached barrier fragments found and no evidence found of barrier debris penetrating the vehicle occupant compartment. Secondly no deformation of the occupant compartment during the test. Also, the vehicle remained upright during the entire duration of the crash. The maximum equivalent static impact load of 559.61 kN was calculated from the acceleration-time history recorded during the crash test.

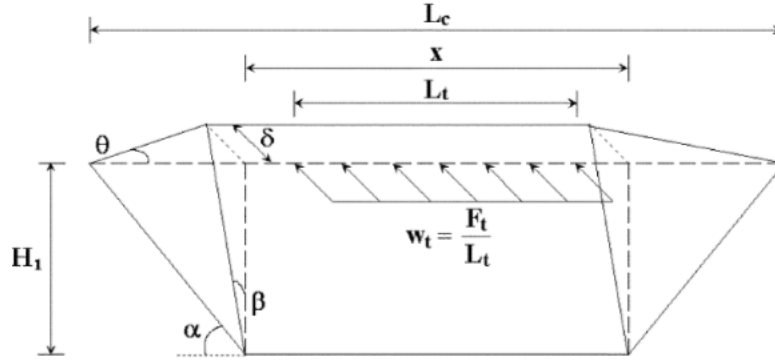
Figure 2.8 Trapezoidal yield-line pattern at interior location (Fadaee et al., 2018)

The trapezoidal yield-line pattern consists of two diagonal yield lines (one on each side of the transverse loading) extending a horizontal yield-line across the wall-deck interface as shown in Figure 2.8 (Fadaee et al., 2018). At the back side of the barrier wall, two vertical yield-lines exist, one at each boundary location of the transverse load.

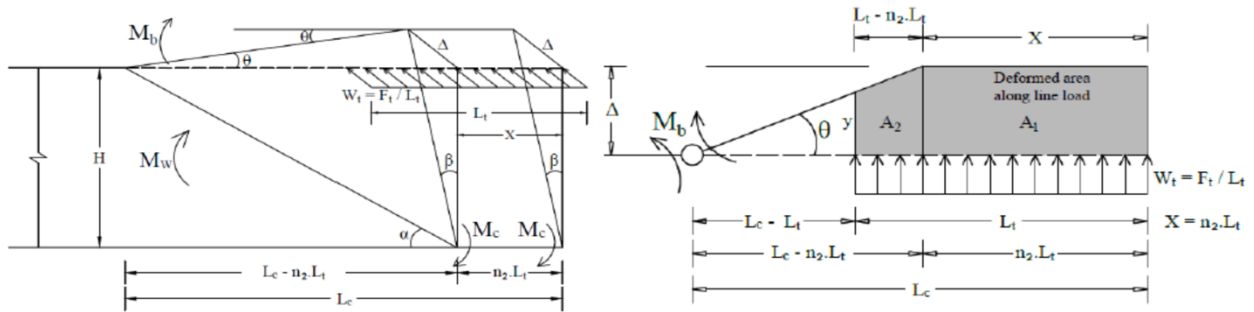
Figure 2.12 Trapzoidal yield line pattern at end location when  $X < L_t$  (Fadaee et al., 2018)

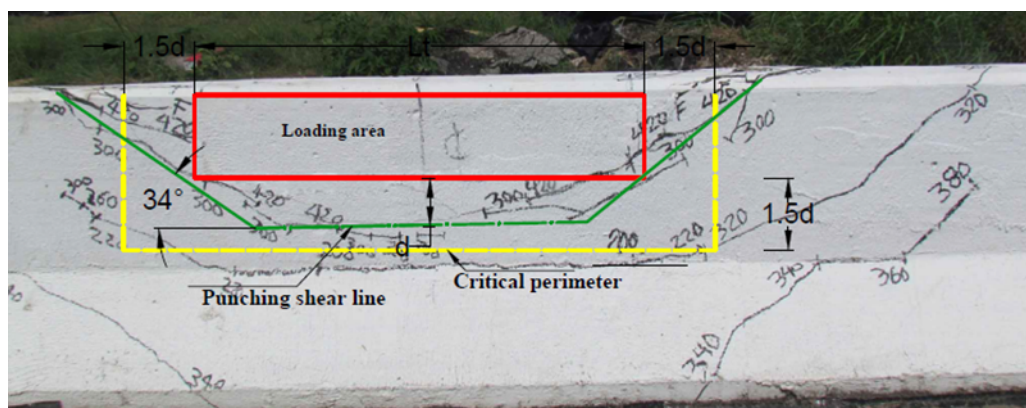
Figure 2.13 Visual illustration of critical shear perimeter on tested barrier wall (Khederzadeh & Sennah, 2014)

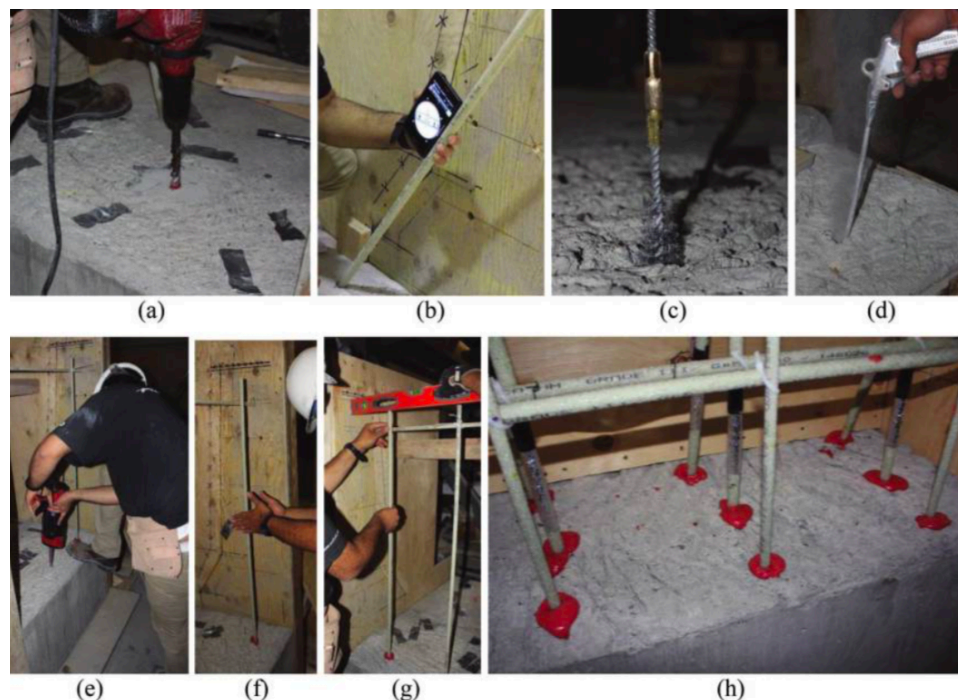
Figure 2.18 Procedure for post-installation of GFRP bars into existing deck (Rostami et al., 2017)

A deteriorated GFRP bridge barrier can also be repaired by post-installing reinforcement into the existing deck slab. The damaged barrier section is saw-cut so that just the deck slab remains. The next step is to drill holes in the deck slab at the required embedment length and orientation. An epoxy filling is then inserted into each of the holes, followed by the insertion of the new GFRP bars via a twisting motion. Shown in Figure 2. 18 shows a typical procedure carried out by (Rostami et al., 2017) for post-installing GFRP bars into an existing concrete deck. This repair method was proved to be adequate regarding structural integrity since the experimental ultimate loads of the tested specimens were greater than the CHBDC design values.

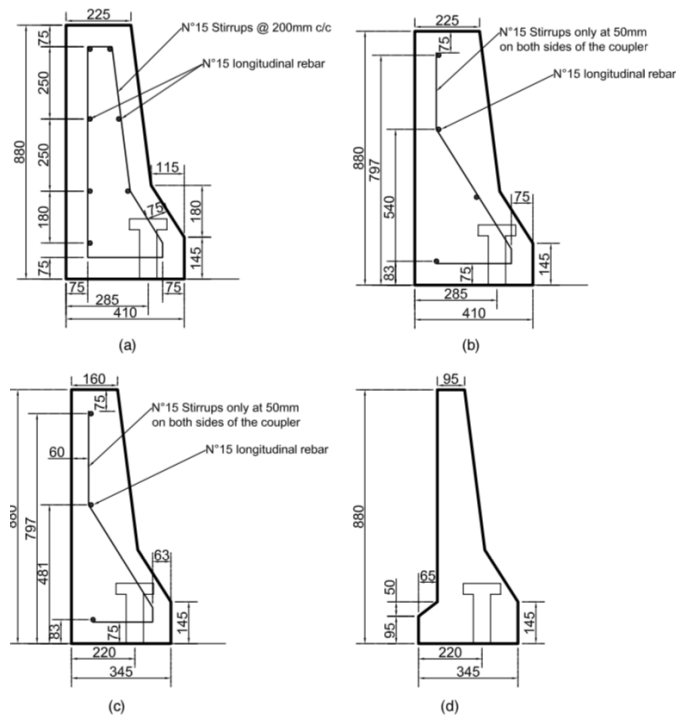
Figure 2.19 Structural design of each precast sample: (a) HPC 50 MPa; (b) FRC 50 MPa-1%; (c) FRC 70 MPa-1.5%; (d) FRC 120 MPa-4% (Charron et al., 2011)

research to verify the performance of precast FRC barriers. Three different FRC samples were constructed with varying percentage of steel fibres (1%, 1.5%, and 4%), concrete strength (50 MPa, 70 MPa, and 120 MPa), and parapet thickness (225 mm, 160 mm, and 95 mm). These samples were compared to an on-site constructed high-performance concrete (HPC) barrier with a concrete strength of 50 MPa. Each sample was tested under static and dynamic conditions using quasi-static loading. The results of both the static and dynamic tests show that each of the FRC barriers yield a higher maximum strength than the HPC barrier, refer to Table 2.6. However, the researchers noted that the HPC barrier was not designed optimally and was included for comparison only.

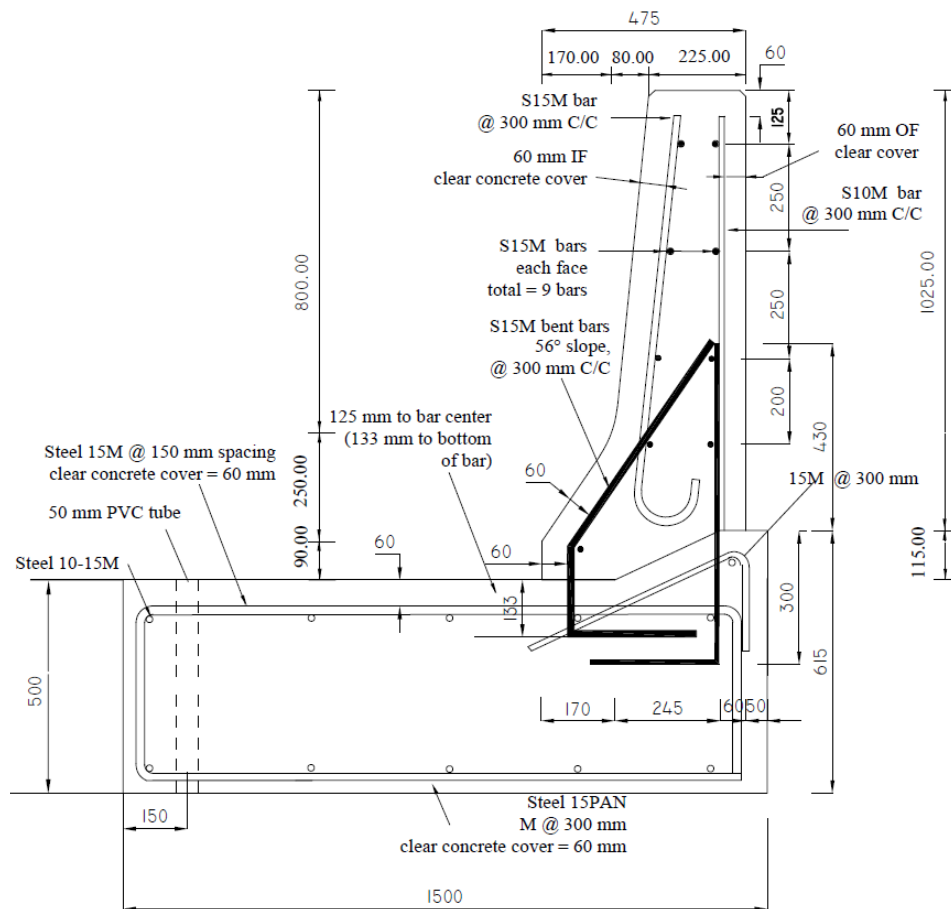
Figure 3.1 Cross-section of barrier specimen with thick base

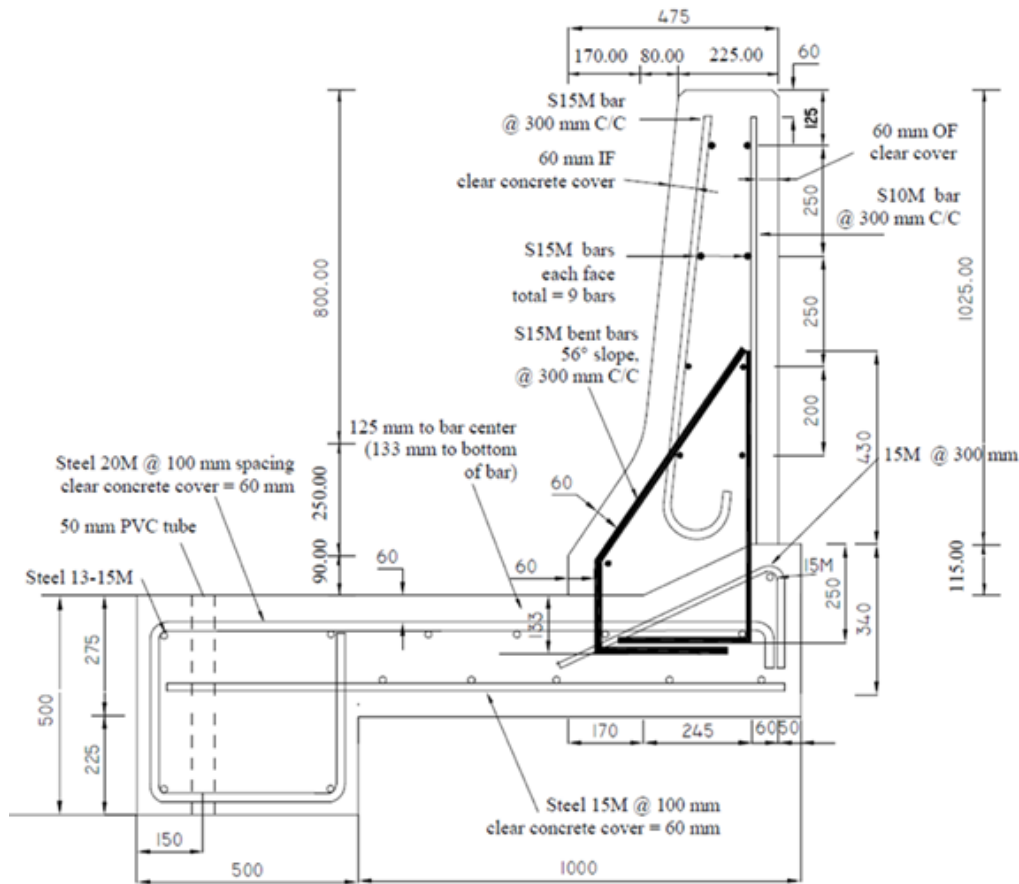
Figure 3.2 Cross-section of barrier specimen with deck slab cantilever

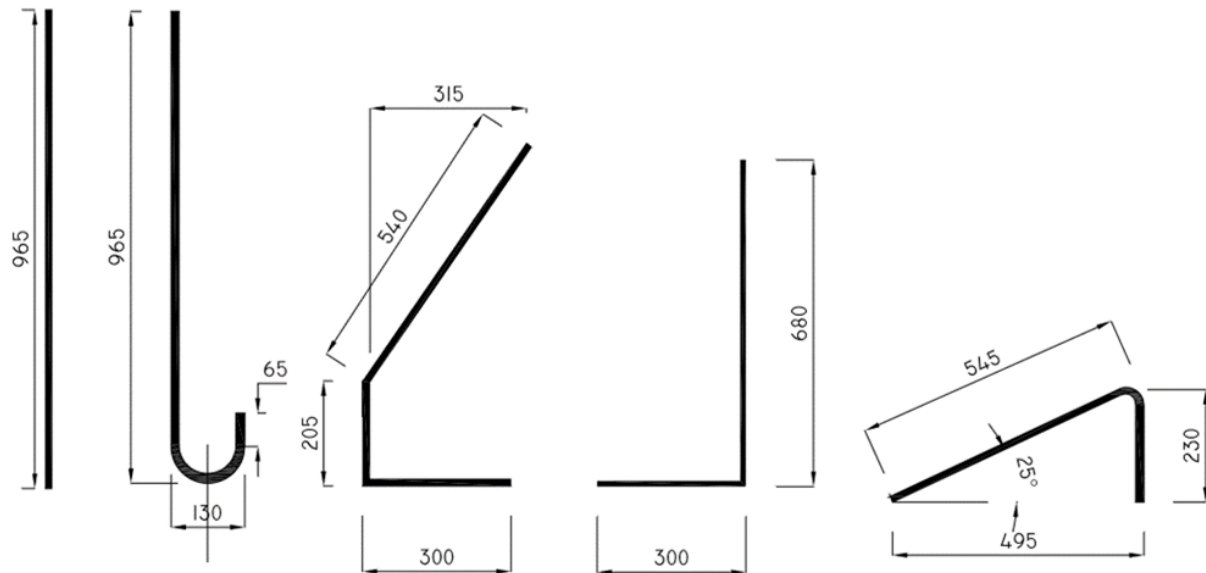
Figure 3.4 Reinforcement details

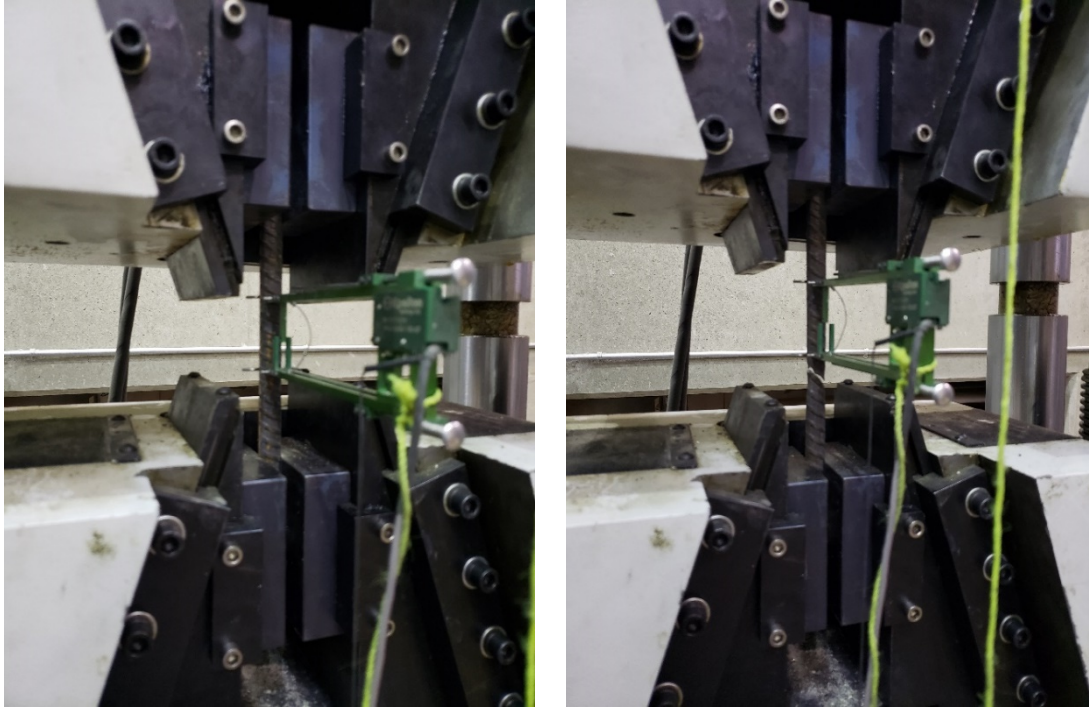
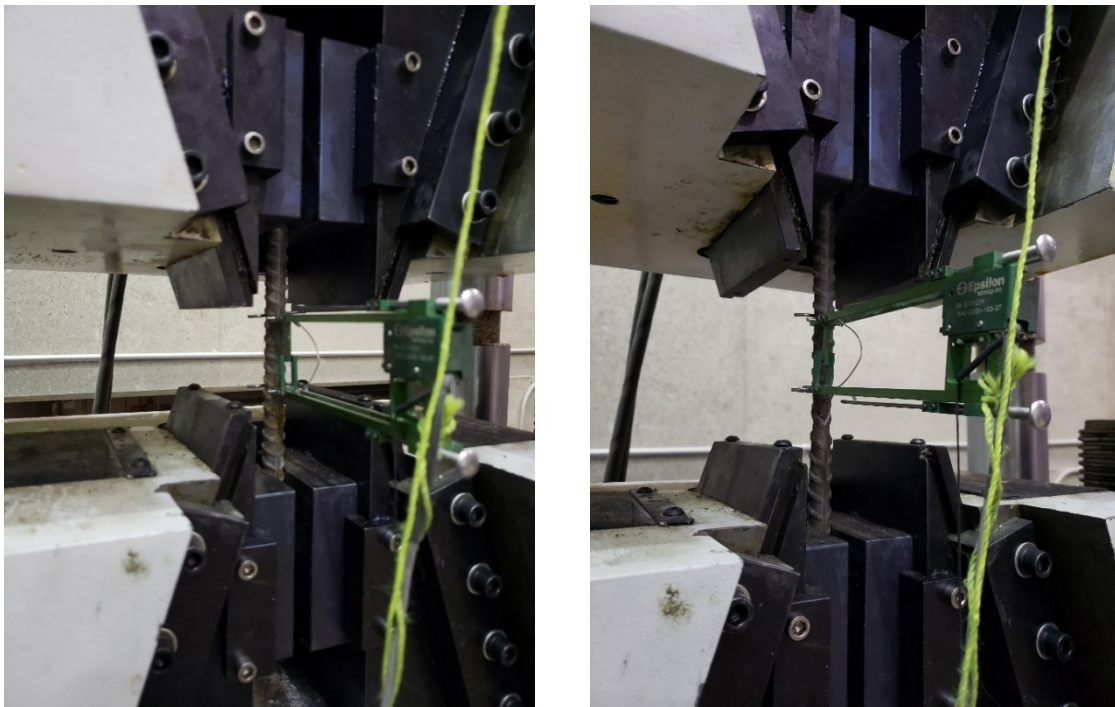
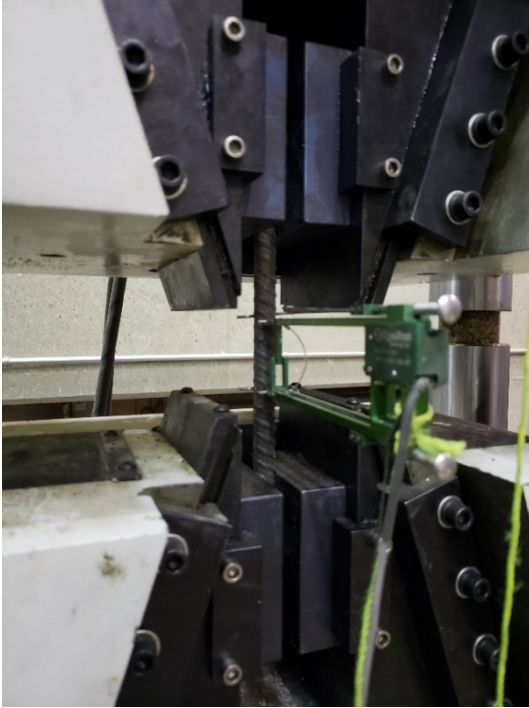
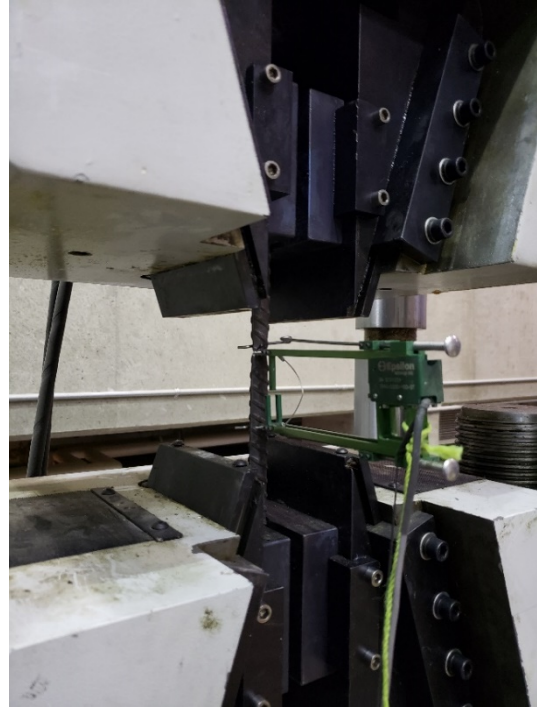
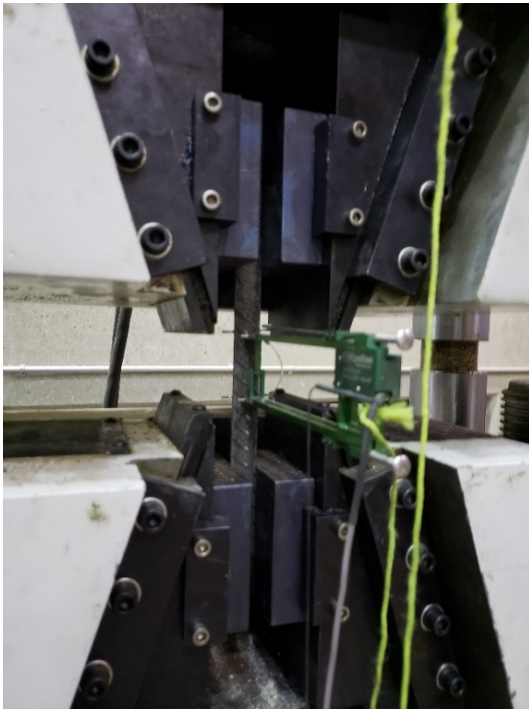
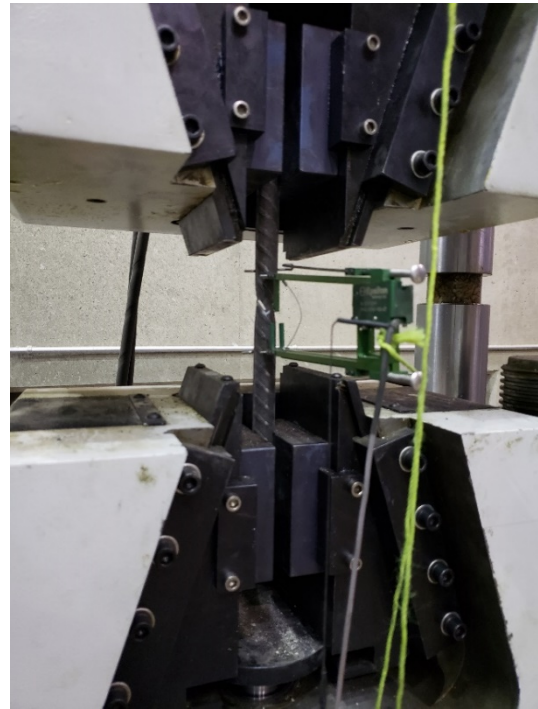
(a) Views of the test setup for 15M reinforcing steel coupon # 1 before testing (left) and after failure (right)

(b) Views of the test setup for 15M reinforcing steel coupon # 2 before testing (left) and after failure (right)

(c) Views of the test setup for 15M reinforcing steel coupon # 3 before testing (left) and after failure (right)

(d) Views of the test setup for 20M reinforcing steel coupon # 1 before testing (left) and after failure (right)

Figure 3.6 Views of the tensile test setup and the failed reinforcing steel coupons

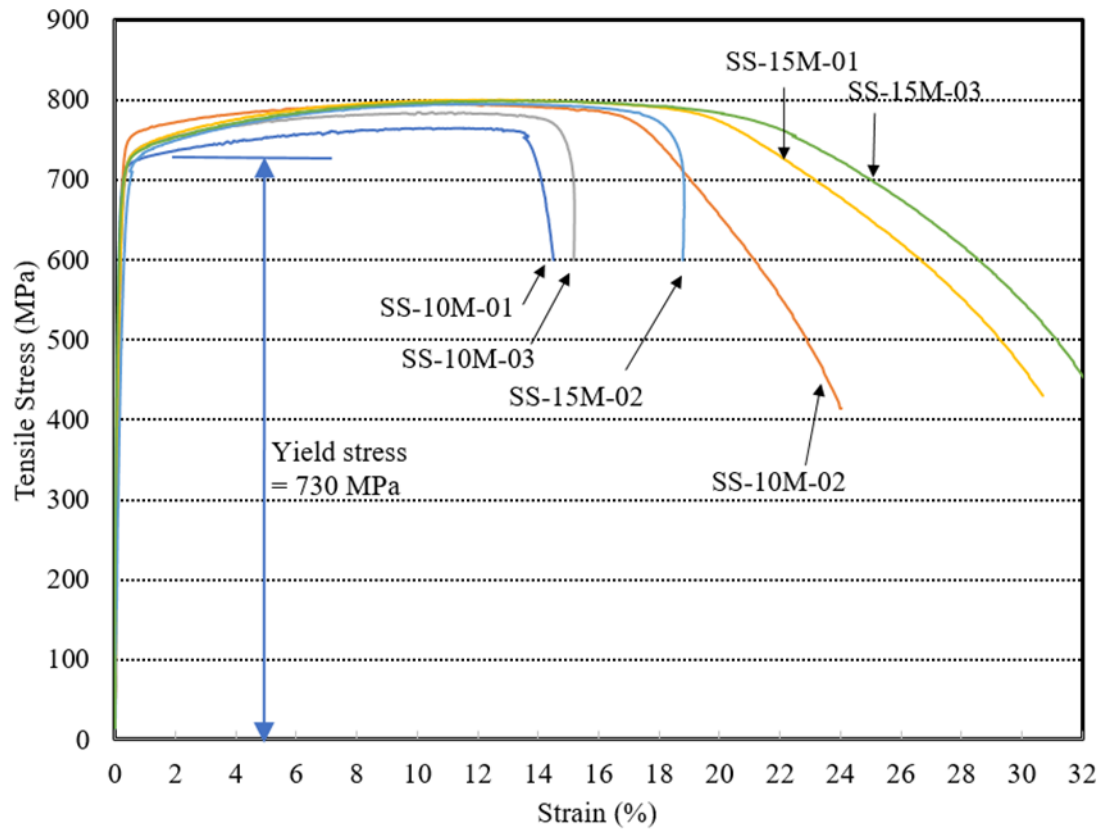
Figure 3.7 Tensile stress-strain relationship for stainless steel bars

specimens before and after tensile testing. Results show that the average yield strength of the stainless steel is 730 MPa.

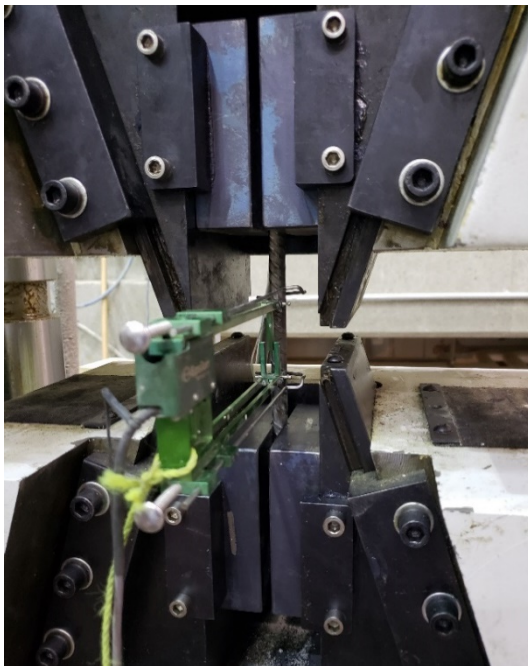
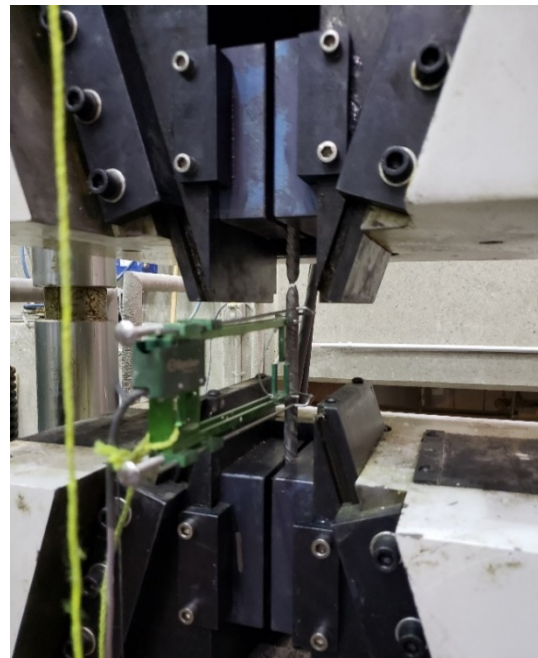
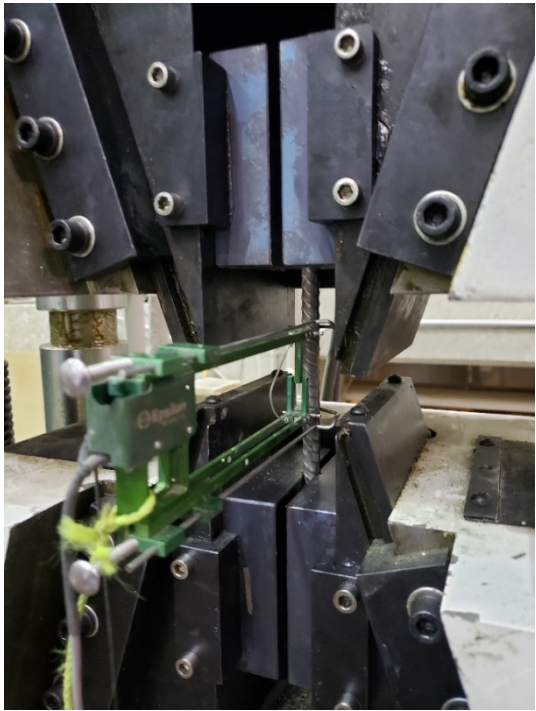
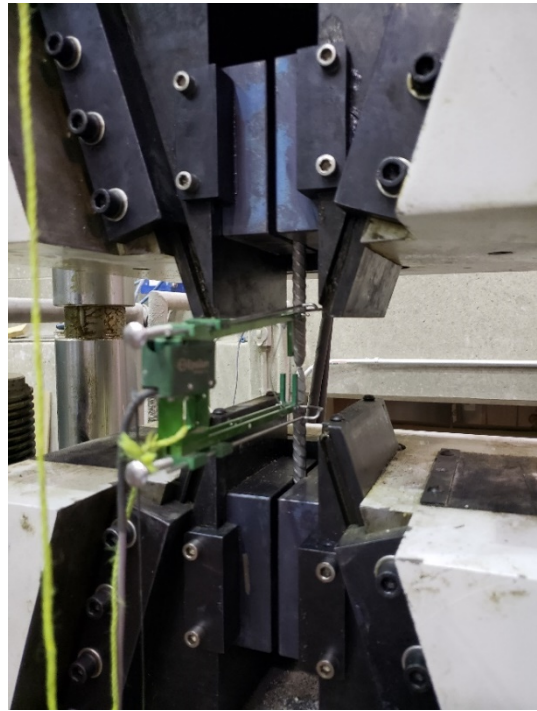
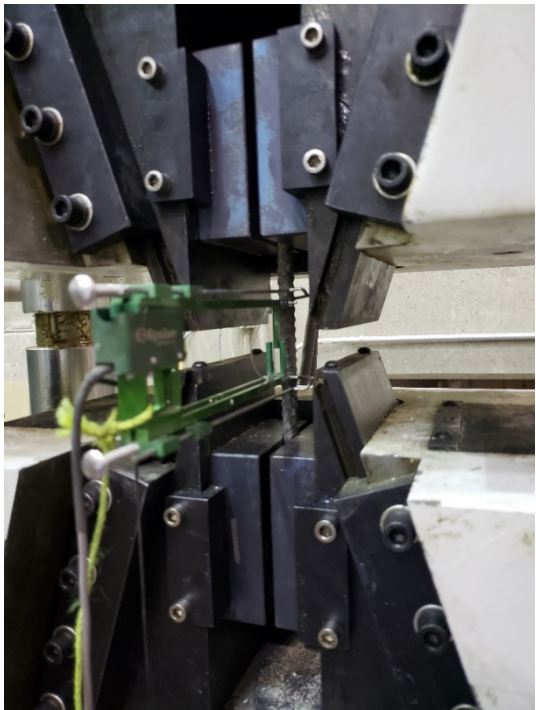
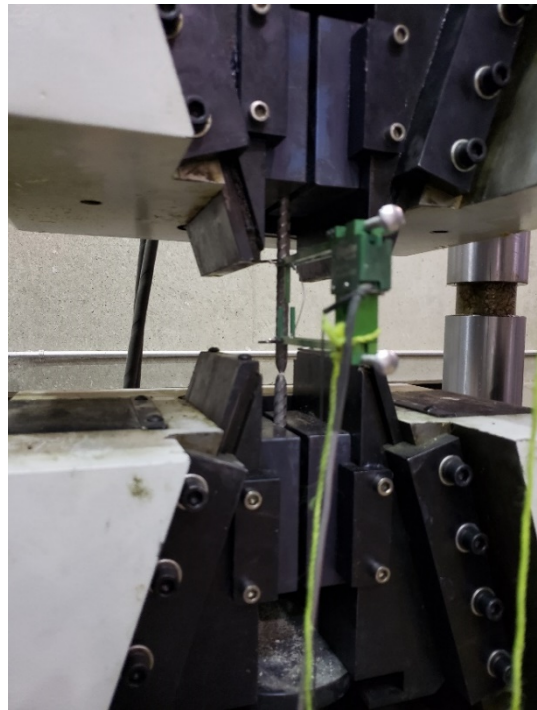
(a) Views of the test setup for 15M stainless steel coupon # 1 before testing (left) and after failure (right)

(b) Views of the test setup for 15M stainless steel coupon # 2 before testing (left) and after failure (right)

(c) Views of the test setup for 15M stainless steel coupon # 3 before testing (left) and after failure (right)

Figure 3.8 Views of the tensile test setup and failed stainless-steel coupons

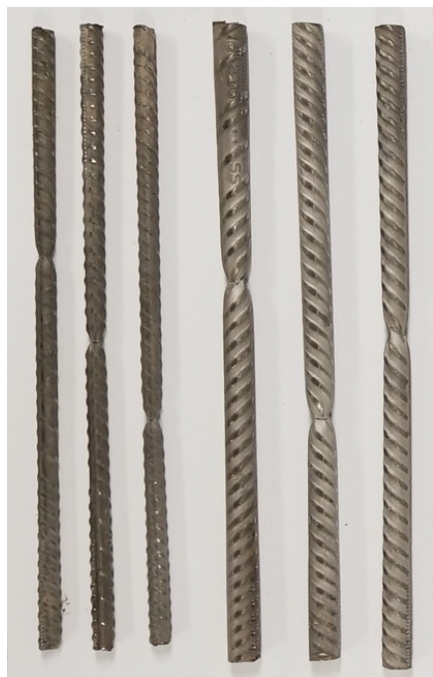
(g) View of the failed stainless-steel coupons

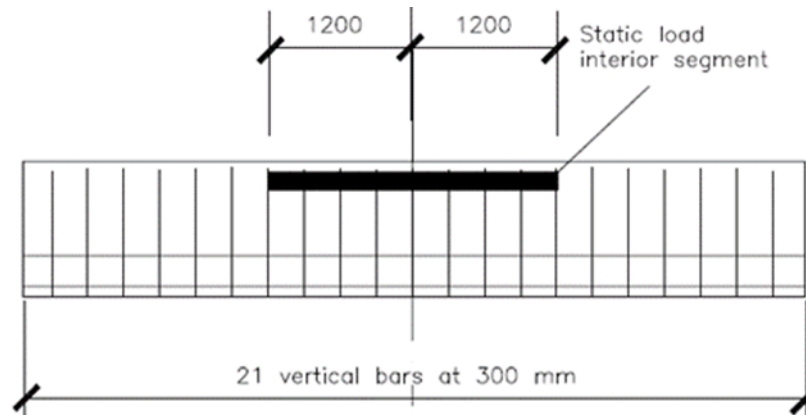
Figure 3.11 Elevation of front vertical reinforcement arrangement for barrier specimens S-3 and S-4 with interior loading

Figures 3.11 and 3.12 show the arrangement of the vertical reinforcement in the traffic side of the barrier walls of 6.5 m and 4.5 m long, respectively. It should be noted that MTO standard drawing specifies double such front vertical reinforcement at barrier ends. Each barrier specimen was instrumented with potentiometers (POT's/LVDT's) to measure horizontal and vertical displacement of the barrier. Figure 3.13, 3.14, 3.15 and 3.16 show locations of potentiometers in specimens S-1, S-2, S-3 and S-4, respectively.

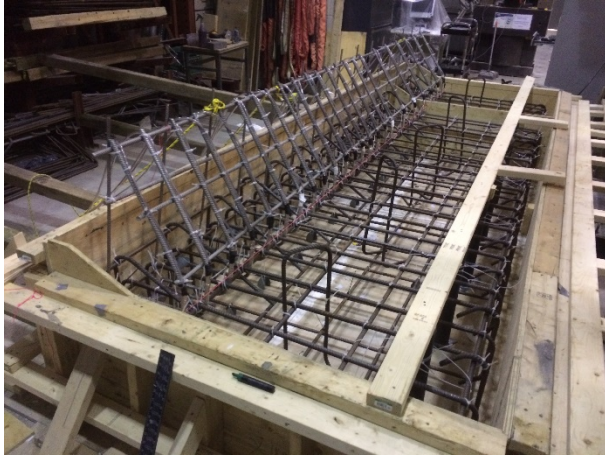
a) Reinforcement before casting the base

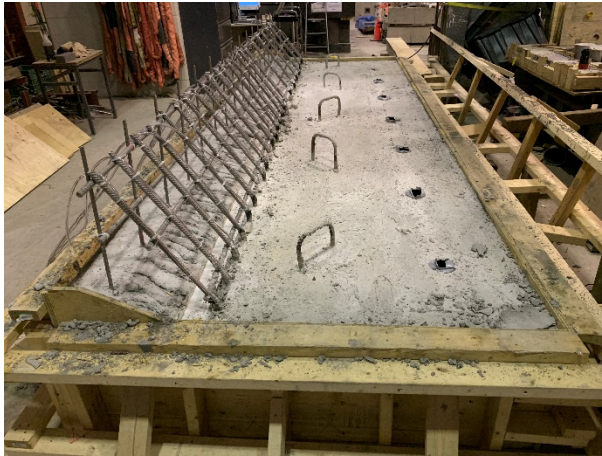
c) Stainless steel bars after casting the base

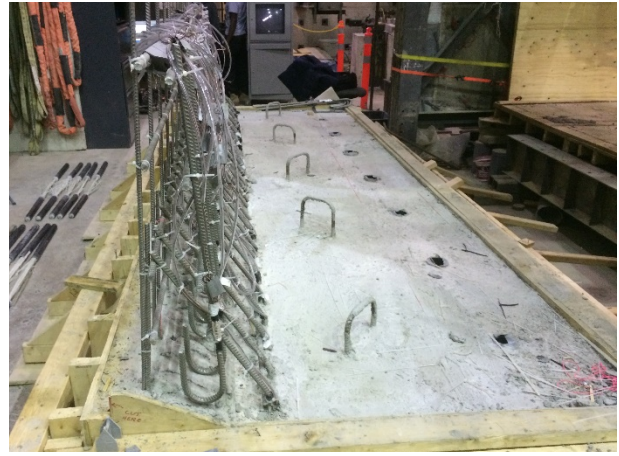
d) Side view of barrier reinforcement

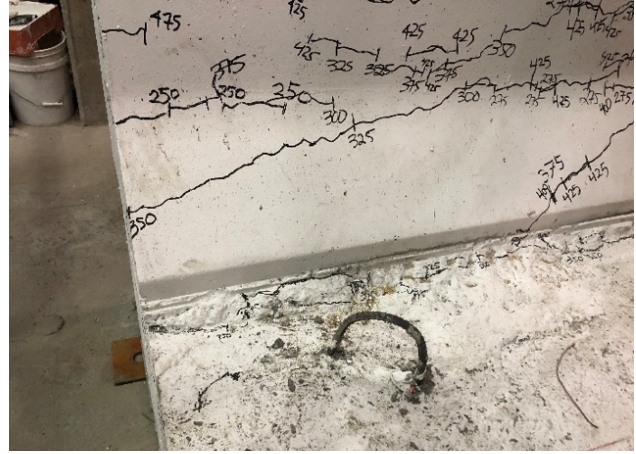
b) Horizontal flexural crack in the barrier wall and along barrier-base interface

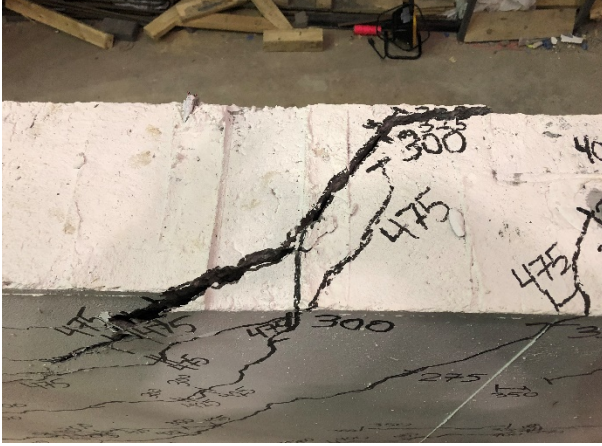
g) Top view of punching shear through barrier thickness

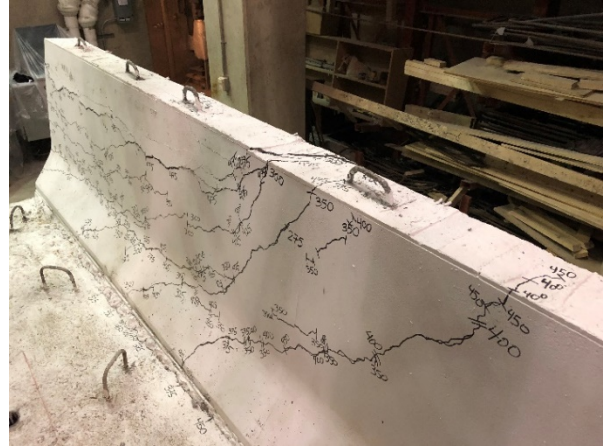
h) Side view of punching shear failure

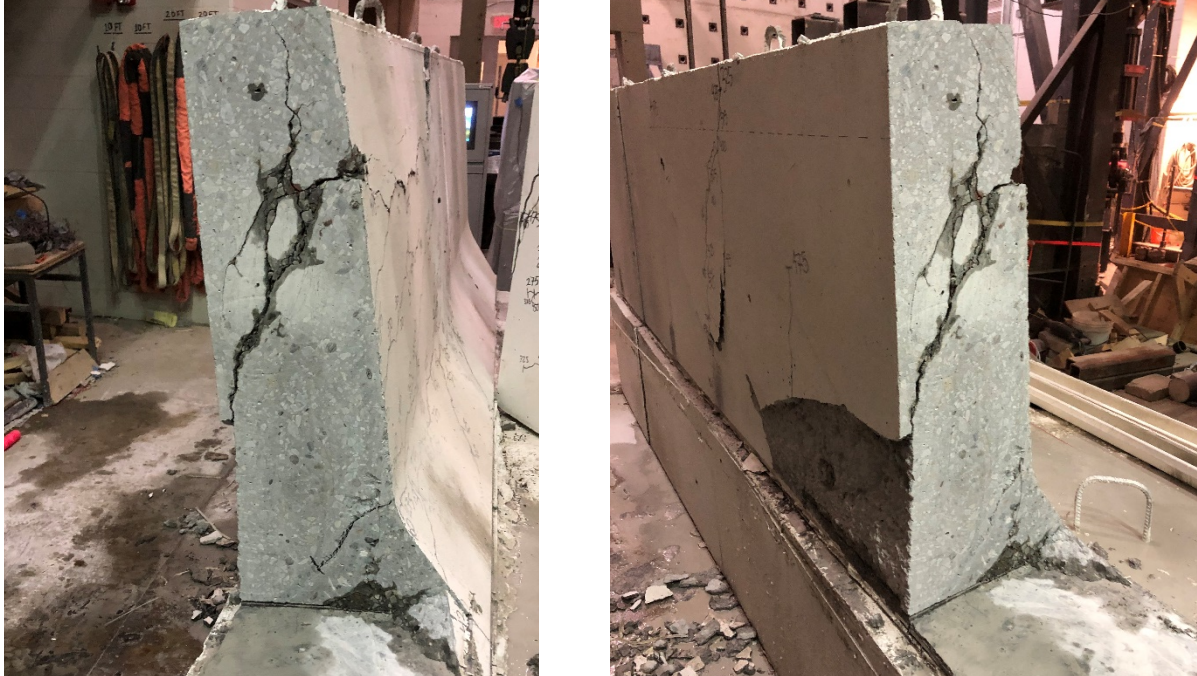
Figure 4.3 Saw cut at center of 1 m from the south end of barrier specimen S-1, looking north, showing 38° angle of punching shear failure

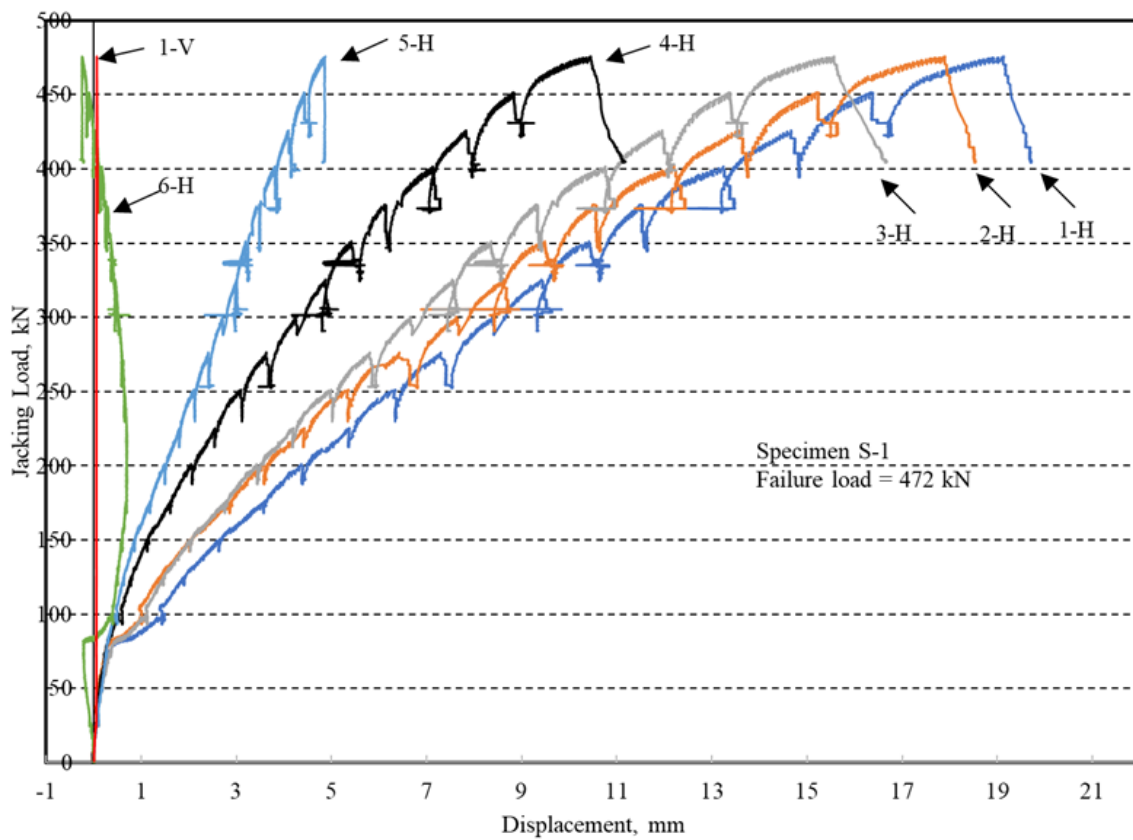
Figure 4.4 Load-deflection relationship of specimen S-1

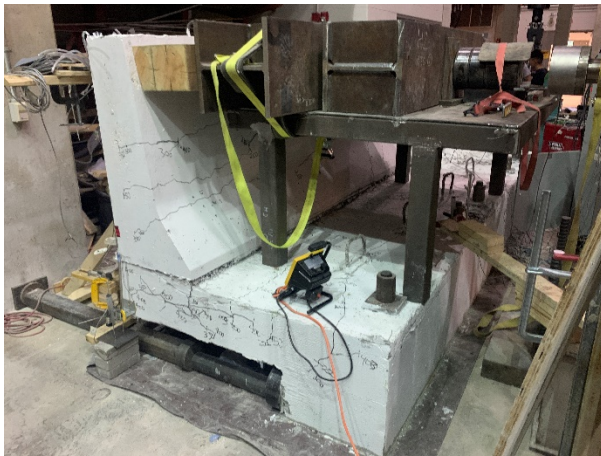
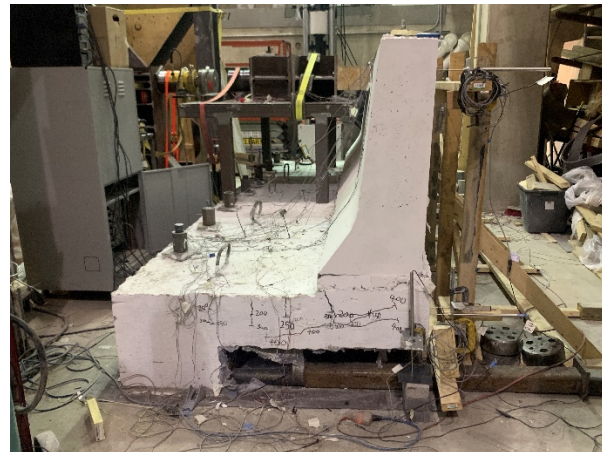
a) South side of the barrier wall

b) North side of the barrier wall

Figure 4.5 Views of crack pattern and failure mode for specimen S-2 before removing the testing frame

failure load was recorded as 403 kN which is greater than the CHBDC factored design transverse loading of 357 kN, leading to a capacity-demand ratio (CDR) of 1.13. Figure 4.8 shows the load-deflection relationship for specimen S-2. At the failure load, the maximum recorded deflection at the loaded end of the barrier was 40 mm, while the maximum deflection at the unloaded end was 25 mm. The recorded barrier uplift at the location of the tie-down system was 0.7 mm at the failure load which is considered negligible. The deck slab maximum deflection at the ultimate load was 22 mm and 19 mm at the loaded and unloaded ends of the barrier wall, respectively, which confirmed be considerable bending deformation of the deck slab cantilever and associated failure mode.

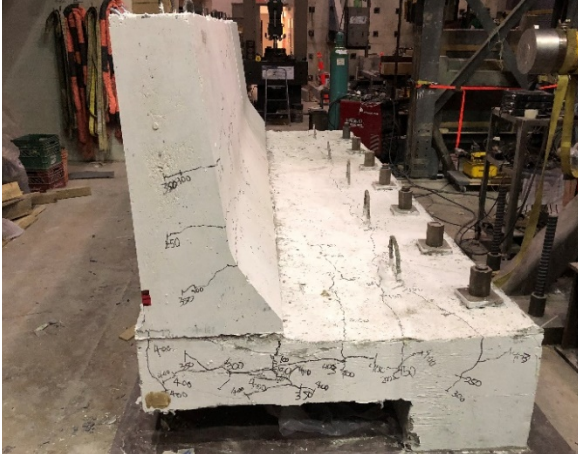
a) Flexural cracks in the barrier wall and deck at the south end

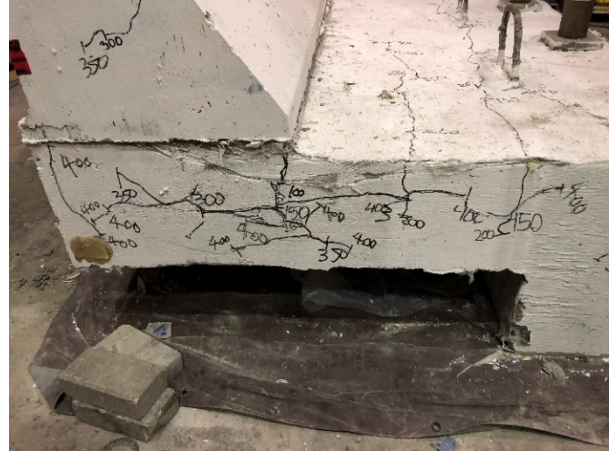
b) Close-up view of flexural cracks and bar anchorage crack in the deck cantilever

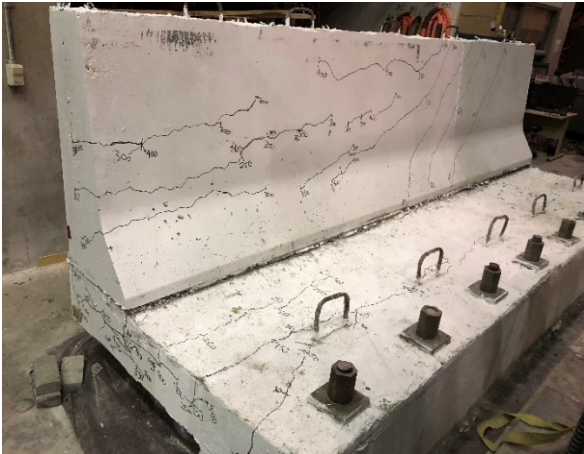
g) Flexural cracks in the barrier and deck viewed from the south side

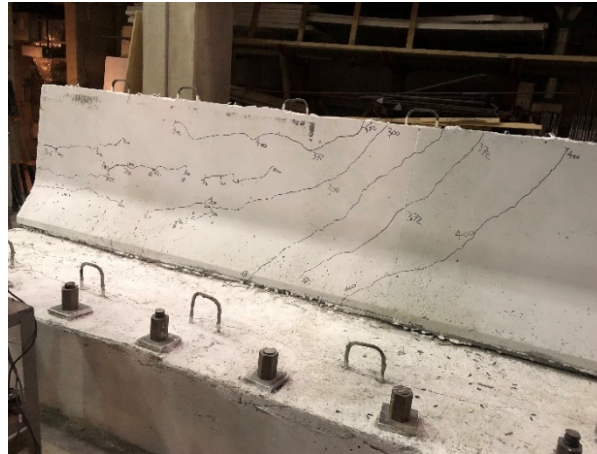
h) Front view of flexural cracks in the wall

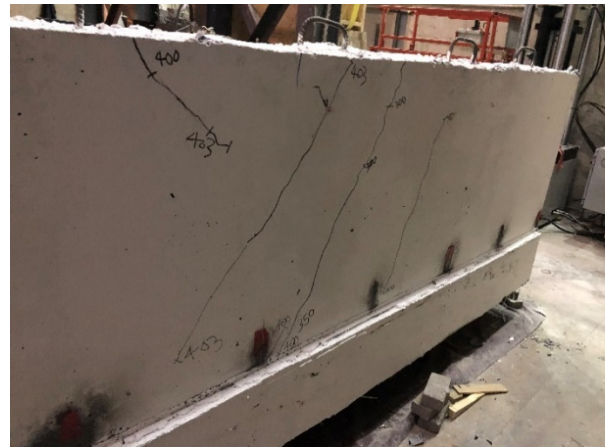
j) Sign of diagonal crack at top of the barrier wall at potential location of punching shear

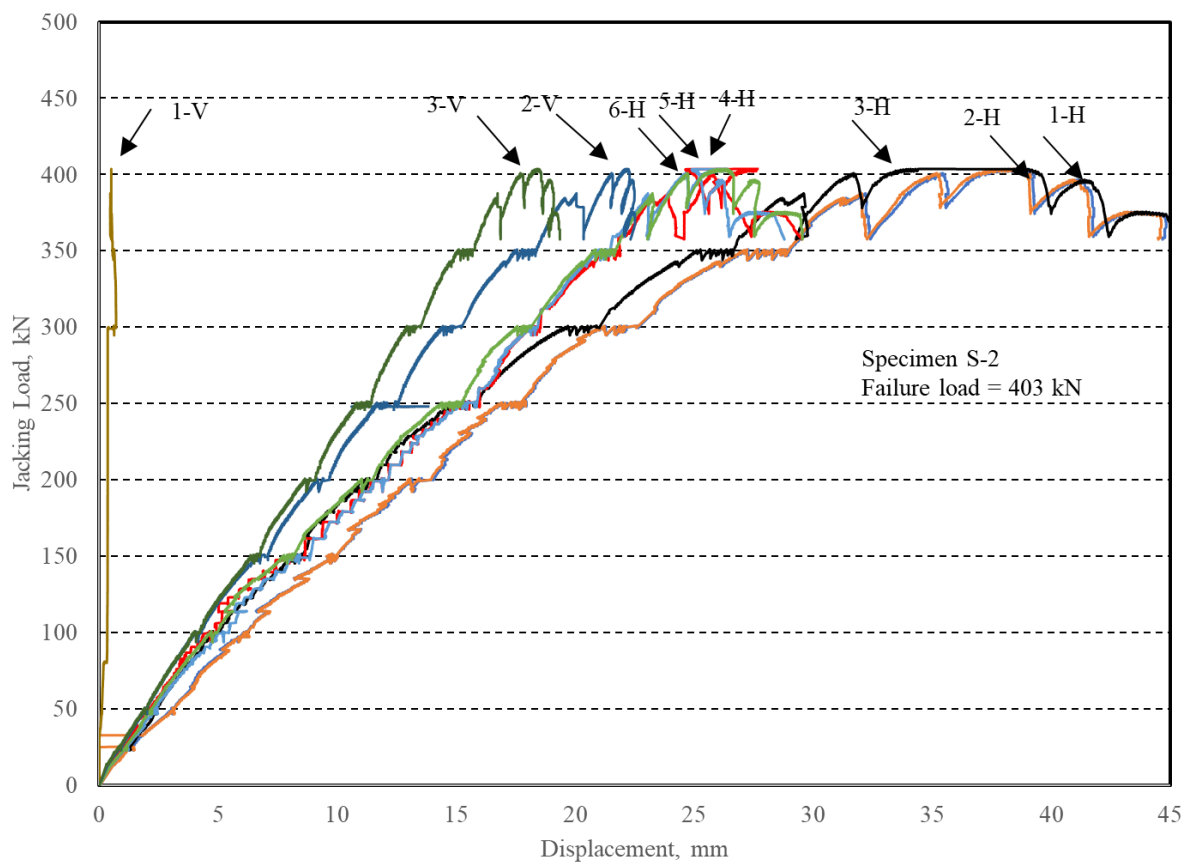
Figure 4.8 Load-deflection relationship for specimen S-2

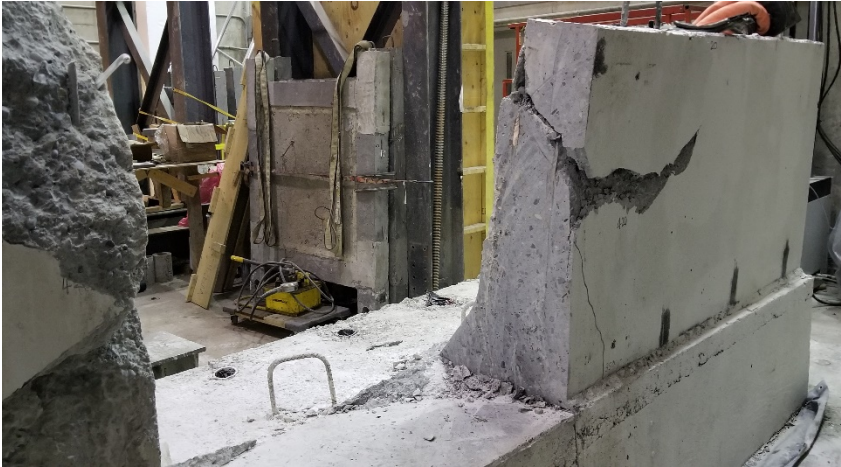
a) Saw cast at 1 m away from the center of applied load towards the south end showing  $40^\circ$  angle for the punching shear crack

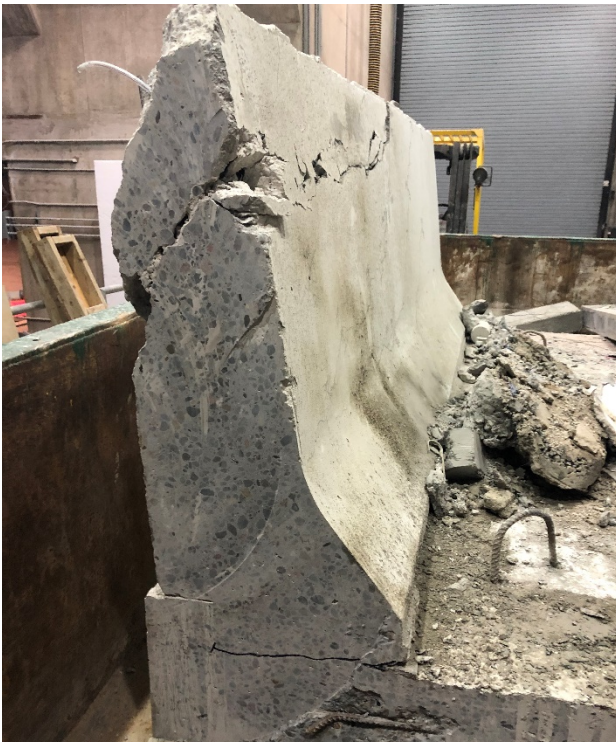
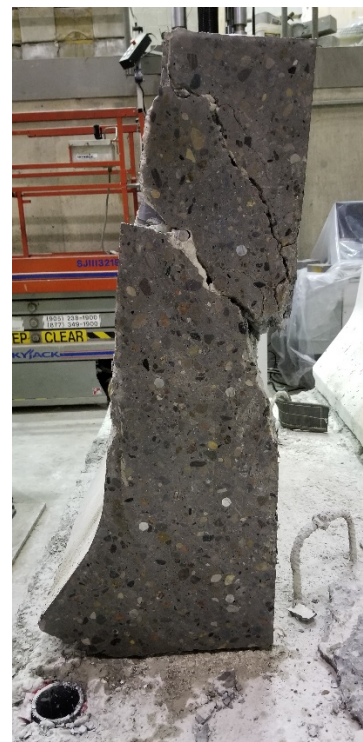
b) Saw cast at 100 mm away from the center of applied load towards the north end showing  $40^\circ$  angle for the global punching shear crack while the local punching shear crack appeared on top of it in the right photo

Figure 4.11 Views of crack pattern and failure mode for specimen S-3 after saw-cut
