**EXPERIMENTAL STUDY ON THE STRENGTH OF TL-5 CONCRETE BRIDGE  
BARRIER REINFORCED WITH STAINLESS STEEL BARS**

An MRP  
presented to Ryerson University

in partial fulfillment of the  
requirements for the degree of  
Master of Engineering  
in the program of  
Civil Engineering

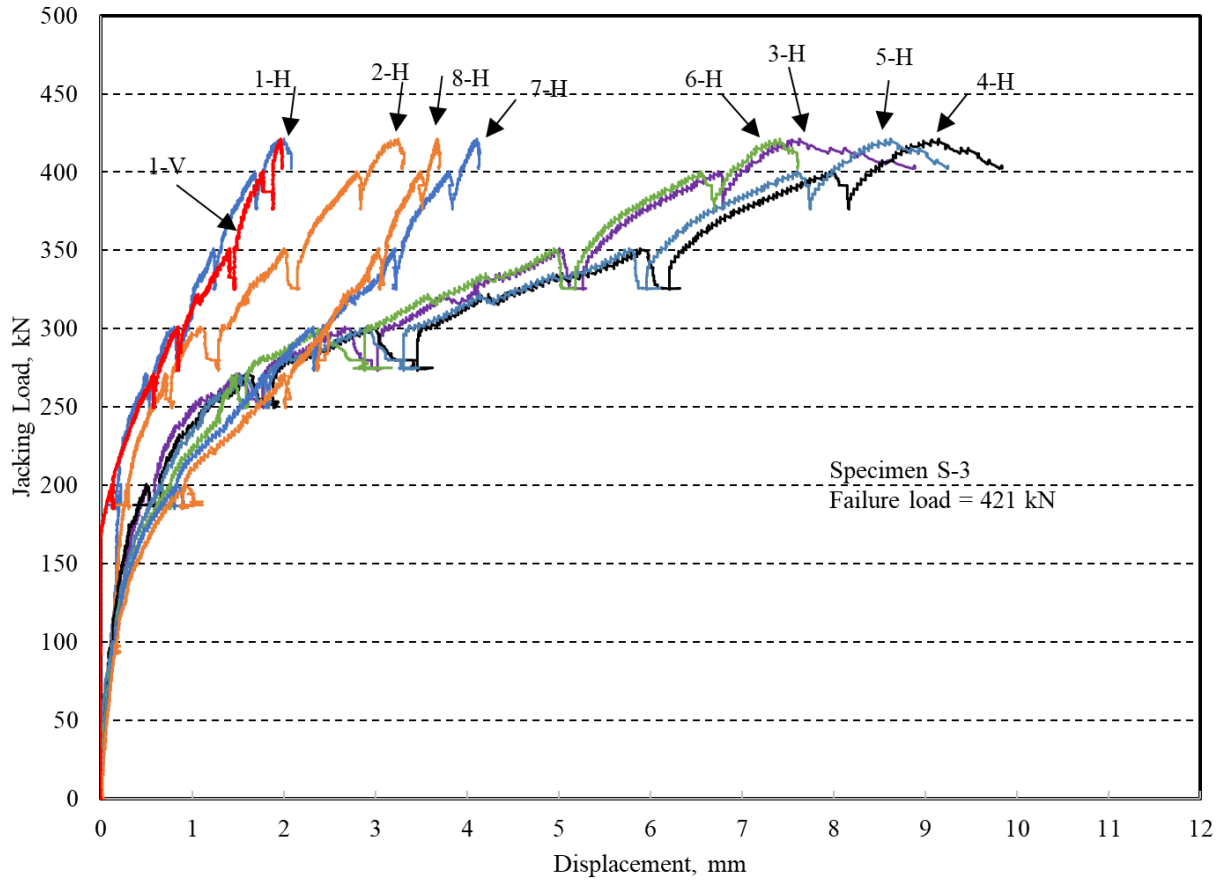
Figure 4.12 Load-deflection relationship for specimen S-3

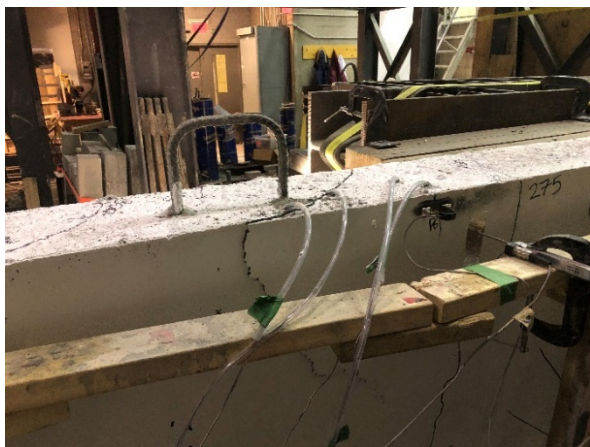
d) Punching shear crack appeared at the north end of the timber block of the loading frame

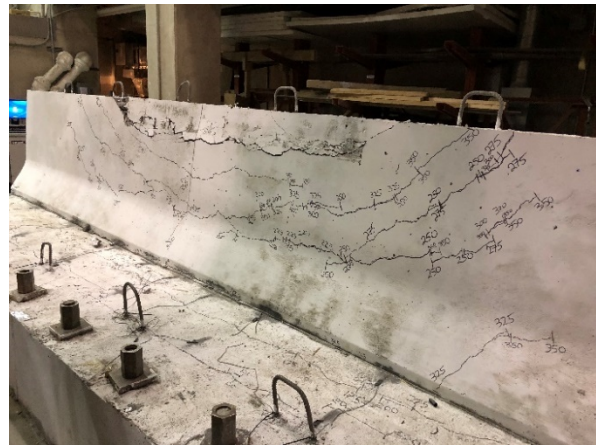
f) Flexural cracks extending all over the deck cantilever within and outside length

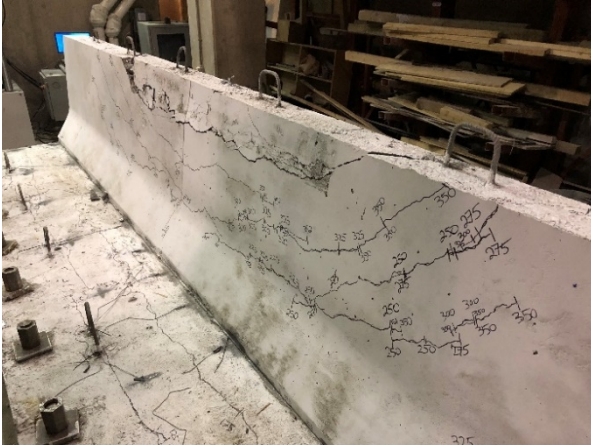
g) Looking south, horizontal cracks within the loaded length, in the tapered portion only, extending diagonally in the unloaded barrier portion

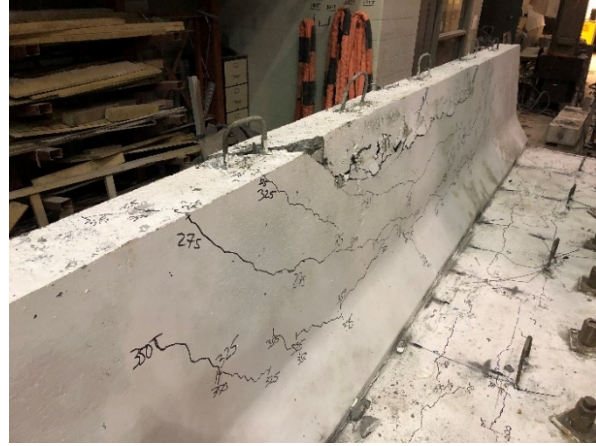
h) Looking north, horizontal cracks within the loaded length, in the tapered portion only, extending diagonally in the unloaded barrier portion

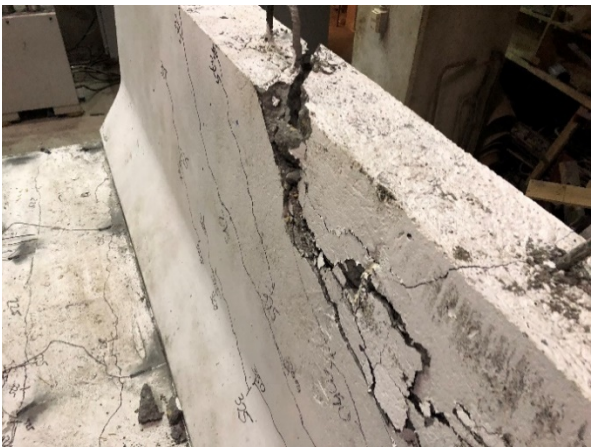
i) First punching shear crack to appear at the south end of the loaded length

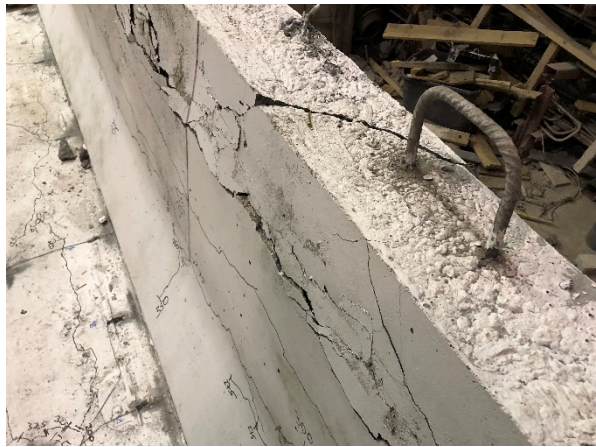
j) Local punching shear crack accompanied the first punching shear crack without extending further when attempting to increase the applied load

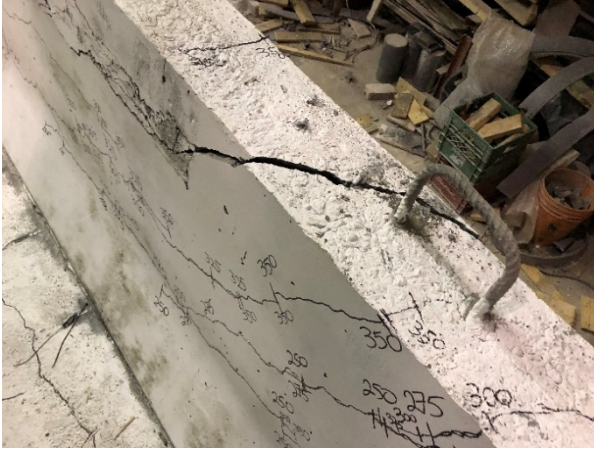
k) Second punching shear crack appeared at the north end of the loaded length when attempting to increase the applied load

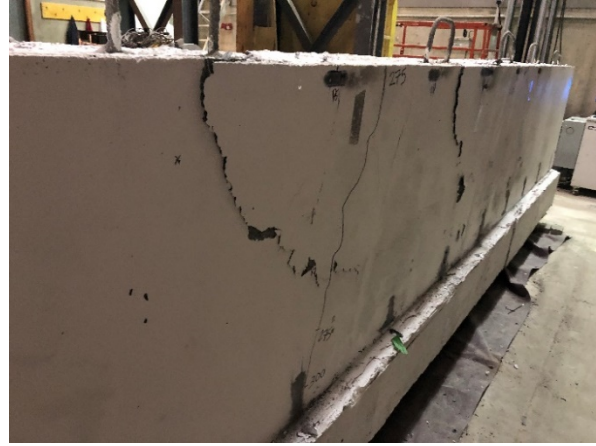
l) Punching shear cracks at beginning and end of the loaded length jointed together with signs of concrete popout when attempting to increase applied load

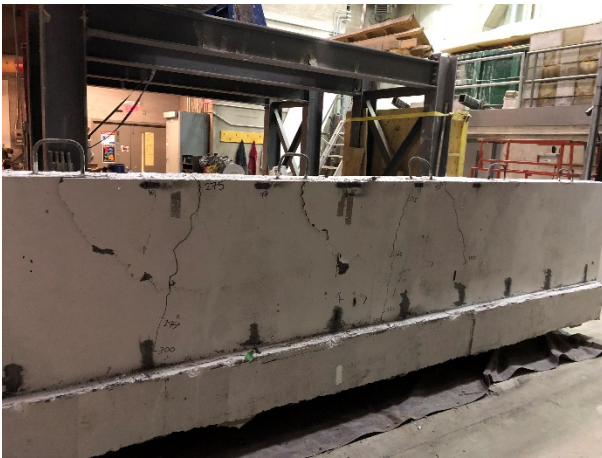
m) Slightly vertical cracks appeared within the loaded length close to failure load

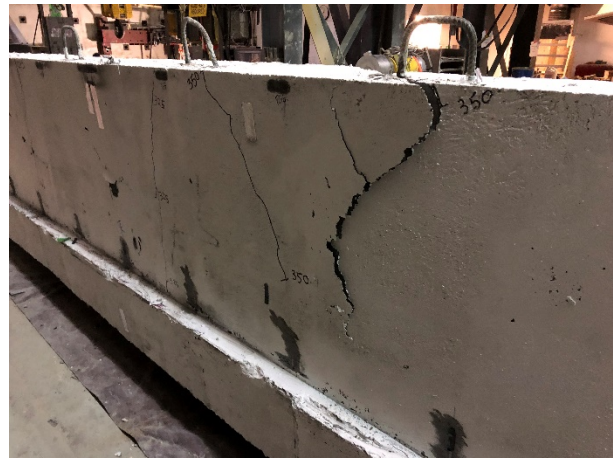
n) Punching shear crack at the south end of the loaded length

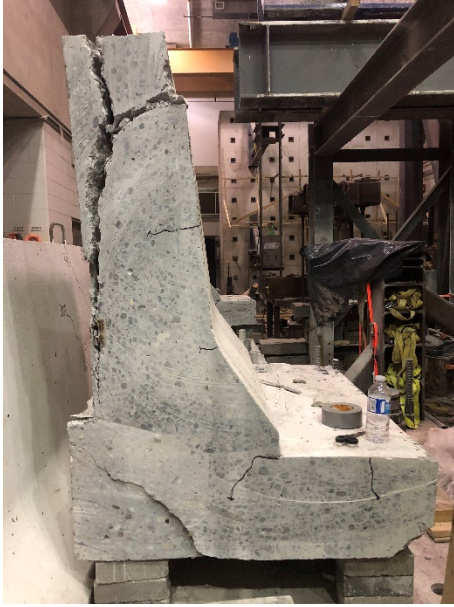
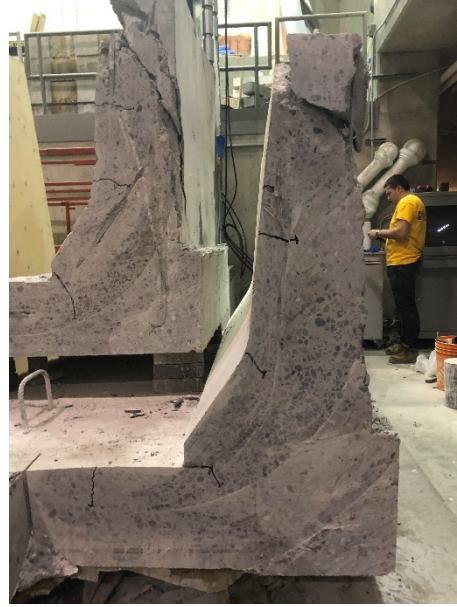
a) Saw cast at 1 m away from the centre of applied load towards the south end showing punching shear crack

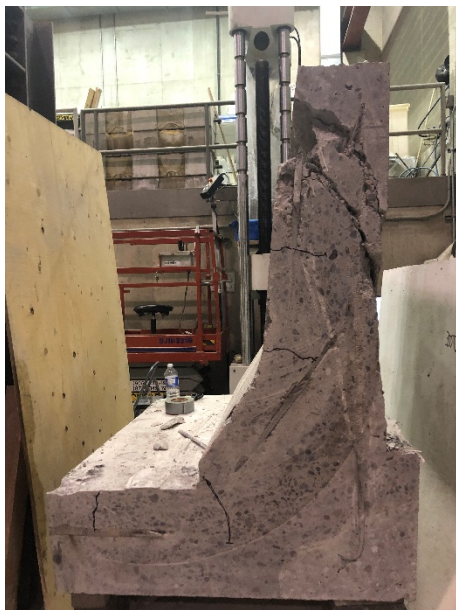
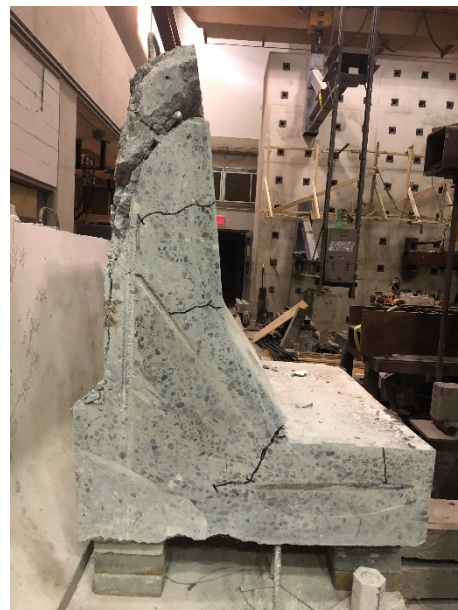
b) Saw cast at 100 mm away from the centre of applied load towards the north end showing 40° angle for the global punching shear crack while the local punching shear crack appeared on top of it in the left photo

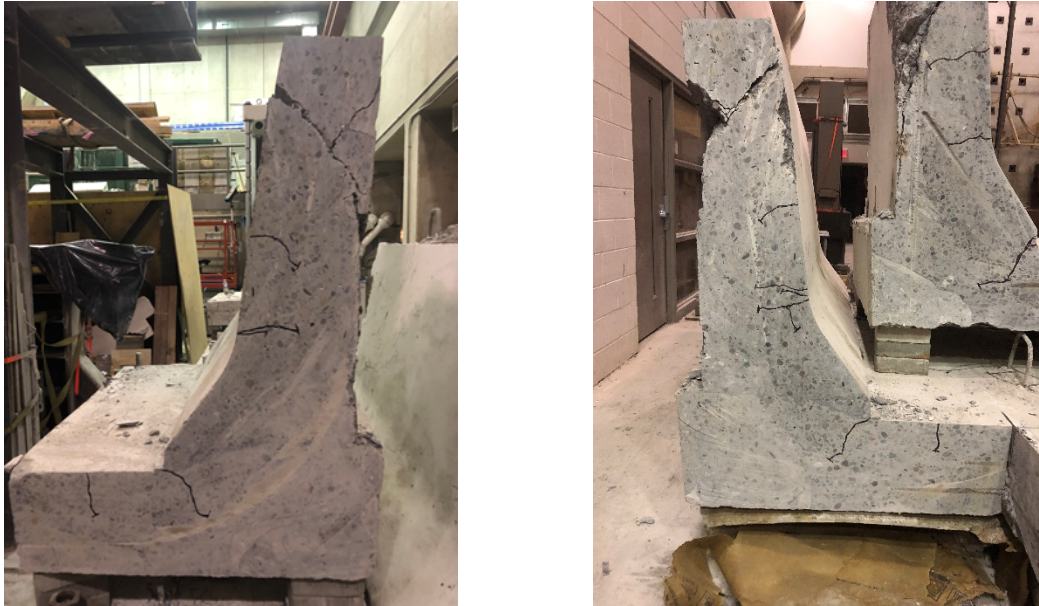
c) Saw cast at 1 m away from the centre of applied load towards the south end showing punching a  $40^\circ$  punching shear crack

Figure 4.15 Views of cracks and punching failure mode for specimen S-4 after saw-cut

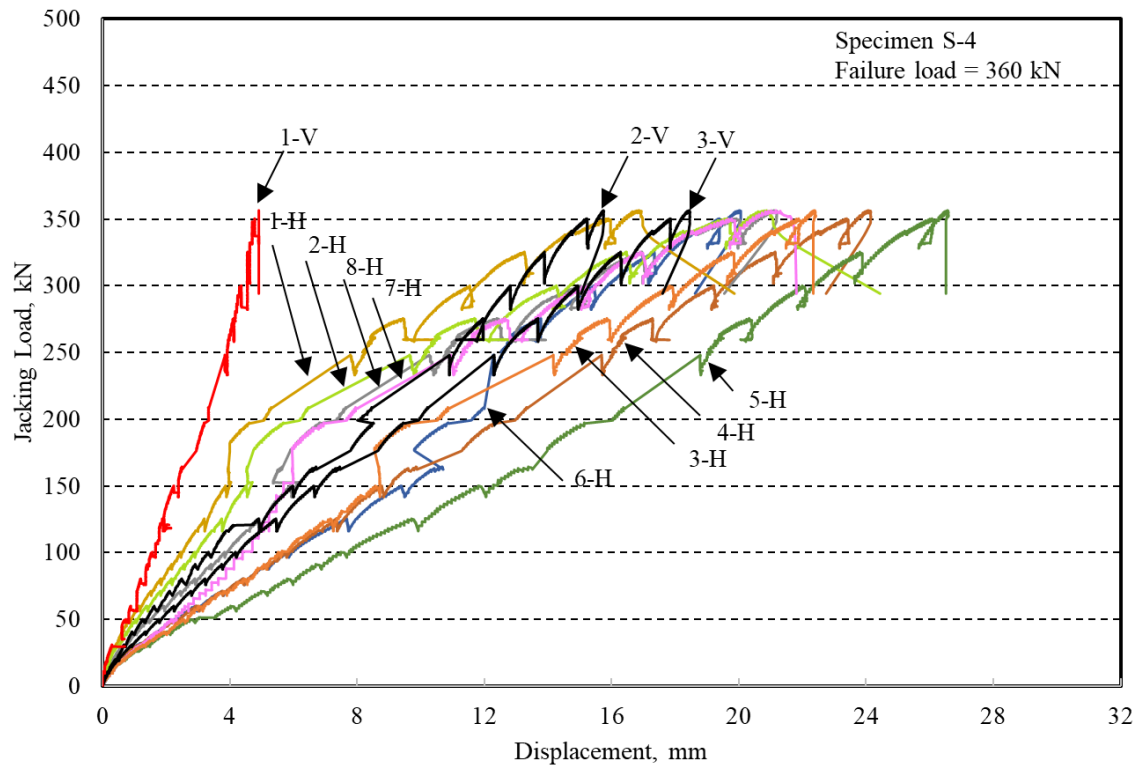
Figure 4.16 Load-deflection relationship for specimen S-4
