# **A Proposed Laboratory Method to Evaluate Durability of Concrete Pavement Joints against Freezing in the Presence of Deicer Salts**

**Ramy Elbakari and Medhat H. Shehata\***

Department of Civil Engineering, Ryerson University

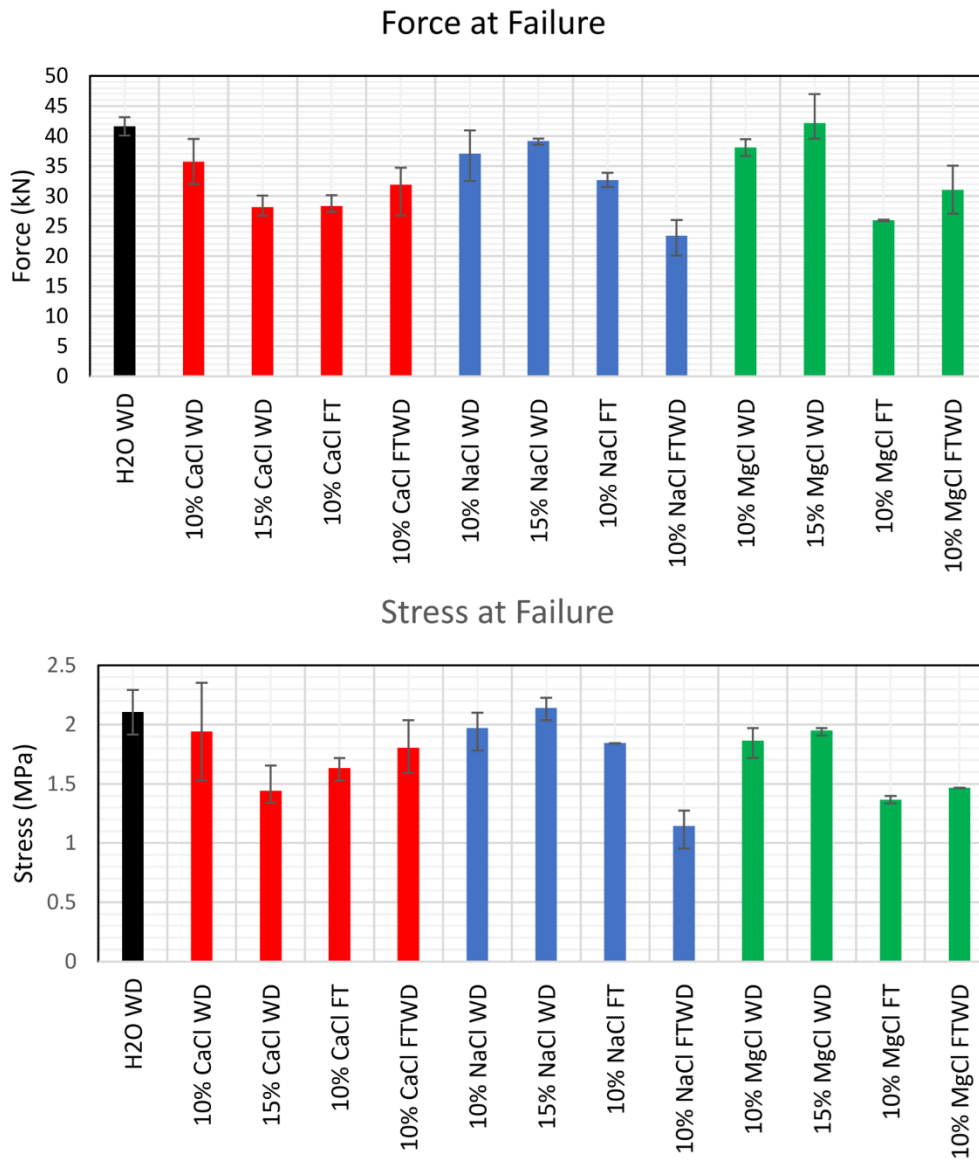
**Fig. 4.** Load at failure and stress for all exposures: (i) black: control using water in WD, (ii) red: calcium chloride, (iii) blue, sodium chloride, and (iv) green: magnesium chloride. Error bar represents min/max.

A total of fifty-one slabs were tested; eight of them failed in shear and, therefore, were excluded from the results. Fig 4 shows the stress and load at failure for samples exposed to all exposures and different salts. The results will be referred to when analyzing the results of each exposure in the coming paragraphs.

As presented in Fig. 4, both the force and stress portray similar relative performance for each exposure. As expected, the water control sample - under WD exposure - showed the highest strength. It is interesting to note the difference between the samples under wetting/drying at 10% and 15% concentrations. The strength of the 10% concentration sample under WD decreased slightly from the control sample while upholding relatively higher strength than the rest of the exposures, although this sample suffered significant visible damage, as will be shown later. The

**Fig. 4.** Load at failure and stress for all exposures: (i) black: control using water in WD, (ii) red: calcium chloride, (iii) blue, sodium chloride, and (iv) green: magnesium chloride. Error bar represents min/max.

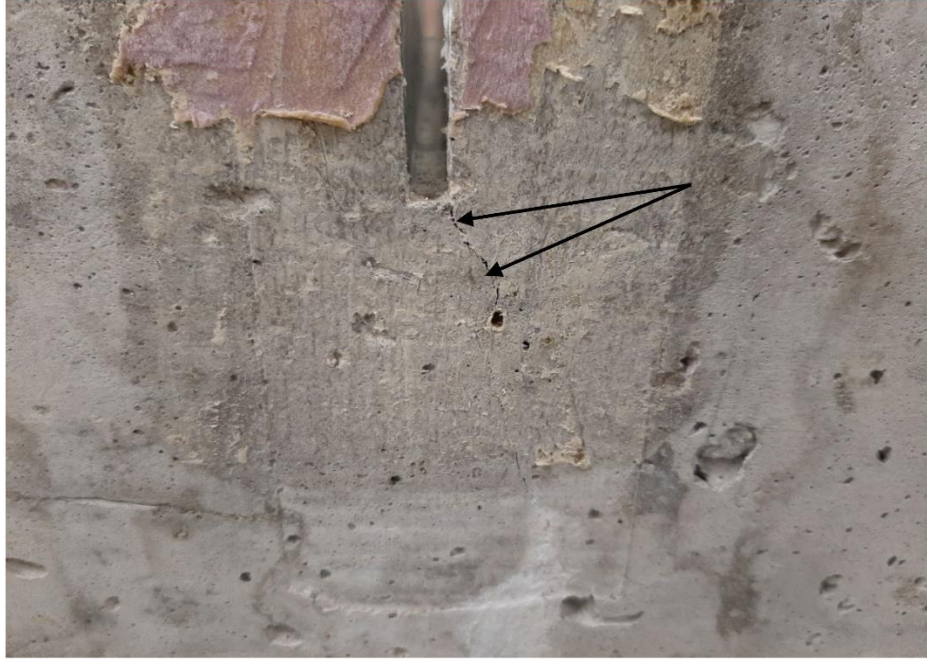
**Fig. 5.** Typical cracks developed in control samples under FT and FTW at the end of the 50 cycles

Samples tested without salts under FT and FTWD showed failure before loading. Cracks in the middle of the slabs - under the joints - were noticed at the end of the 50 cycles and prior to loading, as shown in Fig 5. It is believed that the cracks are due to the pressure resulting from ice formation in the joints themselves rather than ice formation within the pores of the concrete. Knowing that pressure produced due to freezing of salt solution is lower than that of ice formation from pure water (Valenza et al. 2005), it was thought that slabs tested under freezing/thawing in the presence of salts are unlikely to fail in the same way. This assumption was confirmed when analyzing the results of exposures with salts. Under salt exposures, the tested samples showed a considerable load before failure, while the load in the case of the cracked control samples was negligible. Moreover, the results under salt exposures showed that cycles of FTWD cause more damage than FT alone, even though FTWD cycles have only 25 cycles of freezing/thawing compared to 50 cycles in the case of FT. This observation confirms that pressure produced from ice formation in the joints did not have a role in the damage when tested with salt solutions; otherwise, samples under FT would have shown lower strength. The control sample tested under wetting/during did not fail the same way and was used as the control or baseline sample for comparison with salt exposures.

**Fig. 5.** Typical cracks developed on FT and FTW control samples at the end of the 50 cycles

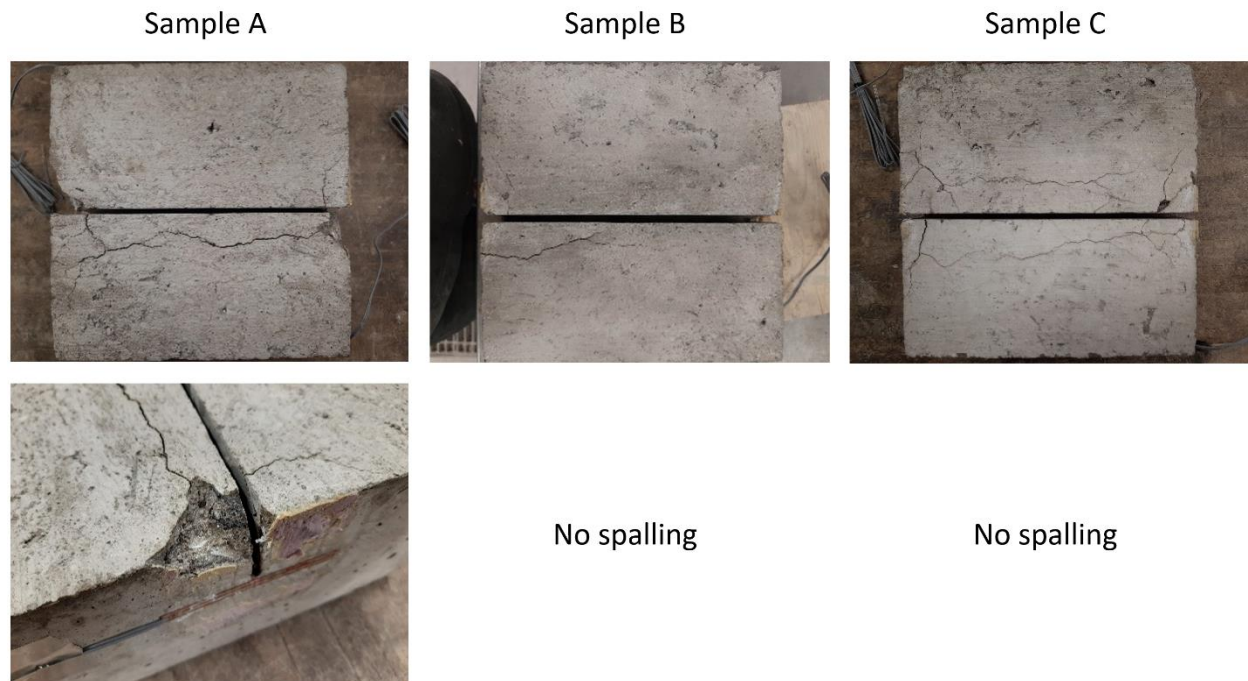
**Fig. 8.** Visual damage for 10%  $\text{CaCl}_2$  under WD

In addition to evaluating force and stress-strain curves, samples were inspected for visual damage. As observed from Fig. 7 and Fig. 8, both samples tested in WD showed higher spalling and cracking levels compared to other exposures, with the sample tested with 15% concentration showing greater damage than the one tested with 10% concentration. The other two samples, the 10%  $\text{CaCl}_2$  FTWD and 10%  $\text{CaCl}_2$  FT, showed no visual damage. Therefore, it can be concluded that the wetting and drying exposure leads to more damage than freezing/thawing, likely due to the production of calcium oxychloride evident by the cracking visible on the slabs. According to Qiao et al. (2018c) and Wang et al. (2019), higher calcium chloride concentrations and greater exposure duration lead to higher levels of calcium oxychloride production. As stated earlier, higher levels of damage were produced in the 15% WD samples, followed by the 10% WD samples, while no cracking was present in the 10% FT or FTWD. Under FTWD exposure, the sample was only exposed to 25 cycles of wet-dry; therefore, it is apparent that the number of cycles is not enough to produce sufficient levels of chemical damage or expansion that lead to surface cracking during the test duration. Consequently, it can be concluded that the plausible formation of calcium oxychloride results in critical damage at high concentrations such as 15% or higher, while the 10% concentration appears to be slower in promoting damage during 50 cycles of wetting and drying. Likely, for the oxychloride expansion inside the pores of the concrete to inflict visible damage and reflect a significant reduction in flexural strength, high quantities of the compound (oxychloride)

It is evident that in the case of calcium chloride under WD cycles, visual damage occurs before reduced strength, as reflected from the case of 10% concentration. The reason is that a reduced strength requires the salt to penetrate deeper below the joints to affect the bending test. Hence, both strength loss and visual damage assessment are required to evaluate the results.

**Fig. 8.** Visual damage for 10% WD CaCl<sub>2</sub>

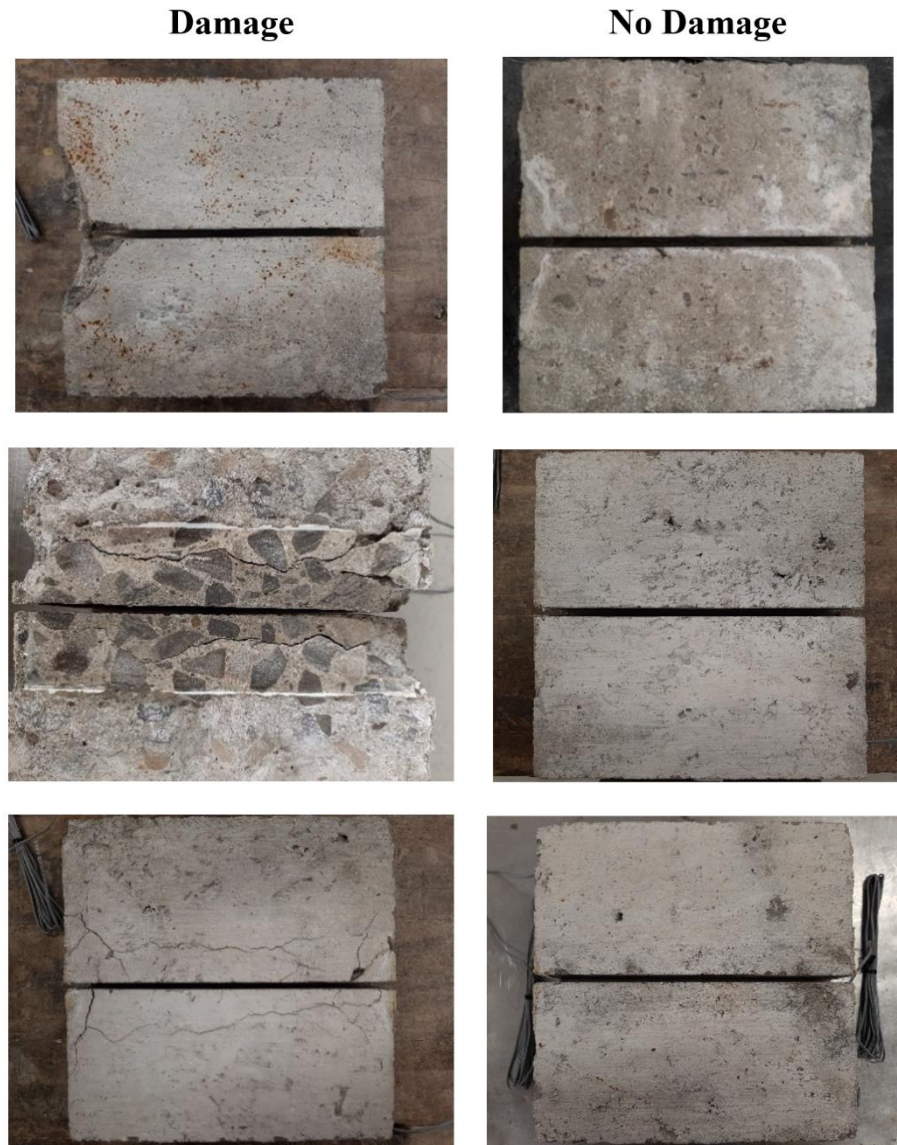
**Fig. 14.** Visual Damage Classification

The visual damage observed here was mainly in the form of spalling and cracking, similar to what was observed under field exposure (Chan et al. 2020). Based on the tested samples, a visual index of more than two steps (damaged or undamaged) could not be developed here. Also, a more detailed index covering crack width and density could not be established as it requires more testing. Based on the results, samples could be classified as damaged or no damage, as shown in Fig. 14.

**Fig. 14.** Visual Damage Classification
