BONDED-BOLTED COMBINATION REPAIR OF A
COMPOSITE FUSELAGE SECTION

A project

Aerospace Engineering

Master of Engineering, Aerospace Engineering, Ryerson University (2017)

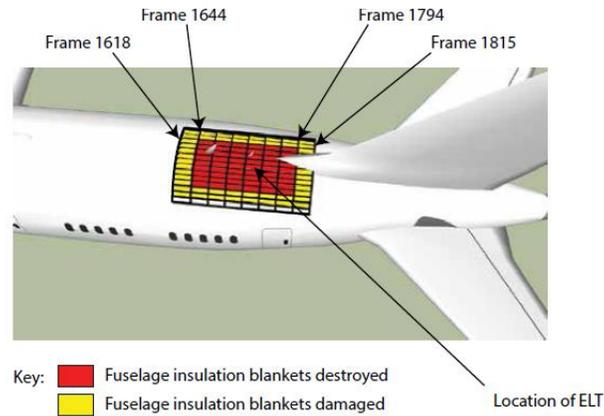
Figure 1: Damaged section of aircraft [1]

In July 2013, a Boeing B787 aircraft suffered fire damage to its rear section caused by an Emergency Locator Transmitter (ELT) battery short circuit. The damaged area was 9.5 square meters and the result was that the fuselage skin, stringers, frames, and insulation blankets in this area had been damaged or destroyed. Figure 1 provides a representation of the insulations blankets and frames in the damaged section.

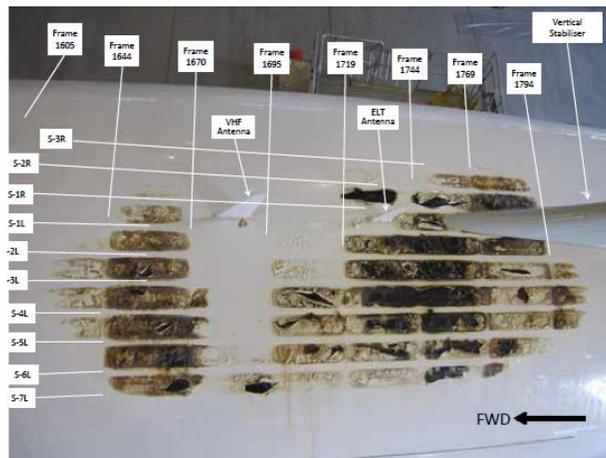
Figure 2: External skin damage [1]

Areas adjacent to the ELT suffered severe structural damage in the form of significant resin loss and ply disbonding in the fuselage skin and frames [1]. The ELT, its mounting plate, and sections of the frames to which it was attached all suffered severe thermal damage [1]. Fire damage on the skin was interior between a number of stringers and exterior in the location of the ELT as shown in Figure 2.

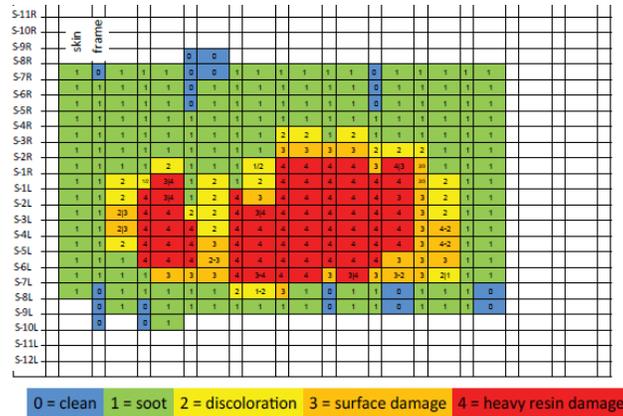
Figure 3: Plot of interior skin damage [1]

The frames and skin in the highly-damaged areas suffered an almost total resin loss. Following a visual test of the area, an ultrasonic test was performed. The ultrasonic survey identified areas of skin which had voids present or showed evidence of disbonding [1] as shown in Figure 3.

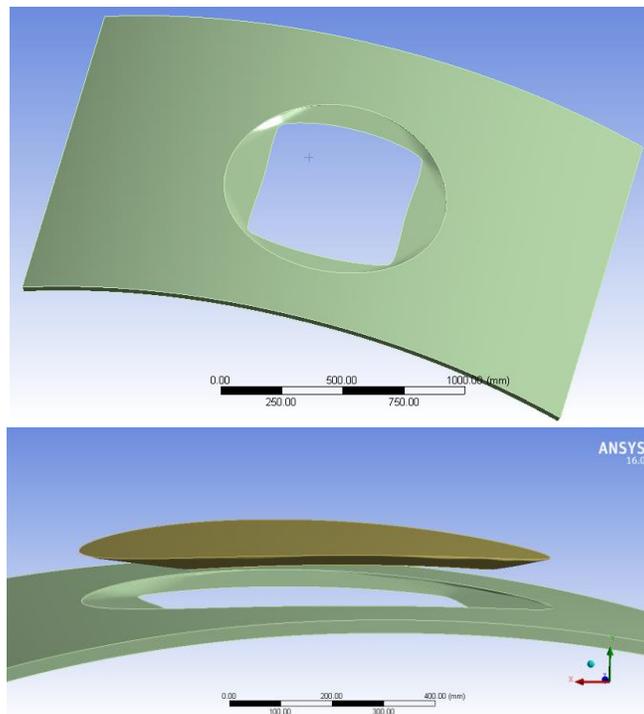
Figure 8: Repair patch

The 3 ft outer diameter patch design with an 8° flush scarf taper is as shown in Figure 8. Gama et al. (2004) noted that scarf angles between 2° to 6° were used with thin structures and researched using larger angles (11.3° and 18.4°) for thicker structures to conserve the amount of material removed during the repair process. This is a disadvantage of the scarf repair as it can require the removal of an excess amount of good material from the repair area. Increasing the scarf angle, however, causes more load to be taken by the adhesive and can ultimately result in failure of the bond in the adhesive layer.

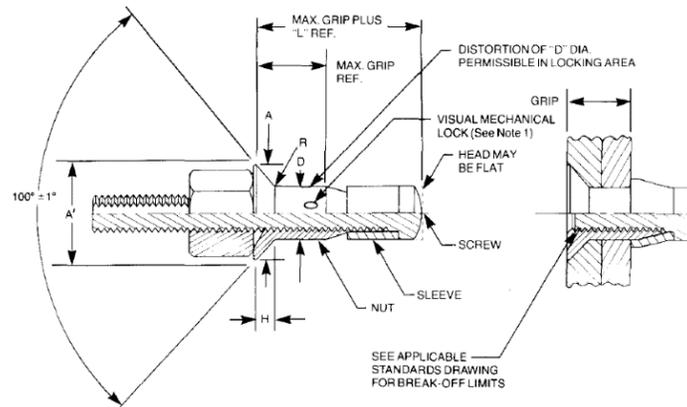
Figure 9: Visu-Lok II 100° Flush Head Series [9]

The fasteners selected for use in the bolted portion of the repair were the Visu-Lok fasteners similar to the schematic shown in Figure 9. This type of self-locking fastener consists of a preassembled nut, threaded bolt and sleeve [7]. The installation can be done by one person and can be accomplished by either hand or using power tools operating at standard air pressure levels [8].

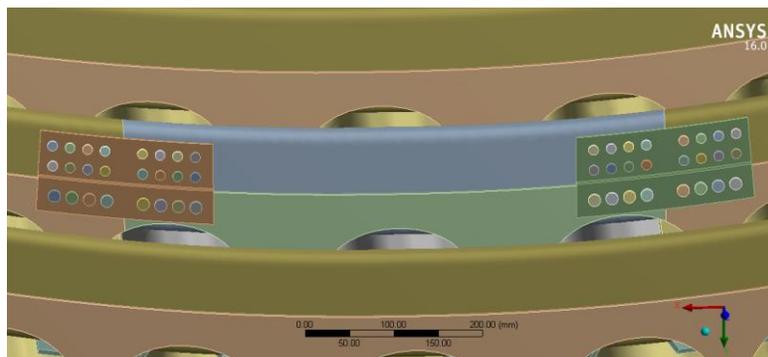
Figure 10: Bolted model design

The bolted model has three rows of eight fasteners as shown in Figure 10 all with off the shelf diameters D. The fasteners in the top two rows have a diameter of 0.2 inches while the bottom row fasteners have a diameter of 0.25 inches.

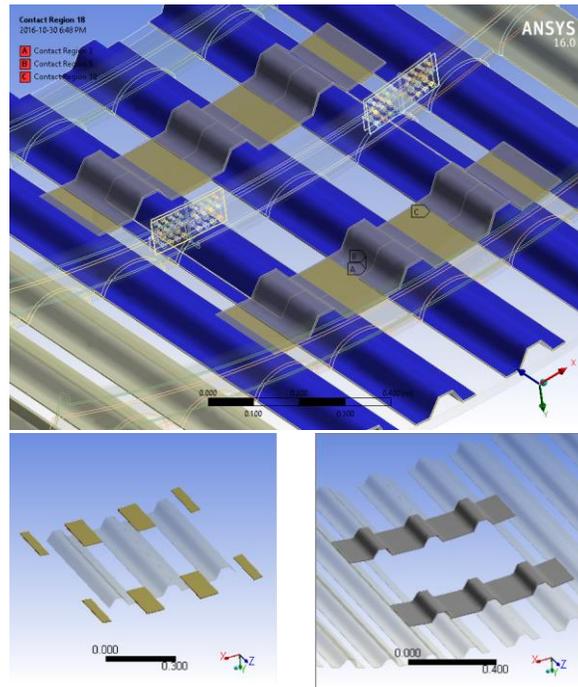
Figure 11: Composite straps a) flat b) molded straps

In an effort to reinforce the area where the patch and fuselage meet, two sets of composite straps attached to the inside of the fuselage were used in the design: flat, and molded as shown in Figure 11. The flat straps are between 85.7×100 mm and 41.2×100 mm plates while the molded straps are designed to fit over the stringers. In addition, both composite straps have the same stacking sequence as the stringers.

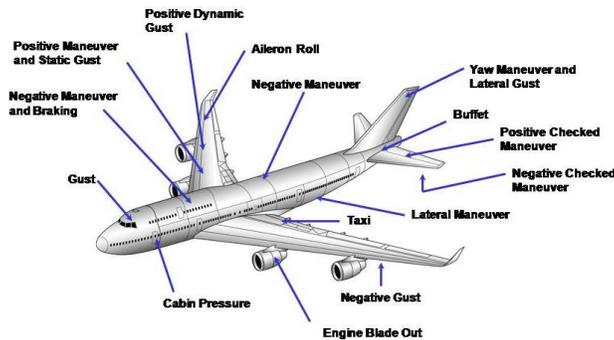
Figure 12: Important loads based on aircraft sections [11]

loads, along with fatigue loads were not considered to simplify the analysis and obtain more reliable results. Figure 12 gives an indication of how various in-flight conditions can affect certain sections of the aircraft. Due to the location of the damage, the most important loads will be those due to the pressure differential between the cabin and the outside atmosphere and the compressive loads attributed to the bending of the fuselage during flight, although the latter will not be included in this analysis. Table 1 shows the variables which were used to carry out the finite element analysis.

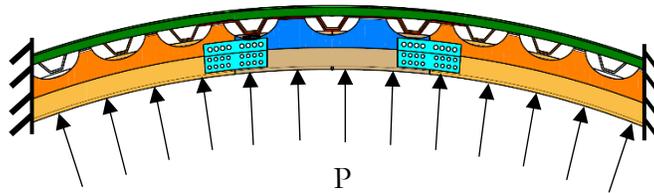
Figure 14: Model free body diagram

The composite analysis was carried out in the Ansys workbench using the composite pre-processing and mechanical model component systems and the static structural analysis systems. The model assumed for the analysis had a total of 3,317,540 solid elements and other model information can be found in Appendix A. A free body diagram of the model with fixed supports and applied load P is as

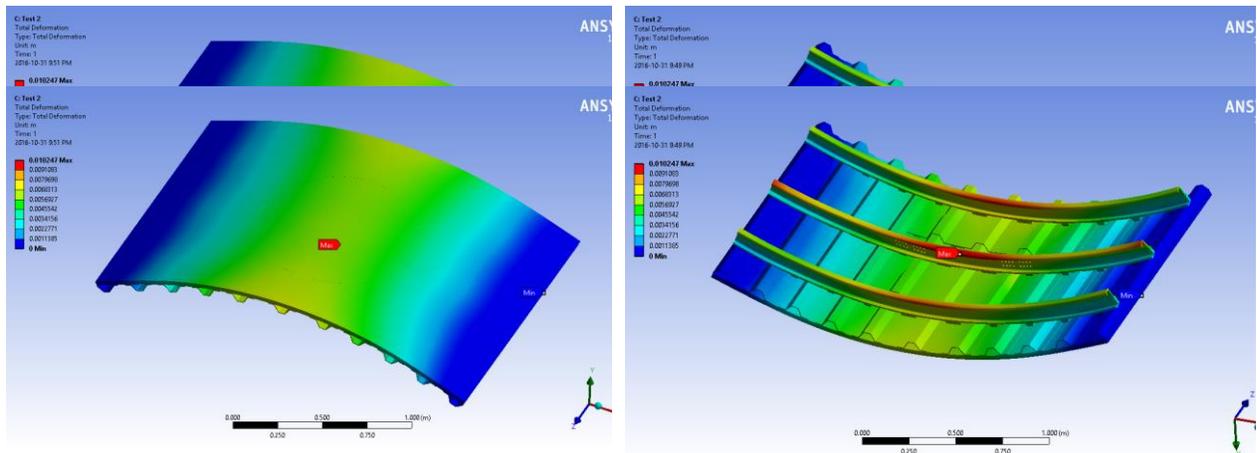
Figure 13: Deformation plot for repair section

The adhesive layer was represented by the bonded contact type definition in Ansys and the results of applying the load on the repair model are shown in the form of a displacement, and maximum principal stress plots as shown in Figure 13 and Figure 15 respectively.

From Figure 13, it can be seen that the greatest deformation occurs in and around the area where the damaged section has been removed. This was expected because the removal of the damaged section introduced a discontinuity to the structure which would affect the load and stress distribution. Using the principal stress distribution, shown in Figure 15, it could be inferred that the use of the bonded repair did not introduce a huge stress discontinuity in the damaged region. Figure 16 and Figure 17 show the deformation and stress plots for an undamaged fuselage section. Comparing the deformation plots for the repaired and undamaged section, it can be seen that the maximum deformation of the undamaged section is greater than that of the repaired section, almost 1.8 times more. However, comparing the deformation of the undamaged and repaired skin of the two models, it was found that these were very similar.

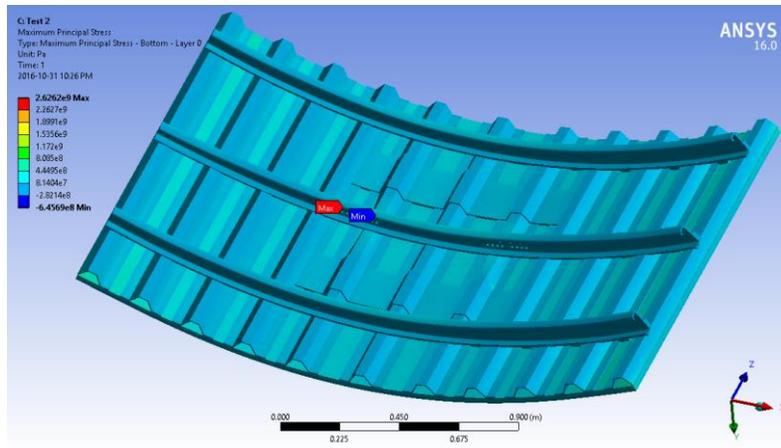
Figure 15: Maximum principal stress plot for repair section

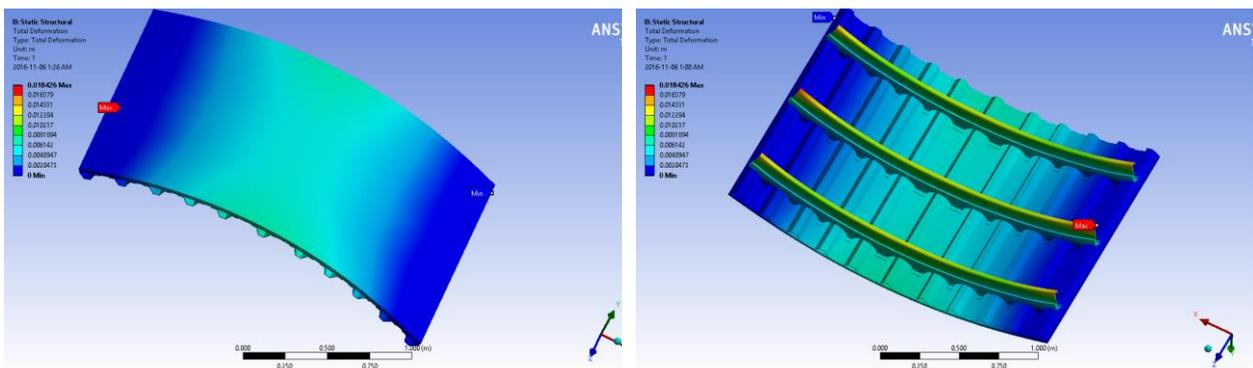
Figure 16: Deformation in an undamaged section

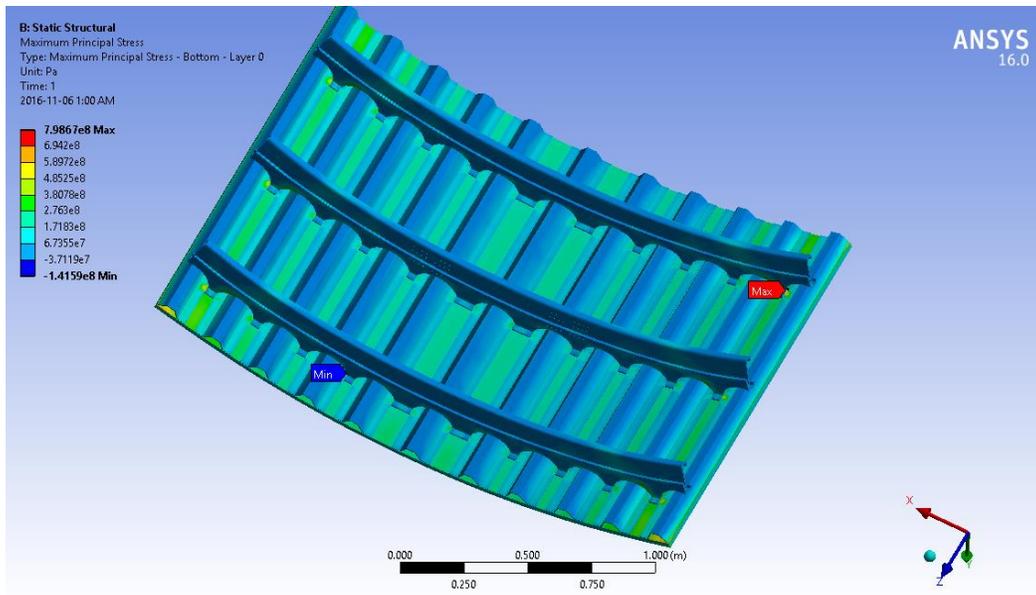
Figure 17: Maximum principal stress plot for an undamaged section

Comparing the principal stress plots for the damaged and undamaged sections, it can be seen that the maximum stress in the undamaged section is over three times as much as that in the repaired section. The results indicate that the overall stiffness of the model increased with the application of the bonded bolted combination repair.

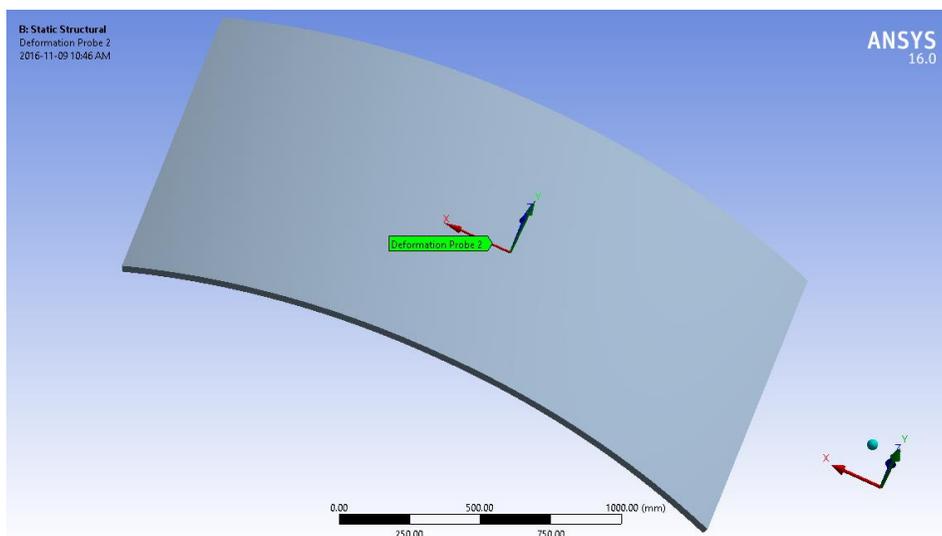
Figure 18: Central node on element for patch test

This test can be used to determine if the elements can represent rigid body motion and a constant state of strain [14] by applying boundary displacements. The process involved applying an arbitrary displacement of $x = 10\text{mm}$ to the nodes on the boundary of the element while keeping the displacements in the other directions (x and z), and the forces as zero. To pass the test, the computed x - and z - displacements along with the strains at the node located as shown in Figure 18 had to be zero. Sample results from the test are shown in Figure 2 and it can be seen that the element passed the displacement test

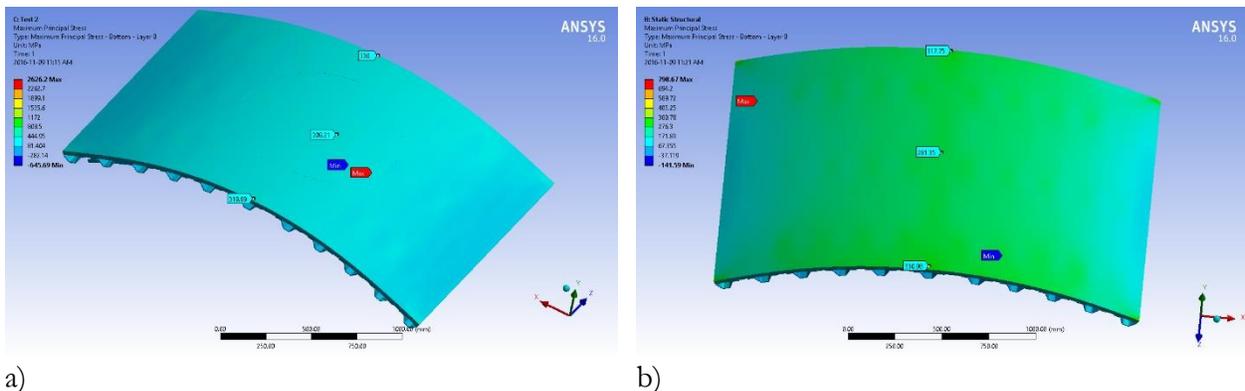
Figure 19: Principal stress plots with centrally placed stress probes (a) repaired section (b) undamaged section

A closer look at the stress and displacement probes placed centrally on the fuselage skin gives a clearer picture of the results from the analysis. Figure 19 shows the principal stress plot comparisons. The deformation and principal stress in the damaged region increased by approximately 10% when compared to the undamaged region. One of the advantages of the bonded repair is that the stacking sequences and materials of the repair can be chosen to match that of the parent structure materials. This is intended to reduce the discontinuity in properties between the parent structure materials and repair patch and could be one of the reasons for this small change in the properties. It may also be possible to reduce further the difference in deformation and stress by reducing the scarf angle of the repair but this would also require the removal of more undamaged material from the structure. One assumption made during the model definition was that the contact between the patch and the parent structure was bonded. This meant that the contacting surfaces were assumed to be glued together in the program during the analysis. It must be noted, however, that the stacking sequence of composite adherends may influence the scarf joint strength and stress resulting in non-uniform stress and shear distribution. The use of a bonded contact type does not account for this variation in the strength and stress and therefore represents a simplification of the joint.

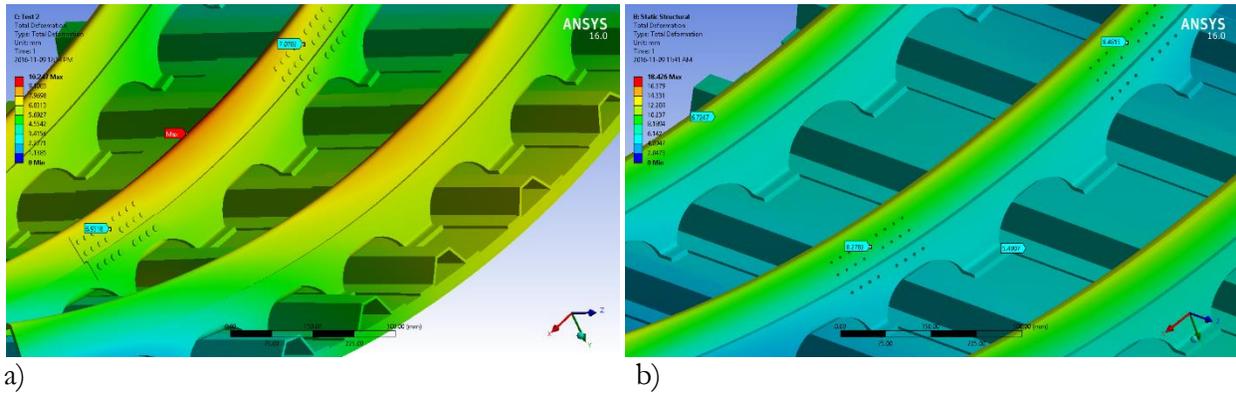
Figure 20: Deformation plots with probes at the bolted repair interface (a) repaired section (b) undamaged section

A look at the inside of the fuselage at the interface between the bolted titanium straps, the repair frame, and the parent structure indicated that there was also a 16% reduction in the deformation in the repair and a 2.5 times increase in the maximum principal stress as compared to the undamaged structure. Unlike with the bonded portion of the repair, there is a greater discrepancy between the material properties in the bolted repair region due to presence of both metal and composite materials. This could mean that the bolted repair region is less ductile than that of the bonded region which would explain the reduction in the deformation and the corresponding increase in the stress. In addition, the presence

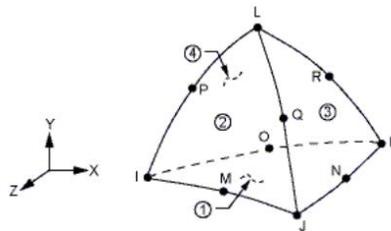
Figure 21: SOLID187 element type [15]

The SOLID187 element type (see Figure 21) is a higher order 3D, 10-node element [15]. This element type has a quadratic displacement behaviour and features 3 degrees of freedom at each node. In addition, it also has plasticity, hyper-elasticity, creep, stress stiffening, large deflection, large strain, and mixed formulation capabilities for simulating deformations of nearly incompressible elastoplastic materials and fully incompressible materials [15].
