# **Experimental investigation on repair and self-healing of tension-induced cracks in reinforced concrete panels**

A Thesis

presented to Ryerson University

in partial fulfillment of the requirements for the degree of  
Master of Applied Science in the program of Civil Engineering

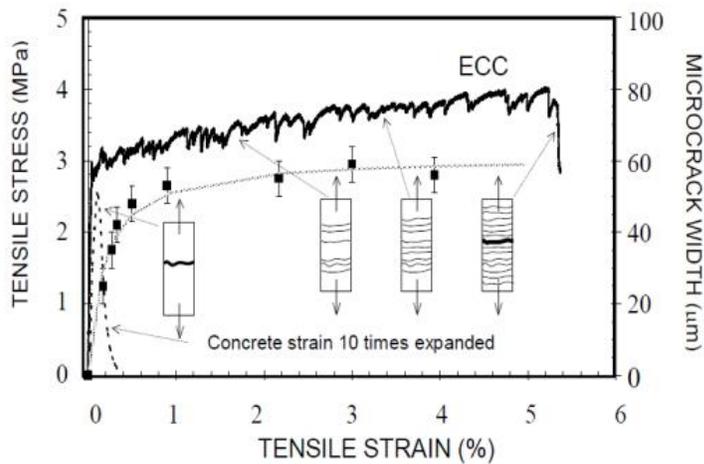
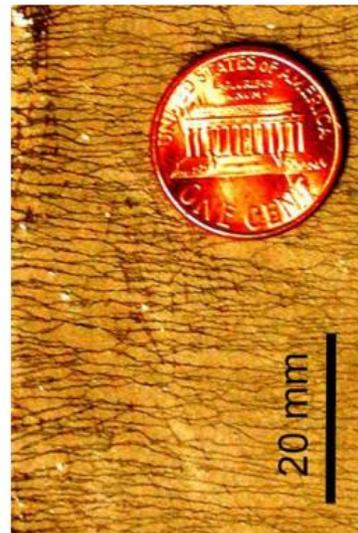
Figure 2-1: ECC mechanical properties a) Typical uniaxial stress-strain curve b) Crack width development (Weimann and Li, 2003)

Strain hardening, defined as the ability of the mix to keep carrying the load even after the formation of the first crack, and usually found in ductile metals such as steel, can be achieved in ECC by incorporating of relatively low content of 2% by volume of PVA fiber. Figure 2-1 illustrates a typical uniaxial tensile stress-strain curve with high strain capacity of around 5%. ECC shows high tensile ductility, strain hardening behavior, as well as strain capacity up to several hundred times of normal concrete. Crack width in ECC remains below 80  $\mu\text{m}$  even at ultimate load. Micro cracking behavior of the ECC is independent of the type of loading and fiber content (Özbay et al., 2013; Yeganeh, 2013; Li, 2019).

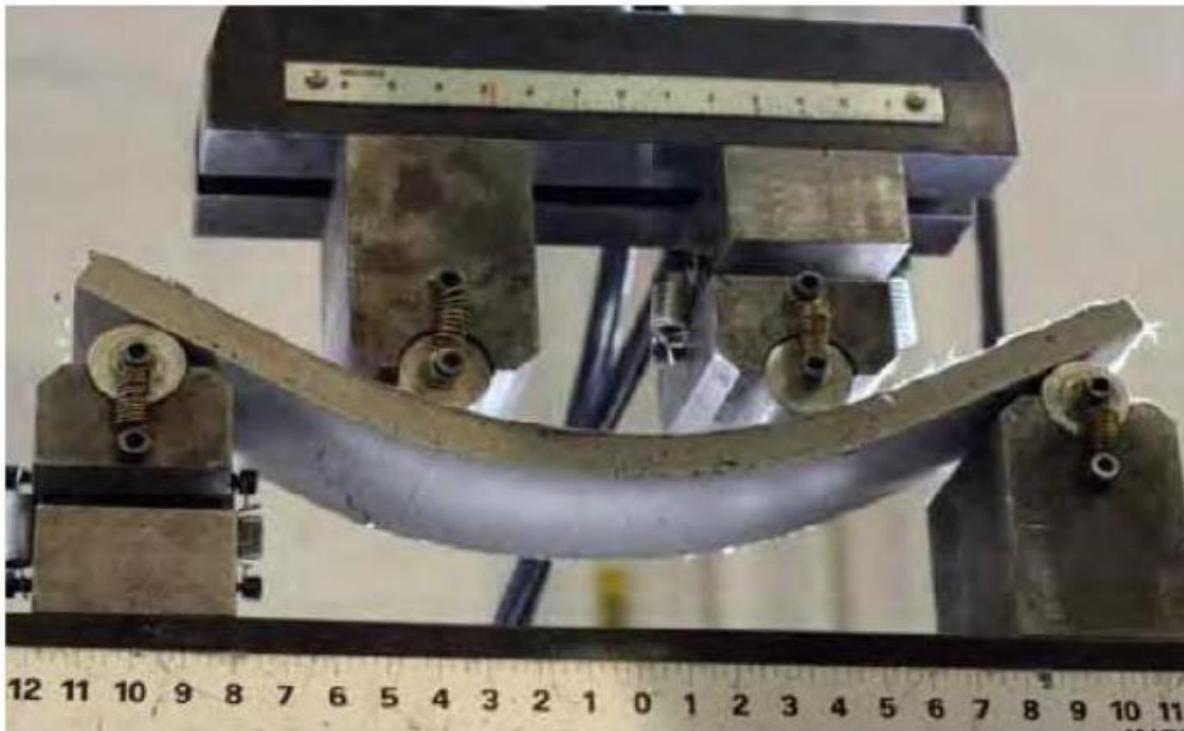
Figure 2-2: ECC beam behavior under flexural loading (Li, 2011)

Under flexural loading, the ECC beam behaves the same as a ductile metal in its plastic range of deformation, which is shown in Figure 2-2. Moreover, ECC behavior in compression is similar to a high strength concrete reaching around 60 MPa (Lepech and Li, 2008; Li, 2019).

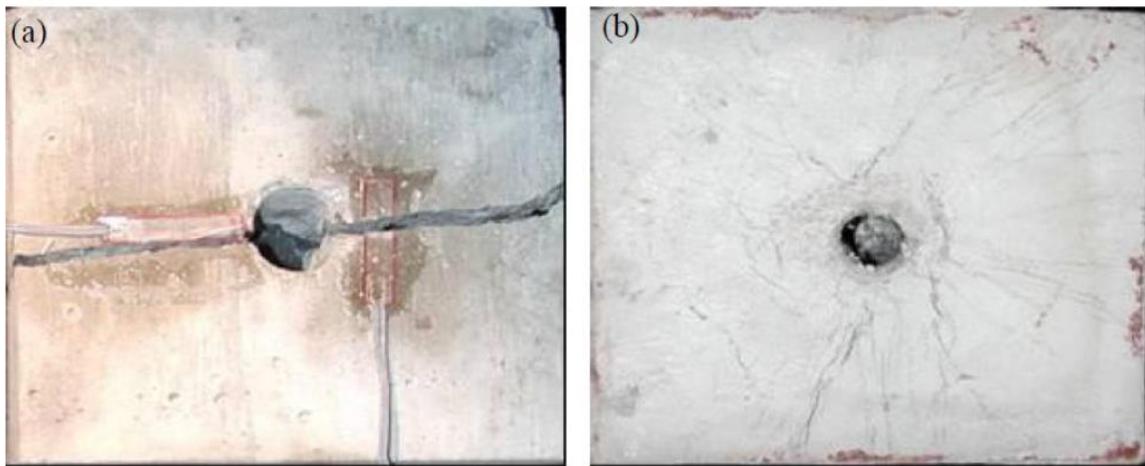
a) NC

b) ECC

Figure 2-3: Failure modes of the specimens a) NC b) ECC  
(Sahmaran and Li, 2010; Mavani, 2012)

corrodes, the rust forms on top of the rebar occupies a bigger volume causing a tensile circumferential stress state (hoop stress) on the concrete cover. More rebar corrosion and rust formation results in applying higher tensile stress on the concrete cover and eventually exceeding the tensile strength of the concrete which leads to cracking, propagation of the crack, and concrete spalling. Kanda et al. (2003) and Miyazato and Hiraishi (2005) investigated the spalling resistance by pushing a tapered steel into a hole in ECC and NC slabs. Effort has been made to simulate the tensile circumferential stress on the concrete generated by corroded rebar (rebar + rust). Based on the results, ECC experienced a ductile failure mode by formation of radial micro-cracks, while NC slabs failed in brittle nature by formation and propagation of one or several major cracks. At the same compressive strength level, ECC slabs tolerated significantly higher loads (30 kN) compared to NC sample (7 kN). Failure modes of ECC and NC slabs are illustrated in Figure 2-3.

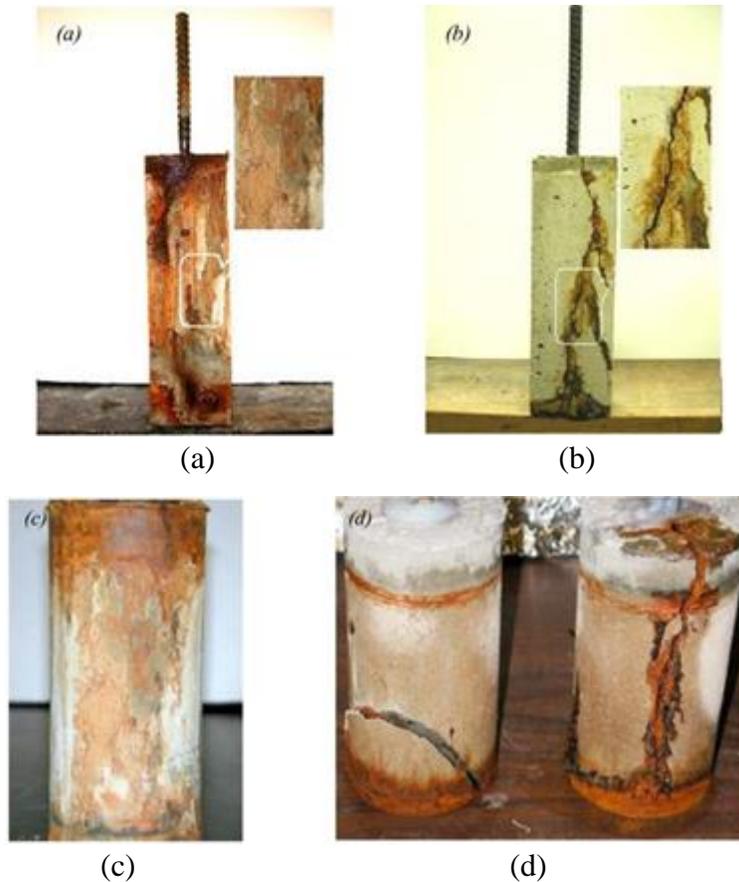
Figure 2-5: Reinforced ECC and mortar samples after exposure to accelerated corrosion: (a): R/ECC prisms after 300 hours of accelerated corrosion, (b): R/mortar prisms after 75 hours of accelerated corrosion, (c): R/ECC cylinder samples after 350 hours of accelerated corrosion, (d): R/mortar cylinder samples after 95 hours of accelerated corrosion (Sahmaran et al., 2008; Mavani, 2012)

micro-cracking behavior of ECC resulted in a large number of cracks along with crack width up to 0.1 mm at higher levels of corrosion. Moreover, R/ECC specimens recovered almost 100% of the initial flexural capacity after 50 hours of accelerated corrosion. R/ECC samples showed 55% reduction in flexural capacity after 300 hours of accelerated corrosion. Figure 2-5 illustrates the R/ECC and R/mortar prisms and cylinders after various times of exposure to chloride solution.

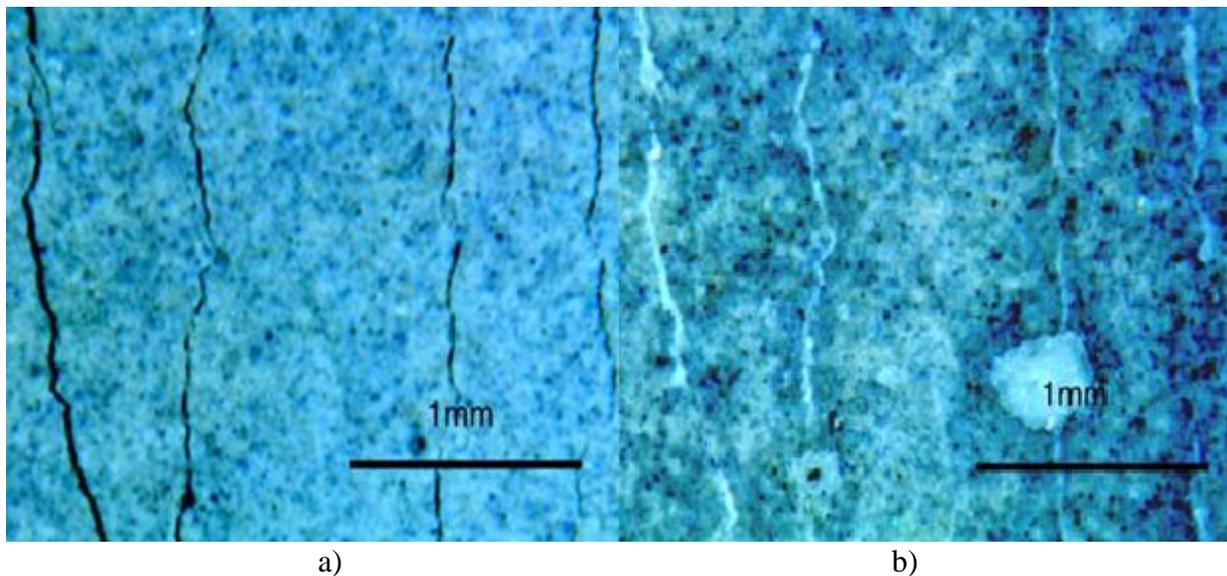
Figure 2-6: Self-healing of micro-cracks in ECC specimens a) Before self-healing b) After self-healing, (Yang et al. 2009)

specimens in terms of mechanical and transport properties recovery. Two cyclic wetting and drying regimes were used in that study including one cyclic (CR1) regime to simulate outdoor environments such as rainy and uncloudy days as well as another cyclic regime (CR2) to simulate outdoor environments alternating between rainy days and days with sunshine and high temperature. Specimens with dimension of 230 mm by 76 mm by 13 mm were used in this study. ECC specimens were preloaded up to various uniaxial tensile strain levels from 0.35 to 3% at the age of 6 months. In the next step, specimens were exposed to ten wetting and drying cycles. It was found that limiting the crack width below 0.15 mm in cementitious materials was of prime importance to achieve high levels of self-healing. It was observed by Yang et al. (2009) that ECC cracked specimens retained 76% to 100% of their original resonant frequency value and achieved a considerable rebound in stiffness. The study confirmed great self-healing potential of ECC in exposure to wetting and drying cycles, as illustrated in Figure 2-6.

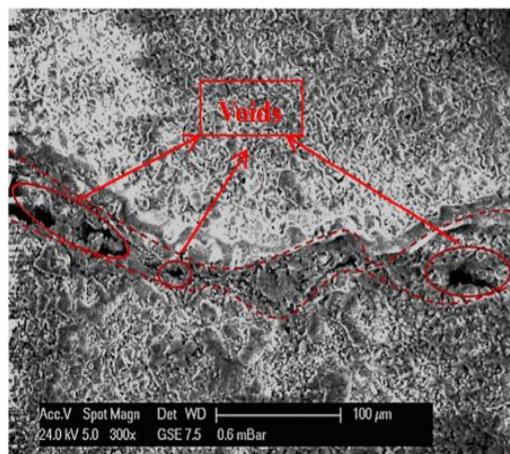
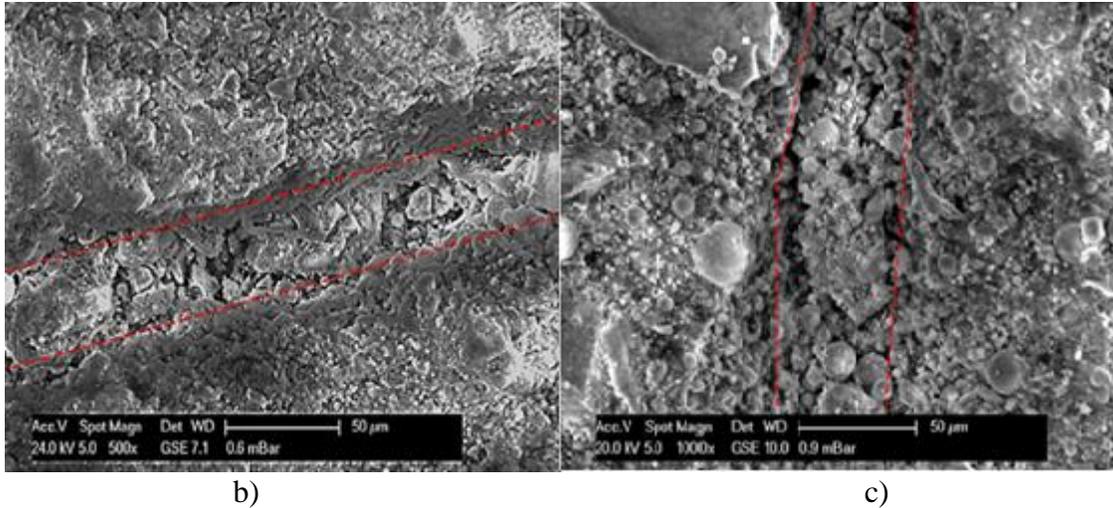
Figure 2-7: Self-healing products within the crack exposed to a) 20 ° C water b) 60 ° C water c) Saturated calcium hydroxide solution  $\text{Ca}(\text{OH})_2$ , (Zhang and Zhang, 2017)

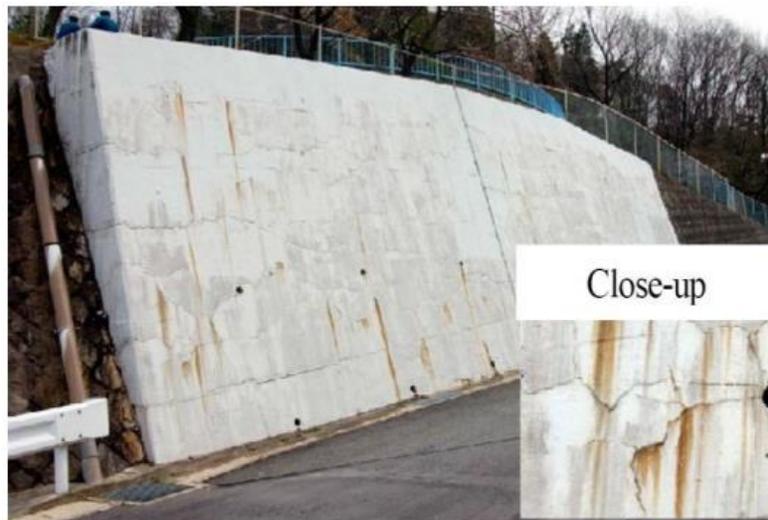
Figure 2-8: Deterioration due to Alkali-silica reaction (ASR) in a gravity retaining wall in Gifu, Japan (Rokugo et al., 2005; Yeganeh, 2013)

Applicability of ECC in construction and repair of real-world full-scale structures are briefly emphasized in this part. Figure 2-8 shows a gravity retaining wall in Gifu, Japan with approximate dimensions of 18 m width and 5 m height, which was built in 1970s and experienced deterioration due to alkali silica reaction (ASR) (Rokugo et al., 2005).

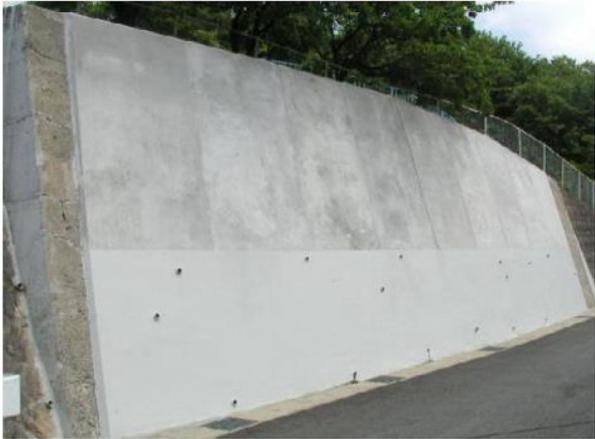
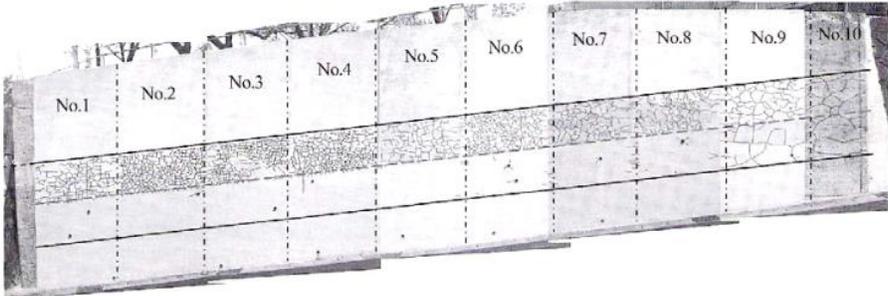
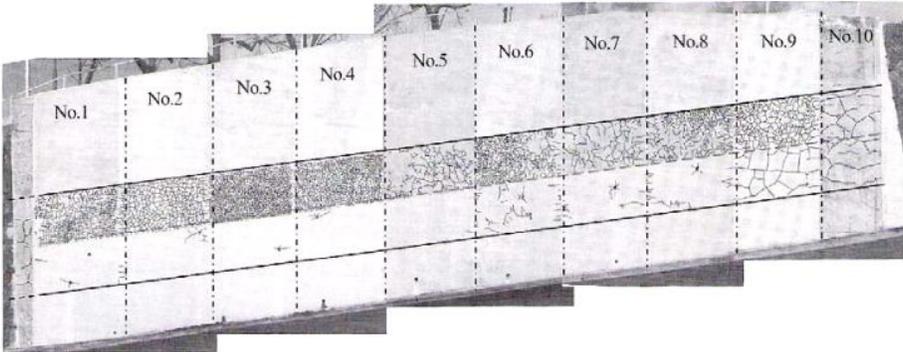
Figure 2-9: Repair of a gravity retaining wall using ECC (a) Condition of the wall after the repair program (b) Cracking behavior of the wall after the repair at 12 months (c) Cracking behavior of the wall after the repair at 24 months (Rokugo et al., 2005)

However, blocks repaired with NC experienced crack widths of  $200\ \mu\text{m}$  and  $300\ \mu\text{m}$  at 10 and 24 months, respectively. Figure 2-9 illustrates the cracking behavior and condition of the wall after the repair using ECC and NC after 12 and 24 months. Blocks 1-8 were repaired using ECC, block 9 using NC, and block 10 without repair.

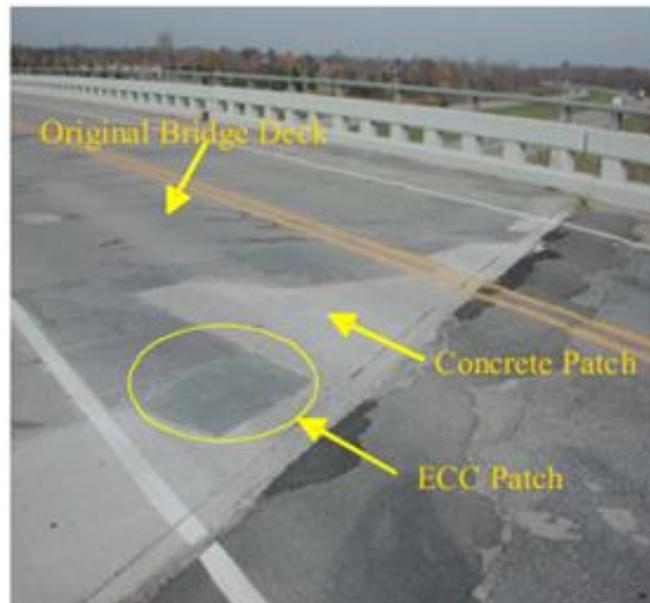
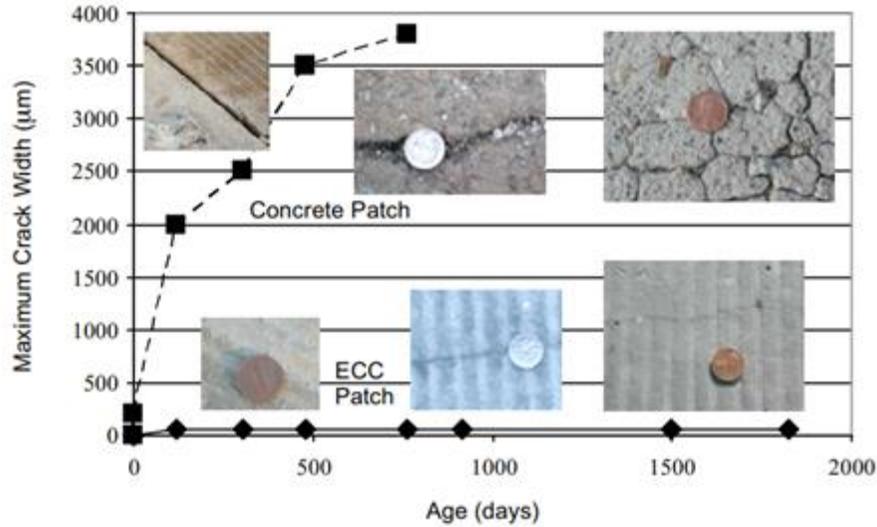
Figure 2-10: ECC repair application (a) Patch repair of bridge deck of the Curtis Road over M-14 in Southern Michigan (b) Crack width development versus time in ECC and concrete repair layers (Li and Lepech, 2004; Yeganeh, 2013)

In another project, ECC was used as patch repair for the bridge deck of the Curtis Road over M-14 in Southern Michigan in 2002. A complete summary of this repair project, which was performed in cooperation with the Michigan Department of Transportation (MDOT), has been presented by Li and Lepech (2004). In this project, two types of materials were used, including ECC and a concrete patching material commonly used by MDOT, and performances were compared under the same loading and environmental conditions (Figure 2-10a). A large number of heavily loaded 11 axle trucks travel on this road. After observing the crack width on the repaired bridge for more than 6 Michigan Winter freeze thaw cycles. The performances of ECC and concrete repair layers is illustrated in Figure 2-10b. It was found that ECC repaired layer showed micro-cracking behavior with crack width limited to  $30\ \mu\text{m}$  under combined loading and environmental condition, while concrete repair layer experienced cracks as wide as 3.8 mm at 780 days after the repair.

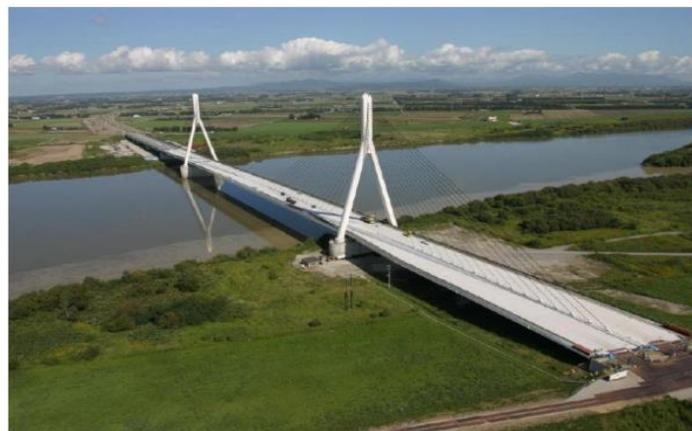
Figure 2-11: Mihara Bridge in Hokkaido, Japan (Mitamura et al., 2005)

The next real-life application of ECC was for Mihara Bridge in Hokkaido, Japan with a bridge length of 972 m and central span of 340 m, as shown in Figure 2-11 (Mitamura et al., 2005). In this project, which was performed in 2004, half of the asphalt overlay was replaced by ECC layer with 40 mm thickness. The project required 800 m<sup>3</sup> of ECC and the bridge was opened to traffic in 2005. Using ECC/steel deck composite section along with micro-cracking behavior and high tensile ductility of ECC resulted in improving the structural performance of the deck, reducing the weight and materials by 40%, as well as elimination of the expansion joints.

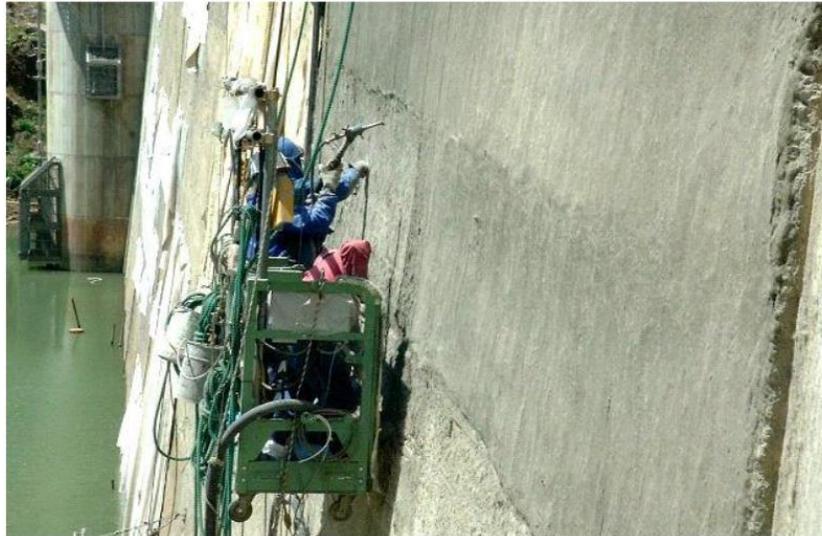
Figure 2-12: Water-proofing of Mitaka Dam in Hiroshima-Prefecture, Japan in 2003 by spraying ECC repair layer (Kojima et al., 2004)

Another repair project performed in full-scale using ECC was the repair of Mitaka Dam in Hiroshima-Prefecture, Japan in 2003 (Kojima et al., 2004). Mitaka dam, which is an over 60-year old structure, was suffering from different modes of deterioration including cracking and concrete spalling resulted in leakage of water. In this repair project a 20 mm layer of ECC was used to be sprayed directly over a 600  $m^2$  of the dam surface, as illustrated in Figure 2-12.

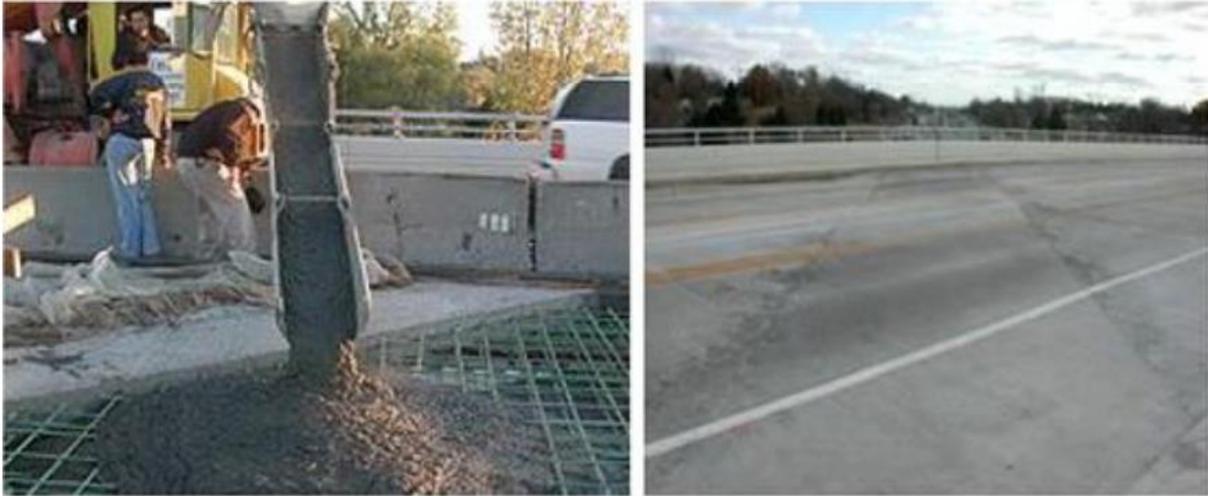
Figure 2-13: ECC link slab of Grove Street Bridge, Michigan, USA a) ECC casting b) Finished surface (Qian et al., 2009)

Another field application of ECC is in the construction of the bridge link slab. Figure 2-13 shows the casting the link slab of the Grove Street Bridge in Southeast Michigan using ECC in 2005 by collaboration of MDOT. The purpose of this project was to use ECC link slab as a replacement for typical bridge deck expansion joints in simply supported multi-span bridges. A volume of around 32  $m^3$  of ECC was used in this project to be cast in place using standard ready-mix concrete trucks. By benefiting from superior mechanical performance of ECC including high ductility and tensile strain capacity of above 2%, ECC link slabs can successfully tolerate thermal deformation of adjacent spans in a multi-span bridge. Therefore, it can be used as an appropriate choice for traditional bridge expansion joints.

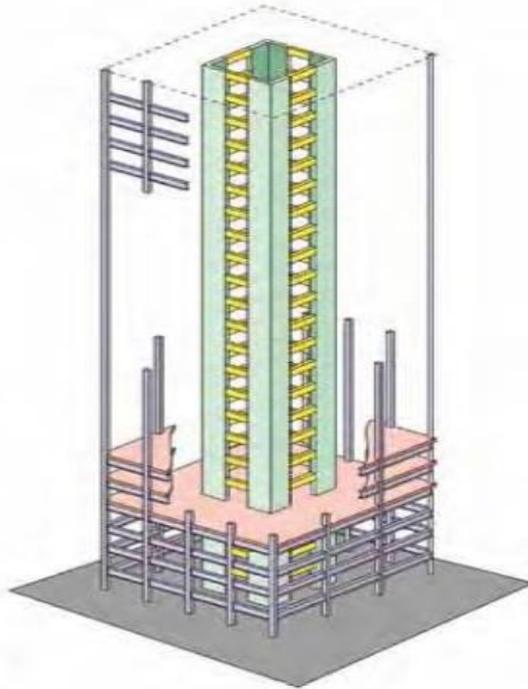
Figure 2-14: Schematic of using ECC coupling beams (in yellow) in high-rise buildings (Maruta et al., 2005; Yeganeh, 2013)

As another application of ECC in real-world structures, it was used as the coupling beams in construction of high-rise concrete structures. (Maruta et al., 2005). A coupling beam is an element connecting two core walls in high-rise buildings. Use of a ductile material with high levels of energy absorption such as ECC can be very advantageous as a coupling beam in high-rise buildings, especially in zones with high seismic risk. Precast ECC coupling beams have been used in building core for seismic resistance in 41-story Nabeaure and Glorio Roppongiin Yokohoma towers in Yokohoma, Japan (four coupling beams per floor), as shown schematically in Figure 2-14 (Yeganeh, 2013).

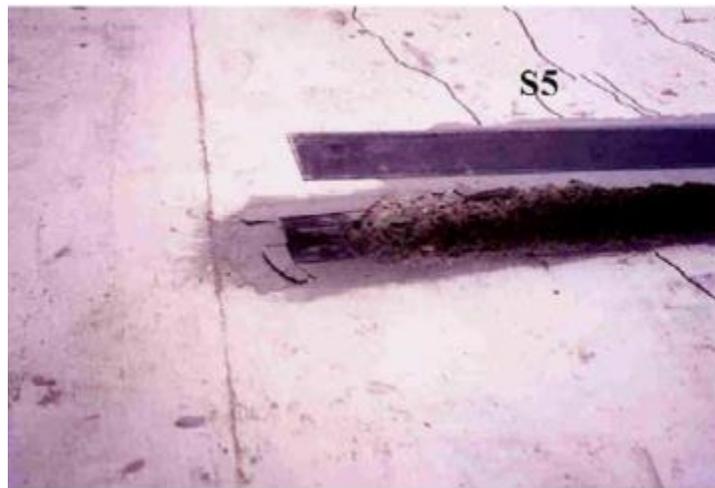
Figure 2-15: Premature failure due to CFRP strip peeling (Thanoon et al., 2005)

slab. Specimens repaired with cement grout, epoxy injection, and ferrocement layer recovered capacity of the cracked RC slab and showed similar behavior as the control sample in terms of strength and ductility. However, RC slabs repaired with CFRP strip and section enlargement improved the structural strength by 77% and 130%, respectively, while showed lower levels of ductility compared to the control sample. It is interesting to note that premature failure due to peeling of CFRP strip was observed followed by a sudden failure, as shown in Figure 2-15. This indicated the premature failure of the CFRP repaired specimen which was governed by peeling of the CFRP strip rather than achieving the full capacity and failure by rupture of the CFRP strip.

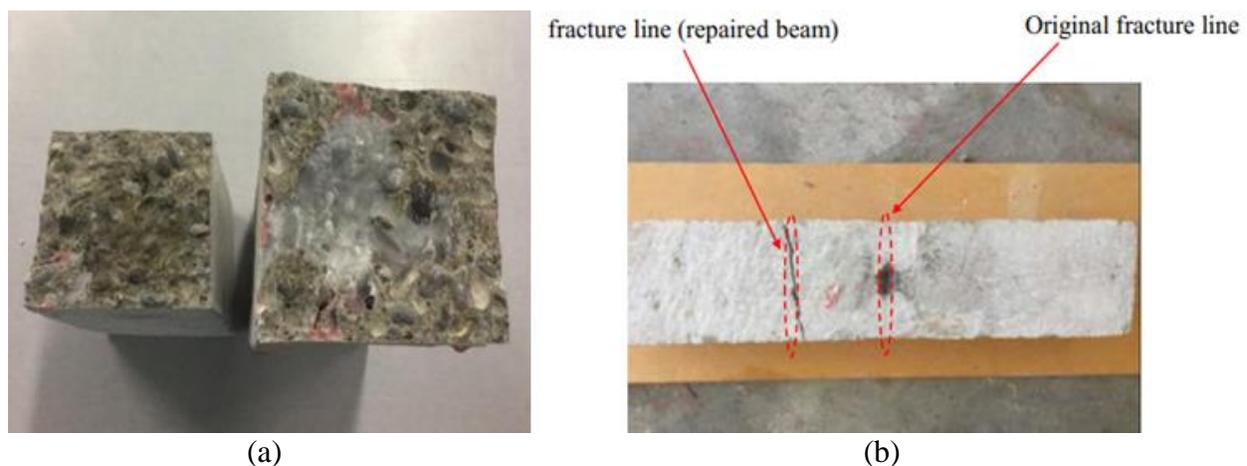
Figure 2-16: Failure of the beams repaired with epoxy a) Failure of the type 1 epoxy at original cracked section b) Failure of type 2 and type 3 epoxies at different location from original fracture line (Griffin et al., 2017)

70 MPa. Type 2 epoxy had compressive strength of 70 MPa and flexural tensile strength of 45 MPa, while the viscosity of type 2 epoxy was not reported. Type 3 epoxy had low viscosity of 145 mPas, and highest flexural tensile strength of 60 MPa and compressive strength of 75 MPa. Type 3 epoxy was applied using gravity filling method, while type 1 and type 2 epoxies were applied using low-pressure injection method. Repaired samples were tested under flexural loading until failure. It was found by Griffin et al. (2017) that failure of the beams repaired with type 1 epoxy occurred at the initial crack section, while failure in beams repaired with type 2 and type 3 epoxies occurred at a different location from the original fracture line, as shown in Figure 2-16.

It was concluded by Griffin et al. (2017) that type 2 and type 3 epoxies showed better performance by restoring the structural strength of the beams, while beams repaired type 1 epoxy achieved 71% of the failure load of the beams before repair. The study confirmed the effectiveness of epoxy in recovering the structural strength of damaged concrete members and also highlighted the importance of epoxy viscosity in a repair program using epoxy.

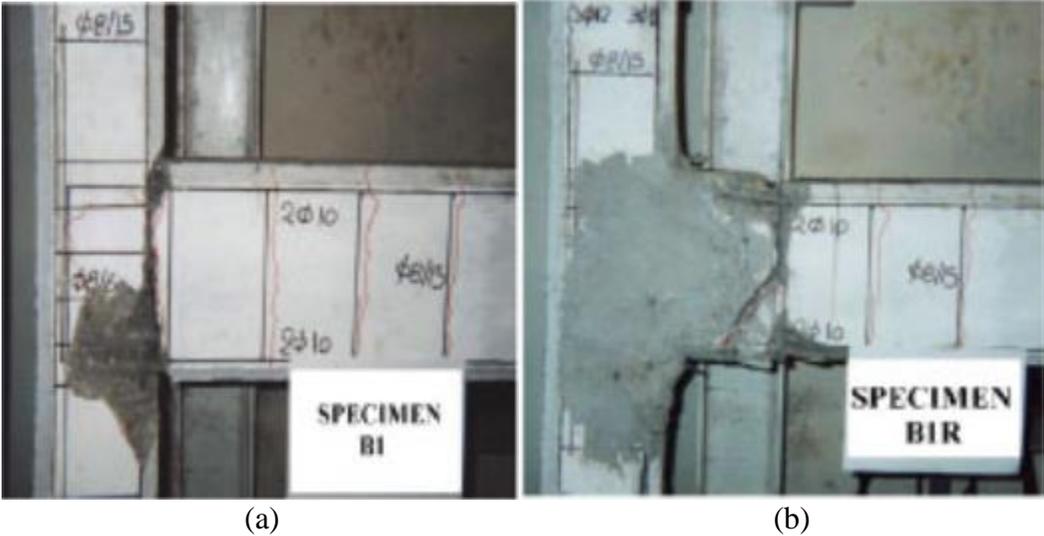
Figure 2-17: Failure of the beam-column joint under cyclic loading a) Failure occurrence at the joint before repair b) Failure occurrence outside of the joint after repair with epoxy injection (Karayannis and Sirkelis, 2008)

Karayannis and Sirkelis (2008) performed a study on the repair of RC beam-column joints by incorporating CFRP jacketing and epoxy injection under cyclic axial load applied to the column. A total number of 12 external beam-column joint connection sub-assemblages were repaired and tested under cyclic loading. Two repair methods were used, including epoxy injection and combination of epoxy injection and CFRP sheet external wrapping. CFRP was also used to wrap critical regions of the beam and column members of the specimen to provide confinement for these regions as well as providing anchorage for FRP sheets used to wrap the joint body. Based on the experimental results, it was concluded by Karayannis and Sirkelis (2008) that use of epoxy injection method could recover the structural strength of the damaged joint under cyclic loading and also failure occurred outside of the repaired area injected with epoxy, as shown in Figure 2-17. Moreover, simultaneous application of epoxy injection and CFRP sheets jacketing significantly improved the structural capacity, ductility, and energy absorption of the beam-column joint connection under cyclic loading. Damages in the repaired specimen using epoxy injection and CFRP jacketing occurred away from the joint near the end of the repaired area wrapped by CFRP

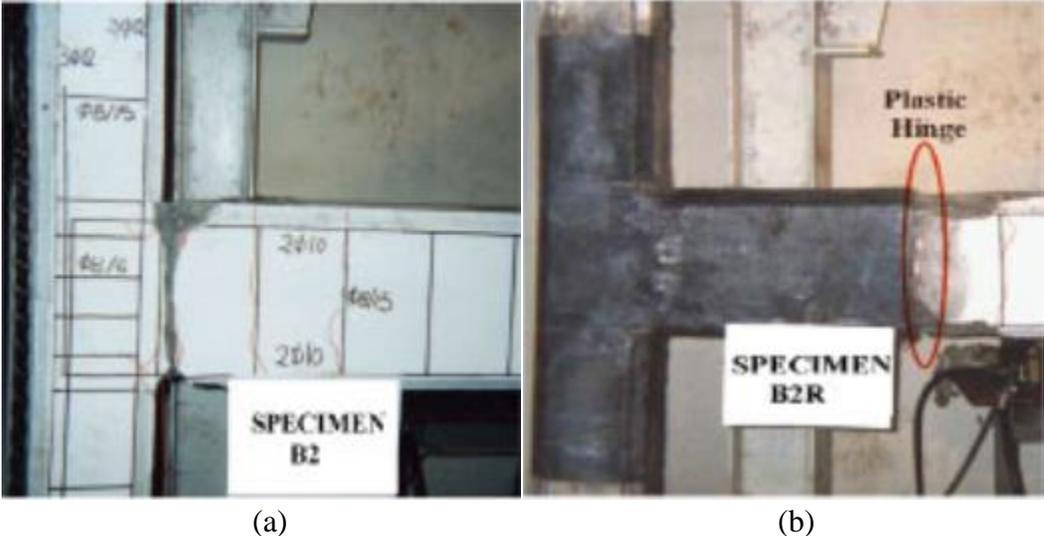
Figure 2-18: Failure of the beam-column joint under cyclic loading a) Failure occurrence at the joint before repair b) Failure occurrence outside of the strengthened area after repair with epoxy injection and CFRP jacketing (Karayannis and Sirkelis, 2008)

sheets, as illustrated in Figure 2-18. The study highlighted the effectiveness of the epoxy injection, and combination of epoxy injection and CFRP jacketing in repair and strengthening of the beam-column joints under cyclic loading.

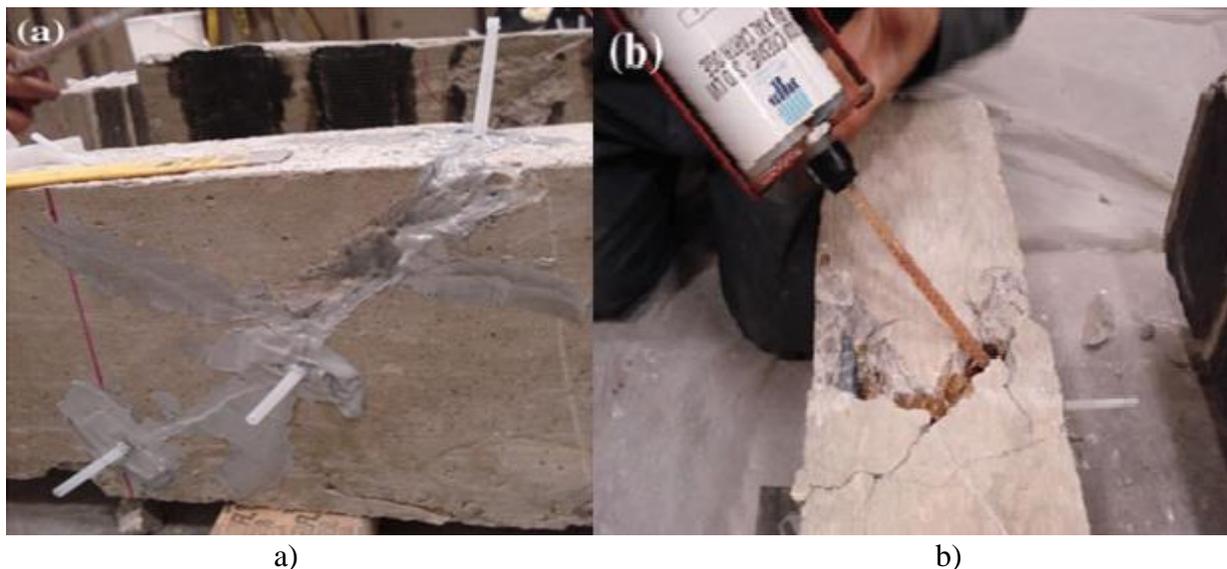
a) Sealing the cracked surface and installing the injection ports b) Low-pressure epoxy injection  
(Nikopour and Nehdi, 2011)

Nikopour and Nehdi (2011) performed a study on the repair of shear deficient RC beams using hybrid unidirectional FRP sheets and epoxy injection. A total number of 6 full-scale RC beams with cross section of 150 mm width and 250 mm height and having the length of 2438 mm were fabricated. Beams were designed as over-reinforced in flexure to make sure the ultimate shear capacity was reached before failure occurred in flexure. The experimental program was performed in two phases. In the first phase, 4 shear deficient beams having hybrid unidirectional side bonded FRP sheets and 2 control beams as control sample were tested under cyclic loading. CFRP sheets, and combinations of carbon-aramid, carbon-glass, and glass-glass fiber reinforced polymer sheets were used as external wrapping of 4 shear deficient beams to be tested under cyclic loading. In the next phase, 3 of the beams were repaired using epoxy injection and also simultaneous application of epoxy injection and carbon fiber reinforced polymer (CFRP) sheets and retested under four-point static loading. Figure 2-19 shows the procedure of repairing the RC beams with low-pressure

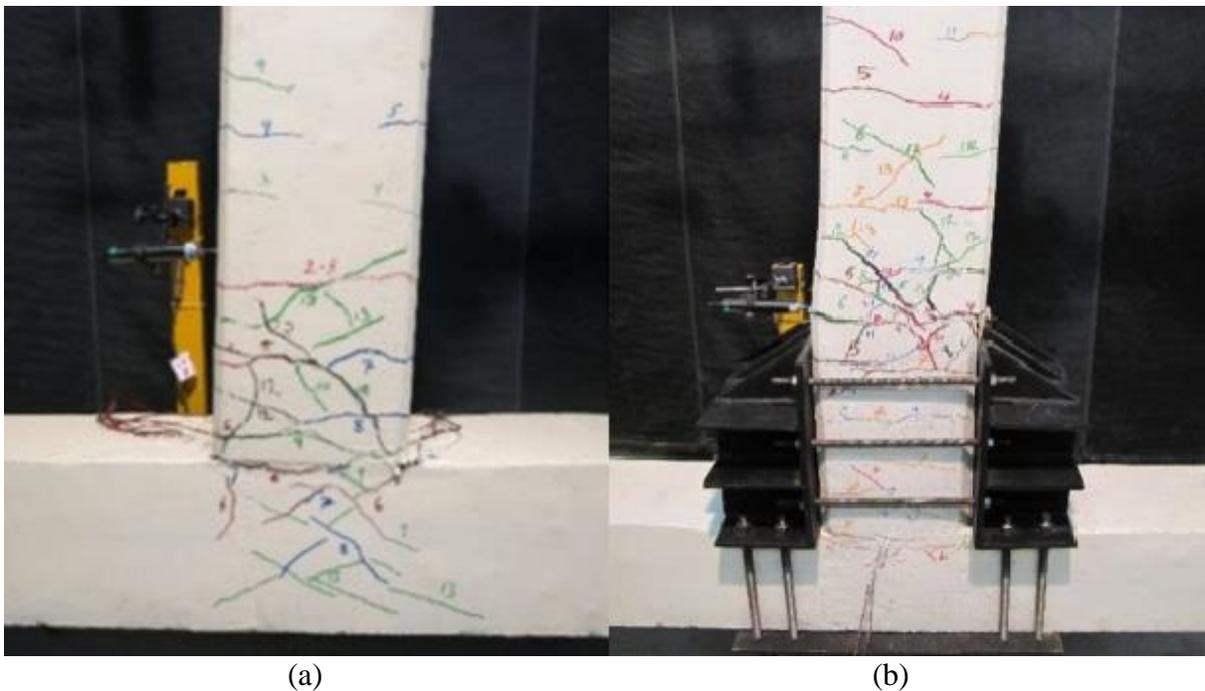
Figure 2-20: Failure of the beam-column joint under lateral cyclic loading a) Formation of plastic hinge at the joint location b) Formation of the plastic hinge in the beam member away from the joint (Torabi and Maheri, 2016)

In another study performed by Torabi and Maheri (2016) effectiveness of section enlargement using stiffened steel plates in repairing full-scale external beam-column joints was investigated under quasi-static cyclic loading. For this purpose, an external full-scale beam-column joint was fabricated and tested under lateral cyclic loading. In the next step, the beam-column joint was repaired using joint enlargement method. Joint cracks were epoxy injected followed by filling the damaged area by pouring fresh concrete. Next, stiffened steel plate was placed and fixed at joint location. The retrofitted specimen was tested up to failure under lateral cyclic loading. Seismic parameters such as strength, ductility, energy absorption, and stiffness were recorded and analyzed

to determine the effectiveness of the repair program. It was found by Torabi and Maheri (2016) that repairing the beam-column joint by incorporating stiffened steel plate under lateral cyclic loading improved the strength by 35%, reduced the ductility, and increased the stiffness of the joint. Moreover, plastic hinge relocated to the beam member away from the joint in the repaired joint. Failure location and formation of plastic hinge in the specimen before and after applying the repair is illustrated in Figure 2-20. The study confirmed applicability of the stiffened steel plate repair technique in strengthening of the beam-column joints under lateral cyclic loading.

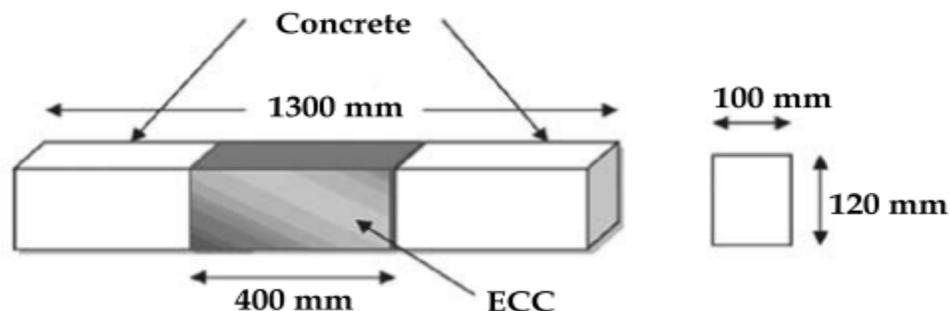
Figure 2-21: Strengthening with ECC at plastic hinge region (Sing and Sivasubramanian, 2013)

Sing and Sivasubramanian (2013) performed a study on the effect of strengthening RC beams with ECC under flexural loading. A total number of 12 half-scale RC beams were fabricated and tested under four-point loading. Two strengthening methods were used including strengthening partially at plastic hinge region with ECC and strengthening with ECC layers on the entire tension side, as shown in Figure 2-21 and Figure 2-22.

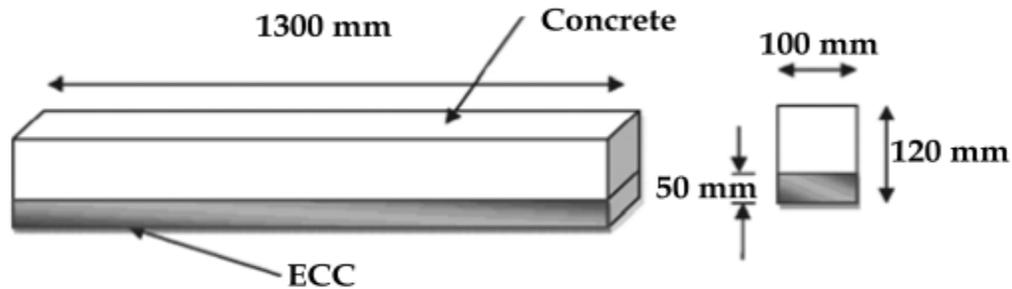
Figure 2-22: Strengthening with ECC layer on the tension side (Sing and Sivasubramanian, 2013)

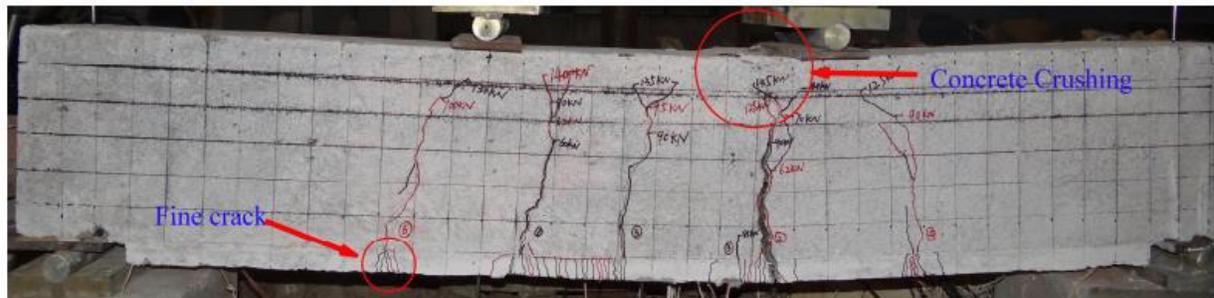
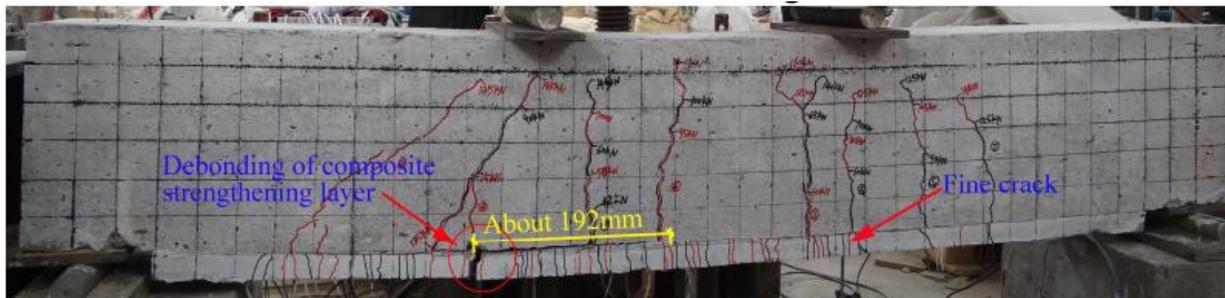
Figure 2-23: Failure mode of the strengthened RC beams with BFRP grid and ECC a) BFRP tensile rupture and concrete crushing b) BFRP tensile rupture and debonding of the strengthening layer (Wang and Zheng, 2015)

tensile rupture of the BFRP grid along with concrete crushing or debonding of strengthening layer was identified as failure mode of strengthened beam specimens, as shown in Figure 2-23. It was found by Wang and Zheng (2015) that strengthened beam specimens showed considerably higher flexural stiffness and load bearing capacity compared to control samples. The study confirmed the effectiveness of the combined application of BFRP grid and ECC in flexural strengthening of the RC beams.

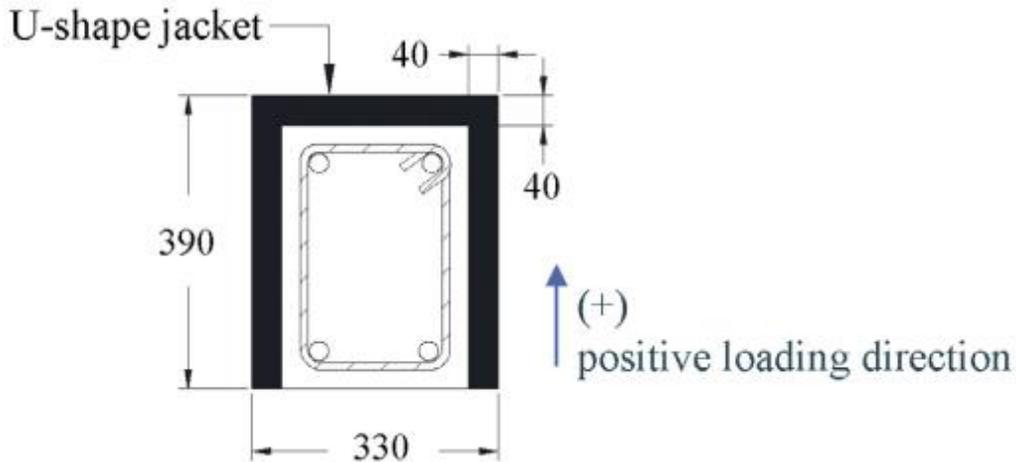
Figure 2-24: Cross-section of the strengthened RC beams with 40 mm thick U-shape ECC jacketing (Hung and Chen, 2016)

Hung and Chen (2016) investigated the effectiveness of ECC jacketing in strengthening of shear deficient RC cantilever beams under cyclic loading. A total number of 5 RC cantilever beams were fabricated and tested under cyclic loading including five beam specimens, strengthened with ECC jacketing, along with one control sample without jacketing. Beam specimens had similar cross-section dimensions of 250 mm width by 350 mm depth and overall length of 1200 mm. Strengthening method involved U-shape (three-sided) ECC jacketing with a constant thickness of 40 mm, as shown in Figure 2-24. Test variables included use of ECC or mortar as the jacketing material, presence of reinforcement in the jacketing layer, and use of welded steel bar or wire mesh as the reinforcement of the jacketing layer. Strengthened beam specimens were tested under cyclic loading and the structural performance was evaluated by analyzing hysteretic loops, damage patterns, energy dissipation capacities, strain development in the rebars, shear distortions, and failure modes. It was observed by Hung and Chen (2016) that ECC jacketing without steel reinforcement was capable of improving the cyclic behavior of the RC cantilever beams. Reinforcing the ECC jacketing layer with steel mesh further improved the structural performance of the strengthened beam specimen. The study confirmed the effectiveness of ECC jacketing with a single layer of steel mesh in strengthening of the RC cantilever beams under cyclic loading.

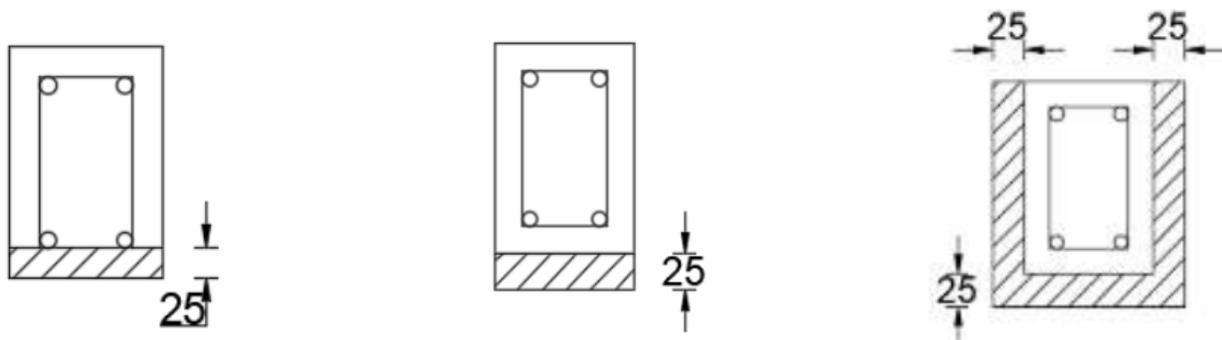
Figure 2-25: Strengthening methods of RC beam specimens with ECC layer in flexure (Shriram et al., 2018)

Shriram et al. (2018) performed an investigation on strengthening of RC beams using ECC in shear and flexure. A total number of 4 RC beams were fabricated and tested under four-point loading. Beam specimens had similar cross section dimensions of 100 mm width and 150 mm height along with an overall length of 1000 mm. Polyester fibers content of 1% by volume was used in ECC mix. Three methods were used to strengthen the RC beams including embedment of 25 mm ECC layer as the concrete cover on the tension side of the beam, applying the 25 mm ECC layer on the tension face of the beam, and applying the 25 mm ECC layer on the tension side as well as both sides of the beam. One of the beams was used as the control sample without strengthening, as shown in Figure 2-25. Beam specimens were tested in flexure under four-point loading condition.

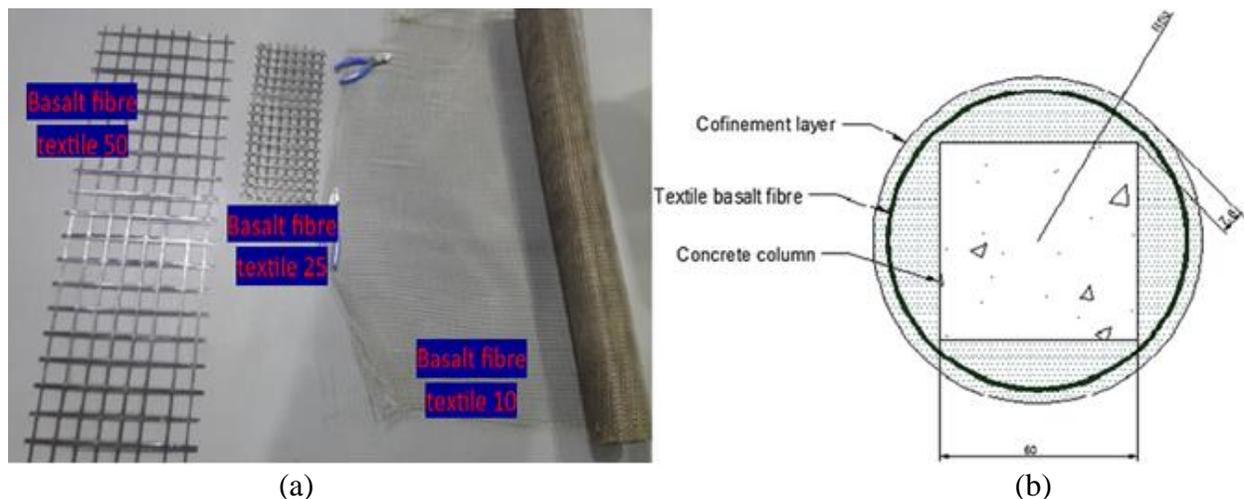
Figure 2-26: Column strengthening with ECC and BFRP textile a) Basalt fiber mesh textile b) Confined column details (AL-Gemeel and Zhuge, 2018)

mm, as well as 3 columns strengthened with cement mortar as the matrix and BFRP grid with spacing of 25 mm. Basalt fiber mesh types and confined column details are shown in Figure 2-26. Experimental variables included the basalt fiber textile (basalt fiber grid spacing) and use of ECC or cement mortar as the matrix for the BFRP grid. Compressive strength test was performed on all RC column specimens according to ASTM standards up to failure. Experimental results were recorded and compared to the control samples. It was observed that column specimens strengthened using just ECC and using basalt fiber textile with ECC matrix exhibited significantly higher load bearing capacity compared to columns without strengthening and column specimens strengthened with basalt fiber textile with cement mortar matrix. The study confirmed the effectiveness of ECC alone as well as basalt fiber textile with ECC matrix in confining non-circular RC columns under axial compressive loading.

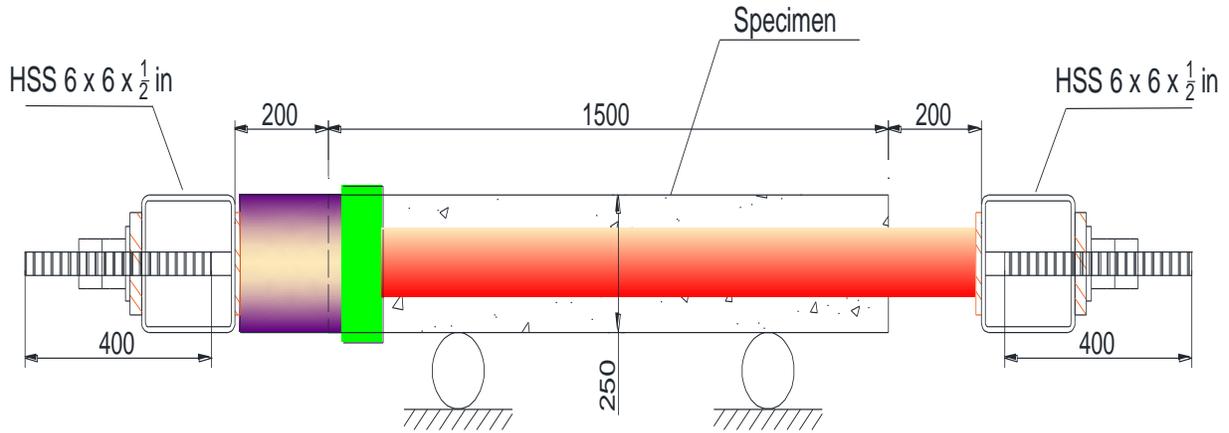
Figure 3.2: Side view of the test setup

length is 3000 mm with an embedded part of 1500 mm inside the sample while extruded out of the RC panel 750 mm on each of the north and south ends, by passing through the holes fabricated in the middle of the HSS. Both ends of the rebar are then fixed by welding the nuts which are placed at the back of the HSS. Moreover, in order to provide a free sliding boundary condition, specimens are supported on rollers at both ends in the direction of tensile loading, as shown in Figure 3.2.

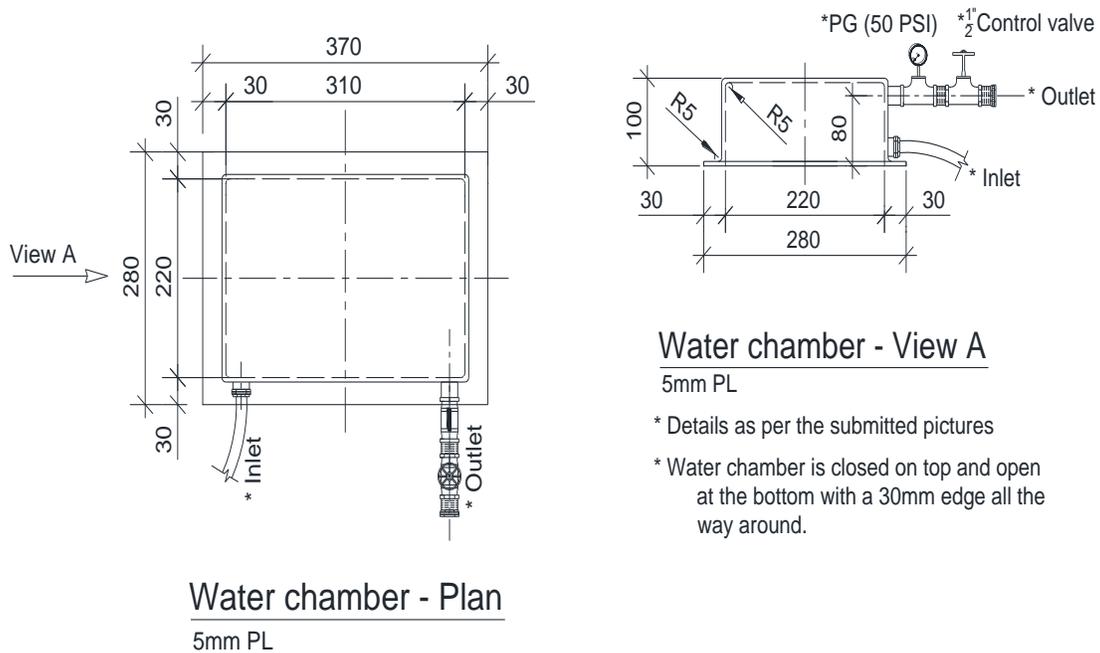
Figure 3.3: Details of the water pressure chamber

In order to inspect the leakage behavior of the RC panel through visual observation, installation of the water chamber is required to maintain the desired water pressure over the cracked region. The water pressure chamber is designed and fabricated of 5 mm steel plate and illustrated in Figure 3.3. The water chamber is placed in the middle of the section (750 mm from each end), where the major crack forms in the specimens. A 25 mm thick layer of gum rubber pad is placed between the water pressure chamber and concrete surface in order to provide flexibility for free deformation of the RC panel along the tension loading axis. A water-resistant silicone is used to seal the entire contact area between rubber pad and concrete surface as well as rubber pad and water chamber. The water chamber mounted on the specimen along with the gum rubber pad is shown in Figure 3.4.
