# **Experimental investigation on repair and self-healing of tension-induced cracks in reinforced concrete panels**

A Thesis

presented to Ryerson University

in partial fulfillment of the requirements for the degree of  
Master of Applied Science in the program of Civil Engineering

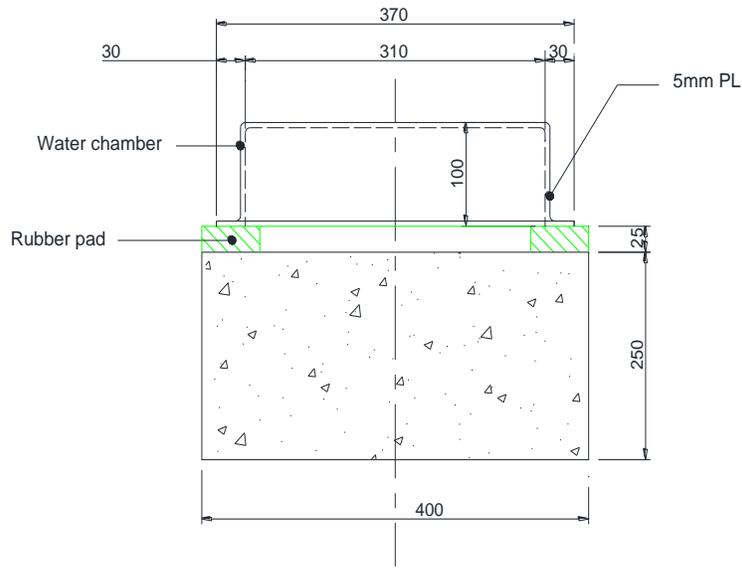
Figure 3.4: Water chamber mounted on the specimen

In order to inspect the leakage behavior of the RC panel through visual observation, installation of the water chamber is required to maintain the desired water pressure over the cracked region. The water pressure chamber is designed and fabricated of 5 mm steel plate and illustrated in Figure 3.3. The water chamber is placed in the middle of the section (750 mm from each end), where the major crack forms in the specimens. A 25 mm thick layer of gum rubber pad is placed between the water pressure chamber and concrete surface in order to provide flexibility for free deformation of the RC panel along the tension loading axis. A water-resistant silicone is used to seal the entire contact area between rubber pad and concrete surface as well as rubber pad and water chamber. The water chamber mounted on the specimen along with the gum rubber pad is shown in Figure 3.4.

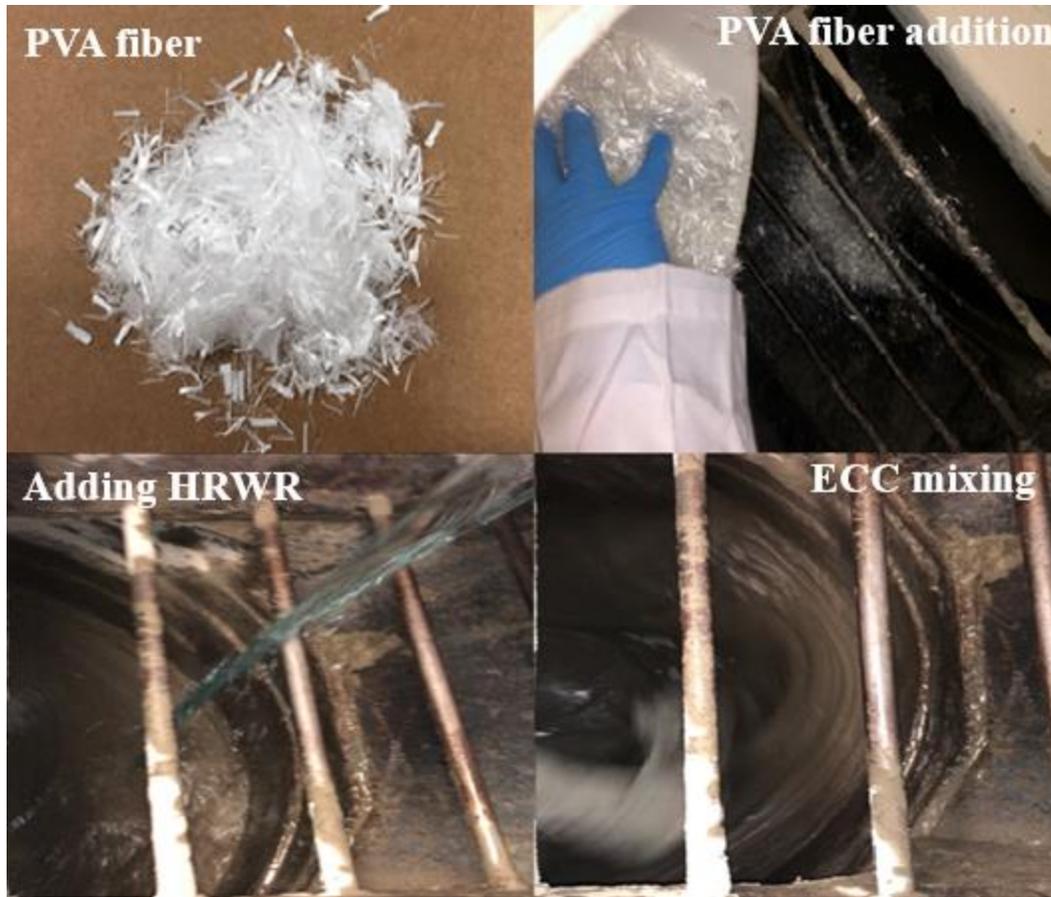
Figure 3.5: ECC mixing

introduced to the shear mixer and mixed for one minute. Then 50% of the HRWR and 75% of water were mixed and added to the mixer gradually and mixed with other materials for 2 to 3 minutes. After that, the remaining of the water and HRWR were added to the mix with the same procedure and mixed for an additional 2 minutes to achieve the desirable flow-ability and consistency. Finally, the PVA fibers was added to the shear mixer and mixed for 3 minutes until full dispersion of fibers with mortar mixture. The mixing procedure of ECC is shown in Figure 3.5.

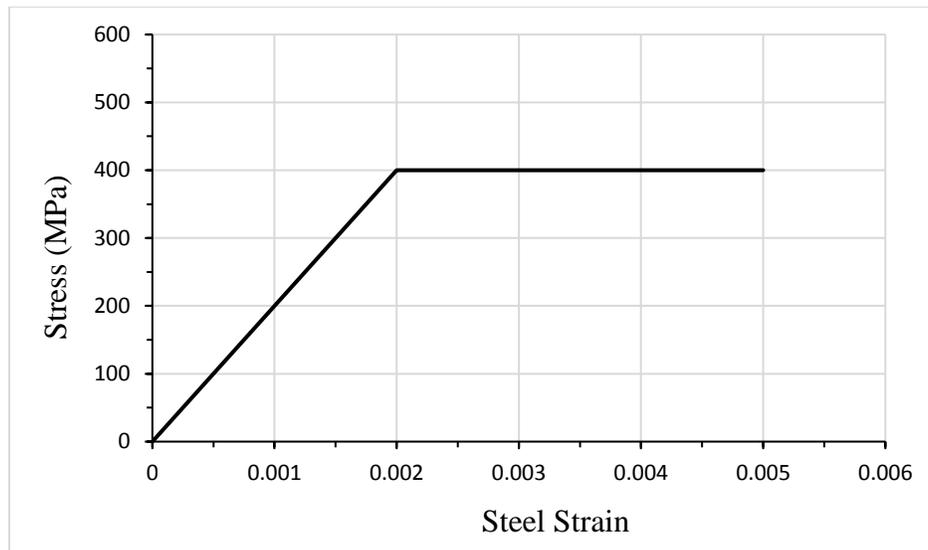
Figure 3.6: Rebar stress-strain curve

A single 35 mm rebar ( $\rho = 1\%$ ) was used as the longitudinal reinforcement for each specimen and it was placed at the center of the RC panel to prevent any eccentricity during loading. The rebar used in this experimental program was Grade 400 steel which was conforming to the Canadian Standard Association (CSA). The properties of tested rebar are shown in Figure 3.6 and Table 3.2.

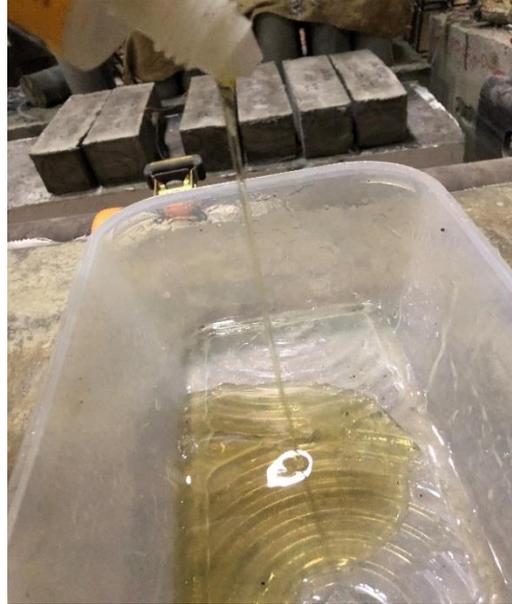
Figure 3.7: Low viscosity of the high-strength epoxy

A high-strength low-viscosity epoxy was used as the repair material in this experimental program. Epoxy is a two-part product consisting of the resin and hardener that should be mixed before injection with 2:1 ratio (by volume), respectively. A high-pressure injection method was used to ensure that the epoxy penetrated through the depth of the section filling the crack. The epoxy has a low viscosity of 375 cps, as can be seen in Figure 3-7, which allows penetration and sealing of fine, hairline cracks. Epoxy starts to harden after 3-3.5 hours at room temperature (23° C) and it can achieve a high early strength of up to 5 times stronger than concrete in a short curing time. It is a moisture tolerant adhesive that can be used for “can’t dry” cracks and surfaces. However, it cannot be used for injection of cracks under active hydrostatic pressure. Also, it is not suitable to be injected into cracks greater than 6 mm in width. This type of epoxy conforms to current ASTM C881 (2015) and AASHTO M 235-13 (2018) specifications. The material properties of epoxy at room temperature (23° C) are shown in Table 3.3.

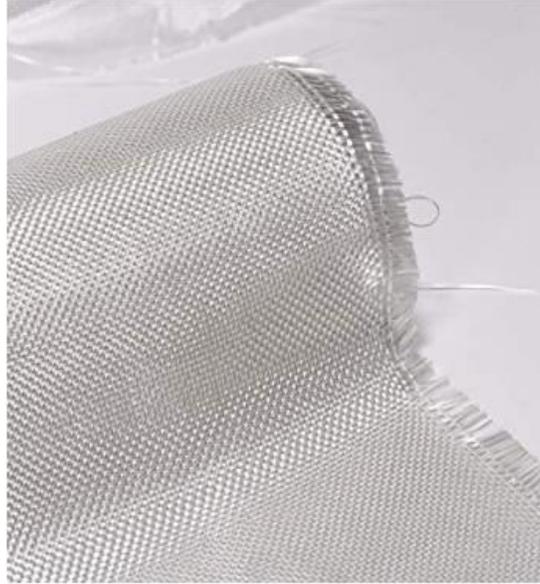
Figure 3.8: Glass fiber fabric

Fiber reinforced polymer (FRP) is a composite material made of a polymer matrix reinforced with fibers. The common types of fiber used in industry are Glass, Carbon, Aramid, and Basalt. Glass fiber reinforced polymer (GFRP) laminate was used for this experimental program to repair the

RC panels, which is shown in Figure 3.8. A unidirectional E-glass type of fiber fabric was used in conjunction with epoxy laminating resin to provide composite strengthening system. GFRP laminate is flexible and can be wrapped around complex shapes. Being non-corrosive, acid resistant, and proved good resistance to impact are among other advantages of the GFRP laminates. It is also light-weight and has minimum impact on the aesthetic of the structure. E-glass fiber properties are presented in Table 3.4.

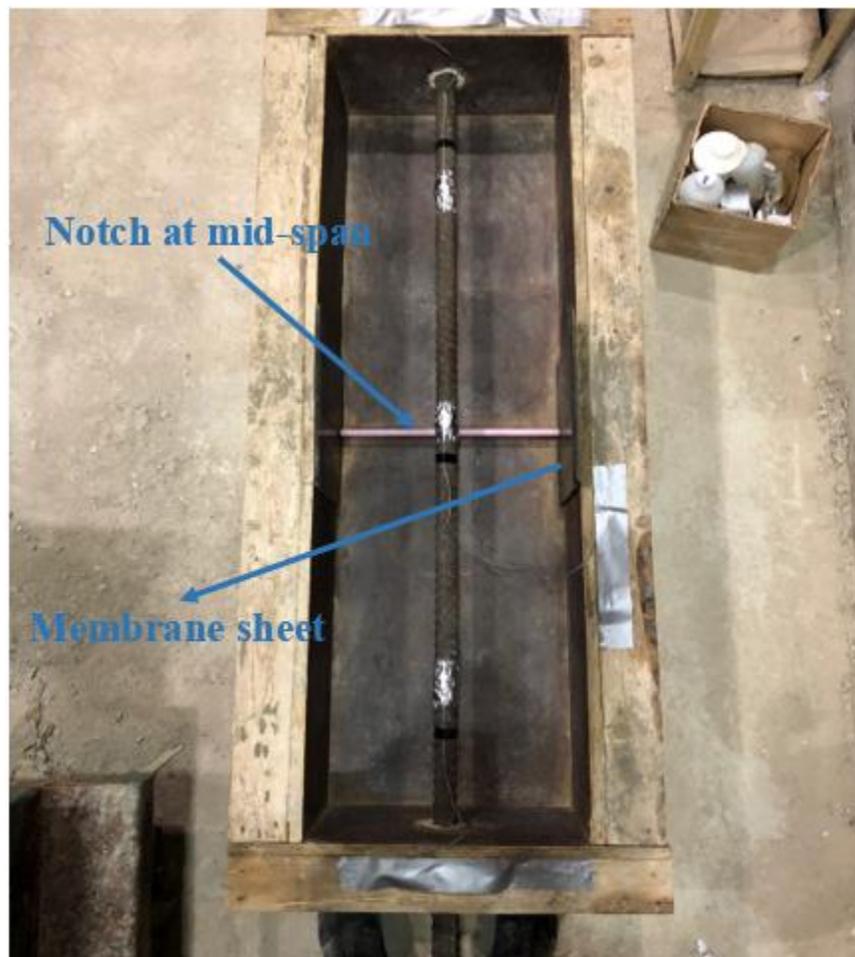
Figure 3.9: Typical RC panel form work

The fabrication and casting of the specimens were done in two stages including NC panels and the ECC repair layer. As the NC panels, a total number of 4 specimens were cast using normal concrete (NC) in a prepared wooden form-work. Figure 3.9 illustrates the typical form-work along with the rebar located in the center of the cross section, position of the steel strain gauges, as well as the notch and two thin membrane sheets in the middle of the specimen length.

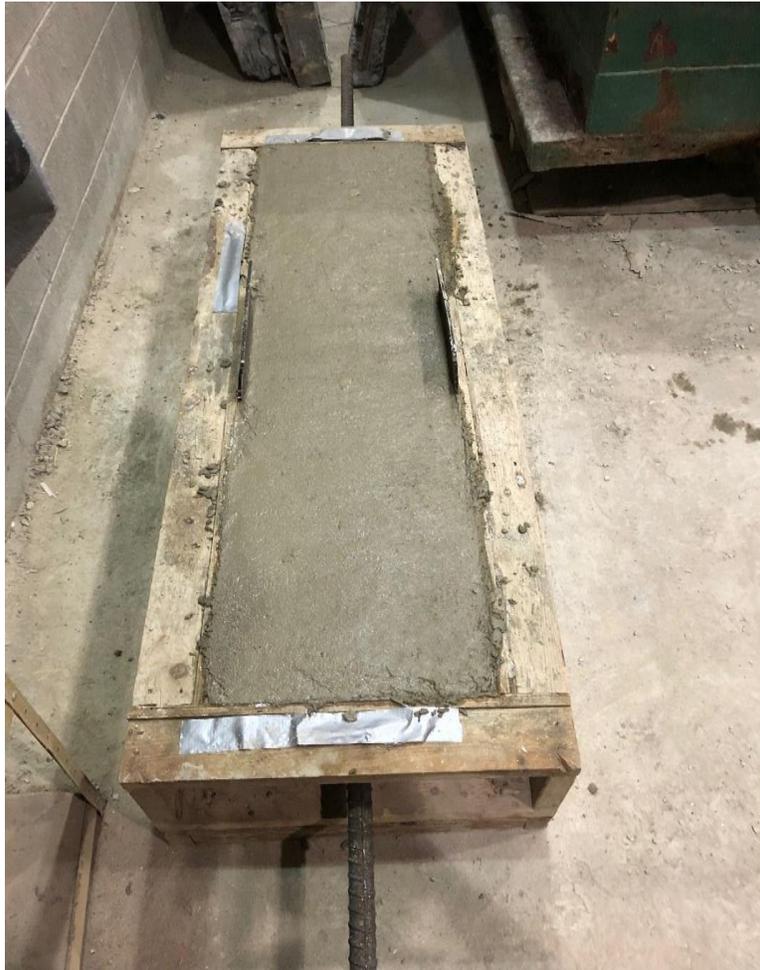
Figure 3.10: Typical reinforced normal concrete panel after casting

each batch, 12-cylinder samples with 200 mm height and 100 mm diameter were cast for tensile strength, 7-day compressive strength, and 28-day compressive strength tests. Cast specimen is shown in Figure 3.10.

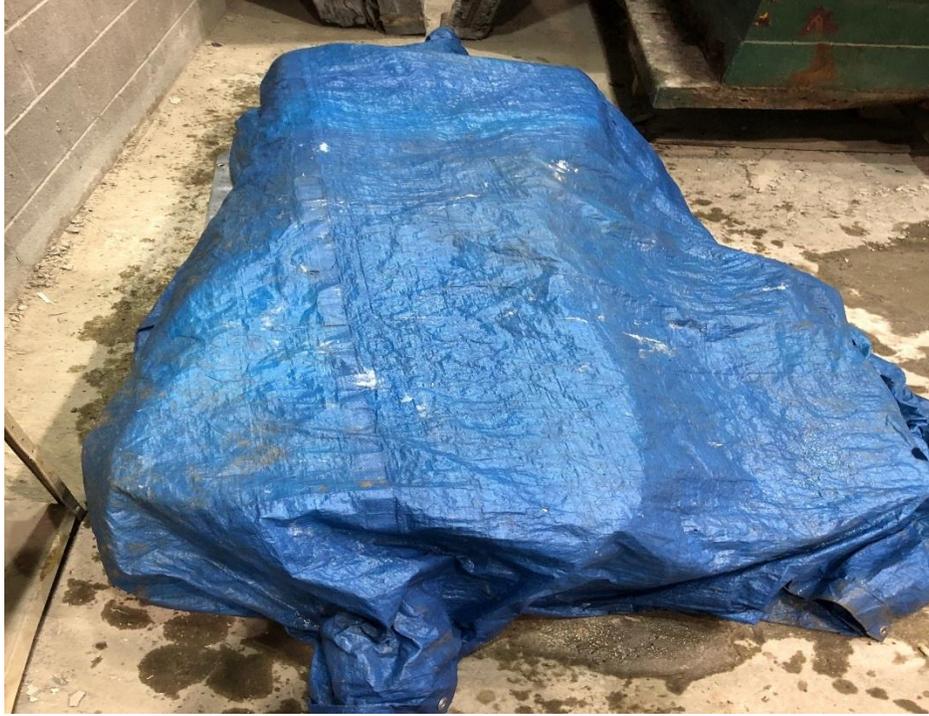
Figure 3.11: Moist curing of the RC panels after casting

The specimens and poured controlled samples were covered with impermeable sheets right after the casting. The form-works for all the samples were removed 72 hours after the casting. Specimens were moist cured until the age of 7 days using wet burlaps in the relative humidity of  $50\% \pm 2.5\%$  and temperature of  $24 \pm 2^\circ\text{C}$  in the laboratory conditions, followed by air-curing until the testing age of 28-day. Moist curing of the RC panels is shown in Figure 3.11.

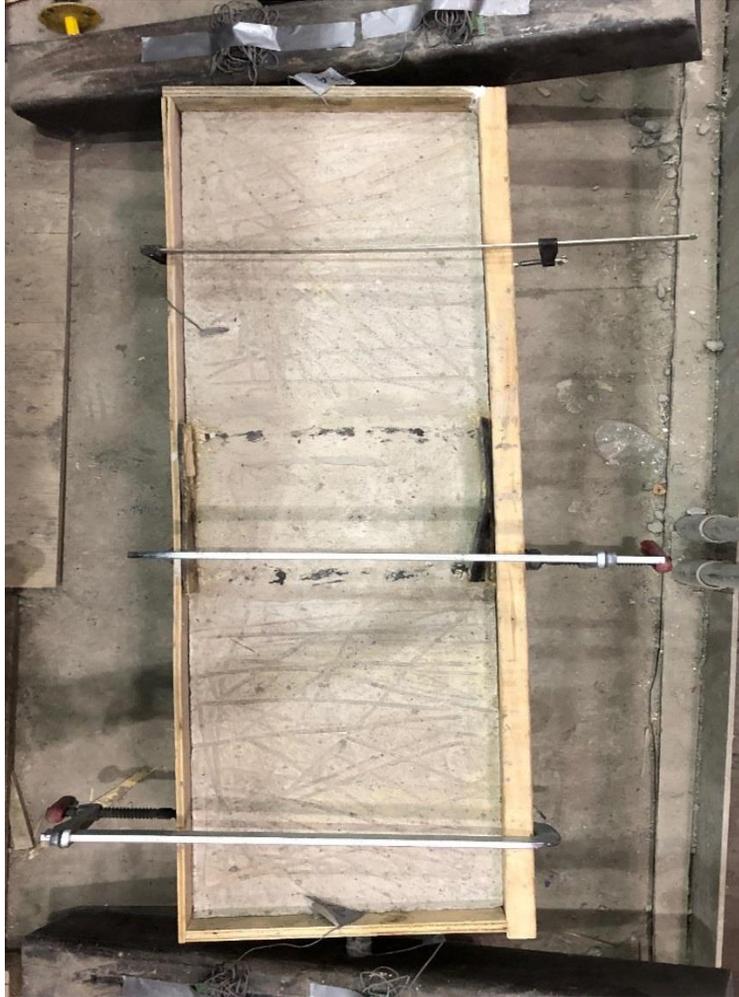
Figure 3.12: Repair layer formwork on top of the RC panel

After testing the NC panels under monotonic tension loading, a wooden formwork was prepared on top of the RC panel for casting the repair layer using ECC, which is shown in Figure 3.12. In order to provide proper bonding between the ECC repair layer and the main RC panel, concrete grinding was performed on the top surface of the RC panel in different locations up to the depth of half of the maximum size aggregates (10 mm), followed by wire brushing. Also, the RC panel surface was moistened just before casting the ECC repair layer to improve the bonding.

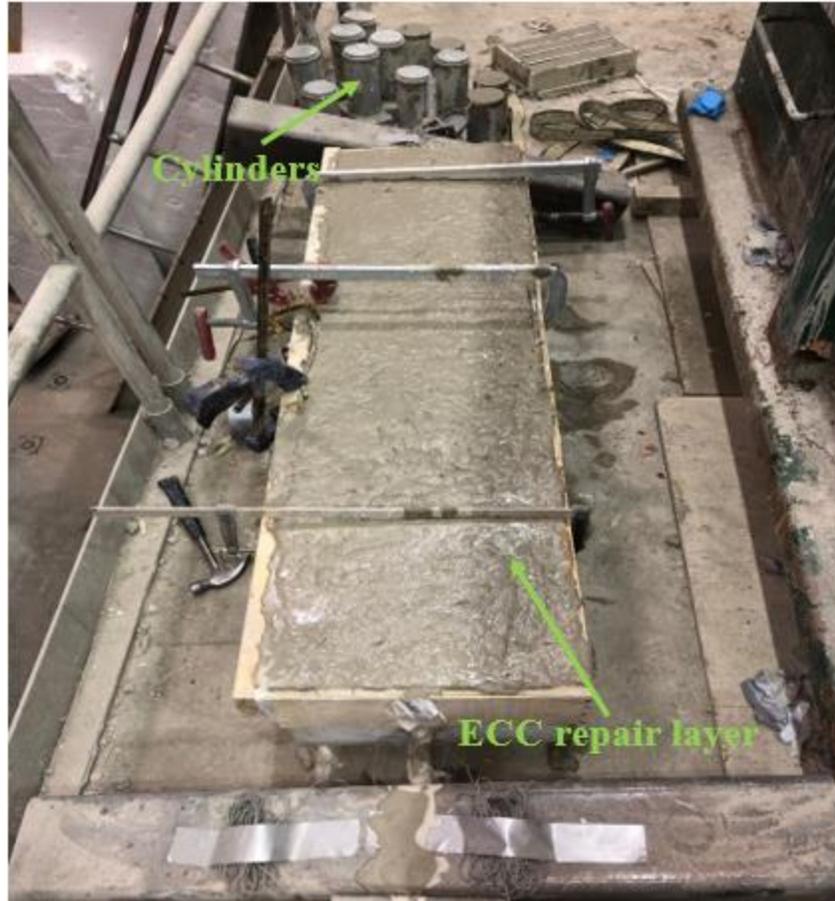
Figure 3.13: ECC repair layer after casting with control samples

A total volume of 100-liter ECC was used to fill the form-work along with 12 cylinders with 200 mm height and 100 mm diameter for tensile strength, 7-day compressive strength, 28-day compressive strength tests. Figure 3.13 illustrates the ECC repair layer after casting with control samples. The formwork of the ECC repair layer and control samples were removed after 72 hours of casting. The ECC samples were covered with wet burlaps and impermeable plastic sheets to provide moist curing right after the casting until the age of 28 days. Then, specimen was air-cured until the testing age of 28-day in the laboratory conditions.

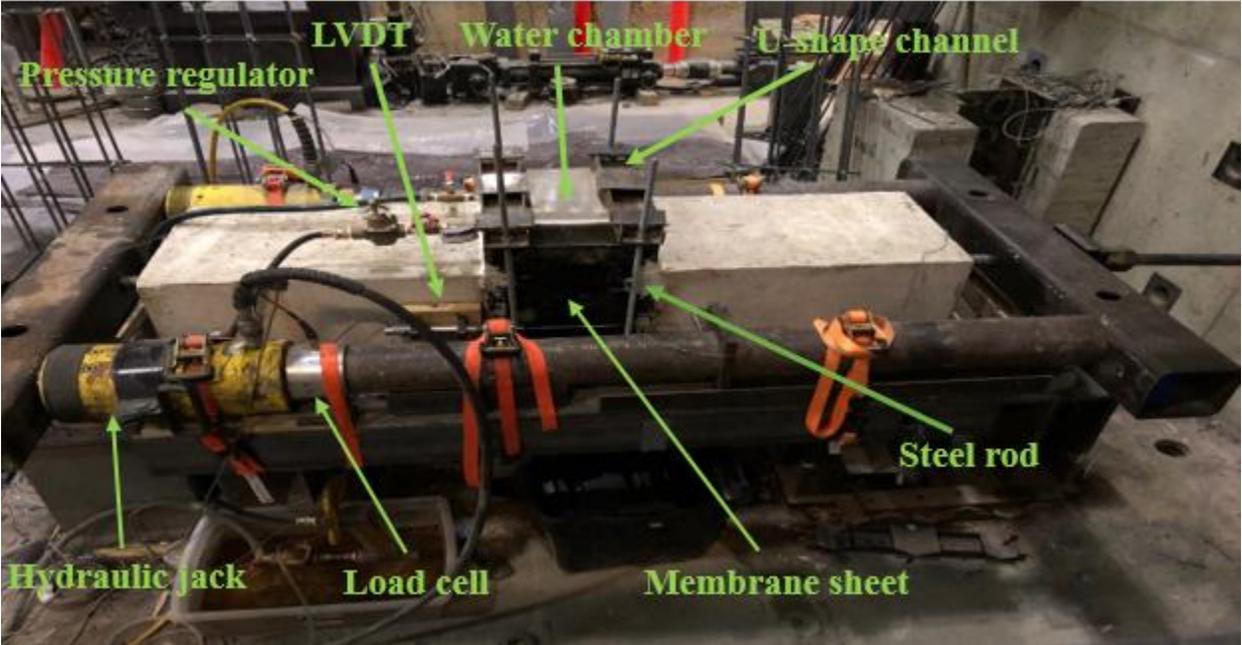
Figure 3.15: Actual side view of the specimen

Figure 3.15 and Figure 3-16 illustrate the actual side view of the RC panel along with the locations of the steel strain gauges, LVDTs, water chamber and pressure valve, hydraulic jacks and HSSs, load cells, membrane sheets, water pressure regulator and pressure gauge, and U-shape channels tightening the water chambers through 4x20 mm steel rods to prevent any leakage in the contact area of the water chamber, and gum rubber pad on the top surface of the specimen.

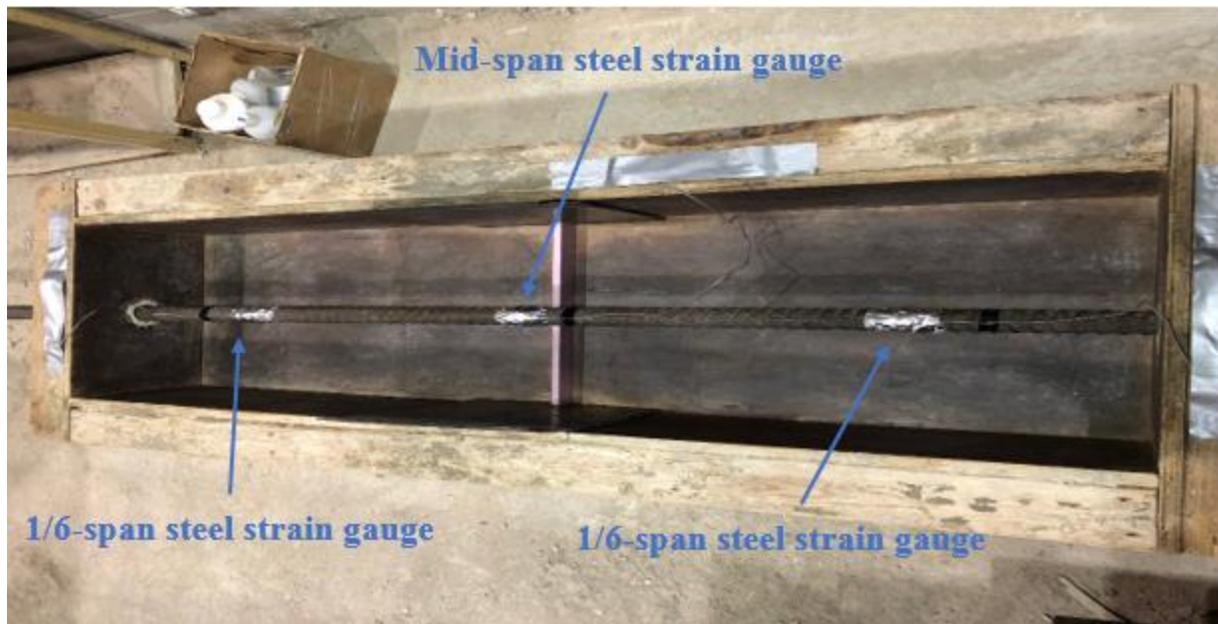
Figure 3-16: Arrangement of steel strain gauges on the rebar

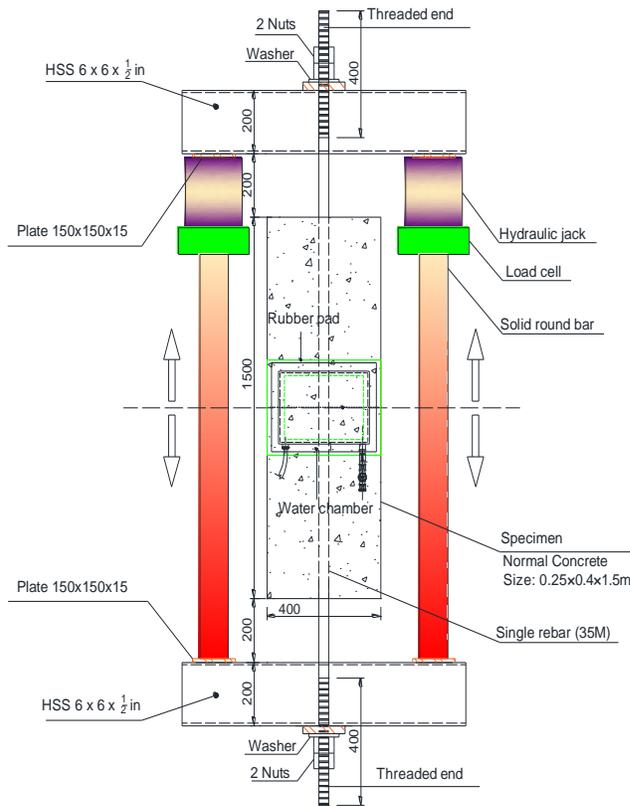
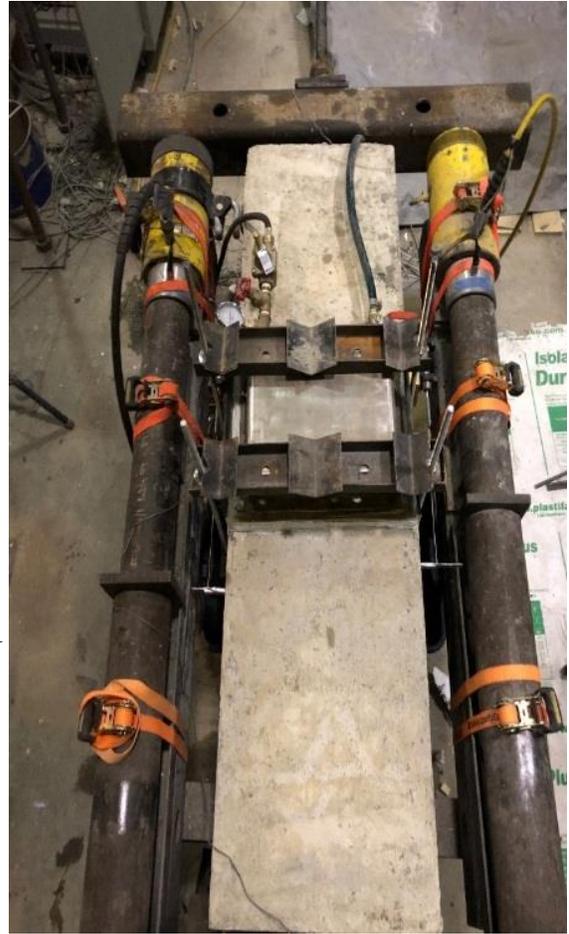
Figure 3-17: plan view of the specimen and loading test setup

The NC panels is carefully placed in the test setup. Steel strain gauges, LVDTs, load cells, and hydraulic jacks are in place. Figure 3-17 shows the plan view of the specimen and loading test setup. Water pressure chamber is mounted on top of the specimen and tightened using U-shape channels and four steel rods. Figure 3-18 presents the water pressure chamber mounted on top of the NC panel. Water pressure is fixed at 4 psi in the water chamber. Direct tensile loading is applied at increments of 10 kN to the specimen. Load is increased until formation of the major crack at the pre-determined location (mid-span), as shown in Figure 3-19, along with leakage initiation. Load, strain, crack width, and displacement data are recorded at each increment. Crack width was measure using a crack scope with magnification of 25X.

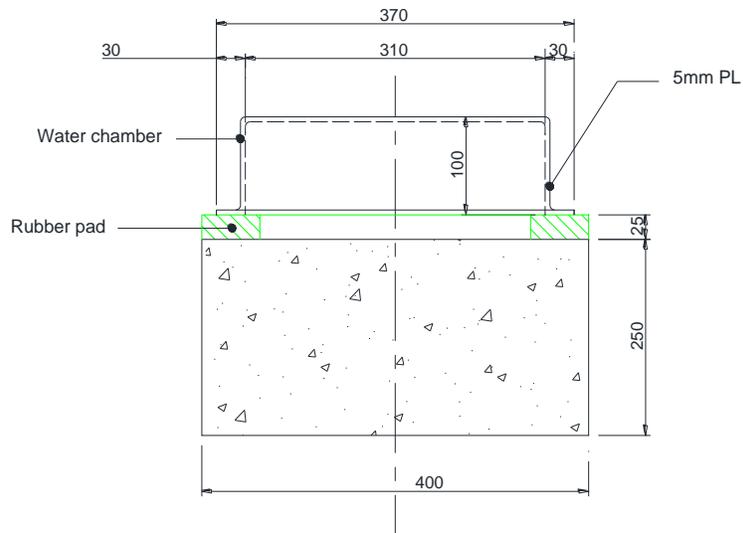
Figure 3-18: Water pressure chamber mounted on NC panel

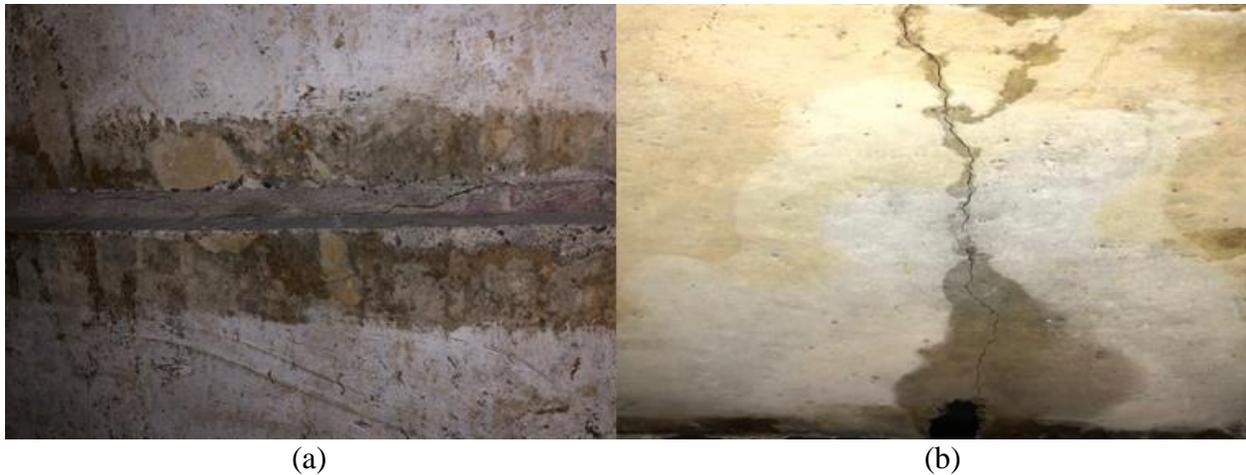
Figure 3-19: Crack formation in NC panel under direct tension a) Bottom face b) Side face

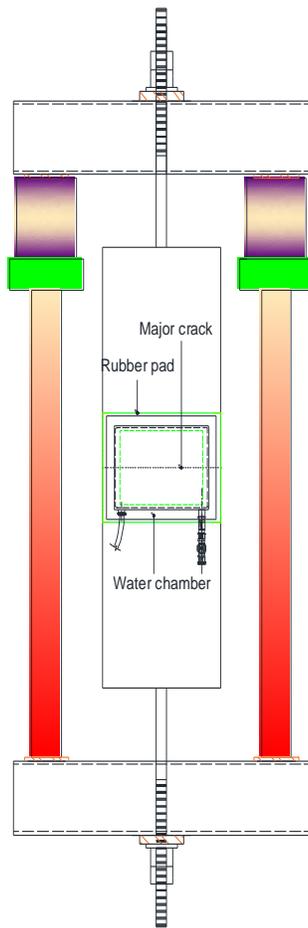
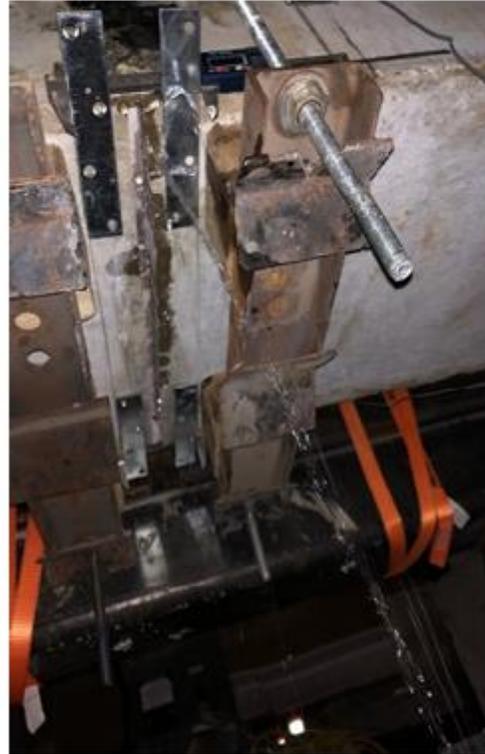
Figure 3-20: Extreme leakage through a major crack in one of the NC specimens (before repair)

Load is kept increasing until the formation of a major crack at mid-span along with a constant leakage. Loading is stopped at this stage and leakage rate of the NC specimen is recorded under water pressures of 4, 8, 12, and 16 psi. Figure 3-20 shows the extreme leakage through a major crack in one of the NC specimens before repair. In order to investigate the self-healing behavior of the NC specimens under sustained tensile loading, water pressure in chamber is fixed at 7 psi and leakage rate is continuously recorded to achieve a constant leakage rate or 100% self-healing of the tension-induced cracks. Self-healing test is divided in to two parts including short-term self-healing and long-term self-healing. In short-term investigation of the self-healing during the first 35 hours, the amount of water penetrating through the full depth of the NC panel and leaking from the bottom surface is measured continuously over one-hour time intervals (each time for 60 minutes). In long term investigation of the self-healing, during the first 35 hours leakage rate is recorded continuously each hour (each time for 60 minutes), while during the period of time between 35 hours up to the end of the test, leakage rate is measured for one-hour duration every 6 hours.

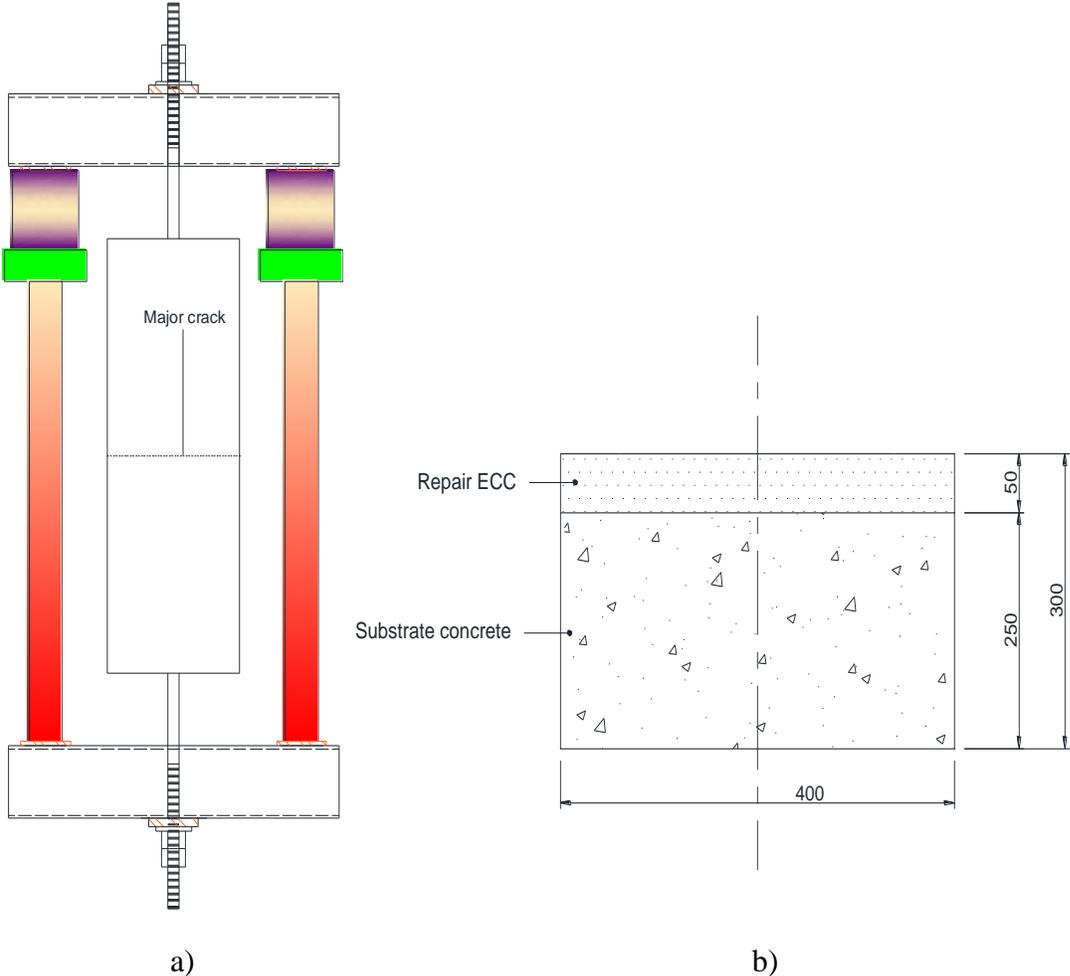
Figure 3-21: Releasing the tensile load and applying the repair a) NC specimen after releasing the tensile load and removing the water chamber and rubber pad b) NC specimen after applying a 50 mm ECC repair layer

fly ash. Detailed procedure of applying the repair materials are discussed in section 3.4.2. Figure 3-21a illustrates the specimen after releasing the tensile load and removing the water chamber and rubber pad. Figure 3-21b shows the NC specimen with a 50 mm ECC repair layer. Actual NC specimens repaired with ECC and GFRP laminates are shown in Figures 3-22a and 3-22b. Moreover, Figure 3-23 illustrates the top and bottom surfaces of a NC specimen repaired with high-strength epoxy injection at mid-span crack

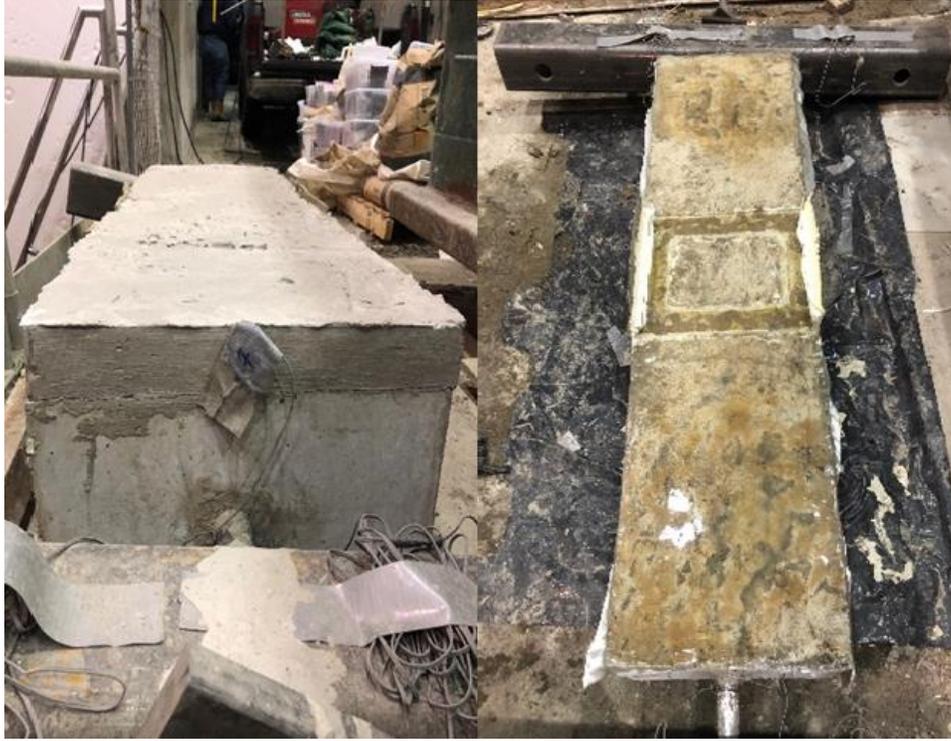
Figure 3-22: NC specimen repaired with a) ECC overlay b) GFRP laminates

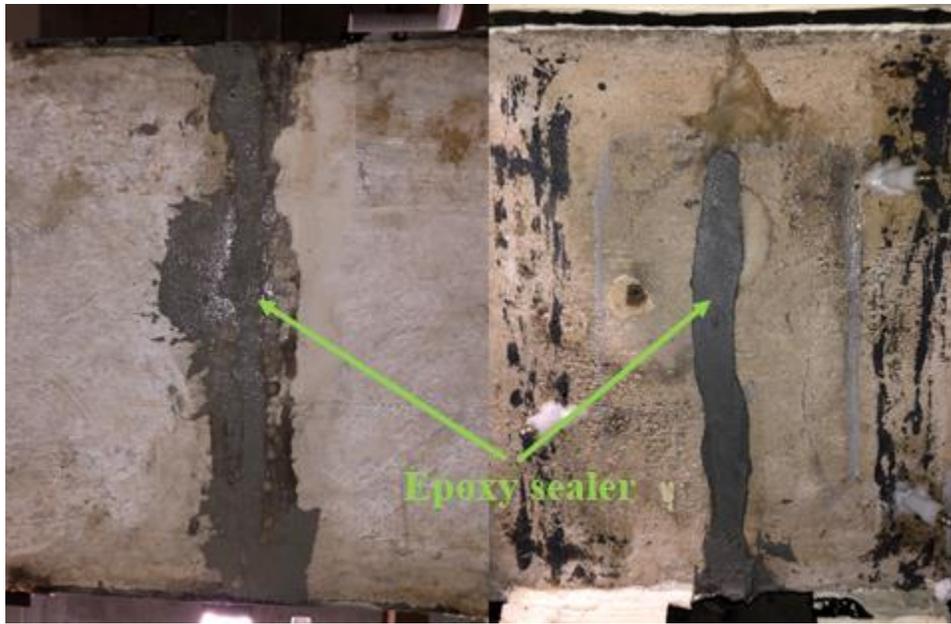
Figure 3-23: Top and bottom surfaces of a NC specimen repaired with high-strength epoxy injection at mid-span crack a) Bottom surface b) Top surface

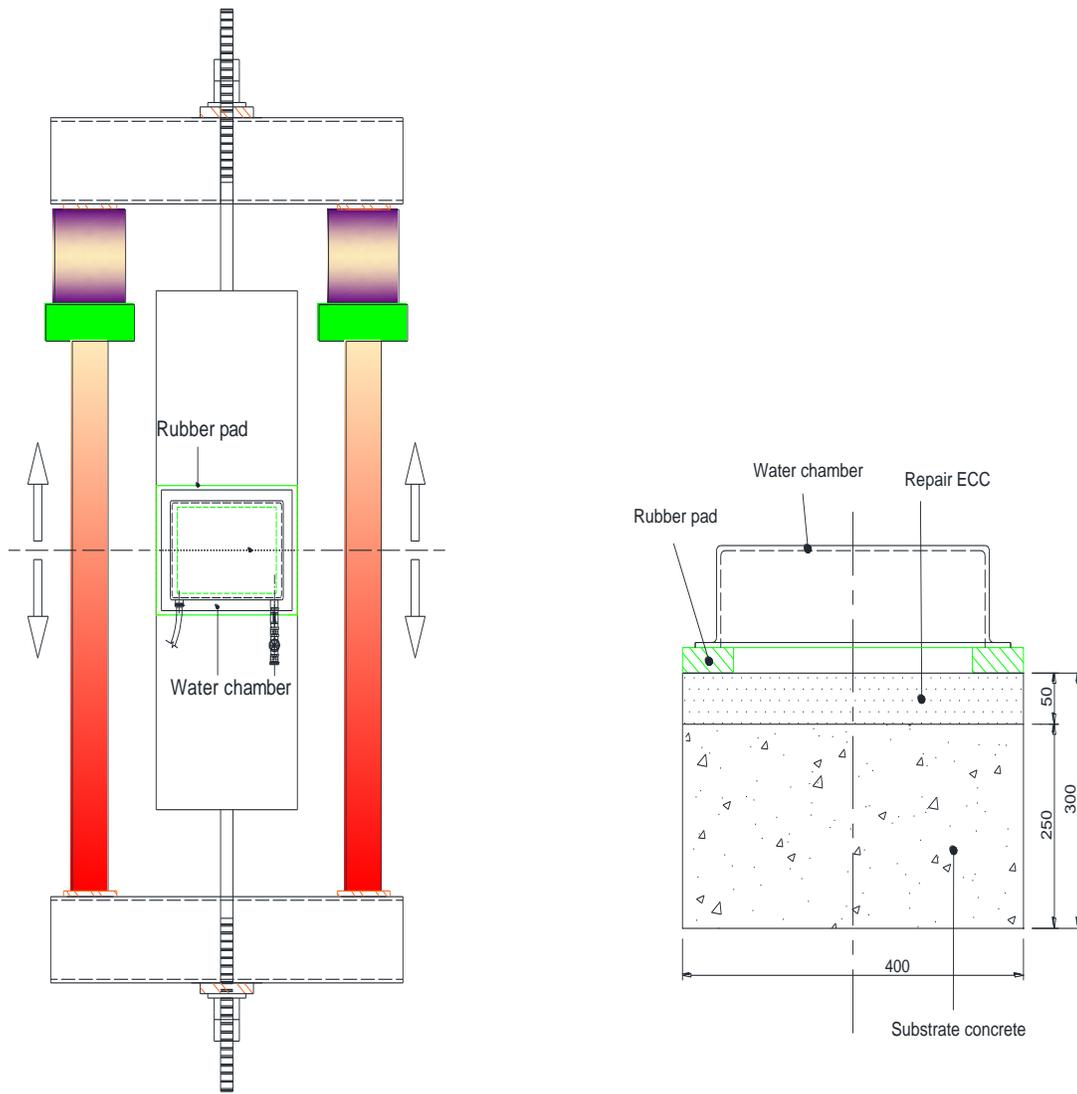
Figure 3-24: Repaired NC specimen in the re-load test setup

Repair materials are applied to the NC specimen and are left for curing to achieve the specified strength. Then, rubber pad and water chamber are placed again on top of the sample and tightened with steel rods and U-shape channels. Direct tensile is re-applied to the specimen at increments of 10 kN. Tensile loading is kept increasing until either failure of the repair material and leakage initiation, or reaching the yielding strain in the rebar. Leakage rate of the repaired NC specimen is measured under various water pressures of 4, 8, 12, and 16 psi. In case of reaching the yielding strain of the rebar without any failure of the repair material, test is stopped due to safety reasons. Figure 3.24 shows a repaired NC specimen in the re-load test setup. NC specimens repaired with 50 mm layer of ECC slag, 50 mm layer of ECC fly ash, 2 layers of GFRP laminates, and high-strength epoxy injection in the re-load test setup are illustrated in Figures 3-25 to Figure 3-27.

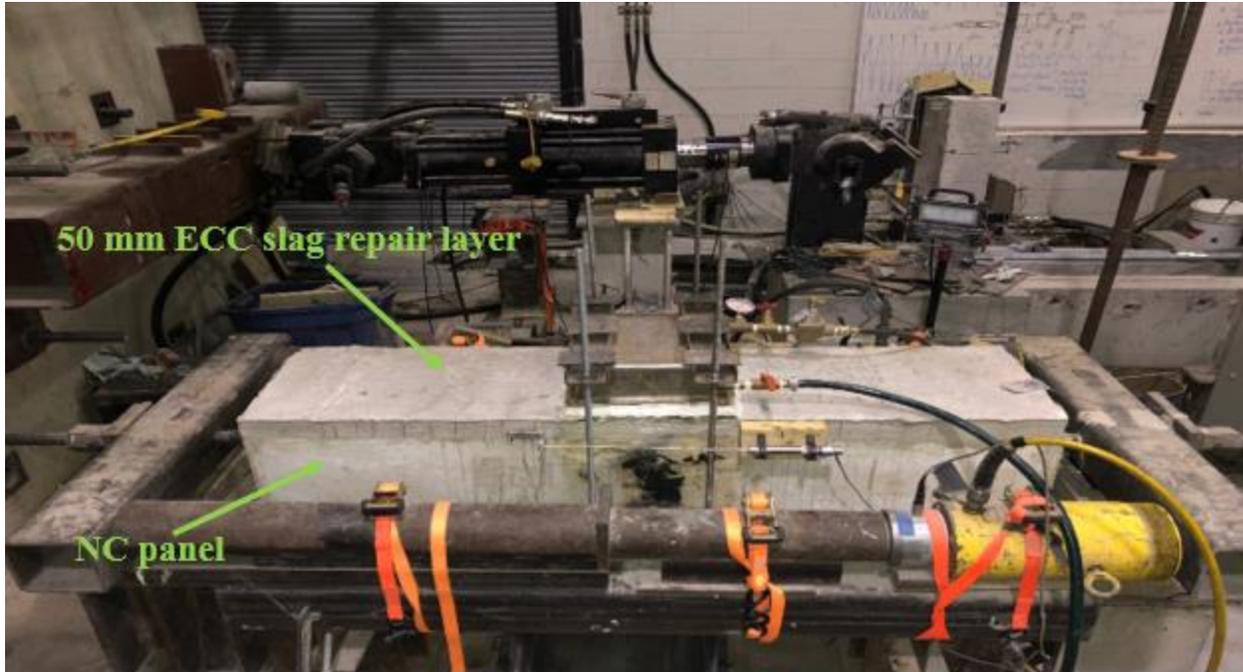
Figure 3-25: NC specimen repaired with a 50 mm layer of ECC slag

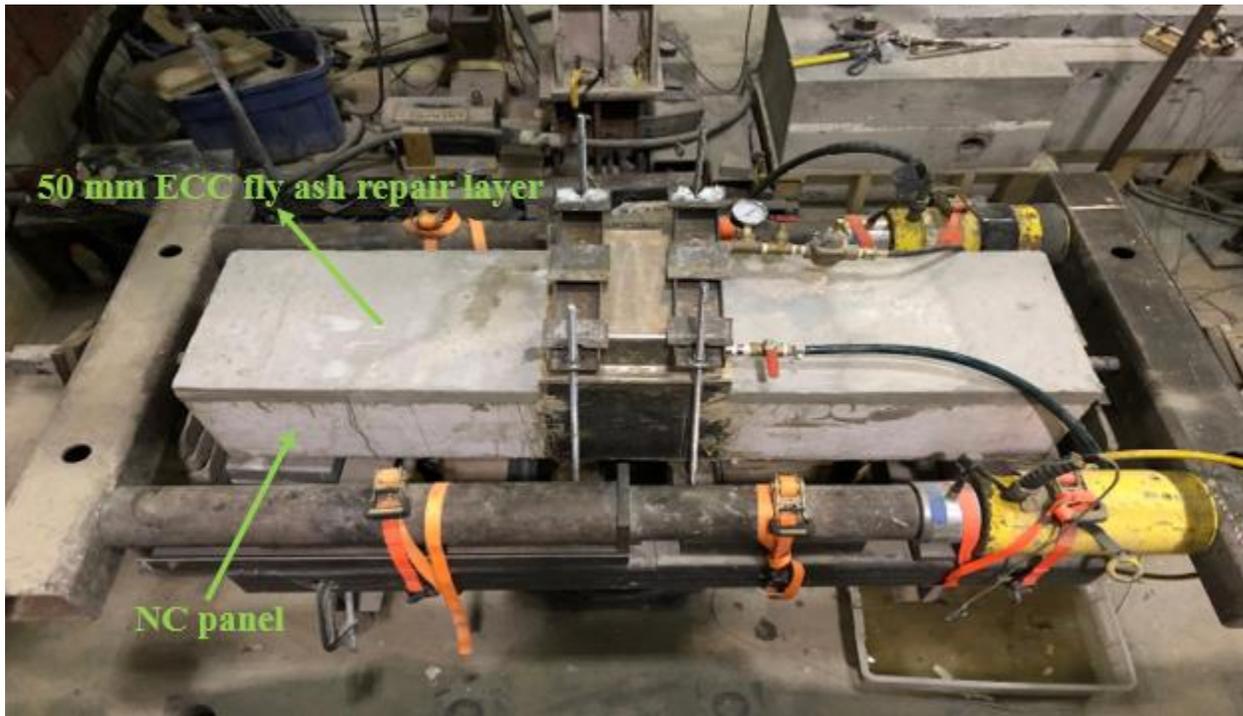
Figure 3-26: NC specimen repaired with a 50 mm layer of ECC fly ash

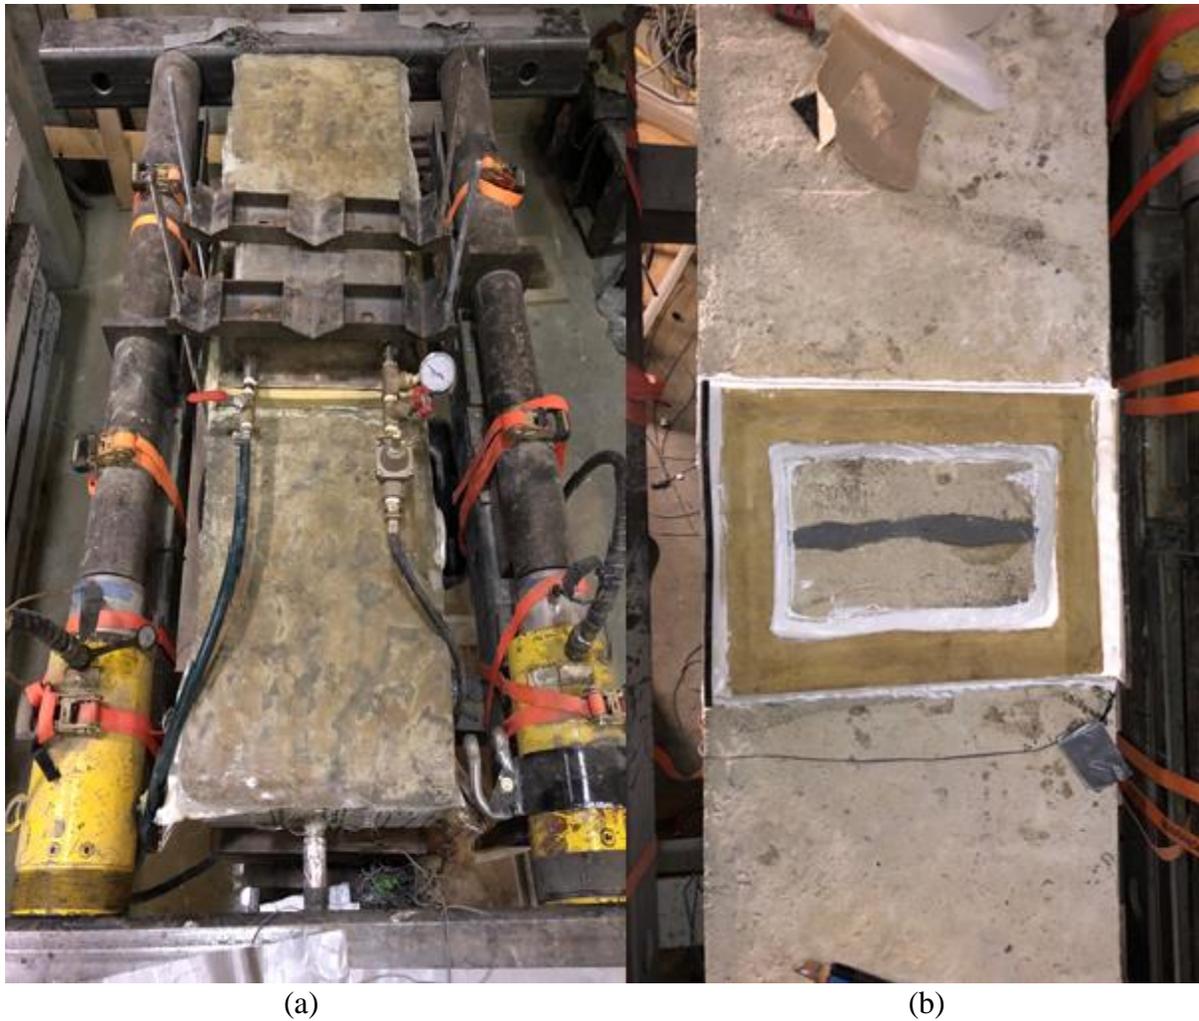
Figure 3-27: NC specimen repaired with a) GFRP laminates b) High-strength epoxy injection

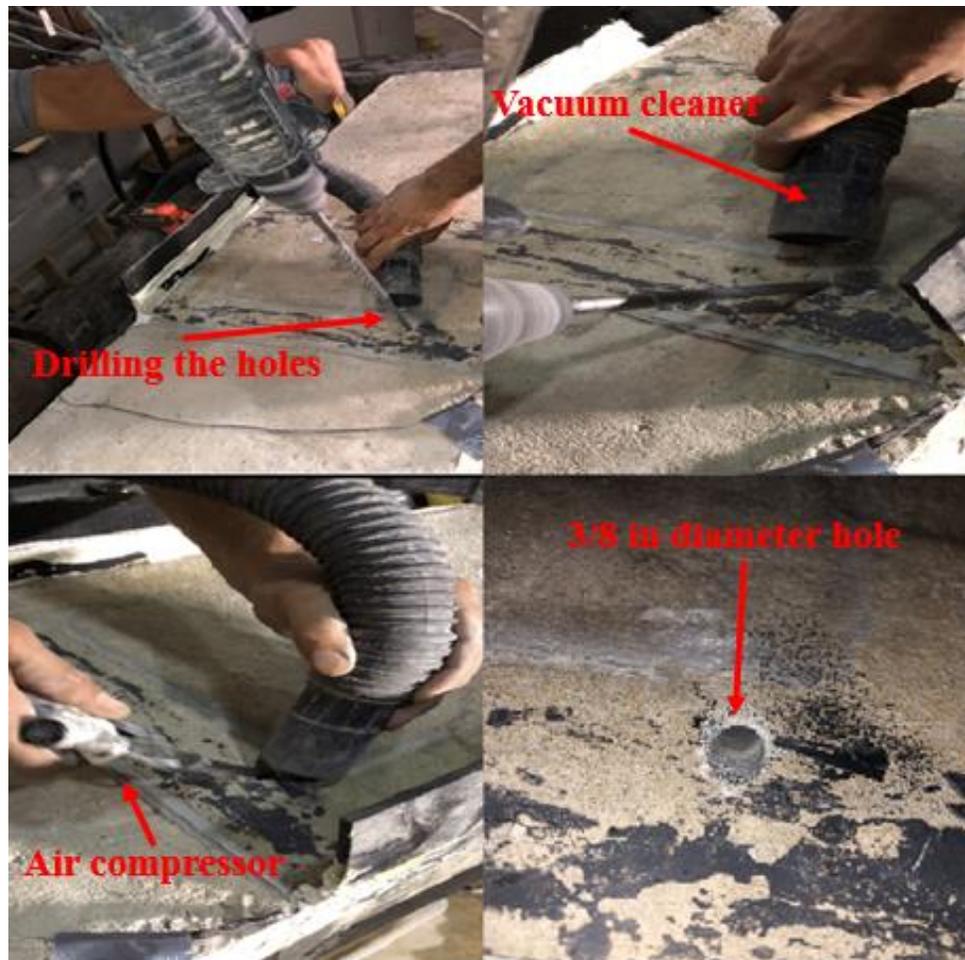
Figure 3-28: Procedure of drilling the NC panel and removing the dust using vacuum cleaner and air compressor

In this experimental program, due to very low viscosity of the epoxy chosen for the repair, the possibility of low-pressure injection was evaluated at first. For this purpose, the specimen was re-loaded up to 200 kN to make a wider crack width. An average crack width of 0.5- 0.55 mm was achieved at this level of loading. Despite the relatively large crack of width 0.5 mm and low viscosity of the epoxy, injection of the epoxy using low-pressure method was not possible. Therefore, high-pressure injection was performed at the same level of loading and crack width. The material properties of the high-strength low-viscosity epoxy used for injection was explained in section 3-2-3. High-pressure injection was performed in the following steps. At first, 3 holes with diameter of 3/8 in were drilled inside the NC panel with different inclinations and lengths. It is worth-mentioning that the holes should pass through the cracked plane to ensure that the injected epoxy will fill the crack. The dust resulted from drilling the concrete was removed by using a

vacuum cleaner as well as air compressor. The procedure of drilling the NC panel and removing the dust is shown in Figure 3-28.

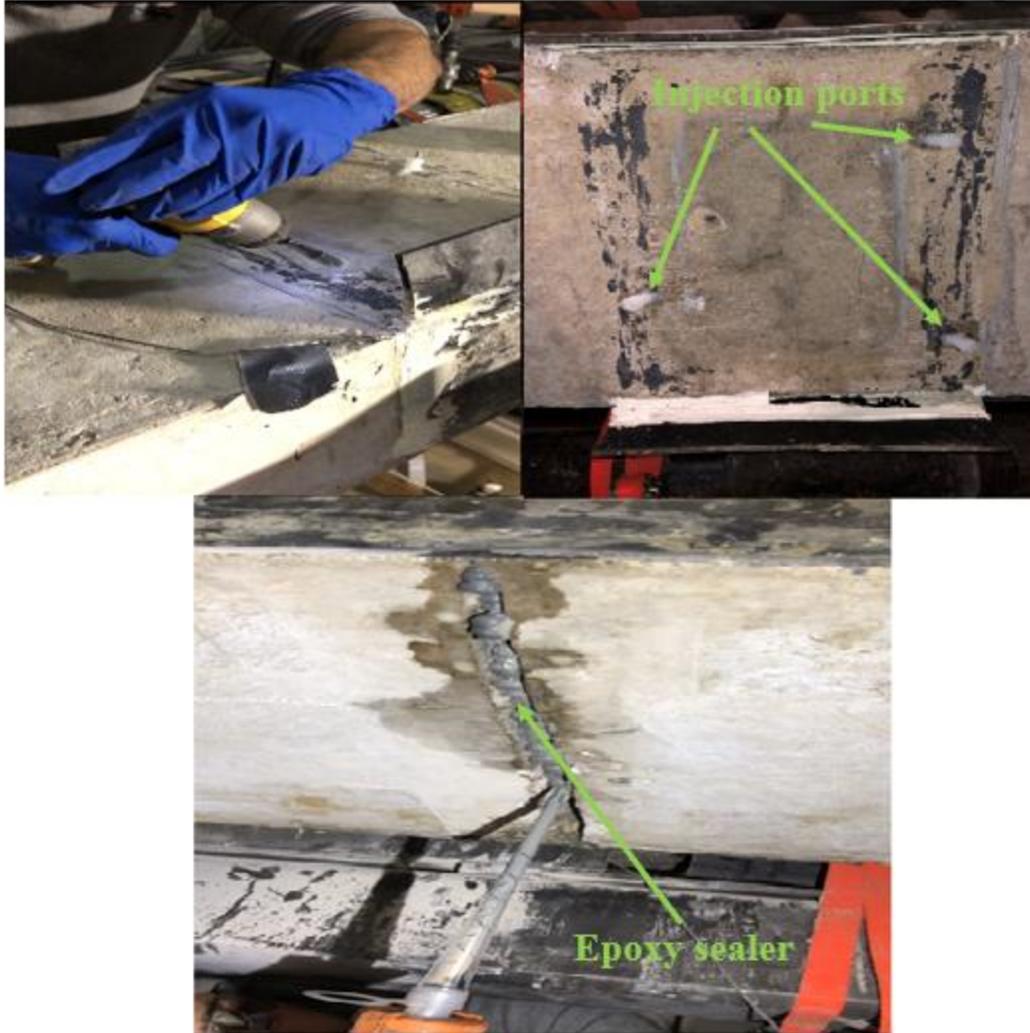
Figure 3-29: Installation of the injection ports on top of the holes and sealing the bottom surface of the NC panel at crack location

In the next step, injection ports were installed on top of the holes. Moreover, the top and bottom surfaces of the panel at cracked section were sealed using an epoxy sealer to form a high-build protective layer on the concrete surface and prevent dripping during the high-pressure epoxy injection. There was no need to seal the sides of the panel as both sides were already sealed using waterproof membrane sheets and a water-resistant adhesive for the leakage test. Figure 3-29 illustrates installing the ports on top of the holes and sealing the bottom surface of the concrete panel at the crack location.
