# **Experimental investigation on repair and self-healing of tension-induced cracks in reinforced concrete panels**

A Thesis

presented to Ryerson University

in partial fulfillment of the requirements for the degree of  
Master of Applied Science in the program of Civil Engineering

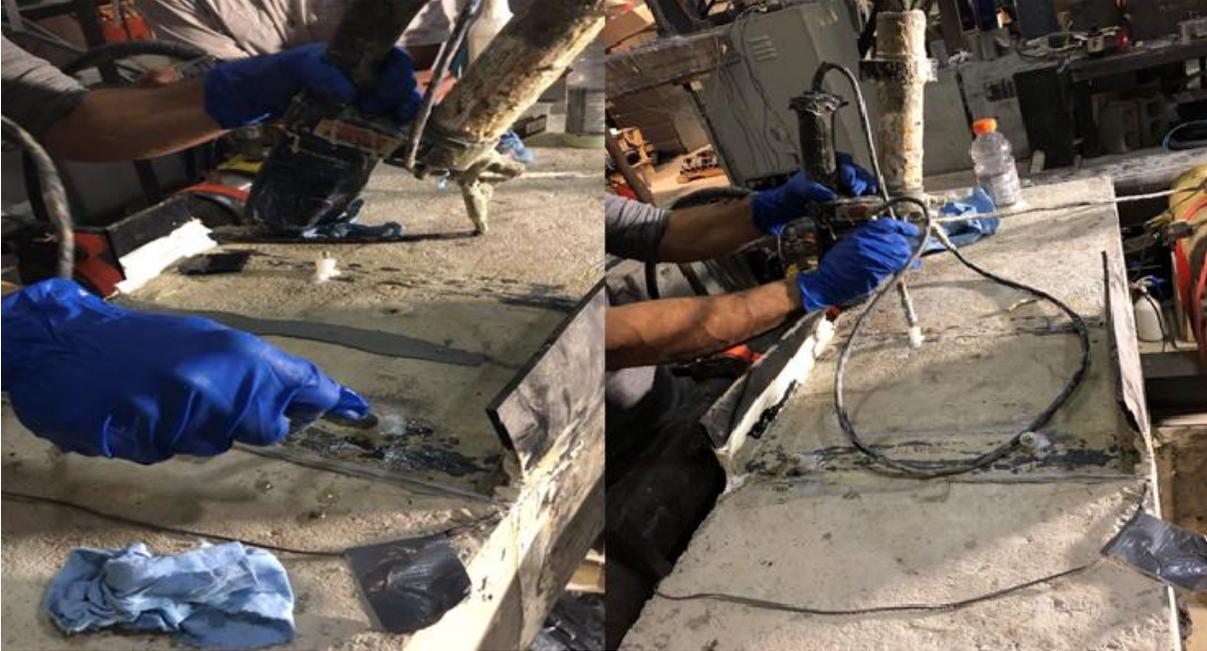
Figure 3-30: High-pressure epoxy injection

Next, epoxy was injected using a high-pressure pump reaching 1000 psi to ensure epoxy filled the entire depth of crack, which is shown in Figure 3-30.

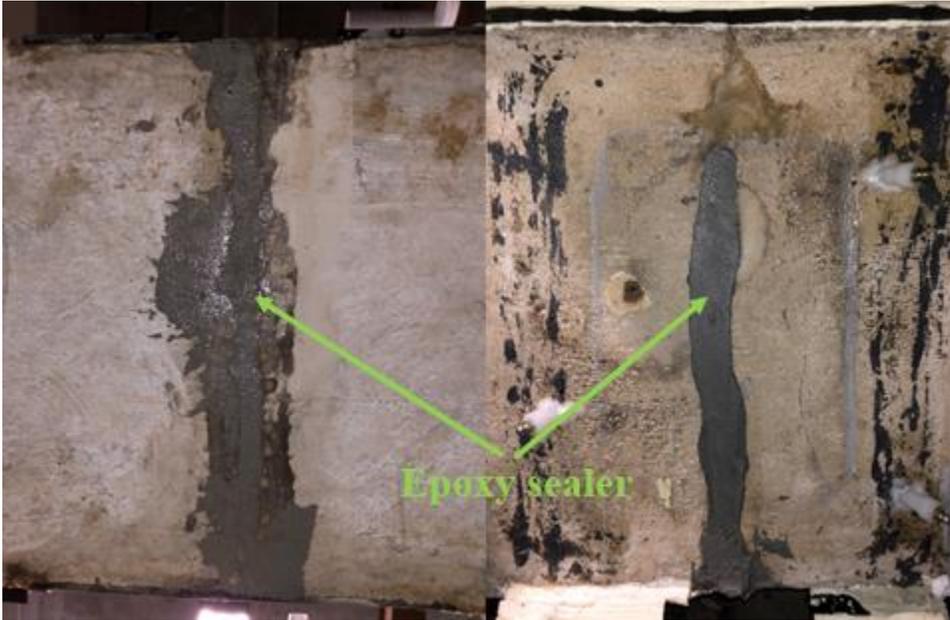
Figure 3-31: Finished surfaces of the NC panel after high-pressure epoxy injection a) Bottom surface b) Top surface

After performing the high-pressure epoxy injection, the tensile load was released which was followed by dripping a few amount of epoxy indicating that the entire depth of the crack was filled with epoxy (residual crack width of 0.22 mm). Then the epoxy was let to cure for two weeks to gain high-strength specified in the data-sheet including high tensile and bond strength. The

finished surfaces of the NC panel at top and bottom after the injection of the epoxy are shown in Figure 3-31.

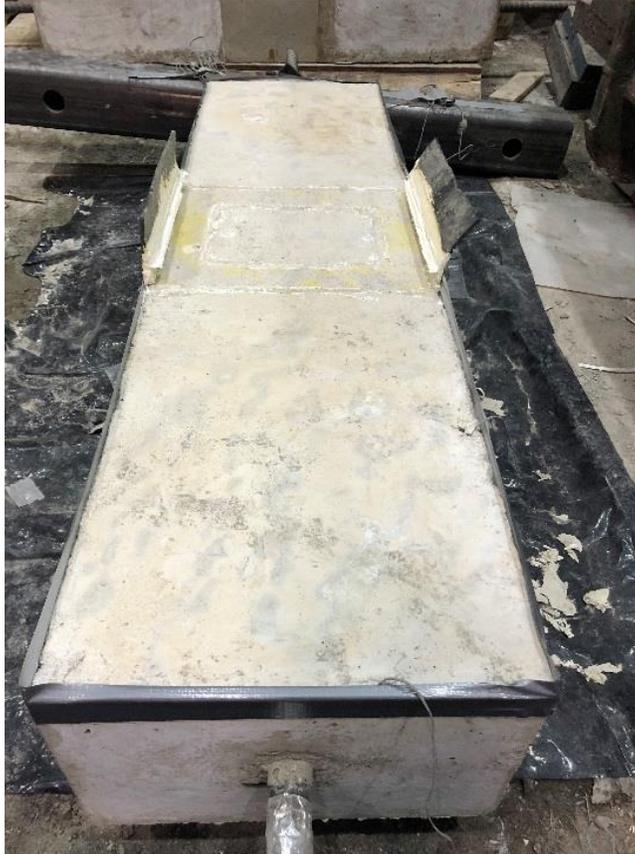
Figure 3-32: Prepared surface of the RC panel for applying GFRP

Glass fiber reinforced polymer (GFRP) laminate was used for this experimental program to repair the NC panels. A unidirectional E-glass type of fiber fabric was used in conjunction with epoxy laminating resin to provide composite strengthening system. Material properties of the E-glass fiber, epoxy resin system, and cured GFRP laminate were discussed in section 3-2-4. It is worth-mentioning that the GFRP laminate was applied on the top surface of the RC panel, where the water pressure is applied, to simulate repairing a water tank by applying the GFRP laminate inside it. Applying the GFRP laminate performed in the following steps. The first step which greatly affects the quality of the repair program is surface preparation. It is common practice to prepare the concrete surface by sandblasting to expose the coarse and fine aggregates according to ACI 546R (2014). The surface of the RC panel was ready enough for proper applying of the GFRP without the need for sandblasting. In the next step, all the dust was removed from the concrete surface using a vacuum cleaner and air compressor. Moreover, the concrete surface must be free from grease and oil and dry with maximum surface moisture less than 4% by weight. Next, the evenness of the RC panel surface was measured by placing a straight edge against the concrete surface. This is an important point to note the uneven surface will result in failure of the GFRP laminate by premature peeling under loading. The prepared surface of the RC panel is shown in Figure 3-32.

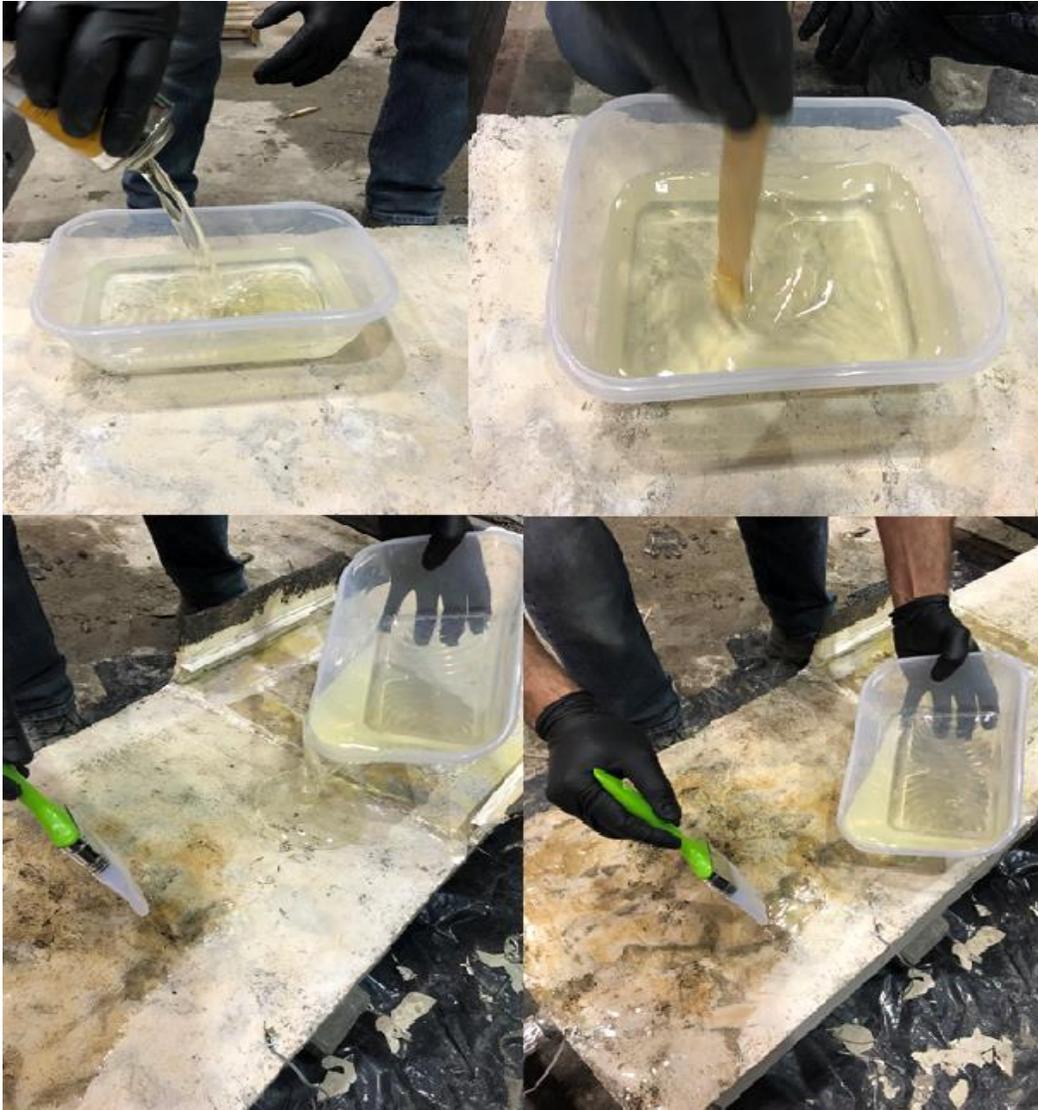
Figure 3-33: Mixing the resin and hardener and applying the epoxy resin system on the top surface of the RC panel

Next, the glass fiber fabrics were wiped out with acetone to remove any other excess residue from it. In the next step, resin and slow hardener were mixed together properly and applied on the entire concrete surface using a painting brush, which illustrated in Figure 3-33.

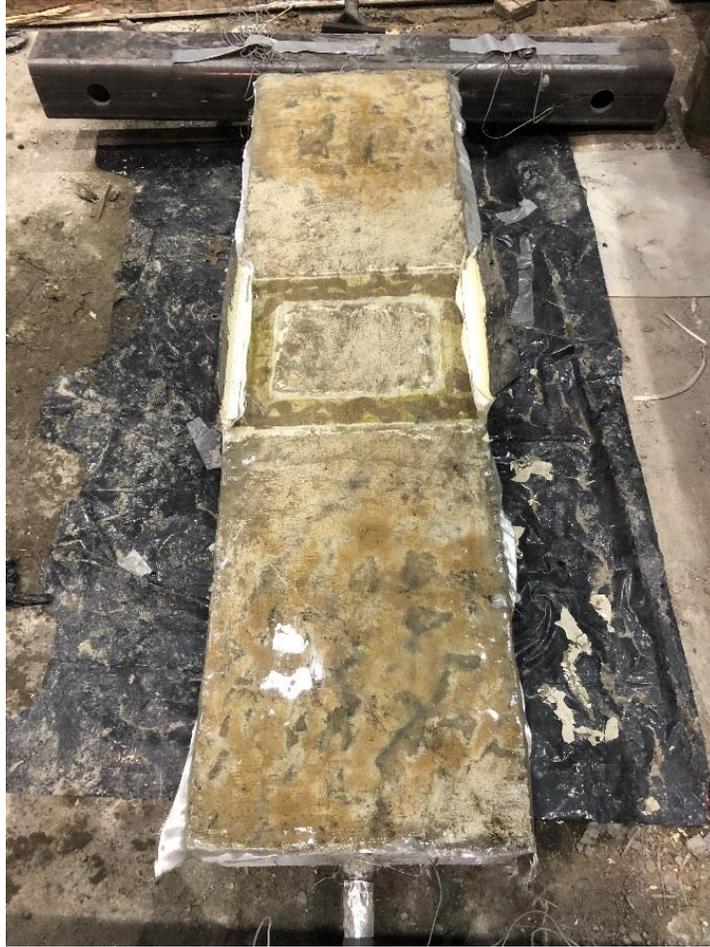
Figure 3-34: Finished surface of the RC after applying the GFRP

In order to prevent the failure of the GFRP laminate and prevent the leakage after repair, and based on the tensile strength of the cured GFRP laminate and nominal laminate thickness and also by considering the maximum load that can be applied on the RC panel, it was decided to use two layers of GFRP. The first layer of GFRP was placed carefully on the surface of the RC panel and pressed in place using a hard rubber roller to remove any possible voids between the GFRP layer and concrete surface. Epoxy resin was applied again and second layer of GFRP was placed followed by applying the epoxy resin using the painting brush. Figure 3-34 shows the finished surface of the RC panel after applying the GFRP.

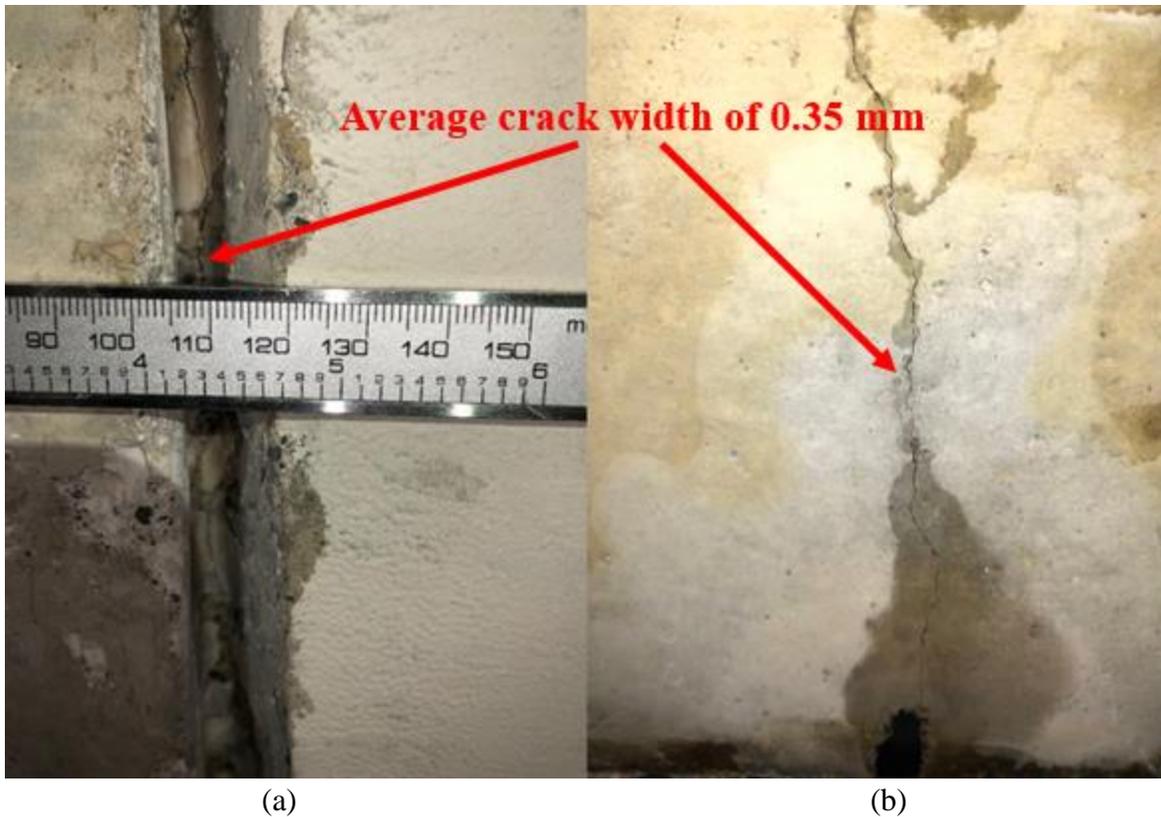
Figure 4-1: NC specimen cracked at mid-span a) Bottom face b) Side face

RC panels made with NC were tested under monotonic tensile loading according to the test procedure and test setup outlined in Chapter 3. Tensile load was applied using the hydraulic jacks to create a full-depth crack at the middle of the specimens, where the notch was placed. Brittle nature of NC resulted in formation of a full depth crack followed by high rate of leakage. Sudden cracking of NC panel along with simultaneous strength failure and leakage initiation indicate how brittle and catastrophic regular RC panels could be in terms of serviceability performance. The load at leakage initiation and the corresponding crack width under direct tensile load as well as the residual crack width in NC panels after releasing the load are presented in Table 4-1. The load at which leakage started varied from 114 kN to 127 kN. NC4 exhibited the highest load of 127 kN, while the lowest load at leakage initiation of 114 kN occurred in NC2. All NC specimens experienced average crack width in the range of 0.3 to 0.4 mm, which provided almost the same condition before repair for all samples and helped to make a better comparison in terms of the efficiency of the repair materials. Figure 4-1 shows NC specimen mid-span crack at bottom and side surfaces.

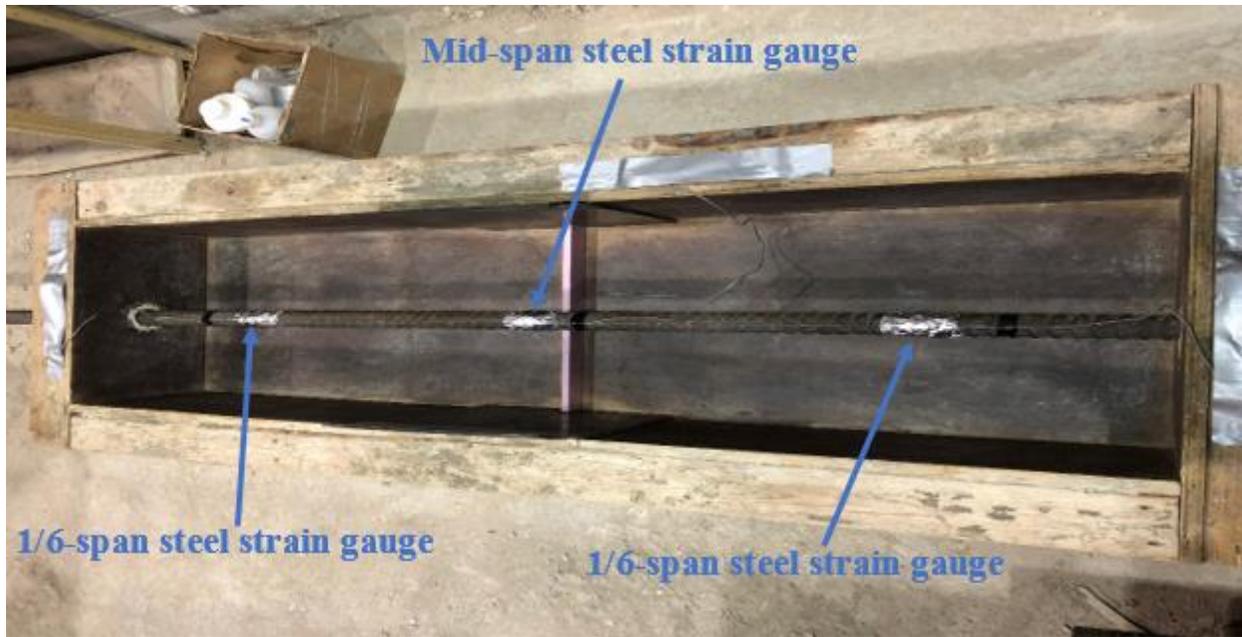
Figure 4-2: Arrangement of steel strain gauges on the rebar

Three steel strain gauges were placed on the single rebar, one in the middle of the sample (notch location), and two other steel strain gauges at 1/6 of the span from each end of the specimen, as shown in Figure 4-2.

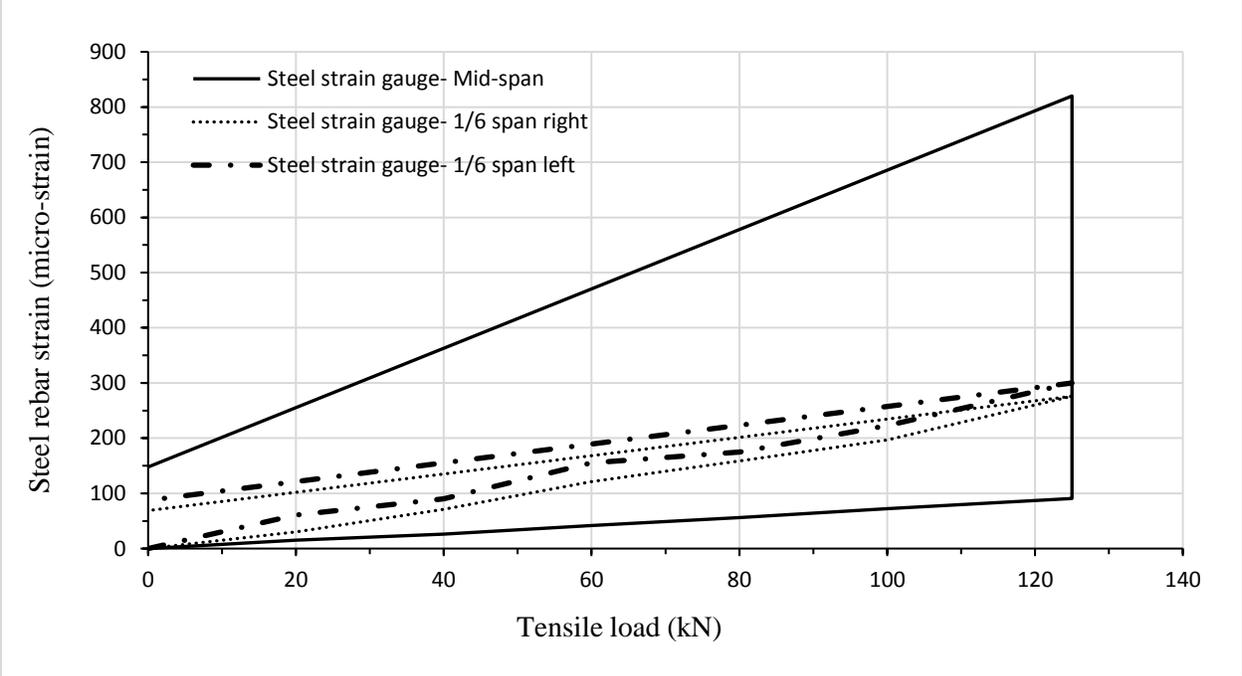
(a) NC1

Figure 4-3: Steel strain development at typical strain gauge in a) NC1 b) NC2 c) NC3 d) NC4 (before repair)

Figures 4-3 (a-d) show the development of tensile steel strain at various locations of the specimens. As expected, the tensile strain increased in the rebar gradually by applying the monotonic tension loading. At this stage of loading concrete section is uncracked and still capable of carrying the tensile load. Therefore, applied tensile load is transferred to the concrete through the bonding between the rebar and concrete. This was followed by a sudden jump of the steel strain (at mid-span) at cracking load of the NC specimens. This can be explained by the fact that after cracking of the concrete section, it is no longer able to carry the tensile load and consequently rebar has to carry all the tension at cracked section at mid-span, where the crack occurred. Since the loading stopped at this stage, no cracking was developed at other locations of the span and that represents the absence of any jump in steel strain at other steel strain gauges. As designed, the tensile strain in the rebar did not reach the yielding strain before the repair in any of the NC specimens. The reason for keeping the rebar strain far less than the yielding strain of the rebar is to prevent possible yielding of the rebar before the repair and to allow the specimens to reach higher levels of loading

after being repaired. The maximum tensile strain occurred at mid-span (crack location) in all NC samples ranged between 750 and 851 micro-strain, which were all less than half of the steel yielding strain with maximum of 851 micro-strain in NC4 and minimum of 750 micro-strain in NC2.

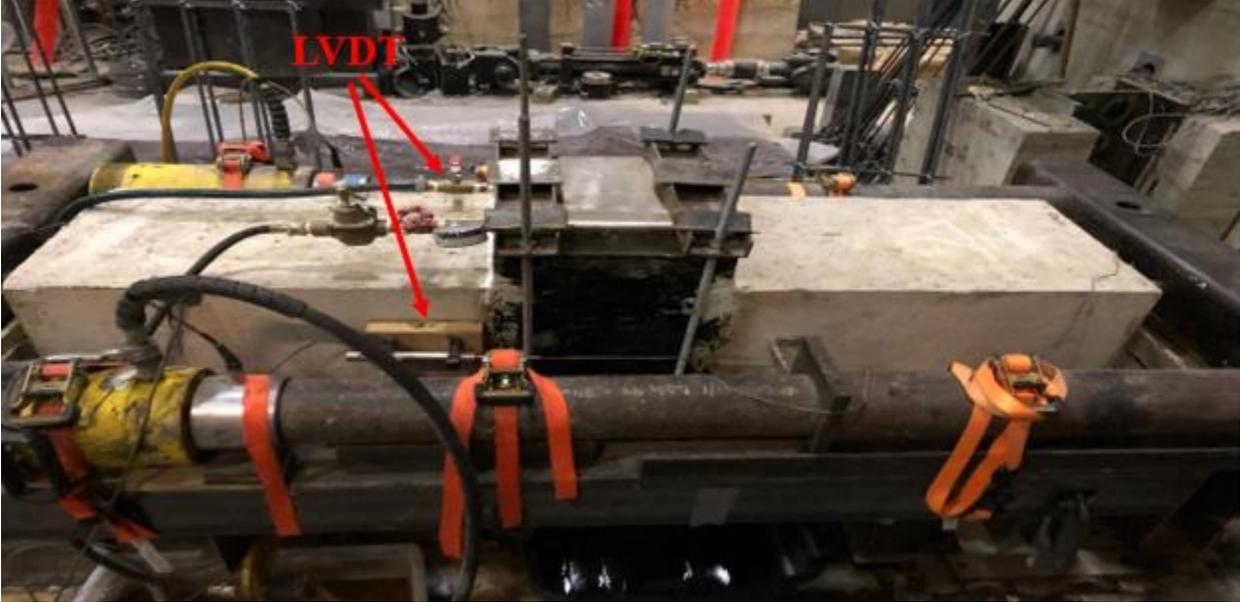
Figure 4-4: Locations of LVDTs at the middle of the specimen

Two LVDTs were attached to the sides of the sample at mid-span to measure the horizontal displacement of the NC specimens with respect to the mid-span (crack location), representing the mid-span crack width, as shown in Figure 4.4. Figures 4-5 (a-d) illustrate the load versus relative horizontal displacement of the NC specimens. The horizontal displacement does not change significantly by applying the tensile load to the specimen. However, a sudden jump can be observed in the load displacement responses at the cracking load of the specimens. This can be explained by brittle cracking of the concrete section at the weakest section (mid-span) resulting in a sharp increase in the horizontal displacement of the samples. The maximum horizontal displacement of the specimens varied from 0.28 mm to 0.38 mm. The lowest horizontal displacement belonged to NC2 with 0.28 mm at the load of 112 kN (mid-span crack width of 0.3 mm), while NC4 experienced the highest horizontal displacement of 0.38 mm at the load of 127 kN (mid-span crack width of 0.35-0.4 mm). The residual horizontal displacement in specimens

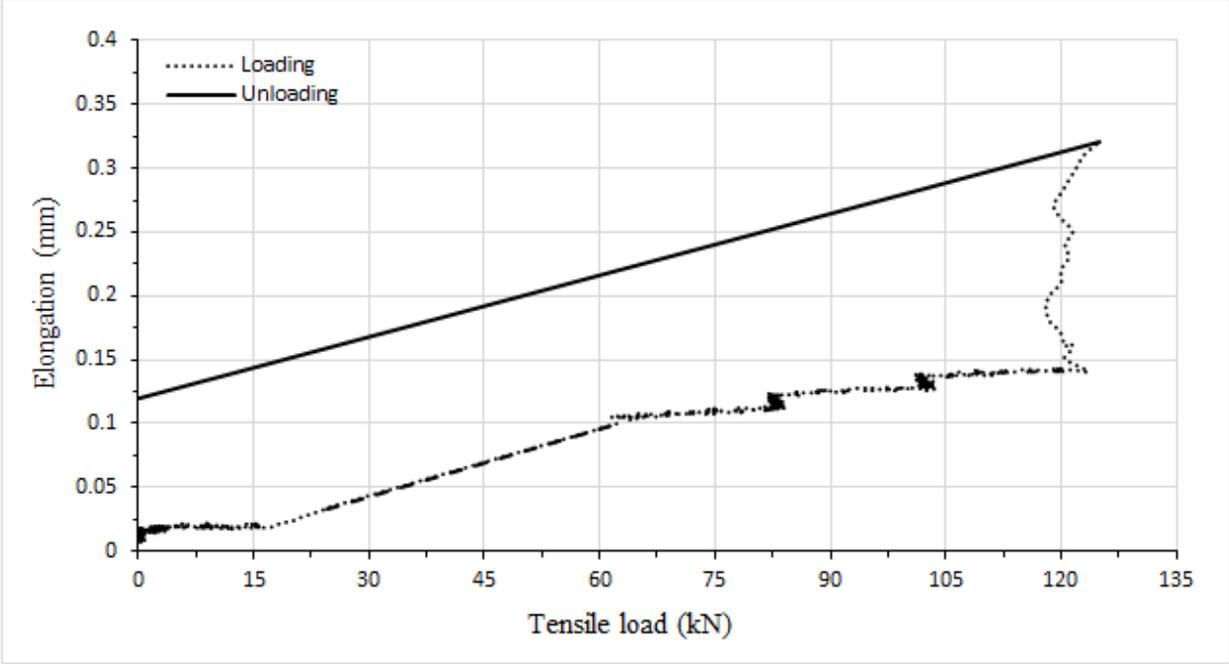
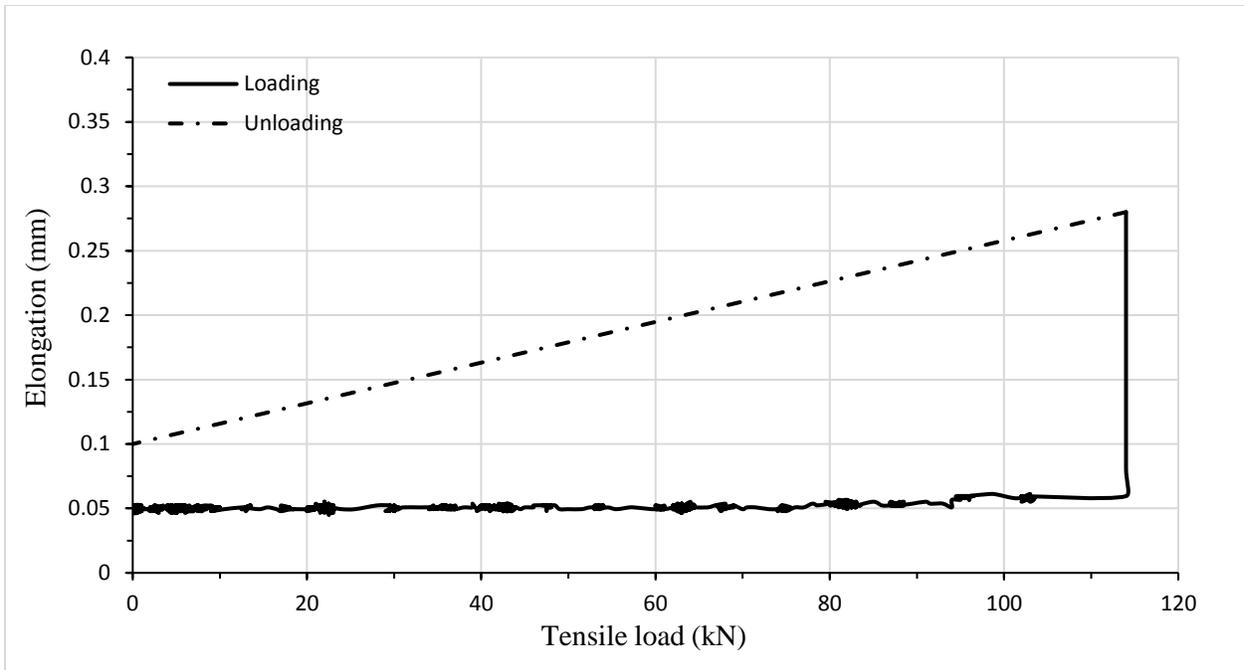
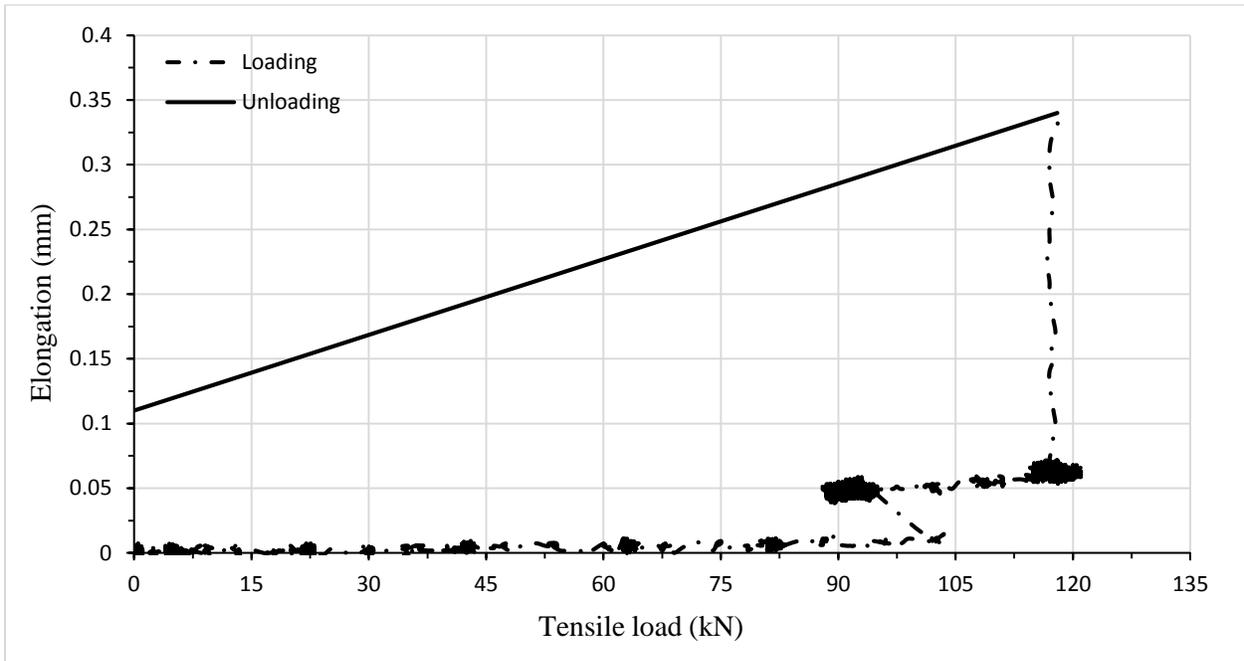
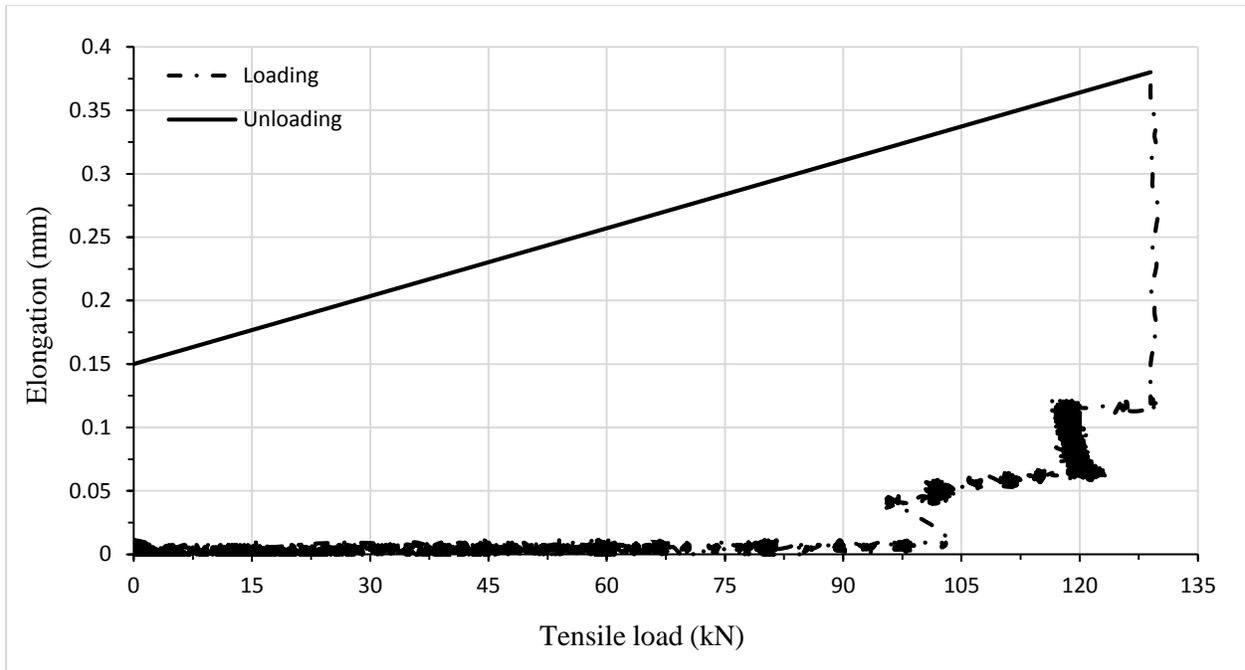
Figure 4-5: Load- relative horizontal displacement at mid-span of a) NC1 b) NC2 c) NC3 d) NC4 (before repair)

after releasing the load ranges between 0.1 to 0.15 mm which is an indication of the residual crack in NC panels (residual cracks ranged between 0.07 to 0.13 mm).

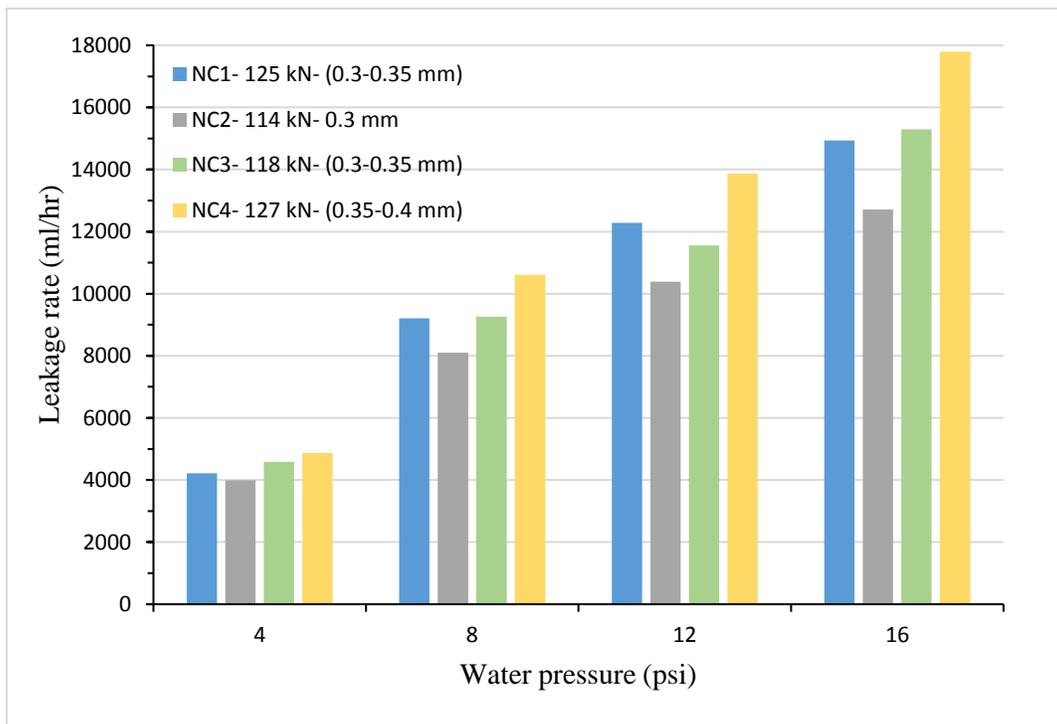
Figure 4-6: Leakage rate of the NC panels under different water pressures

However, NC4 having the highest cracking load and crack width exhibited the highest leakage rate. It can be observed in Figure 4-6 that increasing the water pressure resulted in higher leakage in all NC samples. Leakage rate of the NC1 and NC2 enhanced from 4218 ml/hr to 14935 ml/hr and 3996 ml/hr to 12710 ml/hr, respectively, by increasing the water pressure from 4 psi to 16 psi. Furthermore, increasing the water pressure from 4 psi to 16 psi enhanced the leakage rate of NC3 and NC4 from 4589 ml/hr to 15295 ml/hr and 4870 ml/hr to 17790 ml/hr, respectively. Figure 4-7 illustrates the high rate of leakage in NC samples before the repair.

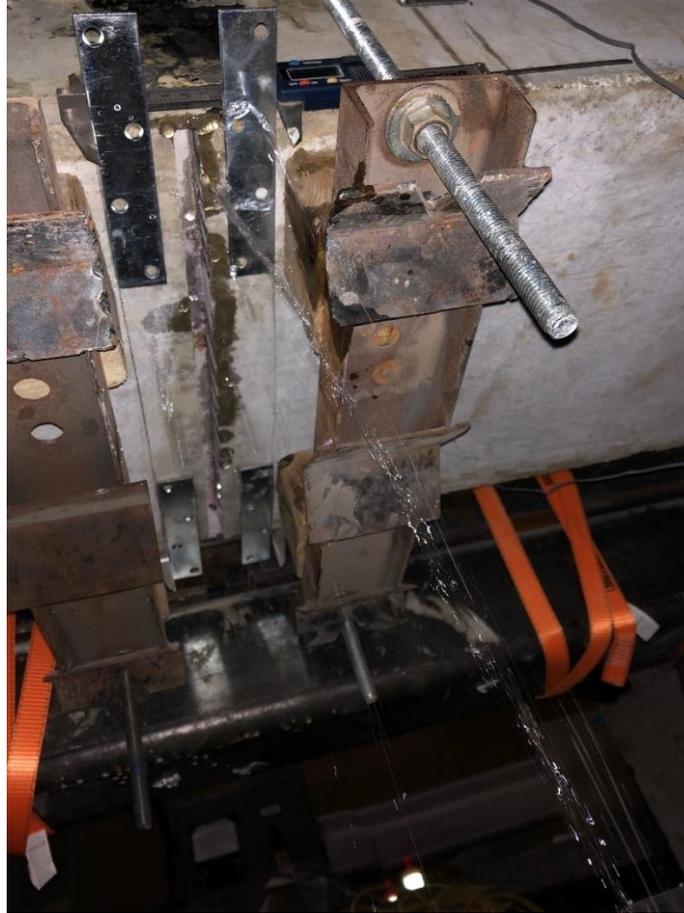
Figure 4-7: Extensive leakage in NC specimens at crack initiation (before repair)

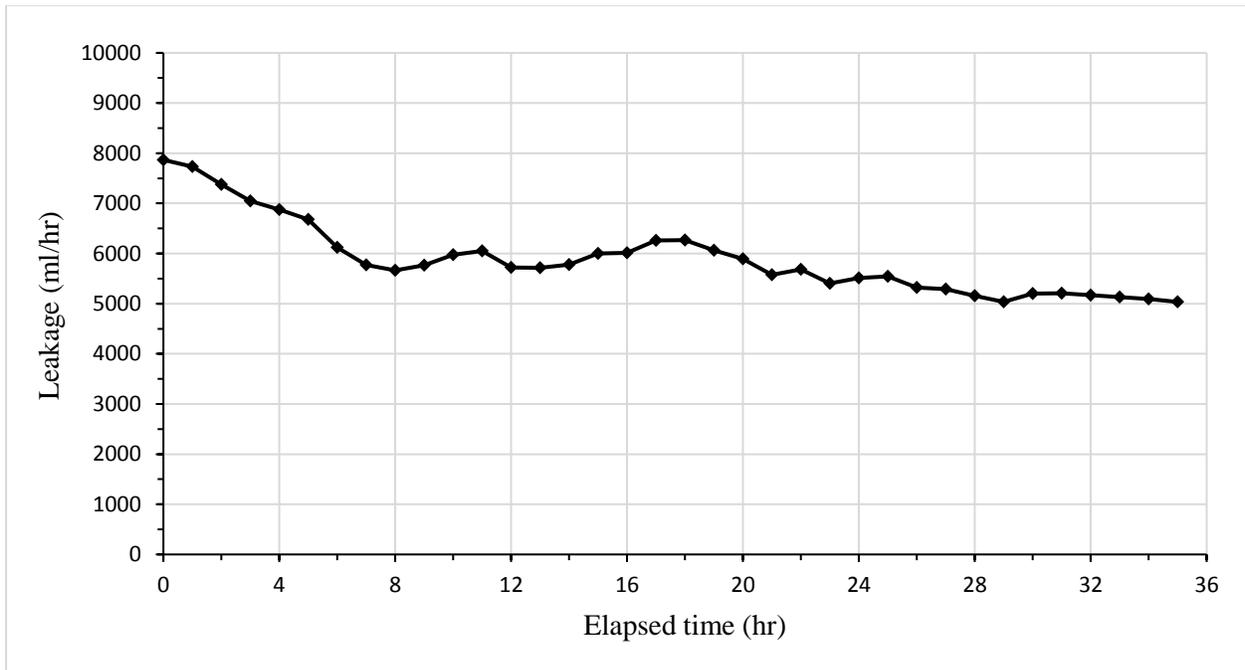
Figure 4-8: Short-term self-healing of NC2 sample (before repair)

Self-healing ability of the NC panels was investigated by monitoring the leakage rate of the NC2 under water pressure of 7 psi (48.27 kPa or 4.93 m height of water) and sustained monotonic tensile loading of 114 kN. For this purpose, after measuring the leakage rate of the samples under different water pressure, the water pressure was fixed at 7 psi and the leakage rate was recorded to attain a constant leakage rate or 100% self-healing of the tension-induced cracks. As the time prolonged, tension induced crack started to heal and resulted in reducing the leakage rate. Short-term self-healing of the NC2 specimen during the first 35 hours is shown in Figure 4-8. The leakage rate

decreased from 7867 ml/hr to 5035 ml/hr by 36% during the first 35 hours of leakage monitoring. NC2 sample exhibited a significant reduction of 19% in the leakage rate during the first 8 hours. It means that NC2 experienced almost 50% of the short-term self-healing (35 hours) during the first 8 hours. This can be explained by the fact that there are more available un-reacted cementitious materials during the first few hours to hydrate and block the water pathway through the crack by self-healing products. Therefore, self-healing rate decays over time.

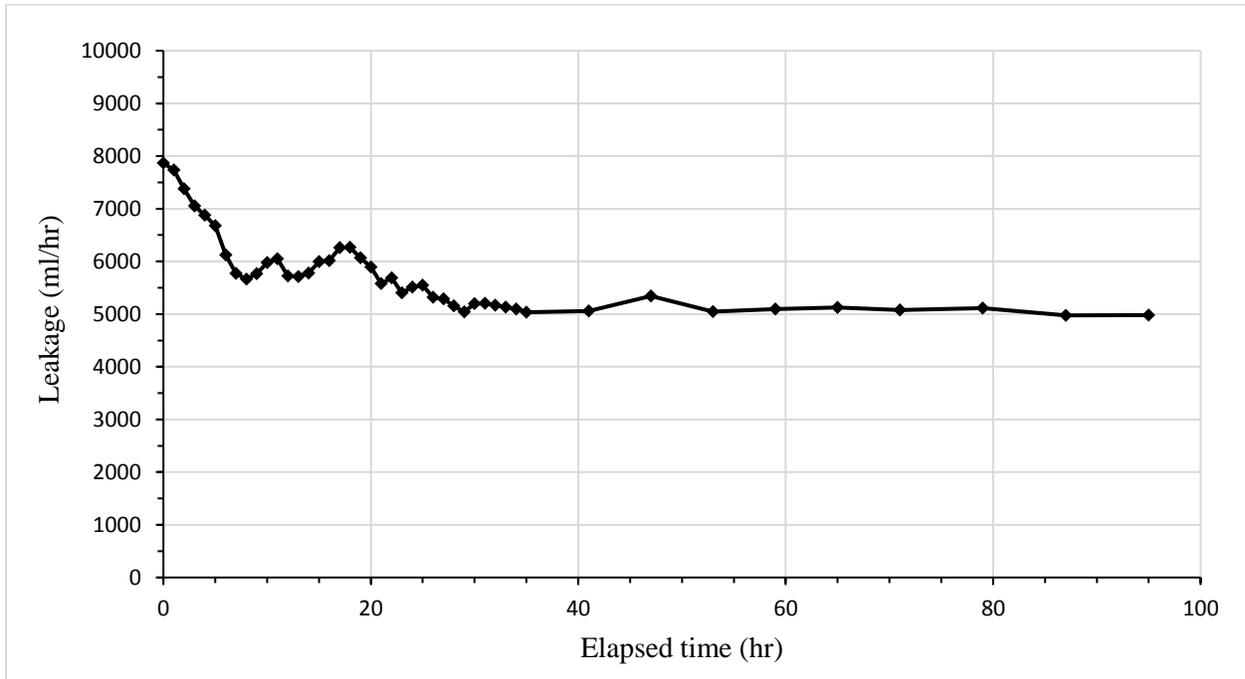
Figure 4-9: Long-term self-healing of NC2 sample (before repair)

Long-term self-healing of the NC2 specimen is illustrated in Figure 4-9. No significant change in the leakage rate was observed after 35 hours of monitoring the leakage. Therefore, recording the leakage rate was stopped after 4 days (95 hours). Leakage rate of the NC2 sample decreased from 7867 ml/hr to 4983 ml/hr by 37% after 4 days. It means that there was no significant change in the leakage rate of the NC2 sample after 35 hours up to 95 hours. NC2 sample achieved a total self-

healing of 35%, which occurred mostly during the first 35 hours. It is also interesting to note that 19% out of this 35% happened during the first 8 hours.

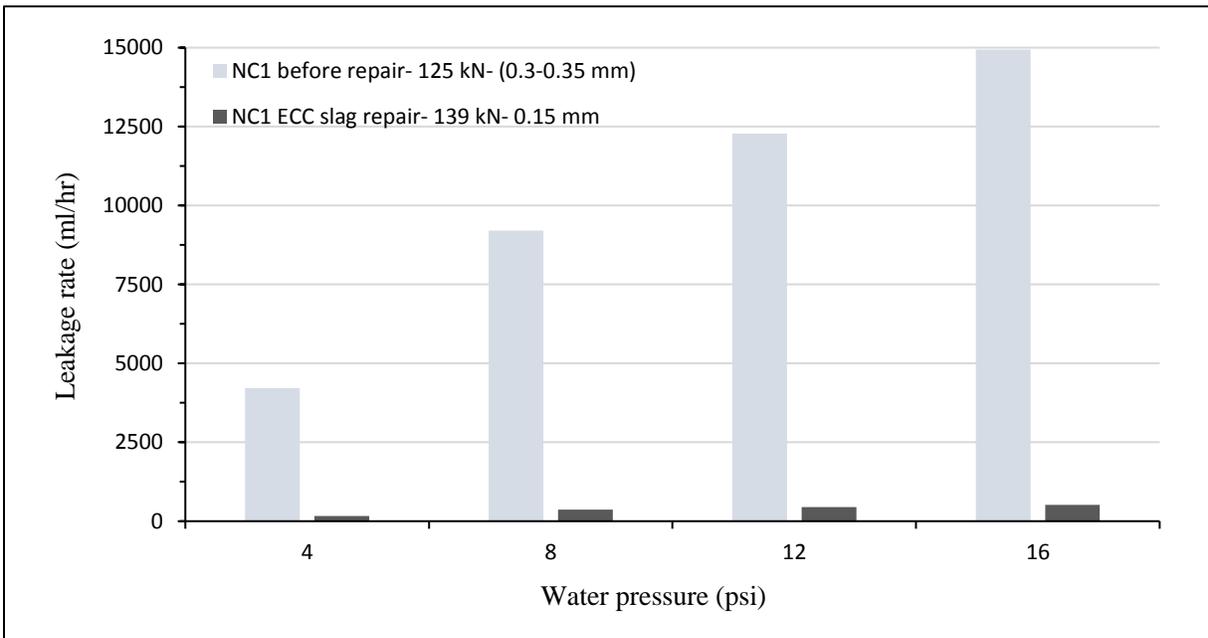
Figure 4-10: Comparison of the leakage behavior of NC before and after repair using ECC slag

At this level of loading, the leakage rate was measured under different water pressures. Figure 4-10 presents the leakage rate in NC1 panel repaired with ECC slag at the loading stage of 139 kN under various water pressures of 4, 8, 12, and 16 psi and compares to the leakage rate under the

same water pressures in NC1 before repair at the loading stage of 125 kN. It can be observed that the leakage rate was significantly decreased after repairing the NC1 specimen with ECC slag even at a higher level of loading. To illustrate, leakage rate of the NC1 sample was recorded as 4218, 9210, 12278, and 14935 ml/hr before the repair under water pressures of 4, 8, 12, and 16 psi, respectively, while the leakage rate considerably reduced to the values of 166, 368, 446, and 517 ml/hr under 4, 8, 12, and 16 psi water pressures in NC1 repaired with ECC slag. Considerably lower leakage rate in NC1 repaired with ECC slag compared to NC1 before repair can be attributed to the presence of micro-cracks in ECC layer. Therefore, water should penetrate through the full depth of micro-cracks in ECC layer, passing through the bond between the ECC layer and NC panel, and travel the depth of the NC panel to leak from the bottom face of the NC panel. This mechanism potentially reduced the leakage rate of the NC1 panel repaired with ECC slag. Figure 4-11 shows the leakage rate of NC1 specimen repaired with ECC slag under water pressure of 8 psi.

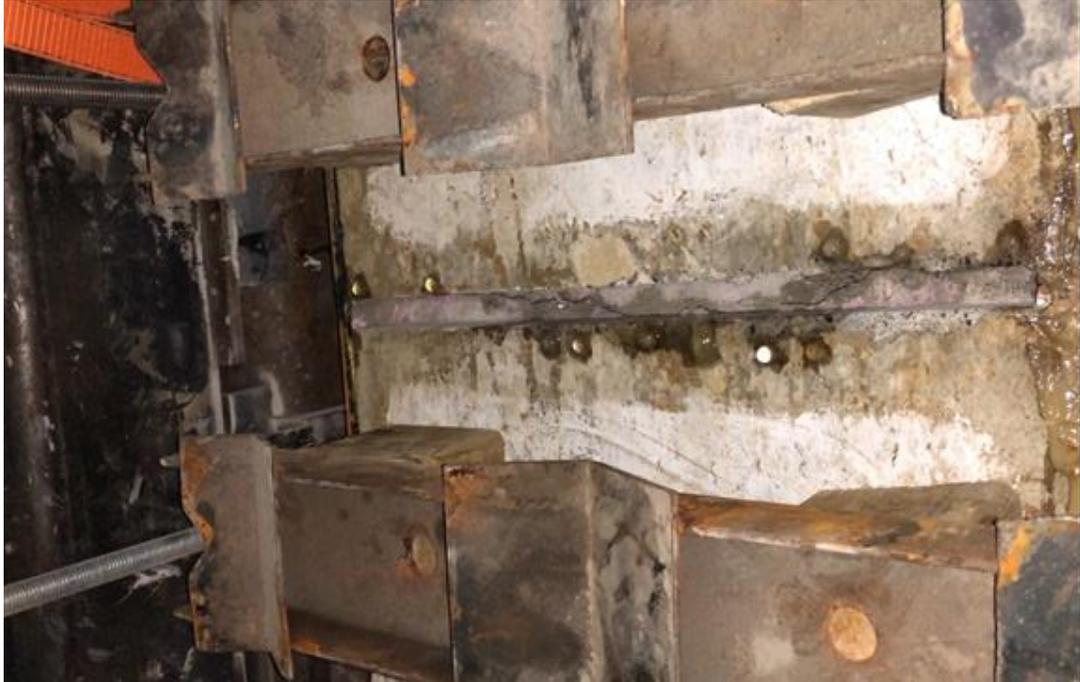
Figure 4-11: Leakage of the NC1 specimen repaired using ECC slag under 8 psi water pressure (bottom face)

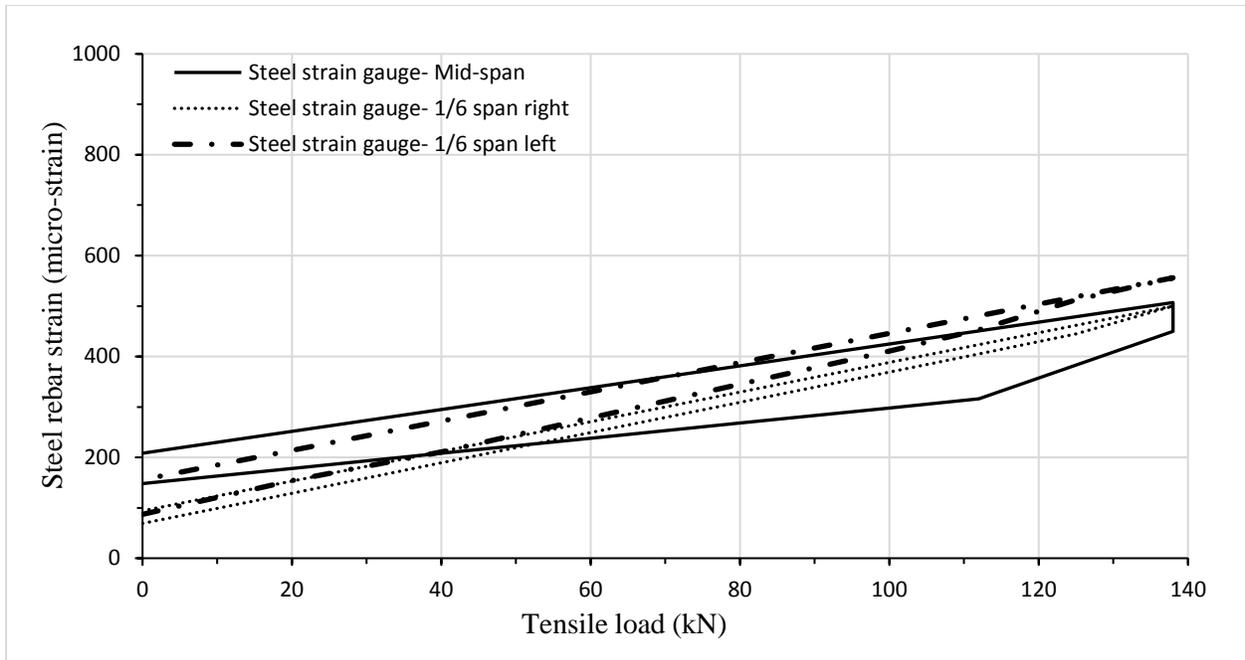
Figure 4-12: Tensile steel strain development in NC1 repaired using ECC slag

Tensile steel strain development in NC1 repaired with ECC slag is shown in Figure 4-12. It is worth mentioning that steel strain shown in the Figure includes the residual strain from previous stage of loading (before repair). Tensile strain gradually increased in the rebar by applying the direct tensile loading on the specimen. At this level of loading, NC panel is cracked at midspan and has no contribution in carrying the tensile load, while ECC repair layer is uncracked and cooperates in carrying the tension along with the rebar. Therefore, the tensile load is transferred from the rebar embedded in the NC panel to the ECC repair layer through the bond between the rebar and NC panel and the bonding between the NC panel and ECC repair layer. At 1/6 span, where two steel strain gauges were placed, both NC panel and ECC repair layer are uncracked and active in tension. Tensile strain in the rebar increased more rapidly by the formation of micro-cracks in ECC repair layer at mid-span.

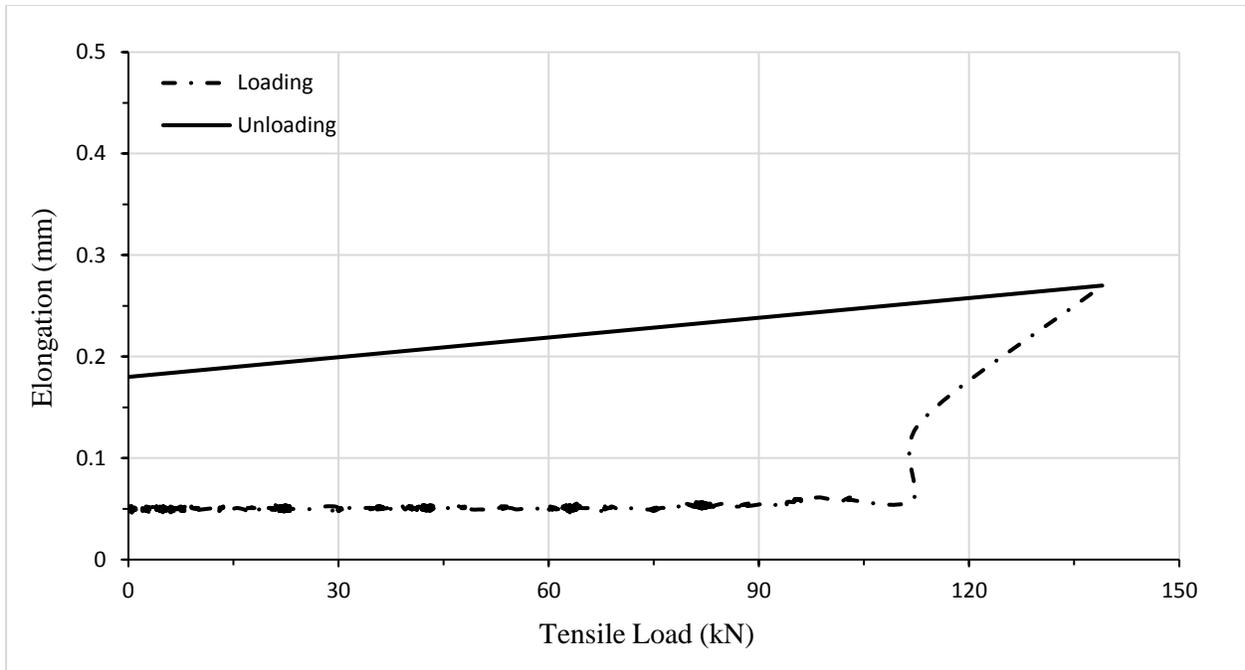
Figure 4-13: Tensile load versus relative horizontal displacement of the repaired NC1 panel with respect to the mid-span (crack location)

Figures 4-13 illustrates the load versus relative horizontal displacement of the repaired NC1 panel with respect to the mid-span (crack location). As the LVDTs were attached to the ECC repair layer, horizontal displacement started from zero excluding the residual crack width in NC1 panel from previous stage of loading. The horizontal displacement of ECC repair layer increased by formation of micro-cracks in ECC repair layer due to increasing the tensile loading. Gradual formation of micro-cracks in ECC layer with limited width of 0.05 to 0.15 mm resulted in horizontal displacement of 0.27 mm in ECC layer with respect to the mid-span.

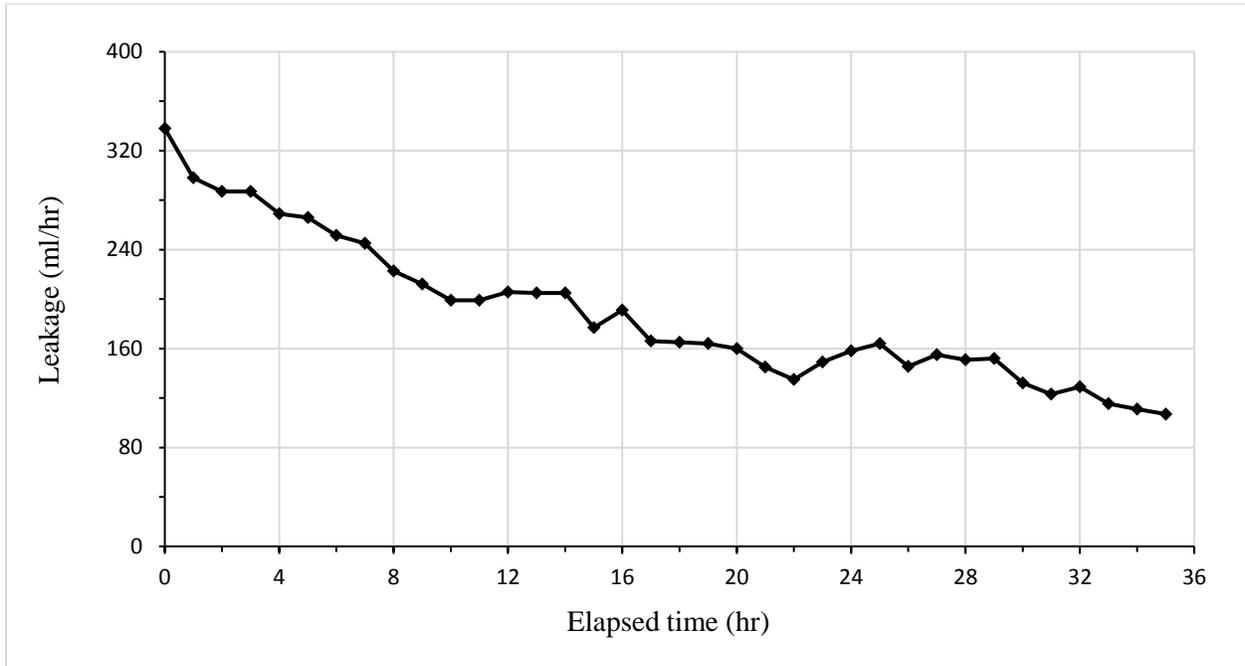
Figure 4-14: Short-term self-healing of the NC1 repaired using ECC slag

After measuring the leakage rate of the NC1 repaired with ECC slag, water pressure in the chamber was set to 7 psi to investigate the self-healing behavior of the 50 mm ECC repair layer on top of the NC panel under a constant load of 139 kN and fixed water pressure of 7 psi. For this purpose, leakage rate of the NC1 repaired with ECC slag was recorded continuously to achieve a constant leakage rate or to attain 100% self-healing of the tension cracks. As the time prolonged, tension induced crack started to heal and resulted in reducing the leakage rate. In short-term investigation of the self-healing, the amount of water penetrated through the full depth of the tension cracks in ECC slag repair layer and NC panel and leaked from the bottom surface on the NC panel was measured over a one-hour time intervals. Short-term self-healing of the NC1 repaired with ECC slag during the first 35 hours is shown in Figure 4-14. The leakage rate reduced by 68% from 338 ml/hr to 107 ml/hr during the first 35 hours. A sharp drop was observed in leakage rate during the first 10 hours in which the leakage rate decreased by 41% from 338 ml/hr to 199 ml/hr. The rate of leakage reduction subsided as the time prolonged which is due to reduction in self-healing

capacity of ECC repair layer and NC panel over time. This can be explained by the fact that there are less available cementitious materials over time to participate in self-healing of the concrete panels.
