# **Experimental investigation on repair and self-healing of tension-induced cracks in reinforced concrete panels**

A Thesis

presented to Ryerson University

in partial fulfillment of the requirements for the degree of  
Master of Applied Science in the program of Civil Engineering

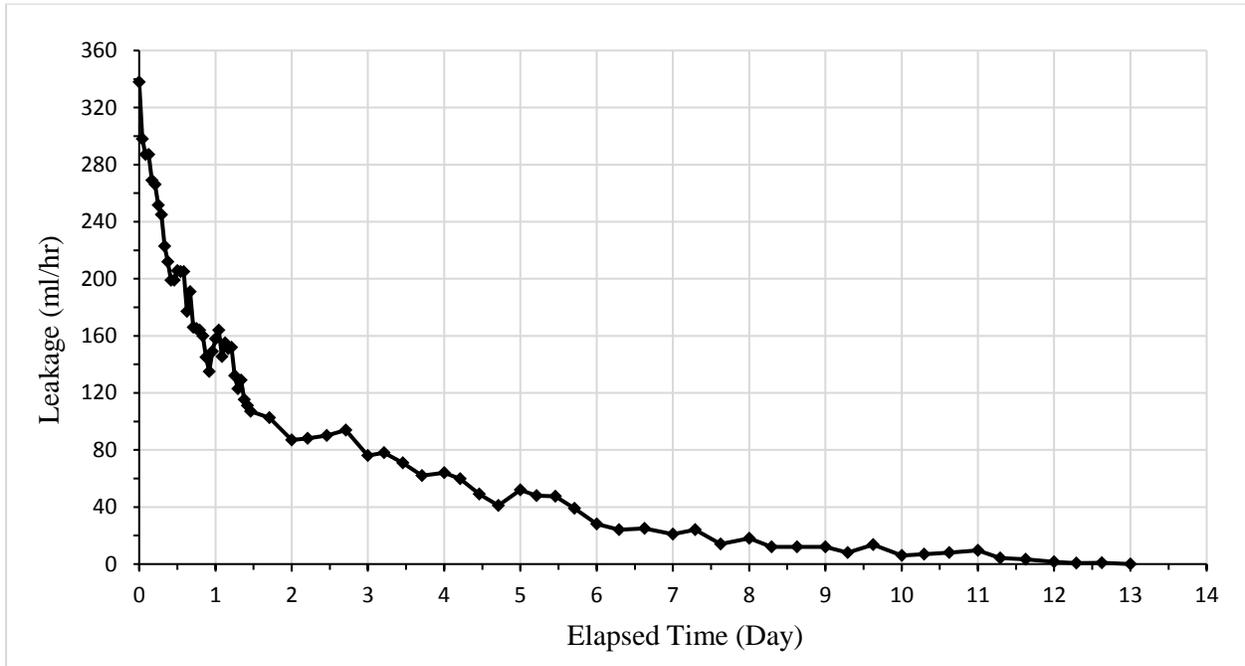
Figure 4-15: Long-term self-healing of the NC1 repaired using ECC slag

Figure 4-15 illustrates the long-term self-healing of the NC1 repaired with ECC slag over the period of 13 days. During the first 35 hours, leakage was recorded continuously each hour, while during the period of time between 35 hours up to 6 days (144 hours), leakage rate was measured for one hour in each 6 hours, followed by the last period of time from 6 days (144 hours) to 13 days (312 hours), leakage rate was recorded for one hour in each 8 hours. Leakage rate in the NC1 repaired with ECC slag reduced to zero after 13 days of monitoring the leakage rate which indicates the water flow with pressure of 7 psi was completely blocked by the self-healing products. Blockage of the water flow could occur either in the ECC repair layer or in the interface between ECC repair layer and NC panel. Achieving the zero-leakage rate is not necessarily an indication of 100% self-healing of the full depth crack in ECC repair layer and NC panel. It is worth-

mentioning that obstruction created by self-healing products in partial depth of the section or in the interface of ECC repair layer and NC panel can prevent the leakage and make flow of water through the depth of the section impossible.

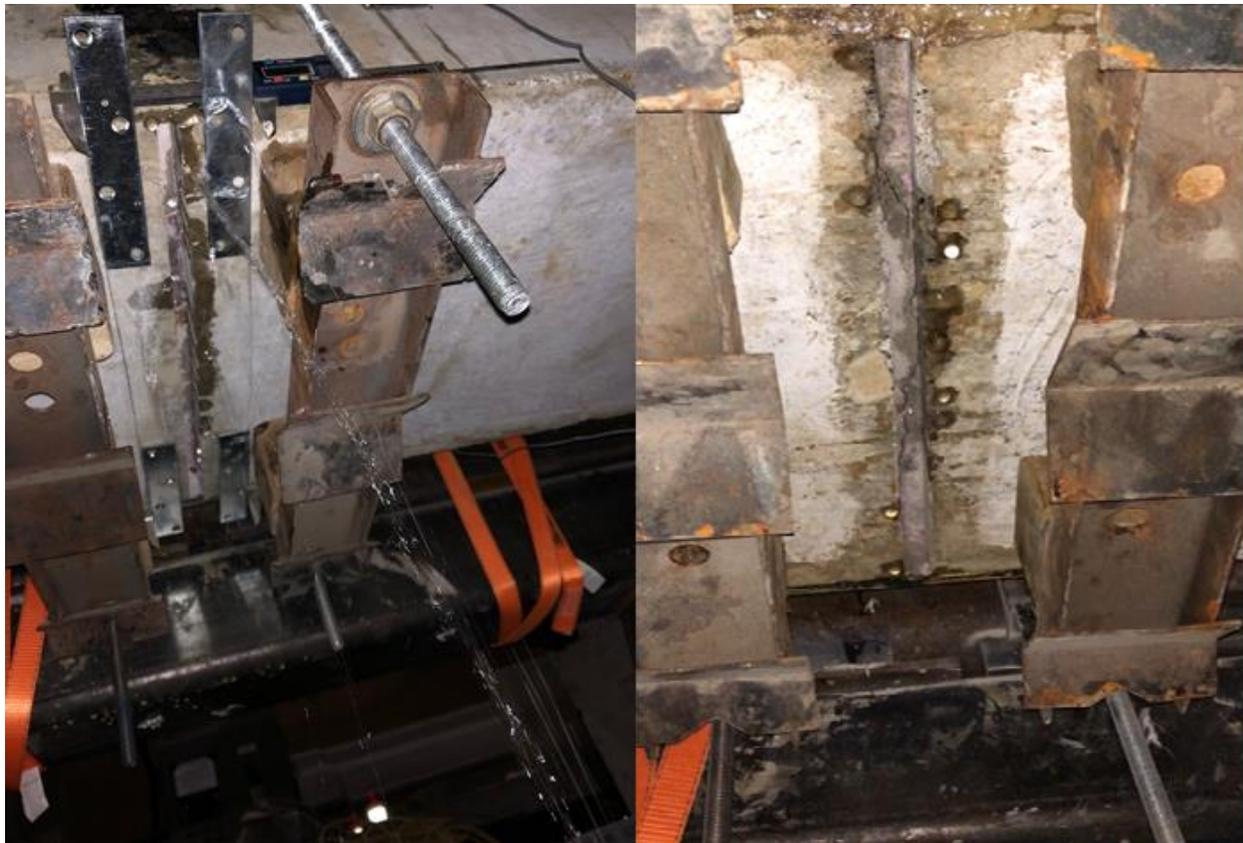
Figure 4-16: Leakage of the NC panel before and after repair using ECC slag a) Before repair b) After repair

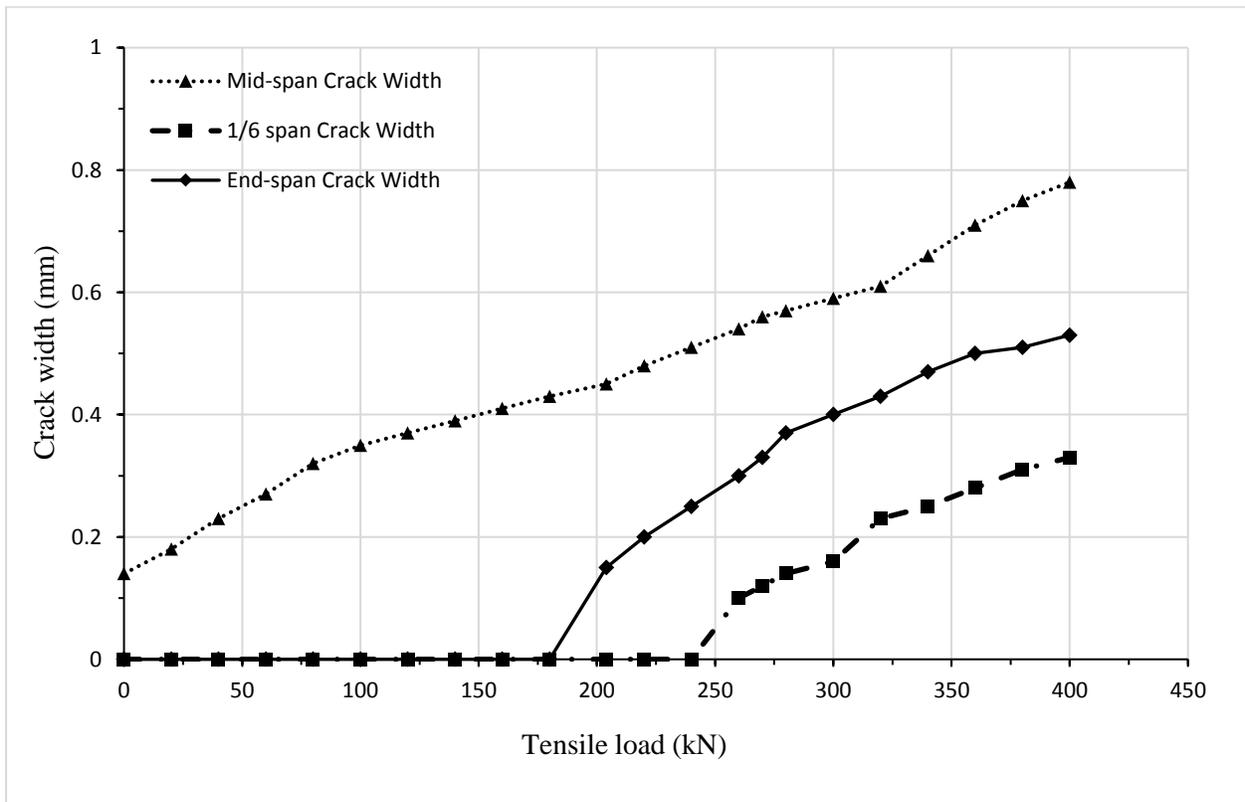
Figure 4-17: Tensile load vs. crack width of the NC2 specimen repaired using GFRP laminate

Failure of the repaired specimen was governed by rebar yielding rather than GFRP laminate tensile rupture or debonding at the interface of GFRP and concrete substrate. Table 4-6 and Figure 4-17 present the average crack width at mid-span, 1/6-spans from the ends, and both end-spans of the NC2 specimen repaired with GFRP laminate at each stage of loading.

It can be observed that the mid-span crack width increased from the residual crack width of 0.14 mm, at the beginning of loading, to 0.78 mm at 400 kN. At the loading stage of 204 kN, bond slip

occurred between the rebar and concrete at both ends of the specimen simultaneously along with a crack as wide as 0.15 mm propagating toward top and bottom surfaces of the NC panel. At this stage of loading, no cracking was observed at 1/6-span and average crack width at mid-span was equal to 0.45 mm. By increasing the tensile load, developed cracks at both ends propagated along the longitudinal direction of the specimen toward mid-span at bottom face. At loading stage of 260 kN, bottom surface cracks propagated in transverse direction (extended to the entire width) causing cracks as wide as 0.1 mm at distance of 205 mm from the north end and 215 mm from the south end of the specimen (almost at 1/6 of the span from the ends). At this stage of loading crack widths at mid-span and end-span were 0.54 mm and 0.3 mm, respectively. By further enhancing the direct tensile loading, cracks widths at mid-span, 1/6-span, and end-span increased gradually reaching 0.78 mm, 0.33 mm, and 0.53 mm at 400 kN, respectively.

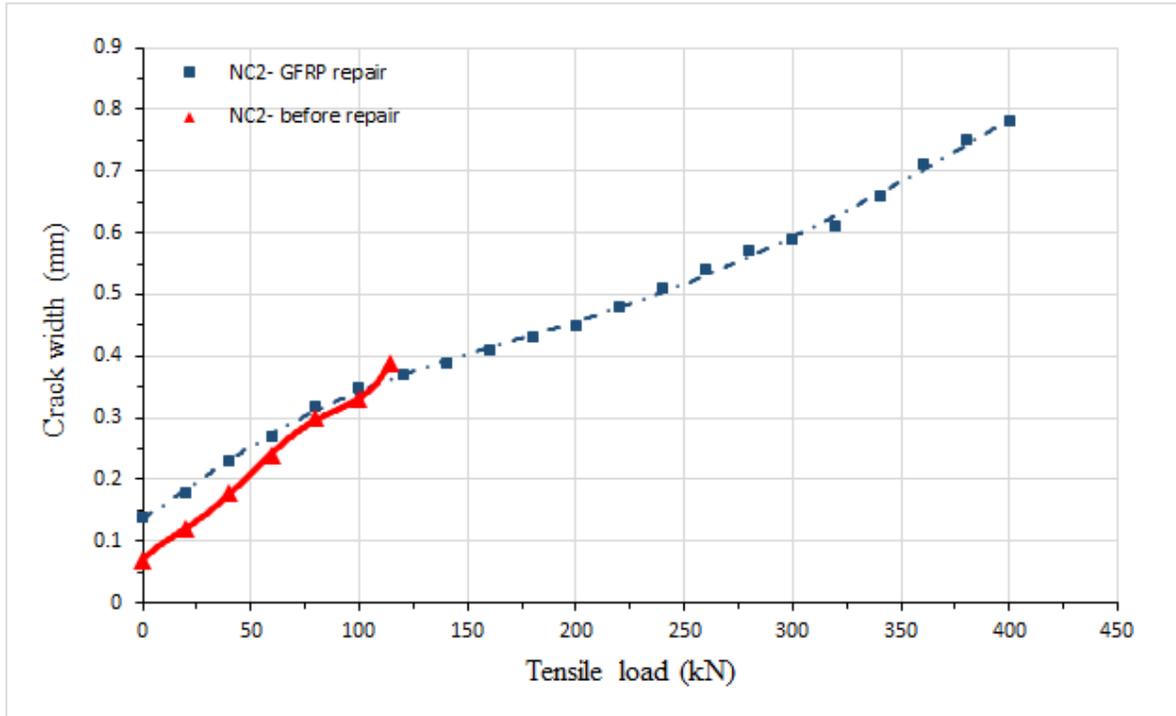
Figure 4-18: Mid-span crack width in NC2 panel before and after GFRP repair

For the purpose of investigating the effect of GFRP laminate on crack width development in the GFRP repaired specimen, a comparison is made between the crack width results in NC2 panel before and after repair using GFRP at various loading stages as shown in Figure 4-18. For this purpose, after measuring the leakage rate of the NC2 panel (before repair), it was re-loaded up to 114 kN to obtain the mid-span crack growth data under direct tensile loading. A residual crack width of 0.14 mm was resulted from this stage of loading. It can be observed that in the range of tensile load lower than 110 kN, crack width developed at mid-span in GFRP repaired specimen is slightly greater compared to NC panel before the repair. This can be attributed to the residual crack width, residual tensile strain in the rebar, and non-recoverable bond-slip between the rebar and concrete resulted from stages of loading before repair. This is an indication of the fact that GFRP laminate has less restraining effect on crack width development at lower range of tensile loads due to initial bond slippage in the interface between the GFRP laminate and concrete surface. However, by increasing the tensile load up to 400 kN, GFRP laminate exhibited more significant restraining effect on mid-span crack width of the NC panel.

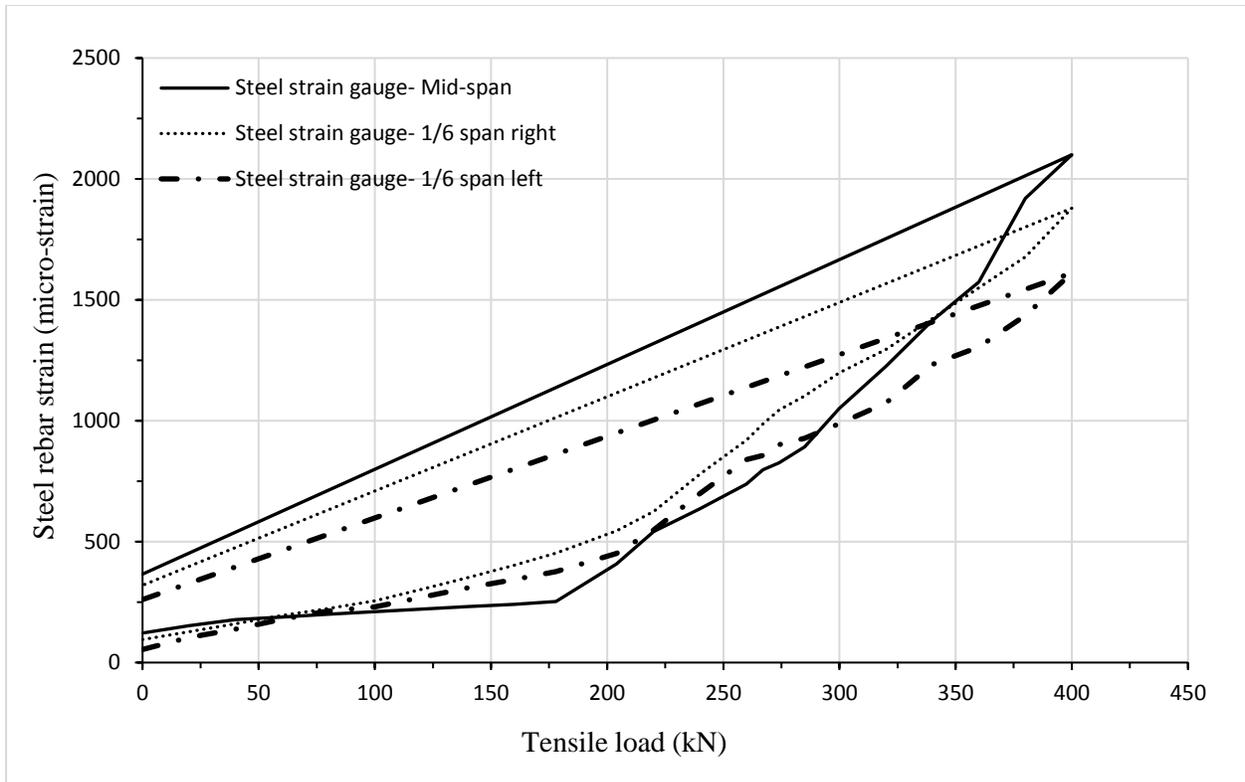
Figure 4-19: Tensile strain development in the rebar in GFRP repaired NC2 panel

Figure 4-19 presents tensile strain development in the rebar. Steel strain started from the residual values from the previous stage of loading. Tensile strain gradually increased in the rebar by applying the direct tensile loading on the specimen. At initial stages of loading, NC panel is cracked at mid-span and does not contribute in carrying the tensile load, while GFRP laminate is active in tension and cooperates in carrying the tensile load along with the rebar. Therefore, the tensile load is transferred from the rebar embedded in the NC panel to the GFRP laminate through the bond between the rebar and NC panel and bonding between the NC panel and GFRP laminate. However, at 1/6-span NC panel is uncracked and still capable of tolerating tensile load. By further applying the tensile load up to 400 kN, rebar tensile strain was increased.

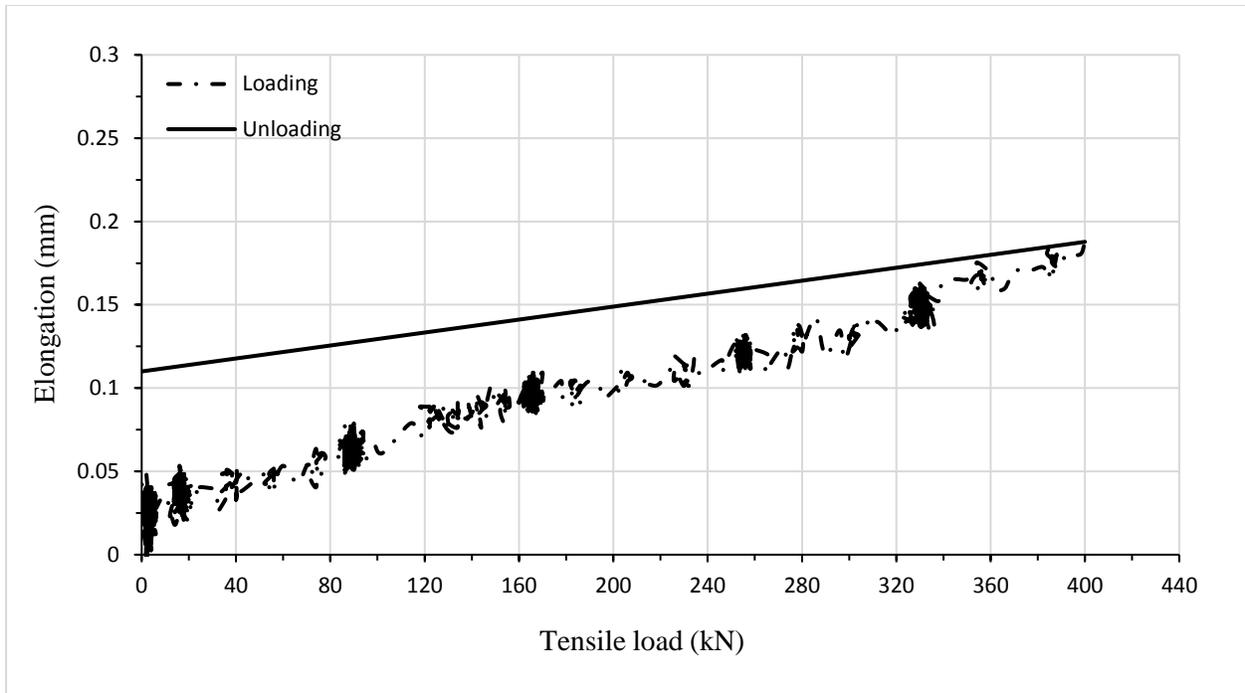
Figure 4-20: Tensile load versus horizontal displacement of the GFRP repaired NC2 specimen with respect to mid-span (crack location)

Figures 4-20 illustrates the load versus relative horizontal displacement of the NC panel with respect to the mid-span (crack location). The horizontal displacement of the specimen starts from zero and does not include the residual crack from previous steps of loadings (before repair). The horizontal displacement of the NC panel increased by widening of the crack in NC panel at mid-span due to incrementally increasing the tensile loading.

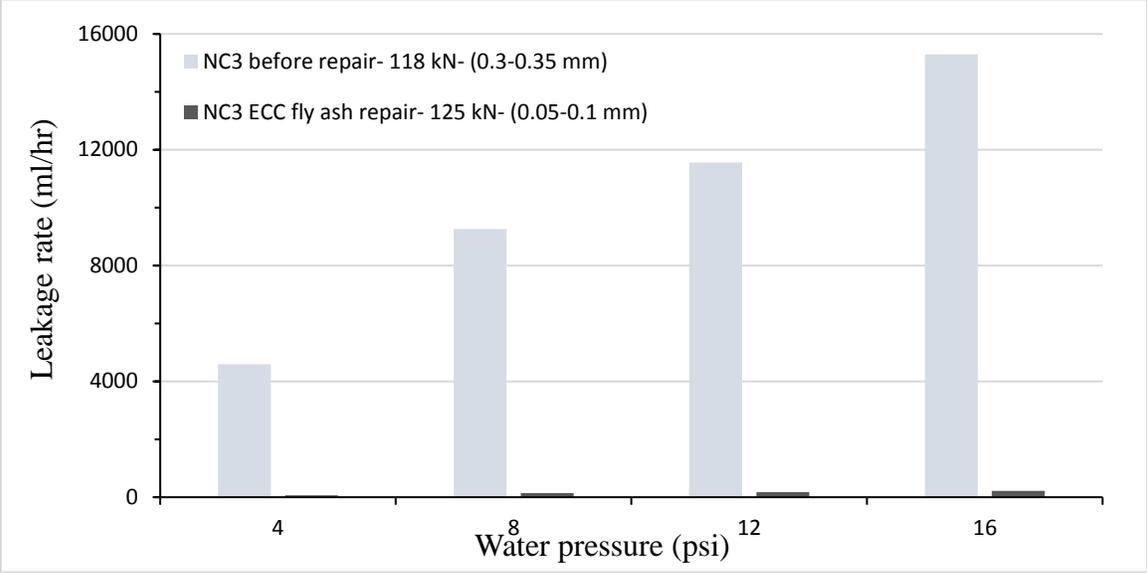
Figure 4-21: Comparison of the leakage behavior of NC3 before and after repair using ECC fly ash

At this stage of loading, the leakage rate was measured under different water pressures. Figure 4-21 presents the leakage rate in NC3 repaired with ECC fly ash at the loading stage of 125 kN under various water pressures of 4, 8, 12, and 16 psi and compares to the leakage rate under the same water pressures in NC3 before repair at the loading stage of 118 kN. A significant reduction in the leakage rate was observed after repairing the NC3 specimen with ECC fly ash even at a higher level of loading. To illustrate, leakage rate of the NC3 specimen recorded as 4589, 9262, 11556, and 15295 ml/hr before the repair under water pressures of 4, 8, 12, and 16 psi, respectively, while the leakage rate considerably decreased to the values of 67, 145, 179, and 215 ml/hr under 4, 8, 12, and 16 psi water pressures in NC1 repaired with ECC fly ash. Considerably lower leakage rate in NC3 panel repaired with ECC fly ash compared to NC3 panel before repair can be attributed to the formation of micro-cracks in ECC layer. Therefore, water should penetrate through the full depth of micro-cracks in ECC layer, passing through the bond between the ECC layer and NC panel, and travel the full depth of the NC panel to leak from the bottom face of the NC panel. This

mechanism potentially reduced the leakage rate of the NC3 repaired with ECC fly ash. Figure 4-22 illustrates low leakage rate of NC panel repaired using ECC fly ash.

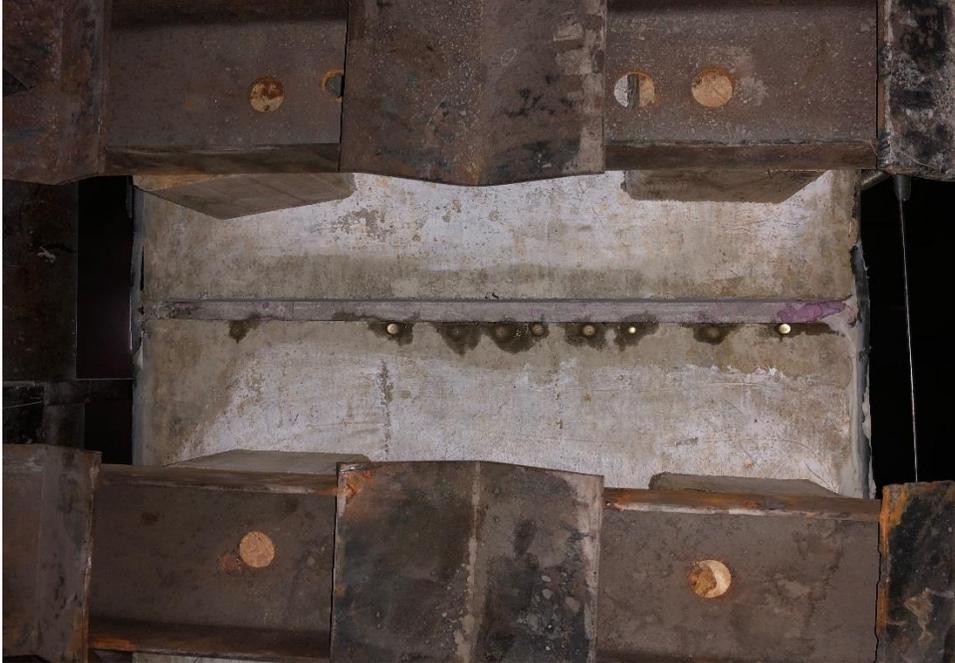
Figure 4-22: Leakage of the NC3 specimen repaired using ECC fly ash under 8 psi water pressure (bottom face)

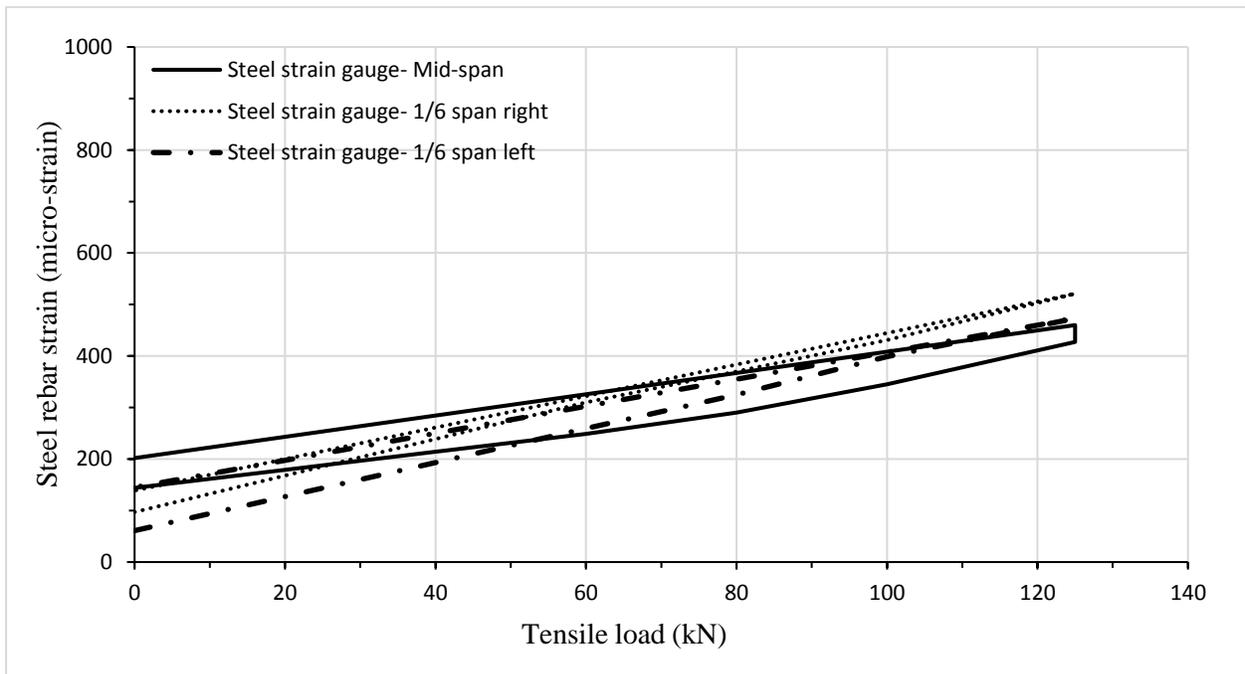
Figure 4-23: Tensile steel strain development in NC3 repaired using ECC fly ash

Tensile steel strain development in NC3 repaired with ECC fly ash is shown in Figure 4-23. Steel strain started from the residual strain in the rebar from previous stage of loading (before repair). Tensile strain gradually increased in the rebar by incrementally applying the direct tensile loading on the specimen. At this level of loading, NC panel is cracked at midspan and has no contribution in carrying the tensile load, while ECC repair layer is uncracked and cooperates in carrying the tension along with the rebar. Therefore, the tensile load is transferred from the rebar embedded in the NC panel to the ECC repair layer through the bond between the rebar and NC panel and the bonding between the NC panel and ECC repair layer. At 1/6-span, where two steel strain gauges are placed, both NC panel and ECC repair layer are uncracked and active in tension. Tensile strain in the rebar increased more rapidly by the formation of micro-cracks in ECC repair layer at mid-span.

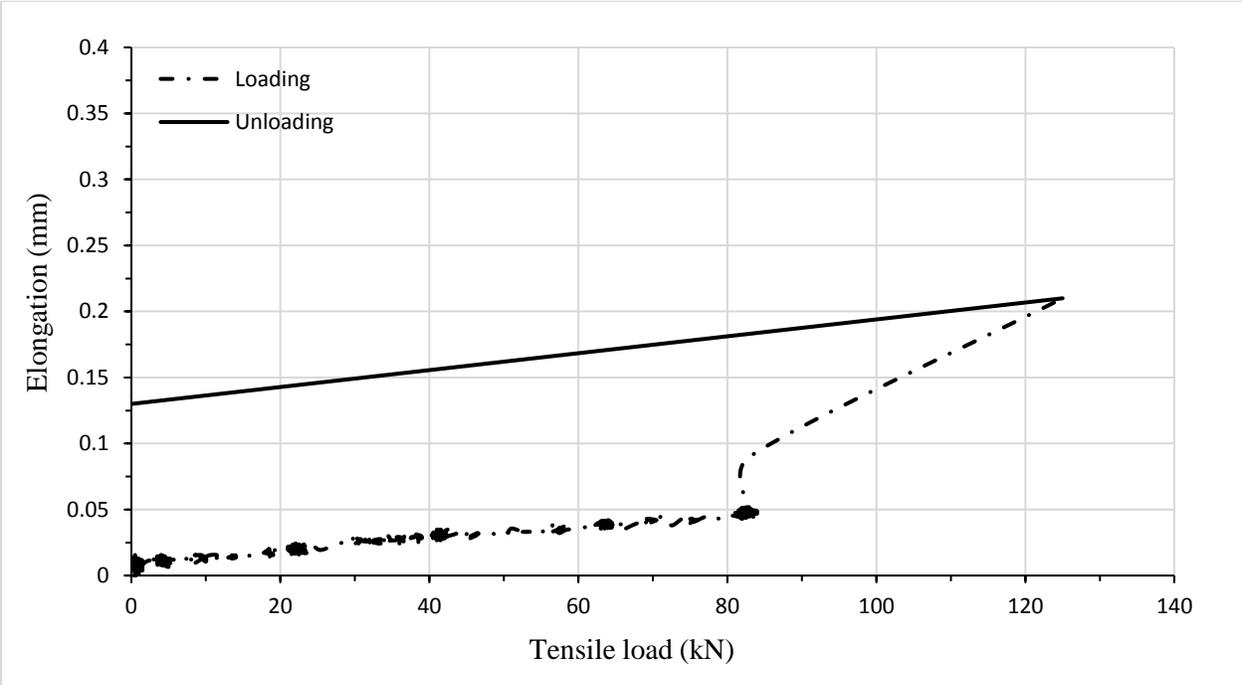
Figure 4-24: Tensile load versus relative horizontal displacement of the NC3 panel with respect to the mid-span (crack location)

Figures 4-24 illustrates the load versus relative horizontal displacement of the repaired NC3 panel with respect to the mid-span (crack location). As the LVDTs were attached to the ECC repair layer,

horizontal displacement started from zero, not including the residual crack width in NC3 panel from previous stage of loading. The horizontal displacement of the ECC layer increased by the formation of micro-cracks in ECC fly ash repair layer due to increasing the tensile loading. Gradual formation of micro-cracks in ECC layer with limited width of 0.05 to 0.1 mm resulted in horizontal displacement of 0.21 mm in ECC layer with respect to the mid-span.

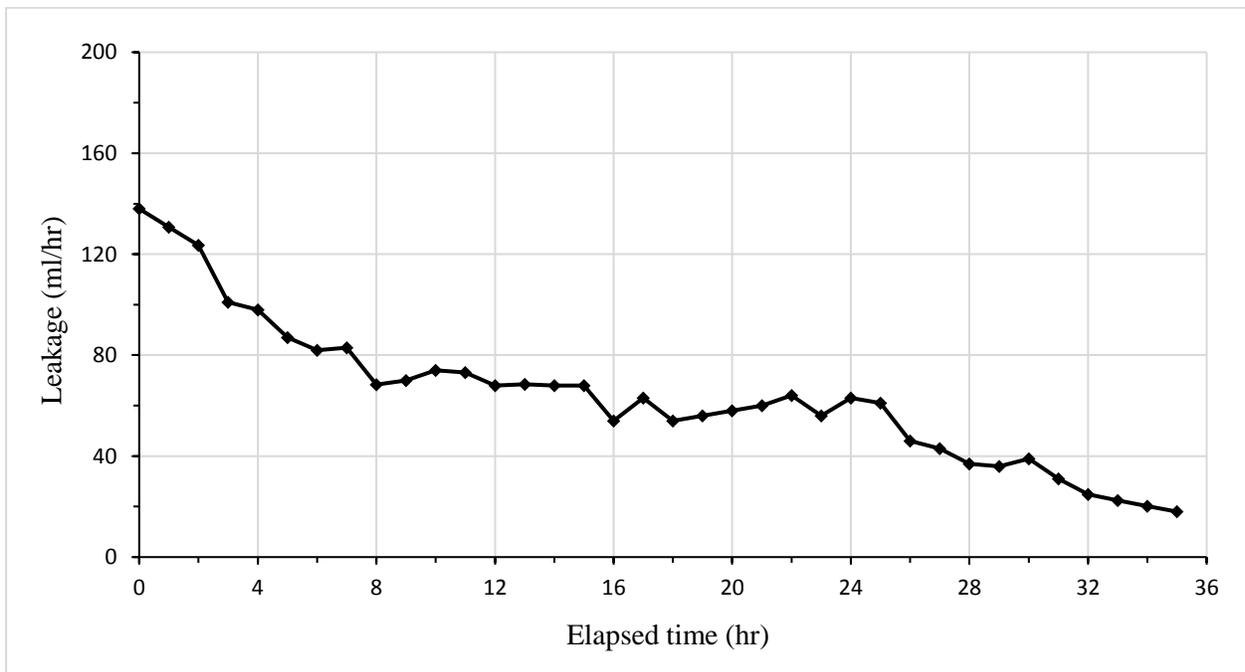
Figure 4-25: Short-term self-healing of NC3 panel repaired using ECC fly ash

After recording the leakage rate of the NC3 panel repaired with ECC fly ash, water pressure in the chamber was set to 7 psi to investigate the self-healing behavior of the 50 mm ECC repair layer on top of the NC panel under a constant load of 125 kN and fixed water pressure of 7 psi. For this purpose, leakage rate of the NC1 repaired with ECC fly ash was recorded continuously to achieve a constant leakage rate or to attain 100% self-healing of the tension cracks. As the time prolonged, tension induced crack started to heal and resulted in reducing the leakage rate. In short-term investigation of the self-healing, the amount of water penetrated through the full depth of the

tension cracks in ECC fly ash repair layer and NC panel and leaked from the bottom surface on the NC panel was measured over a one-hour time intervals. Short-term self-healing of the NC3 repaired with ECC fly ash during the first 35 hours is shown in Figure 4-25. The leakage rate reduced by 75% from 138 ml/hr to 35 ml/hr during the first 35 hours. A sharp drop was observed in leakage rate during the first 8 hours in which the leakage rate decreased by 50% from 138 ml/hr to 68 ml/hr. The rate of leakage reduction subsided as the time prolonged which is due to reduction in self-healing capacity of ECC repair layer and NC panel over time. This can be explained by the fact that there are less available cementitious materials over time to participate in self-healing of the concrete panels.

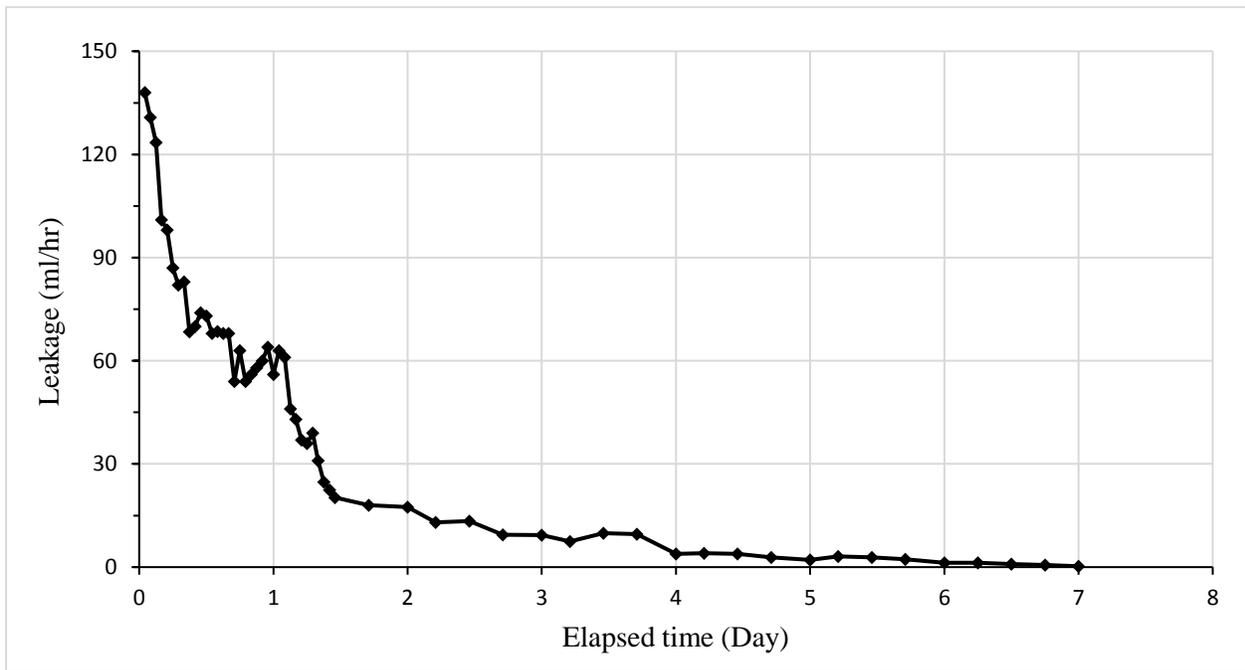
Figure 4-26: Long-term self-healing of NC3 panel repaired using ECC fly ash

Figure 4-26 illustrates the long-term self-healing of the NC3 repaired with ECC fly ash over the period of 7 days. During the first 35 hours, leakage was recorded continuously each hour, while during the period of time between 35 hours up to 7 days (168 hours), leakage rate was measured

for one hour in each 6 hours. Leakage rate in the NC3 repaired with ECC fly ash reduced to zero after 7 days of monitoring the leakage rate which indicates the water flow with pressure of 7 psi was completely blocked by the self-healing products. Blockage of the water flow could occur either in the ECC repair layer or in the interface between ECC repair layer and NC panel. Achieving the zero-leakage rate does not necessarily indicates 100% self-healing of the full depth crack in ECC repair layer and NC panel. It is worth-mentioning that obstruction created by self-healing products in partial depth of the section or in the interface of ECC repair layer and NC panel can prevent the leakage and make flow of water through the depth of the section impossible. Moreover, use of fly ash in ECC mix design as supplementary cementitious material resulted in smaller crack width along with higher self-healing capacity of the ECC fly ash repair layer compared to the ECC slag repair layer.

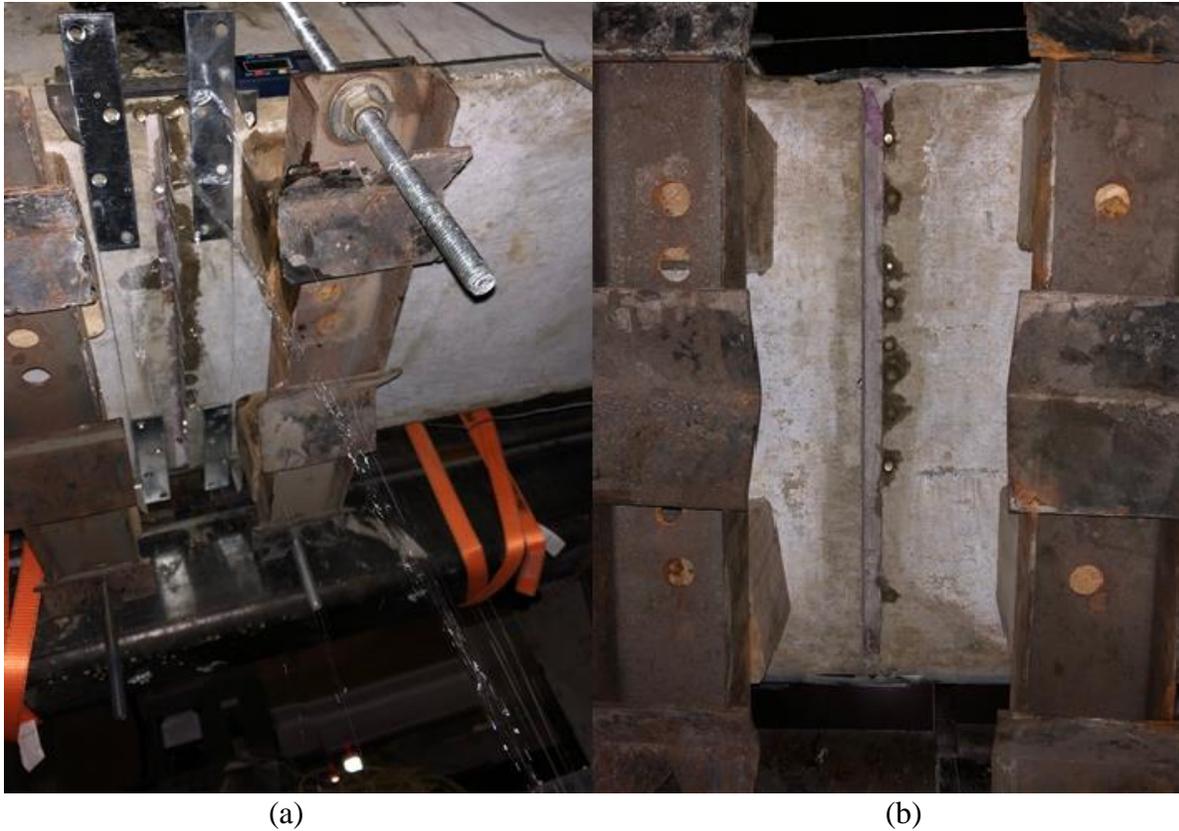
Figure 4-27: Leakage of the NC panel before and after repair using ECC fly ash a) Before repair  
b) After repair

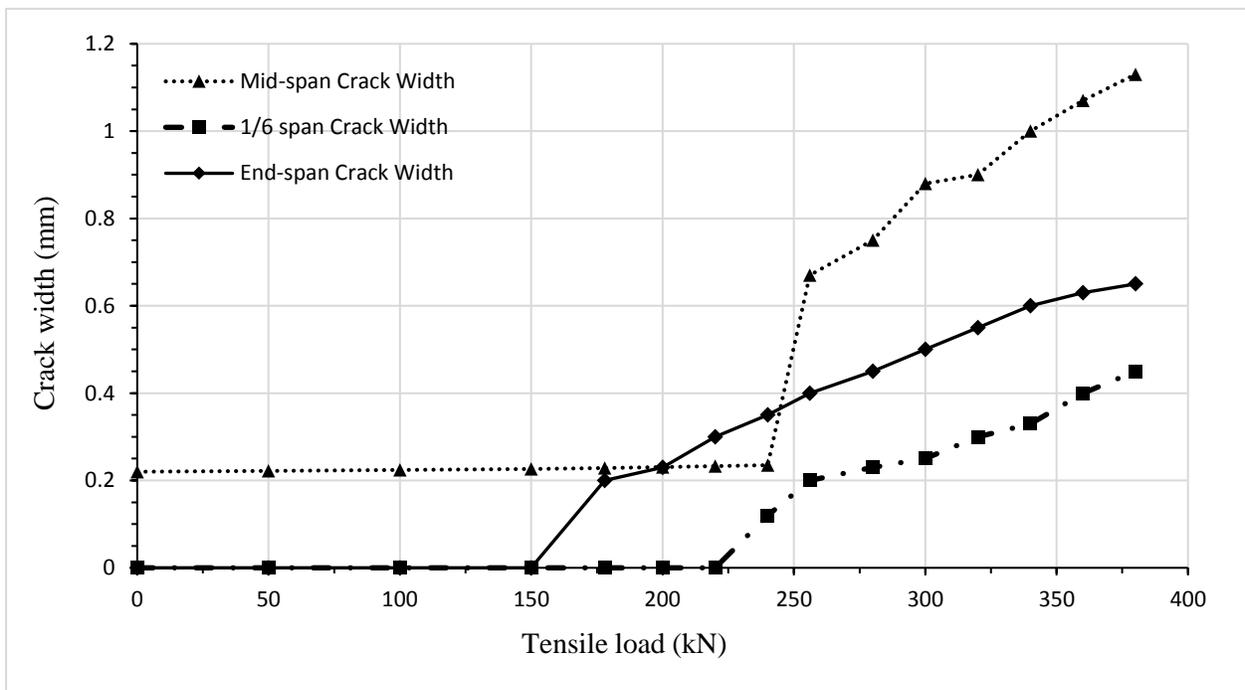
Figure 4-28: Tensile load and crack width of the NC4 specimen repaired using epoxy

It can be observed that the mid-span crack width increased from the residual crack width of 0.22 mm, from previous loading, to 1.1-1.15 mm at 380 kN. By incrementally increasing the tensile loading, at the loading stage of 178 kN, bond slip occurred between the rebar and concrete at both ends of the specimen simultaneously resulted in a crack as wide as 0.2 mm propagating toward top and bottom surfaces of the NC panel. At this stage of loading, no cracking occurred at 1/6-span and no significant change was observed at mid-span maintaining the same residual crack width of 0.22 mm. By further increasing the tensile load, developed cracks at both ends propagated along the longitudinal direction of the specimen toward mid-span. At loading stage of 240 kN, cracks propagated in transverse direction (extended to the entire width) causing cracks as wide as 0.1-0.15 mm at distance of 240 mm from the north end and 265 mm from the south end of the specimen (almost at 1/6 of the span). At this stage of loading, epoxy was still capable of carrying the tensile

load resulted in keeping the mid-span crack at almost residual value of 0.22 to 0.23 mm, while crack widths at end-span reached 0.35 mm. It is interesting to note that up to this stage of loading, no failure was observed in epoxy at crack location and epoxy was still active in tension, carrying the tensile load, and preventing crack width growth and leakage initiation. Finally, by enhancing the tensile load to 256 kN, epoxy failure occurred. Due to brittle nature of the epoxy, crack width substantially increased to the value of 0.65-0.7 mm followed by a high rate of leakage at mid-span. At this stage of loading, crack widths at 1/6-span and end-span were 0.2 mm and 0.4-0.45 mm, respectively. Further increase in tensile load resulted in widening the crack at mid-span, 1/6-span, and end-span. Loading of the specimen stopped at loading stage of 380 kN due to safety reasons, as the tensile strain in the rebar exceeded the yielding strain. Crack width at mid-span, 1/6-span, and end-span reached 1.1-1.15 mm, 0.45 mm, and 0.65 mm, respectively, at tensile load of 380 kN.

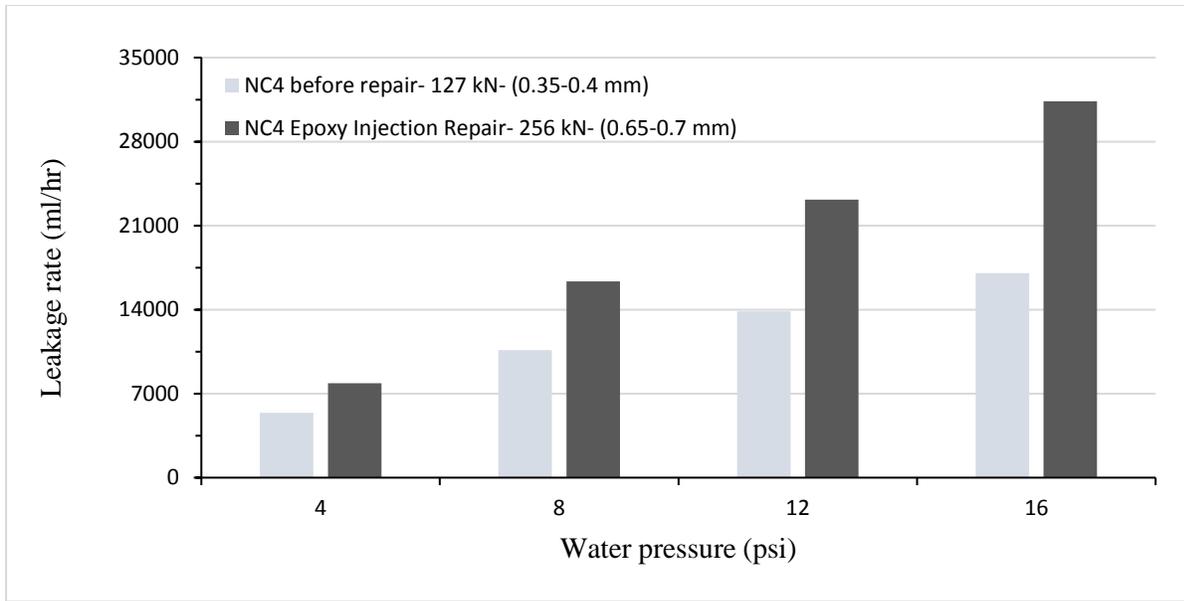
Figure 4-29: Comparison of the leakage behavior of NC4 before and after repair using epoxy

At this stage of loading, the leakage rate was measured under different water pressures. Figure 4-29 shows the leakage rate in NC4 panel repaired using epoxy at the loading stage of 256 kN under various water pressures of 4, 8, 12, and 16 psi and compares to the leakage rate under the same water pressures in NC4 Panel before repair at the loading stage of 127 kN. A higher leakage rate was observed in NC4 panel repaired with epoxy compared to NC4 panel before repair. This can be explained by the higher tensile load and crack width at which leakage rate was measured in epoxy repaired NC panel in comparison to NC panel before. It is evident that epoxy exhibited considerable bond strength and tensile strength and successfully increased the load bearing capacity of the NC panel under direct tensile loading. However, due to brittle nature of the epoxy, failure of the epoxy, which occurred at high levels of tensile load, resulted in a large crack width followed by a high leakage rate. To illustrate, the leakage of the NC4 panel before repair was measured at 5404, 10614, 13872, and 17038 ml/hr under water pressures of 4, 8, 12, and 16 Psi at tensile loading of 127 kN along with mid-span crack width of 0.35-0.4 mm. However, higher leakage rate of 7864, 16354, 23155, and 31357 ml/hr was recorded under the same water pressures at loading stage of 256 kN along with crack width of 0.65-0.7 mm at mid-span crack. It is worth-mentioning that higher leakage rate recorded after failure NC panel repaired with epoxy at 256 kN compared to NC panel before repair leakage rate at 127 kN does not necessarily mean that epoxy was unable to improve the leakage behavior of the NC panel, as the leakage rate of the epoxy repaired NC panel was recorded at considerably higher level of loading and crack width. Figure 4-30 shows the failure of the epoxy at mid-span crack followed by a high rate of leakage.

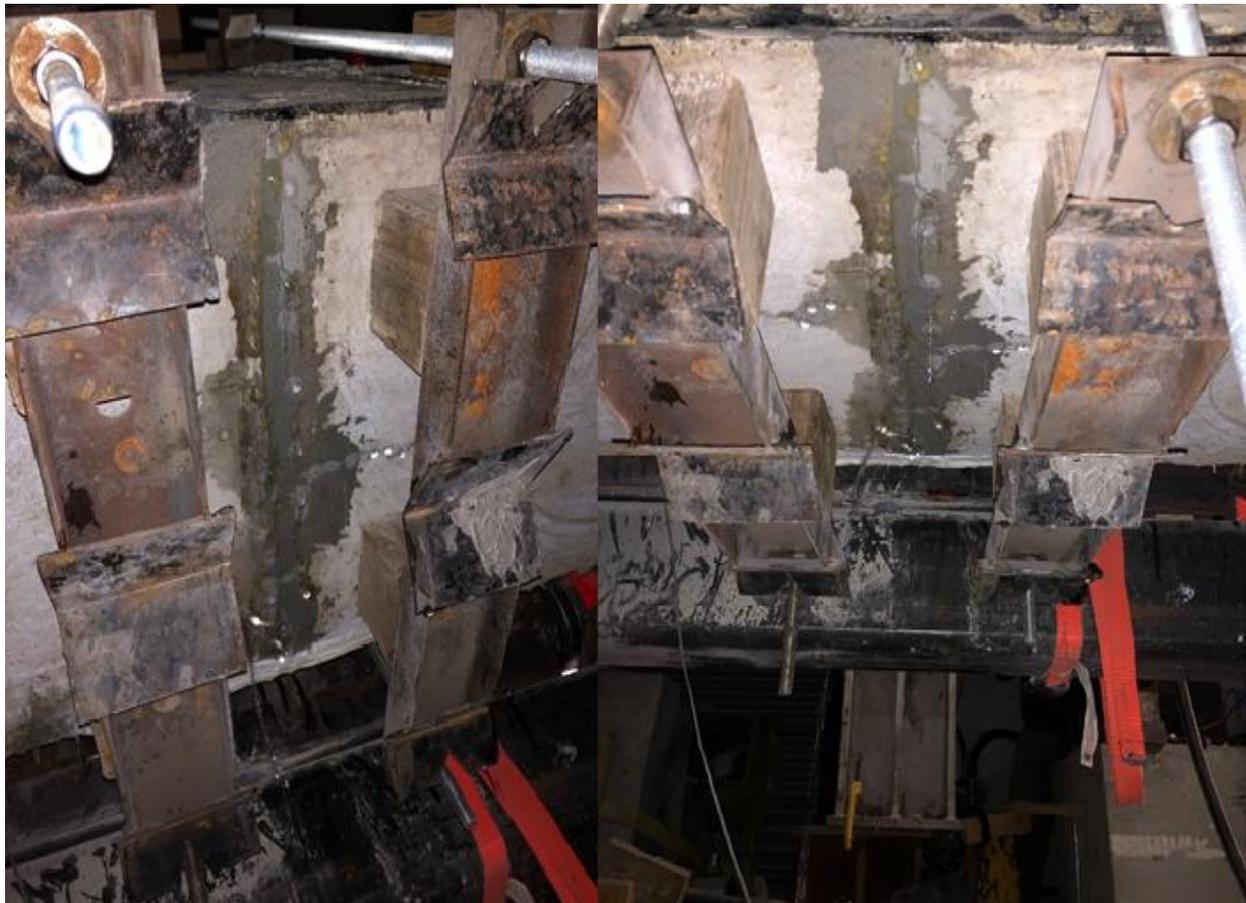
Figure 4-30: Brittle failure of the epoxy at crack location (mid-span) and high leakage rate

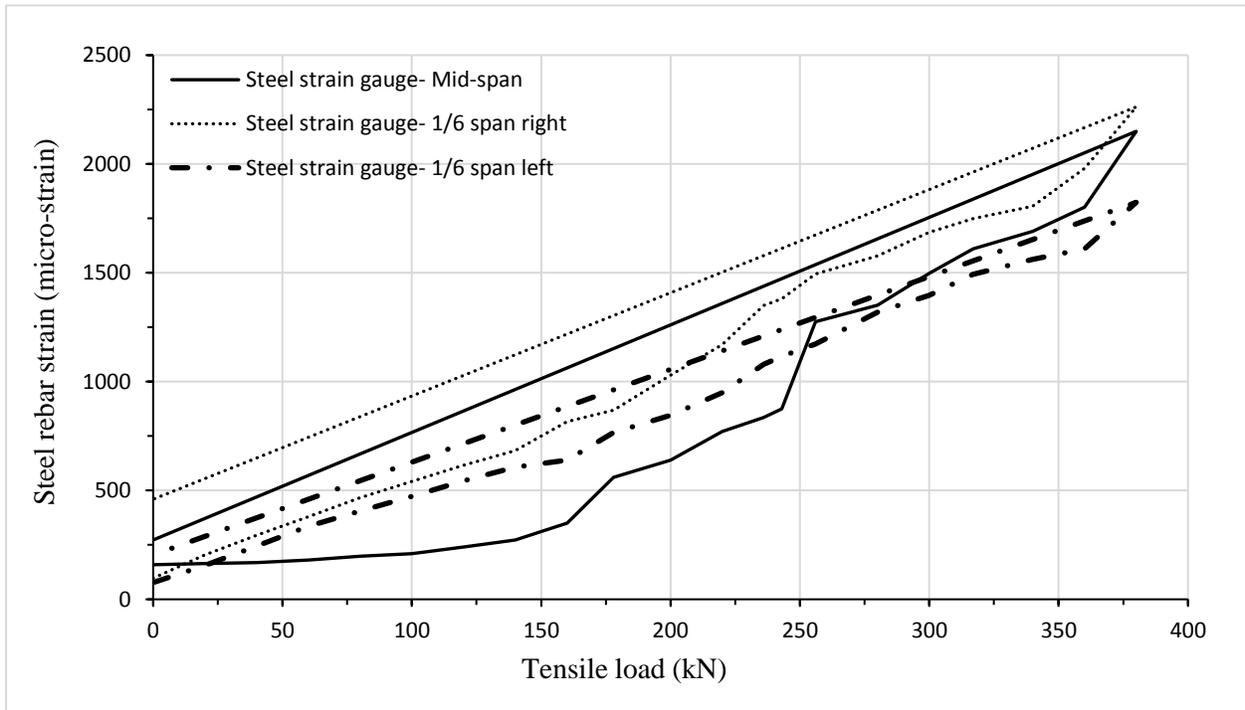
Figure 4-31- Tensile steel strain development in NC4 panel repaired using high-strength epoxy

Figure 4-31 illustrates the tensile steel strain development in NC3 repaired with high-strength epoxy. Steel strain started from the residual strain in the rebar from previous stage of loading (before repair). Gradual increasing of the tensile strain in the rebar was observed by incrementally applying the direct tensile loading on the specimen. At initial levels of loading, epoxy is active in tension and contributes in carrying the tensile load. Therefore, tensile loading is transferred to the epoxy through the bond between the rebar and NC panel. Tensile strain in the rebar at mid-span experienced a sharp increase at loading stage of 256 kN, at which failure of the high-strength epoxy occurred. At this level of loading, epoxy is no longer capable of carrying the tensile load and the

whole tensile is tolerated by the rebar. Sudden increase in the tensile strain of the rebar at load of 256 kN can be attributed to the brittle failure of the epoxy at mid-span crack.

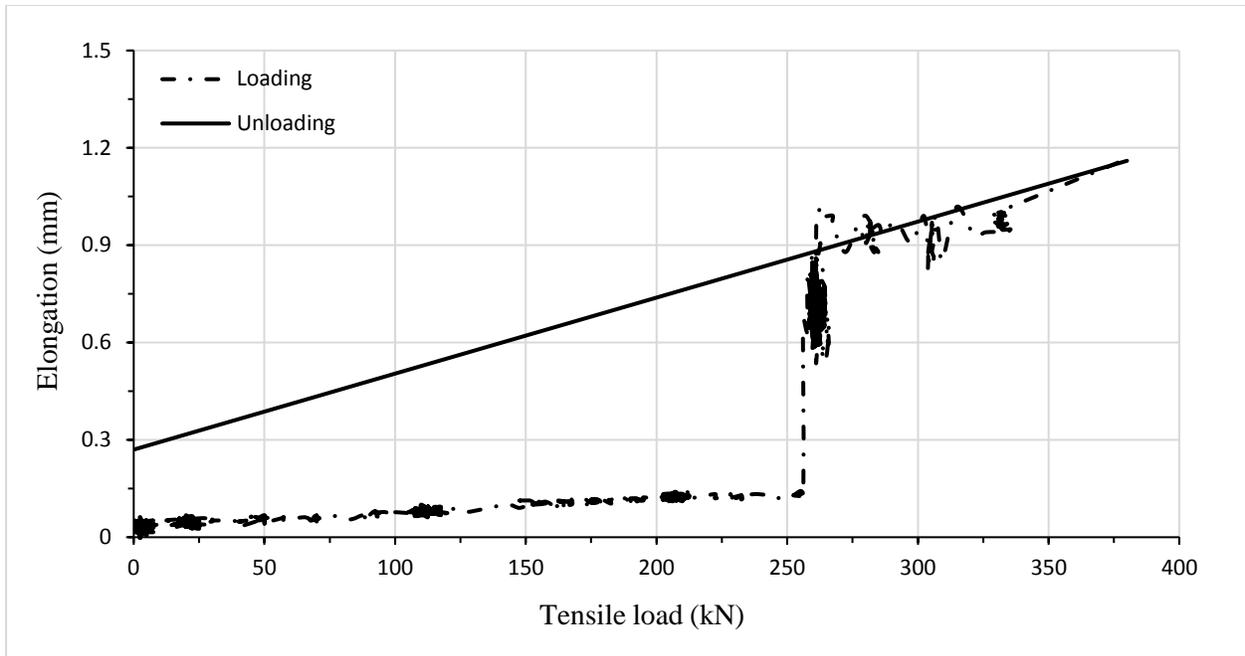
Figure 4-32: Tensile load versus relative horizontal displacement of the NC4 panel with respect to the mid-span (crack location)

Tensile load versus relative horizontal displacement of the NC4 panel with respect to the mid-span (crack location) is shown in Figure 4-32. The horizontal displacement of the specimen starts from

zero and does not include the residual crack from previous steps of loadings (before repair). The horizontal displacement of the NC4 panel increased slowly by increasing the tensile loading applied on the specimen, followed by sudden sharp increase at tensile loading level of 256 kN due to brittle failure of the epoxy and substantial widening of the mid-span crack.

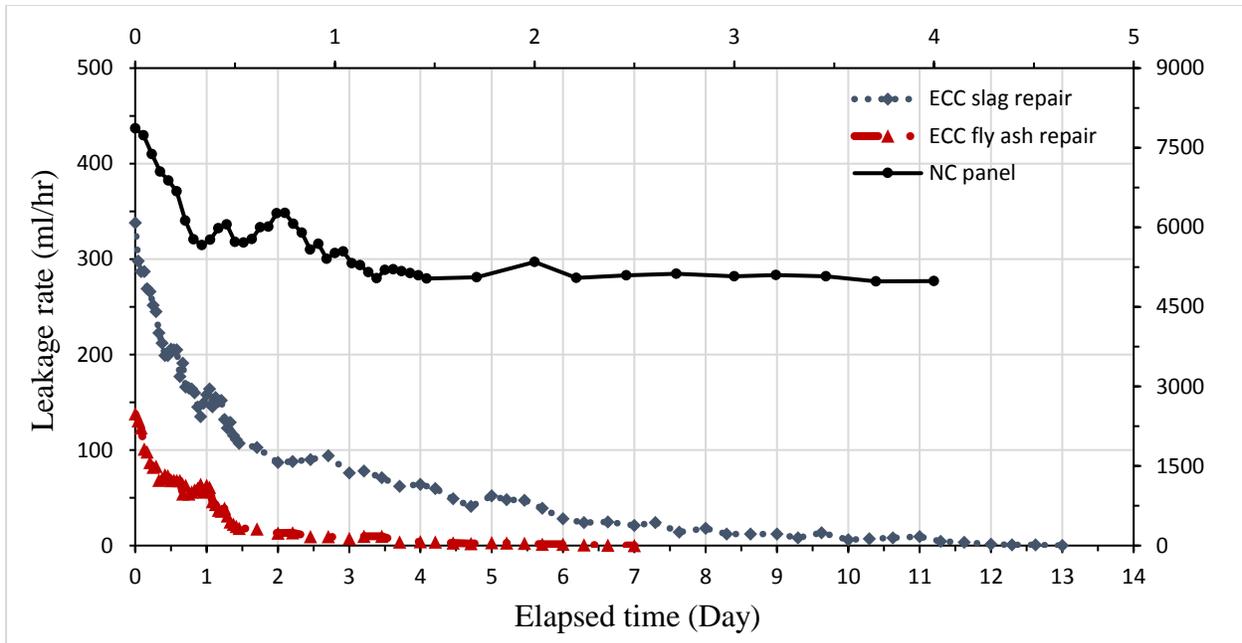
Figure 4-33: Comparison of the self-healing behavior of the NC panel before and after repair using ECC slag and ECC fly ash

Figure 4-33 summarizes and compares the self-healing behavior of the NC panels before and after repair using ECC slag and ECC fly ash. Self-healing behavior of the panels was investigated through measuring the leakage rate of the panel under sustained tensile loading and constant water pressure of 7 psi. As the time prolonged, tension induced crack started to heal and resulted in reducing the leakage rate. NC panel experienced a sharp drop in the leakage rate during the first 8 hours. Leakage rate of the NC panel before repair decreased from 7867 ml/hr to 4983 ml/hr by 37% after 4 days (as shown on secondary axes in Figure 4-33). However, no significant change in the leakage rate occurred after 35 hours. This can be explained by the fact that there are more available un-reacted cementitious materials during the first few hours to hydrate and block the water pathway through the crack by self-healing products. Therefore, self-healing rate decays over time.

reduction subsided as the time prolonged which is due to reduction in self-healing capacity of ECC repair layer and NC panel over time. This can be explained by the fact that there are less available cementitious materials over time to participate in self-healing of the concrete panels. Leakage rate of the ECC slag repaired panel reduced to zero after 13 days of monitoring the leakage rate which indicates the water flow with pressure of 7 psi was completely blocked by the self-healing products. Blockage of the water flow could occur either in the ECC repair layer or in the interface between ECC repair layer and NC panel.

The leakage rate of the NC panel repaired with ECC fly ash reduced by 75% from 138 ml/hr to 35 ml/hr during the first 35 hours. A sharp drop was observed in leakage rate during the first 8 hours in which the leakage rate decreased by 50% from 138 ml/hr to 68 ml/hr. The rate of leakage reduction dwindled as the time prolonged which is due to reduction in self-healing capacity of ECC repair layer and NC panel over time. This may attribute to less available cementitious materials over time to take part in self-healing of the concrete panels. Leakage rate in the NC panel repaired with ECC fly ash reduced to zero after 7 days of monitoring the leakage rate which indicates the water flow with pressure of 7 psi was completely blocked by the self-healing products. Blockage of the water flow could occur either in the ECC repair layer or in the interface between ECC repair layer and NC panel.

Comparison between self-healing behavior of the NC panel and ECC slag and ECC fly ash repaired panels reveals superior self-healing ability of the ECC compared to NC panel. Repair of NC panel with 50 mm thick layer of ECC significantly improved self-healing behavior of the panel. High self-healing potential of the ECC can be attributed to the availability of high volumes of unreacted cementitious materials as well as its multiple micro-cracking behavior. Multiple micro-cracking behavior by developing cracks as small as 0.1 mm in ECC results in an initial leakage rate significantly lower than NC panel as well as higher possibility of sealing the crack by self-healing products resulted from hydration of unreacted cementitious materials. Use of fly ash in ECC as supplementary cementitious material resulted in smaller crack width along with higher self-healing capacity of the ECC fly ash repair layer compared to the ECC slag repair layer.
