# **Experimental investigation on repair and self-healing of tension-induced cracks in reinforced concrete panels**

A Thesis

presented to Ryerson University

in partial fulfillment of the requirements for the degree of  
Master of Applied Science in the program of Civil Engineering

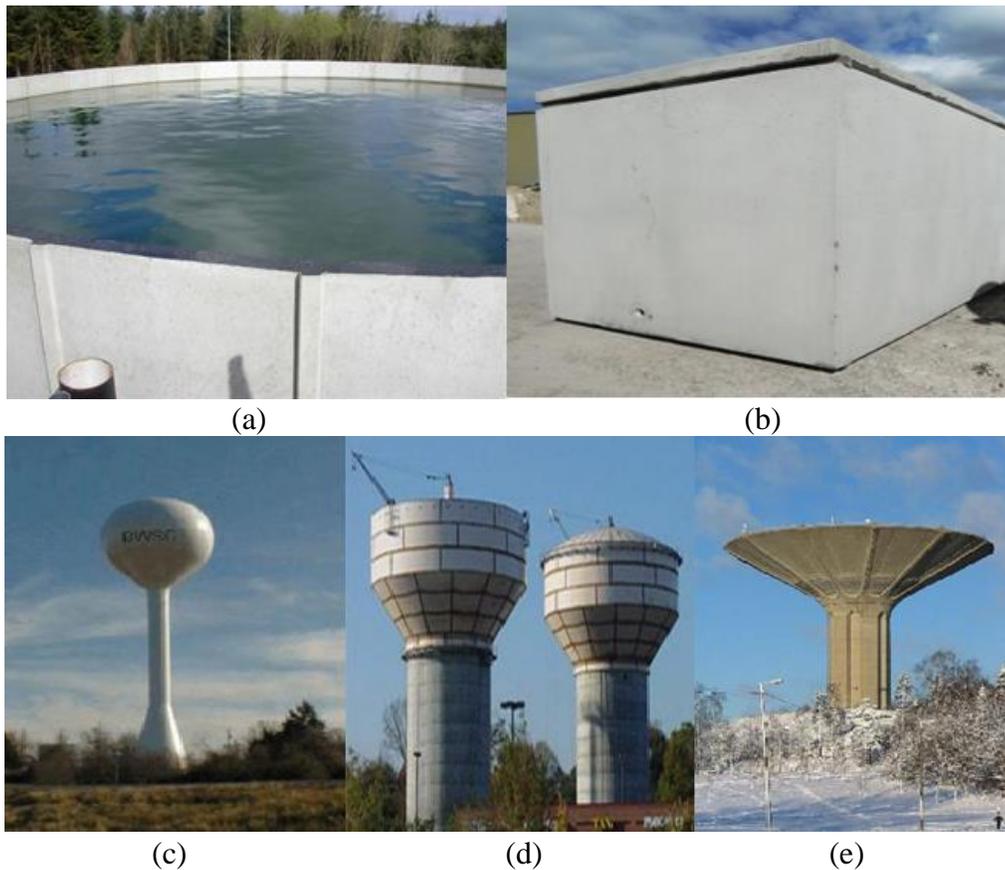
Figure 4-34: Different shapes of the tanks: a) Circular b) Rectangular c) Spherical d) Intze e) Circular with conical bottom

RC tanks are constructed to store water, liquid petroleum, and other liquids. Design of RC tanks are generally performed based on placement condition and shape of the tank. Tanks are usually made in different shapes including circular, rectangular, spherical, intze, and circular tanks with conical bottom. Circular tanks have the lowest surface area in comparison with other shapes for a specific capacity of the tank, resulting in use of less materials for construction of circular tanks. However, fabrication of form-work for circular tanks is more challenging and expensive compared to other tank shapes. In terms of placement condition, RC tanks can be divided to underground tanks, tanks resting on the ground, and overhead tanks. Classification of the tanks based on tank shape and location is shown in Figures 4-34 and 4-35.

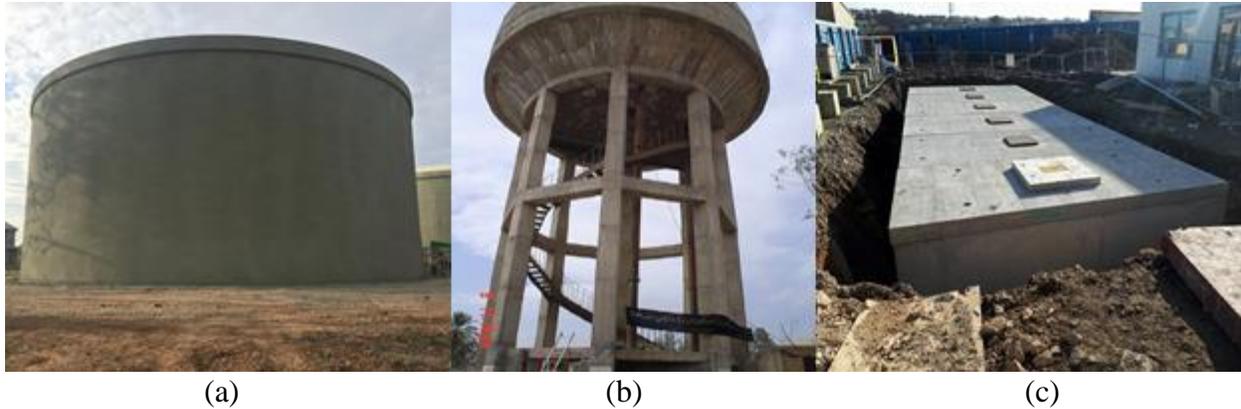
Figure 4-35: Classification of the tanks based on placement condition: a) Resting on the ground  
b) Elevated c) Underground

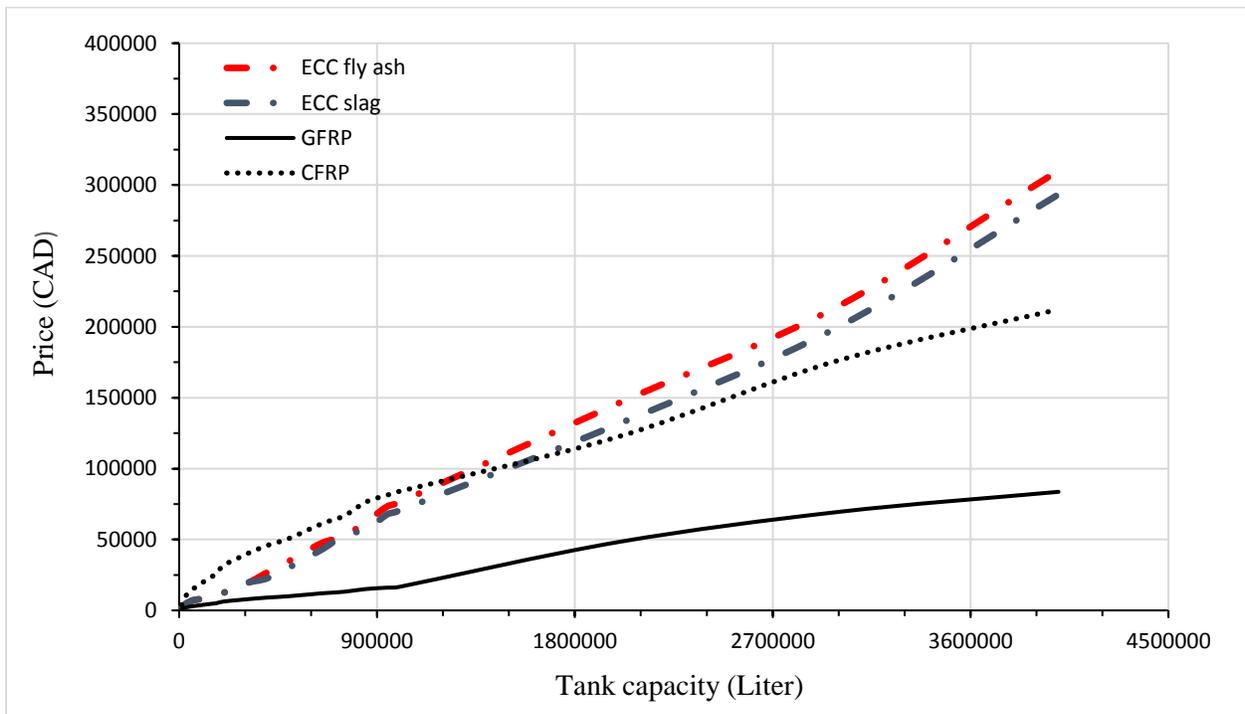
Figure 4-36: Total cost of repair for commercial and industrial tanks (up to 4,000,000 Liter)

Figures 4.36 illustrates the total cost of repairing the commercial and industrial RC tanks with capacity up to 4,000,000 Liter. It can be observed that the repair cost of all materials increased continuously by enlarging the tanks. GFRP laminate exhibited the lowest price among all repair materials in repairing RC tanks with capacities up to 4,000,000 Liter. ECC fly ash and ECC slag showed almost the same cost of repair due to similar quantity required for the repair and similar mix design. For the tank capacities up to almost 1,500,000 Liter, repairing the tank using CFRP laminate showed the highest price, while for the tank capacity greater than 1,500,000 Liter, ECC overlay system exhibited the highest price. The total price of repairing a RC tank with capacity of 1,000,000 using ECC fly ash, ECC slag, GFRP laminate, and CFRP laminate was 76057, 70295, 16551, and 83897 CAD, respectively. However, by enlarging the tank to a capacity of 4,000,000 Liter, the total cost of repair by incorporating ECC fly ash, ECC slag, GFRP laminate, and CFRP laminate were 310069, 293373, 83642, and 21262 CAD, respectively.

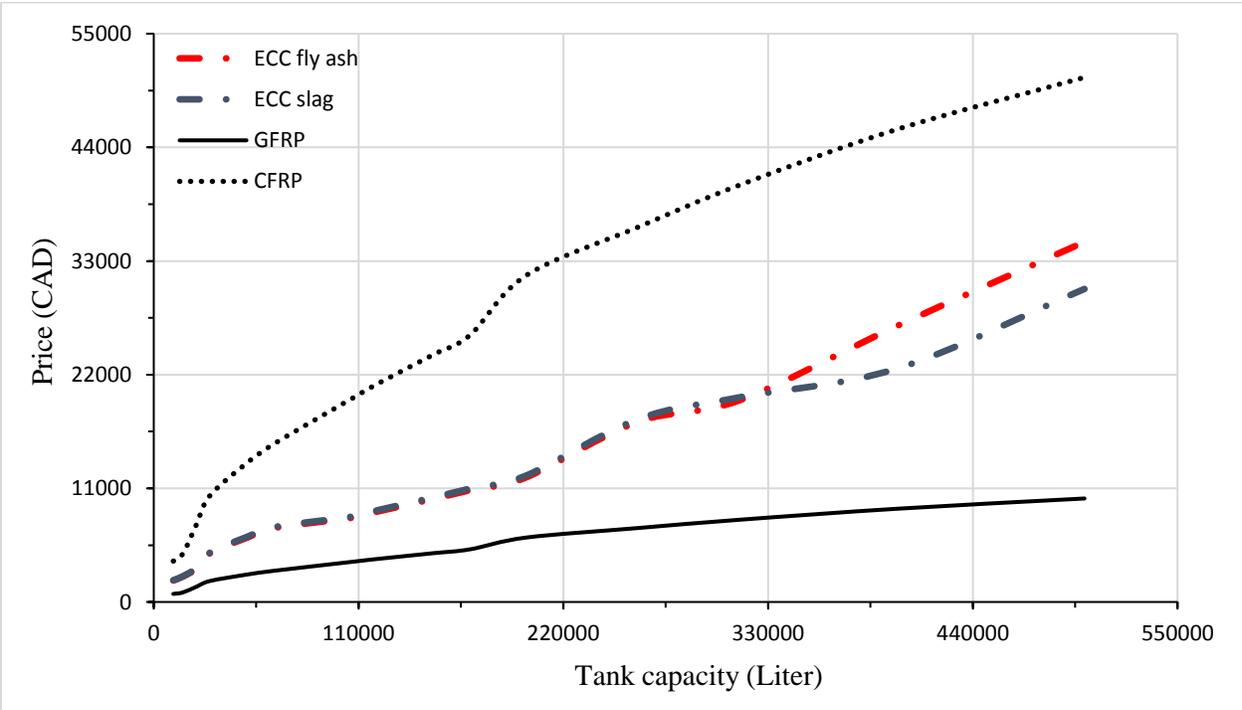
Figure 4-37: Total cost of repair for residential tanks (up to 500,000 Liter)

Figure 4-37 shows the repair cost of residential RC tanks with capacity up to 500,000 Liter. It can be observed that ECC fly ash and ECC slag showed almost the same price in repairing the RC tanks. Moreover, repairing the tank with CFRP laminate exhibited the highest price, while GFRP laminate showed the lowest price in repairing residential tanks with capacity up to 500,000 Liter compared to other repair materials. For example, the total price of repairing a RC tank with capacity of 500,000 Liter using ECC fly ash, ECC slag, GFRP laminate, and CFRP laminate were 34849, 30298, 10016, and 50774 CAD, respectively.
